Ivy Farm Baldock Road Royston Hertfordshire

Historic Buildings Recording

OA East Report No: 1226

Historic Building Survey

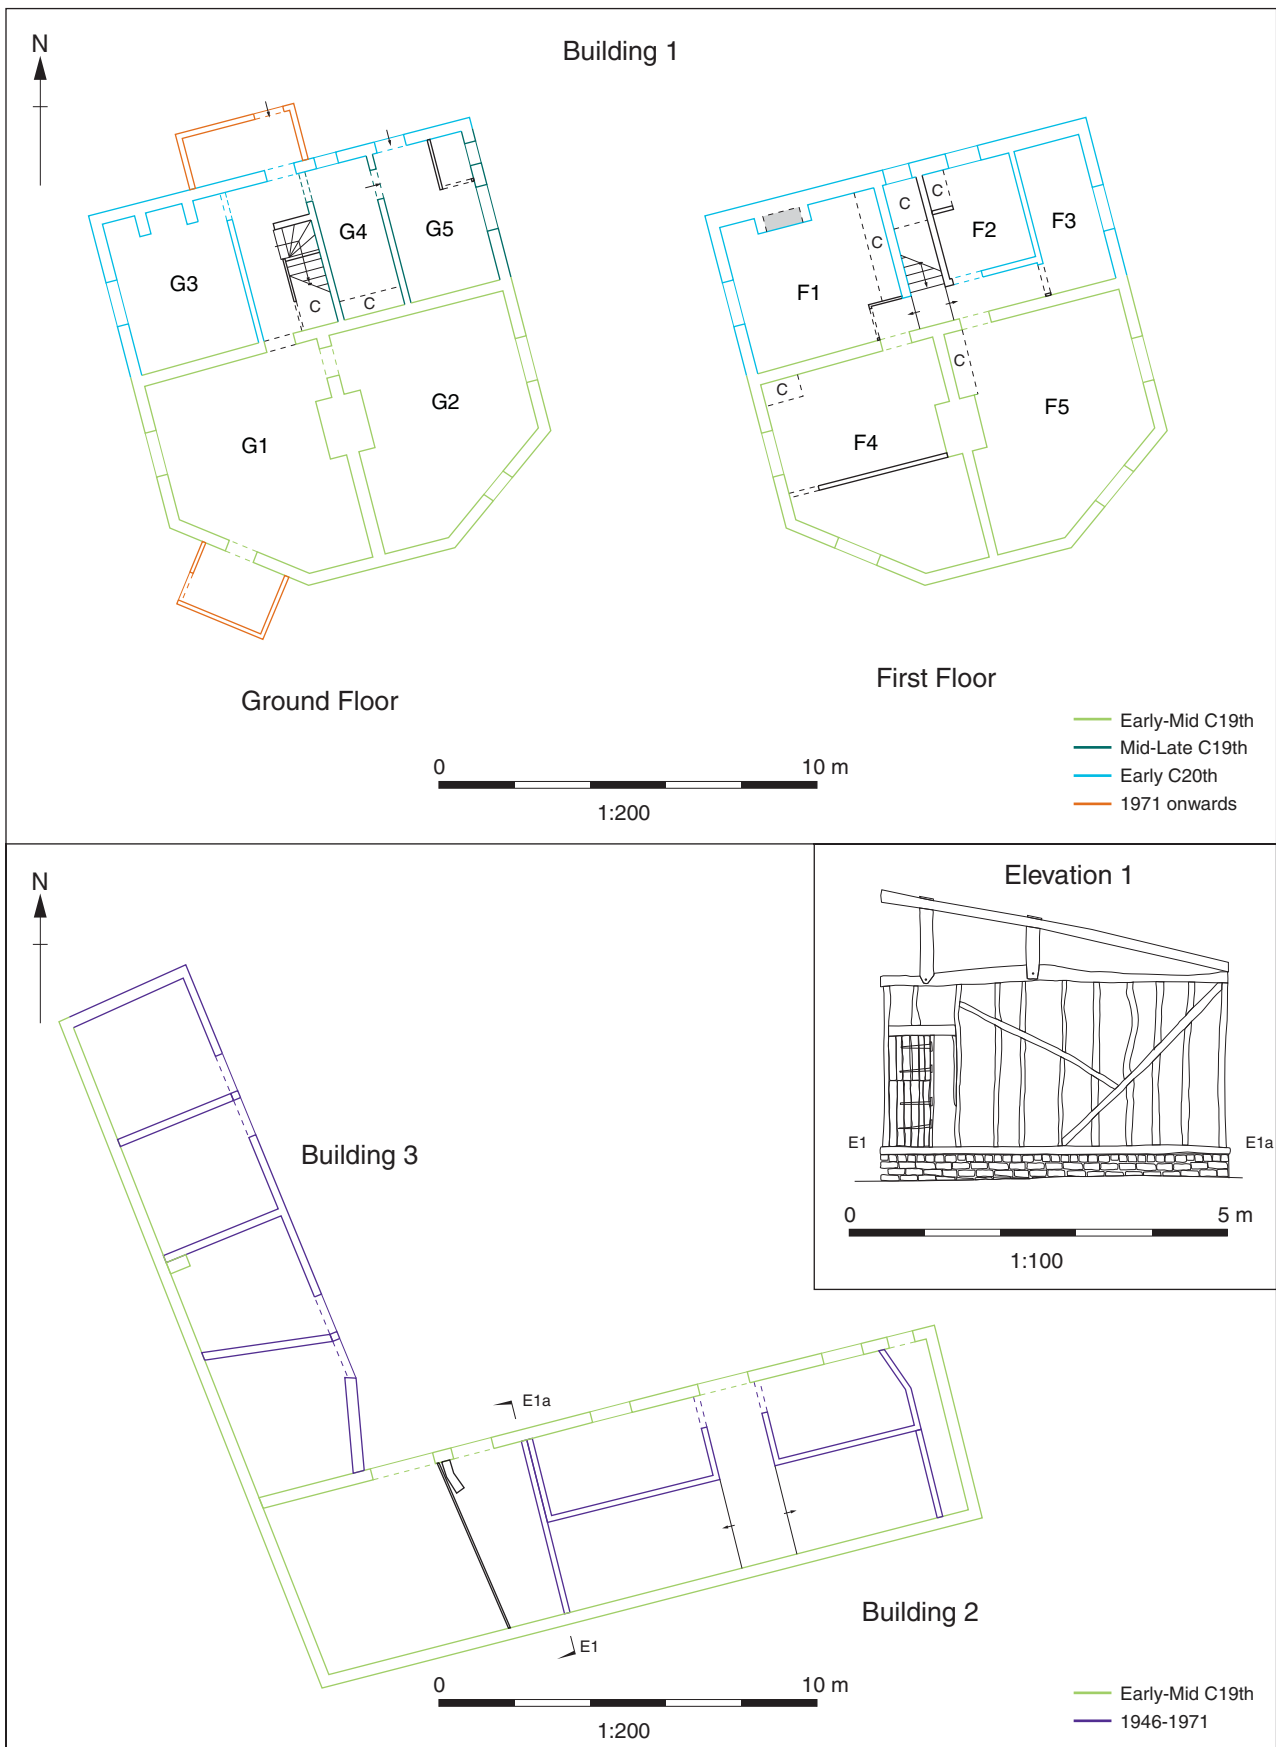
Figure 11: Building 1, ground and first floor plans

- 3.1.7 The ground floor has four rooms (Figure 11): two reception rooms (G1 and G2), kitchen (G3) utility room (G4) and bathroom (G5). There are three entrances to the house; a door on the south elevation (which opens into G1) and two doors on the rear, north-facing elevation which open into the hallway and into G5. There is a double-back fireplace which serves G1 and G2; both had replacement fireplaces and surrounds (plates 7 and 8). There is also evidence of a range in the kitchen (G3), although the iron range itself is no longer present (plate 9). To the immediate left of the rear entrance to the house is a step down into a store/larder area (G4). The walls in this room are painted yellow and there is an original built-in storage cupboard at the end of the room (plate 10). A further step down, through another door leads into another room (G5), again with bare, painted brick walls. A toilet has been added into the corner of this room, screened off by modern, thin partition boards. The wall on the southern side of this room however, is not brick and appeared from a small amount of investigation behind the skirting board, to be constructed of flint and rendered with cement. It was also noted that the wall separating G1 and G2 from G3-6 was thicker than all of the other walls, measuring approximately 30cm in thickness.

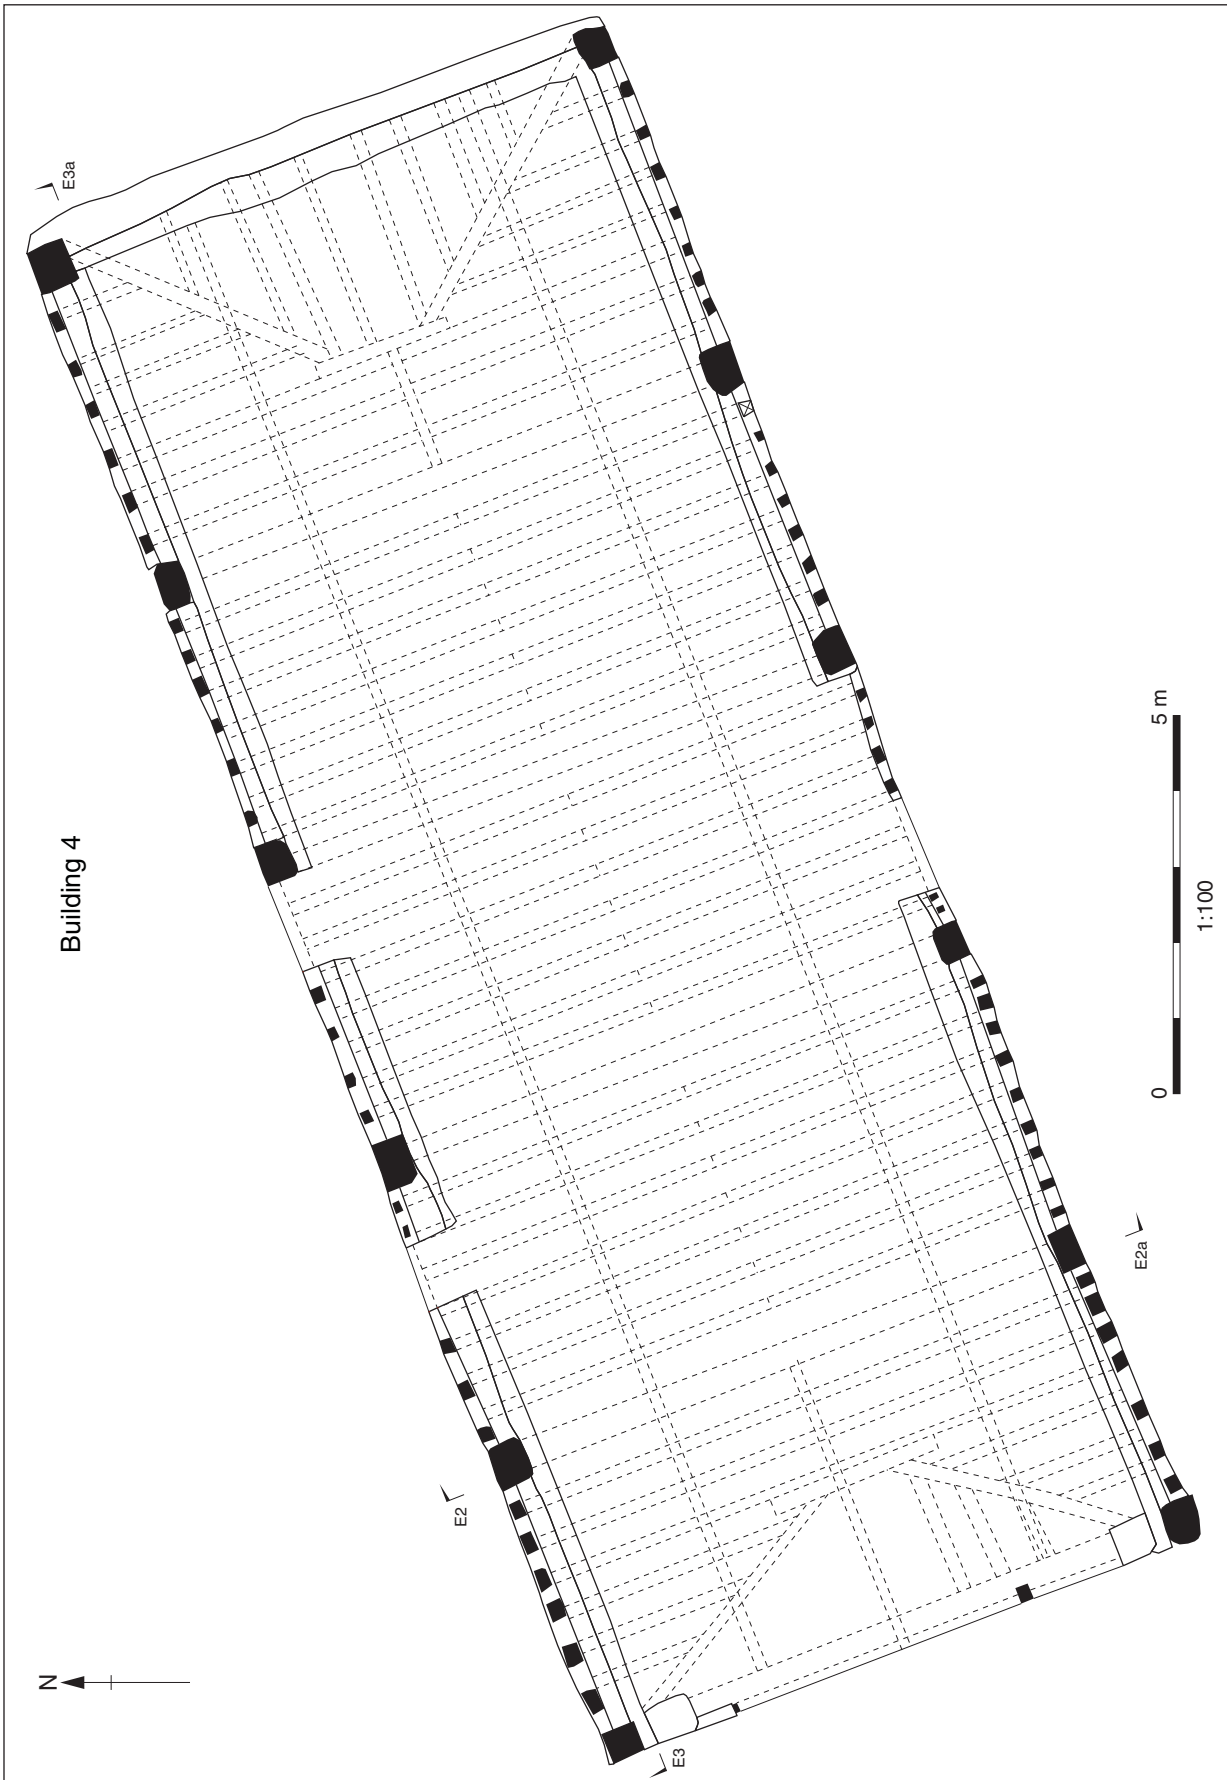
Figure 12: Building 4, floor plan

3.4.6 The structure comprises 6 timber frames defining five open bays (Figure 12 and plates 21 and 22). The end frames are without trusses having originally been hipped but later altered (retained rafters) to accommodate flat gables. The frame is set upon a flint plinth with localised replacement with brick and blockwork and some sections of lime render. A typical frame comprises opposing posts on sole plates with a large tie beam clasp the wall plate (Figure 13, elevation 2). The posts are braced to the tie beam. The upper frame is of principal (slender) rafters supported on a single clasped purlin set upon collars, in turn supported by slender (mostly replaced) raked struts. The roof does not include a ridge plate and all members appeared to have been pegged from the west side. In addition to the sole and wall plate the intermediate structure comprises a mid rail with regular upper and lower studs.

Frame 1	Original post and tie beam
Frame 2	Most complete. Includes original posts, braces, tie beam. Later queen struts.
Frame 3	North and south posts reinforced. Empty mortises to soffit of tie beam suggest re-used timber. Brace on south side includes a carpenter's mark unrelated to adjacent structure, again suggesting reused elements
Frame 4	Re-used post, tie beam and braces (braces not received in mortice on posts). North post reinforced. redundant mortises to tie-beam soffit.
Frame 5	Replaced tie-beam, missing queen strut and collar, reinforced north and south posts.
Frame 6	Original posts, tie-beam and former hipped roof rafters

North wall	
Frame 1-2	original mid rail and studs, brick plinth
Frame 2-3	original mid rail and studs, truncated for inserted pedestrian door
Frame 3-4	original mid rail and studs, flint plinth with render
Frame 4-5	original mid rail and studs, brick plinth
Frame 5-6	original mid rail and studs, brick and flint plinth
South wall (Figure 13, elevation 3)	
Frame 1-2	original mid rail, localised stud replacement. Brick and flint plinth
Frame 2-3	original mid rail and upper studs, replaced lower studs. Brick and flint plinth
Frame 3-4	all replacement timber, no plinth (location of former entrance)
Frame 4-5	original mid rail and upper studs, replacement lower studs. modern brick plinth
Frame 5-6	original mid rail, localised stud replacement. Brick and flint plinth
East wall	
Mostly original studs with localised replacement; concrete block plinth replacement to

north; brick and flint plinth; inserted door; mixed and inadequate bracing
West Wall
All modern studs; truncated central post; inserted large double door and pedestrian door.
Carpenters marks
the frame has plentiful and visible carpenters assembly marks. These were noted to be of Roman numeral form, mostly sequential and present to studs/mid rails, posts and tie-beams (not all surfaces closely inspected). The southern posts of frames 2, 3 and 4 were noted to be marked V, VI, VII and further suggest re-use of an earlier frame or parts of it.

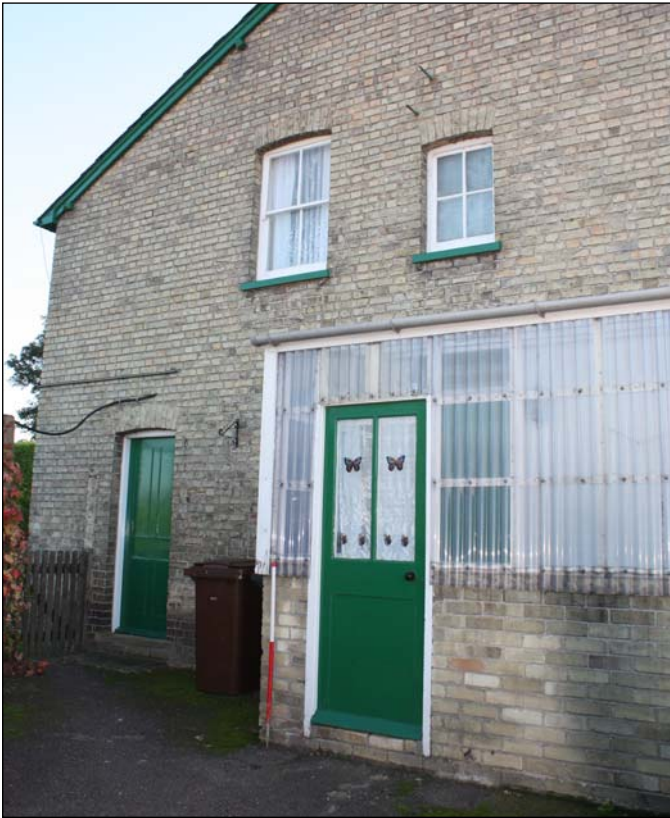
Plate 5: Building 1, Farmhouse, viewed from north-west

3.1.4 The south facing elevation (plate 5) is constructed entirely from a pale Arleseey (?) brick laid in a Flemish Bond. There are two windows on the first floor: a four pane, two-part vertical sliding sash on the left and smaller four-pane single part window with frosted glass on the right. On the ground floor there are two doors openings: one with a green painted replacement wooden door in a wooden frame below a brick arch of stretchers

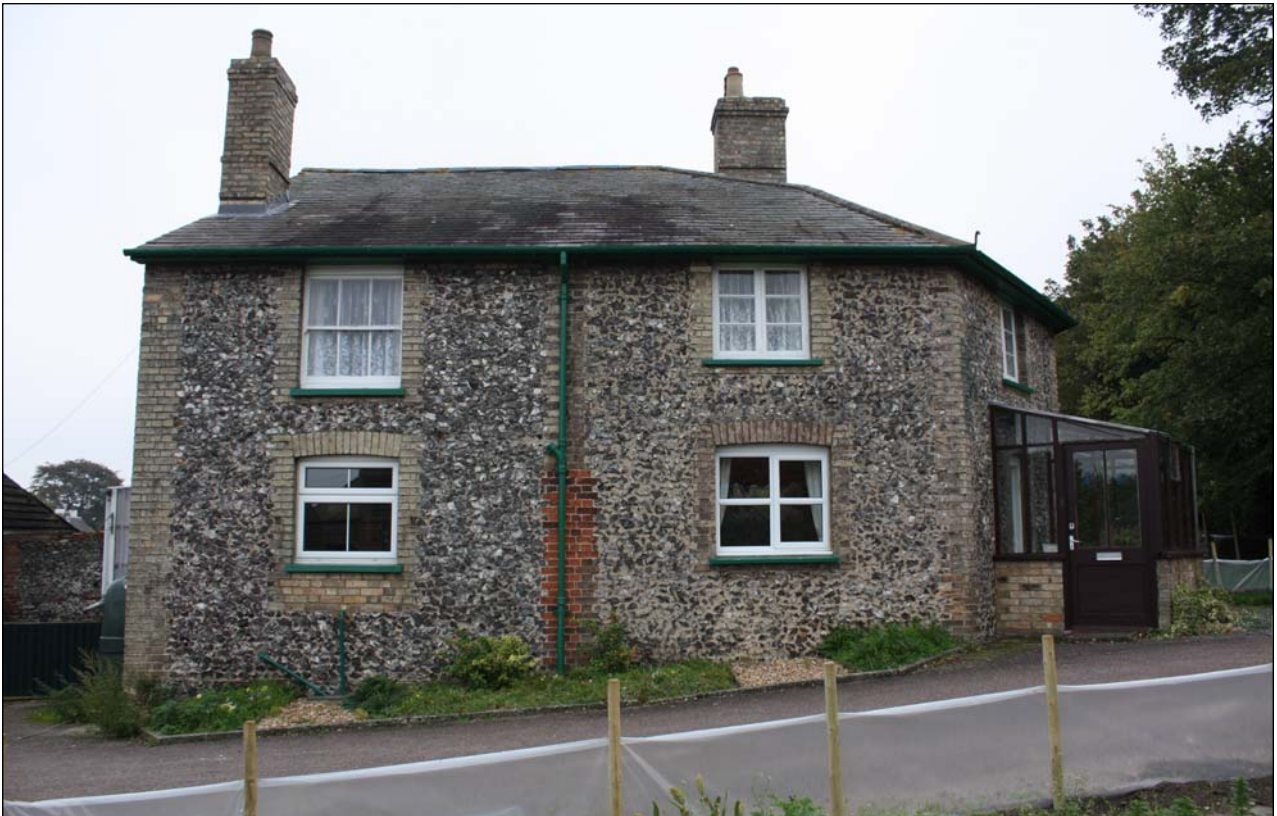
Plate 6: Building 1, Farmhouse, viewed from west

- 3.1.5 The west-facing elevation (plate 6) shows the same detail as recorded in the east-facing side; the distinct phases of construction/repair indicated in the finish of the flint render. This elevation however, has red brick which separates the phases. There are four windows on this side; two on the ground floor and two on the first floor. The first floor had a six-pane, two-part vertical sliding sash on the left and a six pane, two-part casement window on the right. On the ground floor, both windows are modern UPVC replacements, the one on the left has brick in-fill below indicating there was a wider opening here originally for a longer window.

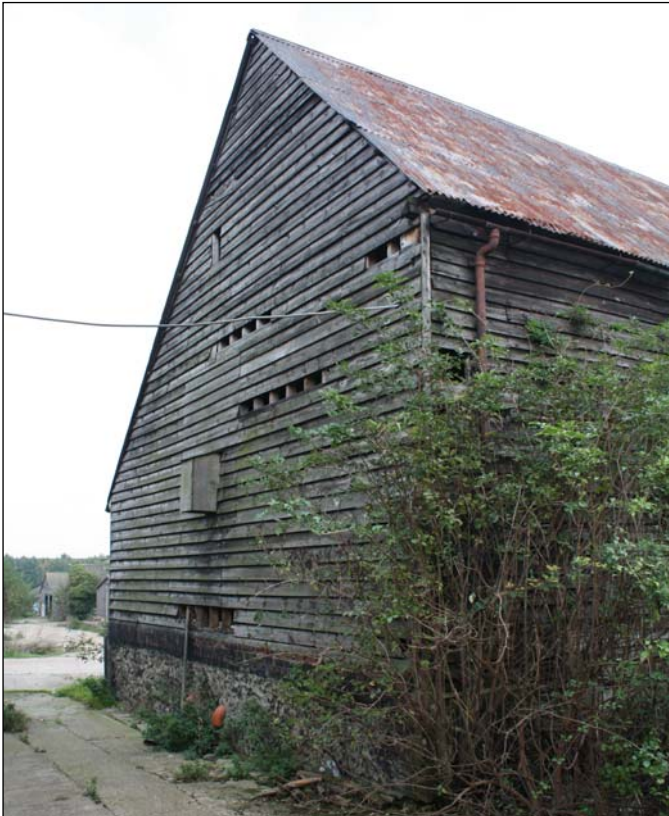
3.5.5 The west-facing elevation (plate 25) shows the weatherboarding continuing on this side with some exposed timber framing where the board has been removed/deteriorated. At

Plate 25: Building 5, gable-end, viewed from south

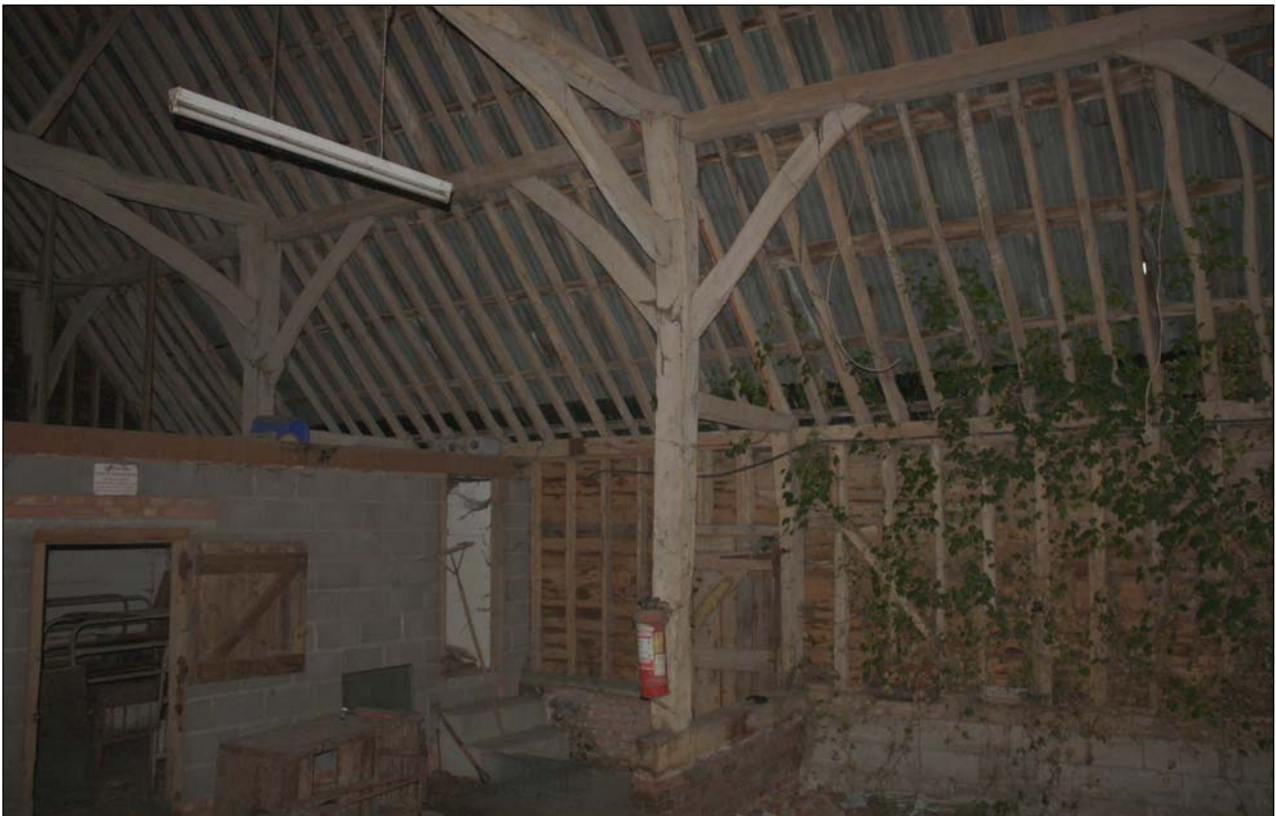
- 3.5.6 The barn is timber framed and comprises four frames defining three wide internal bays (Figure 14). The north side is aisled (plate 26) and the interior has been partly converted with the construction of a concrete block single storey structure within the western bay and half (plate 27). The inside of this breezeblock structure indicates it has been most recently used to house farm animals (plate 28). The barn is set upon a flint plinth wall although parts of the north and south wall have been replaced with sections of concrete block and modern brick.

Plate 26: Building 5, Internal view of aisled posts and modern structure

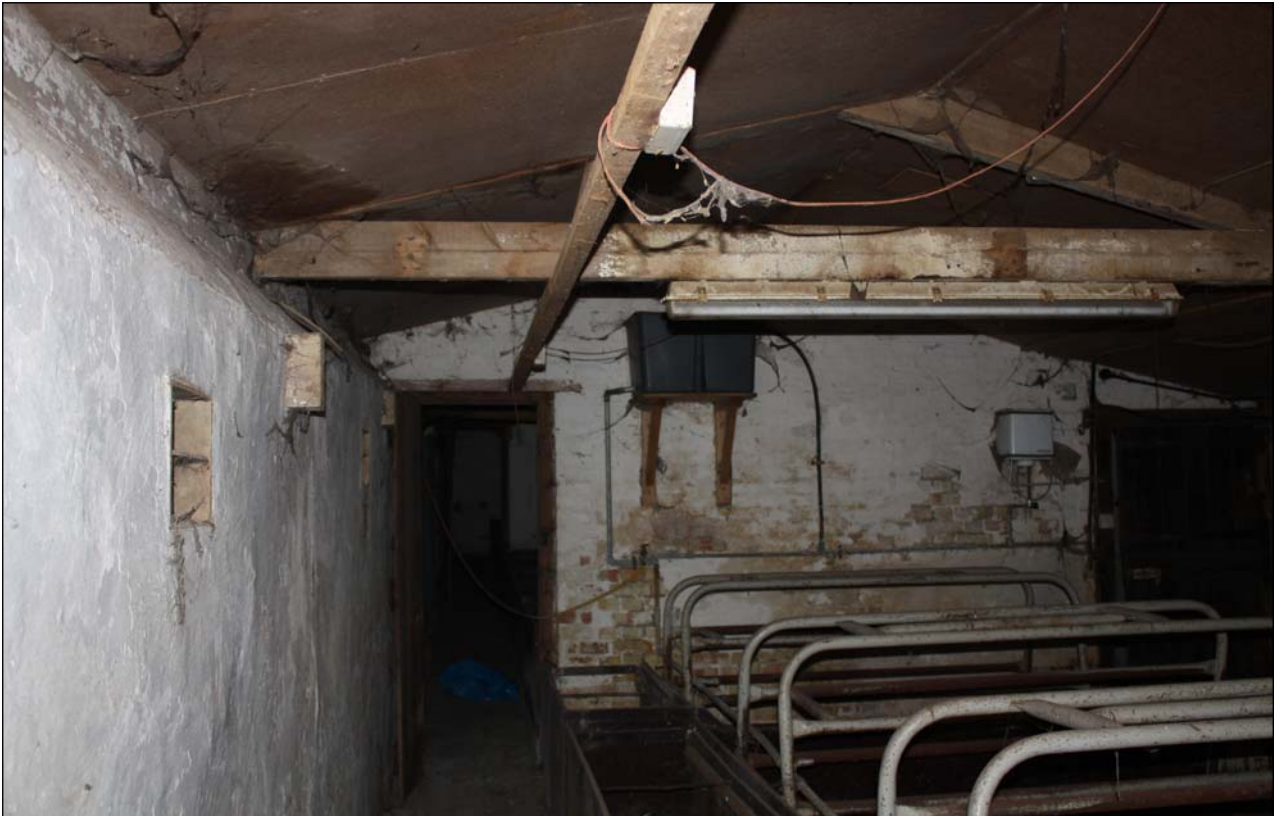
- 3.6.6 Internally, the northern end of this side of the building has been very much altered and adapted to suit its most recent function to house farm animals (plate 35). This part of the building was accessed from inside Building 5 and from a modern entrance located on the western side (to the north of Building 7). Little detail other than the original flint wall and the sub-dividing brick walls is visible inside. The roof structure appears to have been replaced and mostly concealed by a modern inserted ceiling. It was possible to see where the roof supports rested on the dividing flint wall (plate 35).

Plate 35: Building 6, internal view

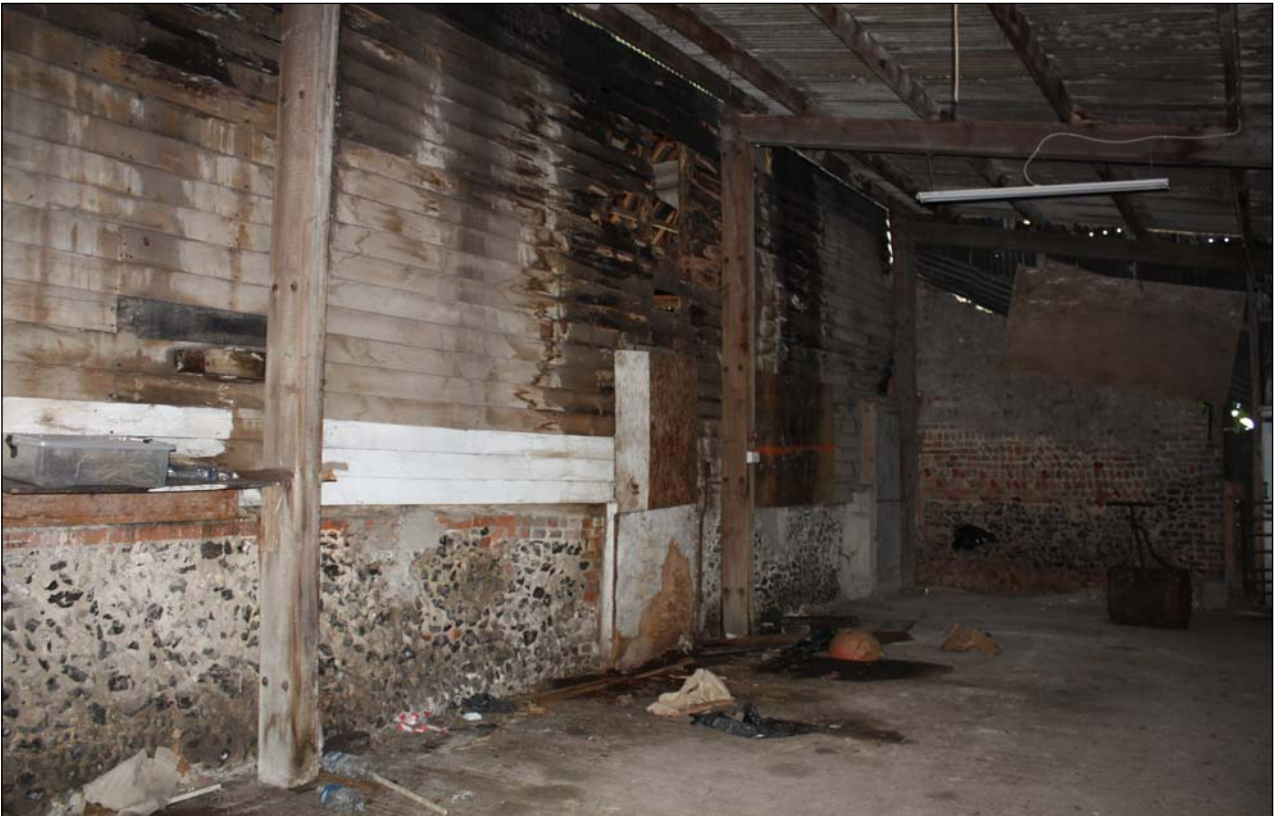
- 3.8.3 Although not part of the survey, the inside of Building 11 (located on the north side of Building 4) was inspected. The current building is a 20th century replacement of the range recorded on the 19th century maps, however, the flint wall which formed the eastern end of Building 12 and perhaps a subdivision within the original building in this location was visible (plate 40).

Plate 40: Detail of flint wall and northern elevation of Building 4, viewed from inside Building 11
