Repairs to the Castle  
Mill Stream Wall  
Paradise Street  
**Oxford**

**Archaeological  
Watching Brief Report**

April 2011

**Client: St Peter's College**

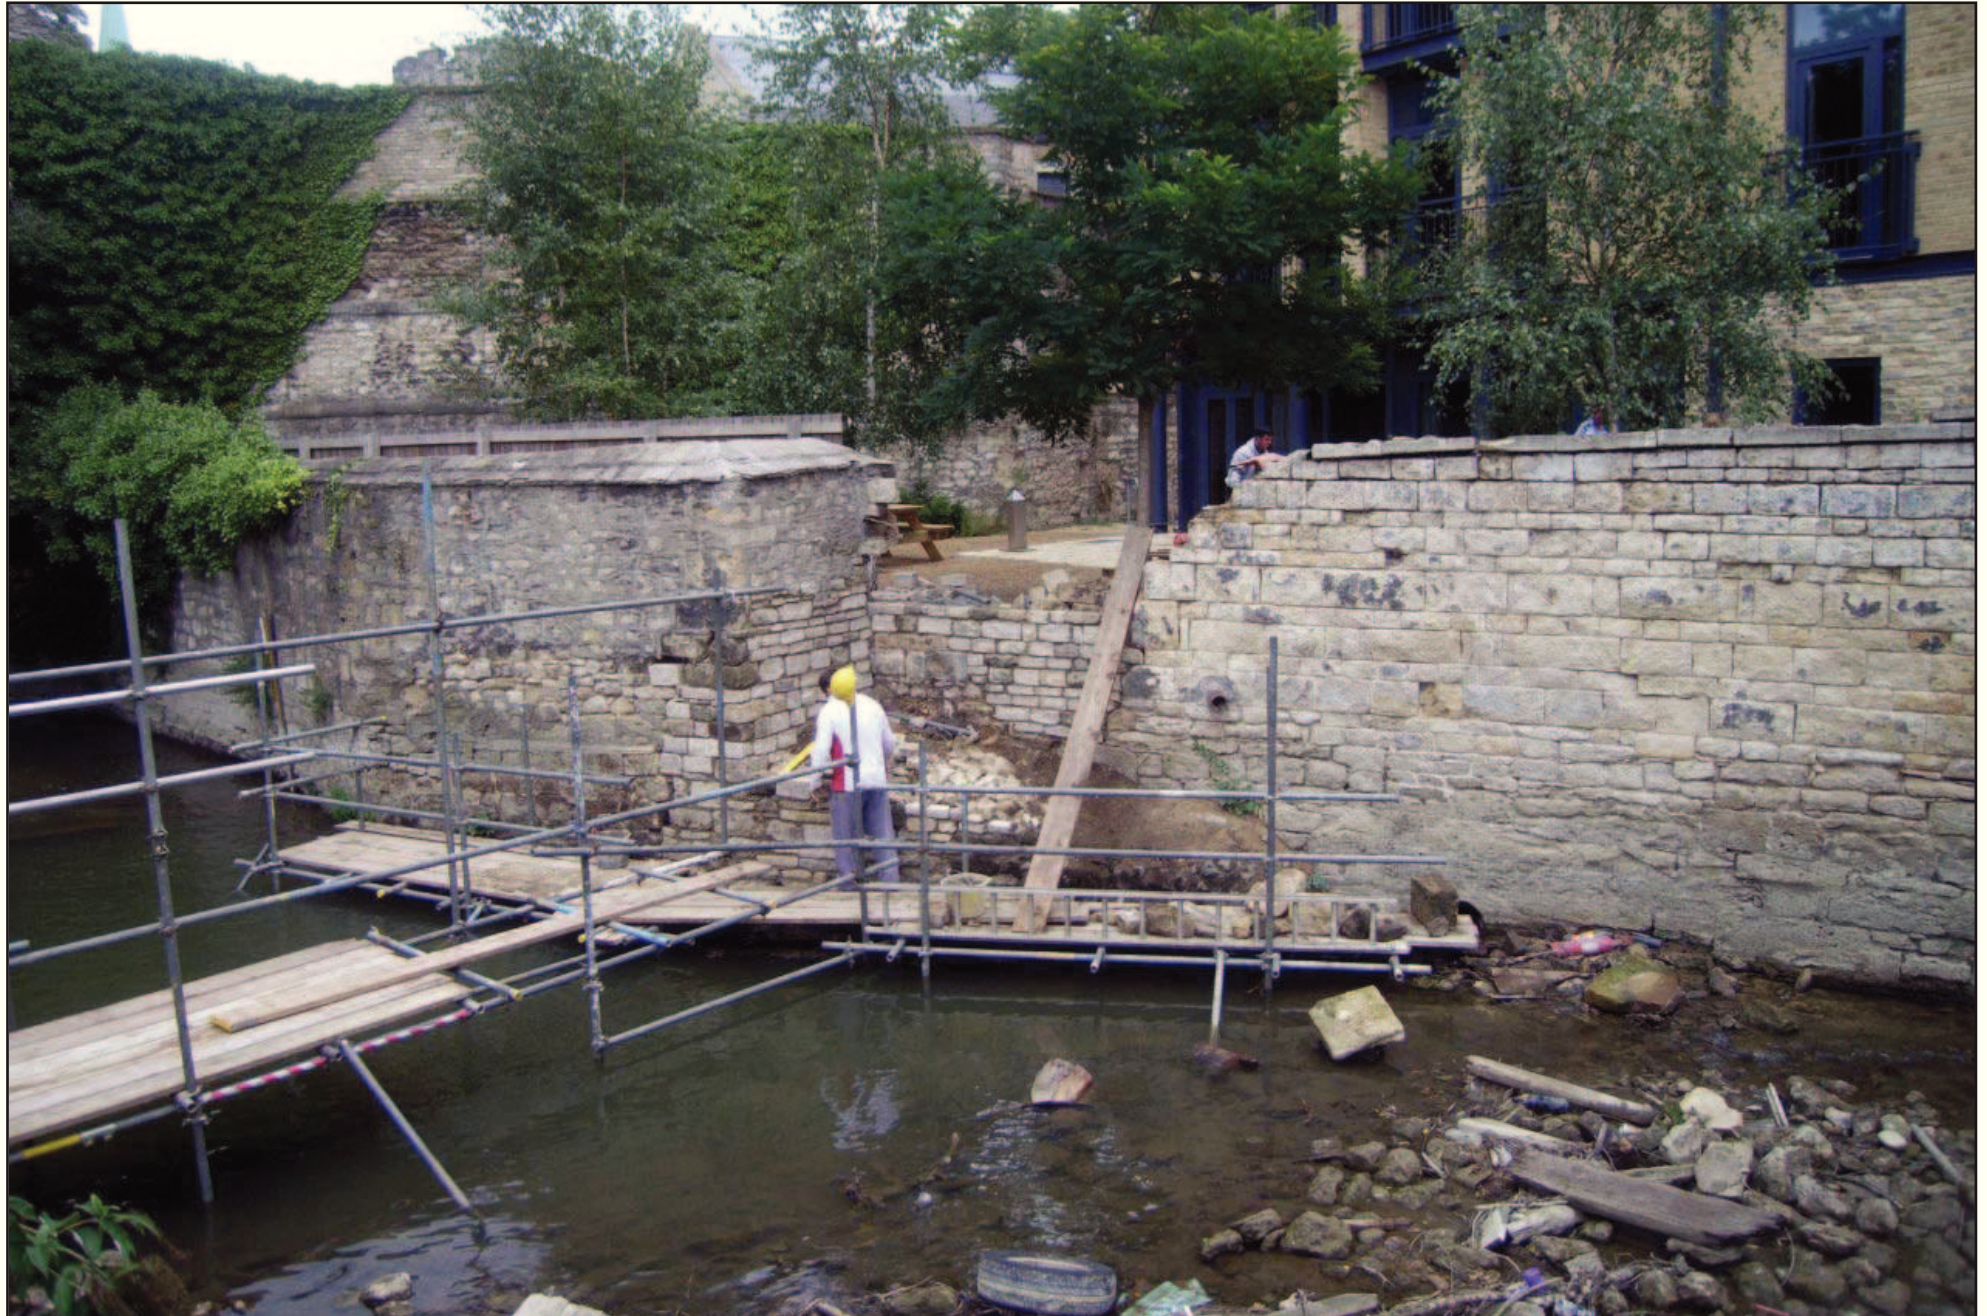
Plate 1: Repair work underway

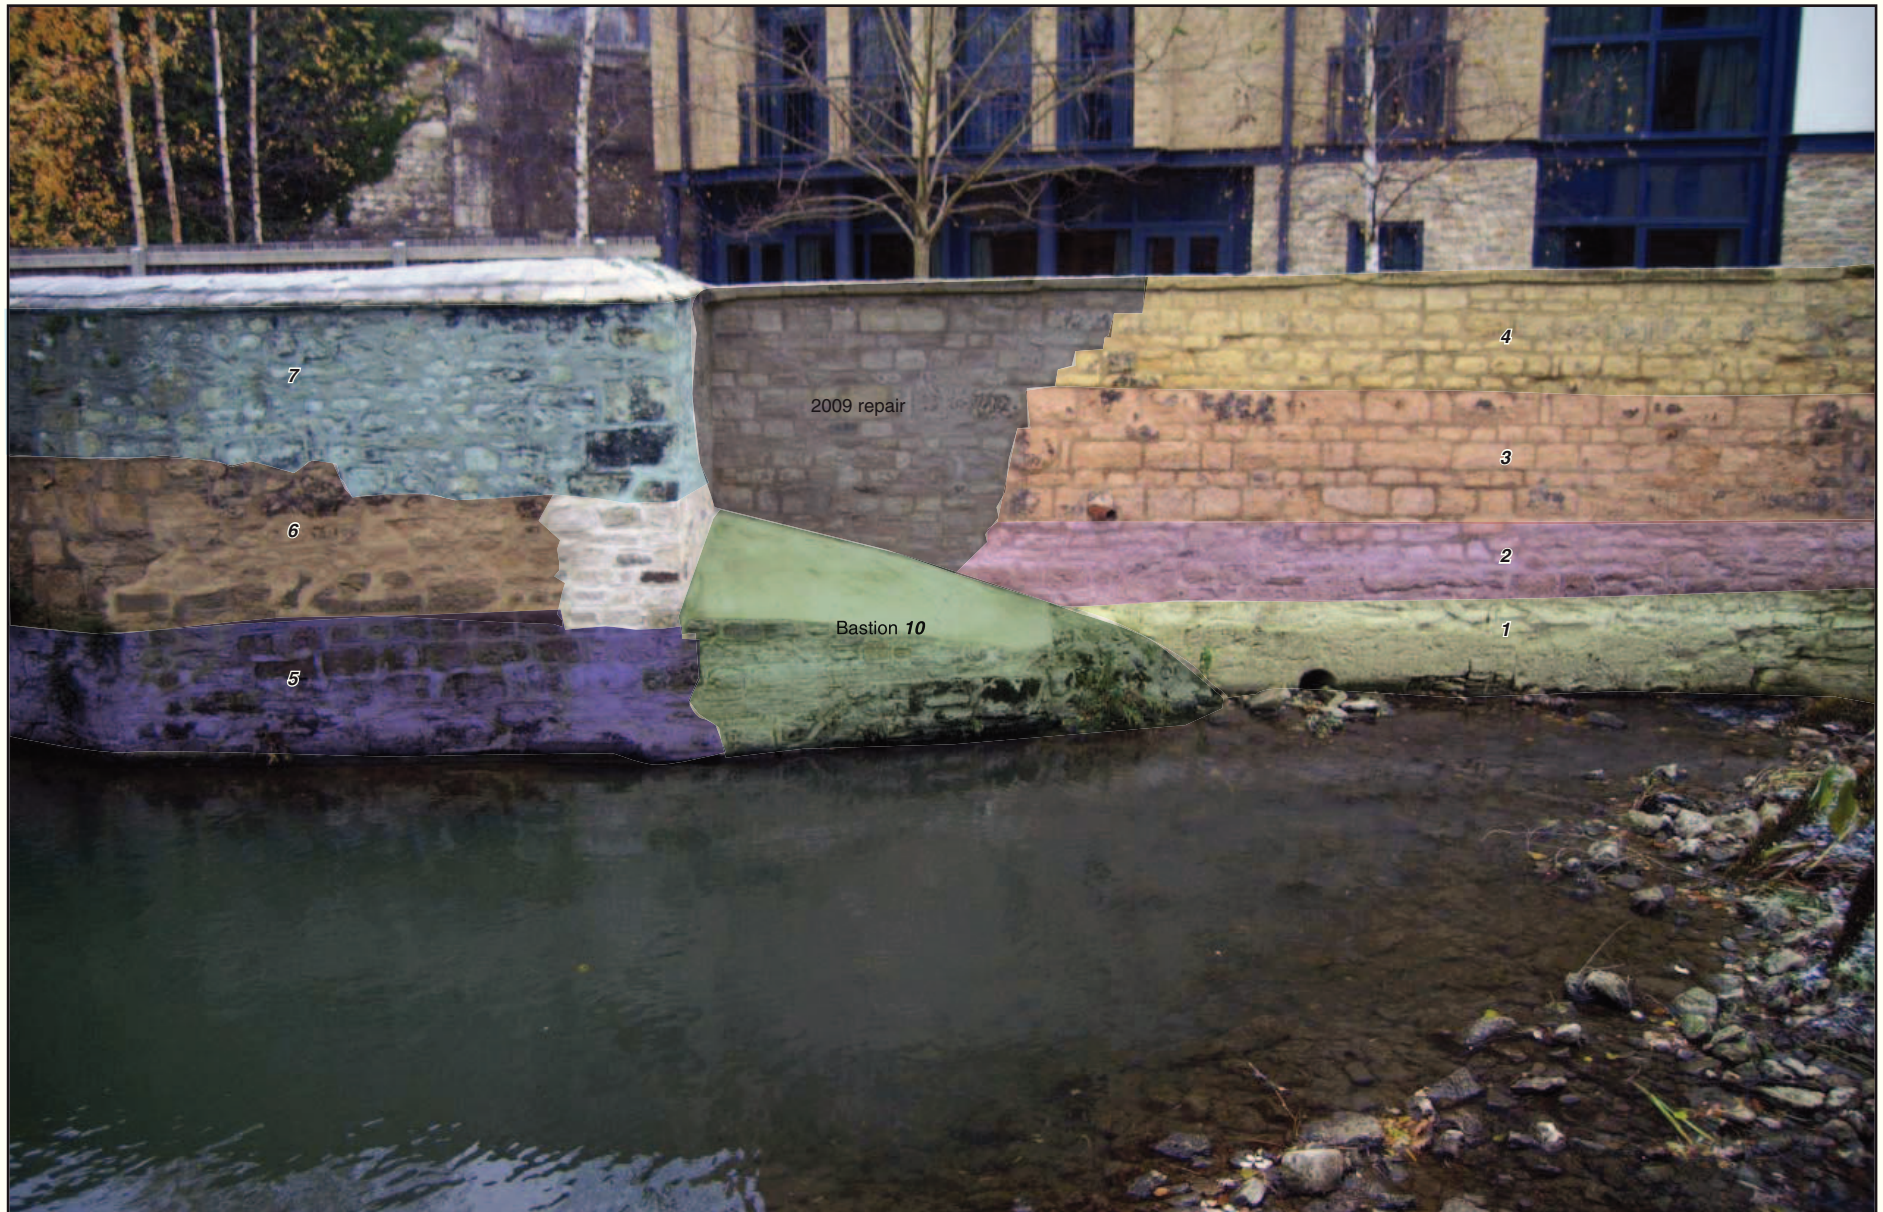
- 4.1.1 The presence of the butt joint between the northern and southern lengths of the wall suggests that there is at least two phases of construction evident at this point.

Plate 2: Phases of work within wall

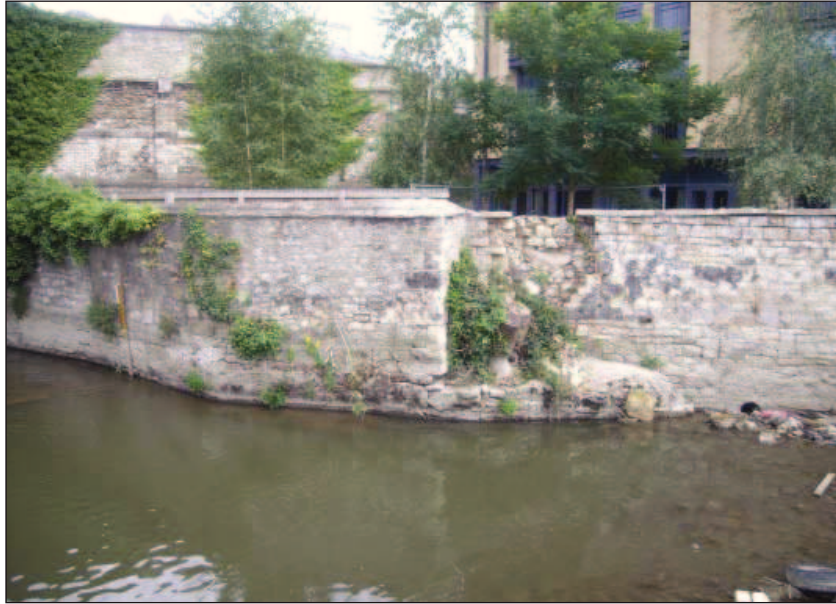
Plate 3: General view of wall prior to start of conservation works

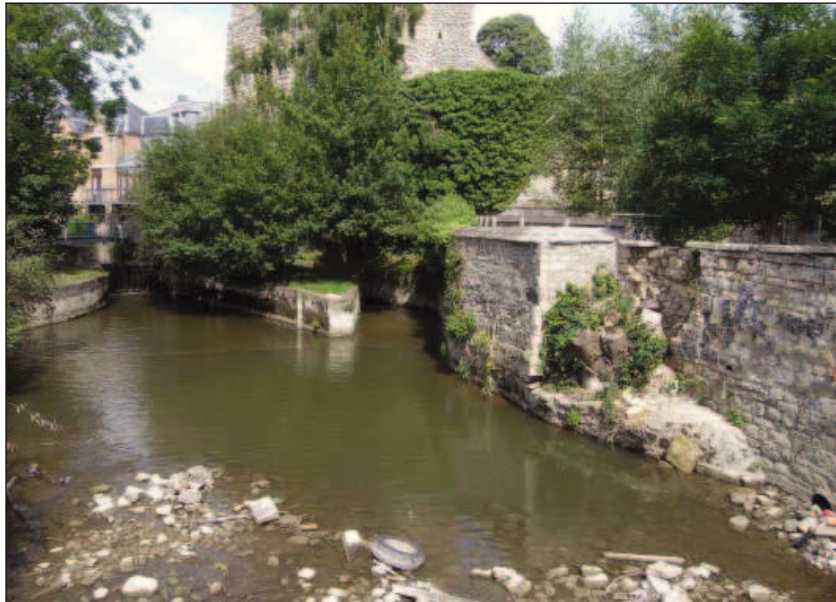
Plate 4: General view of wall from south with St George's Tower in background

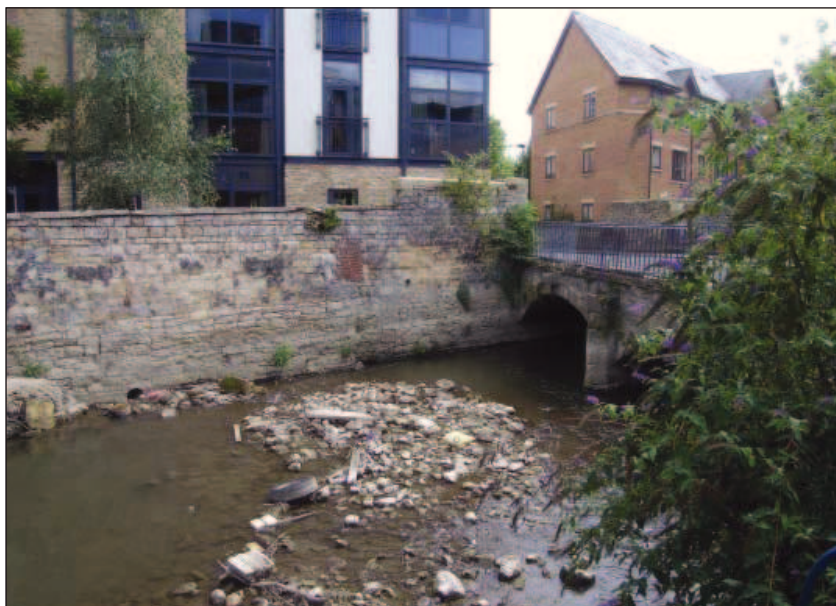
- 4.1.6 The revetment wall along the eastern side of the streamway south of Swan Bridge shows similarity of construction and that it is possible that the two lengths of wall together with Swan Bridge may represent a major reconstruction of the area around Paradise Street.

Plate 5: Revetment wall to south of current area

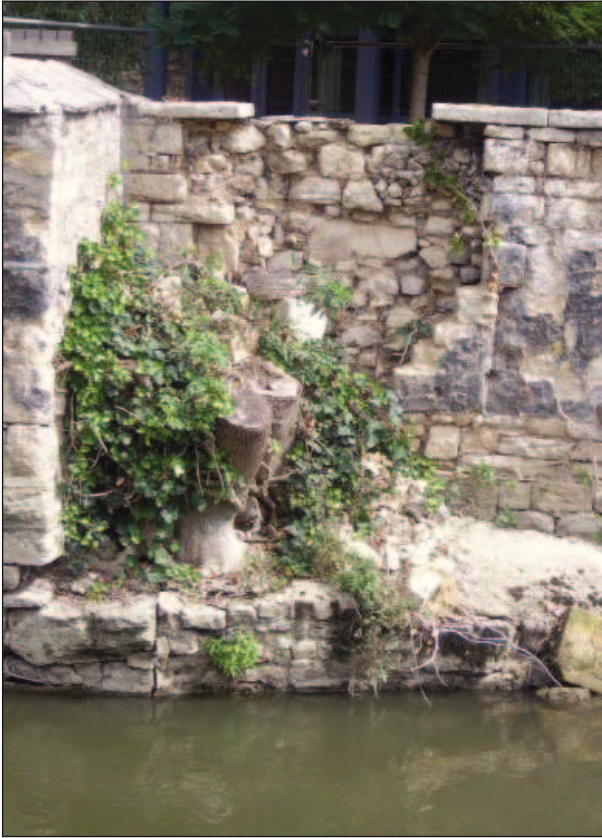
- 2.2.1 The work was undertaken to make good displacement of the stones caused by a tree stool growing out of the wall and whose stump and roots had dislodged many stones, tumbling some into the stream. The wall consisted of two parts: the stream wall, which steps back approximately 1 m from the main line of the stream at this point, and a triangular stone 'bastion' or robin which butts up against the wall protecting the step from erosion. The top of this bastion was originally smoothed off with cement but cracking had allowed silts and seeds to collect. A tree had grown within the cracks and over time its roots had lifted the courses of both the bastion and the wall behind it causing it to become unstable and part of it to tumble into the stream bed. The remedial works undertaken before the wall was reconstructed included the grinding out of the tree stump and diverting the stream flow around the site allowing the tumbled stone to be retrieved.

Plate 6: View of area collapse prior to conservation

- 2.2.2 The rebuilding of both the wall and the bastion required the removal of the loosened courses of stone prior to reconstruction. This work had the potential to expose earlier phases of the stream wall's construction and for the collection of dating evidence from within the wall. The watching brief was undertaken as a series of site visits during this phase of work in order to examine the exposed stonework, in addition a photographic and descriptive record was made of the wall prior to the start of the conservation works.

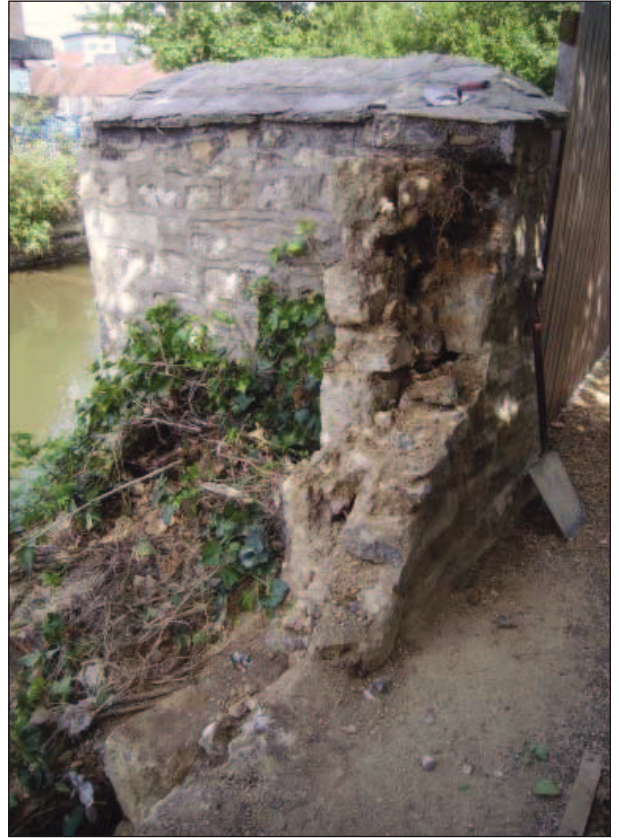
Plate 7: Core of wall during dismantling (north side)

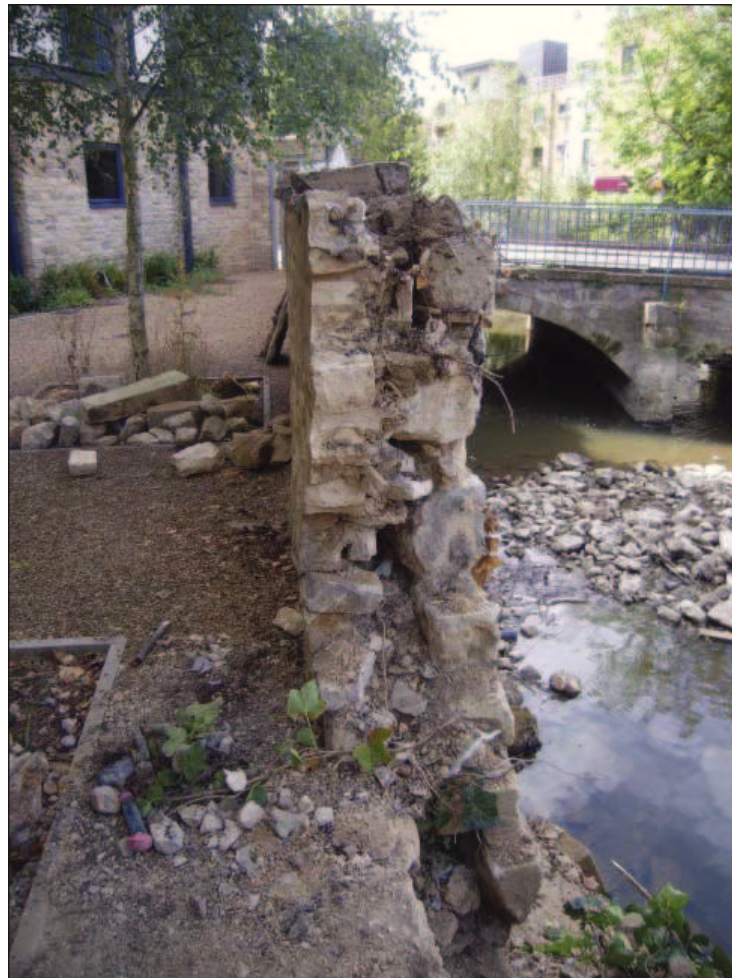
Plate 8: Core of wall during dismantling (south side)
