Four Ashes Hall
Cold Bath House
Enville
Staffordshire

**Historic Building
Investigation and Recording**

May 2012

Historic Building Recording and Investigation

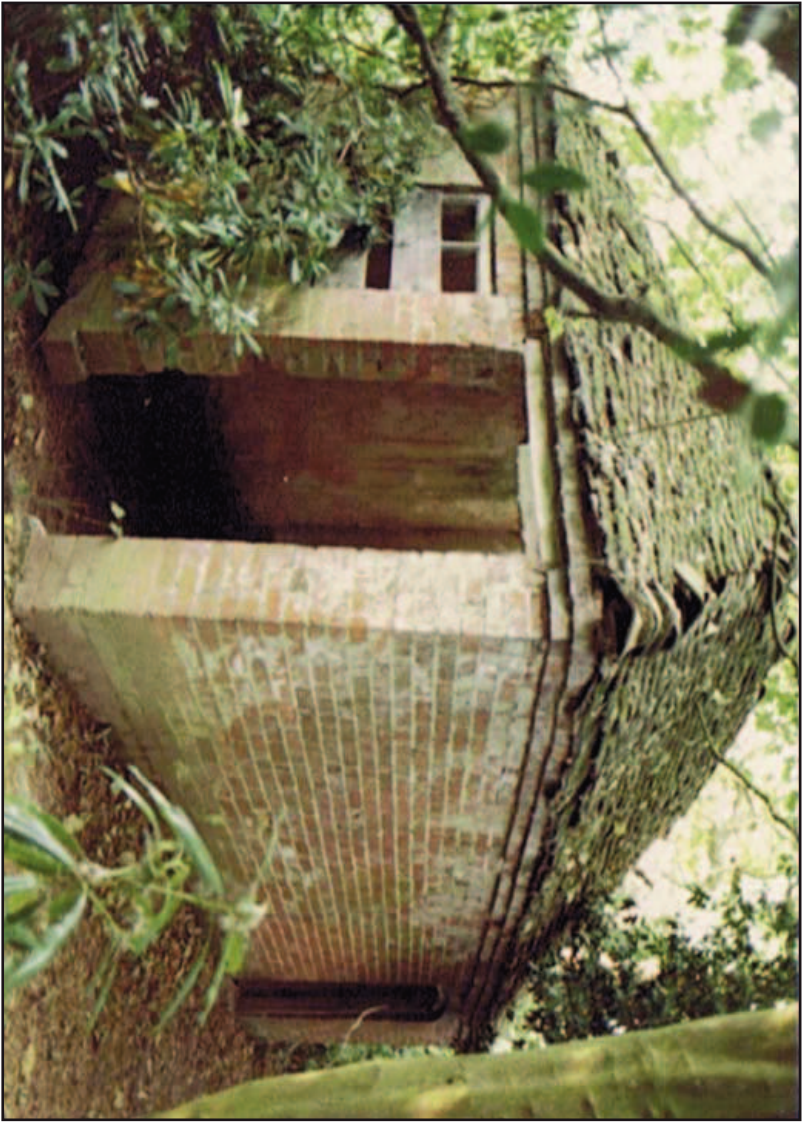
Figure 6: Photograph of bath house prior to its partial demolition

- 2.1.11 Another very important source of information relating to the historic form of the building is a photograph of the bath house before demolition of the southern half of the structure, which has been supplied to OA via PJM Associates (see Fig 6). Further description of the photograph is included below.

- 3.4.9 It is unfortunate that little more than surface footings survive from the east wall of the southern room because this would have provided valuable evidence of whether there is a distinction in the brickwork between the two parts of the wall and whether the northern room was originally a free-standing square plan structure as speculated above. The old photograph probably taken in the later 20th century appears to show the east wall of the southern room as an entirely continuous brick wall from the surviving doorway to the south-eastern corner of the building and with no clear evidence of a structural break between the rooms. However, if there was a structural break then this would have been towards the rear of the photograph and even though it is not visible in the image it is quite possible that there was one.

- 3.4.10 The photograph shows that in the south wall there was a doorway (door not in-situ) and to the west of this a window with simple soldier course course. The window frame was in-situ but it appears the glazing had been lost and it was largely boarded over. The photograph also appears to suggest that there were no windows in the west wall and that the internal face of this wall was rendered. The open doorway in the photograph allows some limited visibility into the southern room and it appears that the pool had by this time been infilled.

- 4.1.6 Understanding of the form of the southern half of the building is greatly helped by the photograph taken before the demolition of the structure. This clearly shows the form of the southern and eastern elevations and it suggests that the internal walls were plastered/rendered. The plaster on the external face of the wall which historically divided the two rooms also shows the height of this plaster and the fact that there would have been a ceiling. This room would have been of a higher status than the unplastered northern room.

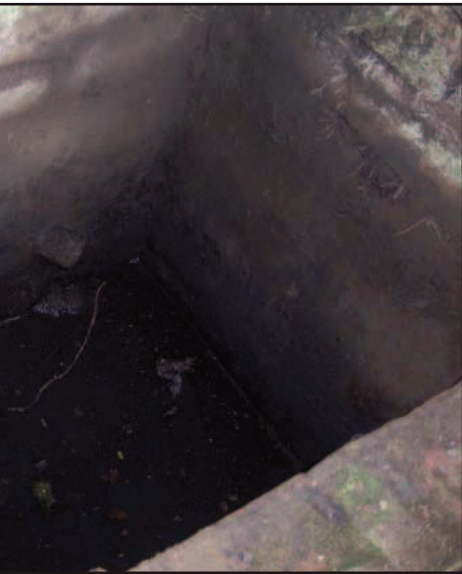
- 3.3.2 **Floor and pits:** The floor is now largely of earth, the previous (probably tiled) floor surface having been removed. The principal feature of interest in the room are a pair of aligned pits, within the floor and towards the centre of the room. The eastern pit is 83 cm long by 53 cm wide and its base is c.88 cm below the former floor level. The northern, eastern and southern walls of the pit are rendered, together with the base, but the western wall is a single skin brick wall dividing this pit from the adjacent pit (detailed further below). At the start of the current project Pit 1 was largely filled with liquid slurry/detritus but this has been largely cleared out and towards the base were a series of ex-situ square floor tiles. It is more likely that these tiles were from the main room and were dumped in the hole rather than being having formed a surface on the base of the pit itself. A feature of interest in the pit is the end of a small pipe (c.5 cm diameter) in the north wall c.15 cm above the base of the pit. This pipe appears to extend in a north-easterly direction away from the pit and bath house and it is probably lined to the former pump house in this area.

pit in bath house with pipe towards base

- 4.1.4 Further intrusive investigation should be made with the aim of more fully understanding the water system at the site. Did the pipe in the small eastern pit connect with the pump house? How did the pump house relate to the cold bath house? If the pump house was formerly an ice house when was it converted? How did the drain at the bottom of the main pool operate?

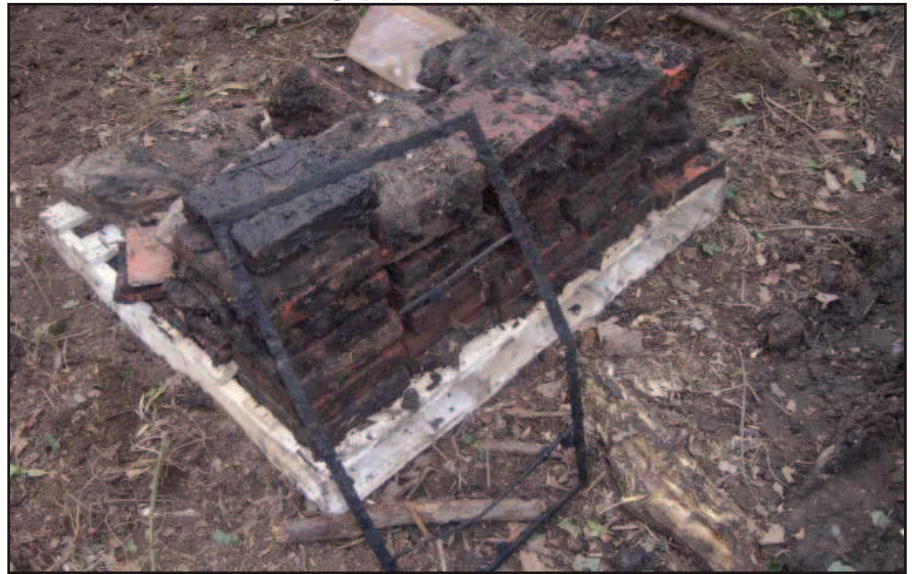
Plate 22: Iron window frame excavated from pool fill.

- 3.4.12 A number of items of interest were retrieved from the fill which was removed from in or around the main pool. This included an iron window frame with four horizontal lights which could have been primary to this building. It also included several chains including one which was fixed to a timber post, an L-shaped iron bracket with bolts in-situ, an iron bar, a series of boards with bevelled edges and a number of long timbers with mortices (possibly from a door frame).

- 4.1.5 Further examination should also be made of the items retrieved from the fill removed from the main pool in the current works. This includes chains, an iron window frame and various timber fragments. It should be possible to identify if some of these fragments were part of the roof or formed a door/window frame.

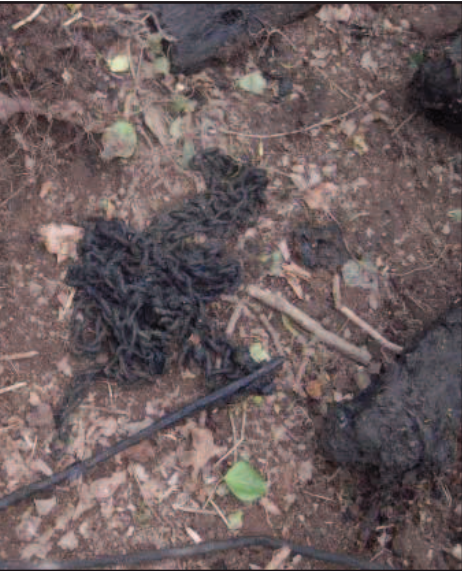
Plate 23: Chain and fittings from pool fill

- 3.4.11 Mrs Nikola Thompson has reported that she has been told that there were formerly a number of chains which hung from the ceiling and which could be used to guide oneself down into the pool.

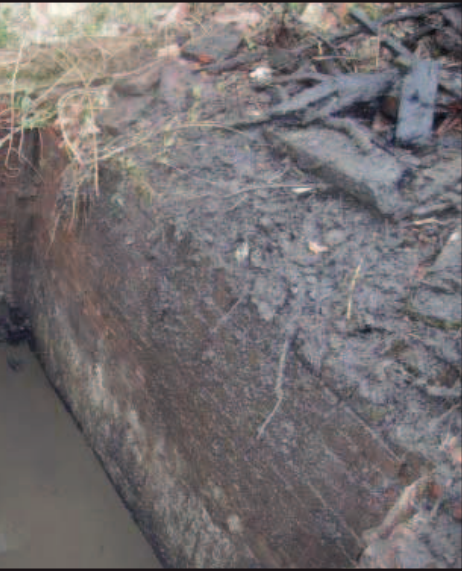
- 3.4.6 **Cold Bath Pool:** The former southern room would have had a broadly square plan and while the eastern half would have been a raised platform adjacent to the fireplace and forming a small changing area, the western half was the location of the substantial cold bath pool itself. This pool has been infilled for many years but it has been emptied and the interior almost entirely exposed in the current project. The pool is 2.6 m long by 1.3 m wide and c.2 m deep. The walls of the pool are lined in red brick and the base is laid with square red tiles, similar to those removed from the pit in the northern room. The lower half of each of the walls has a white encrustation and at the southern end there is a simple set of brick steps which allowed access into the water. The stairs comprise 6 risers and they wind around to the north towards the base.

Former bath house after removal of infill

- 4.1.9 If it is not proposed to reconstruct the southern half of the bath house or if funding would not be available for this in the short term then the main pool and other surface features should be re-buried to protect them.

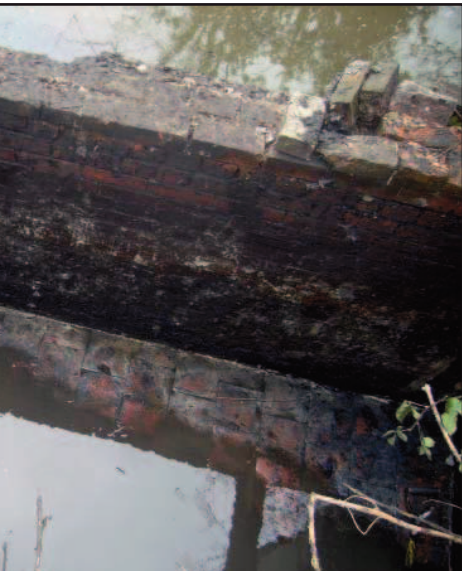
Plate 11: Main pool

- 3.4.7 The south and west external walls, facing the large adjacent, pond are 35 cm wide but the north wall is just a single skin thick and it is constructed against the main wall of the surviving building. These two walls appear to be entirely structurally independent from each other and this suggests very strongly that the pool was a secondary insertion, being built as an addition to the pre-existing building. The east wall of the pool is a retaining structure, supporting the platform/changing area but the surface of this part of the building has not been exposed in the current project.

- 3.4.8 At the north-eastern and south-eastern corners of the pool there are vertical stakes fixed to the walls by iron clamps. These stakes are now heavily corroded, particularly at the tops and bottoms and their purpose is not clear. A small drain with a grille cover was partially uncovered towards the north-eastern corner of the floor of the pool but water rapidly re-filled the base of the pool and it was not possible to examine this closely.

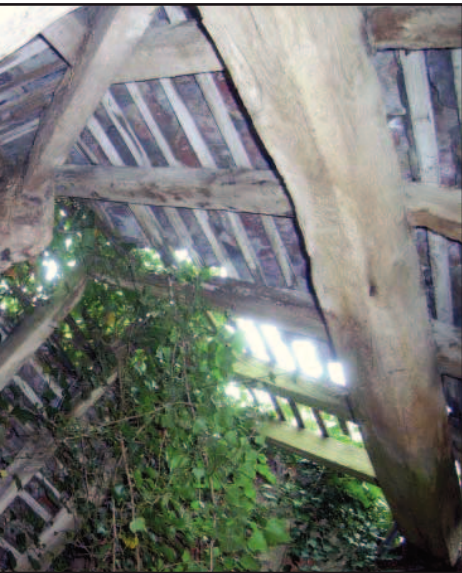
- 3.3.5 **Roof:** The roof structure is entirely exposed, including the undersides of tiles and battens, and appears to be largely primary, consistent with a later 18th or early 19th century date. The north end is hipped while the southern end adjoins the full height brick wall which was originally internal but which now forms the end of the surviving building. The main members are of elm and comprise common rafters (c.9 cm tall x 7 cm wide) which rest on a wall plate (12 x 20 cm) at the top of each wall and are supported by tall hip ridges (22 x 6 cm). At their heads the two hip ridges meet at a block immediately to the north of the first full set of rafters.

- 3.3.7 The roof is strengthened at the north-east and north-west corners by timber braces (15 cm²) resting on top of the wall plates and set at an angle between the two walls. There is a small notch in the top of the northern and eastern wall plates at the point where the corner brace adjoins and it is interesting to note that there is a similar notch in the upper face of the eastern wall plate, towards the south-eastern corner of the building. There is no corner brace here because the roof is not hipped and adjoins the full height brick wall. There is also similar evidence at the south-western corner where there is a bolt hole in the underside of the western wall plate similar to an in-situ bolt at the point where the north-western corner brace adjoins the western wall plate. With this side of the building being open-fronted the arrangement is slightly different to that of the other walls and there is no notch in the upper face of the wall plate.

Roof within surviving part of bath house

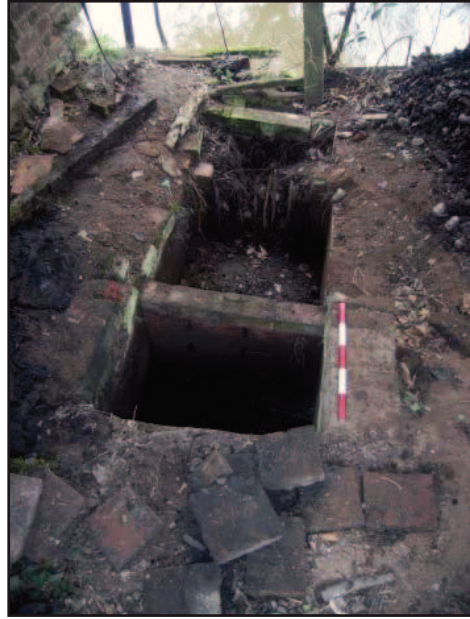
Plate 18: Small pits within bath house

- 3.3.3 The western pit is slightly larger (83 cm²) than the immediately adjacent eastern pit and it is divided from it by a single skin brick wall where the bricks are carefully laid with a number of vertical gaps between bricks to allow water to flow between the pits. The northern and southern walls of this pit were again rendered but the pit was substantially filled with shingle/gravel quite different to the slurry/detritus in the east pit. A quantity of the gravel was removed to expose the pit to a depth of c.80 cm but the excavation did not reach the base of the pit and it appears that it is deeper (probably considerably deeper) than the eastern pit. It may be that the shingle was dumped in the western pit similarly to the different materials dumped in the east pit but the distinct and consistent nature of the fill suggests that the gravel was probably part of a filtration system to remove impurities and to allow relatively clean water into the east pit.

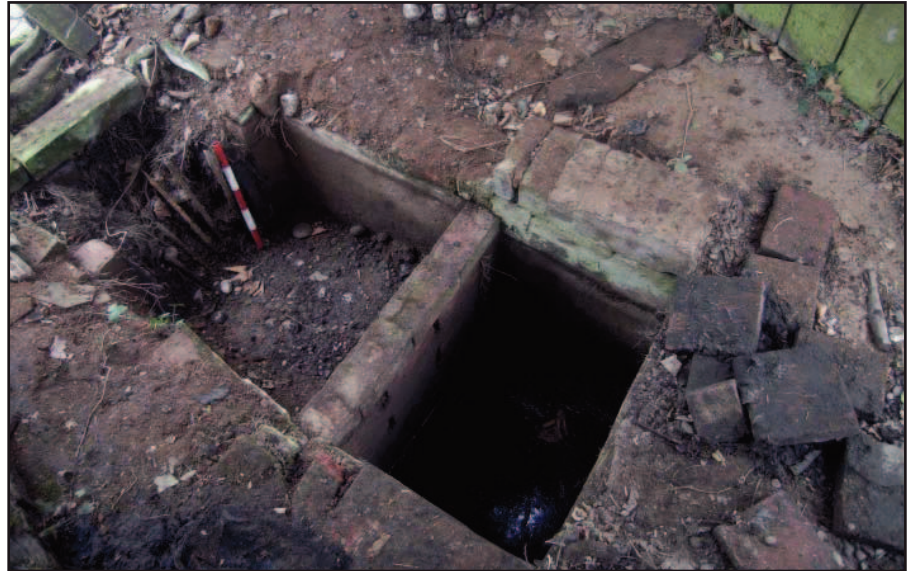
Plate 20: Pits in floor of bath house

- 3.3.4 At the western end of the west pit the fragmentary remains of a grille survive formed from thin, vertically set iron bars and beyond this is a channel (c.48 cm wide) which extends through to an opening in the west wall of the building. The grille has largely corroded away but the remains survive of two vertical timber posts within recesses against the northern and southern walls of the pit. The horizontal upper member of the grille has now been lost so each of the vertical rods are essentially independent from each other. The channel to the west of the grille is now infilled with detritus and it is uncovered but it is very likely that it would originally have been covered. A stone lintel survives toward the eastern end and close to this is a further grille close to the edge of the building. This grille is intact but is a secondary addition and is formed from a iron board with very thin horizontal slits. This grille was clearly intended to stop as many twigs or loose items as possible from entering the pit.
