# Church of St Mary-Le-More Wallingford, Oxfordshire

## Archaeological Watching Brief

**CHURCH OF ST. MARY THE MORE, WALLINGFORD, OXFORDSHIRE**

**ARCHAEOLOGICAL WATCHING BRIEF REPORT**

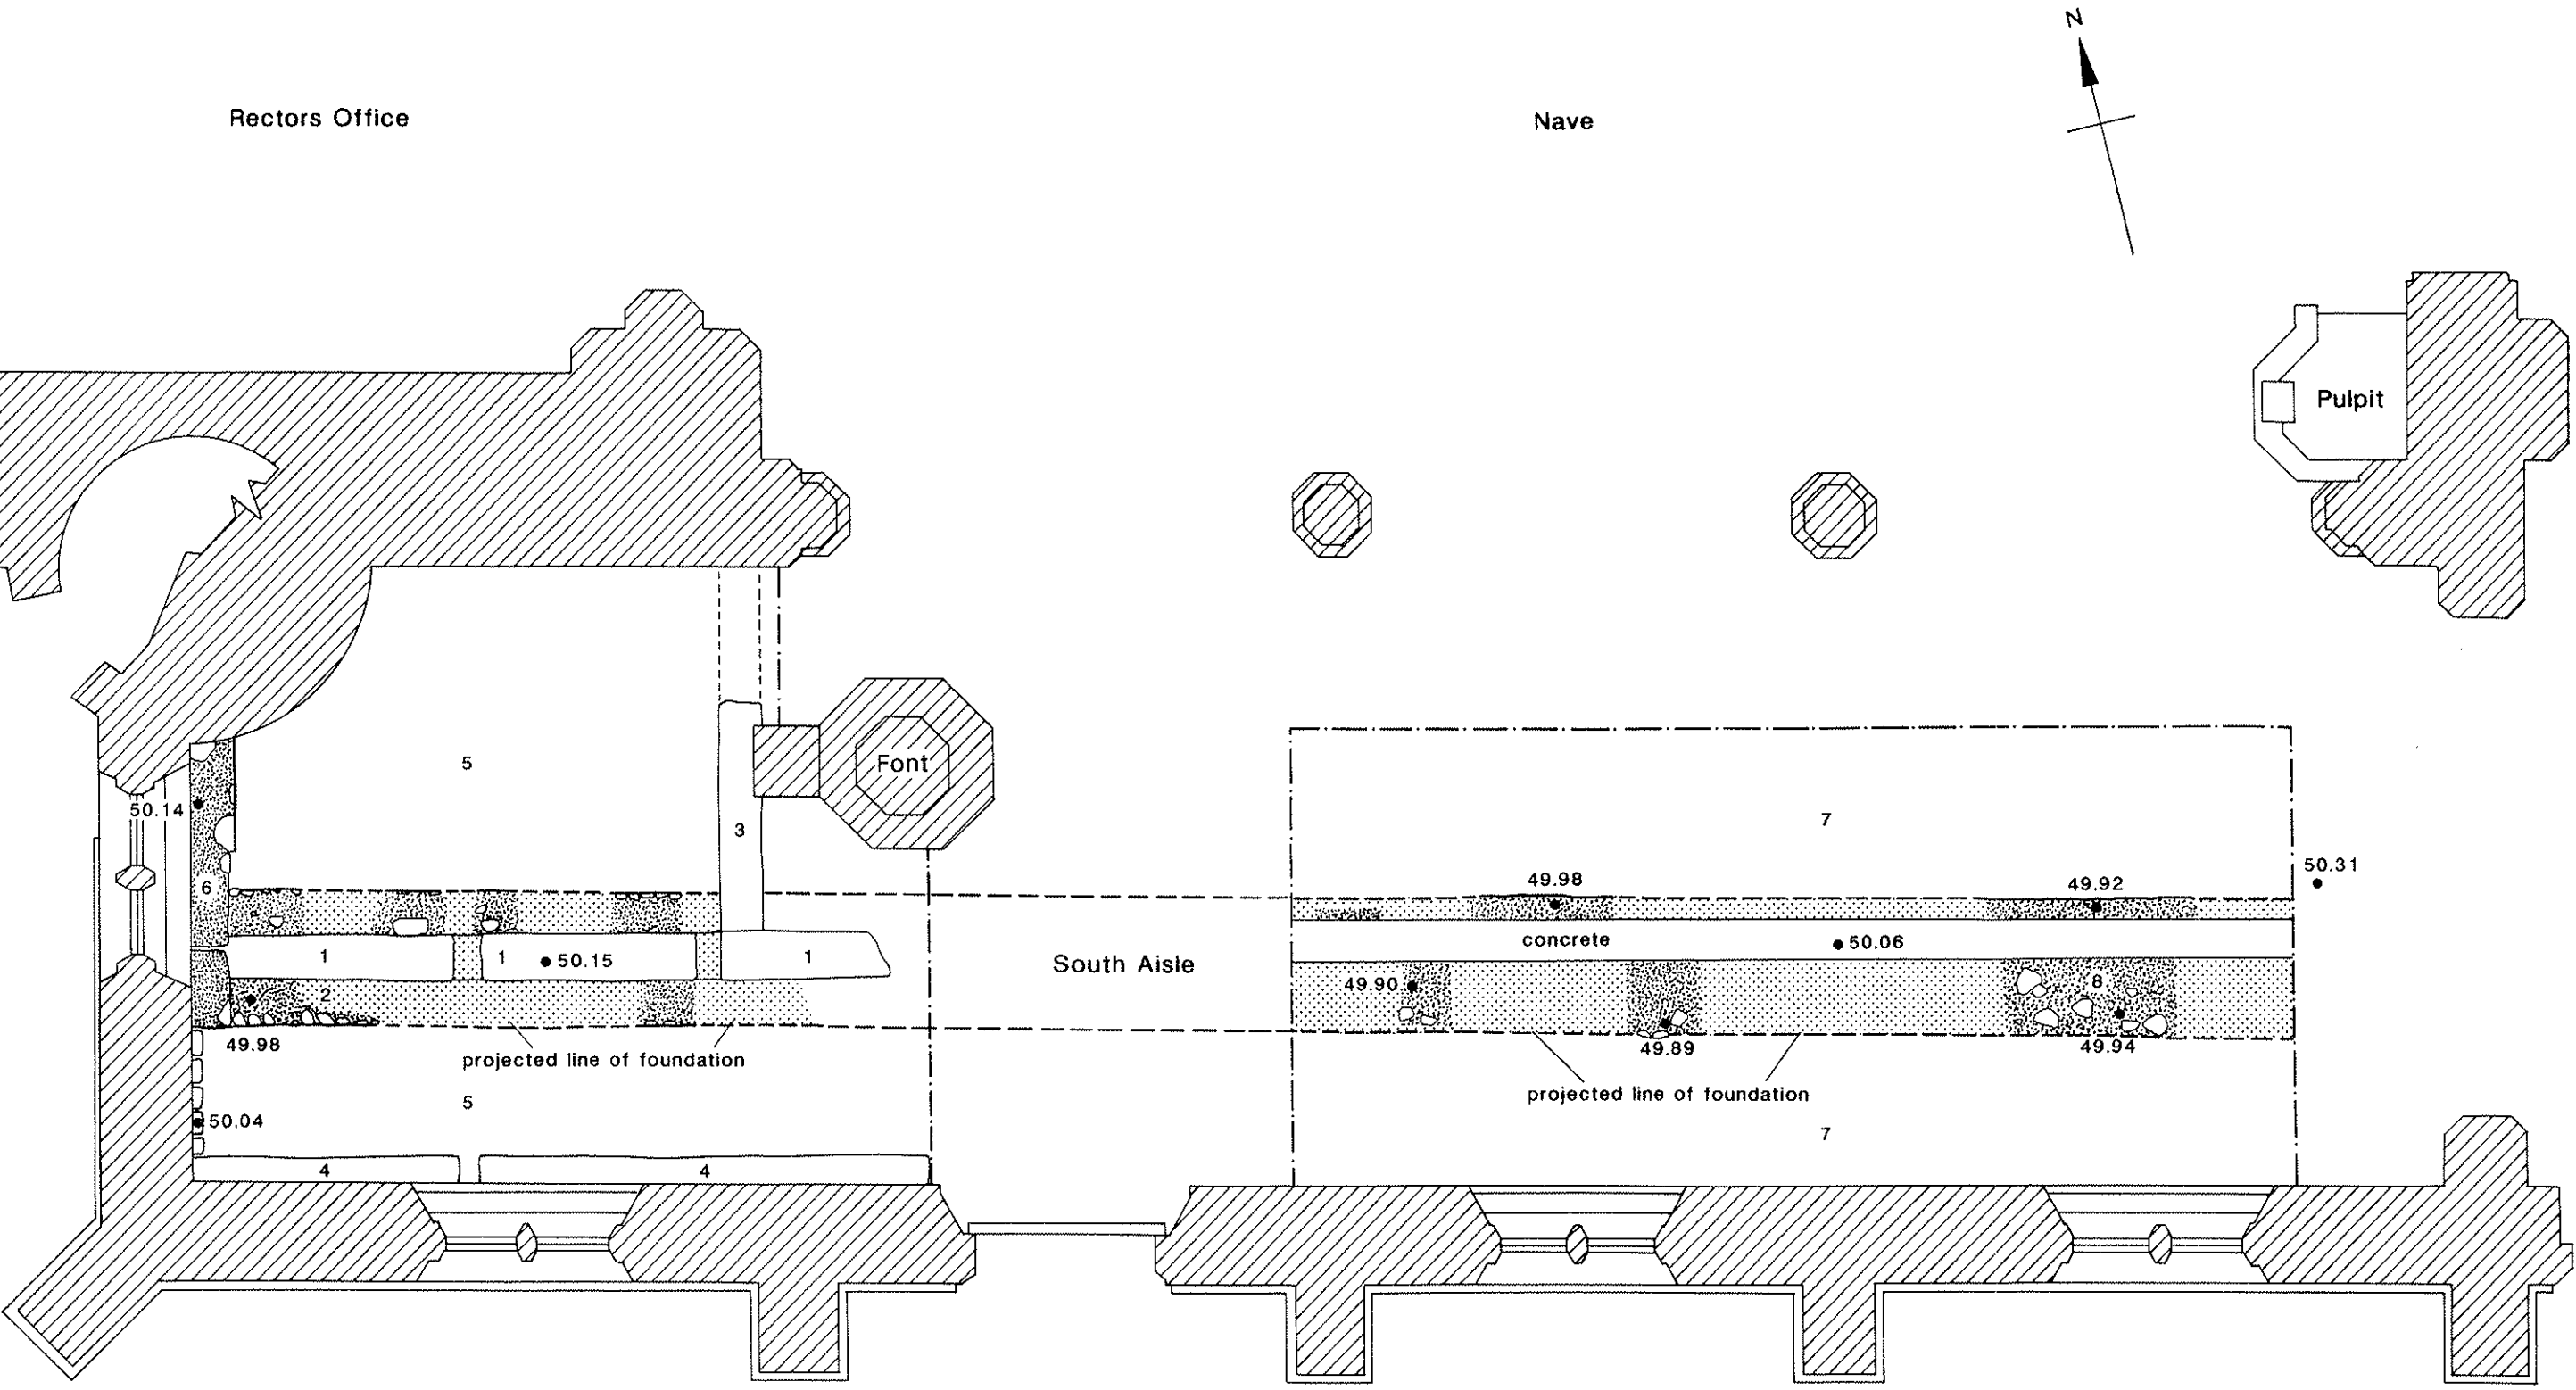
scale 1:50  
figure 2

The sleeper floor support walls had already been removed in the eastern half of the south aisle, and a new concrete wall had been built. Limited excavation revealed the continuation of wall 2 (here numbered as context 8). The wall had the same characteristics, but facing stones (typically 240 mm x 160 mm x 70 mm) were occasionally

present on the internal edge (see Fig. 2).

A segmented floor support wall (1) ran east-west along the earlier wall (2) at the west end of the south aisle. Wall 3 lay perpendicular to 1 immediately to the west of the font. Both walls were 0.4 m wide and 0.22 m high, consisting of rough chalk and limestone blocks, partially faced limestone (both varying in size) and occasional hard-fired red brick, typically 150 mm x 65 mm x 225 mm. The walls were irregularly coursed and bonded with hard grey-white mortar. The west end of wall 1 was cut into wall 2, while wall 3 abutted wall 1.

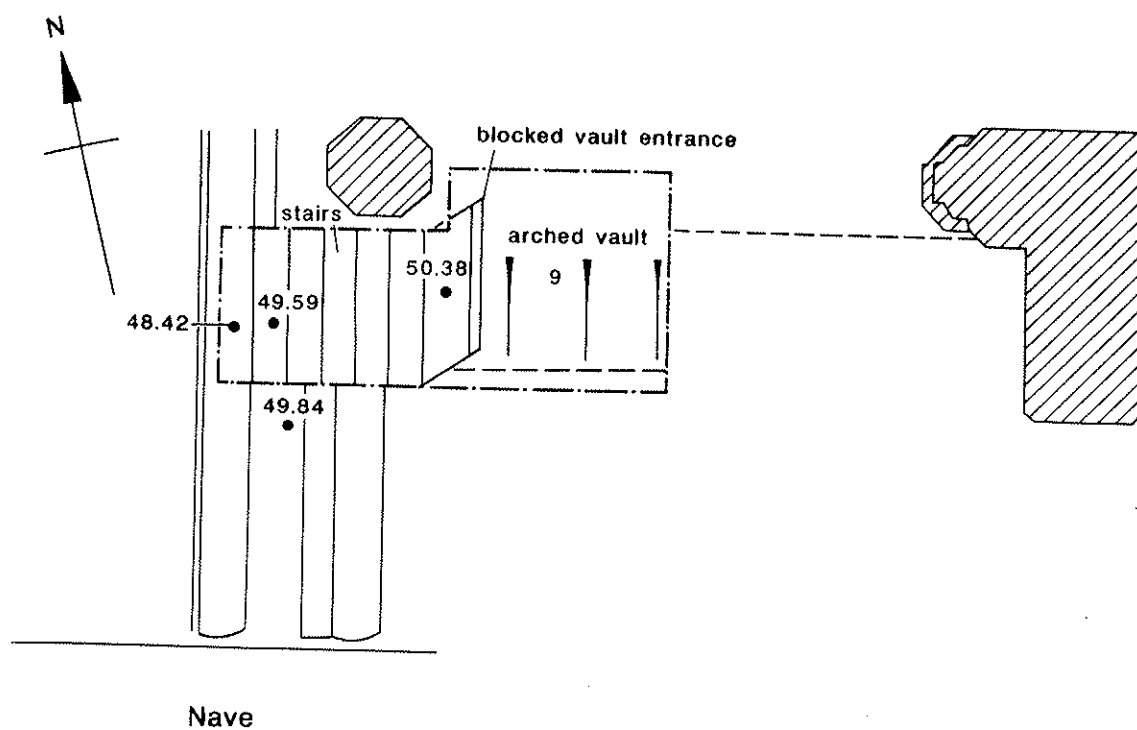
figure 3

A section of floorboards had been lifted between the nave and north aisle (see Fig. 3) revealing an underground brick structure. It was built with red/orange-red hard fired bricks measuring 150 mm x 65 mm x 225 mm with hard grey-white sandy mortar. The structure comprised a staircase (five steps measuring 0.225 m x 1 m x 0.20 m depth) leading down to an arched vault. The entrance had been sealed with a hard mid grey concrete/mortar. The staircase and vault lay within brick retaining walls constructed around a column foundation/base. The complete extent of the vault was not discernible due to the floor support walls built onto the structure.
