# Rectory Farm Barns, Great Shelford, Cambridgeshire

## Historic Building Survey

June 2013

OA East Report No: 1472

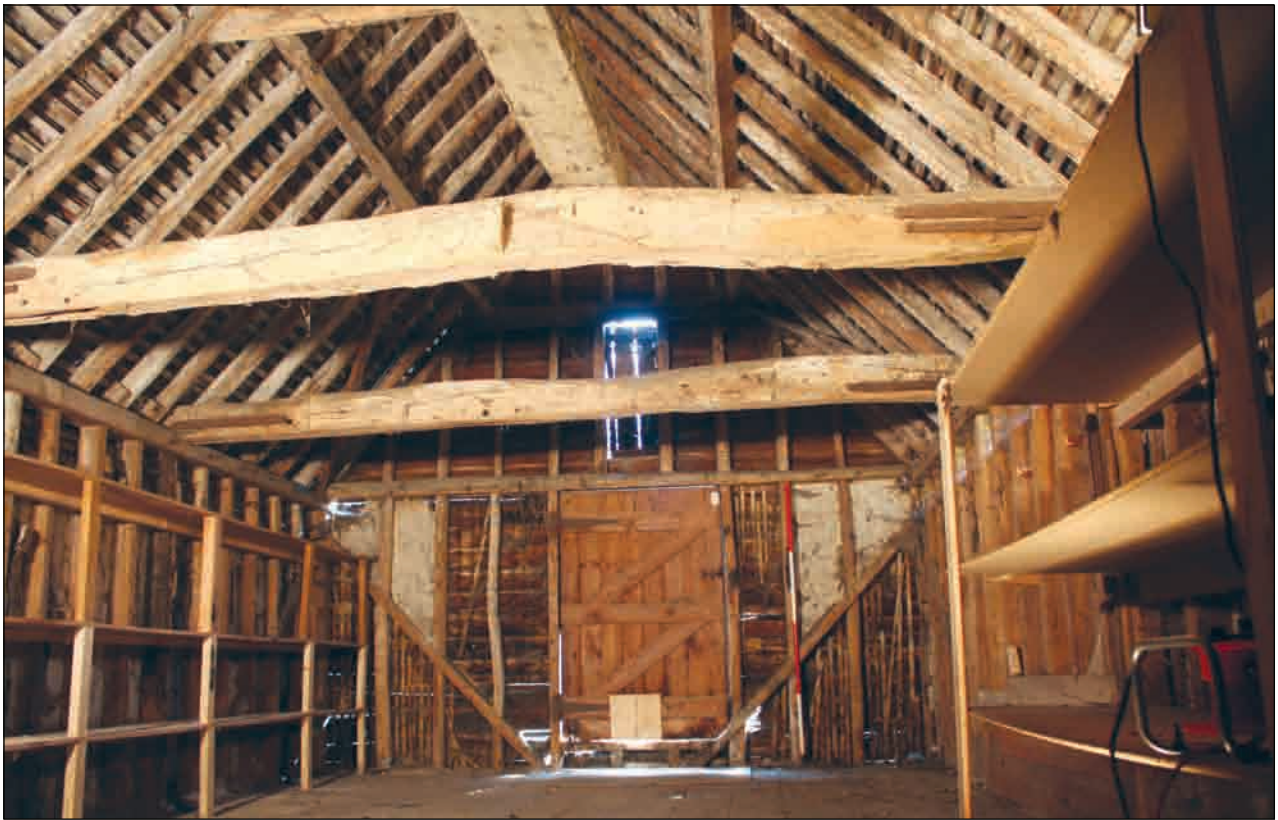
Plate 13: Interior of Building 1

- 4.1.17 The height / position of the loading door noted on the external elevation in relation to that of the tie beams suggests that there could have been a small storage area above (Plate 13) – this is more likely given size of the the remaining roof space than an entire first floor.

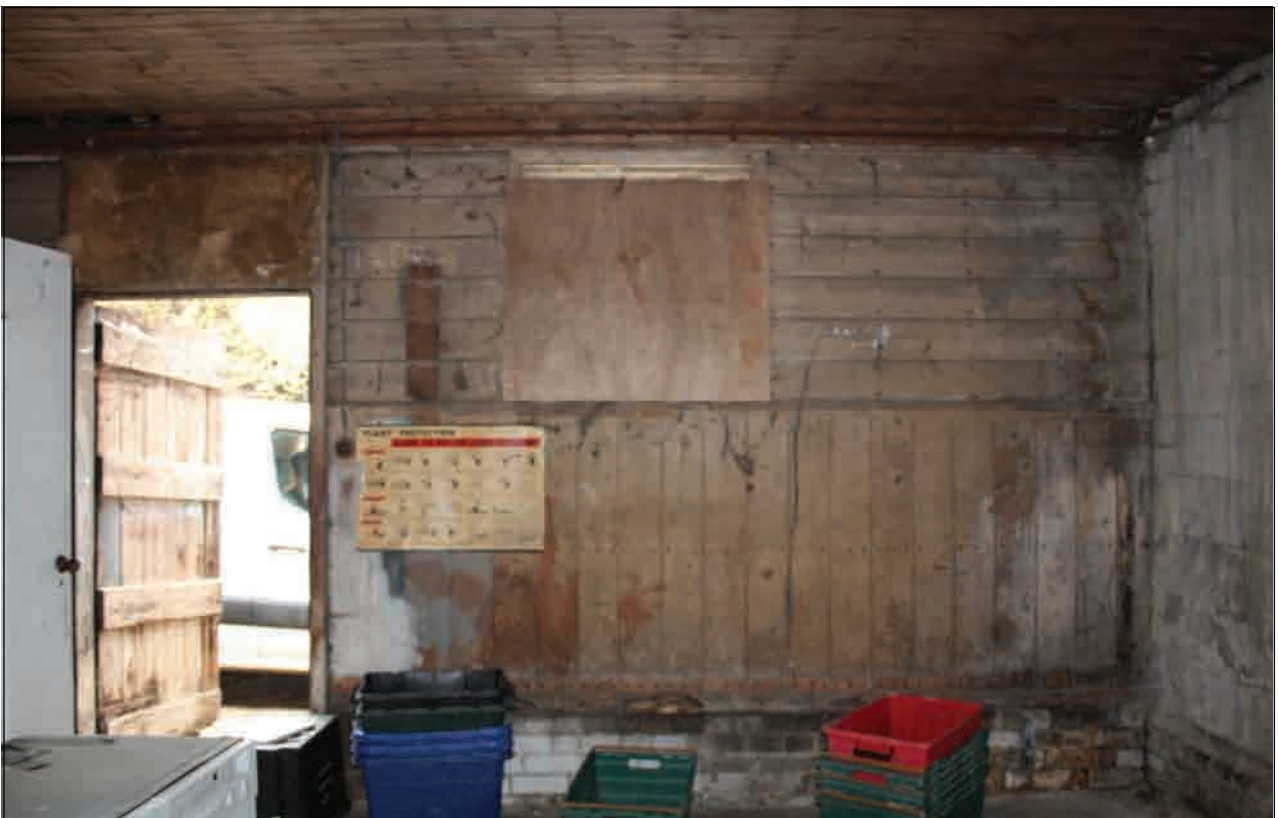
Plate 20: Room G1 interior, Building 2

- 4.2.12 Accessed from the northern-most door on the west-facing elevation, G1 was being used for storage at the time of the survey. The floor was covered in concrete, the ceiling covered with dark-stained tongue and groove boards and the walls were all exposed revealing their original construction materials. To the immediate left on entering, was the brick plinth and clunch block wall of the southern elevation of Building 3 (Plate 19). The opposite wall on entering comprised the flint wall with upper brick courses as noted on the east-facing external elevation. Like the ceiling, the internal wall on the entrance side was covered with tongue and groove boards, wider than those on the ceiling (plate 20).

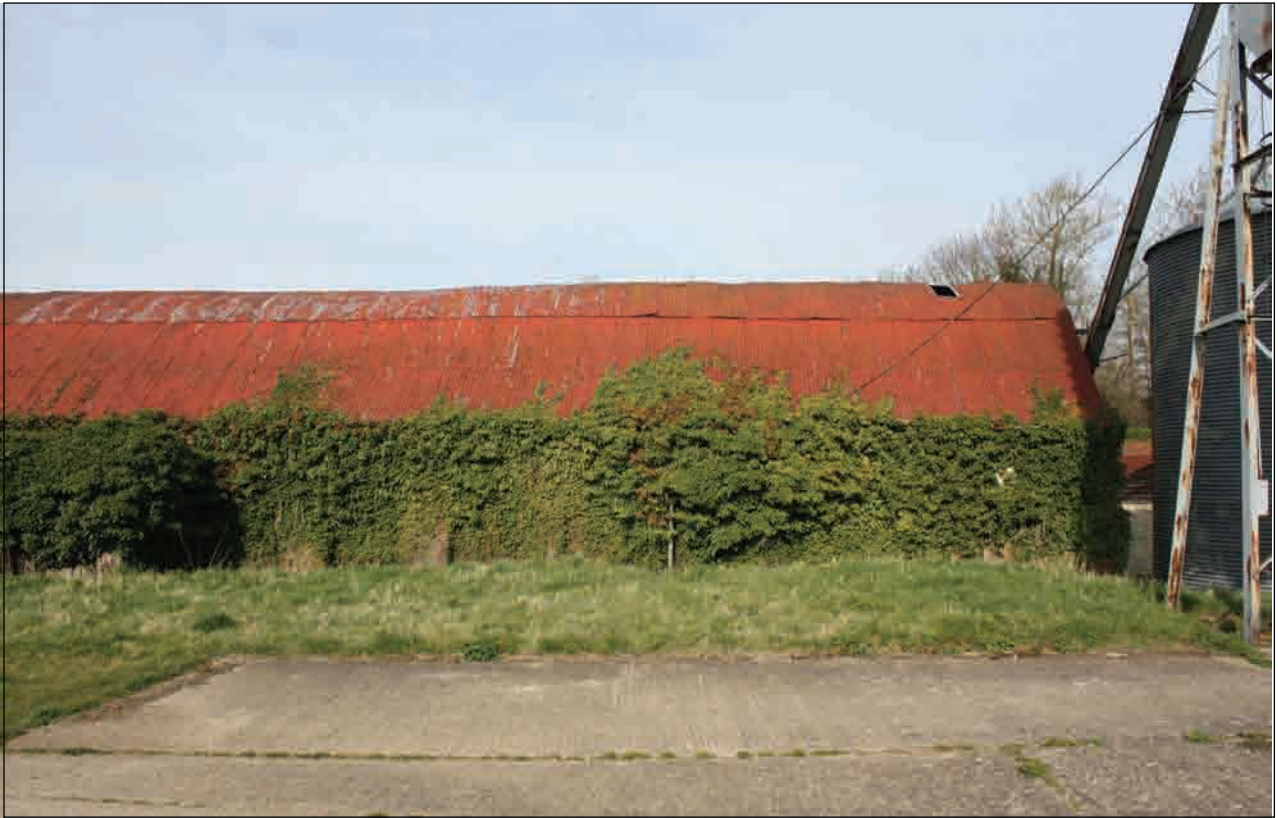
Plate 36: East-facing elevation, Building 3 (northern end)

- 4.3.11 To the immediate right/north of the doorway there was clearly some damage to the original building either through damp or from the addition of this extension. As a result, some of the remaining clunch blocks had badly deteriorated and the lower part of the wall had been under-pinned with modern “feather” textured bricks with an average dimension of 22cm x 6.5cm x 10.5cm (Plate 35). An external tank fed fuel into the building via a pipe.
- 4.3.12 The remaining part of this elevation towards the north was entirely obscured by vegetation, other than two brick buttresses (Plate 36).

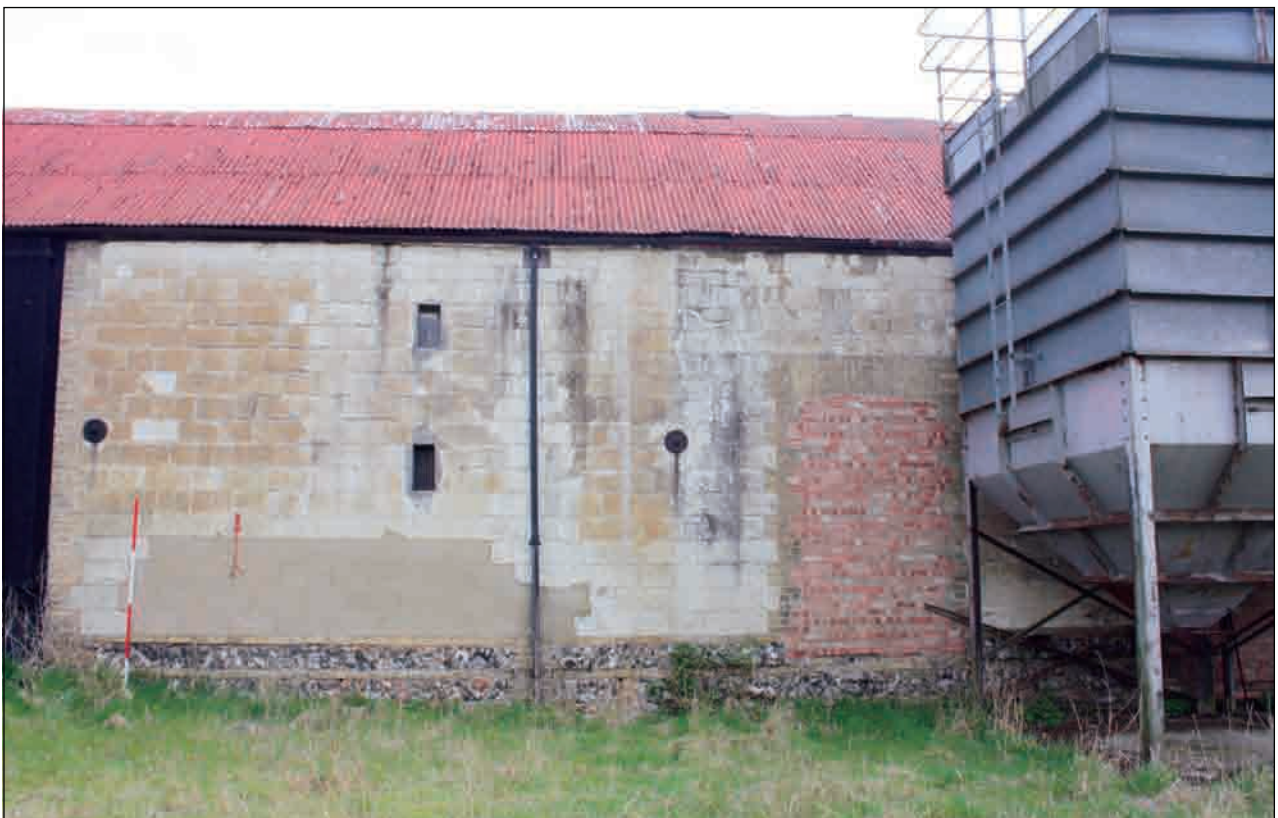
Plate 43: Ventilation openings, structural tie and blocked-up door, west-facing elevation, Building 3

- 4.3.20 Further along this elevation towards the right of the doors were more structural ties and two more ventilation openings as well as a blocked-up doorway (Plate 43). This opening was blocked-up using a pink coloured 20th century brick as used in the construction of the entrance on the north-facing elevation. The 19th century buff coloured bricks of the surround/opening and arch above are contemporary with those noted on the northern end of this elevation and around the barn doors, indicating an original opening in this location.

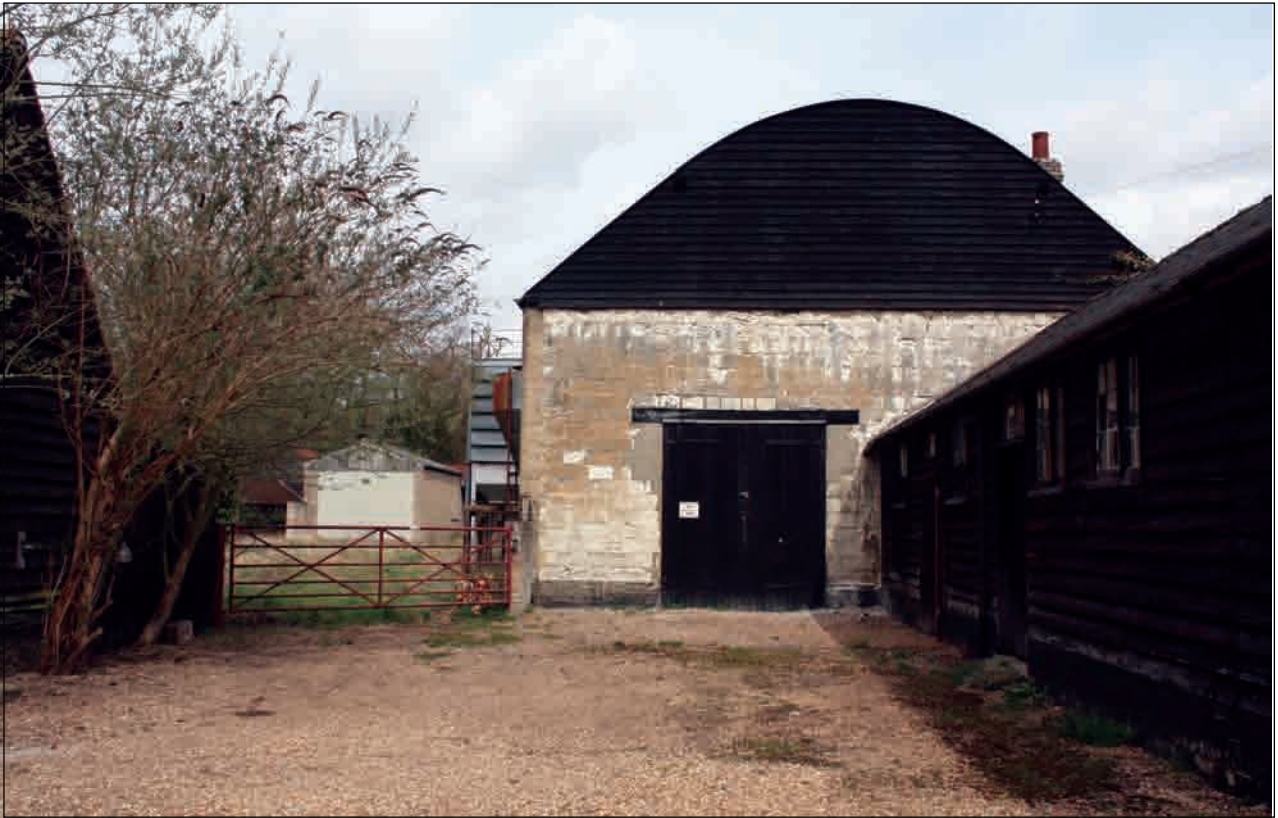
Plate 46: South-facing elevation, Building 3

- 4.3.23 The south-facing elevation faces towards Church Street and is partly obscured by the later addition of Building 2 (Plate 46).
- 4.3.24 There was a small set of double doors providing access into the building at this end. Cement repairs around the opening and the wooden lintel indicates that this was not an original opening and was most likely added or an existing opening made wider after Building 2 was added.
- 4.3.25 This elevation had a brick plinth and quoinstone effect brickwork on the ends. Horizontally laid weather-boards continued to the roofline.

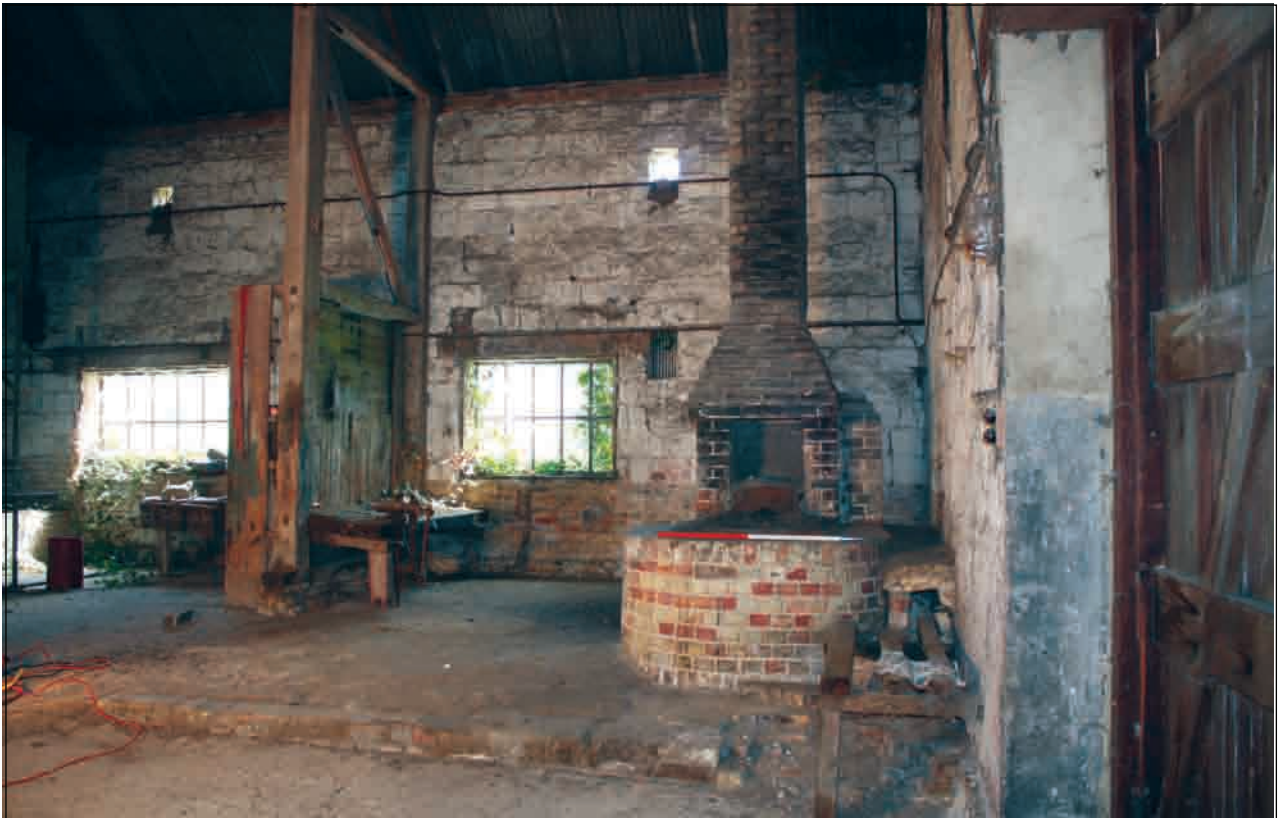
Plate 53: First bay, southern end of Building 3

- 4.3.31 There was a small brick-built forge in the first bay at the southern end of the building which appears to be a later addition to the original construction with a flue extending through the roof (Plates 52 and 53). Although thought to be a later addition, it was probably no later than late 19th century in date and may indicate that this end of the barn had a secondary function in this period, although no forge was noted on any of the Ordnance Survey maps produced around this time.

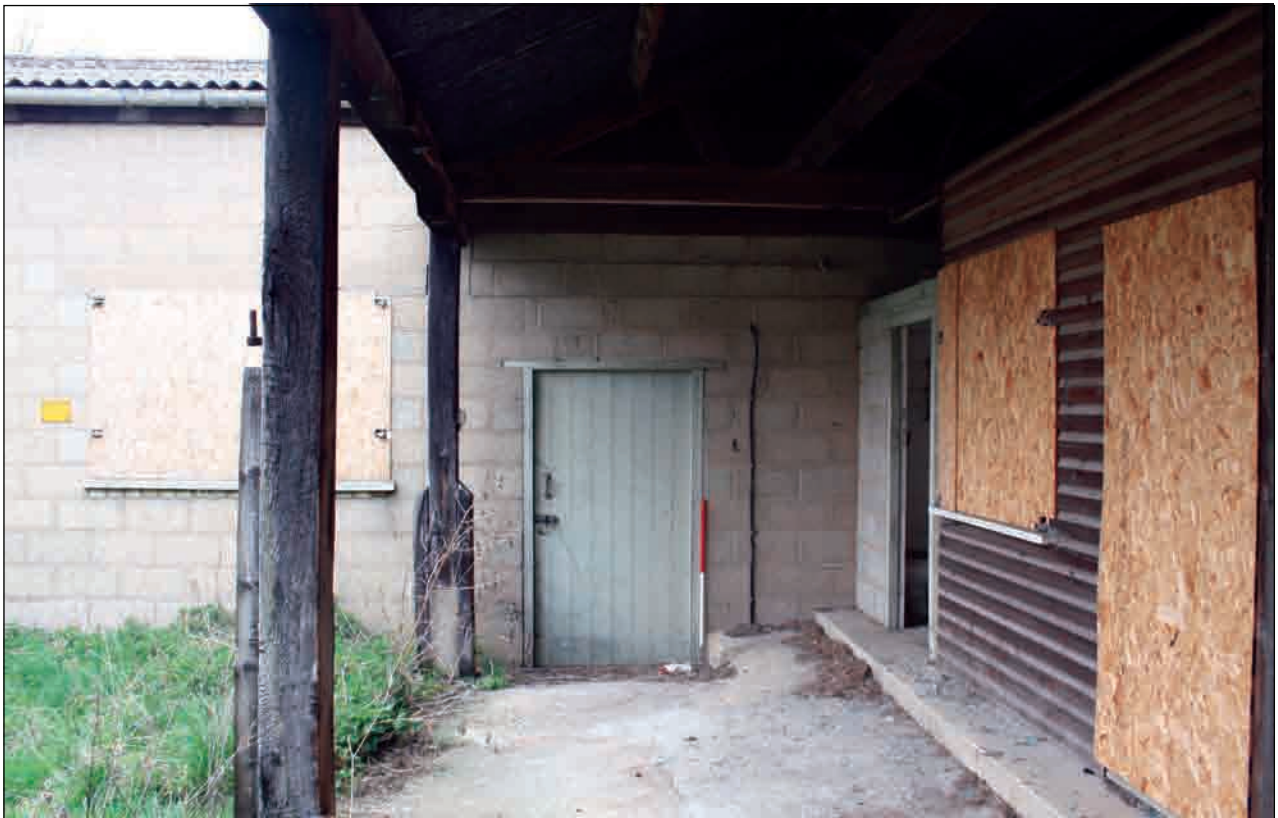
Plate 62: East-facing elevation, Building 4

- 4.4.14 The interior of the shed had little/no features of historical or architectural interest. The floor was covered with concrete and the roof structure was a modern replacement with machine sawn timbers. The rear and right-hand walls (on entering) comprised exposed brick as recorded on the corresponding north and east-facing elevations. On the left on entering was a sub-dividing wall created by the later addition of the breeze-block extension, with door for access (Plate 62).

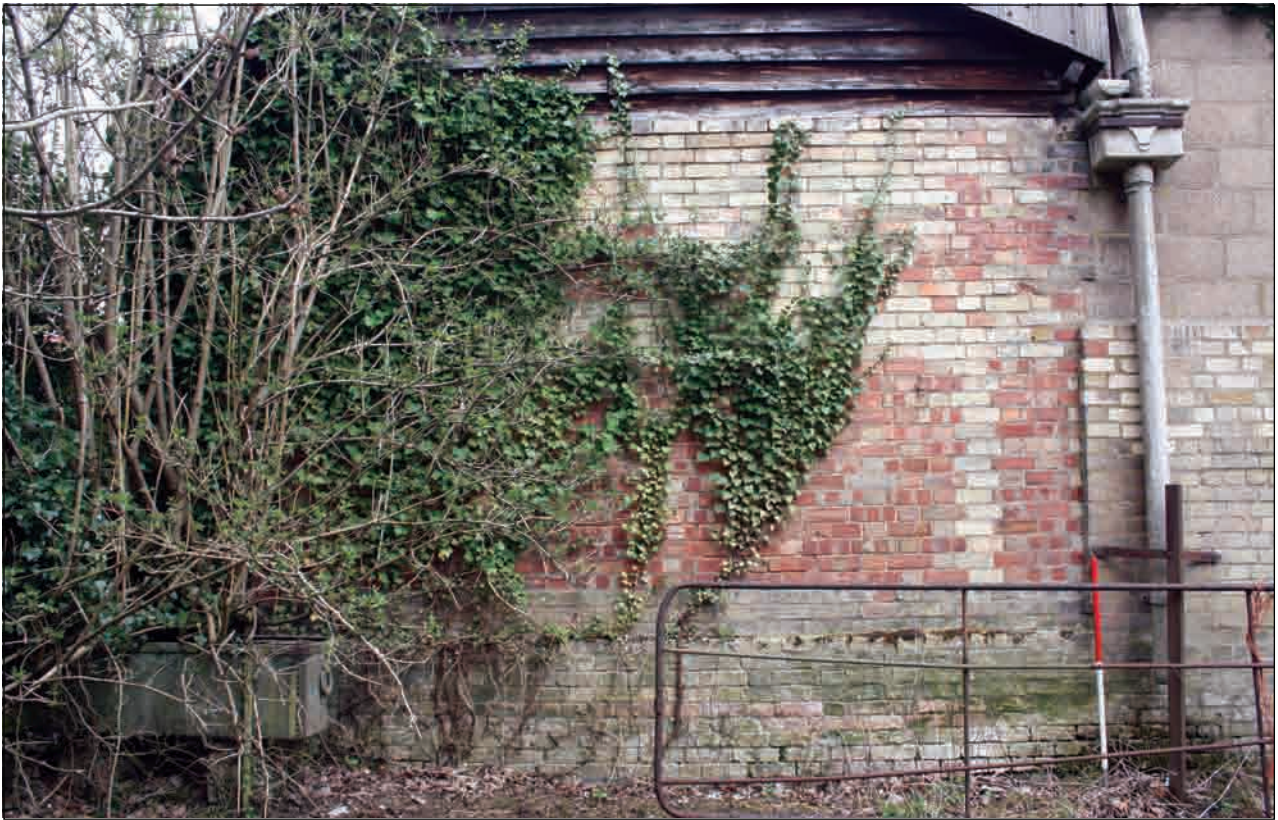
Plate 63: West-facing elevation, Building 4

- 4.4.12 On the left-hand side of this elevation is the other gable end of the brick-built shed (Plate 63). As noted on the north-facing elevation, there appears to have been some re-building of this elevation. The lower courses of brick are as noted on the north-facing elevation and two later phases of re-build/repair are clearly visible with the use of a pink and then a light buff-coloured brick. There were horizontally-laid weather-boards to the roof-line.

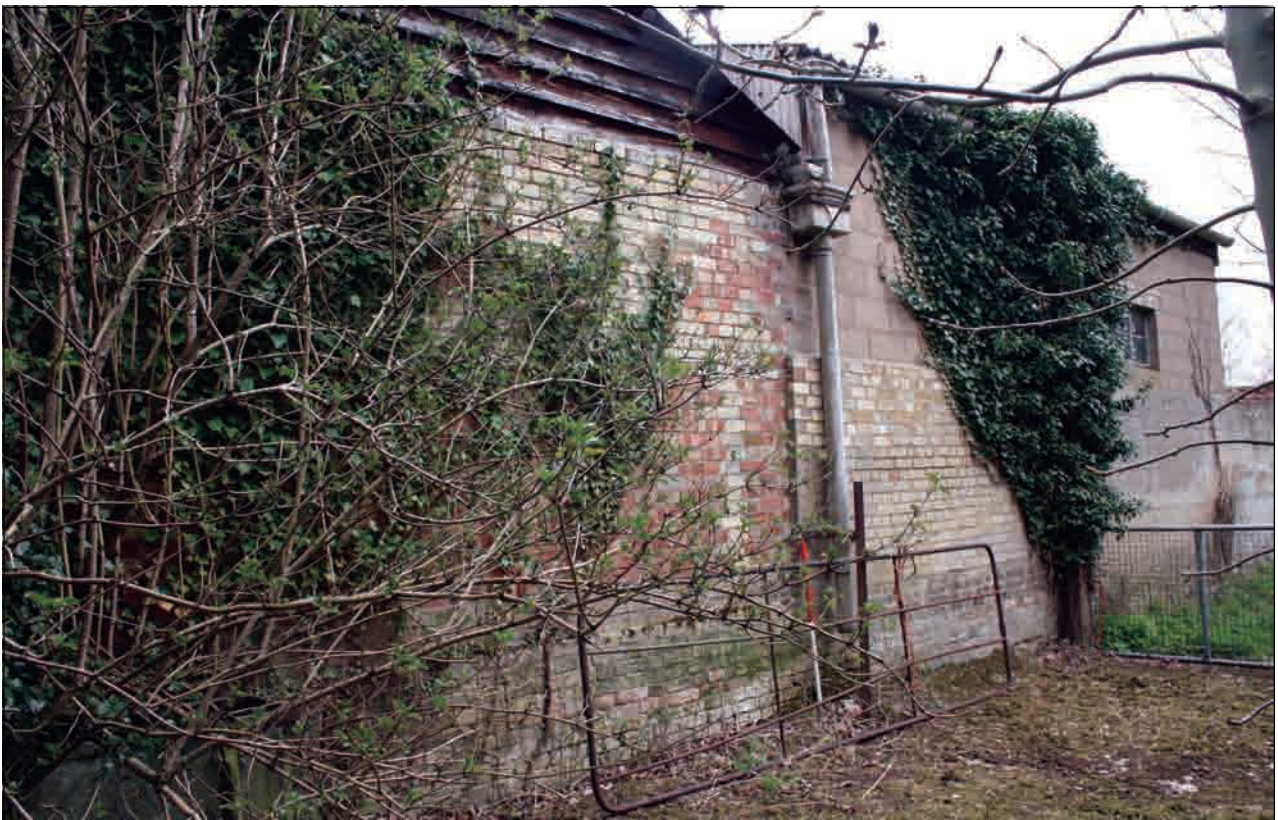
Plate 64: West-facing elevation, Building 4

- 4.4.13 To the right, is the breeze-block construction (Plate 64). Immediately in front of this is a single skin brick wall with two phases of construction – the lower courses appear contemporary with those noted at the base of the open-fronted shed. Upper courses of the wall above are a later buff-coloured brick. This wall is depicted on the 1970-71 Ordnance Survey Map (Figure 9). The breeze-block building has been constructed on top of this wall with a tri-part casement window with concrete cill and brick header lintel.

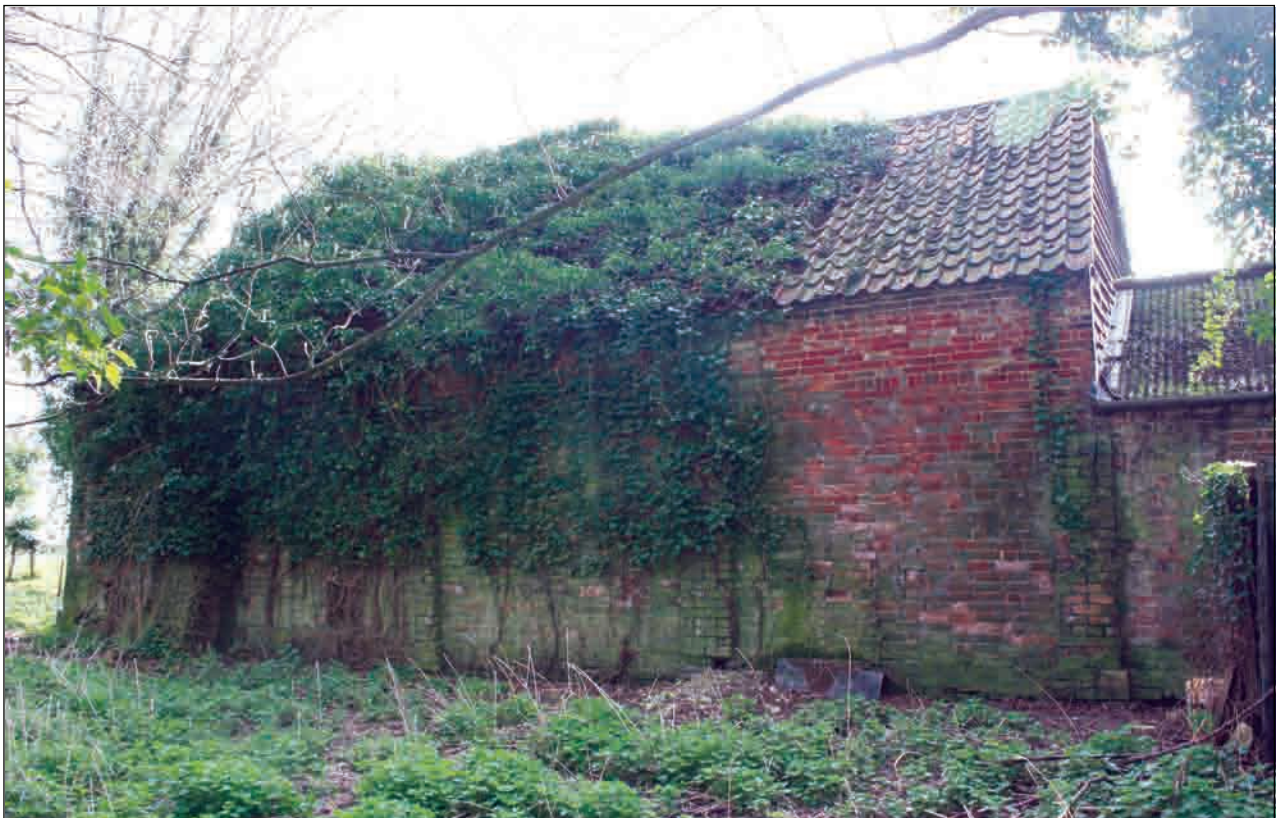
Plate 70: West-facing elevation, Building 5 (north)

- 4.5.7 This elevation faced into a small wooded area outside of the development area and beyond the boundary of the farm. Mostly obscured with ivy, the brickwork was the same as that noted on the previous elevations (Plate 70). There were however, short courses of headers which initially were thought to be former openings, yet closer inspection did not identify any blocked-up windows or doors and these are therefore more likely to be structural repairs or indication of a former lower roofline.

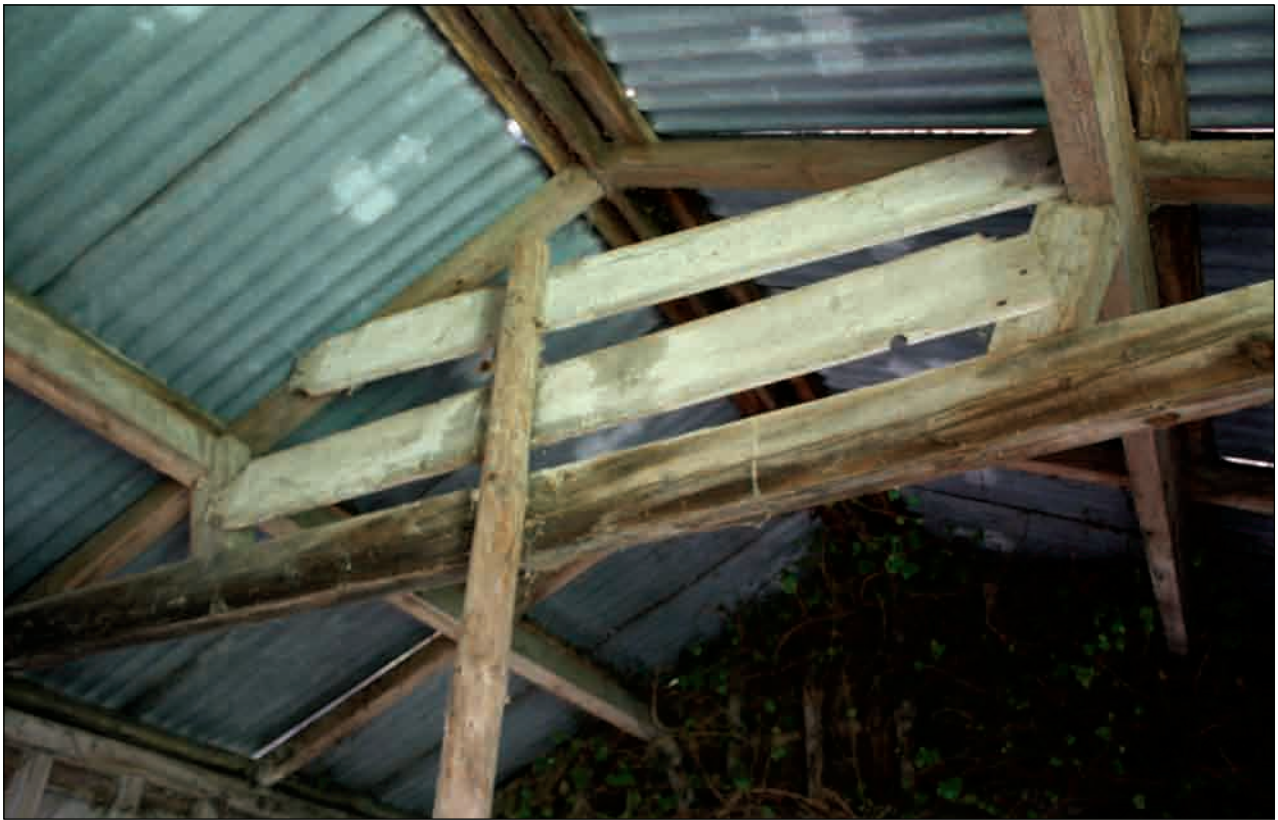
Plate 90: Modern/repaired roof structure, Building 7

- 4.6.11 The roof had been replaced and the asbestos sheet covering was fully exposed. The roof structure had been repaired and additional support added by vertical ties and from a vertical timber post (Plate 90).
