Park Attwood Farm
Bewdley
Worcestershire

Historic Building Recording Report

January 2007

Client: Neil Price

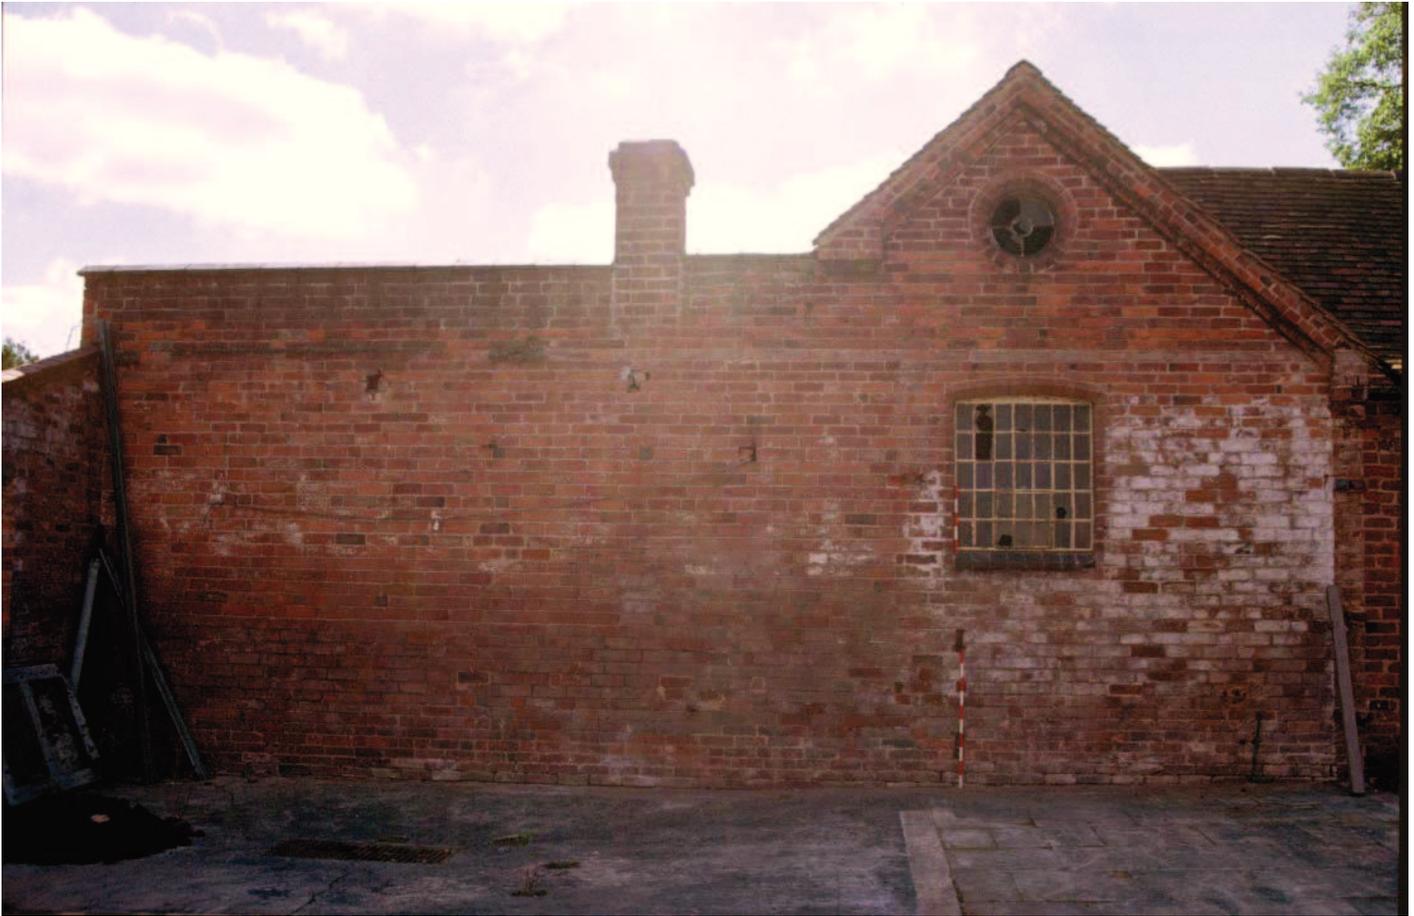
- 3.2.3 The north western gable wall has had its left side raised by approximately ten brick courses during the addition of the external storage extension, the extension was bonded into existing brickwork beneath this point. Care has been taken to replicate the brickwork pattern on the roofline corncicing.

Plate 5: Park Attwood Farm, north elevation - amended gable height to accommodate high wall of extension (01/03)

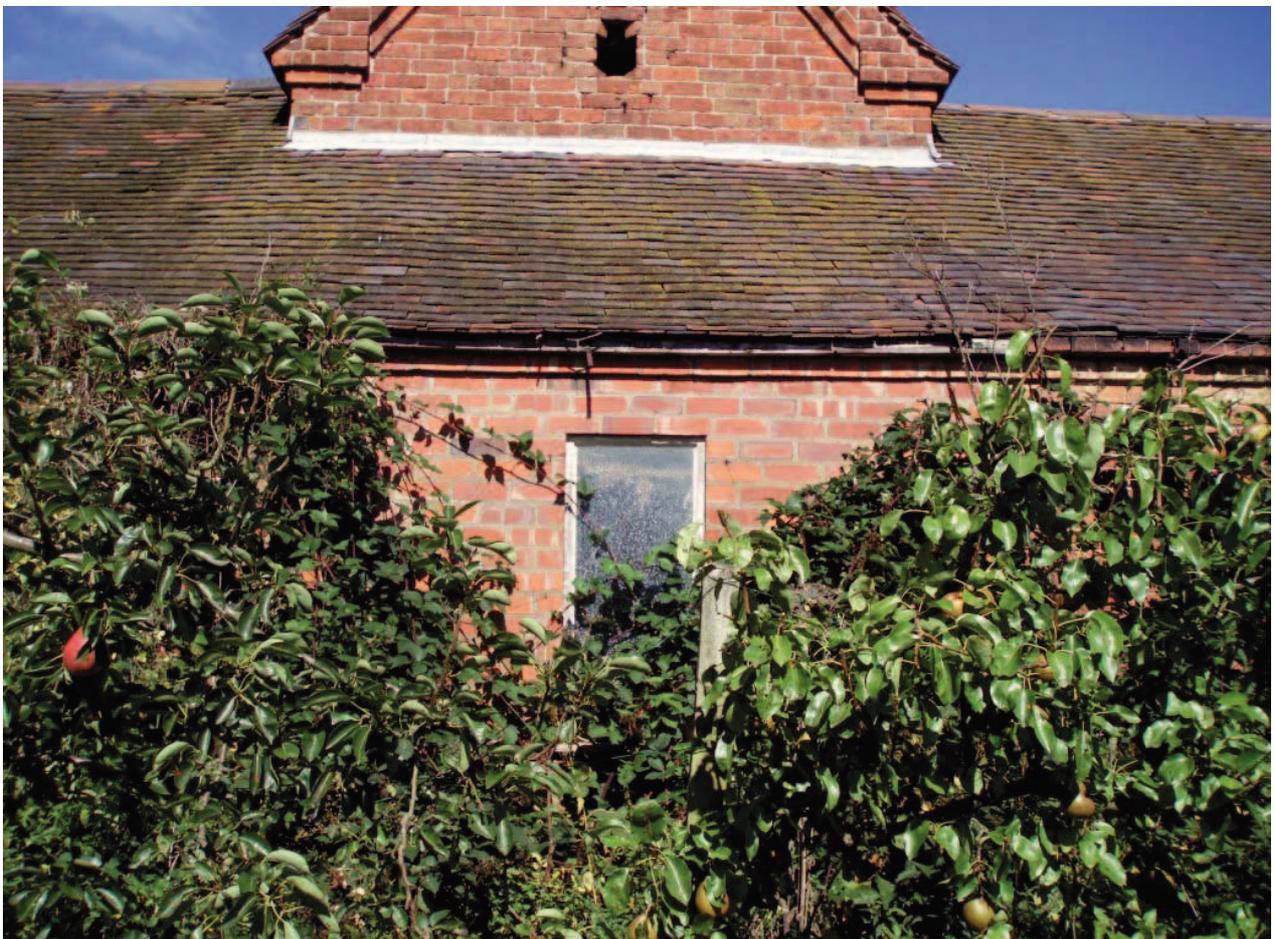
- 3.2.27 Directly beneath the central tower is a section of brick wall with a modern rectangular window within. The wall is of stretcher bond and the straight joints with the original brickwork are hidden by bushes. The cornice header course has been replaced at this point by a length of timber. The window is modern, rectangular in shape with a wooden frame and single pane of frosted glass. This section of walling encloses what was an external covered area (see room 4 below for further details).

Plate 6: Park Attwood Farm, south elevation - exterior of wall enclosing Room 4

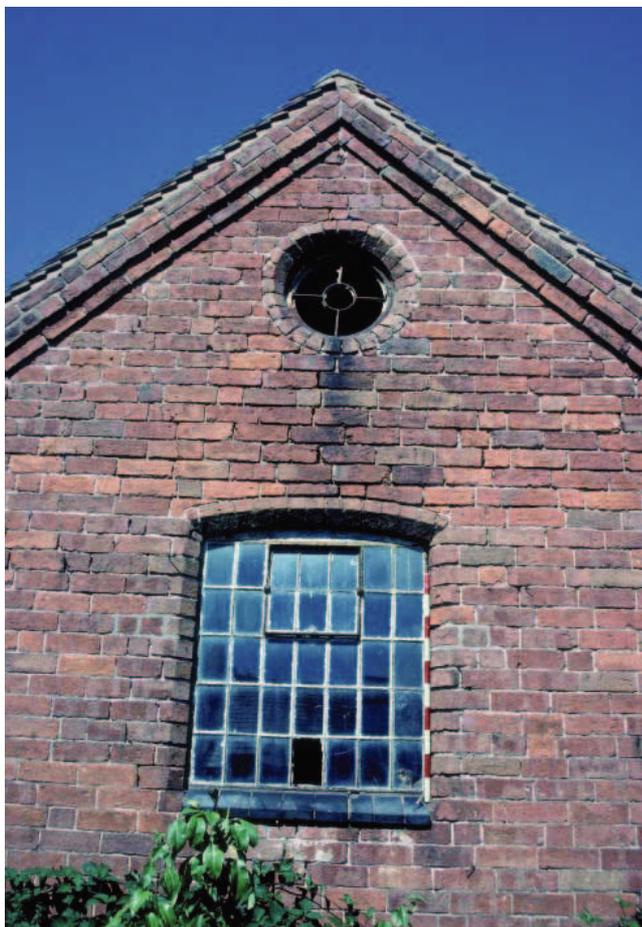
- 3.2.23 The south western gable mirrors the other gable with a small circular window and an arched window beneath. There is evidence of brick replacement and remortaring at the same point either side of the arched window suggesting there was once a fixture at these points which has since been removed and repairs have taken place. There are nails within this wall and the area within the nails shows less weathering than the rest of the wall indicating that at some point the wall was sheltered.

Plate 7: Park Attwood Farm, south elevation
- detail of windows in gable wall (01/33)

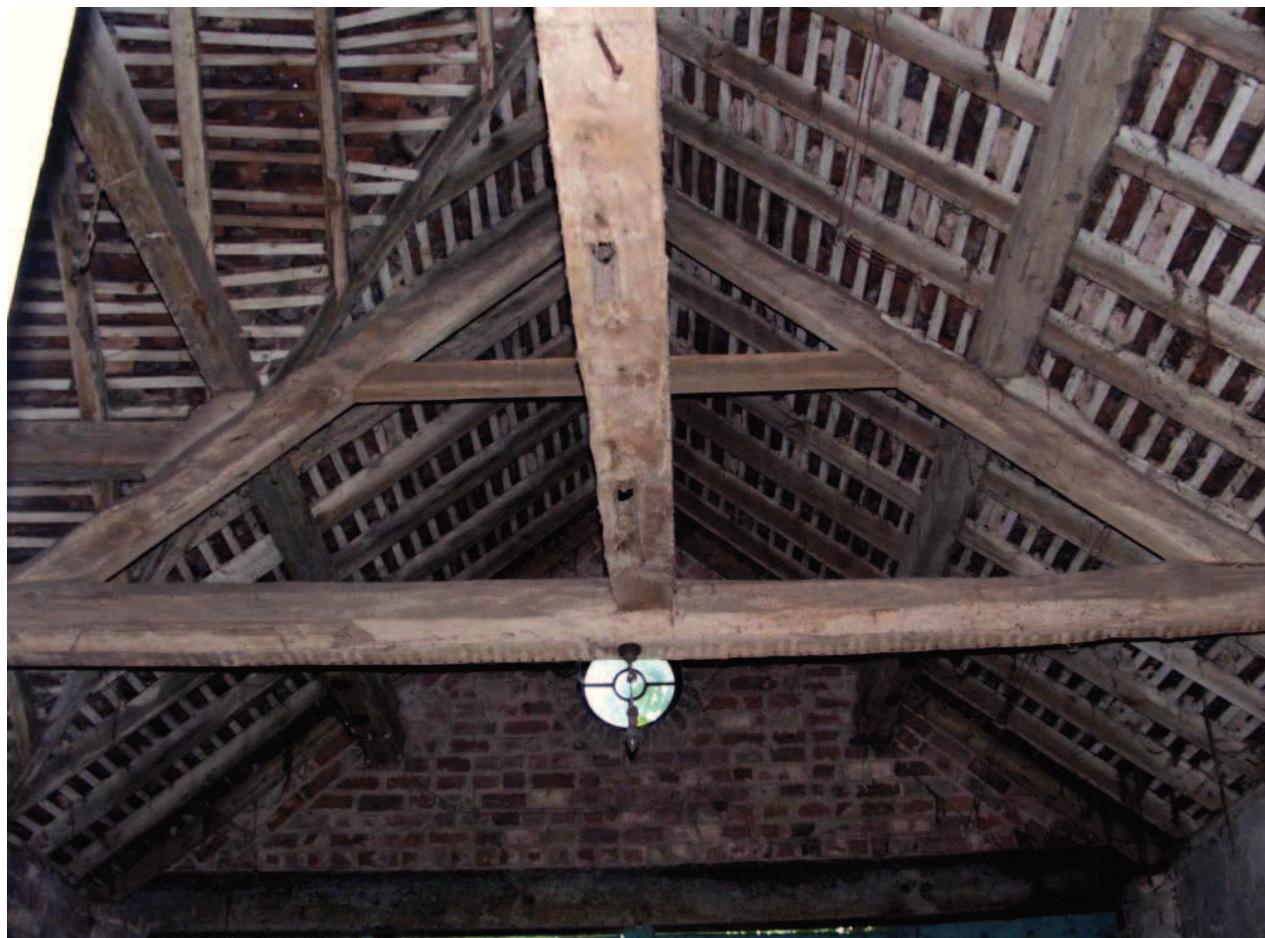
- 3.3.2 The collar rafter roof is formed with a reused truss - the apex does not touch the roof and the purlins are not supported by the truss but by cleats which are attached to the truss. The roof frame has extra support in places by the addition of wood held on with iron pins. The cross beam is probably pine and there is a row of nails and lath and plaster marks underneath showing that there was a ceiling at one time. The collar purlin goes from the central truss to the front wall and has mortice holes on the underside, which suggest that this is reused timber as there is no other evidence for a room division.

Plate 8: Park Attwood Farm, roof structure in Room 1

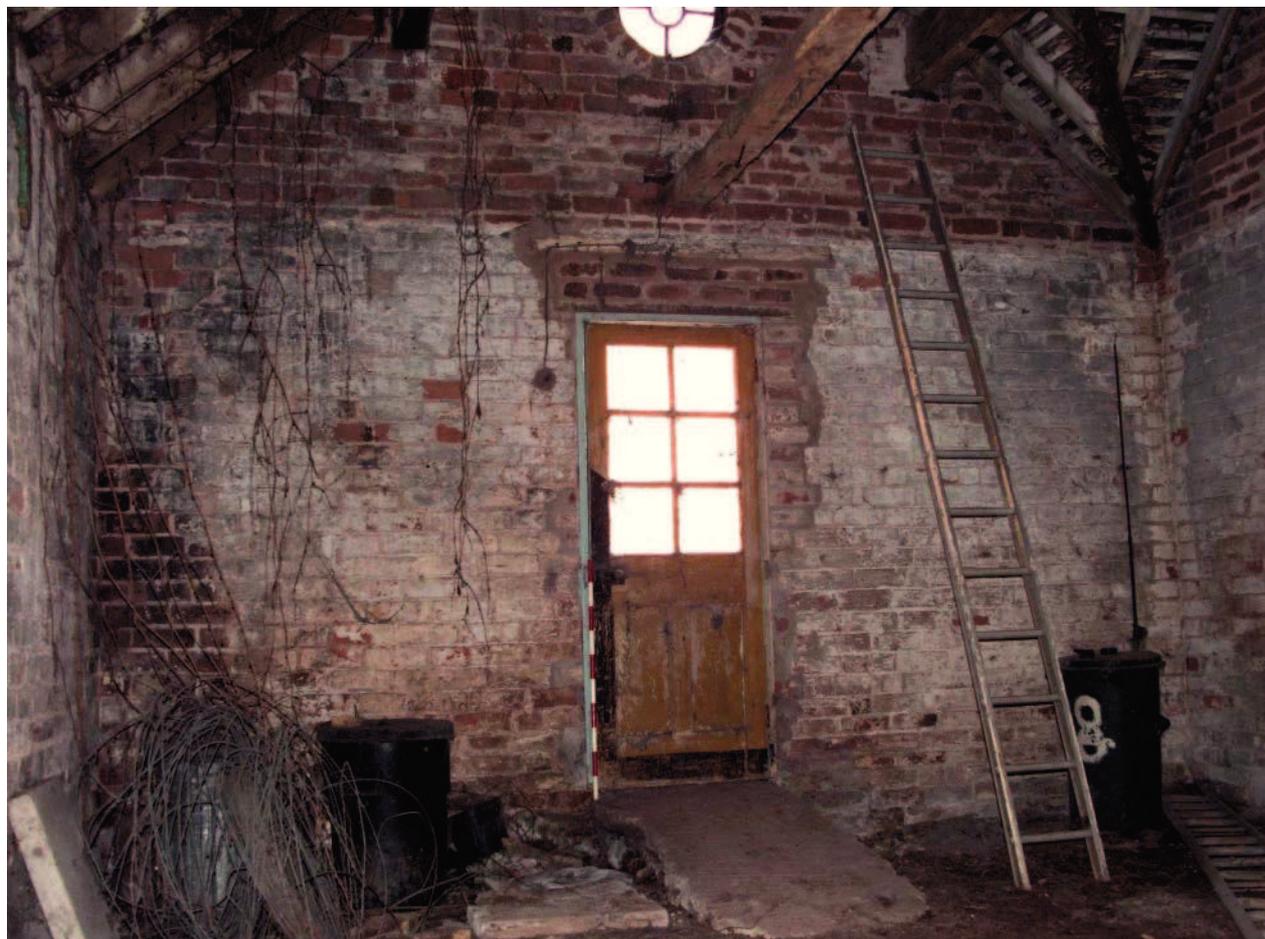
- 3.3.5 The walls have white paint upon the lower section, whilst the upper part of the walls are unpainted, indicating that there once was a ceiling in this room.

Plate 9: Park Attwood Farm, interior of Room 1

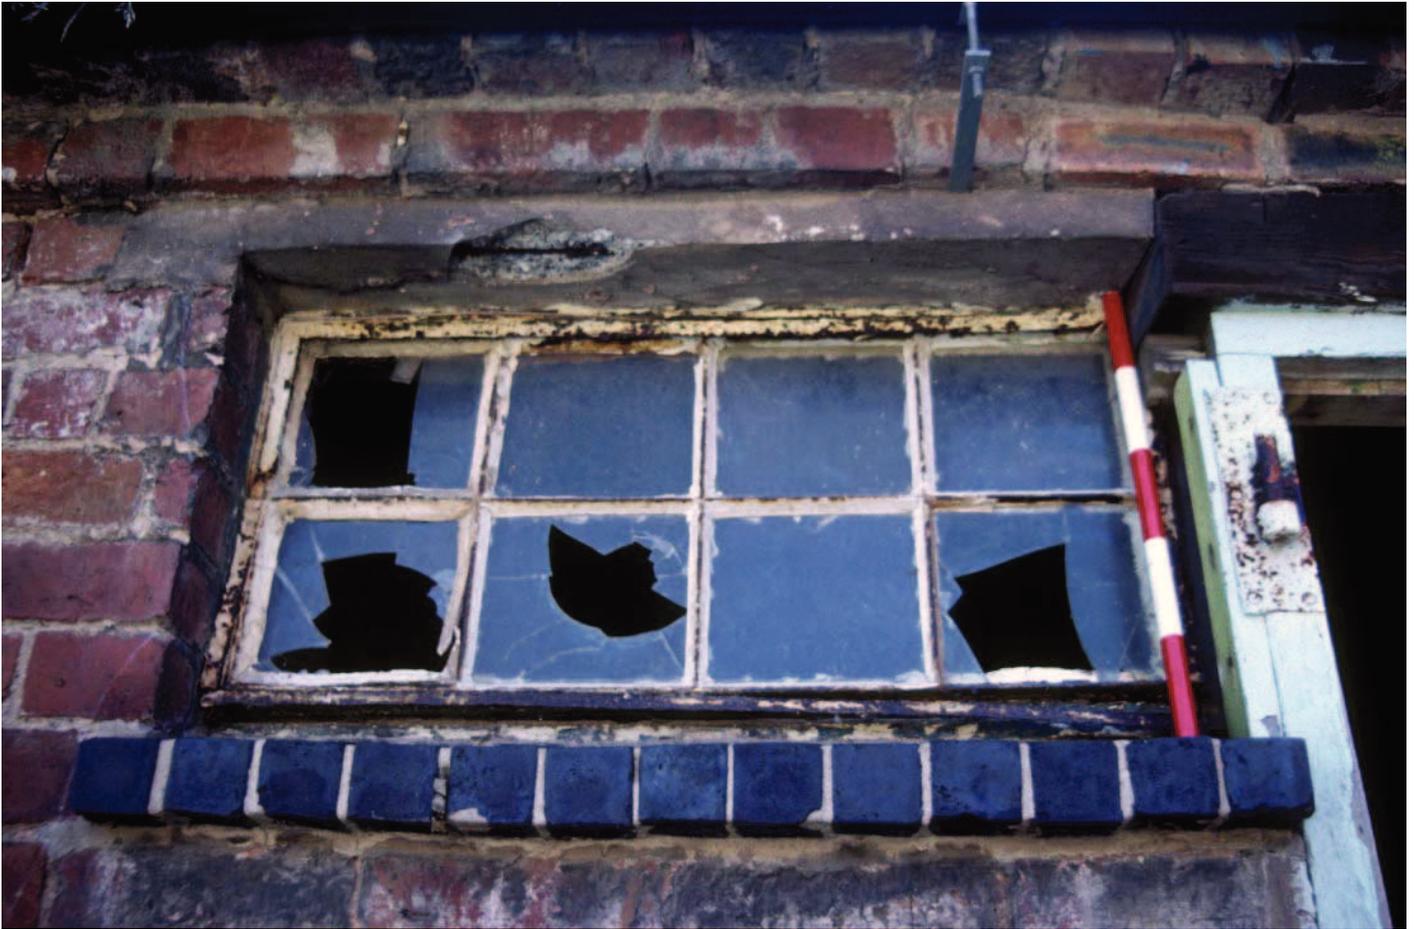
- 3.2.6 The fenestration has been altered by three high level windows which have been inserted into this elevation. These windows have shaped reinforced concrete lintels and straight brick jambs. Black engineering bricks (6 x 6 x 12cm) are used for the sills and the slant of the sill is less than in the original windows. There are mortar repairs around these windows showing they were inserted later.

Plate 11: Park Attwood Farm, inserted window on north elevation (01/35)

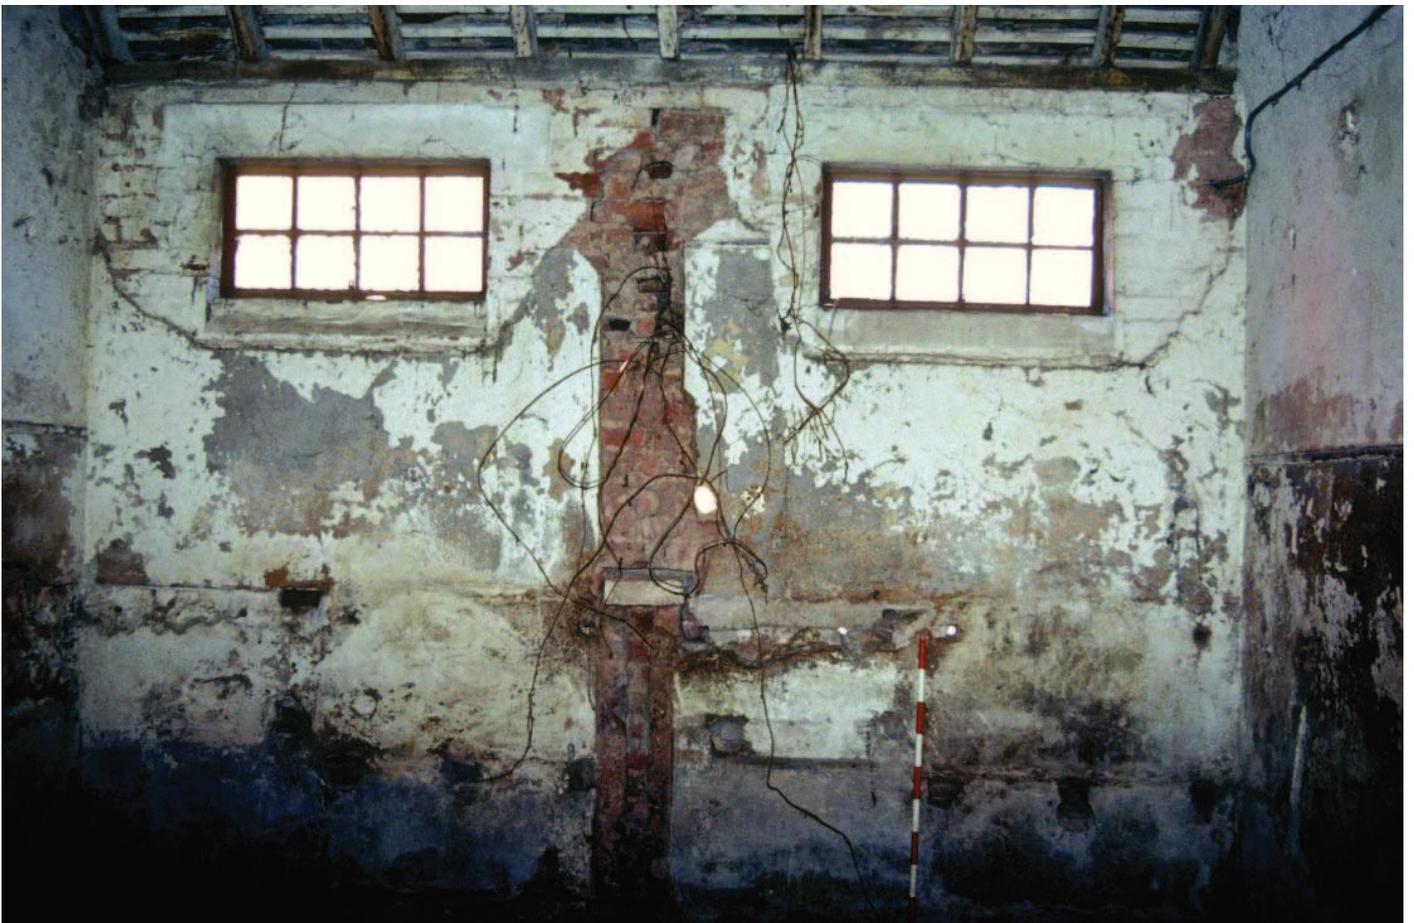
- 3.3.7 The position of the dividing wall can be seen on the front wall. The lower section of this appears to have been bonded into the external wall. The metal fixtures for mangers can also be seen on this wall.

Plate 12: Park Attwood Farm, interior of Room 2 - location of stalls and manger fixtures (02/19)

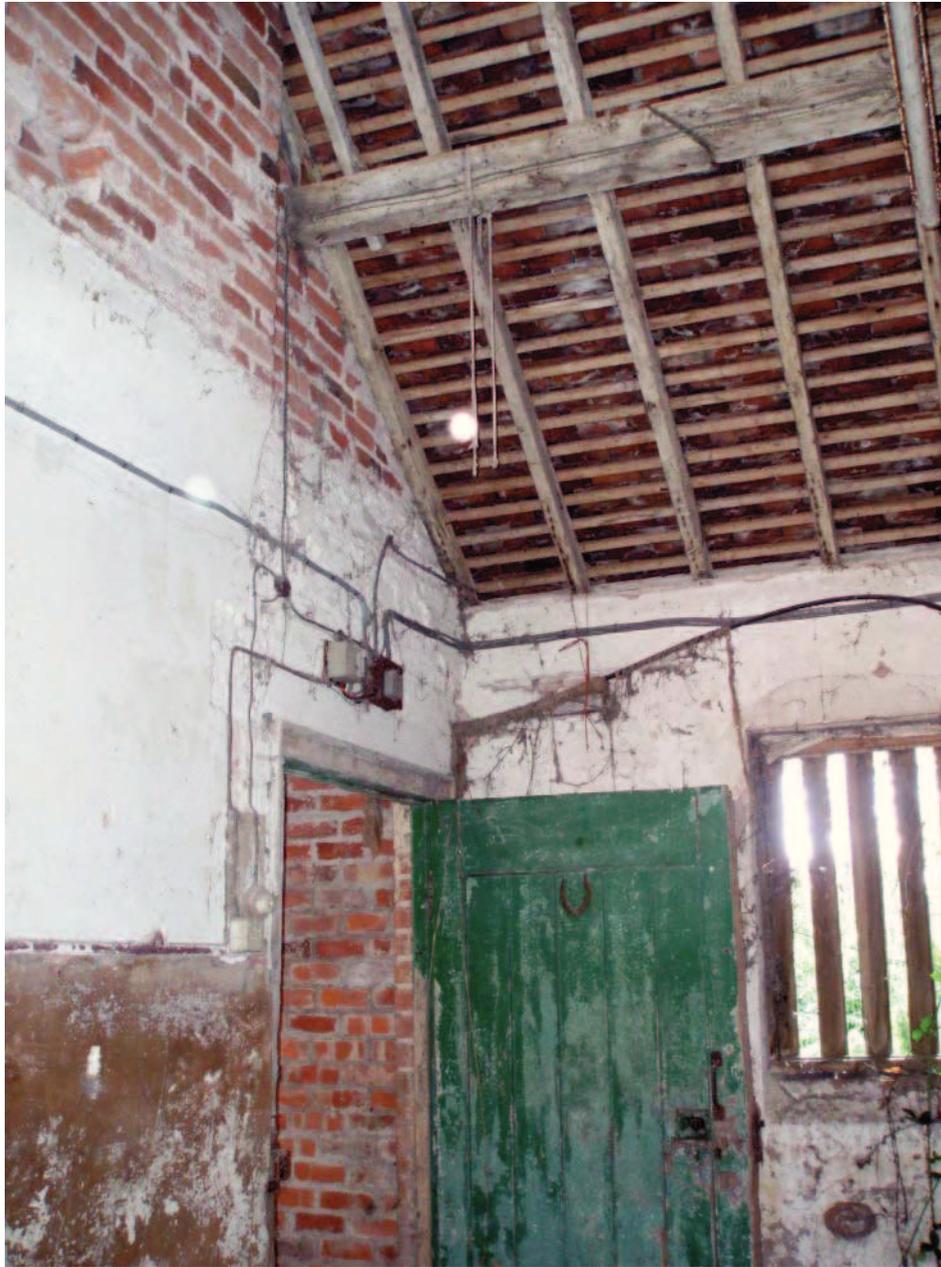
- 3.3.8 The wall dividing Rooms 2 and 3 corbels in the top half, probably to provide extra support to the tower structure above. The walls have been rendered up to ceiling height.

Plate 13: Park Attwood Farm, interior of Room 2 - corbelling of brickwork beneath tower

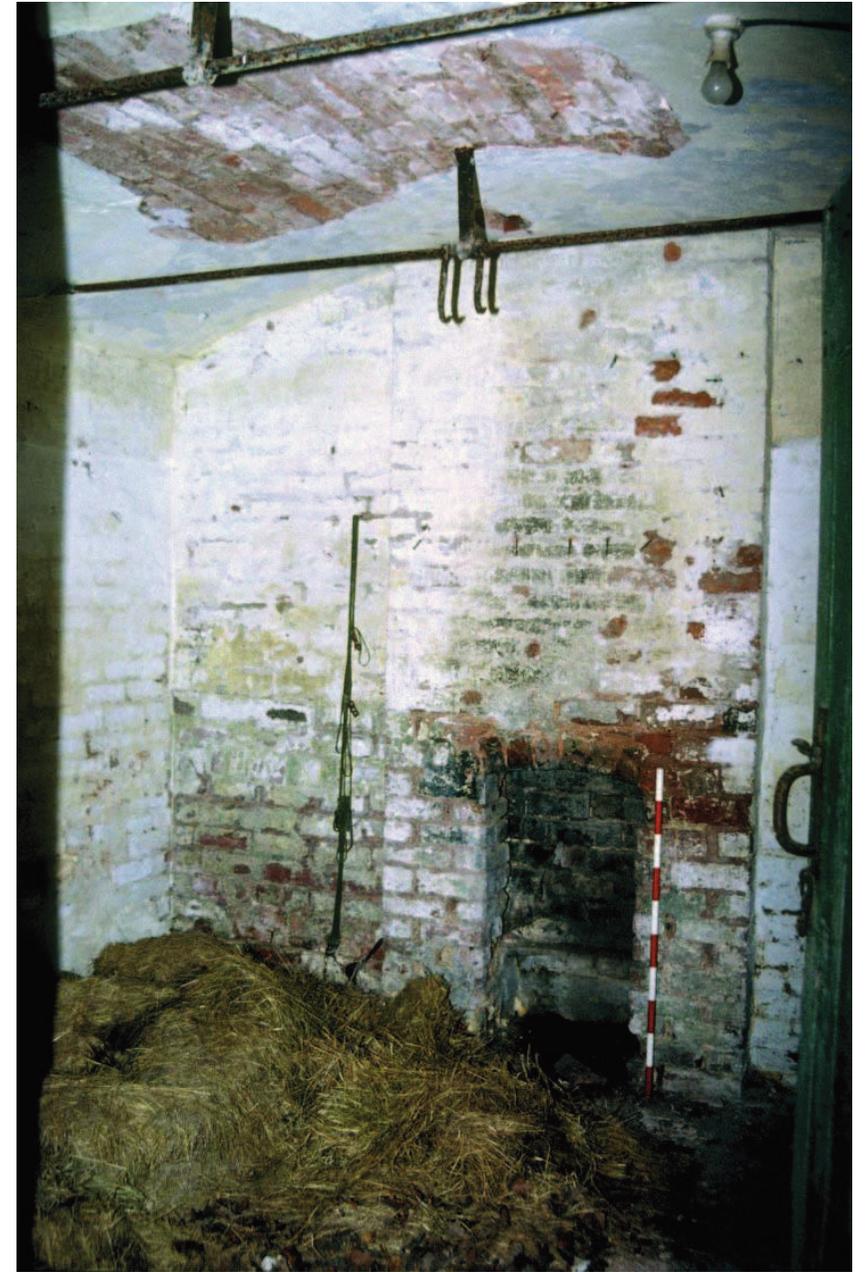
- 3.3.13 Room 3 lies directly beneath the bell tower. The ceiling is arched brickwork and there is a small brick fireplace within a chimney breast in the centre of the exterior wall. Although the room has more recently been used as a tack room, there are metal hooks hanging from rods suspended from the ceiling suggesting that this was originally a curing room.

Plate 14: Park Attwood Farm, interior of Room 3 (02/14)

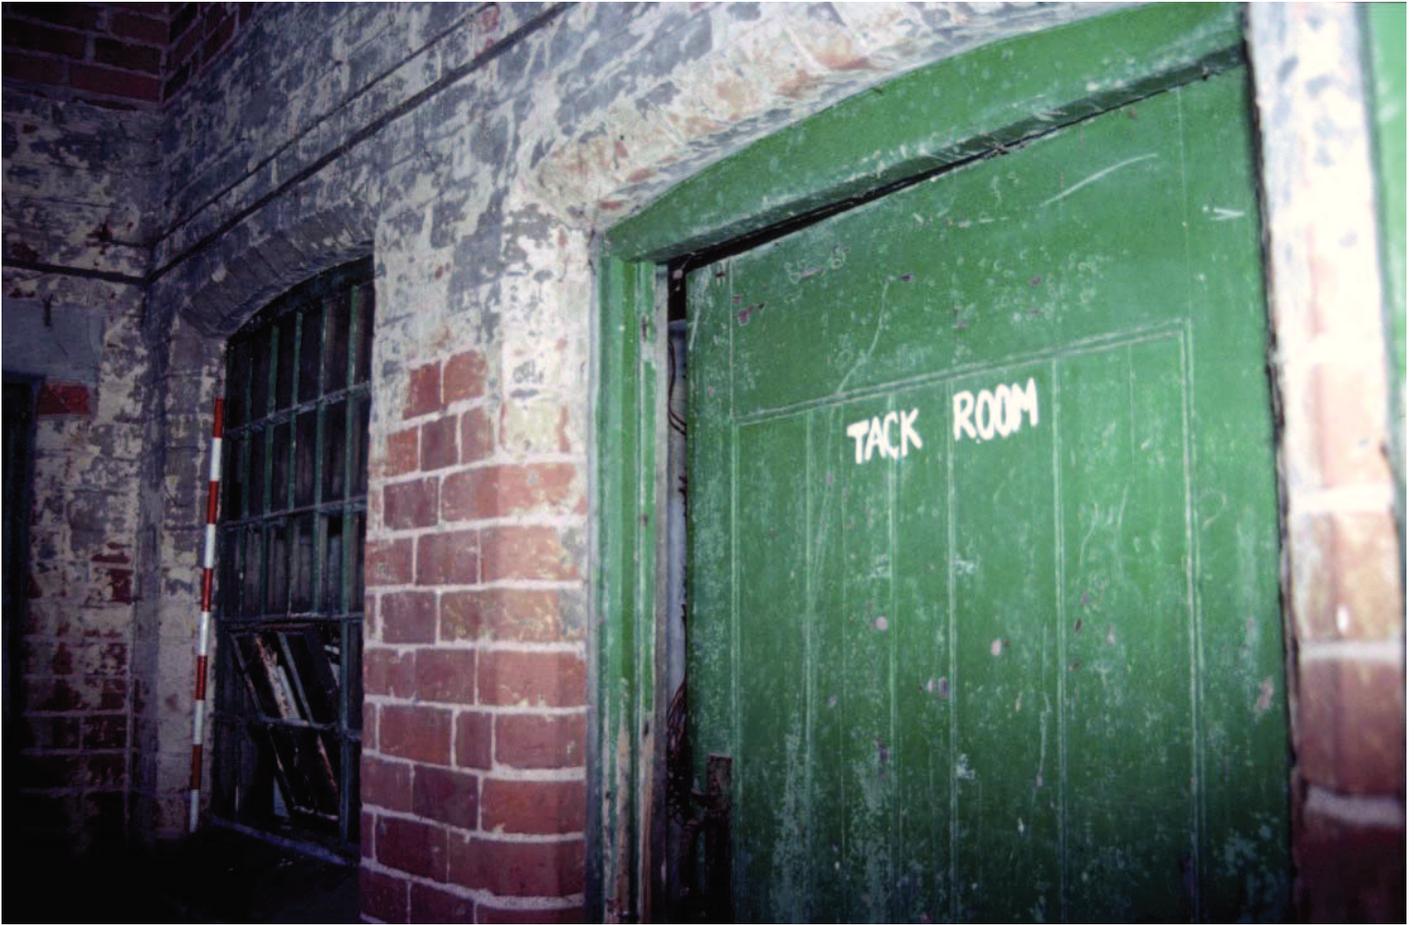
- 3.3.16 Room 4 was originally the exterior of the barn but this section has now been enclosed by a modern brick wall which abuts up to Rooms 2 and 5. There is a rectangular frosted window centred within this wall. There is a concrete lintel to the doorway to Room 5.

Plate 15: Park Attwood Farm, Room 4 - original window and door (02/23)

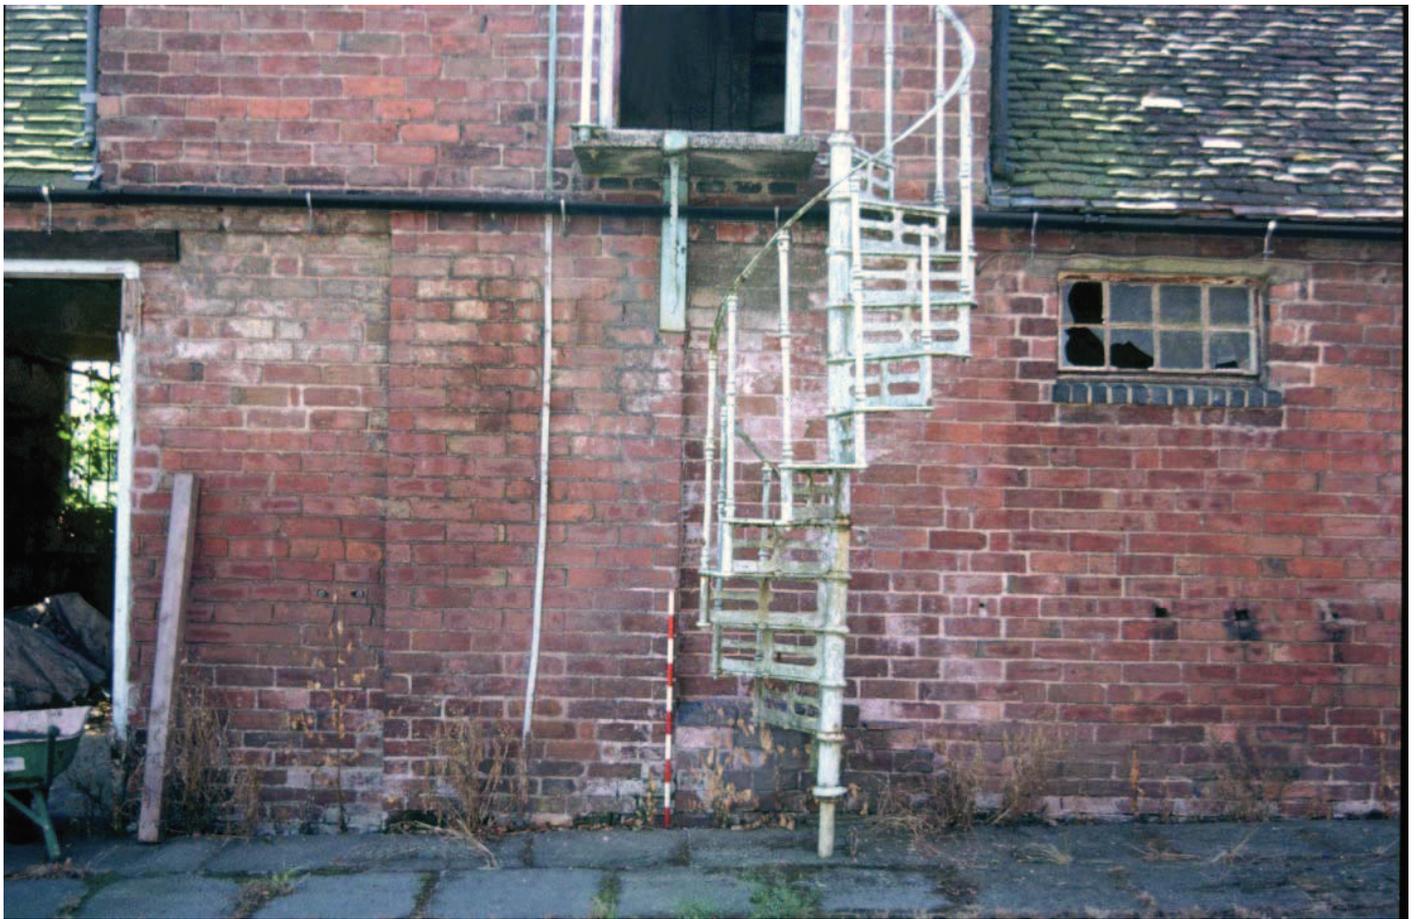
- 3.2.9 There is a cast iron spiral staircase leading to the tower. This style of this staircase appears contemporary with the building design, however there is evidence at ground level that the stair has been moved or remounted upon the wall as there is an extra skin of bricks at this point. The brick bond on the wall changes, further indicating that there was originally another staircase here. The doorway has an arched brick lintel and sits to the right of the gable wall. Unlike the original features of this building the lintel and jambs are not of chamfered bricks suggesting this is a later addition. There is evidence of remortaring either side of the jambs. There is a small concrete platform formed from rough concrete with large pebble inclusions.

Plate 25: Park Attwood Farm, north elevation, brickwork around spiral staircase and inserted window (01/07)

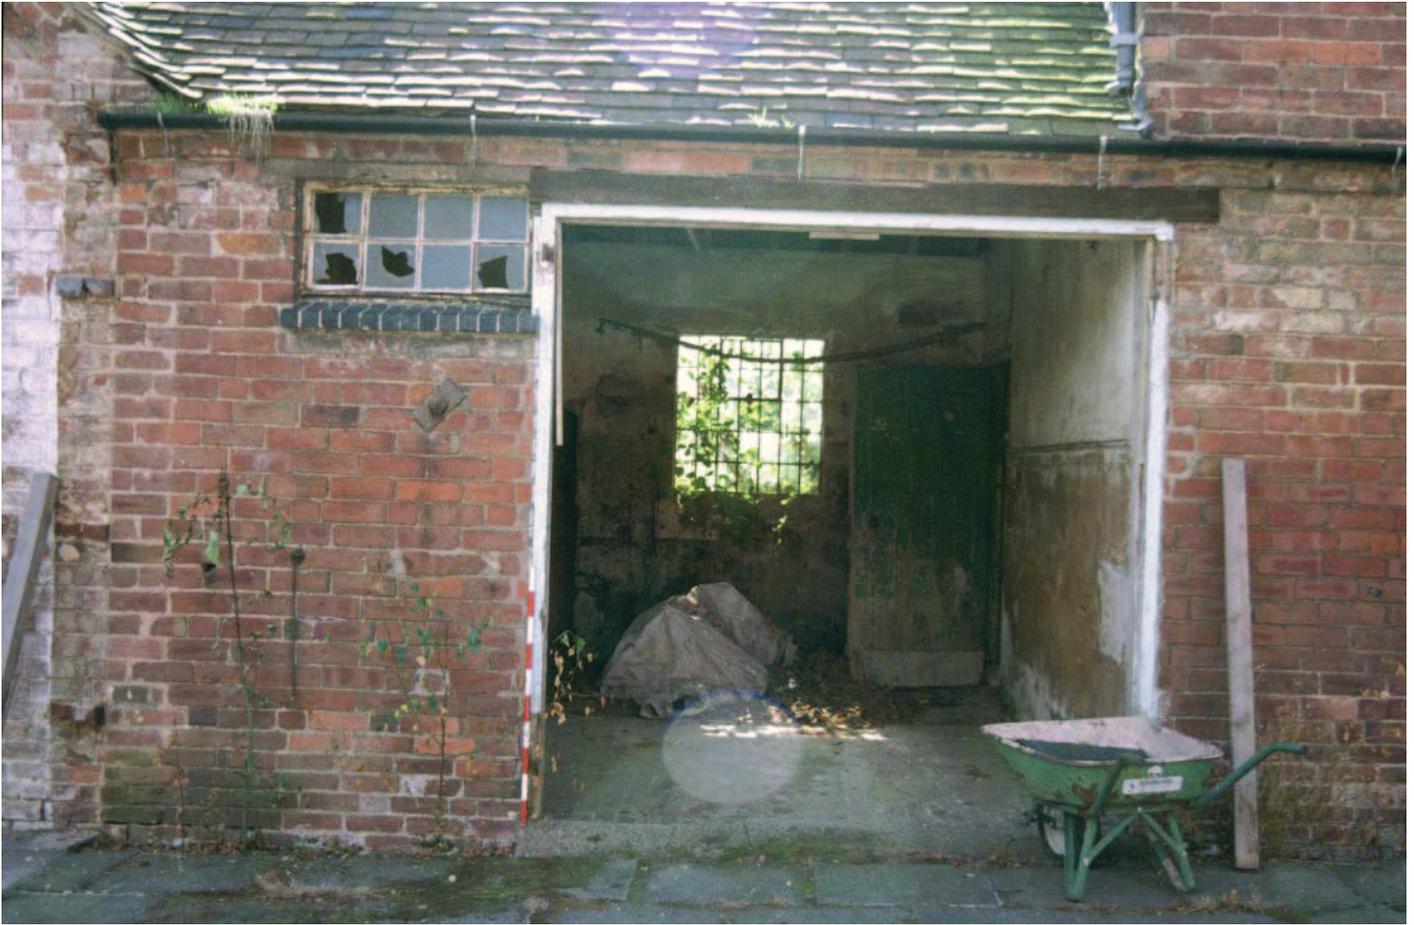
- 3.2.12 The north western gable wall has a doorway leading to Room 1. This doorway has a flat timber lintel. There is evidence of brick repointing or rebuild to either side of the jambs. The inside of this doorway shows another timber lintel two courses higher than the current one. This suggests there have been several alterations at this point. The original opening was probably a window which would have mirrored the left hand gable as the extent of the alterations line up with the left hand side window. Later a doorway was inserted using the topmost lintel. The alterations at this point were painted white during interior decoration. Afterwards a shorter doorway was inserted using the lower lintel.

Plate 27: Park Attwood Farm, doorway in north elevation (01/06)

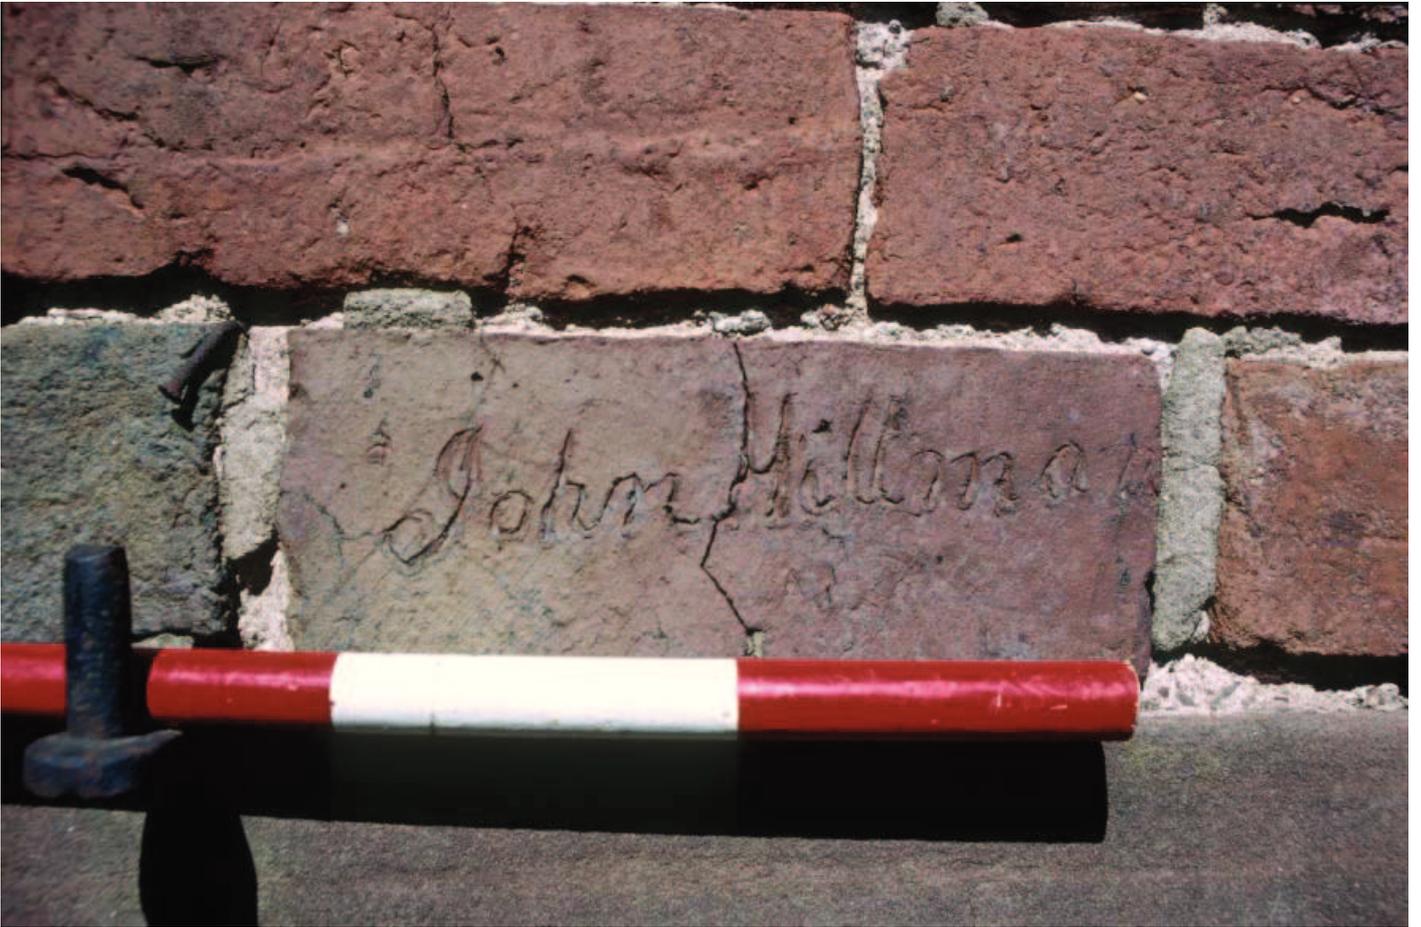
- 3.2.11 Beneath the left hand side cornice detail of this gable is a brick inscribed with the date '1845' which has been overpainted in black. This date fits in with the supposed construction date of the barn.

Plate 29: Park Attwood Farm, inscribed brick in east end of south elevation (01/26)

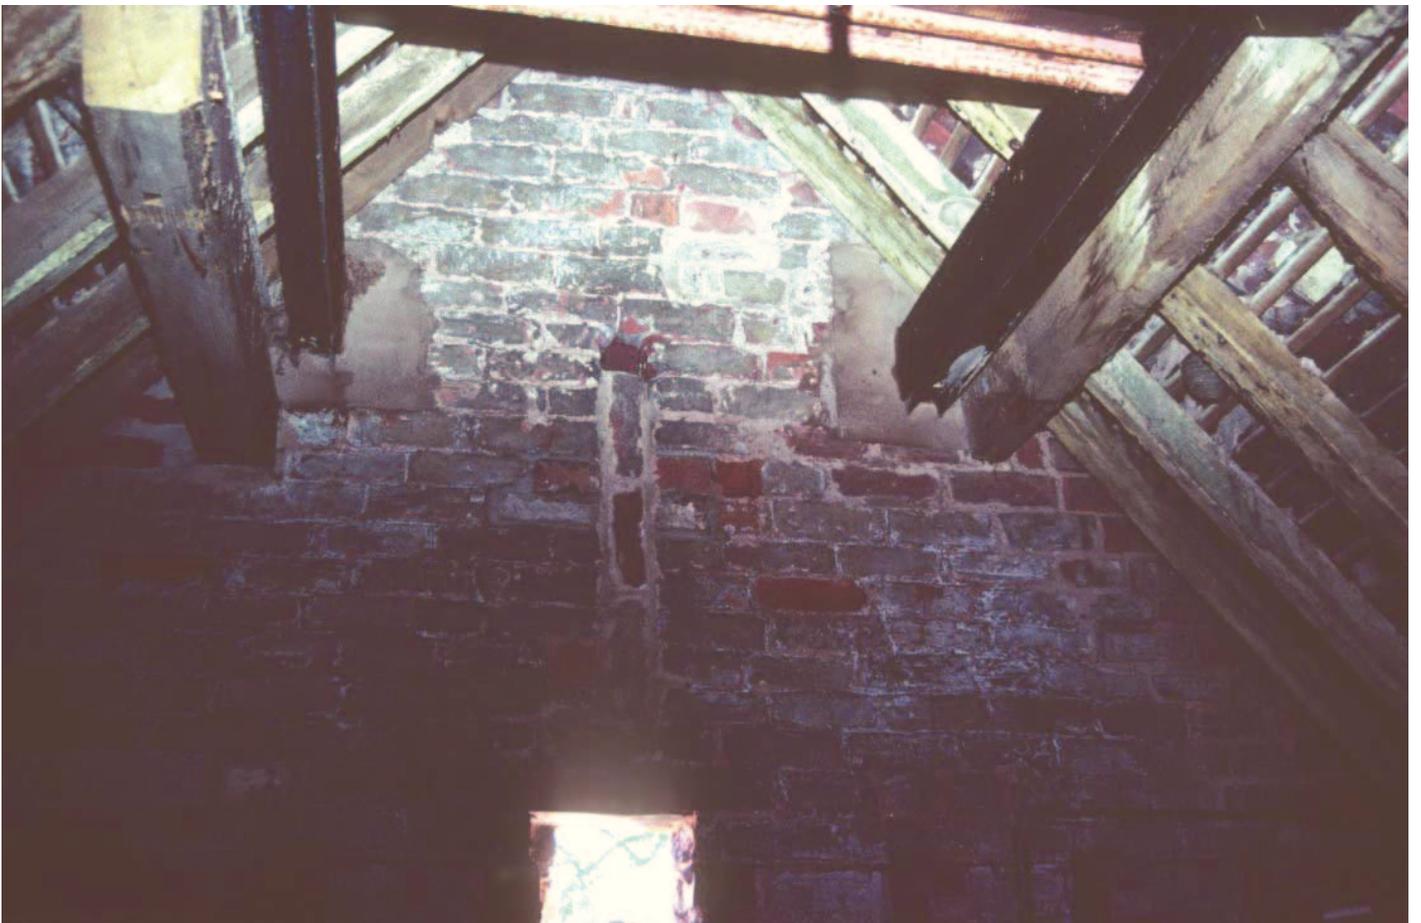
- 3.2.10 On the roof of this tower there is a chimney with brick decoration at the top and a louvered tower which is a recent replacement following collapse.

Plate 30: Park Attwood Farm, the repaired cupola within the bell tower (02/35)
