HERON CORN MILL, BEETHAM,

CUMBRIA

Archaeological Watching Brief and Recording Survey

November 2013

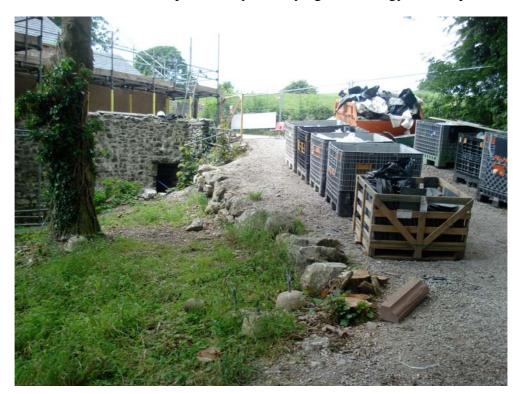
3.2.1 *East of the mill:* a path which slopes down from east of the mill to the tail race is to be re-laid (Plate 1). The path currently comprises limestone rubble *c* 0.5m thick, which has been put down as part of relatively recent landscaping work. Excavation for the new path is not anticipated to extend beyond the limestone rubble and therefore no impact on any underlying archaeology is anticipated.

Plate 1: Path to be re-laid on the east side of the mill, looking west

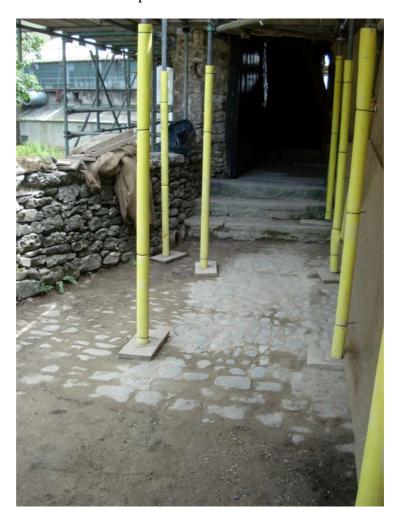
3.2.2 *North-east of the mill:* a path which extends from the north corner of the south-eastern part of the mill building to the path bounding the mill complex to the north (Plate 2) is to be built up to provide level access into the building. This

comprises a stretch of cobbled surface, which is to be left intact, protected and buried. This cobbled surface was subject to English Heritage Level 2 recording (see *Section 3.4*). Three steps into the mill will also be protected and buried. No below ground works are anticipated in this area.

Plate 2: Path to north-east of mill, looking south-east

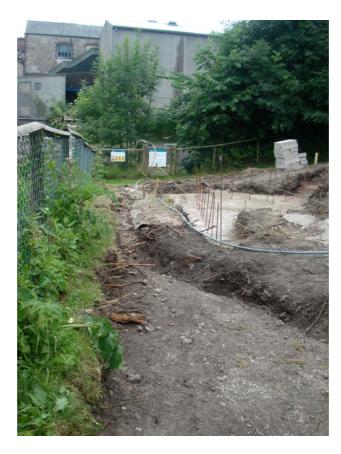
3.2.3 North-east and south-east of the barn: immediately north-east and south-east of the barn was an area that had already been stripped for a cable trench, path and retaining wall (Plate 3). This was the area of the 2006 evaluation trenching carried out by AOC (2006b), within which no finds of archaeological significance were made. The area was much disturbed with tree roots and a modern pipe was also visible just in front of the building (Plate 4). The cable trench was only excavated to c 0.3m in this area, as below this was bedrock, which overlay the cave. Concrete had already been put down in the trench for the retaining wall when the site was visited on the 16th July, but only root disturbed topsoil appeared to have been exposed. Further to the south-east was an area where a new path was being excavated and laid with gravel (Plate 5). Excavations for this were very shallow (c 0.2m max) and comprised topsoil overlying a layer of pale brown clay (Plate 6).

Plate 3: Excavations to the north-east of the barn, looking south

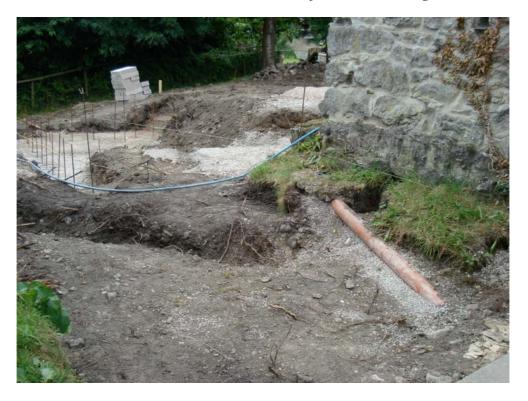
Plate 4: Excavations to the north-east of the barn, showing modern pipe, looking south

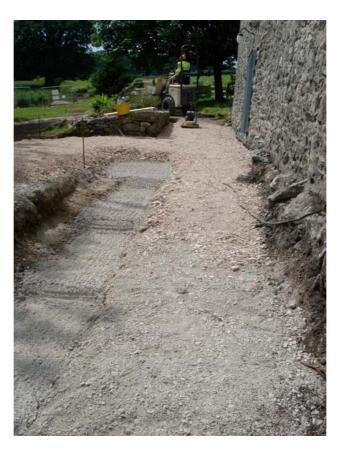
Plate 5: New path alongside south-east wall of the barn, looking west

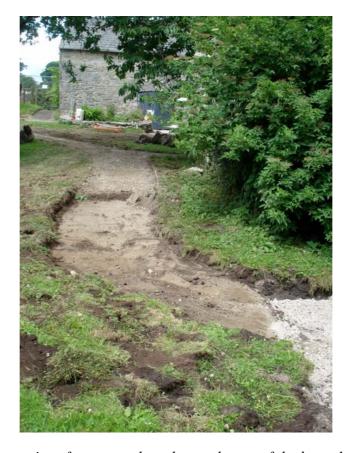
Plate 6: Excavations for new path to the south-east of the barn, looking north

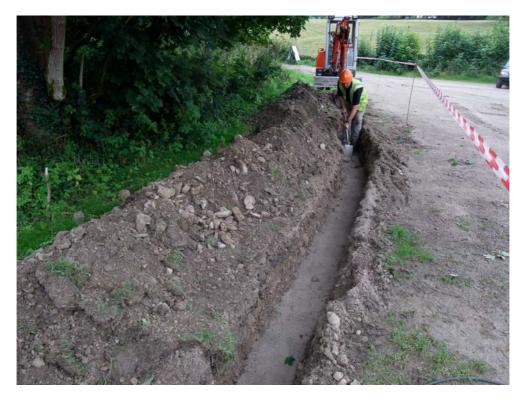
- 3.2.5 Car park to the east of the east site boundary: two cable trenches skirting both the north and south sides of the car park were excavated under watching brief conditions (Fig 2) with a mini-digger to a depth of approximately 0.45m and width of approximately 0.6m. The southern cable trench curved around the southern extent of the car park running parallel with a small stream just on the edge of a patch of woodland (Plate 7). The trench was excavated to a length of approximately 30m. The trench was excavated through gravel that continued down to a depth of around 0.42m below which, topsoil was visible. This pattern continued for the whole length of the trench. No archaeological finds, features or deposits were encountered.

Plate 7: Cable trench excavation on the south side of the car park to the east of the barn, looking west

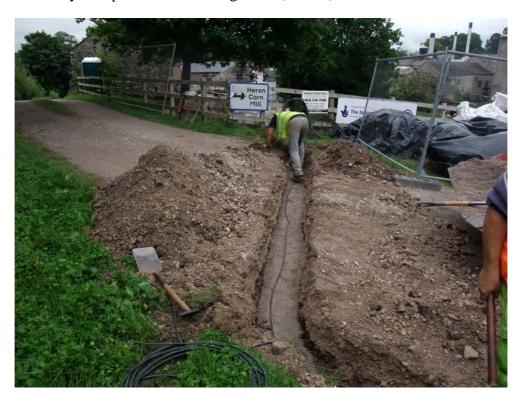
3.2.6 A further cable trench of the same dimensions was excavated at the north side of the car park across the access road to the north of the barn and along the north field boundary (Plate 8). The trench was, again, excavated into the gravel of the car park, which continued to a depth of 0.42m. Below this, was a layer of topsoil within which sections of compacted sub-base material was present. No archaeological finds, features or deposits were encountered. The trench

Plate 8: Cable trench excavation on the north side of the car park, looking east

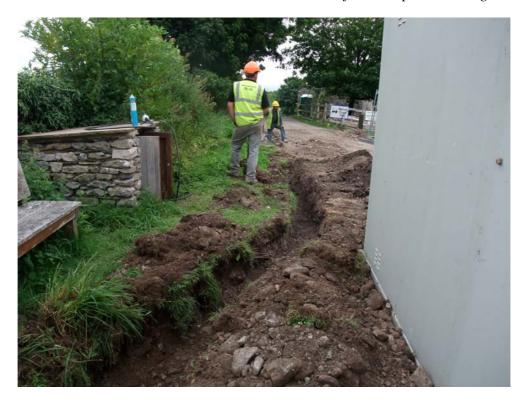
continued into an area of undisturbed ground at the northern edge of the car park, adjacent to a stone field boundary. This part of the trench consisted exclusively of topsoil and/or made ground (Plate 9).

Plate 9: Cable trench at the north edge of the site, looking east

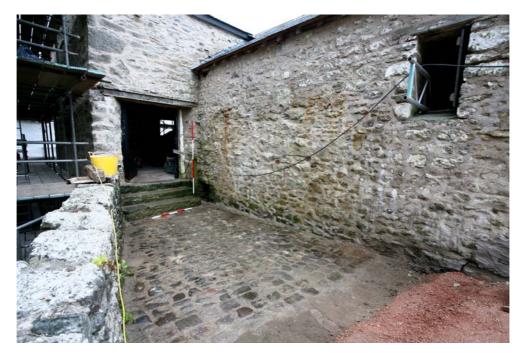
- 3.4.1 The cobble surface at the north-east side of the main mill building had already been subject to watching brief prior to being recorded (see *Section 3.2.2*). The area was visited again on 11th September 2013 in order to carry out the recording to English Heritage Level 2 standard in advance of being covered and preserved *in situ* below a replacement walkway.
- 3.4.2 The area of cobbles is relatively small, covering an area between the mill building and a retaining wall, approximately 5.1m in length and a maximum of 3.2m wide (Fig 5). The cobbles form a walkway allowing access to and from a doorway on the north side of the mill building (Plate 10). It slopes towards a terracotta drainage pipe at the south end of the retaining wall close to the steps.

Plate 10: Cobbled area at the north-east side of the mill, looking south

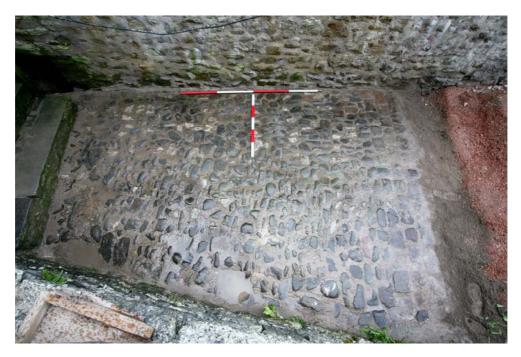
- 3.4.3 The cobbles are mainly of random sizes, the largest being approximately 0.12m by 0.12m; many of which appear to be laid on edge, perpendicular to the wall of the mill building. The northern edge of the cobbles is defined by three rows of squared cobbles, the maximum size being 0.24m by 0.16m (Plate 11). The mortar is mainly cement-based and some areas appear to have been re-laid relatively recently. Most of the cobbles appear to be of riverine origin.
- 3.4.4 The doorway allowing access to and the mill is reached via two steps constructed of sandstone treads upon random sandstone risers (Plate 12). The lower tread is approximately 0.38m wide, the upper being 0.25m wide. All the

Plate 11: Plan view of cobbled surface at the north-east side of the mill

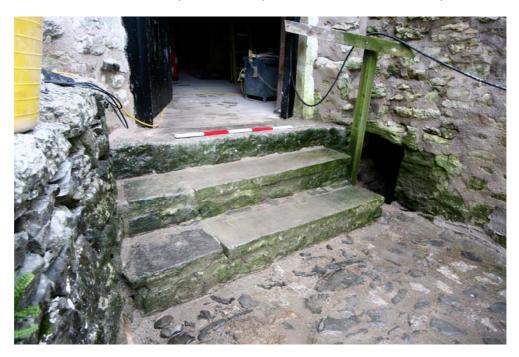
risers are approximately 0.2m high. The steps lead to a limestone threshold. The steps are clearly a later construction.

Plate 12: Steps leading to the mill door on the north-east side, looking south
