Penrith Waste Water Treatment Works, Admin Building, Penrith, Cumbria

Building Investigation

December 2012

UNITED UTILITIES

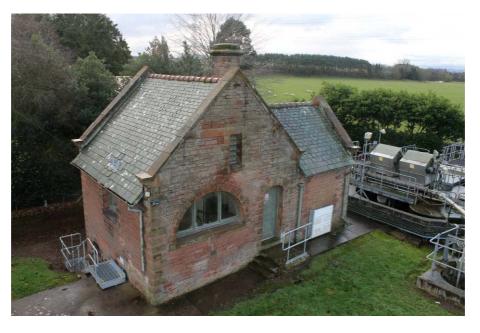
Plate 1: General view of the admin building facing south-west

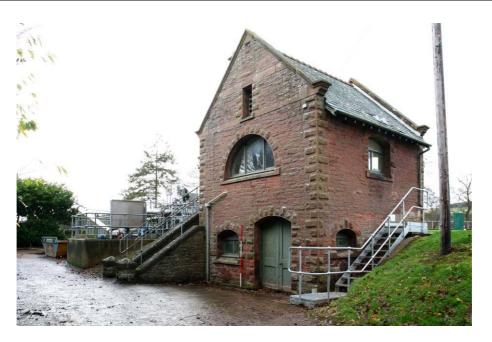
Plate 2: General view of the admin building facing north-west

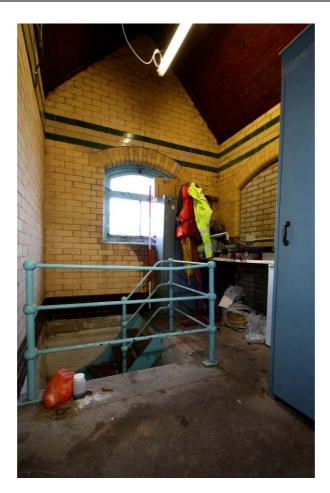
Plate 3: General view of Room 2 facing north-west

- 3.4.4 **Room 2:** access to the basement from Room *1* is available via this room. The room is also accessible externally via a door in the south elevation and previously via a now blocked wide doorway in the north elevation. The blocked door is of similar dimensions to the wide door in Room *3*, and presumably contained the same style of door. The room is quite small but contains the staircase down to the basement, a WC, and lockers and a worktop (Plate 3).

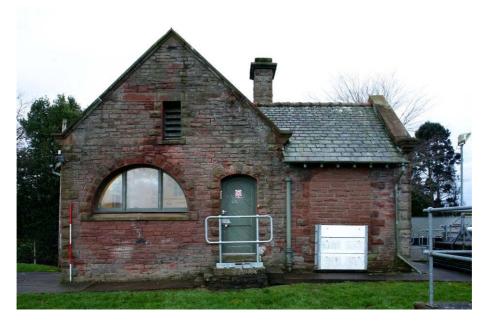
- 3.3.2 The north-facing elevation comprises the gable of Room 1, and the north wall of Room 2 (Plate 4). There is a single door that is accessible via sandstone steps, and a window, together with a louvered opening above the window in the gable. The window is semi-circular and has a slightly projecting sandstone sill. A blocked door is visible at the west side of the elevation that once allowed access into Room 2 (also visible internally, see Section 3.3.4 and Plate 3). Both the remaining and blocked doors have segmental arches. Each slope of the gable has a flat coping with skew corbels at the base. Two ashlar bands are present in the upper section of the gable.

Plate 4: The north-facing elevation facing south

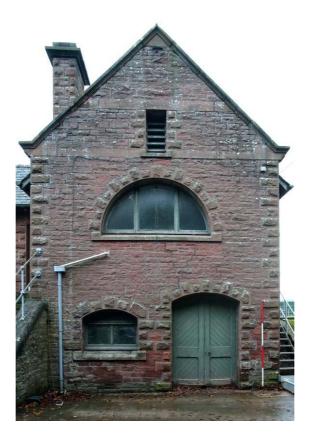
- 3.3.3 The south-facing elevation exhibits the same general outline detail as described for the north-facing elevation, but is of two storeys (Plate 5) and the west side (the south wall of Room 2) is set back by approximately 2.26m. The east side forms the south gable of Room 1a. There is a large window on the upper floor, which is identical to that on the north-facing elevation, together

Plate 5: The south-facing elevation facing north

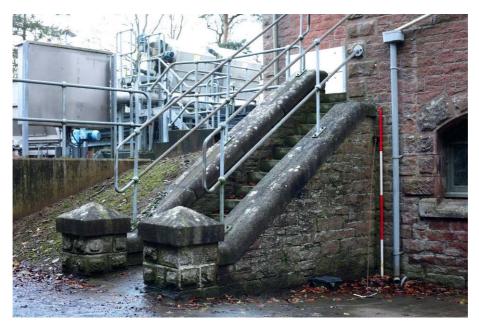
with a smaller window and a double doorway at basement level. The smaller window and door both have segmental arches. A plastic down pipe is present. The west side of the elevation is accessed via a flight of sandstone steps flanked by steel railings atop low stone walls with concrete copings (Plate 6).

Plate 6: View of the flight of steps leading to the west part of the south-facing elevation

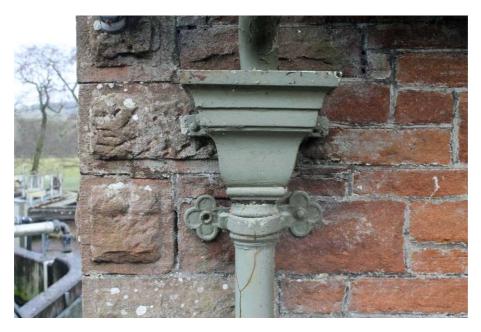
3.3.4 The west side of the south-facing elevation has a single doorway of identical appearance to that on the north-facing elevation. There is also a single cast iron down pipe with a moulded hopper and decorative brackets (Plate 6). There is also a surviving cast iron gutter, to which are attached wrought iron scrolls (Plate 7).

Plate 7: Detail view of the hopper and decorative brackets on the west side of the south-facing elevation

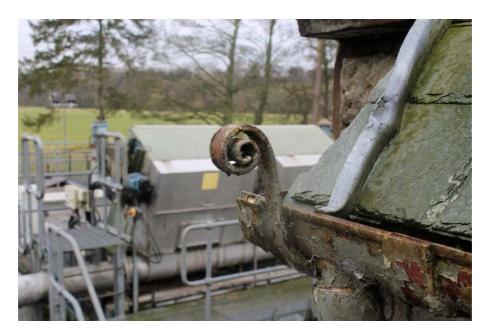
Plate 8: Detail view of a wrought iron scroll attached to the cast iron gutter on the west-side of the south-facing elevation.

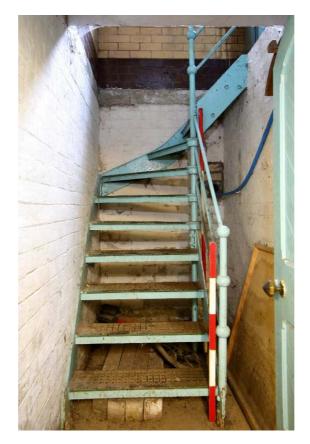
3.4.7 The staircase is of cast iron construction with an iron handrail. It is of quarterturn construction with six straight treads and four winders (Plate 9). Each tread has a grip pattern consisting of perforated holes and a square, raised grid. The stairwell brick walls have been painted white.

Plate 9: General appearance of the staircase.

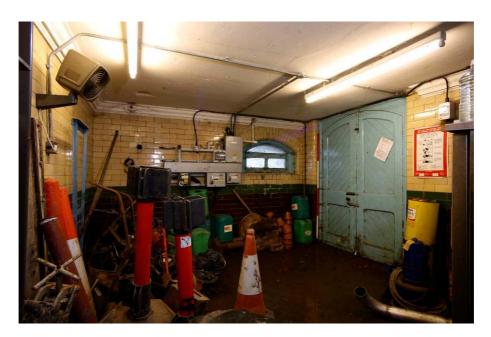
- 3.4.8 **Room 3:** descent of the staircase leads to Room **3** that was being used as a general storage area at the time of the survey (Plate 10). All the brick used in the wall construction are glazed, using the same colours noted in Room **2**. There is a dado band with two courses of green glazed brick, below which are 11 courses of dark burgundy coloured brick. Above the dado band are 13 courses of yellow glazed brick. There is a straight-run plaster cornice running to the whole perimeter of the room. There are two window openings and a wide door, all of which are of the same appearance as those already described. The wide door opening is of the same dimensions as the blocked door in Room **2**.

Plate 10: General view of Room 3 facing southeast

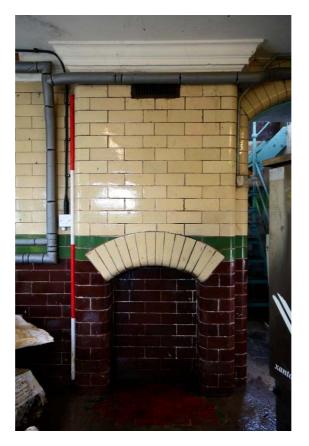
- 3.4.9 Perhaps the most interesting feature in this room is the fireplace set within the shallow chimney breast on the west wall (Plate 11). It measures some 0.63m wide by 0.85m high and 0.23m deep. It has a segmental arch of yellow glazed bricks. There is a tiled hearth present that measures 0.88m by 0.55m, and comprises small, red, rectangular tiles with green border tiles (Plate 12). Above the fireplace, set into the chimney breast is a cast iron vent, which exhibits decorative motifs in the form of circular roundels with clover leaves and foliate elements. The boarded fireplace in Room Ia is probably of the same appearance as that described here.

Plate 11: View of the fireplace in Room 3

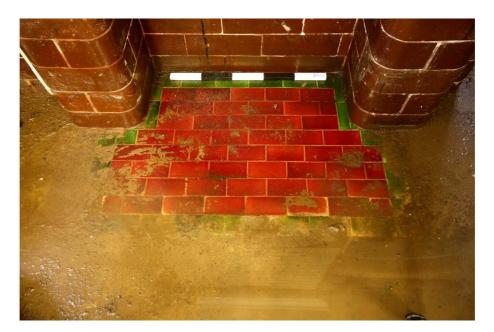
Plate 12: The hearth of the fireplace in Room 3
