Summary Report on the Excavation of the Bow section of the Newport Ship

May 2003

Newport Theatre and Arts Centre

Summary Report on the excavation of the bow section of the Newport Ship

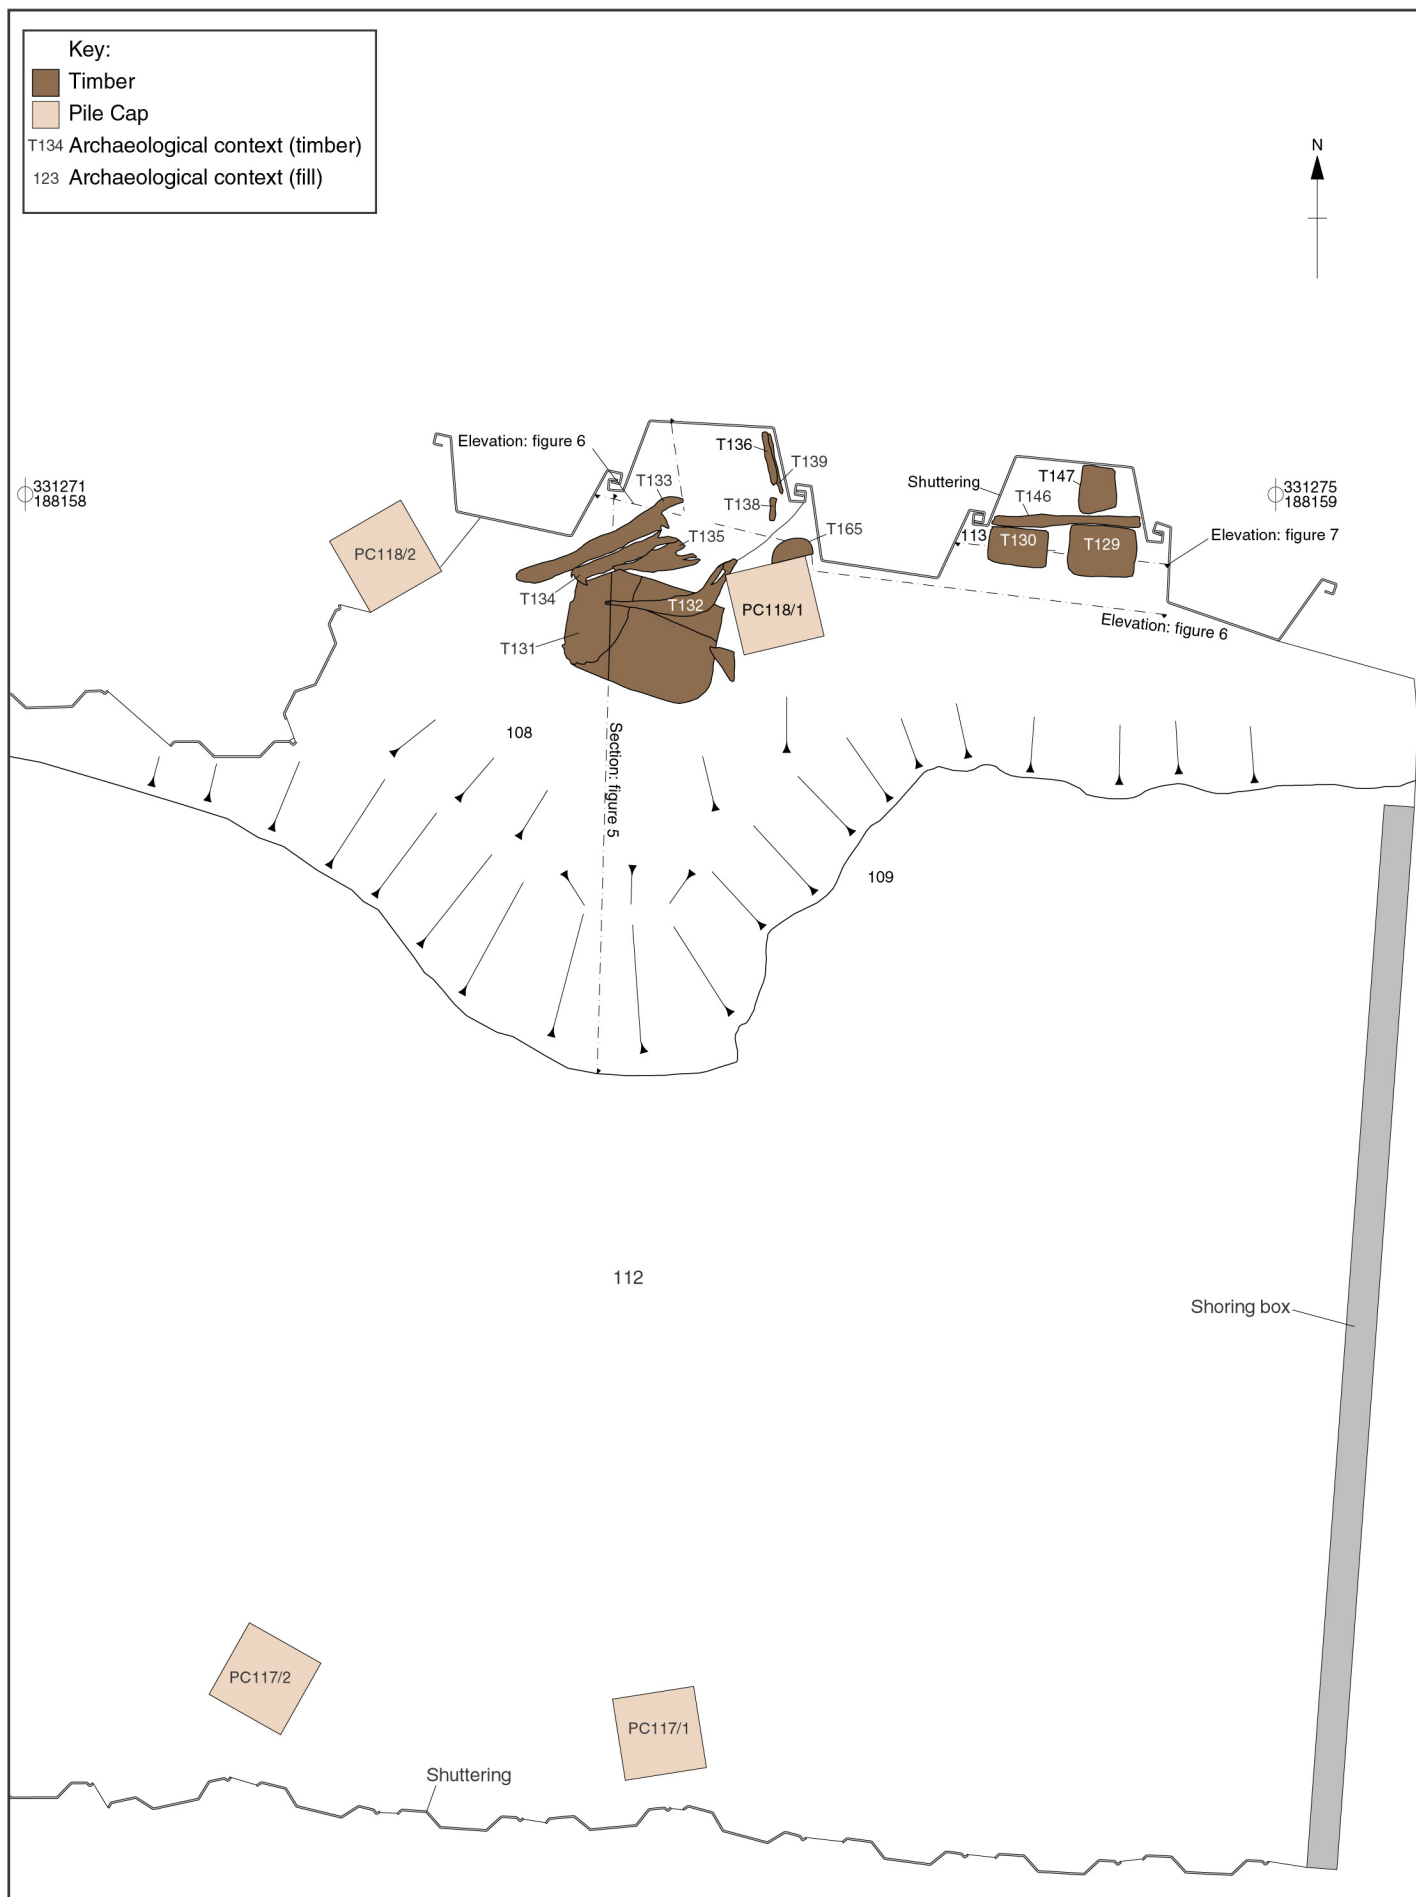
Figure 4: Trench Plan showing principal bow timbers

- 4.2.1 The timbers were well preserved but badly disturbed by trench sheets and driven concrete pile PC118/1. The treenails were also in good condition but the iron nails used to fasten the clinker outer hull planking together were badly corroded. Most of the iron nail-heads were missing. However, the impressions made by these on the outer face of the planking were clearly visible. The absence of any other tool marks around the nail-head impressions suggests that these nail heads were not salvaged in antiquity.

- 5.1.1 Most of the timbers of the bow have been badly displaced by the steel trench sheets and concrete piles, which makes the task of reconstructing the bow more difficult. There are, however, a number of timbers, which are indicative of the original form of the bow. The principle question must be the original angle of the stem post before it was displaced by pile PC118/1.

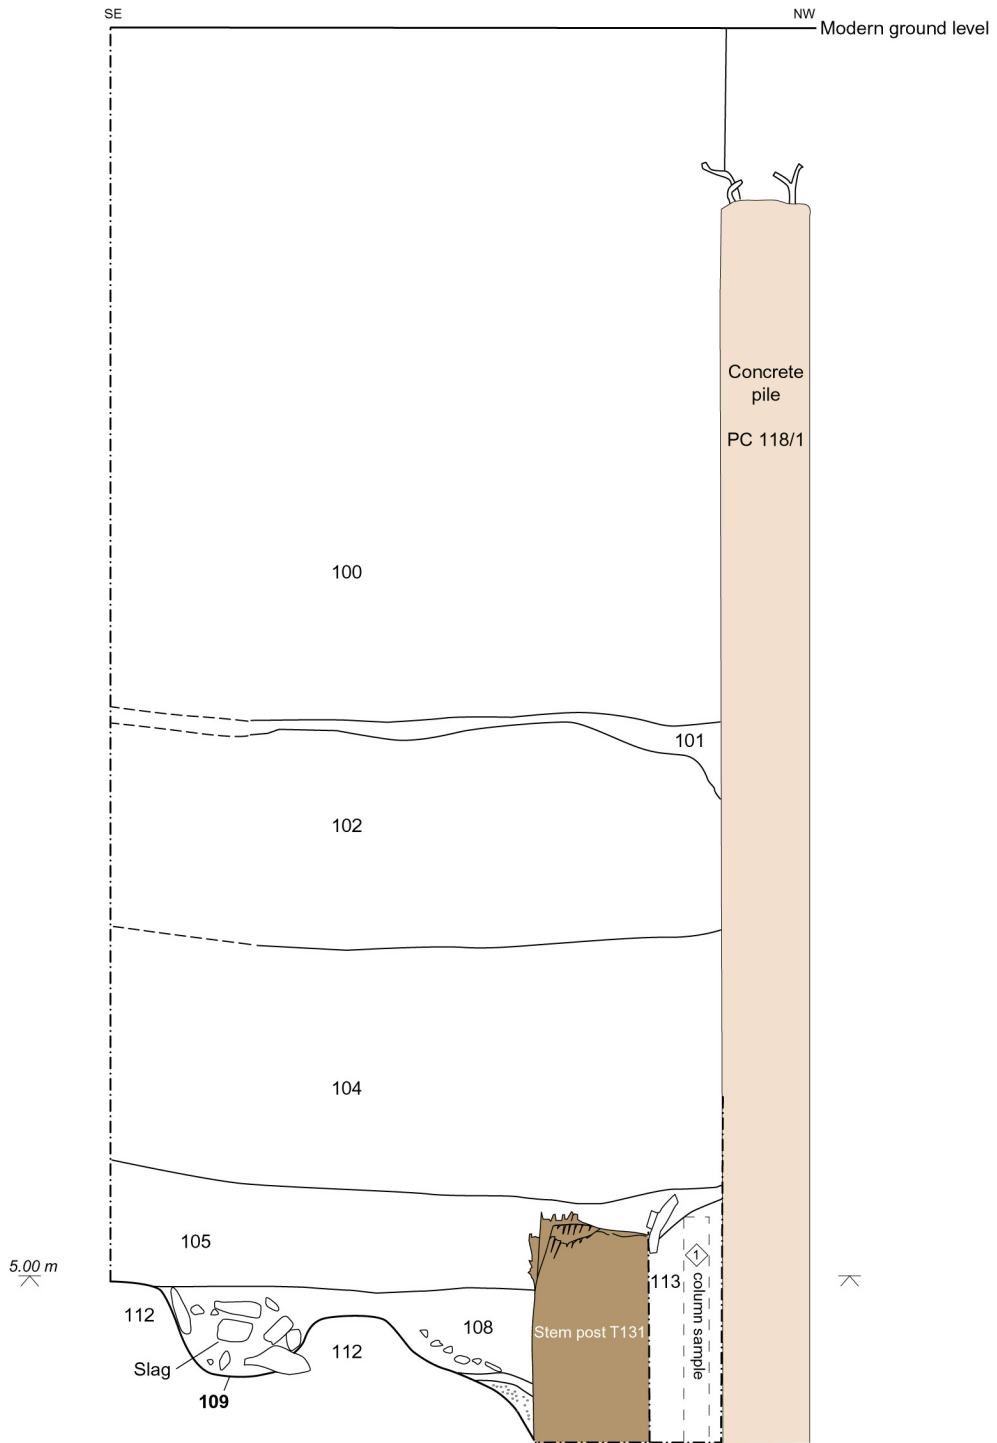
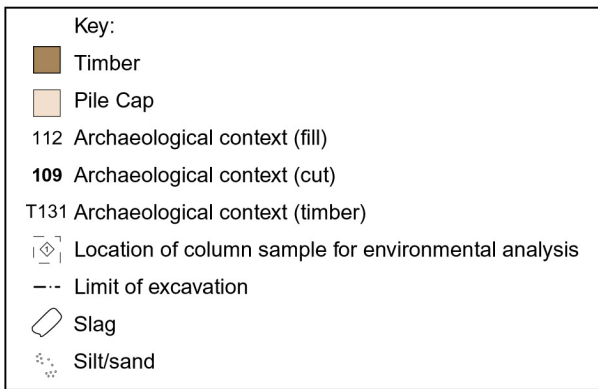
Figure 5: Section through upper deposits in Trench

4.1.1 The top of 'natural' deposit 112 (Keuper Marl clay) was revealed at c 6.3m OD within the trench (c 2.3 m below modern ground level). A distinct east-west orientated boundary between context 112 and a deposit characteristic of alluvial deposition (104) was visible in the trench at this level. This indicated the historic division between dry land and channel/inlet fills.

4.1.3 Natural 112 (its surface probably representing the historic bank) sloped down toward the north of the trench. At the northern limit of the trench at the base of the slope was a blue grey alluvial clay-silt (113). This was the deposit in which the boat timbers were situated.

4.1.4 Further up the slope of 112 was cut 109. It was unclear whether this was indeed a purposeful cut for the dumping of deposit 108 (a grey silt containing 70% metal working residue - slag, tap slag, charcoal, burnt clay, elements of furnace base

charcoal etc) or the eroded edge of the original bank. 'Cut' 109 was c5 m long (visible extent within the trench) and was excavated to a depth of 0.75 m. Deposit 108 filled 109 but had also been dumped up against the boat timbers (stem post 131 and all portside outer planking.)

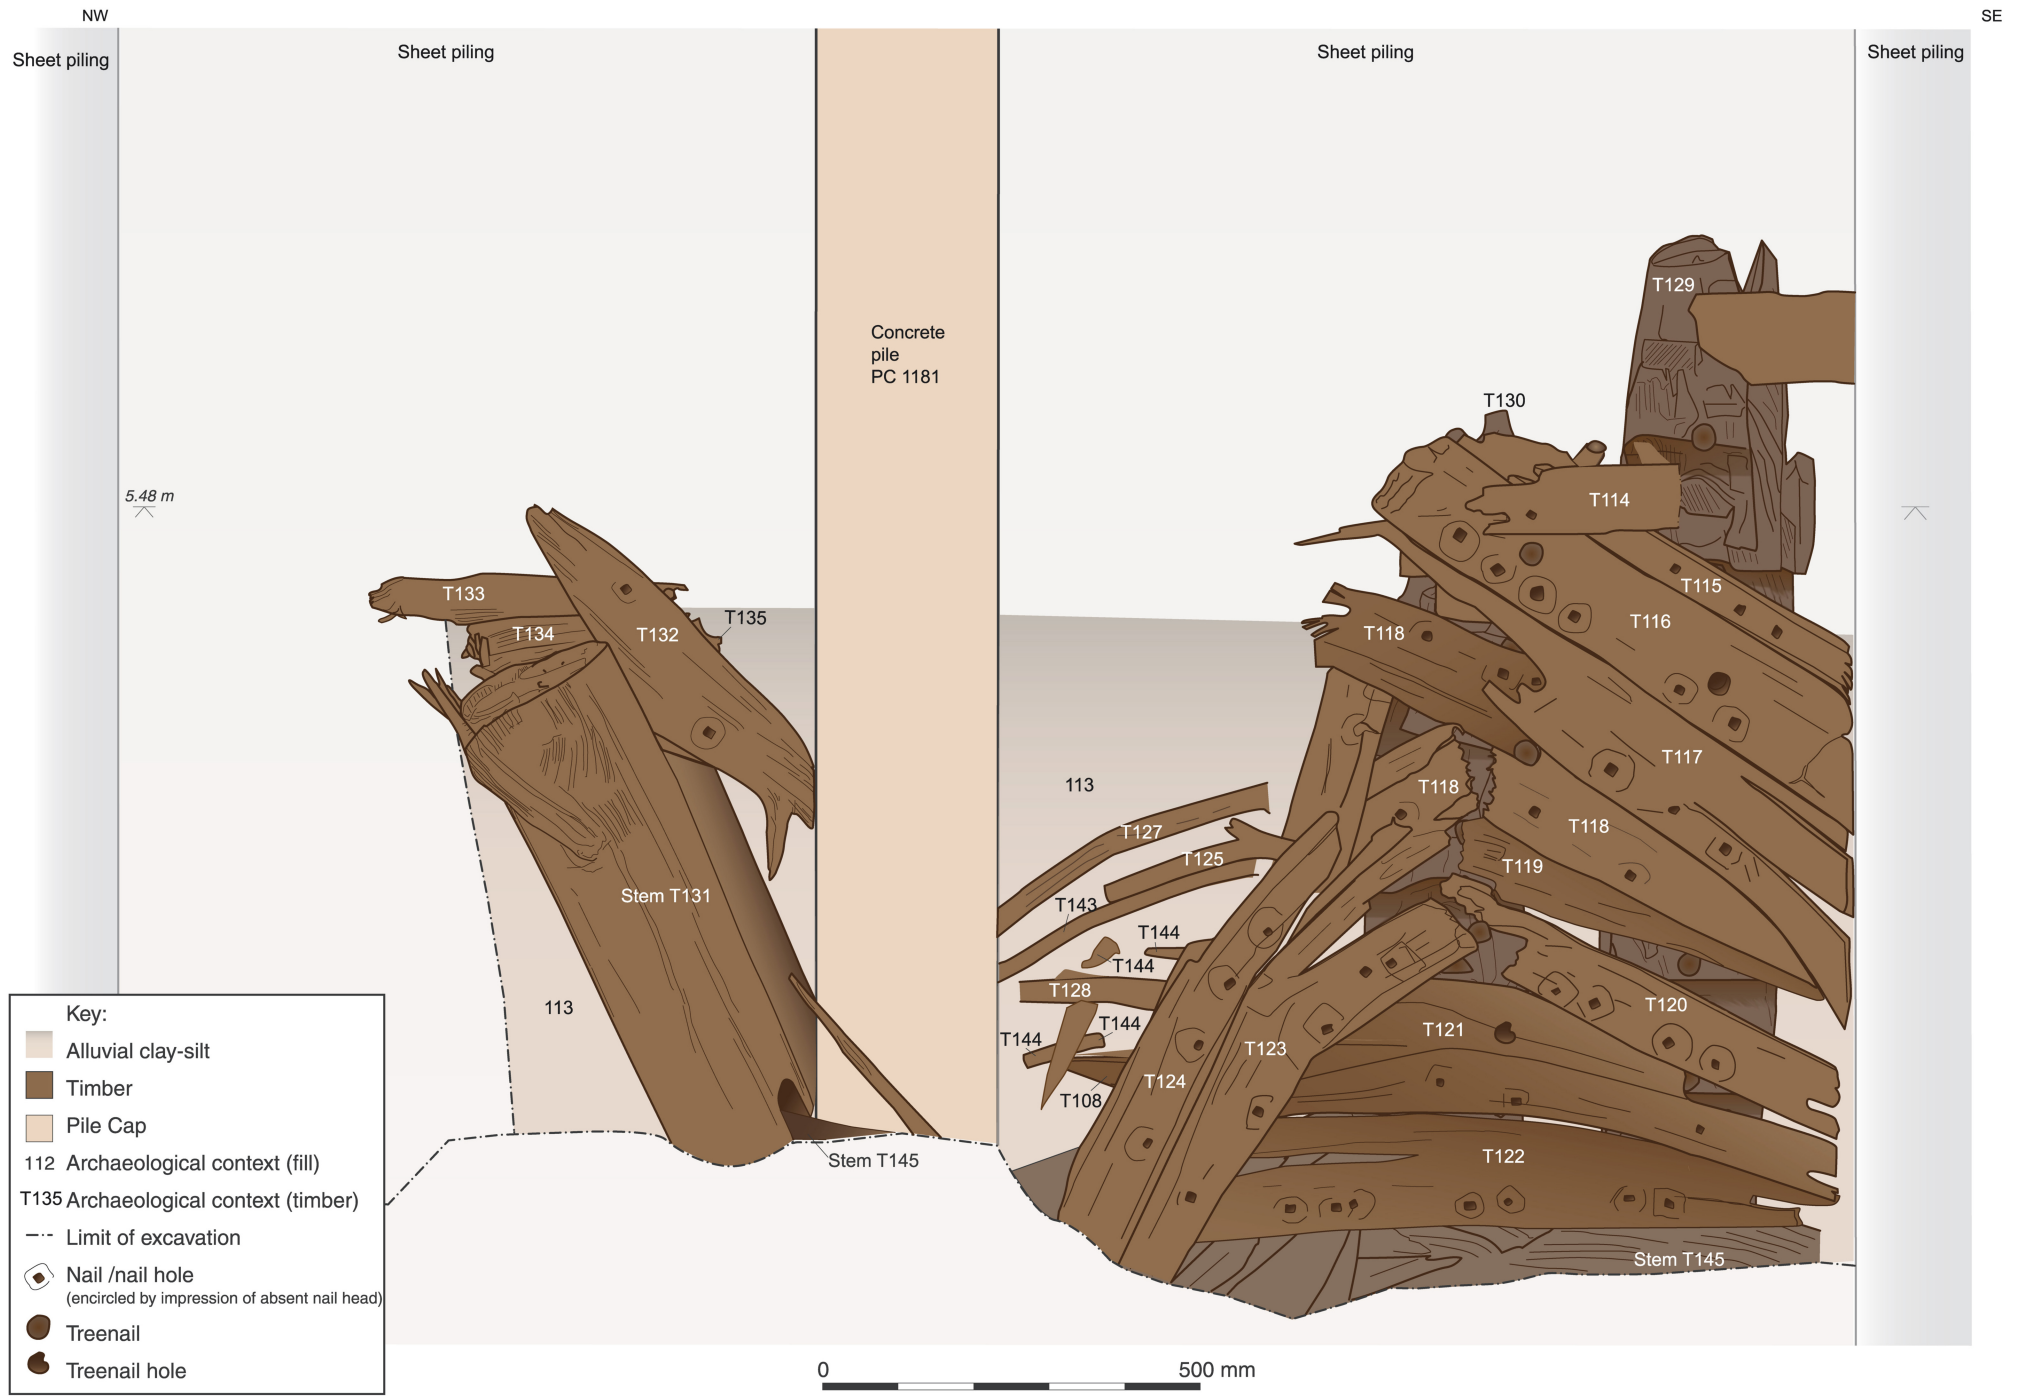
Figure 6: South East facing elevation of bow timbers

- 4.2.2 The end of the stem post had been cut off – probably at the same time as the rest of the vessel was cut down. Markings on the cut face suggest that it was cut through with an axe. The stem post itself was impacted by driven concrete pile PC118/1, pushing the stem downwards and rotating it through about 80°. The stem post was scarf jointed approximately 0.85m to the east (astern) of the cut face. The section of stem (T131) between the cut face and the scarf was recovered. The stem (T145)

- 4.2.3 The forward section of stem post (T131) had rabbets cut into the starboard and port faces for the attachment of the plank ends. The rabbets were 0.13m wide and 0.02m deep. The rabbet on the starboard side showed evidence of repair; it had been enlarged and an additional piece of timber inserted. This was probably to enable the re-attachment of the plank ends after the nails had come loose, possibly due to decay in the stem. The port side rabbet surface was coated with a fibrous material, probably the remains of luting used to waterproof the joint between the plank ends and the stem post.

- 4.2.4 The main section of surviving hull planking was from the port side of the vessel. This consisted of a short length of clinker construction planking. Much of this planking was displaced by the concrete pile (PC118/1) and driven steel trench sheets. Despite this, several planks were still partially attached to frames with treenails. There were nine strakes surviving above the stem post at the point of highest survival, which was in the region of frame (T129). A small, displaced section of planking (T133), (T134) & (T135) from the starboard side of the bow was found just north of the cut-end of the stem post. There was evidence of luting between the overlaps of the outer hull planking. This consisted of a fibrous material, possibly coated with bitumen, extending over most of the width of the planking overlap and thus probably inserted prior to the fastening of the planks.

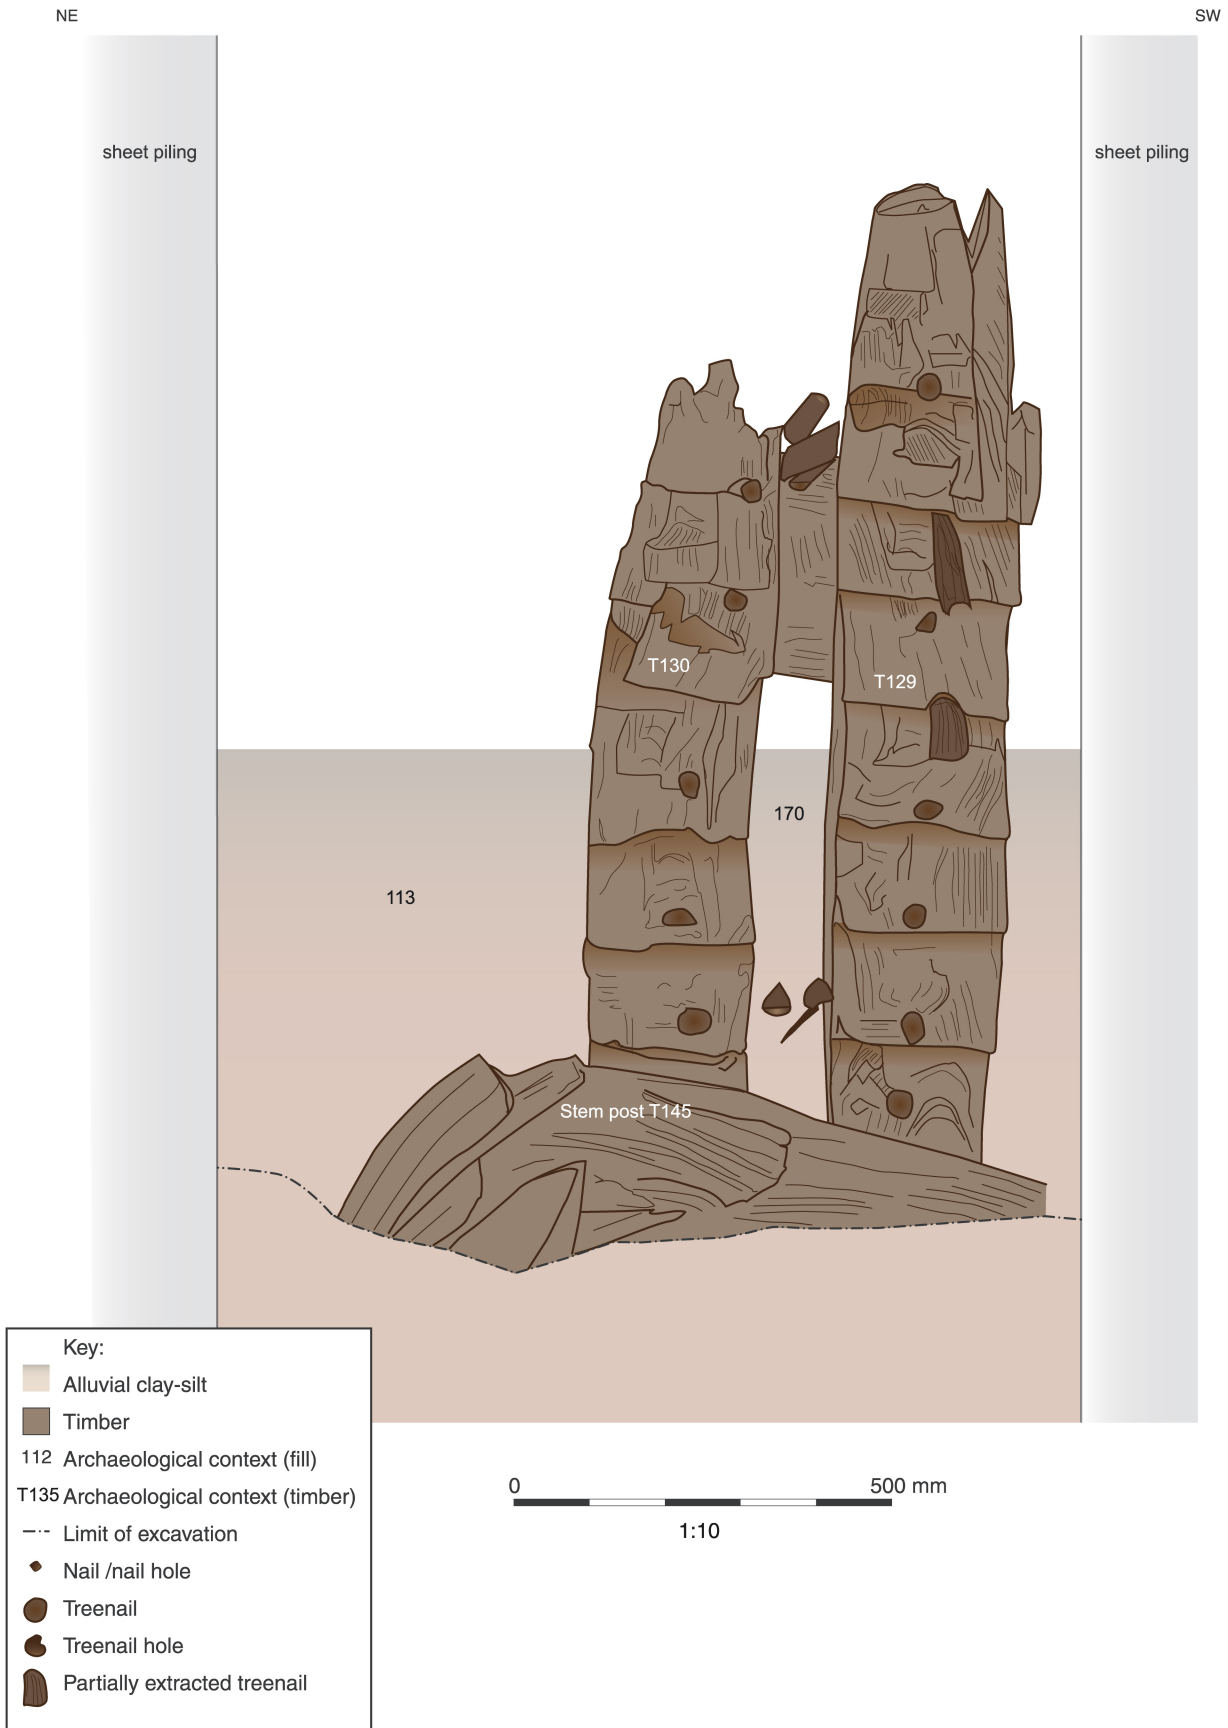
Figure 7: South East facing elevation showing frames and stem post after removal of portside planking

- 4.2.5 Three frames were located within the area excavated. Two, east of pile PC118/1, consisted of the port side frames only (T129) & (T130). Both of these frames exhibit notching on their outboard faces to accommodate the overlaps of the outer hull planking. The majority of the port side planking excavated was originally attached to these frames. There were two stringers (T146) & (T162) on the inboard face of these frames and a rider (T147) in the region of frame (T129). Frame (T129), the two stringers and the rider were recovered as a unit – still fastened together – and careful study of these may show details of construction.

- 4.2.6 The base of both these frames, where they joined the stem post, showed evidence of decay in antiquity. The ends exhibited ragged breaks which were impregnated with the same deposits as those which sealed the upper surface of the stem post (T145) – suggesting that the break had occurred before the infilling of the hull.

- 4.2.7 The remaining frame (T165) was found to the north of pile PC118/1 and was a floor frame with elements of both port and starboard frame surviving. The outboard faces of this frame were smooth without any trace of planking notches. No planking was found associated with this latter frame.

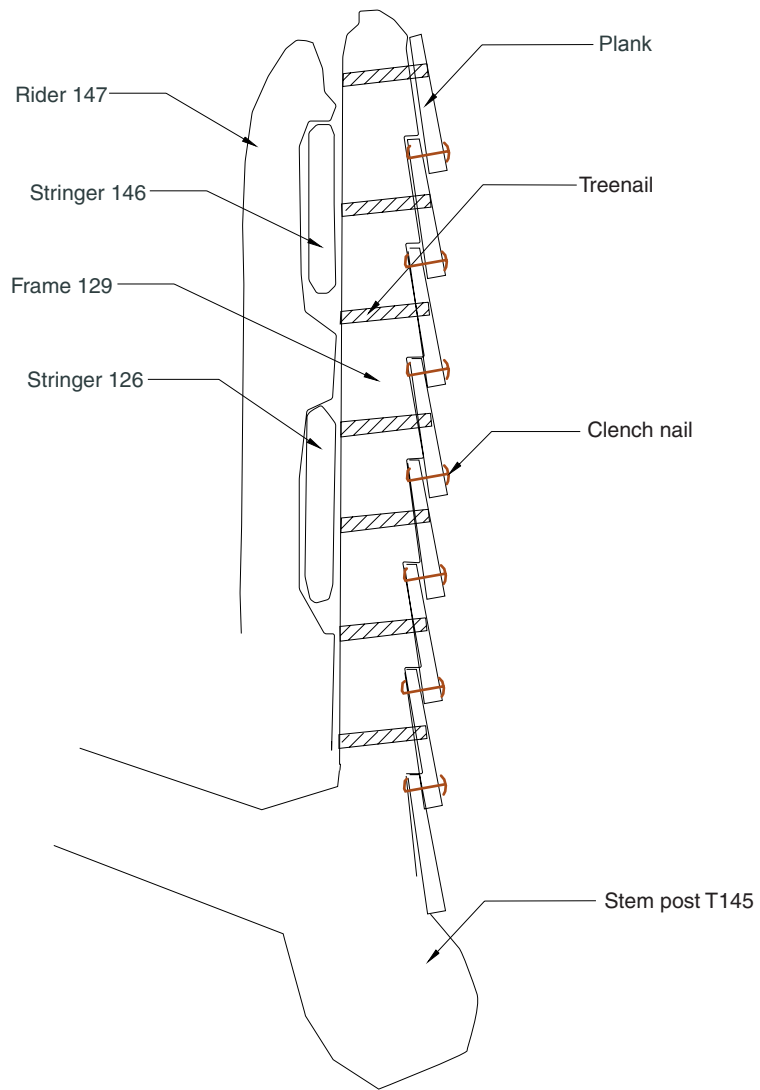
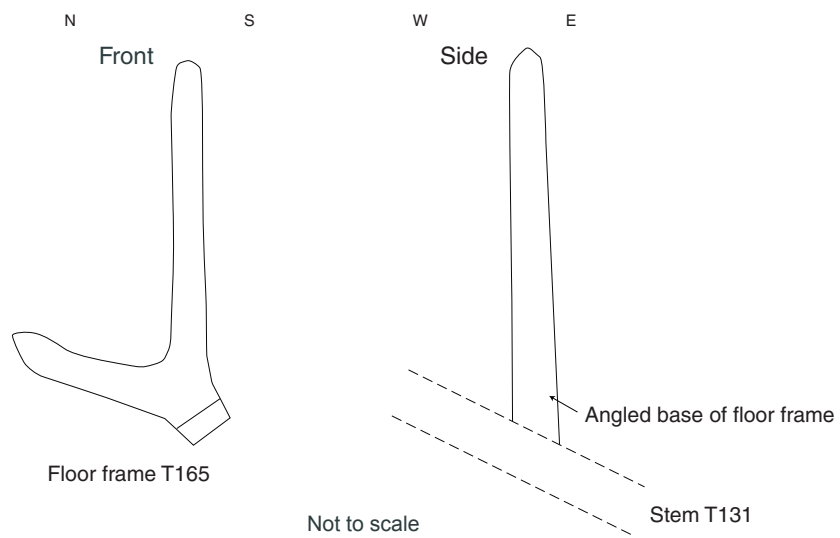
Figure 8: Schematic representation of Hull construction

- 5.1.2 Three of the port side planks exhibit angled plank ends where they would originally have been fastened to the stem post. These are (T132), (T139) and (T149). It seems likely that these angled plank ends fitted flush into the rabbet on the port side of the stem (T131). As both the plank ends and the stem rabbet have clearly visible nail holes, it should be possible to establish the original plank end locations on the stem by matching these up. This should give an indication of the angle of the stem at this point.

- 5.1.3 The most forward floor frame (T165) has a flat cut foot where it would have rested on the stem. This is cut at an angle of approximately 35° from the horizontal. The original position of this frame on the stem can probably be established by markings on the stem and by matching up the fastenings on planks (T132), (T139) and (T149). Once again, the angle of the stem post at this point could then be established.
- 5.1.4 The two port side frames (T129) and (T130) looked to have been the least disturbed of the timbers found and were still sitting on the stem post (T145). Frame (T129) was lifted complete with its associated stringers (T146) & (T162) and rider (T147) – study of this unit may help to establish the original form of the bow.
