ORDSALL HALL REFURBISHMENT, SALFORD

Archaeological Watching Brief and Excavation Report

Oxford Archaeology North March 2012

Urban Vision

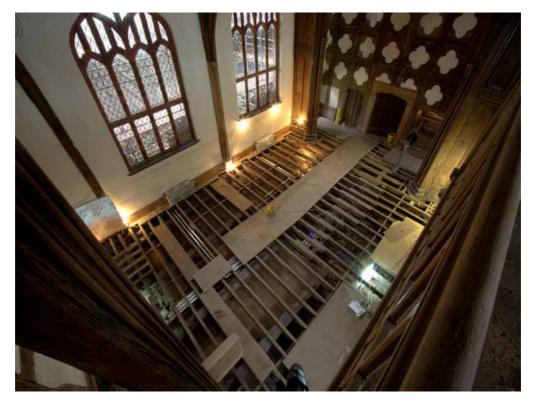
Plate 4: General view of the Great Hall (G4), showing floor construction

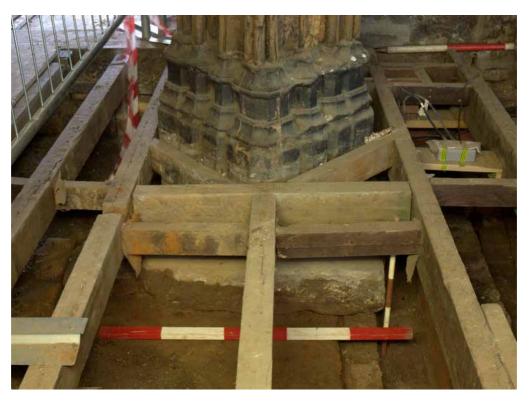
4.2.3 The decorated base of the spere post was diamond-shaped in section, although with a flattened southern side at the point where the wall-frame was joined to the post (Fig 9). The post was supported on a 6" (0.15m) deep, pale-coloured padstone. This was 3'(0.91m) square in plan (Plate 5), and comprised two approximately equally-sized sandstone blocks. This padstone was set on compacted orangey-brown natural sand (*100*). A single-skin brick wall (*103*) underlying the western side of the padstone, formed part of an undercut and later feature (see *Section 5*, below).

Plate 5: Detail of the Spere Post, with sandstone pad below

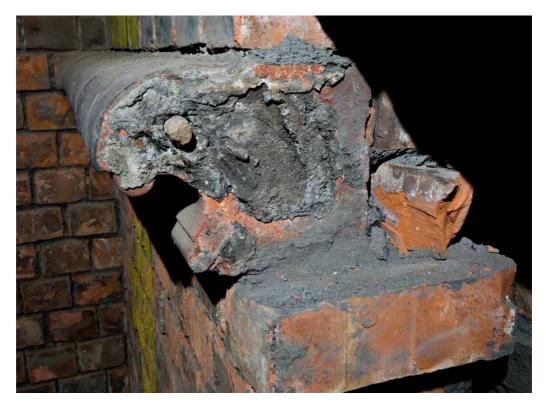
4.2.6 A terracotta string-course was incorporated into the external face of the wall. It was of *ogee cyma recta* style, being positioned at mid-floor level, and matching a similar string-course positioned between the ground and first floors. The individual sections of the string-course were jointed together with timber dowels and liberally bonded with a black sooty mortar (Plate 8). Each section was stamped on the reverse face with the makers mark "JABEZ THOMPSON TERRACOTTA WORKS MANCHESTER", accompanied by the letters "OH", suggesting that the mould was specifically made for Ordsall Hall (Plate 9).

Plate 8: Detail of the Great Hall (G4) string-course

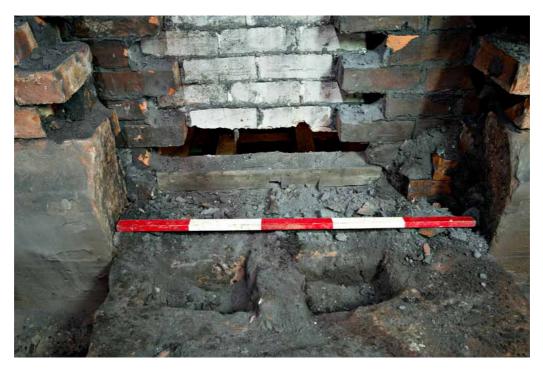
4.2.7 A red sandstone plinth projected slightly from the base of the external face of the wall. It comprised large sandstone blocks 3' x 2' x 9" (910 x 610 x 229mm), narrowing to a chamfer of half that thickness at the top (Plate 10). Removal of a section of the plinth exposed a timber rail, the purpose of which was unclear, although it appeared to be aligned with two rectangular-shaped apertures in the back of the plinth (Plate 10).

Plate 10: Removed section of Plinth, external south wall of Great Hall (G4)

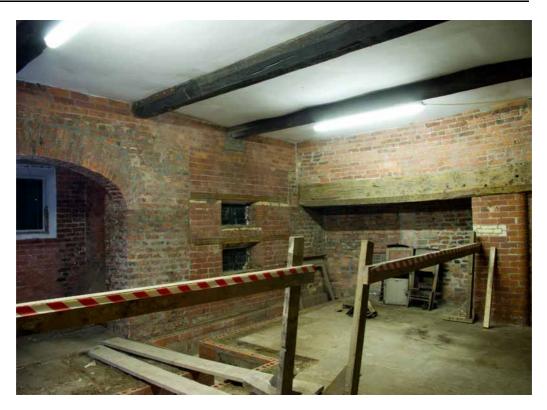
- 4.2.10 All of the walls are of brick construction, and extensive patching and repairs were visible, most of which appears to have been carried out relatively recently using cement-based mortar and a variety of brick types. The earliest fabric was constructed in English Garden Wall bond, typically comprising three courses of stretchers between those of headers, with thin hand-made bricks measuring approximately 9" x 4¼" x 2" (229 x 108 x 50mm), and bonded in a pale lime and sand mortar (Plate 11).

Plate 11: General aspect of the Kitchen (G10), with large inglenook fireplace and bread ovens

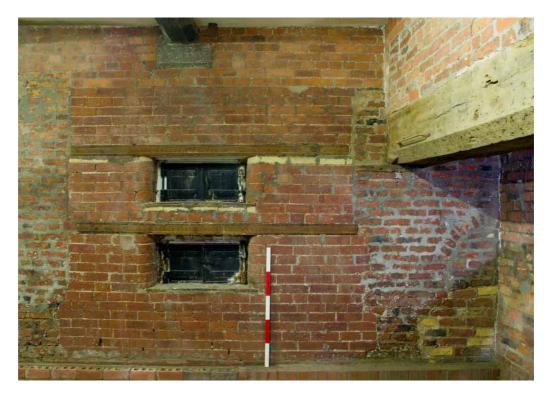
Plate 14: Detail of inserted bread ovens

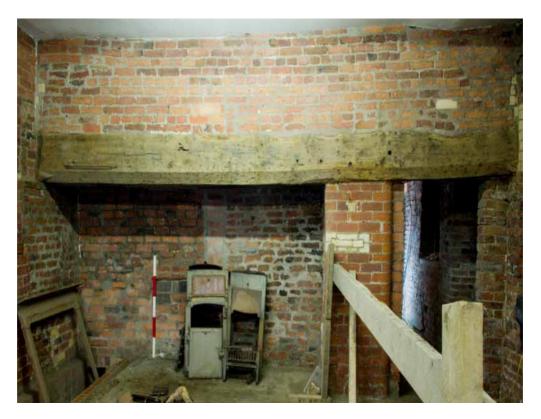
4.2.15 Immediately to the north of the bread ovens, the return of the north wall was incorporated into a large inglenook fireplace. This had been modified on at least one occasion, and comprised the majority of the north elevation, the full brick-thickness firehood being carried on a large-scantling, flat-chamfered bressumer, with decorative broach stops (Plate 15). This spans the full elevation, forming a lintel to a heck passage on the eastern side of the fireplace (Plate 15). This passage had been extensively remodelled, showing evidence for at least three phases, having originally been open into the room to the north, and blocked and re-opened, subsequently.

Plate 15: Inglenook fireplace in the Kitchen (G10)

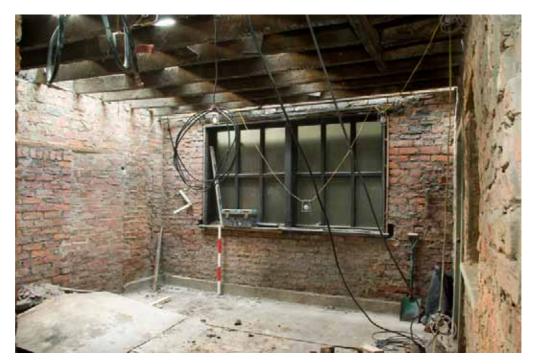
4.2.29 The large horizontal 12-light window in the north elevation (Plate 30) represented a replacement of an apparently similar earlier example. This appeared to be contemporary with the rebuilding of the north wall (Plate 30). This presumably dated to the reduction of the extension to single-storey height, quite probably undertaken during the major remodelling of the property at the turn of the twentieth century.

Plate 30: Rebuilt north wall of the Gardener's Office

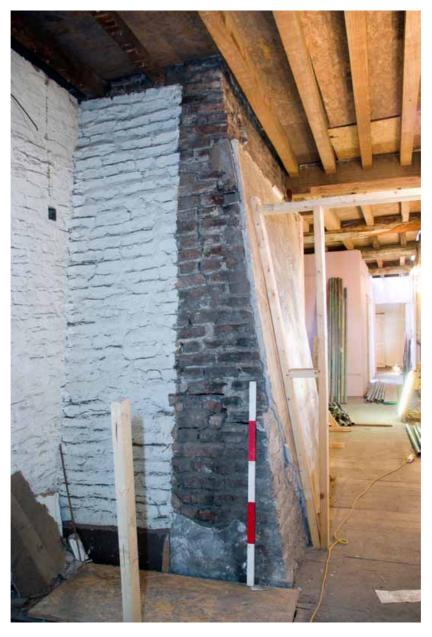
continuation of the brickwork of the stack around its south-eastern corner, where it was constructed in three-stretcher English Garden Wall bond. A small section of plaster, which predated the L-shaped wall, survived at the base of the chimney-stack (Plate 32).

Plate 32: Chimney-stack revealed by removal of a later wall in the Egerton Gallery

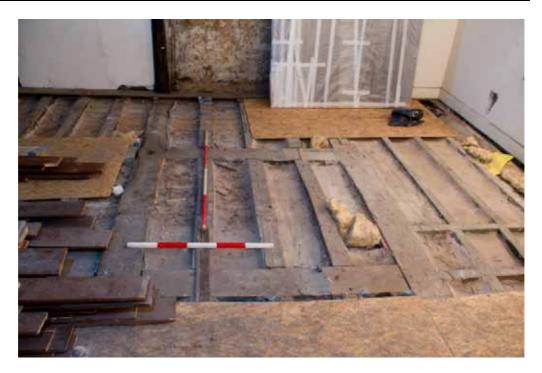
4.2.35 *The Lord's or Great Chamber Floor* (F3): the floor in this room was partly revealed by the removal of much of the existing floor boards (Plate 33). The specification for the refurbishment of the building required that the floor in this room be strengthened, and previous interventions were to be left *in situ* by the contractors. The floor remained in the same condition as when drawn by the GMAU survey of 1993 (GMAU 1995, Fig 9).

Plate 33: Area of floor structure exposed in the Lord's Chamber

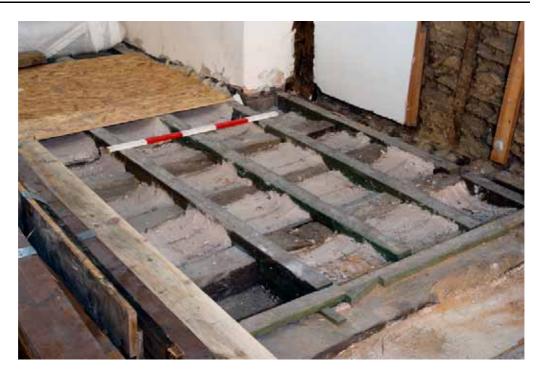
Plate 34: Later joists associated with an extension to the south of the Great Chamber, notched over the earlier fabric

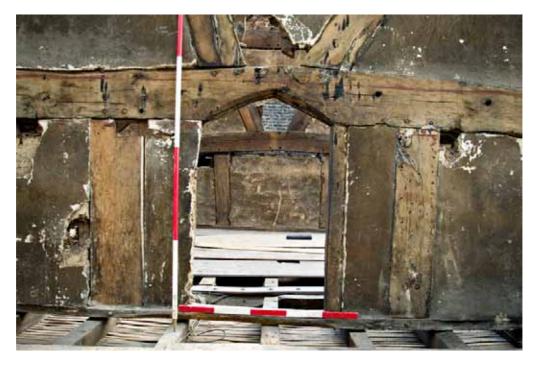
double-pegged within mortices in the tie-beam, and with only single pegs into the much lower-scantling rail at floor level (Plate 37). This rail was almost certainly a replacement, and redundant third peg-holes within the mortices on the soffits of the tie beams suggest that the posts may have also been replaced (Plate 37).

Plate 37: Detail of truss within Room S9, showing pegged assembly

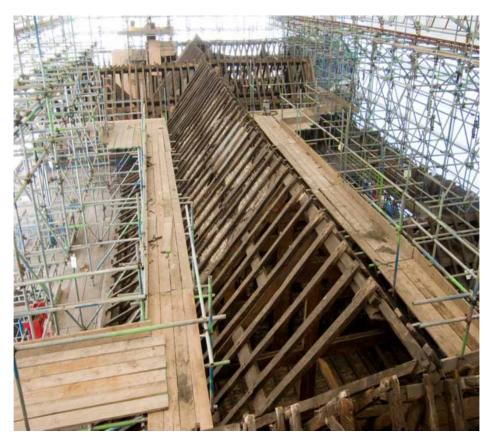
Plate 53: General view of stripped Roof D, with sprocketing to southern parapet

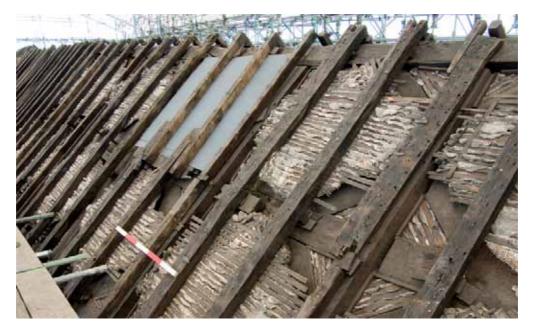
with the ceiling below the steel sheets having been infilled with plaster. Whilst of apparently relatively modern date, the sheets almost certainly represent the replacement of an earlier blocking, which may have failed to maintain a waterproof membrane to the ceiling.

Plate 56: Blocked louvre, southern pitch, Roof D

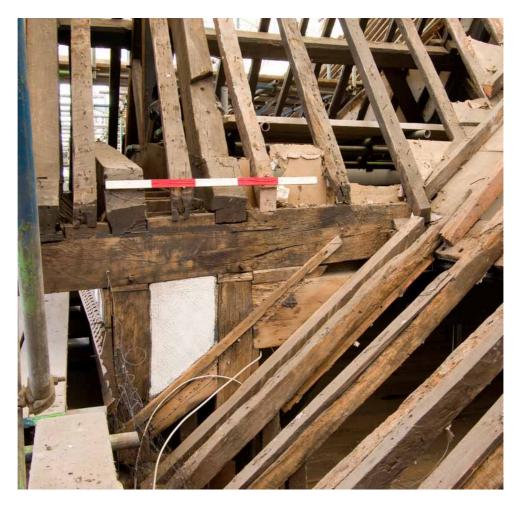
4.4.23 All of the joints were double-pegged, except for the wall-plates, which were triple-pegged onto the wall-frame post (Plate 63), suggesting normal assembly with an internal upstand. The jetty bressumer at the northern end of the roof was single-pegged to the wall-plate (Plate 63). It was rather unusual in that it did not house the studs for the gable façade, instead having only a central wrought-iron bolt (Plate 64), and this probably to strengthen the rail supporting the jetty coving located approximately 3' (0.91m) below (Plate 61). The façade of the southern gable was placed against a repositioned truss, located approximately 2' (0.61m) to the north of the façade (Plate 65). This was presumably originally positioned further out to the south, with a bladed scarf joint immediately below this truss in the eastern wall plate (Plate 64), also suggesting that the roof originally continued for a considerable distance to the south.

Plate 63: Triple-pegged wall frame, showing normal assembly, and with jetty bressumer beam to left (Roof F)

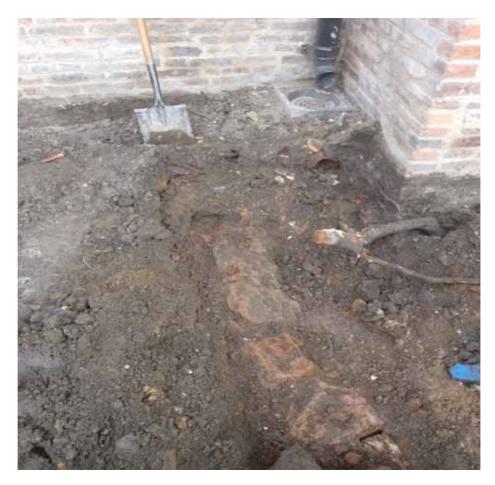
- 4.6.3 Two stone walls (29 and 37) and a stone culvert (30) were partially exposed. Wall 29 (Plates 79 and 80) followed a vague east/west alignment, and appeared to be truncated by the northern end of the west wall of the hall. It comprised a single course of unbonded, worn, yellow sandstone blocks, surviving for a length of 0.75m. These were set on red sandy-clay, which was exposed 1m beneath the modern ground level. A large block, measuring 0.8 x $0.6 \times 0.4m$ was removed from loose deposits above the wall, and was likely to have formed part of an upper course. The projected approximate length of the wall measured 3.30m. It would certainly appear that this wall pre-dates the northern annexe to the west wing

Plate 79: Eastern extent of Wall 29

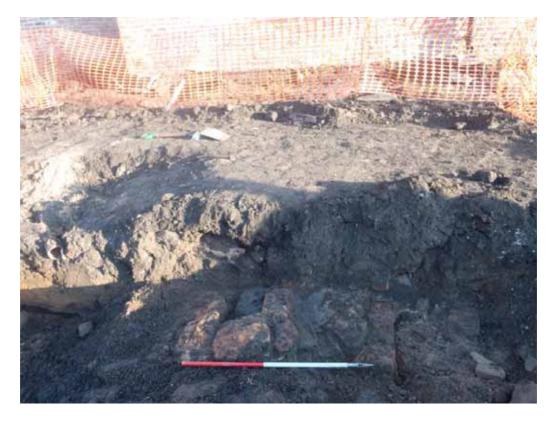
4.6.6 An arrangement of irregular-sized stone blocks and slabs (25; Plate 83) was exposed 5.8m to the west of the hall. It was aligned north/south for a distance of 2.1m, and was 1m wide. The stones are almost certainly the foundations for a wall. The wall overlay a 0.4m thick clay and gravel levelling layer, which in

turn overlay a horizon of red sandy-clay (28). The clay (28) yielded pottery dating no later than the late-seventeenth century. The stone blocks (25) were sealed by a dump of demolition debris (27) containing charred building material, and domestic refuse, including eighteenth-century blackware pottery. This tentatively limits the date of construction of the wall to between the late seventeenth century and eighteenth century, and suggests that the structure it relates to burnt down.

Plate 83: Foundation 25

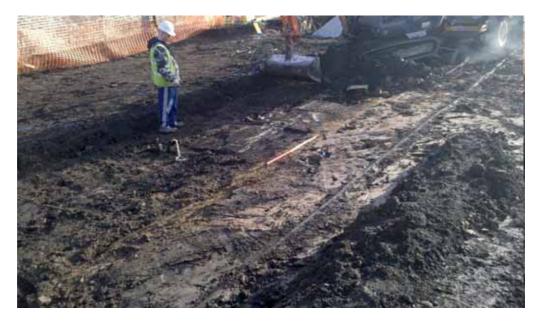
4.6.11 Against the east side of the north end of the wall (2) were the partial remains of a sandstone flag surface (1) (Plate 85). The flags appear to post-date surface 3, and could possibly relate to an abutment of the earlier moat causeway. However, the flagstones, which were exposed at quite a shallow depth, also align with the easterly pavement for the former Rixton Street (OS 1891).

Plate 85: Working shot showing sandstone flags adjacent to wall 2
