Church Farm
Lewknor
Oxfordshire

**Historic Buildings Recording
and Investigation**

Church Farm, Lewknor, Oxfordshire

Historic Building Recording and investigation

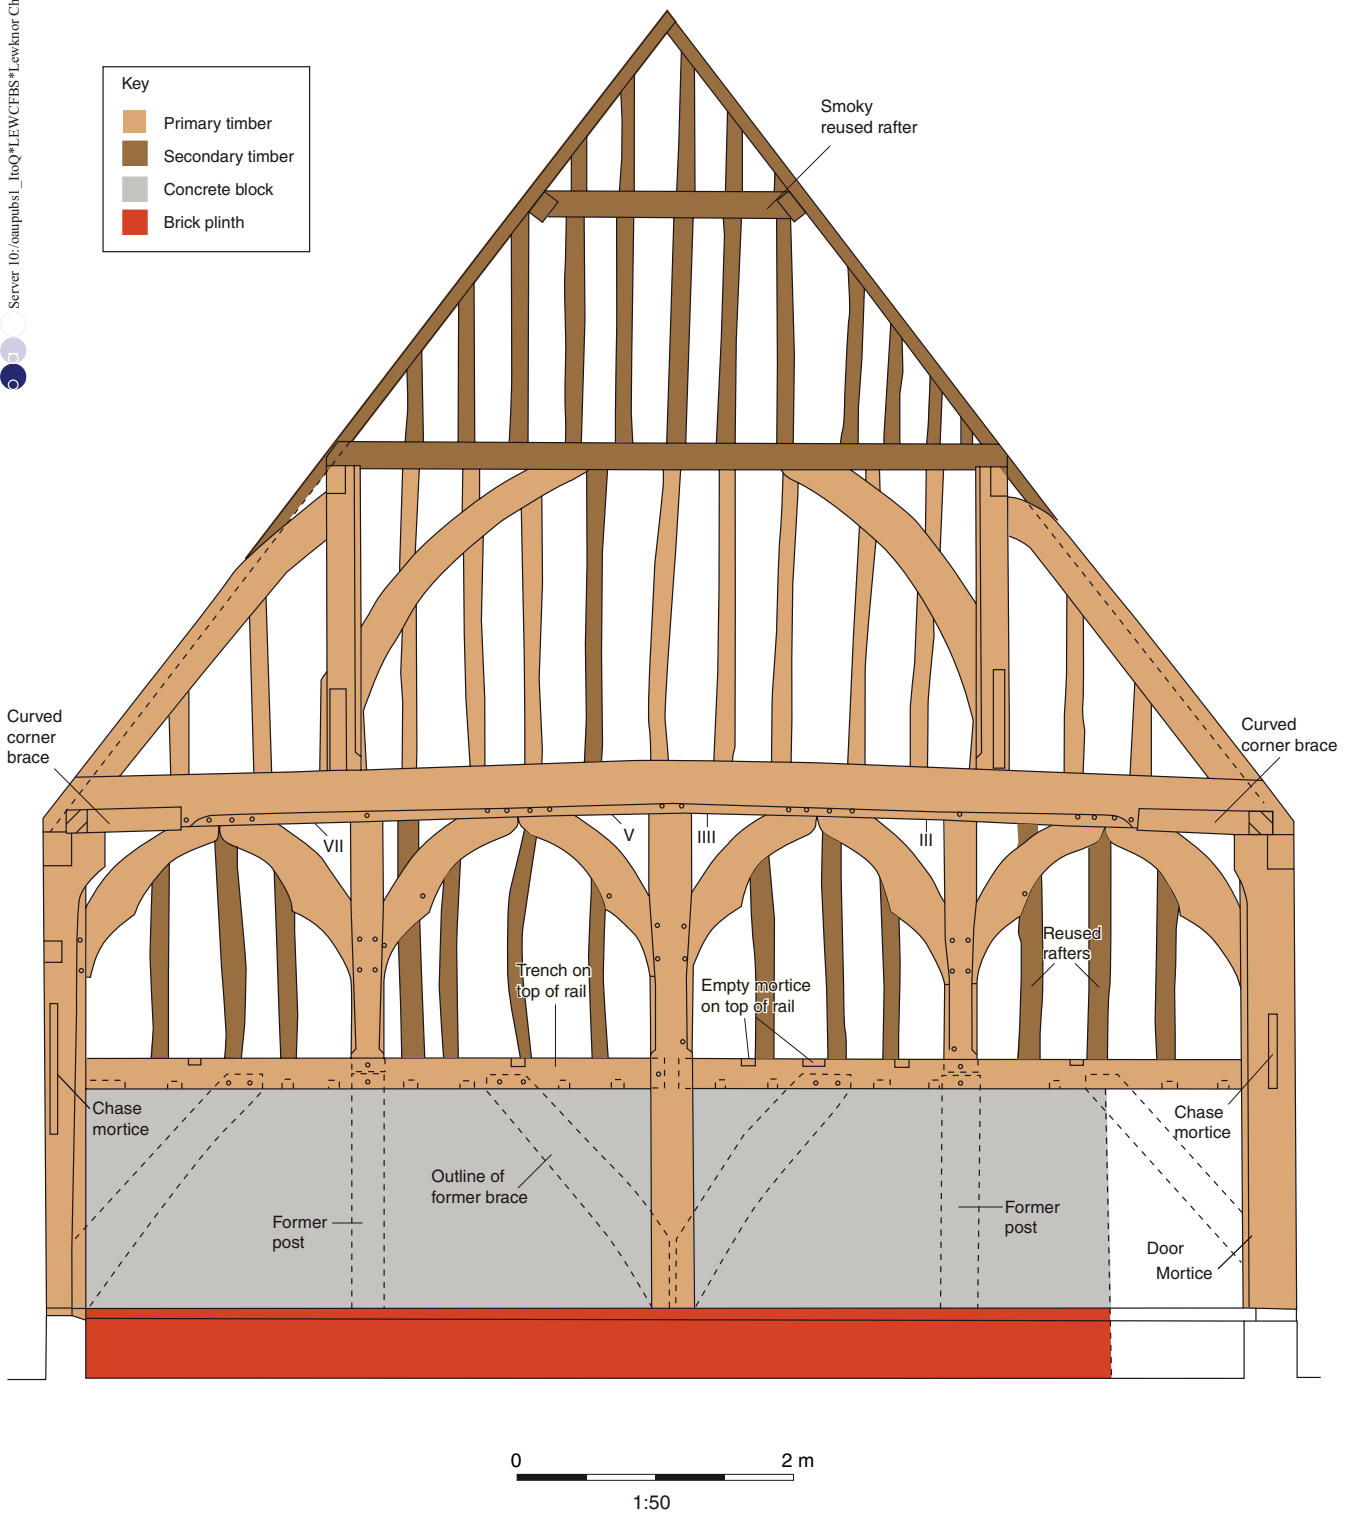
Figure 3: East end wall, internal elevation

- 3.6.2 The east wall (Frame 1) of the barn would have formed the upper (dais) end of the open hall and it is an attractively decorated frame with cusping and mouldings which were clearly intended to impress visitors to the hall (Fig 3, Pl. 12). The wall divides into two main elements: i) the truss and half hipped gable; ii) the wall beneath the truss.
- 3.6.3 The truss comprises tie-beam, principal rafters, lower collar (or upper tie), upper collar, raised aisle posts and curved struts between raised aisle posts and lower collar. Unlike in

- 3.6.4 The tie-beam is chamfered and it is supported by five posts which divide the main wall into four bays. Three of the posts (central and corner posts) are full height from the plinth while the other two posts are smaller in section and only rise from the mid rail. Within each bay there are two scratched Roman numeral carpenter's marks on the tie-beam's soffit which are different to the unusual primary marks found elsewhere in the barn (see below) but are assumed to be primary.

- 3.6.5 Below the tie-beam there are pairs of cusped braces in each of the four bays between post and tie. Behind the braces there are three secondary studs (several smoke blackened reused rafters) in each bay between tie and mid-rail. The studs which hold the weatherboarding are fixed with hand-made nails of probable 18th or 19th century date. In the upper face of the mid-rail there is a trench, apparently along the entirely length of the rail, within which the primary studs from the wall would have sat. These would have supported wattle and daub panels. There are also several other small mortices in the upper face, which appear to be secondary and which are inside (ie to the west of) the trench. At either end of the truss there is a curved horizontal corner brace tenoned into the face of the tie-beam which extends around to the north and south walls. These corner braces are found at each of the four corners of the former hall and they are tenoned into upper wall plates in the long main walls.

- 3.6.6 In the soffit of the mid-rail there are also a series of mortices although at this lowest level the wall has been almost entirely replaced by concrete block which appears to have been constructed since the RCHM recording in 1972. The studs are known to have been intact in 1911 as they are shown in a valuable photograph included in the 2002 report by Dr James Moir of Finial Associates. The three main posts (central and at each corner) survive down to the plinth but the two smaller posts, bracing and studs have all been lost. There are regular mortices for studs as well as two larger ones from the missing posts, and within each bay is a mortice with two pegs which would have housed the upper tenon of a curved brace. It is possible that these braces were cusped similarly to the surviving ones beneath the tie-beam but the photograph from 1911 mentioned above suggests that they were not. The photograph shows plain straight braces but they do not appear to correspond with the existing mortices and smaller posts beneath the mid-rail are not shown suggesting that by 1911 the original arrangement in this area had been substantially altered. Therefore it is still possible that the primary lower braces were cusped but these had been lost before 1911. From the surviving mortices it is apparent that there would just have been a single brace in each bay as opposed to the pair of braces in each bay above the mid-rail. The corresponding lower mortices from the bases of the braces are also apparent with three pegs each in the sides of the the three surviving posts. At the southern end of the wall is a small doorway in the concrete blockwork which leads through into the modern barn (being demolished in the current works). This doorway is clearly modern and would have been blocked by one of the former braces. The plinth is

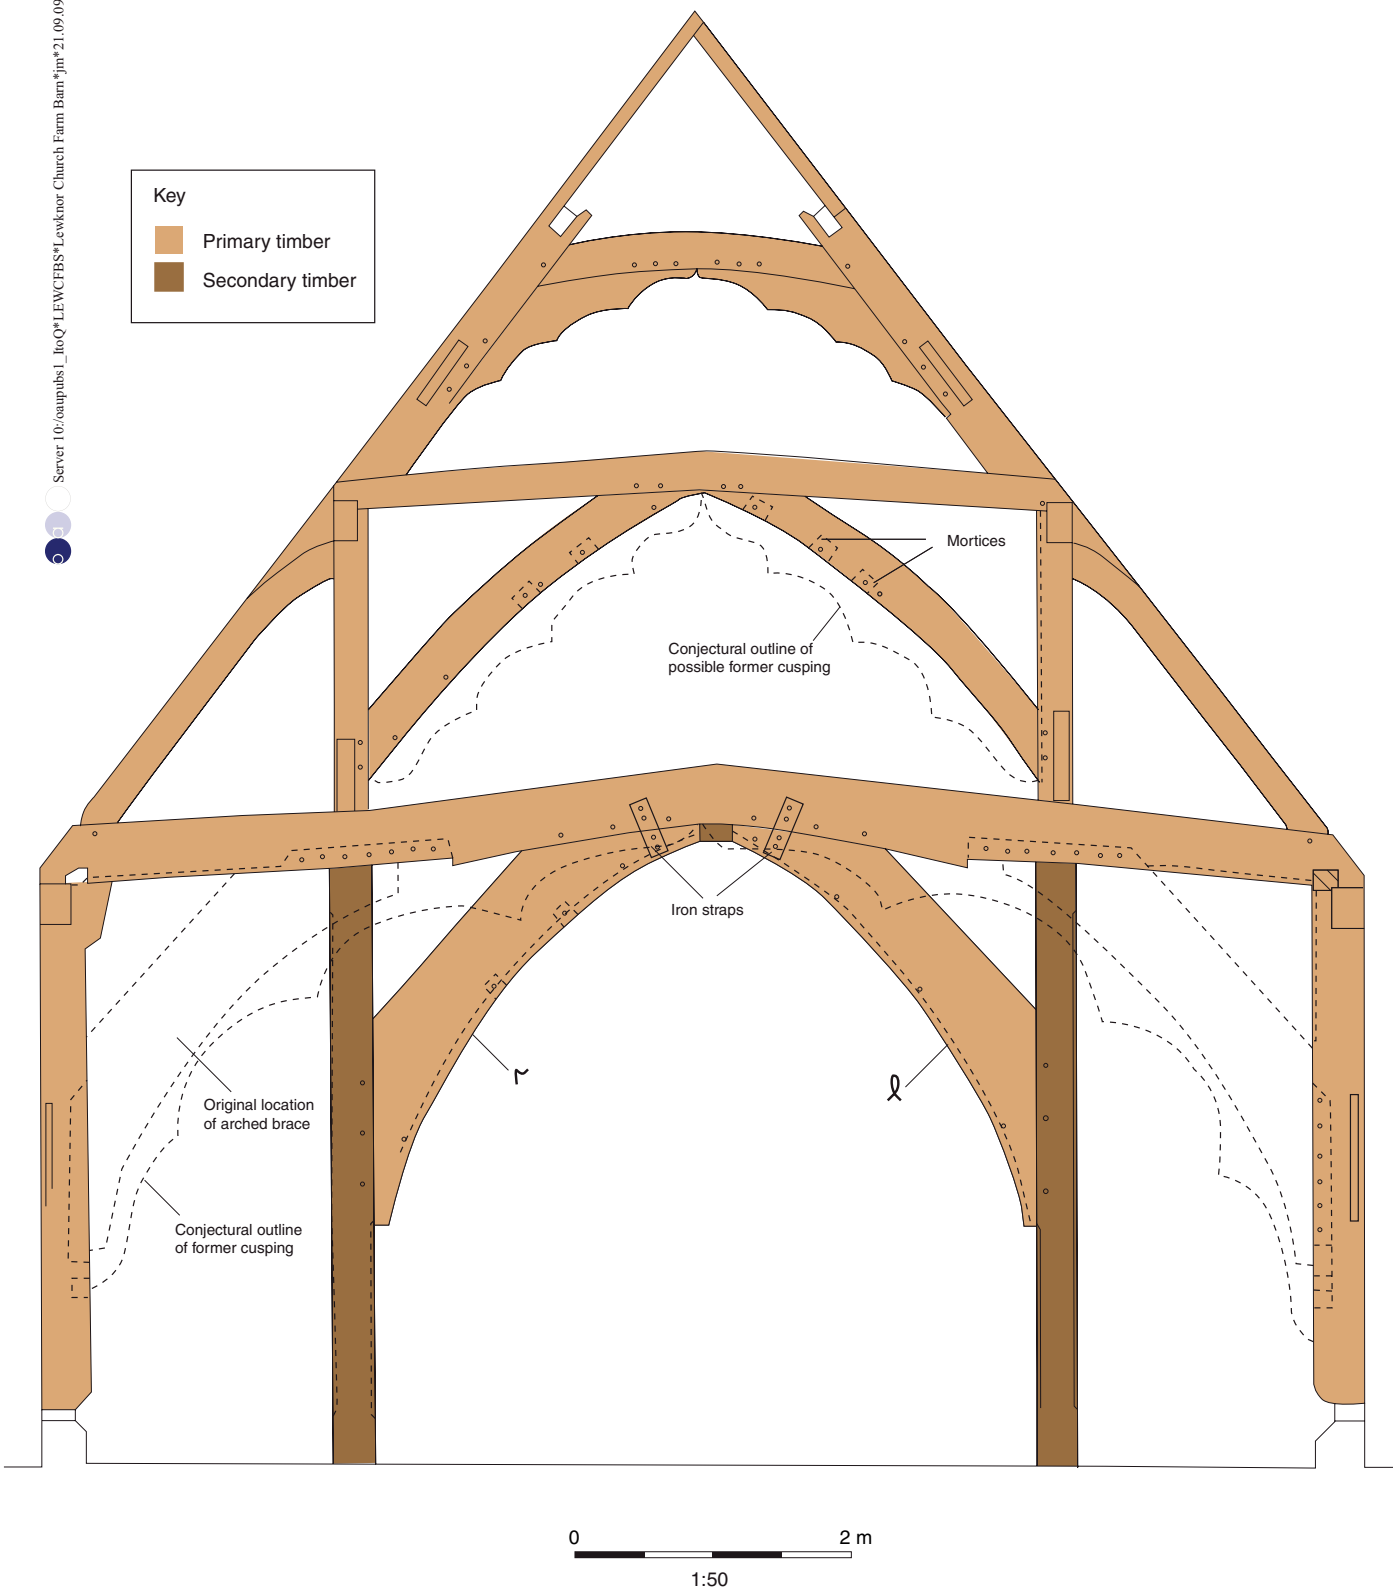
Figure 4: East central truss from west

3.6.8 The cross frame on the east side of the central bay (Frame 2) would have formed the central display truss of the original two-bay open hall. It is now superficially similar to the spere truss on the west side of this bay but this is due to a 20th-century alteration and its primary form would have been significantly different. The original frame would have been formed a remarkably wide, clear span below tie-beam level for a building of this date (c.8.8 m) but it has been altered by the repositioning of the arched braces towards the centre in order to provide greater support for the tie-beam. In the original building these braces would have been supported by the outer posts but they are now supported by inserted 20th-century 'aisle posts'. Large empty mortices with sloped shoulders are clearly visible in both main posts (with 6 peg holes) and in the soffits of the slightly cambered tie-beam (7 peg holes). The lower edge of the tie-beam is cut back slightly towards the outer edges and there is a clear step down at the points where the arched braces would have sat. There is now a small block (c.25 cm wide) between the heads of the two braces whereas they would originally have been c.3.75 m apart.

3.6.10 A number of sections of iron strapping have been added to strengthen the cross-frame including plates between arched braces and tie beam and a long iron strap bolted to the northern post. The west side of this post head has been cut back and re-profiled to the allow the insertion of the ironwork; the east side is jowled. A modern horizontal bearer has been added between the 20th-century 'aisle post' and the main primary post.

3.6.11 The truss within Frame 2 (above the tie) is of raised aisle type and it appears to survive largely intact from its original arrangement. It comprises upper collar, lower collar, principal rafters (diminished above the upper collar), raised aisle posts, lower principals with arched heads supporting the aisle posts, arched braces beneath the lower collar and cusping beneath the upper collar. There are a series of mortices in the soffits of the two braces which presumably would have supported further ogival cusping within the truss.

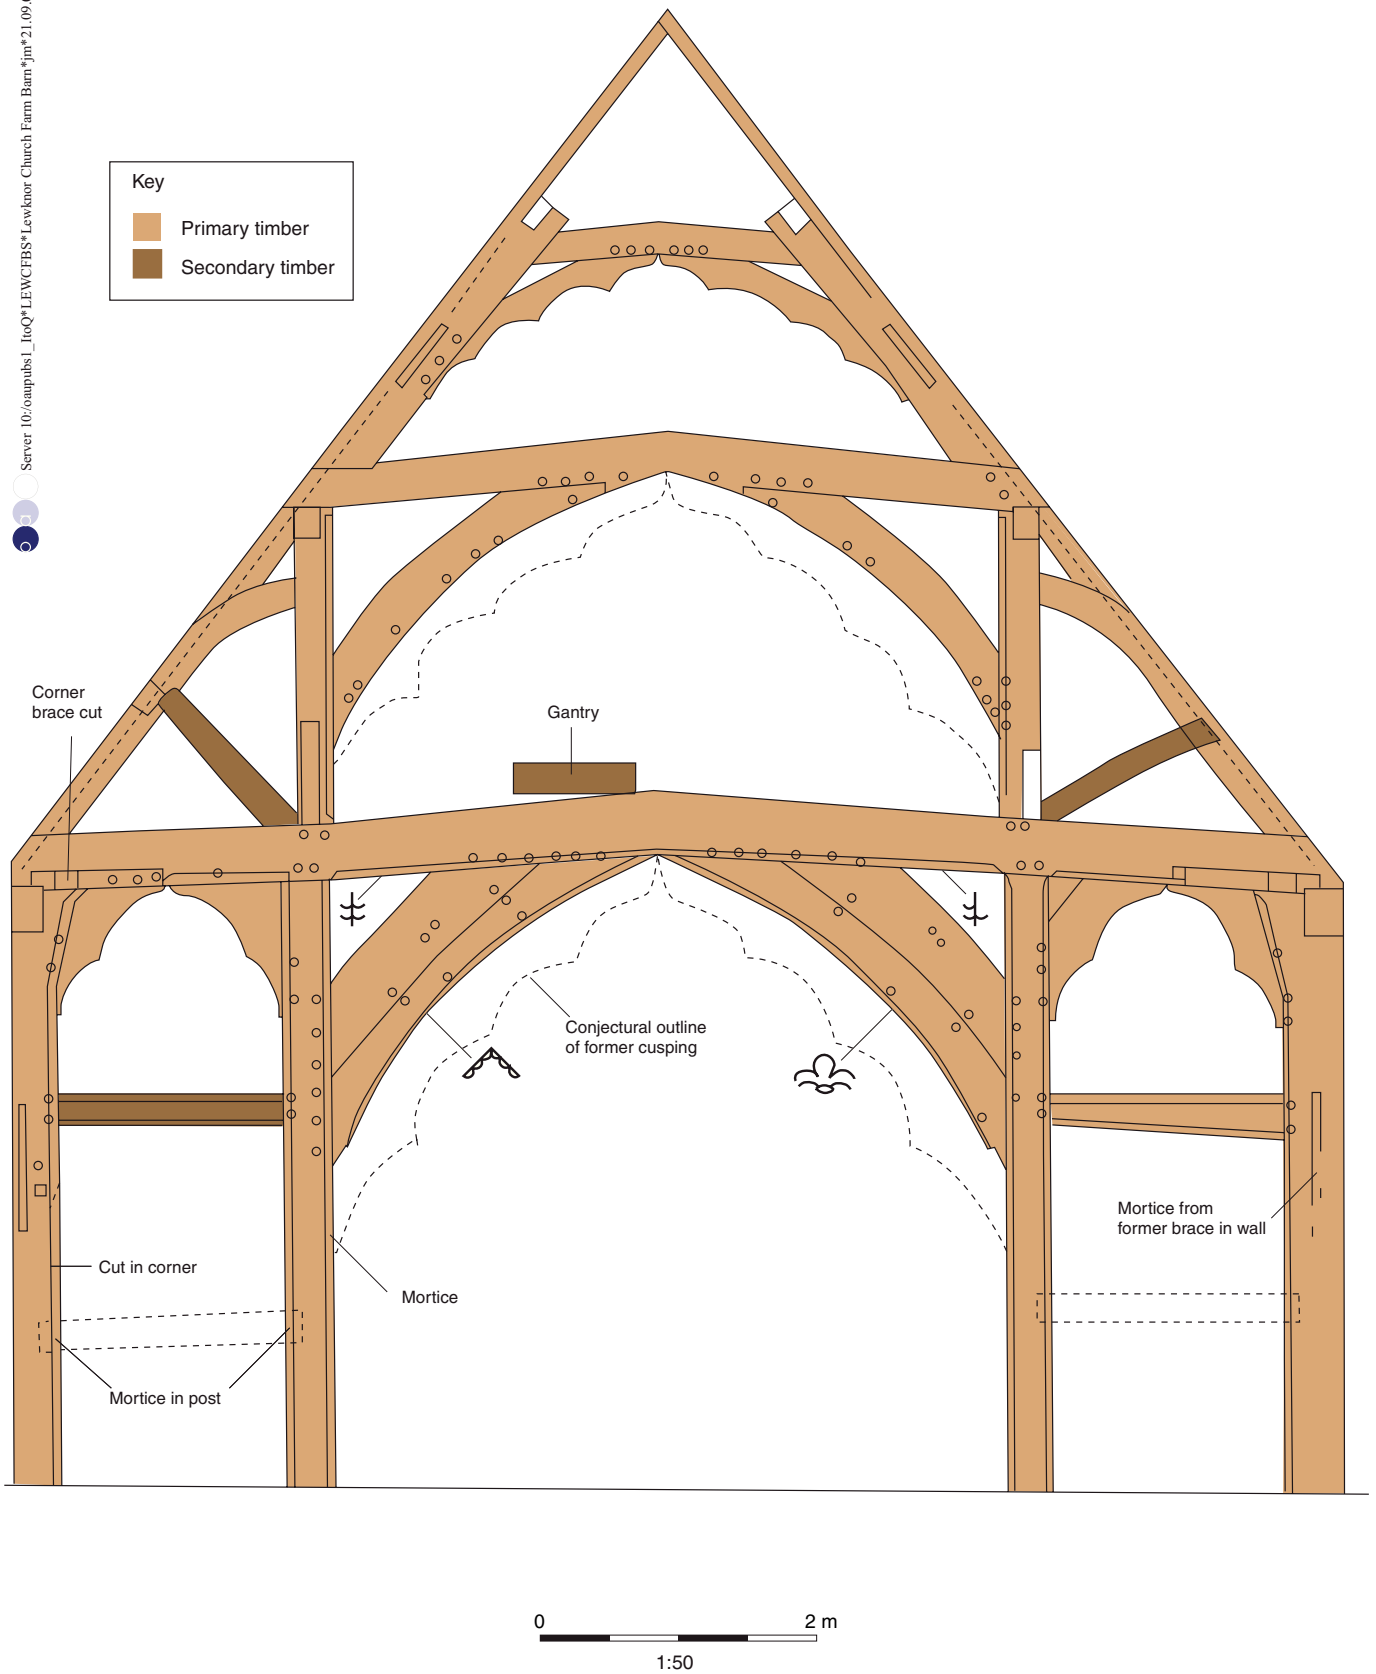
Figure 5: West central truss from east

- 3.6.14 The frame on the west side of the central bay (Frame 3) comprised the spere truss, that is the division between the cross-passage at lower end of the building and the main hall to the east. The spere truss would also have formed the main entrance into the hall. This cross frame remains very close to its original arrangement with very few secondary alterations. The truss is similar to that in Frame 2 with cambered tie-beam, lower collar (also cambered), upper collar, principal rafters (diminished above the upper collar), raised aisle posts, arched braces and lower principals. The upper section of the lower principals curves to meet the face of the raised aisle posts. There is cusping extant below the upper collar and against the adjacent section of the principals and it appears there would have been similar cusping to the arched braces below the lower collar. Each of these braces has a number of peg holes and empty mortices which would almost certainly have supported cusping. The uppermost pair of mortices from the former cusping are in the underside of the lower collar. The lowest sections of each of the two principal rafters is supported by a secondary raking strut, the lower end of which is wedged between tie-beam and the base of the raised aisle post, and a contemporary inserted purlin. The primary lower principal is cut in this area to allow for the insertion of the secondary purlin.

- 3.8.5 On the corresponding soffit of the southern arched brace in the spere truss is an unusual *V shaped mark with half circles (two to one side and three to the other)* and again this was scribe-cut with a race knife (Fig 5). It is likely that the race knife had a central point that enabled the user to make circular shapes of approximately 40mm diameter. This central point is not found on post 18th century race knives. It is again unlikely that this is an assembly mark and is probably a graffiti or decoration.

- 3.8.6 Also on the spere truss a number of similar marks were identified with *half circles and lines* and these do form part of a pattern of assembly marks (Fig 5, Pl 20). Each mark includes a straight central line and half circles branching to either side from this line. On one set of marks there are two half circles to either side while another set has a single half circle to one side and two to the other. Corresponding marks are found to either side of the truss on the tie beam soffit and side of the post. This mark is very similar to arrow style markings seen elsewhere (eg. moulded roof truss in the Chapel Royal Hampton Court Palace c. 1536). It would appear that the lower two half circles denote whether the frame goes on the left or right with only one half circle on one side of the barn and two on the other. This appears to be made with the same size (40mm) circular race knife as the two marks above suggesting they are all of a similar date.

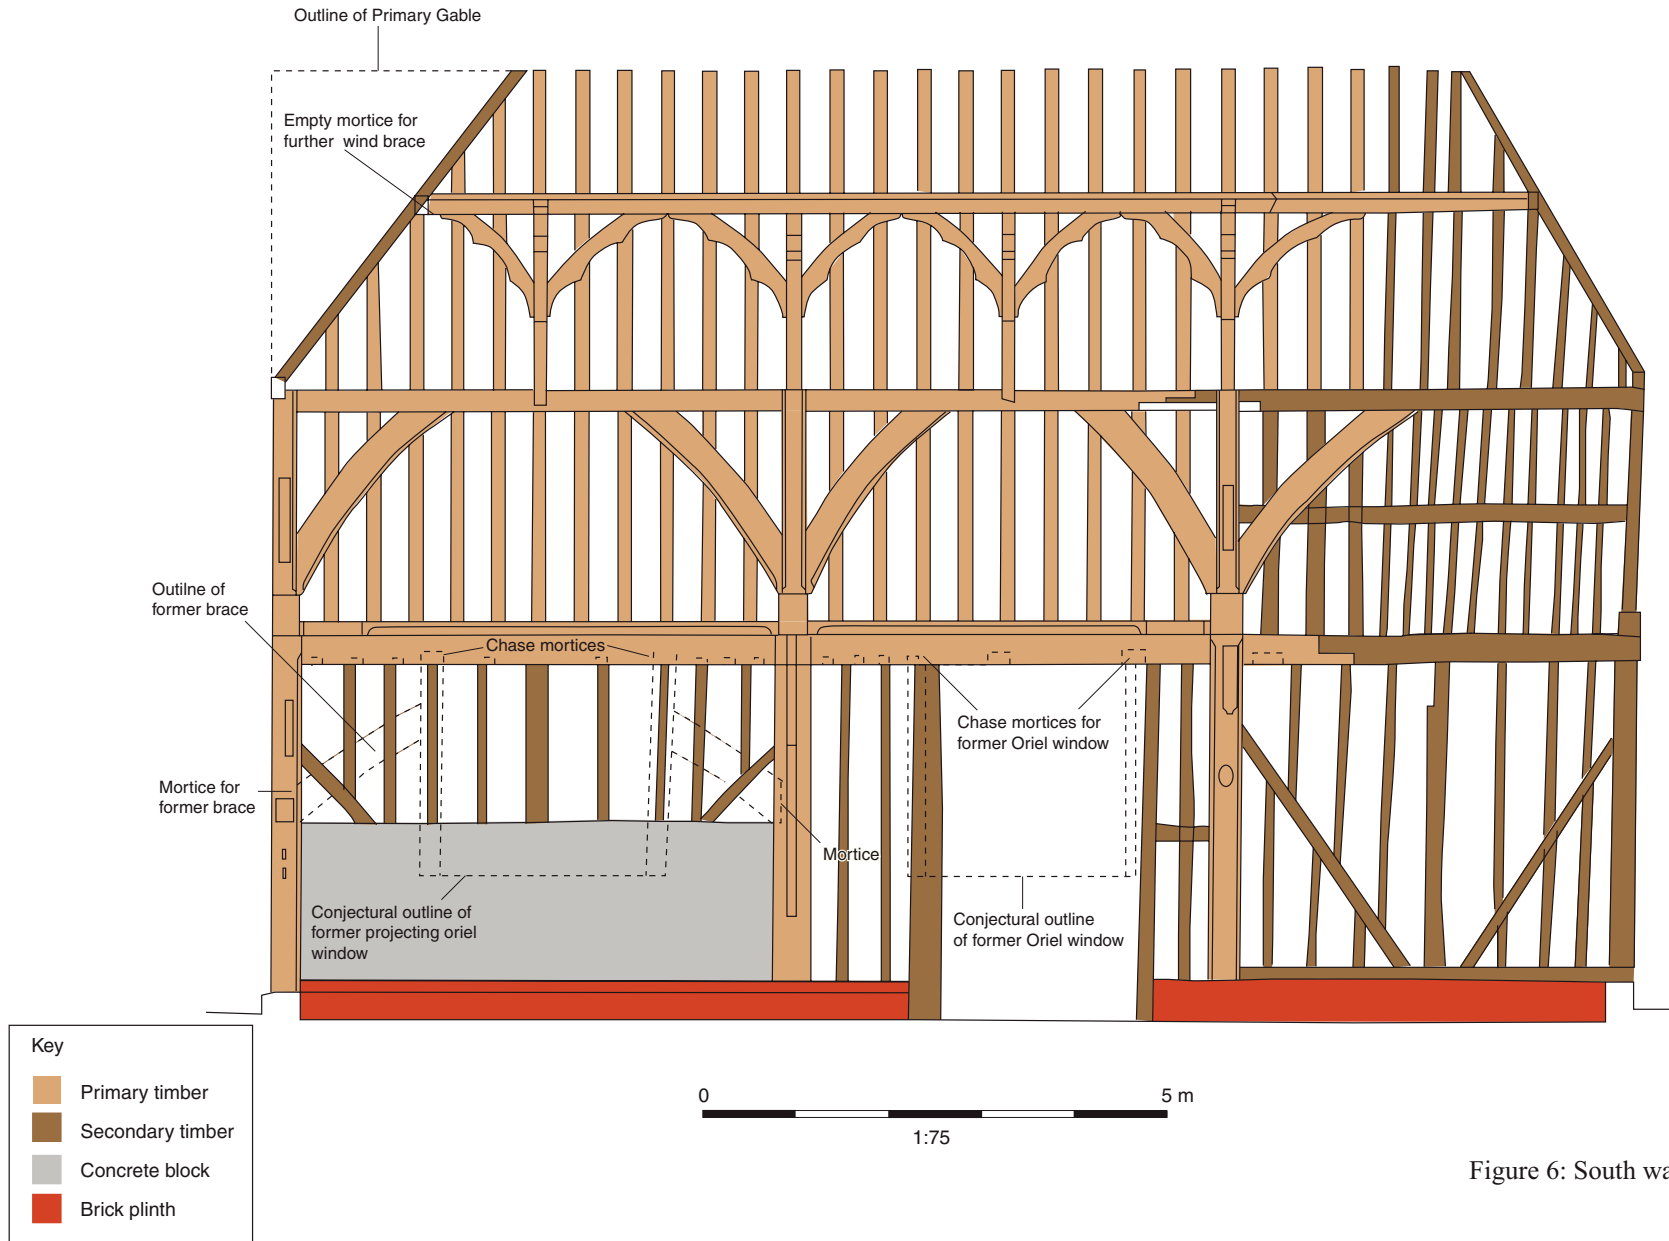
Figure 6: South wall internal elevation

- 3.5.2 The phasing of the south wall divides into the largely primary eastern two bays and the western bay which has been entirely reconstructed, possibly in the 18th century (Fig 6).

- 3.5.4 The main framing in the south wall is entirely secondary but there are a series of empty mortices in the underside of the principal wall plate which provides an indication of the former wall arrangement and this includes some of the most significant features revealed in the current project. Several of the mortices relate to the former wall framing but there are also four horizontal mortices now observed for the first time on the outside of the wallplates, immediately beneath the eaves, two in each of the main bays within the former open hall (central and eastern bays). Located adjacent to vertical mortices for wall posts, the horizontal mortices are chased (i.e. have an angled side) and would have housed horizontal members which projected out from the external walls of the building at an angle rather than at 90 degrees to the wall (Pl. 21).

- 3.5.7 The south wall framing in the western bay is entirely secondary, contemporary with the reconstruction of this end of the building, and it comprises a central post, two raking struts and vertical studs.

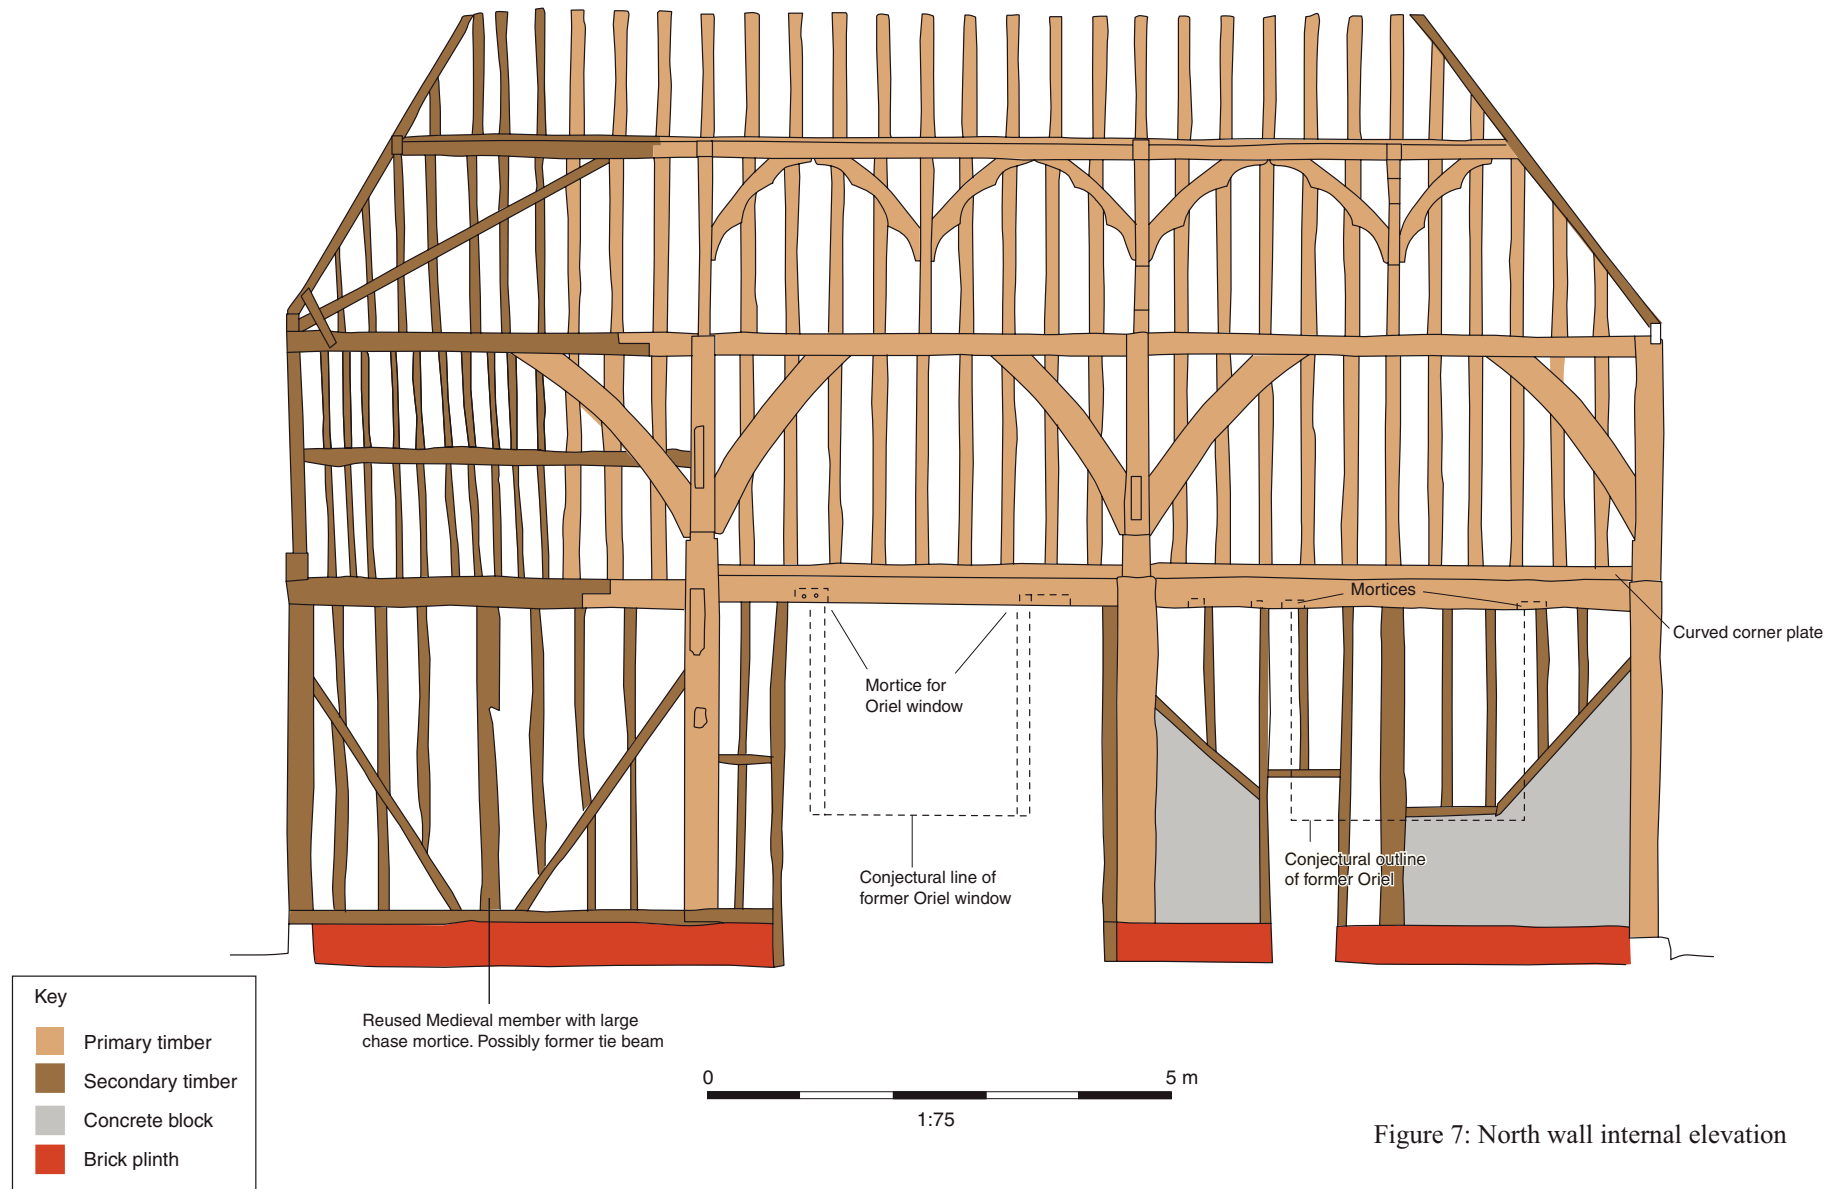
Figure 7: North wall internal elevation

- 3.5.8 *North wall (recorded by OA)***
- 3.5.9 The north wall framing (Fig 7) is also broadly similar to the south wall. The eastern bay of the north wall incorporates concrete blockwork (post 1972) to the lower section and secondary elm stud framing above. One of the members in this frame (the sloped eastern bearer or plate) may be a reused medieval member.

- 3.5.10 The western bay of the north wall again incorporates secondary stud framing but the central post in this area is a reused medieval member with long chase mortice to one side and a deep, tapered trench which re-profiles the same face. The chase mortice and re-profiled face suggest that this member may have been a section from a tie-beam (or possibly collar) and that the chase mortice would have housed an arched brace. The post is 3.43 m long and the uppermost 1.13 m (above the mortice and trench step) is moulded. Assuming this member was a tie-beam the moulded section would have formed the underside of the central part of the truss between the two arched braces. As a comparison the tie-beam in Frame 2 has a moulded central section of almost 4 m long (prior to the 20th-century re-setting of the aisle posts). If this is a surviving, reused tie-beam from the medieval hall it would be of considerable significance and presumably was from the western side of the screens passage (immediately west of Frame 3) or from the service bay beyond this.

- 3.5.11 Similarly to the south wall the wall plate in the central and eastern bays of the north wall has a number of empty mortices and among these are two pairs of horizontal mortices from former projecting oriel windows. These mortices are the same as those in the south wall (detailed above) with slots to the underside for posts and slots to the outer face for projecting members which would have extended from the wall at an angle to it.

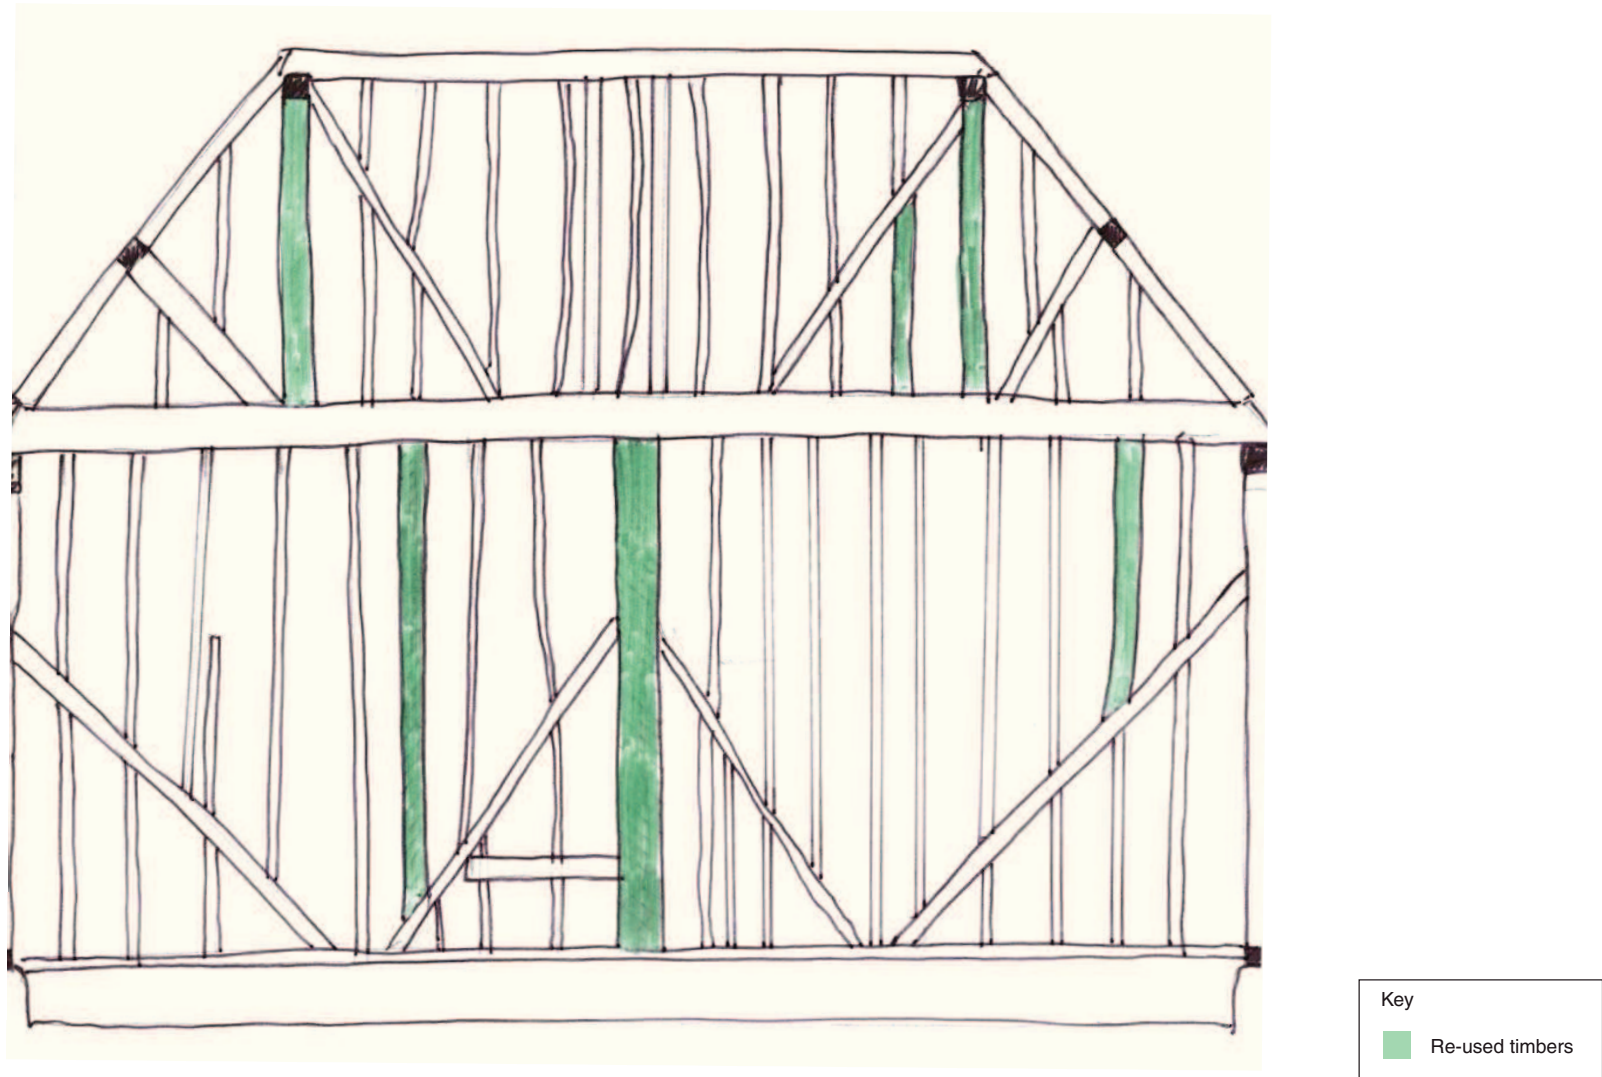
Figure 8: Sketch elevation of west wall showing re-used medieval timbers, (approx 1:50)

- 3.6.18 The west wall now comprises a central post, two further intermediate main posts and four raking struts (between these three and the corner posts). The wall between these posts comprises vertical studs almost all of which appear to be of 20th-century date.

- 3.6.19 The central post is formed from a reused medieval post or tie-beam 3.65 m long by 28 cm wide by 18 cm deep. There are three mortices along the northern edge which would have been the underside (if this was a tie-beam) and two smaller mortices for former studs on the southern (formerly upper) side. The larger mortices along the northern side include

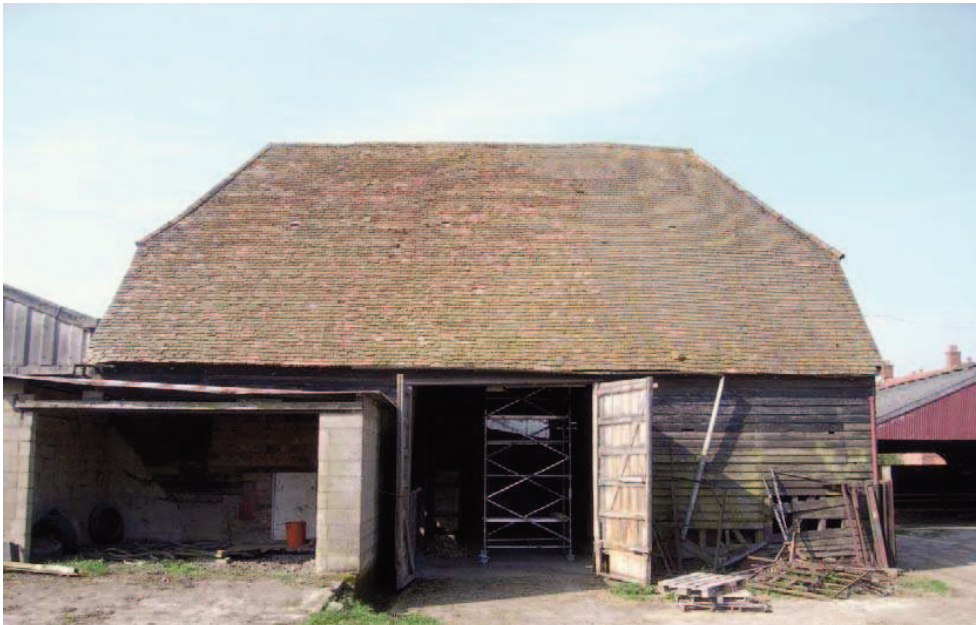
Plate 2: Exterior of barn from north

- 3.3.2 The barn has a half-hipped roof, clad in clay tiles, and the walls, which are largely clad in weatherboarding of several phases, are now in poor condition (Pl.2-4). The exception to this are the lower sections of the east wall and the eastern end of the north and south walls, which were reconstructed in the later 20th-century in concrete blockwork. The main walls are set on a brick plinth and there are tall double threshing doors in both the north and south walls. The external cladding has been stripped and replaced, some of this prior to the site inspection, so the external timber faces were not inspected.

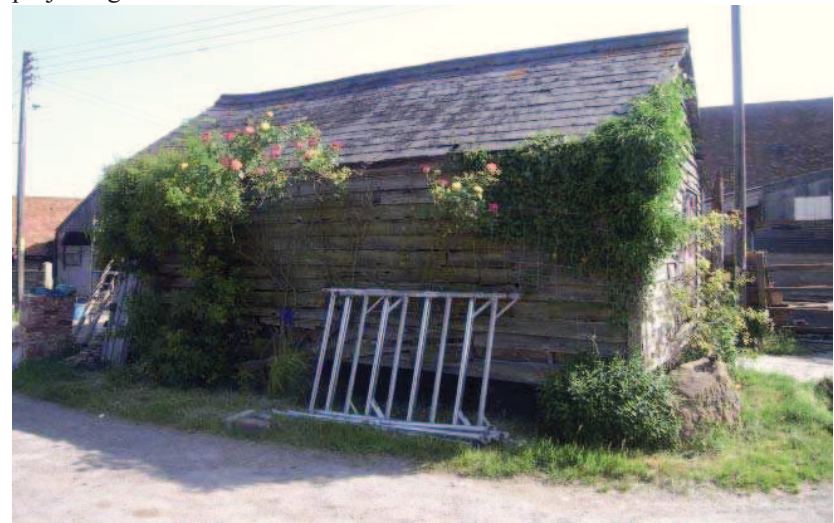
Plate 23: Granary from south

- 4.3.1 The granary (Pl. 23-24) is a rectangular plan, single-storey building (7 x 4.5m) with a slate-covered gabled roof and walls clad in weatherboarding. The condition of the building is now very poor and it is being substantially rebuilt in the current project reusing materials from the existing building.

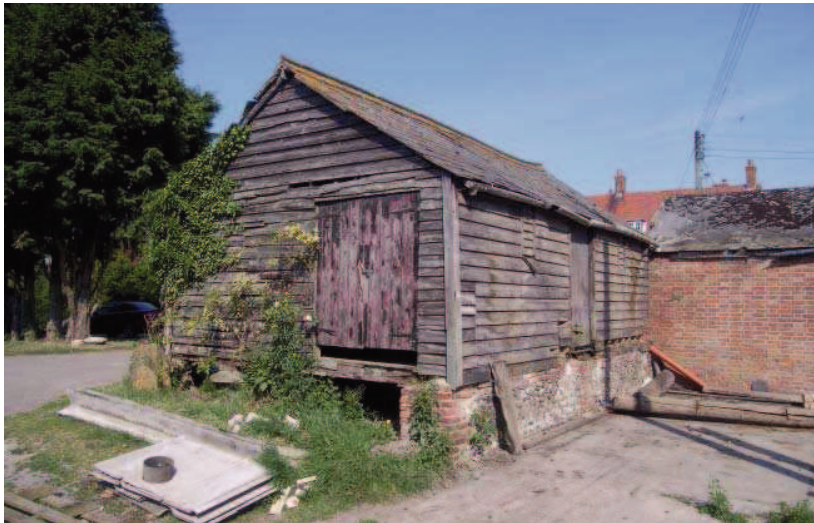
Plate 24: Granary from east

- 4.3.2 The floor of the building is raised above ground level but secondary works have altered the arrangement of primary staddle stones, particularly to the north wall. To this side of the building the staddles have been replaced by a solid plinth comprising three brick piers with flint infill between. The weatherboarding in the north wall shows evidence of patching and alteration. This wall has a central doorway and two small windows, one to each side, which have each been infilled with boarding. The east wall includes a set of double doors at the northern end and there is a single door at the western end of the south wall. The south wall is particularly overgrown and the condition of the weatherboarding is very poor.
