The Old Malthouse Paradise Street Oxford

Historic Buildings Investigation and Recording

July 2013

OA Job No: 5667

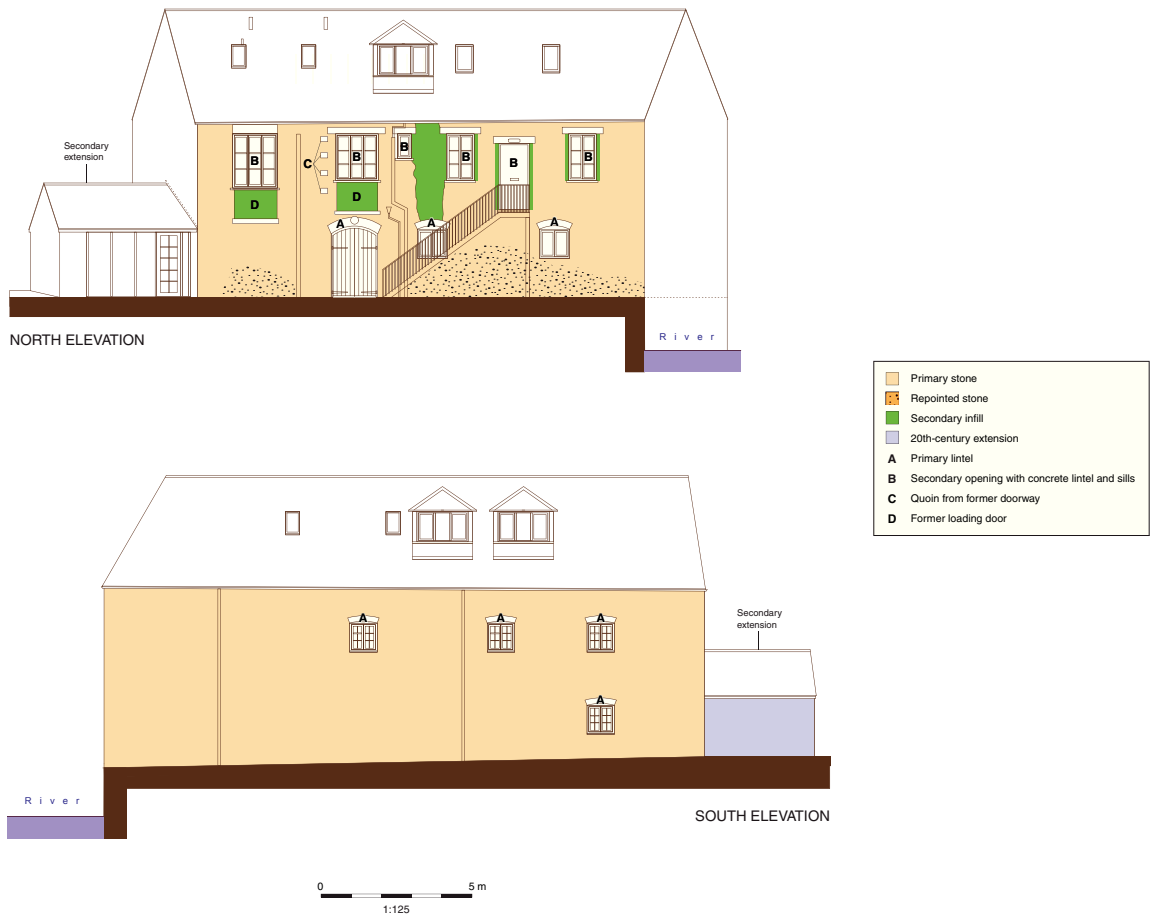
Figure 3: North and south elevations

- 3.2.2 The *north elevation* is the main front of the building facing onto the open yard and it includes the entrances into the structure. The wall is constructed from roughly coursed and squared stonework typical of so many structures in Oxford but there are many areas of patching, phasing and rebuild. There are currently three openings at ground floor: a double doorway beneath segmental stone arch and two smaller windows also beneath primary stone segmental arch windows. There is a large patch of rebuilt stone above the eastern of the two windows.

- 3.2.3 At first floor level there are six openings, five windows and a secondary doorway at the head of a flight of metal stairs inserted in the later 20th century. The six openings have concrete lintels and sills and have clearly been overhauled in the later 20th century (probably when the building was converted to offices). The jambs of the three western openings (two windows and a door) have been reformed and clearly these are entirely secondary but the two larger windows towards the eastern end of the elevation are partially surviving older (probably primary) openings. Each of these two windows are later 20th-century in date but they each have large patches of rebuilt stonework beneath them extending down to lower sills. It thus appears that these would have been two tall loading doors in the eastern half of this elevation. The western of the two windows has a stone sill, showing some deflection and immediately above the primary stone arch of the main entrance door but the eastern sill is of concrete.

- 3.2.4 To the east side of the former loading door above the main entrance to the building there is a curious vertical line of c.6 larger stones together with a structural break. These stones presumably survive from a quoin on the east side of a former doorway slightly wider than the current window. It appears that each of the stones that formed the return into the building has been removed just leaving the stones at the face.

- 3.2.5 Large sections of the lower part of the wall have been repointed with a cement pointing that smoothes the surface of the wall and makes each stone less distinguishable.

- 3.2.6 The *south elevation* forms the rear of the building and compared to the north wall it is relatively featureless. The wall is again constructed from roughly coursed stone and although there are many patches where the character of the stonework appears slightly different to other areas it is not possible to identify clear features such as former blocked openings.

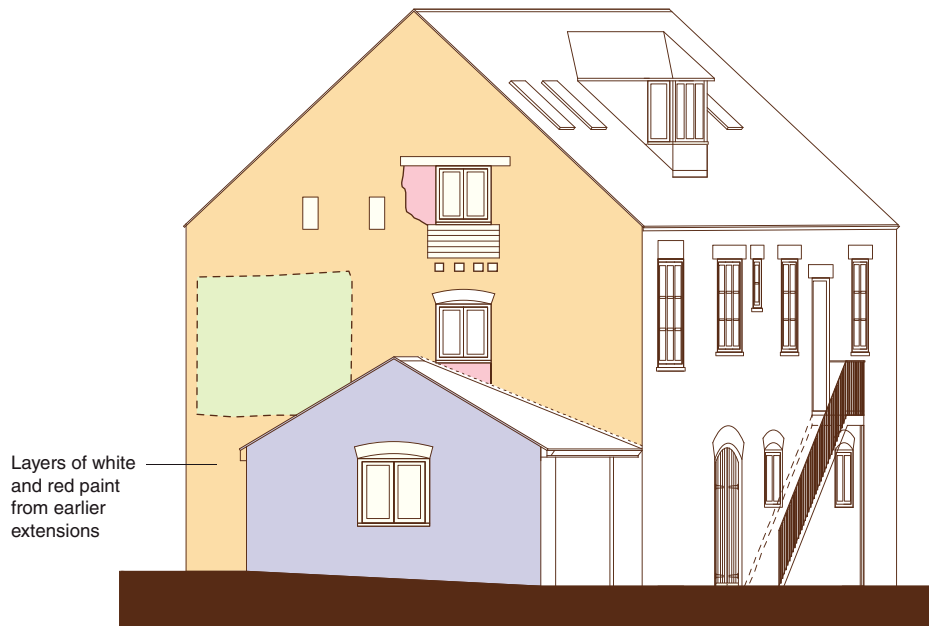
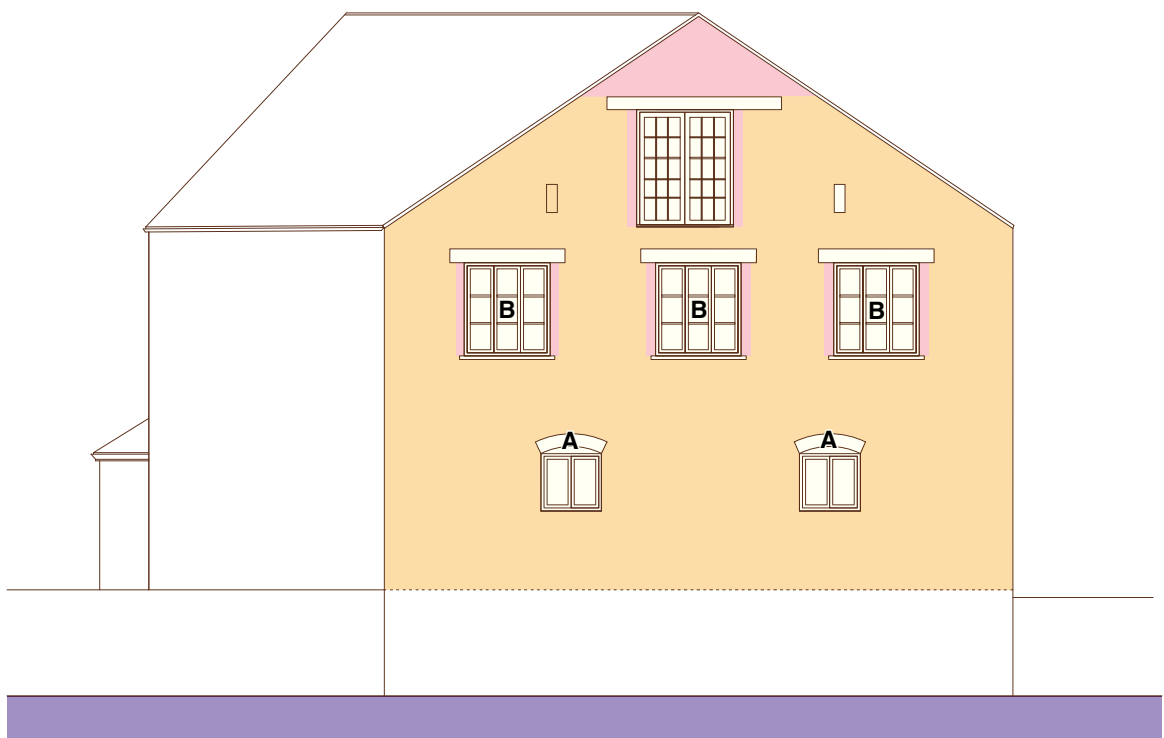
Figure 4: East and west elevations

- 3.2.8 The *west elevation* faces onto the river channel and is again largely constructed from roughly coursed rubble stone with larger stone quoins. The elevation is set on a plinth of much larger coursed stone blocks below ground level which continue down into the river. There is a clear horizon between these and the main wall of the building above.

- 3.2.9 There are two primary openings at ground floor beneath stone segmental arch lintels and at this level the stonework appears relatively little altered. At first floor there are three much larger windows, all of which are secondary insertions beneath concrete lintels and sills and with reformed jambs.

- 3.2.10 The character of the stonework in much of the upper part of the elevation, at gable end level, is different to that in the lower half of the elevation and it may have been at least partially rebuilt. The gable incorporates a large opening with glazed double doors, probably inserted in the later 20th century. The opening is beneath a large timber lintel and the jambs have been reformed in brick. The ends of a series of truncated joists survive at the base of this opening and clearly there was formerly a projecting platform or balcony at this location. There are also two vertical bearers either side of the opening, and continuing down well below it, which also must relate to this former platform. Presumably this was a loading platform with a hoist for transferring materials or produce from the building to the river. Either side of the loading door are vertical, single-light slit windows which have stone jambs and appear primary.

- 3.2.11 The *east elevation* of the primary building has now been obscured at ground floor level by the construction of the single-storey 20th-century extension. The upper part of the primary elevation incorporates two primary vertical slit windows and a larger later 20th-century window which has clearly been converted from a former loading door. Beneath the window there is weatherboarding and immediately beneath this a small visible patch of reformed stonework which would probably have been at the height of the former sill of the door. Immediately to the south of the window the timber lintel extends south beyond the edge of the window and above a clear patch of rebuilt stone the full height of the window. This suggests that the former doorway was wider than the window but the rebuilt stone does not appear to continue down the full height of the door. It may be that there was formerly a wider window, after the removal of the loading door or it could be that the rebuilt patch relates to a former crane/hoist fixed to the wall adjacent to the loading door.

- 3.2.12 Below the loading door is another window with primary segmental stone arch although this feature has largely been obscured by a security grille panel. A straight joint is just visible continuing down the northern jamb beneath the existing window suggesting that this was also formerly a doorway.

- 3.2.13 In the southern half of the east elevation there is evidence of former adjoining structures, almost certainly those shown on historic maps, including a large area at first floor level where the stone is a lighter colour. This must clearly have been a two-storey building against it. It is also interesting to note that at the south-east corner the quoin stones which would have been beneath the extension are much better preserved than at the very corner which are more worn.

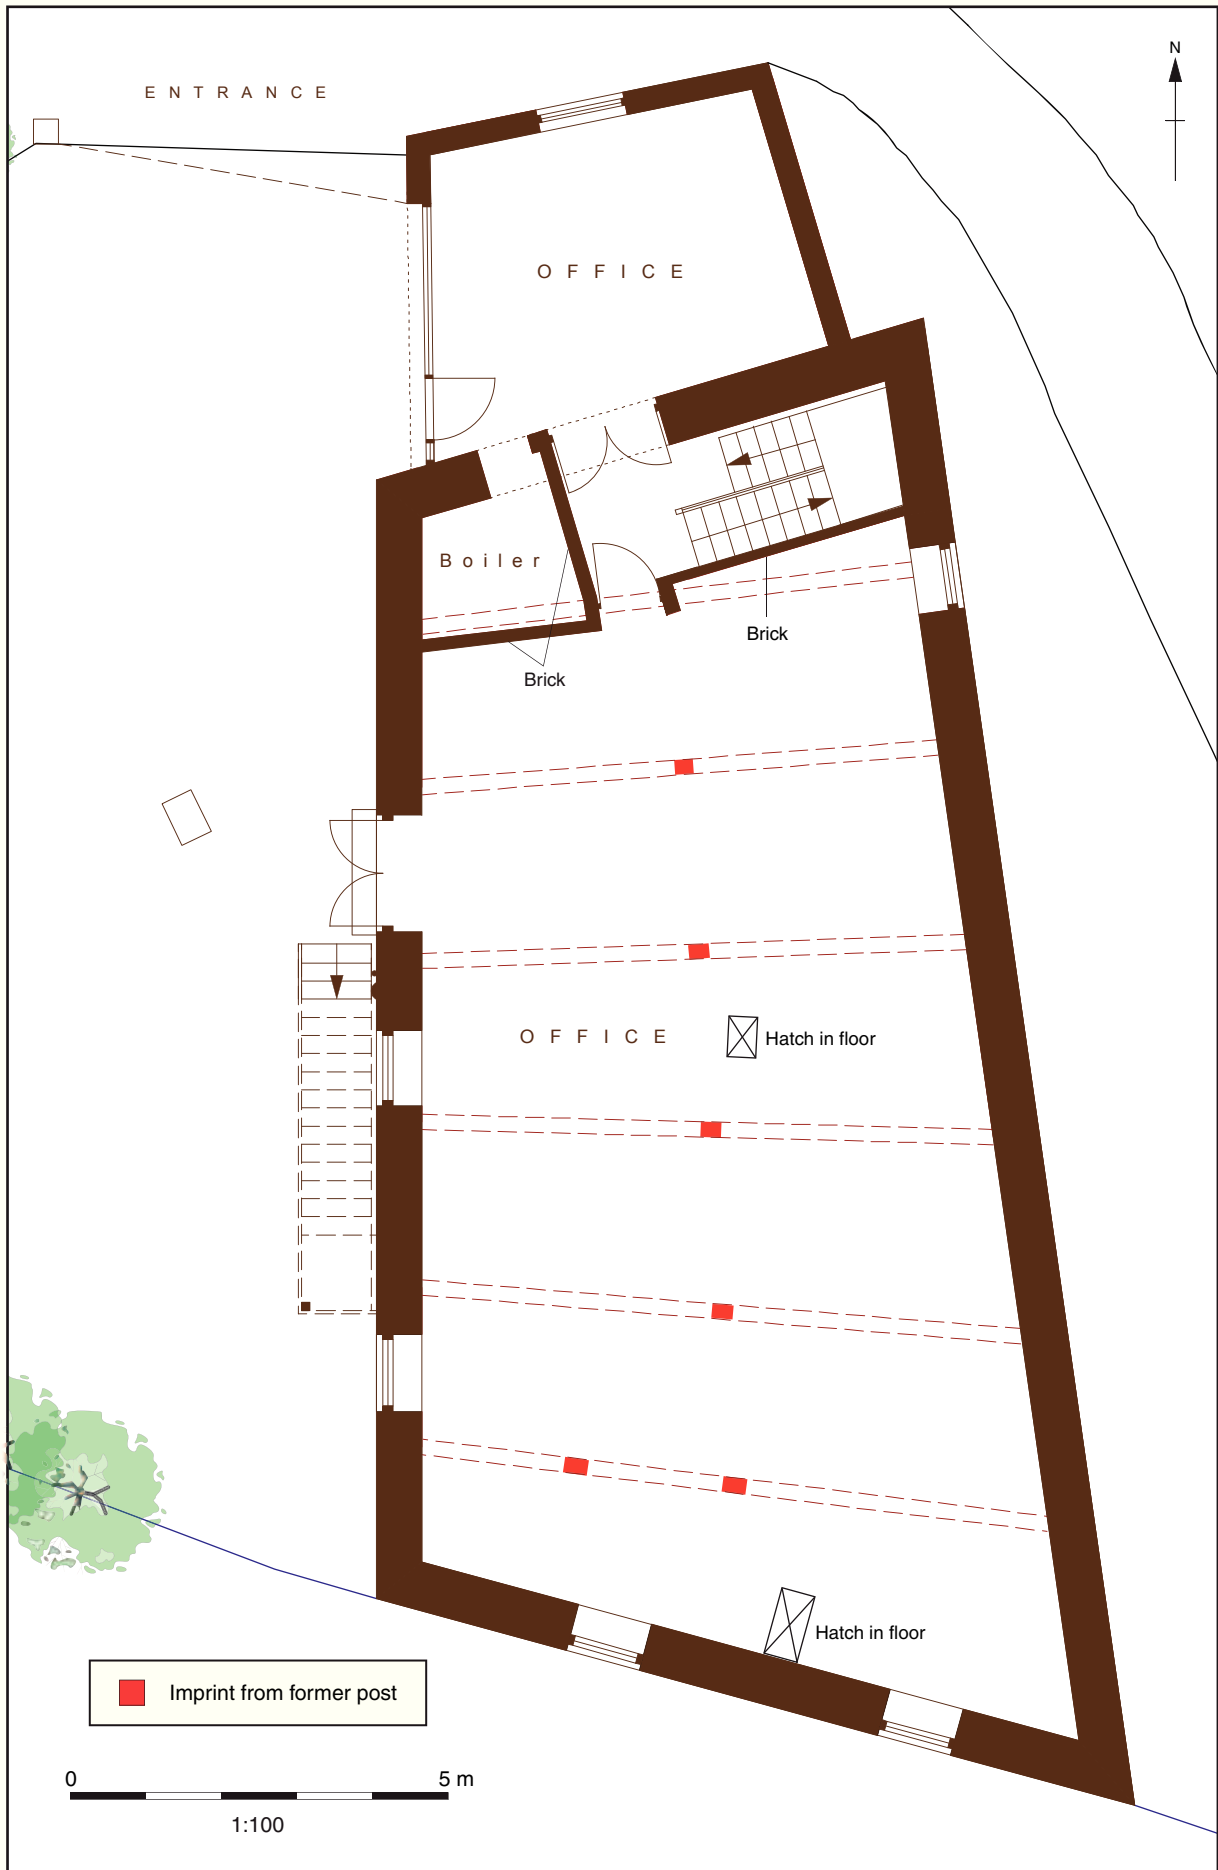
Figure 5: Ground floor plan

- 4.1.1 The ground floor of the building is largely open plan with a separate room in the eastern extension as well as two further small enclosed areas at the east end of the primary building: to the south-east corner is the staircase and to the north-east is a boiler room.

- 4.1.2 The historic form of the main room has been largely lost or obscured although some evidence of former features does survive. The floor above is supported by five principal joists which now span the full width of the room although there is evidence to show that each was formerly supported by a post at its mid point. This evidence comprises a shallow, square trench formed in the underside of each joist as well as a reformed patch directly beneath within the floor slab. Additionally there is also evidence of another post beneath the westernmost principal joist half way between the spine post and the north wall.

- 4.1.3 Other evidence relating to the former use of the building includes two hatches in the floor above, possibly for transferring goods between floors. One of these is against the west wall and is c.80 cm x 40 cm while the other is closer to the centre of the building and is slightly smaller (c.50 cm x 30 cm). The hatch against the west wall may have related to a former hoist which loaded and unloaded goods from the river through the doors at second floor level. It could be that there was a hoist at second floor which passed through the building and a chain or ropes that extended down inside the building.

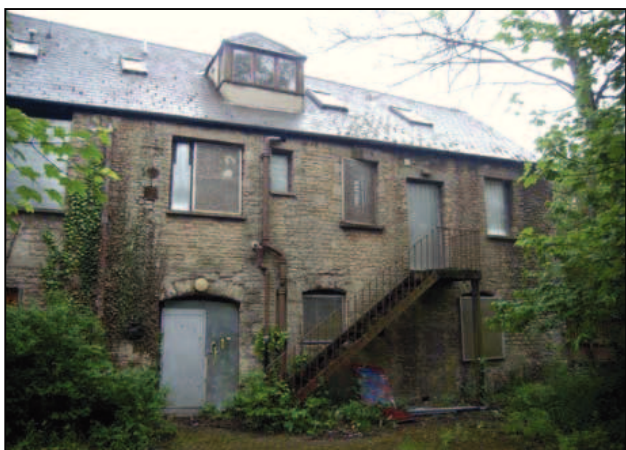
Plate 1: General view of north elevation

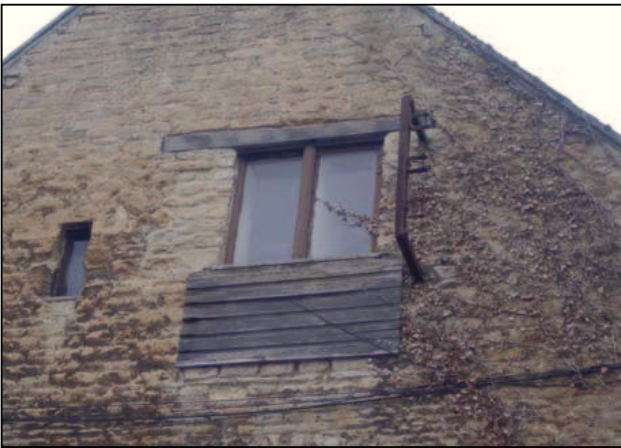
Plate 7: Loading door in east elevation converted to window

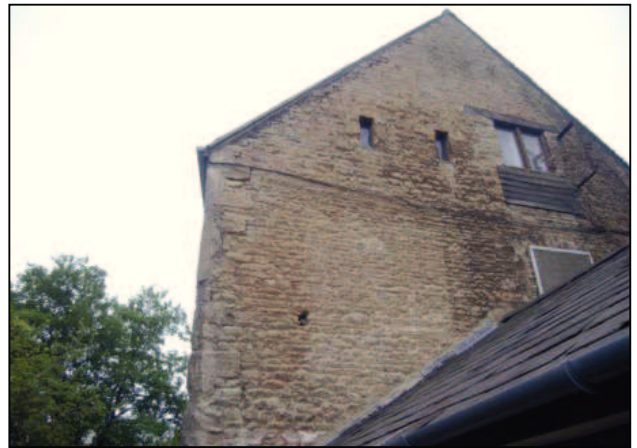
Plate 8: Traces of paint on east elevation

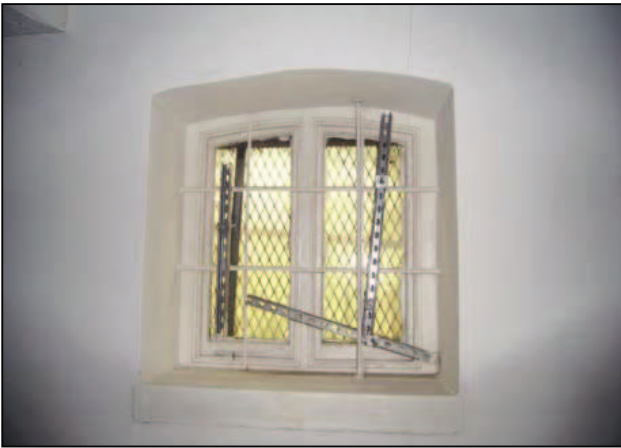
- 4.1.6 The ground floor has plastered walls, presumably dating from the later 20th-century conversion, and a concrete floor slab which retains some traces of lino tiles. The windows in the west and north walls have timber frames and they are suggestive of an earlier 20th or possibly late 19th-century date.

Plate 19: Ground floor window

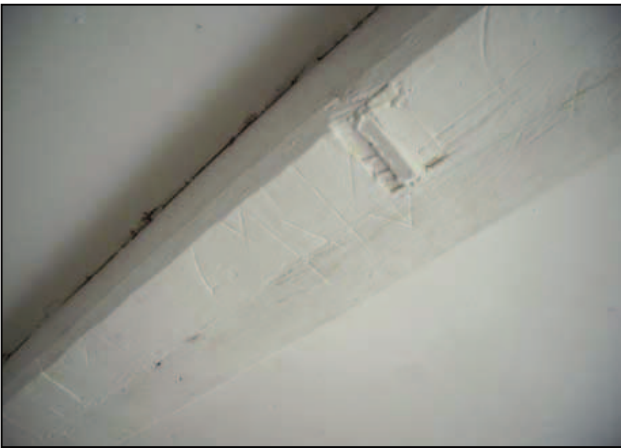
- 4.1.5 The joists themselves have a number of distinctive importers marks that would have been made by the shipping company or trader (probably from the Baltic) to distinguish the destination, quality or grade of the timber balk. The clearest two are on joists 2 and 4 (from the east end) but there are others which have been partially lost when the timber balk is divided into separate members. The building also has numerous similar marks in the roof timbers (detailed further below) and the marks are discussed further in Appendix B.

Plate 23: Importers marks in underside of joist at ground floor

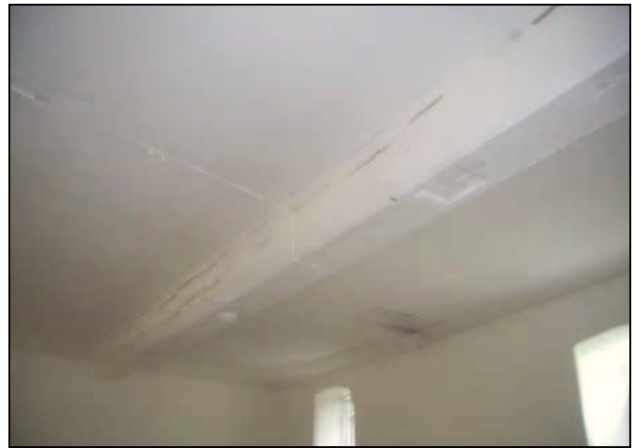
Plate 24: Westernmost joist at ground floor with imprint from former posts

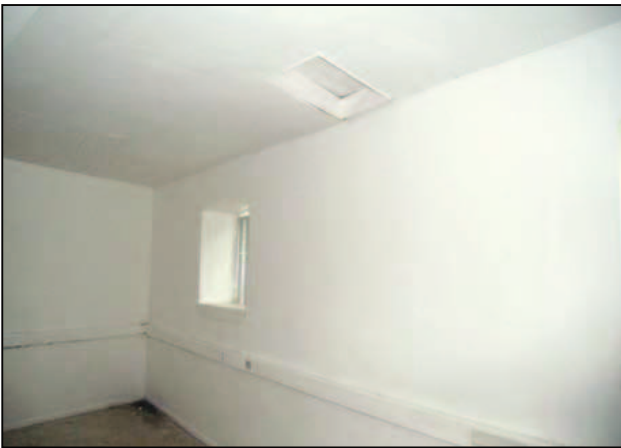
Plate 25: West end of ground floor showing hatch in ceiling

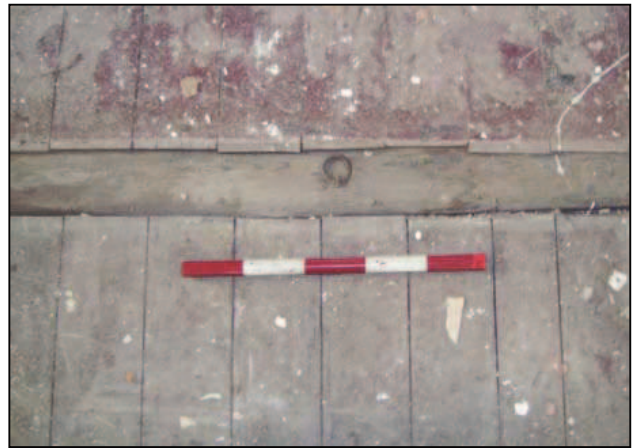
4.2.2 The floor is covered by modern boards laid during the conversion of the building (1980s) but various partitions from this phase have been removed and this has exposed some parts of the older floorboards, which were clearly left in-situ beneath. These older boards are c.27 cm wide and consistent with an earlier 19th century date. The only significant feature revealed within the exposed areas of boarding is a circular iron chain loop (c.5 cm diameter) fixed to the floor. This was located in the northern half of the building and appeared to be on top of a large principal joist (third from the east end) rather than being in one of the floorboards. It is c.1.5 m in from the north wall and appears to have been broadly aligned with one of the bolts which is visible in the underside of the same principal joist. This loop may have related to the former loading door just to the north, possibly for tying a rope to for sacks being raised or lowered. This appears to confirm that this part of the building would not have been a malthouse growing floor (at least in the building's final 'industrial' use as there would not have been a loop such as this within a growing floor

Plate 32: Loop exposed in floor at first floor level

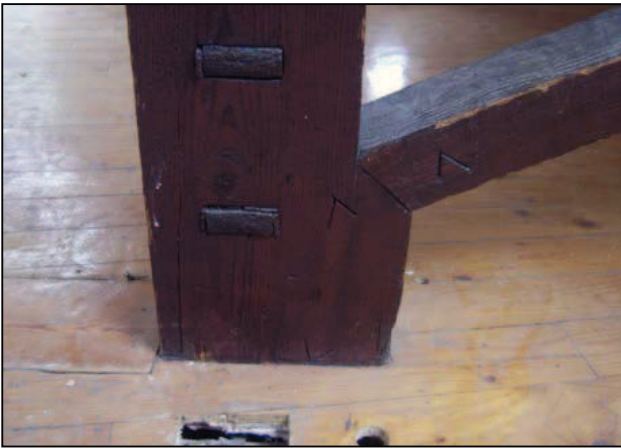
4.3.11 Along with the importers marks there are various chiselled Roman numeral carpenter's marks which are commonly found in early 19th-century buildings although they are not consistent on every truss in this building. The westernmost truss (Truss 5) has several of these marks very clearly visible at joints but there are no marks visible on Trusses 1 or 3 (although Truss 1 is partly obscured by modern plasterboard). On Truss 2 there is a single 'II' on one raking strut and a 'I' on the other raking strut but no other marks. Truss 4 has chiselled marks but not Roman numerals and these may form a separate set (see Appendix B).

Plate 43: Roman numeral carpenter's marks at base of queen post

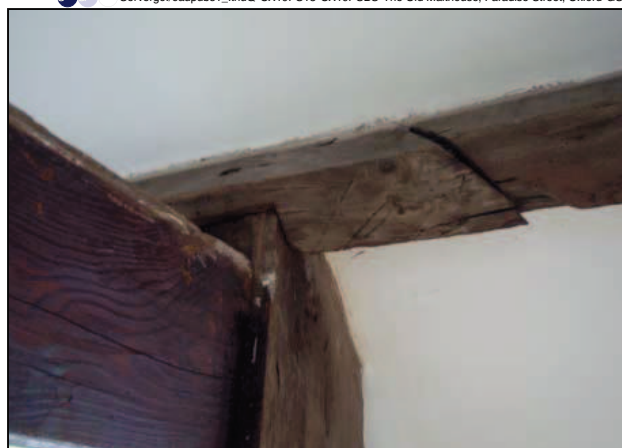
4.3.6 The purlins are truncated at three locations to allow for the insertion of dormer windows in the later 20th-century. There are also separate roof lights laid with the slope and these are also of 20th-century date. The truss main members are tenoned to each other although there are metal straps fixing the base of the queen posts to the joist below.

Plate 50: Purlin scarf detail
