Church Farm Lewknor Oxfordshire

Historic Buildings Recording and Investigation

October 2009

Document Type: Historic Building recording and investigation

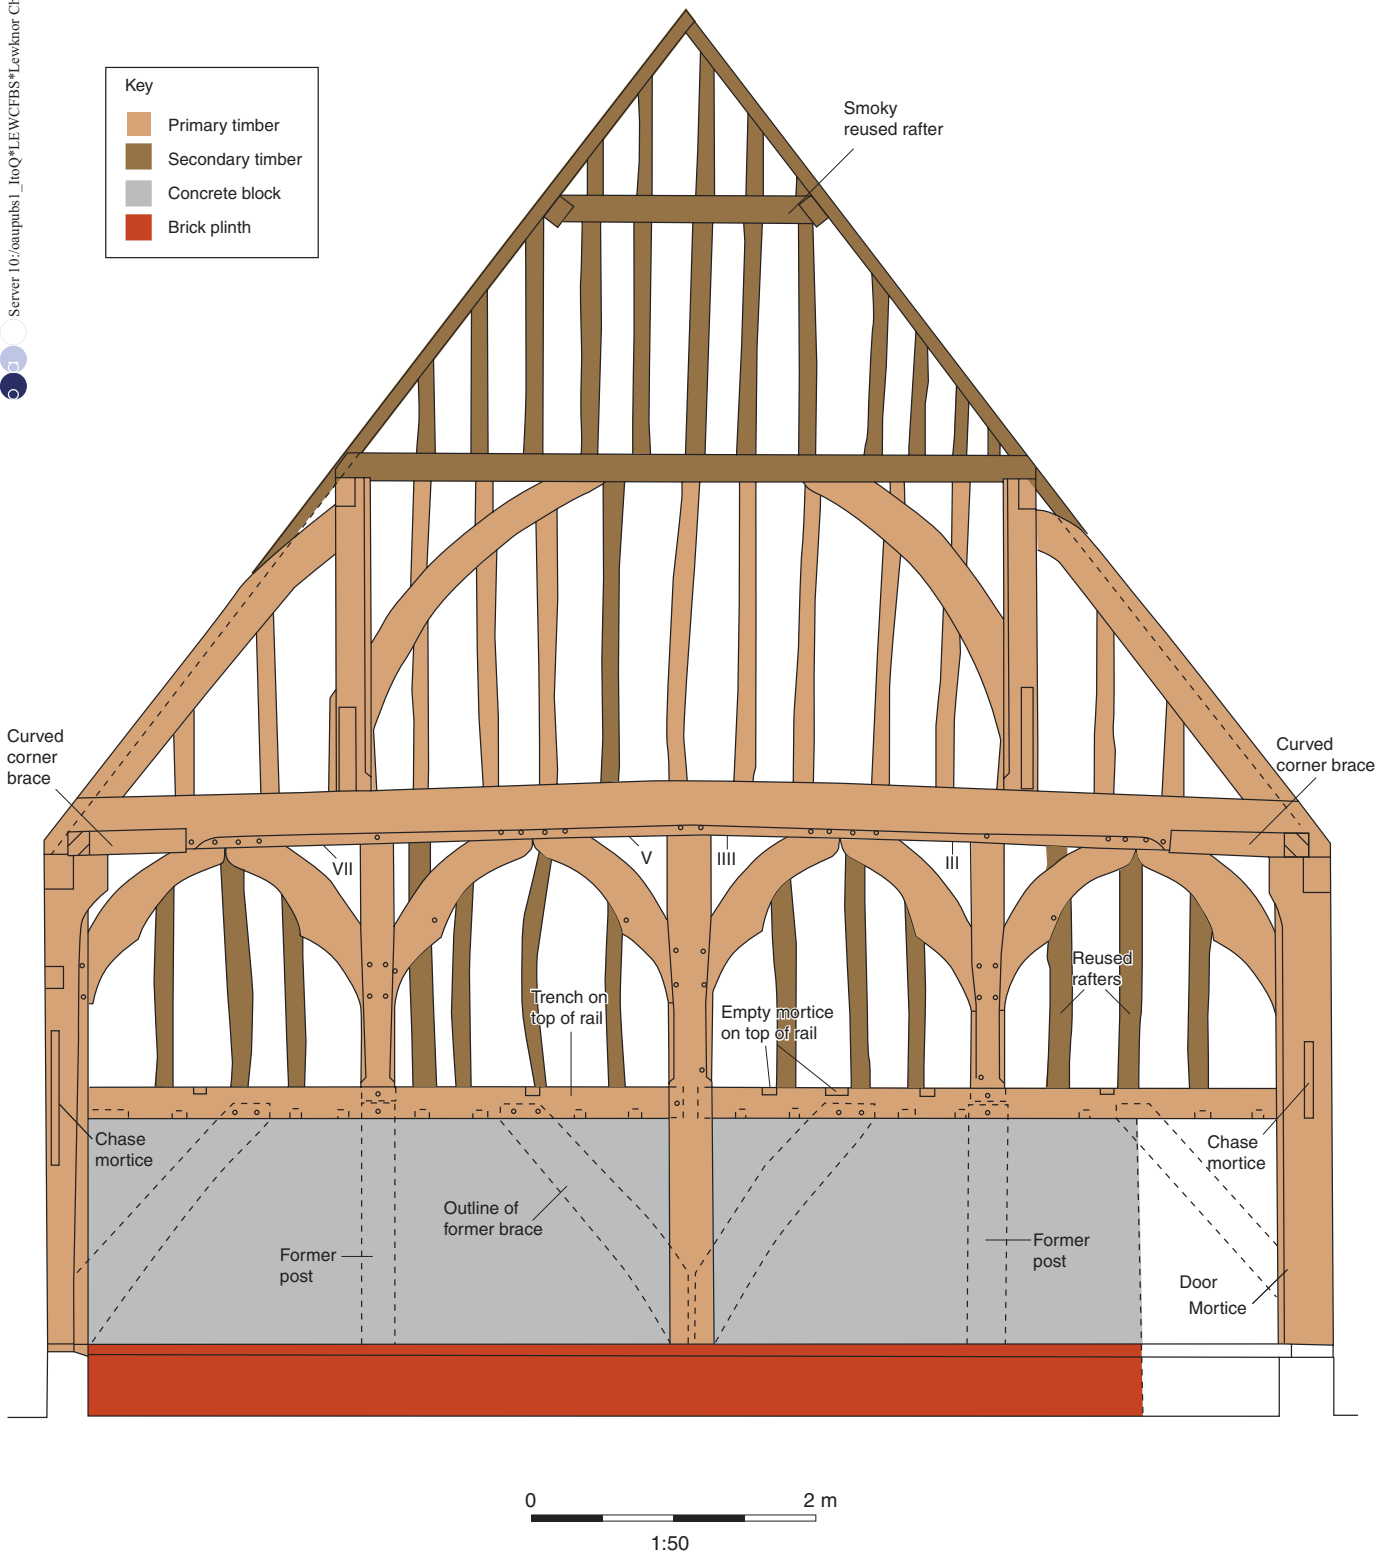
Figure 3: East end wall, internal elevation

- 3.6.2 The east wall (Frame 1) of the barn would have formed the upper (dais) end of the open hall and it is an attractively decorated frame with cusping and mouldings which were clearly intended to impress visitors to the hall (Fig 3, Pl. 12). The wall divides into two main elements: i) the truss and half hipped gable; ii) the wall beneath the truss.
- 3.6.3 The truss comprises tie-beam, principal rafters, lower collar (or upper tie), upper collar, raised aisle posts and curved struts between raised aisle posts and lower collar. Unlike in

the other main frames the principal rafters are not diminished. The upper part of the roof (above the lower collar) is half hipped and this section of the roof has been entirely reconstructed with secondary rafters. The upper collar is a smoke-blackened reused primary rafter. The wall was originally entirely gabled and the half hip is a secondary alteration of unknown date. We can see that the wall must originally have been fully gabled through empty mortices in the purlin soffit for a former further bay of cusped windbraces. These would have extended beyond the current half hip. Between the lower collar and the tie-beam are nine studs which are set behind the primary arched brace and these all appear to be secondary (some reused members) probably dating from the same alterations as the half hip. There are two further studs to each side of the truss beyond the raised aisle posts.

- 3.6.4 The tie-beam is chamfered and it is supported by five posts which divide the main wall into four bays. Three of the posts (central and corner posts) are full height from the plinth while the other two posts are smaller in section and only rise from the mid rail. Within each bay there are two scratched Roman numeral carpenter's marks on the tie-beam's soffit which are different to the unusual primary marks found elsewhere in the barn (see below) but are assumed to be primary.

- 3.6.5 Below the tie-beam there are pairs of cusped braces in each of the four bays between post and tie. Behind the braces there are three secondary studs (several smoke blackened reused rafters) in each bay between tie and mid-rail. The studs which hold the weatherboarding are fixed with hand-made nails of probable 18th or 19th century date. In the upper face of the mid-rail there is a trench, apparently along the entire length of the rail, within which the primary studs from the wall would have sat. These would have supported wattle and daub panels. There are also several other small mortices in the upper face, which appear to be secondary and which are inside (ie to the west of) the trench. At either end of the truss there is a curved horizontal corner brace tenoned into the face of the tie-beam which extends around to the north and south walls. These corner braces are found at each of the four corners of the former hall and they are tenoned into upper wall plates in the long main walls.

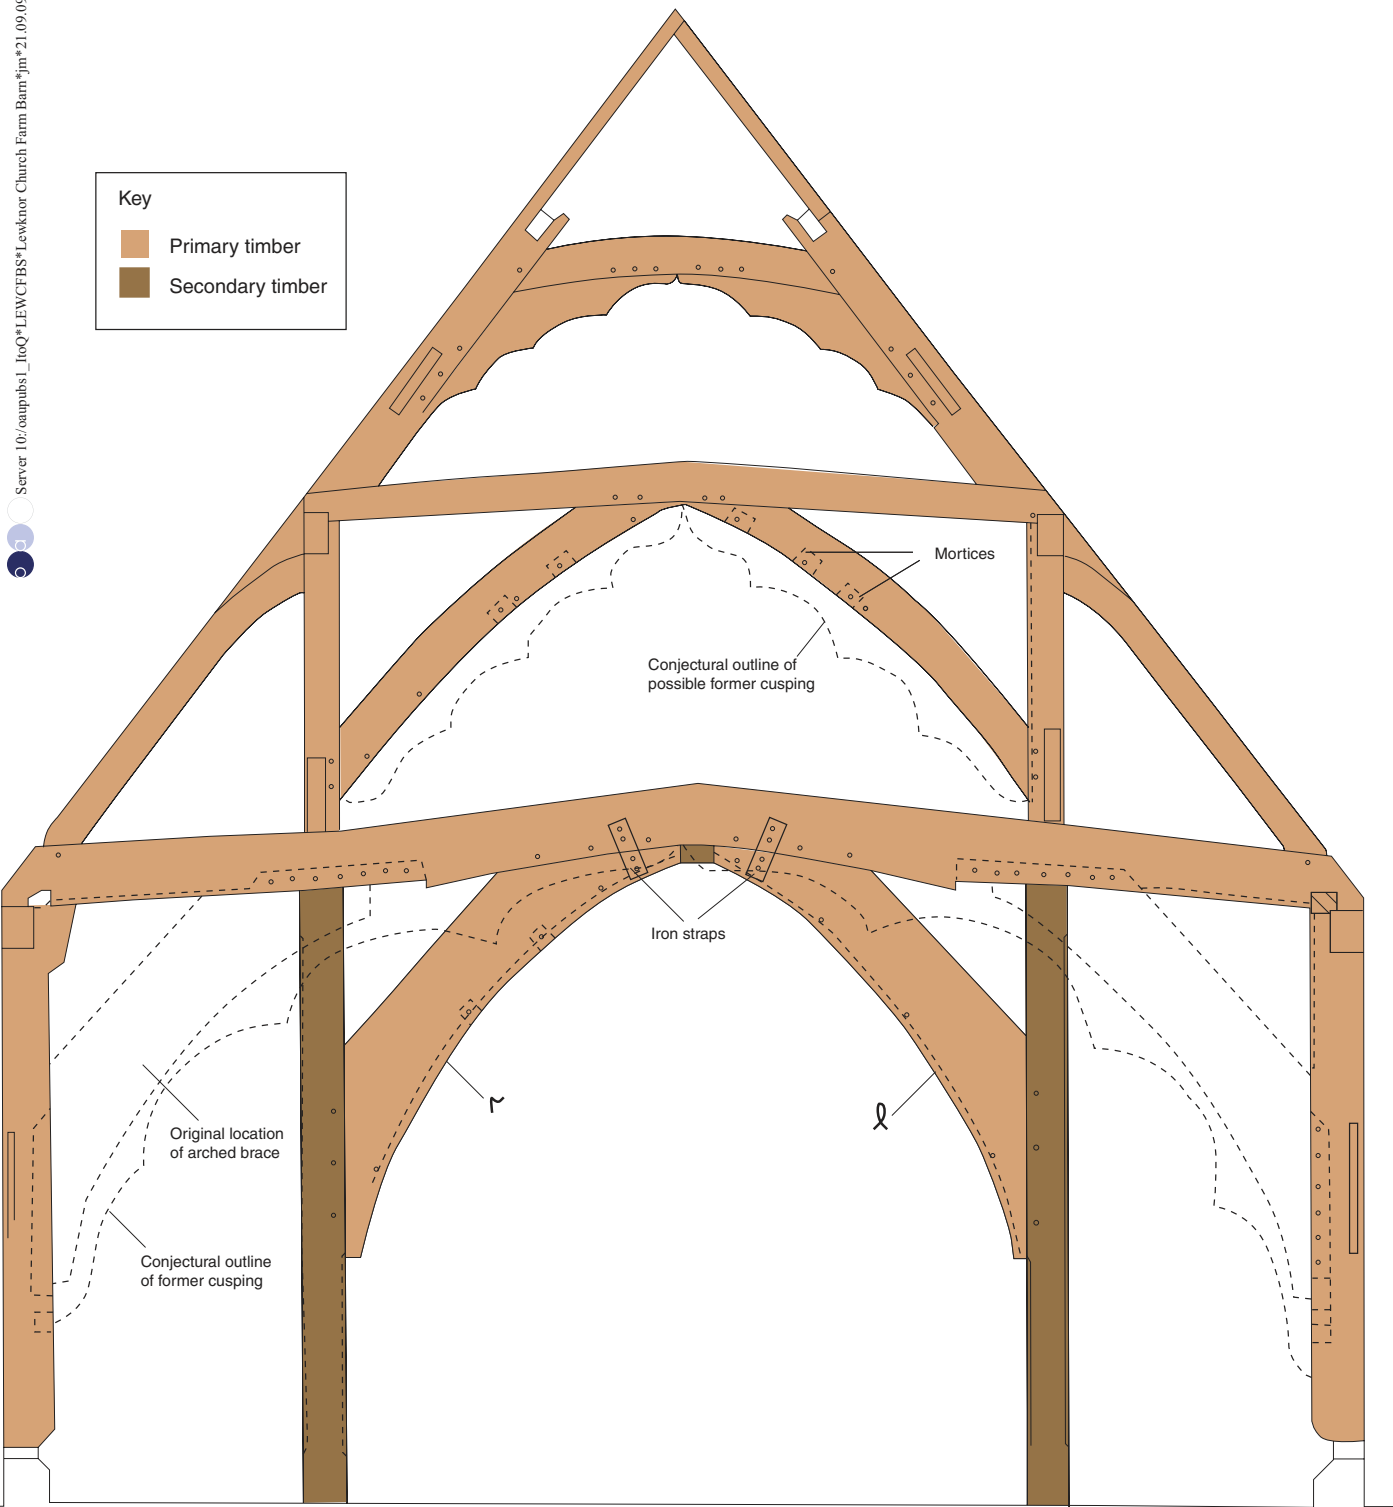
Figure 4: East central truss from west

- 3.6.8 The cross frame on the east side of the central bay (Frame 2) would have formed the central display truss of the original two-bay open hall. It is now superficially similar to the spere truss on the west side of this bay but this is due to a 20th-century alteration and its primary form would have been significantly different. The original frame would have been formed a remarkably wide, clear span below tie-beam level for a building of this date (c.8.8 m) but it has been altered by the repositioning of the arched braces towards the centre in order to provide greater support for the tie-beam. In the original building these braces would have been supported by the outer posts but they are now supported by inserted 20th-century 'aisle posts'. Large empty mortices with sloped shoulders are clearly visible in both main posts (with 6 peg holes) and in the soffits of the slightly cambered tie-beam (7 peg holes). The lower edge of the tie-beam is cut back slightly towards the outer edges and there is a clear step down at the points where the arched braces would have sat. There is now a small block (c.25 cm wide) between the heads of the two braces whereas they would originally have been c.3.75 m apart.

- 3.6.9 It is known that this alteration was undertaken in the 20th century because the braces are shown in their primary position in the photograph referred to above from 1911 (Pl. 1). The photograph shows the southern arched brace supported at its head by a large temporary prop (apparently a circular section post). The arched braces are each formed from a single very large piece of timber (c.70 cm wide at the widest point) but the southern member has had a new section added towards the upper edge on the east face. The two braces are moulded with a central trench to their undersides and they each incorporate three small mortices which probably held cusping to the underside of the braces and tie-beam. There are two similar small empty mortices to the underside of the tie-beam immediate inside (ie towards the centre) of the point where the arched braces would have been located. These presumably helped to hold the upper parts of the cusping. There are further mortices in the faces of the main posts, immediately below where the braces would have adjoined, which presumably housed the bases of the cusping.

- 3.6.10 A number of sections of iron strapping have been added to strengthen the cross-frame including plates between arched braces and tie beam and a long iron strap bolted to the northern post. The west side of this post head has been cut back and re-profiled to the allow the insertion of the ironwork; the east side is jowled. A modern horizontal bearer has been added between the 20th-century 'aisle post' and the main primary post.

- 3.6.11 The truss within Frame 2 (above the tie) is of raised aisle type and it appears to survive largely intact from its original arrangement. It comprises upper collar, lower collar, principal rafters (diminished above the upper collar), raised aisle posts, lower principals with arched heads supporting the aisle posts, arched braces beneath the lower collar and cusping beneath the upper collar. There are a series of mortices in the soffits of the two braces which presumably would have supported further ogival cusping within the truss.

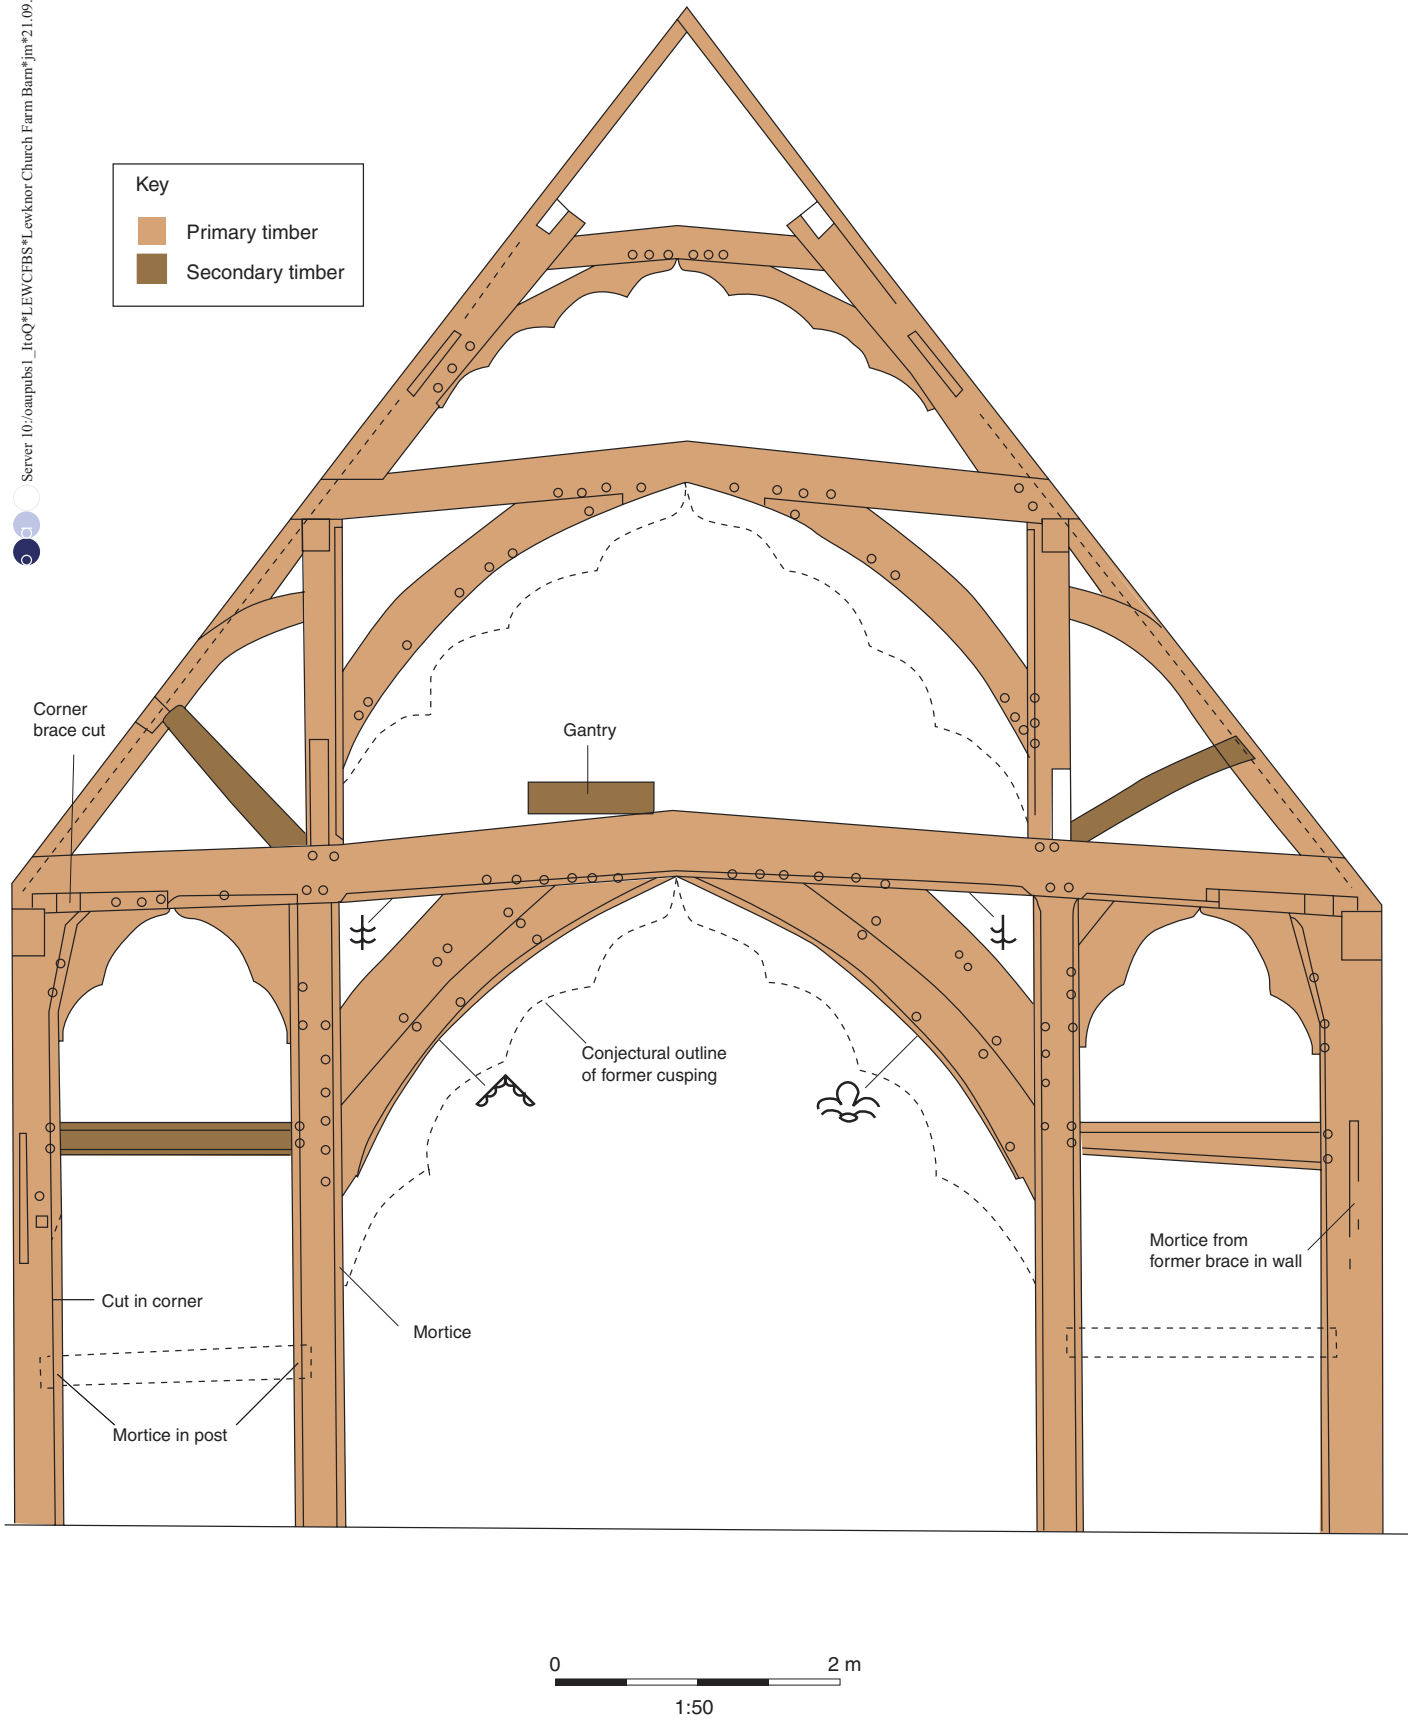
Figure 5: West central truss from east

- 3.8.5 On the corresponding soffit of the southern arched brace in the spere truss is an unusual *V shaped mark with half circles (two to one side and three to the other)* and again this was scribe-cut with a race knife (Fig 5). It is likely that the race knife had a central point that enabled the user to make circular shapes of approximately 40mm diameter. This central point is not found on post 18th century race knives. It is again unlikely that this is an assembly mark and is probably a graffiti or decoration.

- 3.8.6 Also on the spere truss a number of similar marks were identified with *half circles and lines* and these do form part of a pattern of assembly marks (Fig 5, Pl 20). Each mark includes a straight central line and half circles branching to either side from this line. On one set of marks there are two half circles to either side while another set has a single half circle to one side and two to the other. Corresponding marks are found to either side of the truss on the tie beam soffit and side of the post. This mark is very similar to arrow style markings seen elsewhere (eg. moulded roof truss in the Chapel Royal Hampton Court Palace c. 1536). It would appear that the lower two half circles denote whether the frame goes on the left or right with only one half circle on one side of the barn and two on the other. This appears to be made with the same size (40mm) circular race knife as the two marks above suggesting they are all of a similar date.

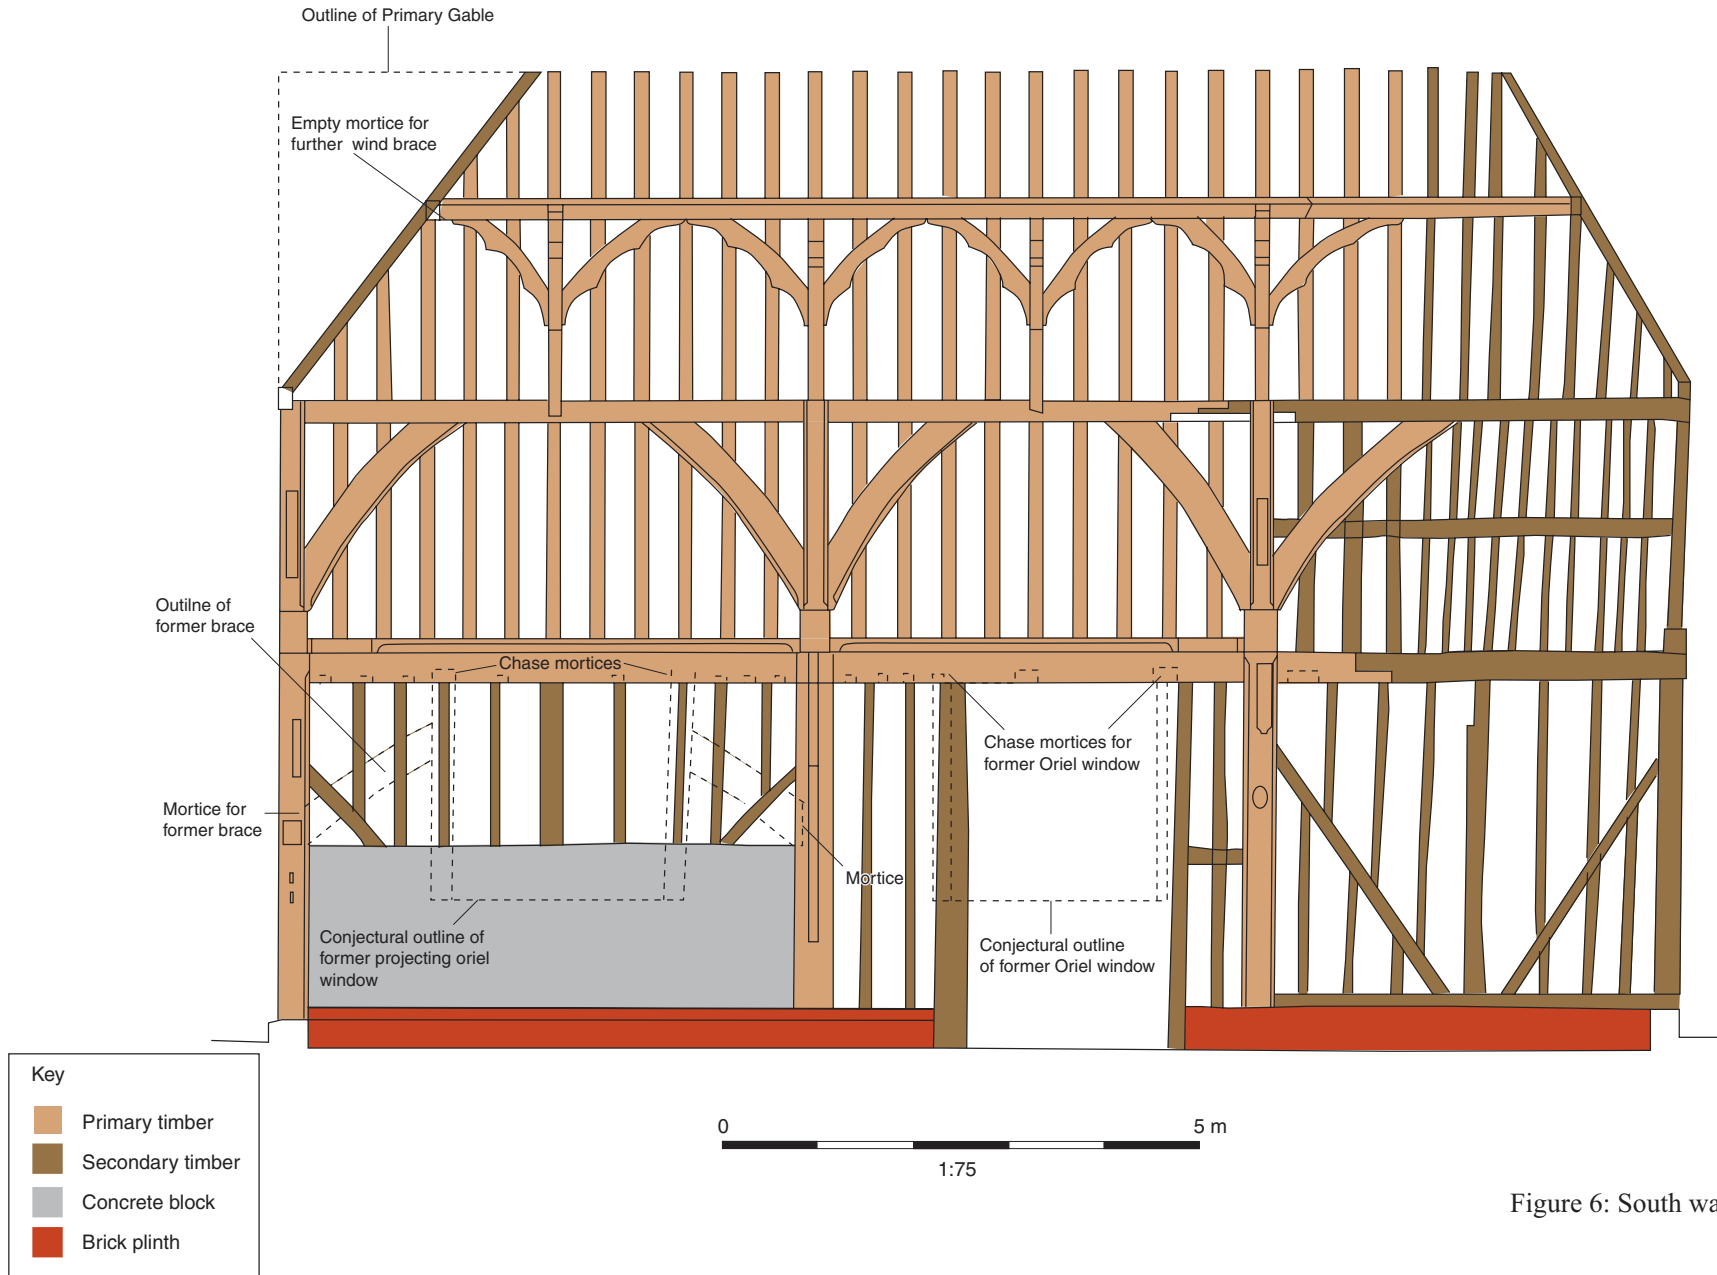
Figure 6: South wall internal elevation

- 3.5.2 The phasing of the south wall divides into the largely primary eastern two bays and the western bay which has been entirely reconstructed, possibly in the 18th century (Fig 6).

- 3.5.4 The main framing in the south wall is entirely secondary but there are a series of empty mortices in the underside of the principal wall plate which provides an indication of the former wall arrangement and this includes some of the most significant features revealed in the current project. Several of the mortices relate to the former wall framing but there are also four horizontal mortices now observed for the first time on the outside of the wallplates, immediately beneath the eaves, two in each of the main bays within the former open hall (central and eastern bays). Located adjacent to vertical mortices for wall posts, the horizontal mortices are chased (i.e. have an angled side) and would have housed horizontal members which projected out from the external walls of the building at an angle rather than at 90 degrees to the wall (Pl. 21).

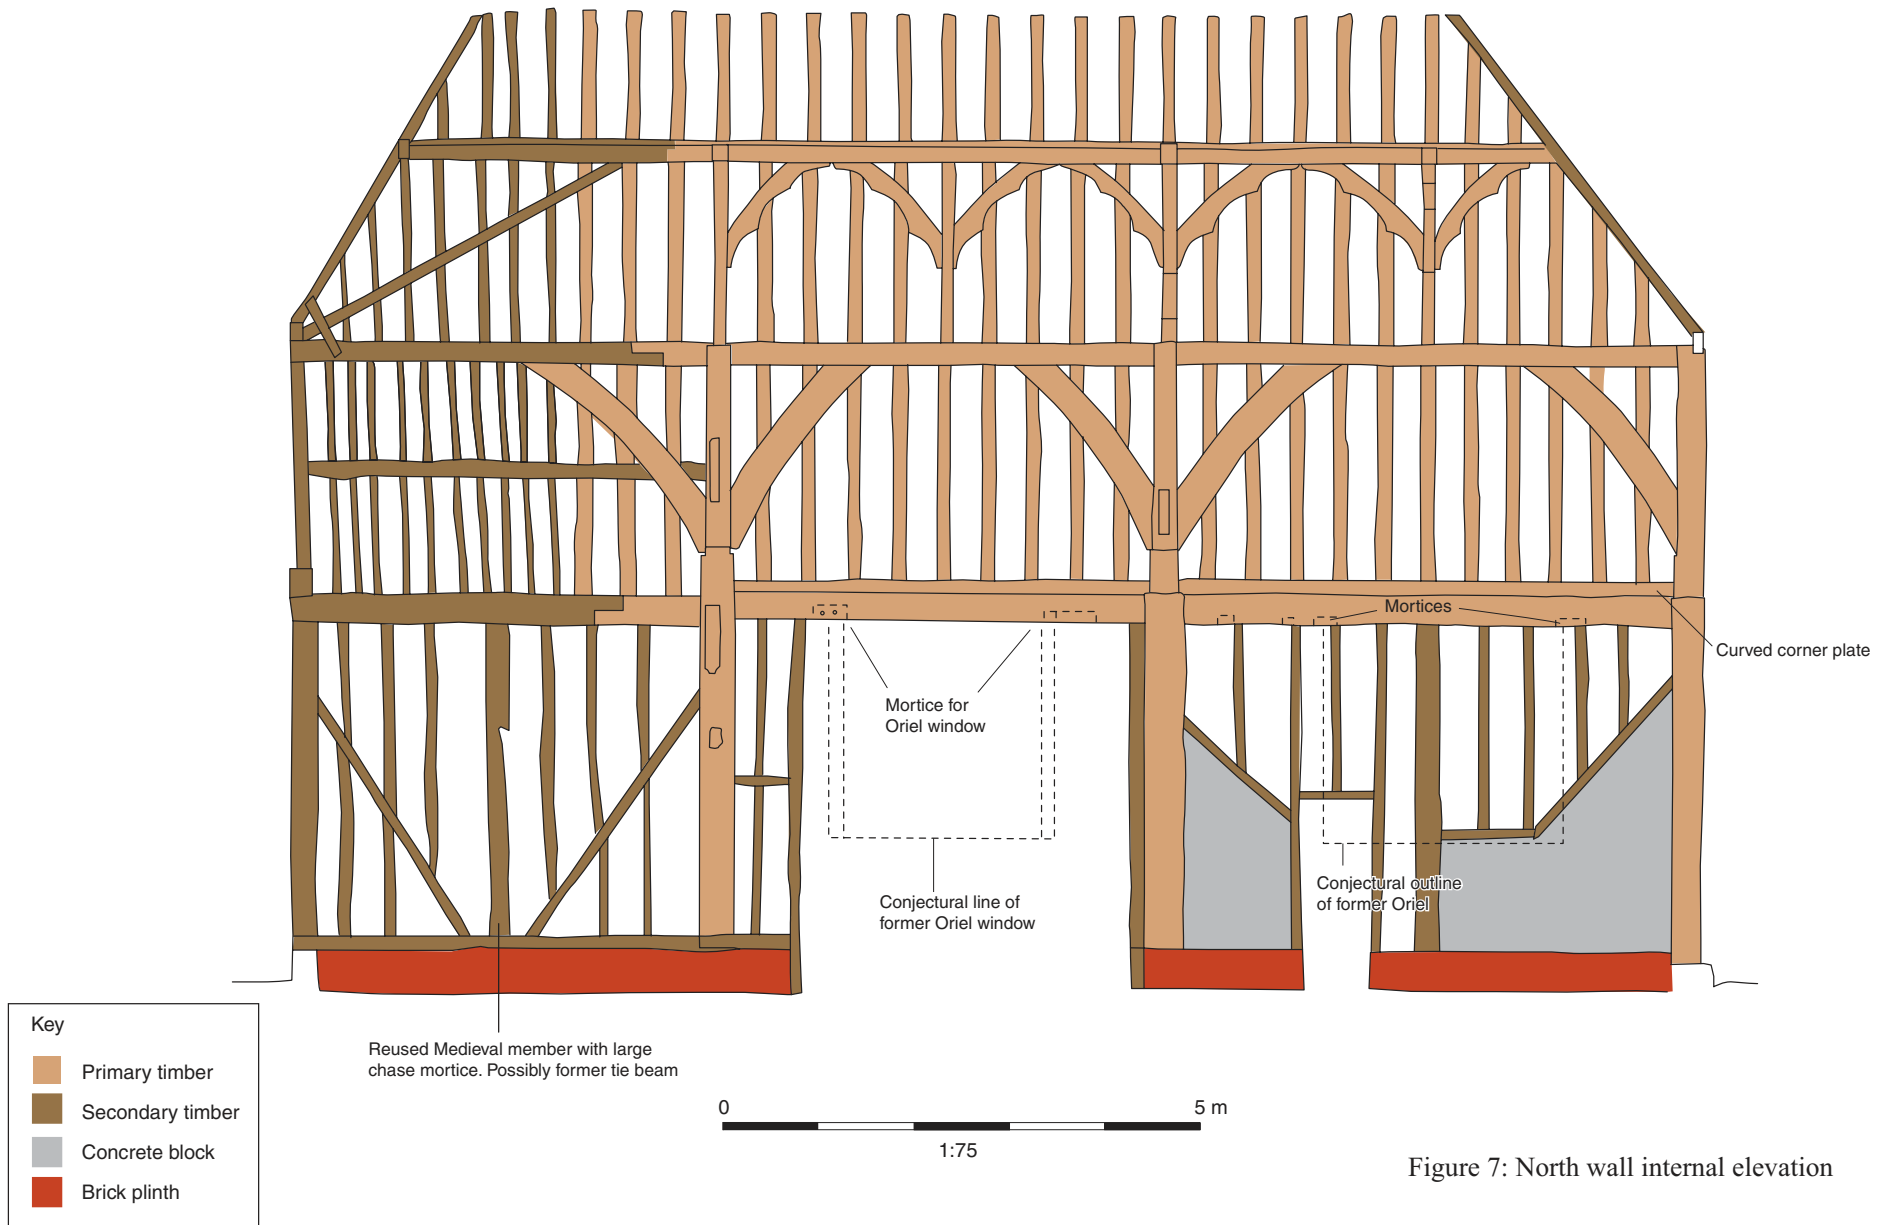
Figure 7: North wall internal elevation

- 3.5.8 *North wall (recorded by OA)***
- 3.5.9 The north wall framing (Fig 7) is also broadly similar to the south wall. The eastern bay of the north wall incorporates concrete blockwork (post 1972) to the lower section and secondary elm stud framing above. One of the members in this frame (the sloped eastern bearer or plate) may be a reused medieval member.

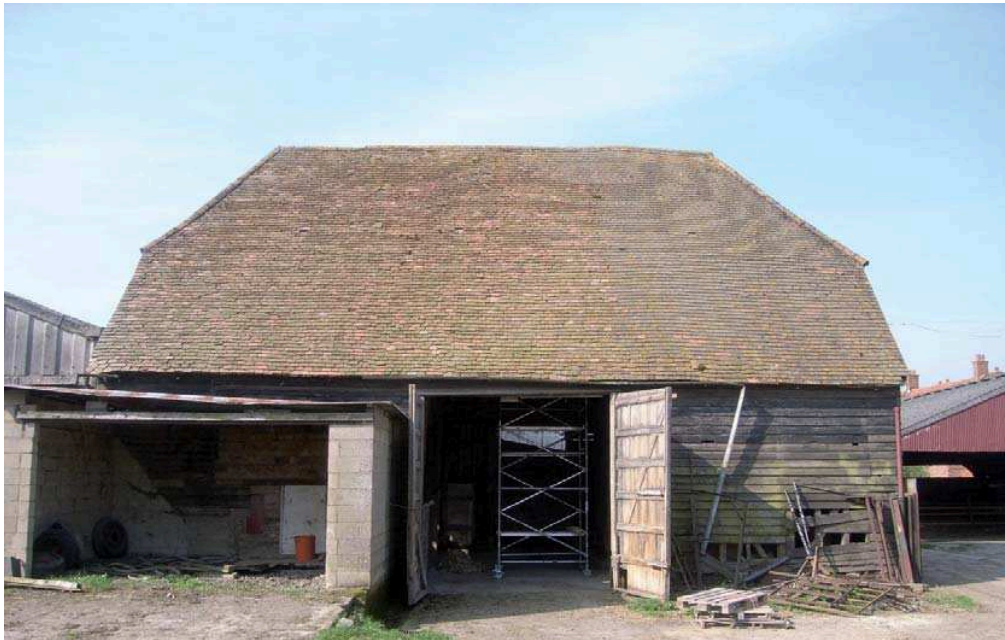
- 3.3.2 The barn has a half-hipped roof, clad in clay tiles, and the walls, which are largely clad in weatherboarding of several phases, are now in poor condition (Pl.2-4). The exception to this are the lower sections of the east wall and the eastern end of the north and south walls, which were reconstructed in the later 20th-century in concrete blockwork. The main walls are set on a brick plinth and there are tall double threshing doors in both the north and south walls. The external cladding has been stripped and replaced, some of this prior to the site inspection, so the external timber faces were not inspected.

Plate 2: Exterior of barn from north

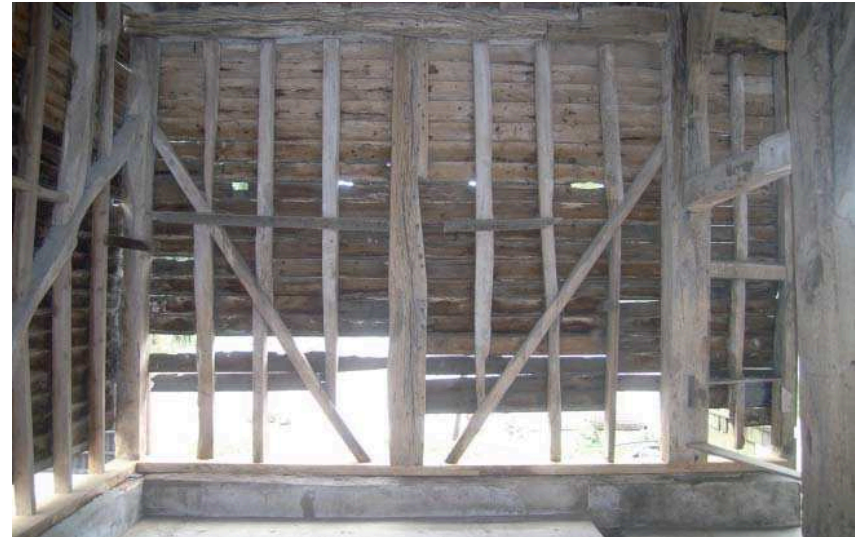
Plate 13: Secondary framing and possibly reused tie at W end of N wall

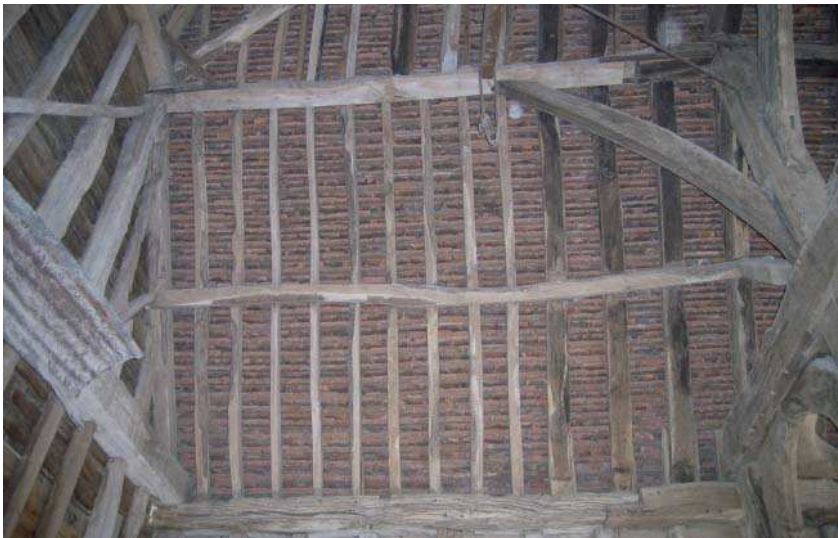
Plate 14: Roof at W end. Rafters to left secondary. Primary smoke blackened rafters to right

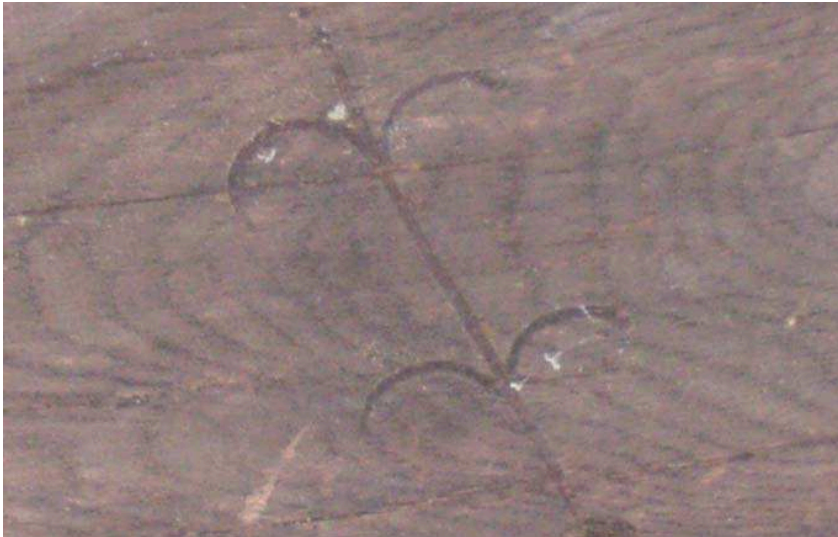
Plate 20: Carpenters mark on Frame 3 (W central)

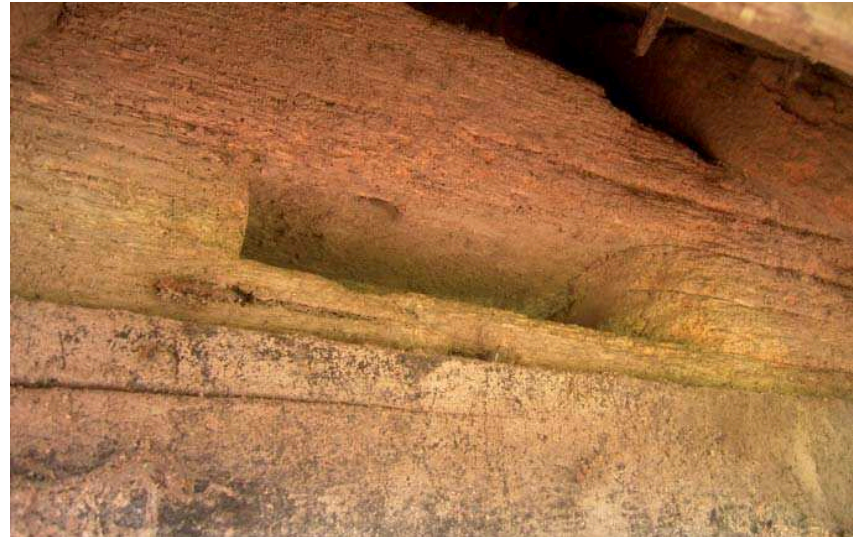
Plate 21: Chase mortise in face of wall plate, under eaves, from former projecting oriel

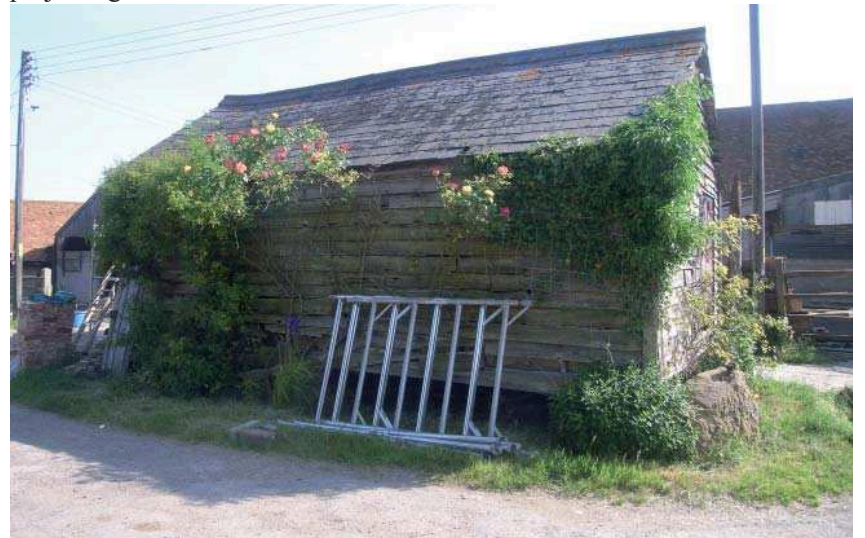
- 4.3.1 The granary (Pl. 23-24) is a rectangular plan, single-storey building (7 x 4.5m) with a slate-covered gabled roof and walls clad in weatherboarding. The condition of the building is now very poor and it is being substantially rebuilt in the current project reusing materials from the existing building.

Plate 23: Granary from south

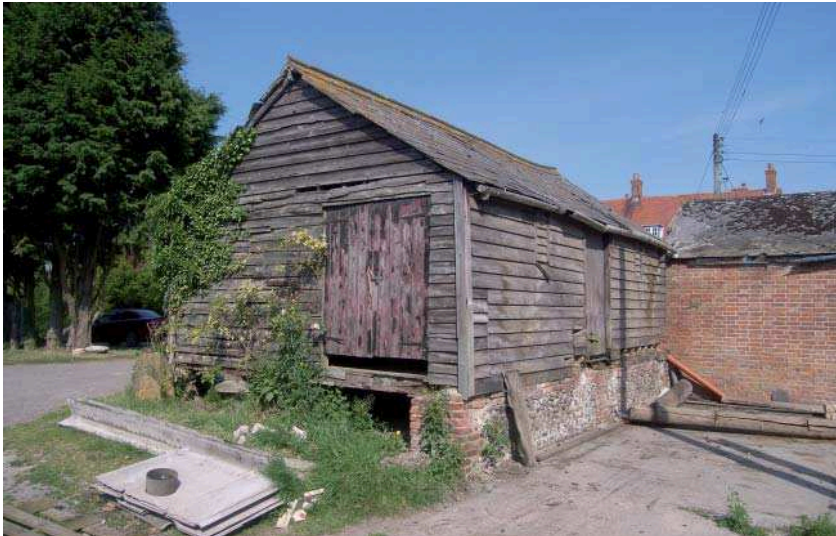
- 4.3.2 The floor of the building is raised above ground level but secondary works have altered the arrangement of primary staddle stones, particularly to the north wall. To this side of the building the staddles have been replaced by a solid plinth comprising three brick piers with flint infill between. The weatherboarding in the north wall shows evidence of patching and alteration. This wall has a central doorway and two small windows, one to each side, which have each been infilled with boarding. The east wall includes a set of double doors at the northern end and there is a single door at the western end of the south wall. The south wall is particularly overgrown and the condition of the weatherboarding is very poor.

Plate 24: Granary from east
