Site/Project Name: **Lewknor Church Farm Barn**

**Church Farm, Lewknor, South Oxfordshire
Written Scheme of Investigation for Building recording**

Church Farm
Lewknor
Oxfordshire

**Historic Buildings Recording
and Investigation**

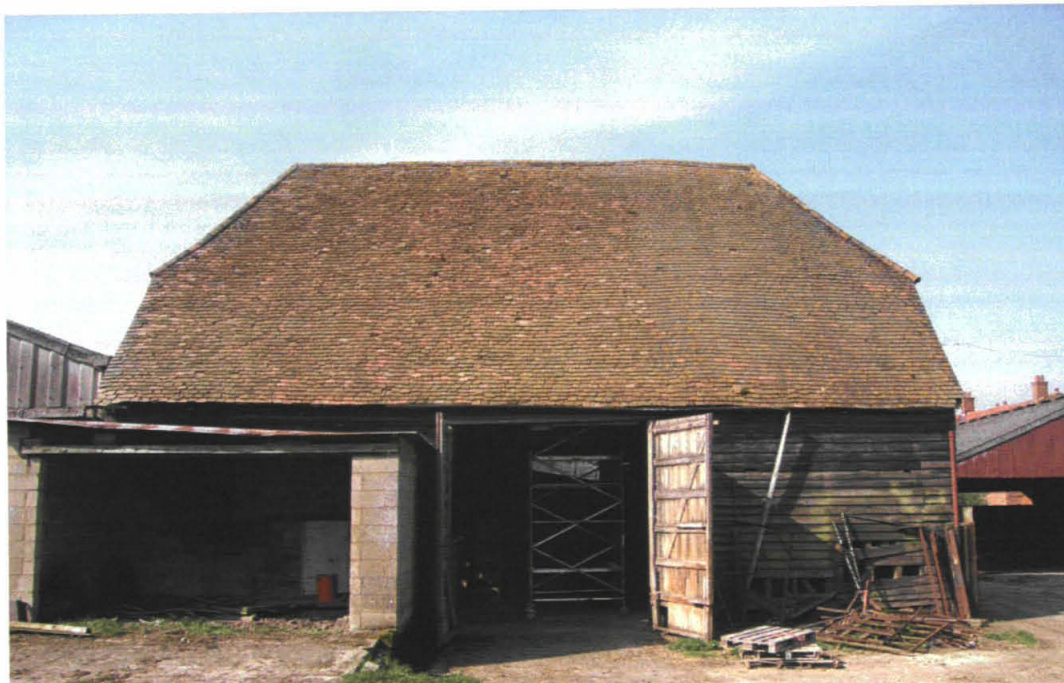
Plate 2: Exterior of barn from north

- 3.3.2 The barn has a half-hipped roof, clad in clay tiles, and the walls, which are largely clad in weatherboarding of several phases, are now in poor condition (Pl.2-4). The exception to this are the lower sections of the east wall and the eastern end of the north and south walls, which were reconstructed in the later 20th-century in concrete blockwork. The main walls are set on a brick plinth and there are tall double threshing doors in both the north and south walls. The external cladding has been stripped and replaced, some of this prior to the site inspection, so the external timber faces were not inspected.

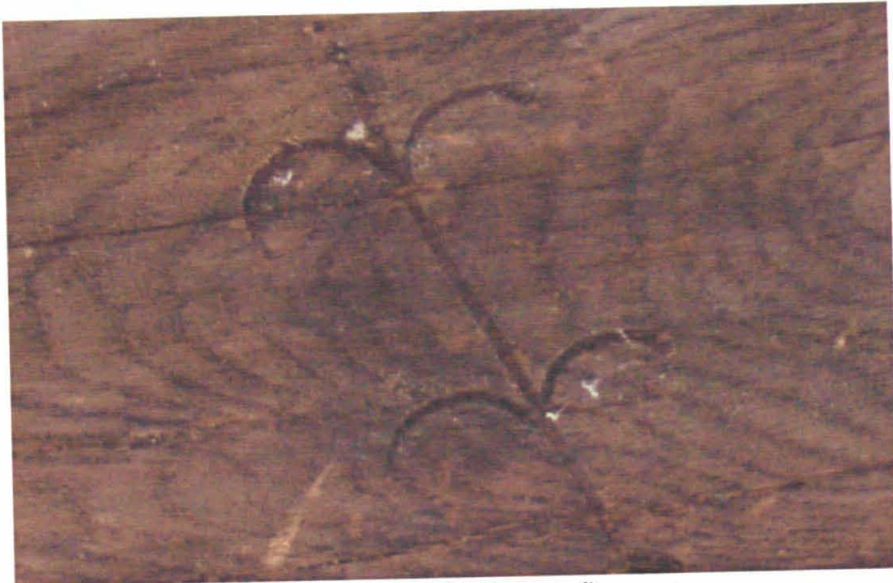
- 3.8.6 Also on the spere truss a number of similar marks were identified with *half circles and lines* and these do form part of a pattern of assembly marks (Fig 5, Pl 20). Each mark includes a straight central line and half circles branching to either side from this line. On one set of marks there are two half circles to either side while another set has a single half circle to one side and two to the other. Corresponding marks are found to either side of the truss on the tie beam soffit and side of the post. This mark is very similar to arrow style markings seen elsewhere (eg. moulded roof truss in the Chapel Royal Hampton Court Palace c. 1536). It would appear that the lower two half circles denote whether the frame goes on the left or right with only one half circle on one side of the barn and two on the other. This appears to be made with the same size (40mm) circular race knife as the two marks above suggesting they are all of a similar date.

Plate 20: Carpenters mark on Frame 3 (W central)

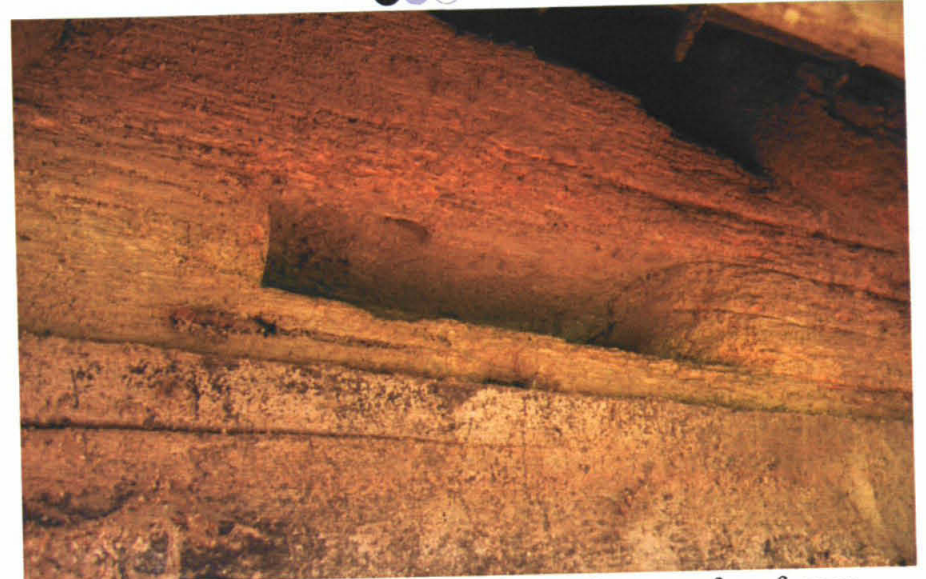
- 3.5.4 The main framing in the south wall is entirely secondary but there are a series of empty mortices in the underside of the principal wall plate which provides an indication of the former wall arrangement and this includes some of the most significant features revealed in the current project. Several of the mortices relate to the former wall framing but there are also four horizontal mortices now observed for the first time on the outside of the wallplates, immediately beneath the eaves, two in each of the main bays within the former open hall (central and eastern bays). Located adjacent to vertical mortices for wall posts, the horizontal mortices are chased (i.e. have an angled side) and would have housed horizontal members which projected out from the external walls of the building at an angle rather than at 90 degrees to the wall (Pl. 21).

Plate 21: Chase mortise in face of wall plate, under eaves, from former projecting oriel

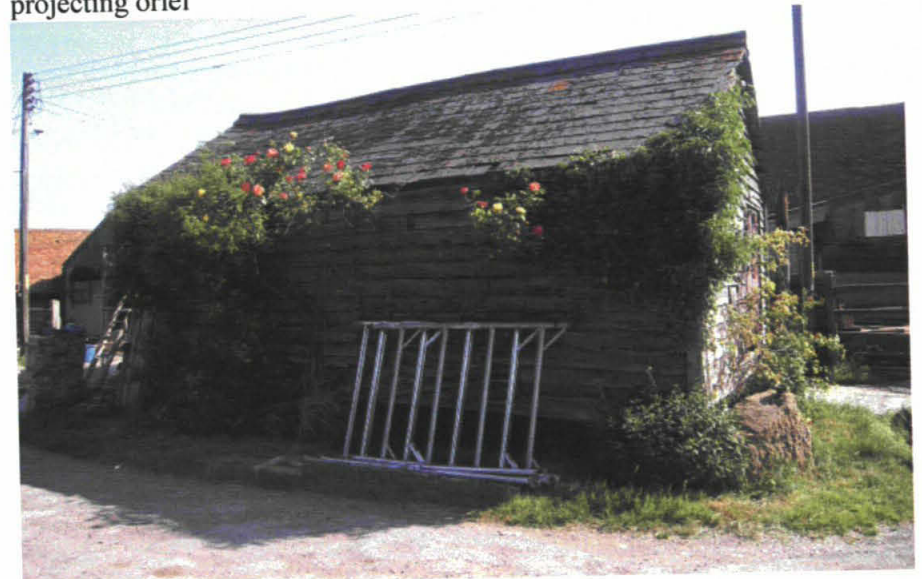
- 4.3.1 The granary (Pl. 23-24) is a rectangular plan, single-storey building (7 x 4.5m) with a slate-covered gabled roof and walls clad in weatherboarding. The condition of the building is now very poor and it is being substantially rebuilt in the current project reusing materials from the existing building.

Plate 23: Granary from south

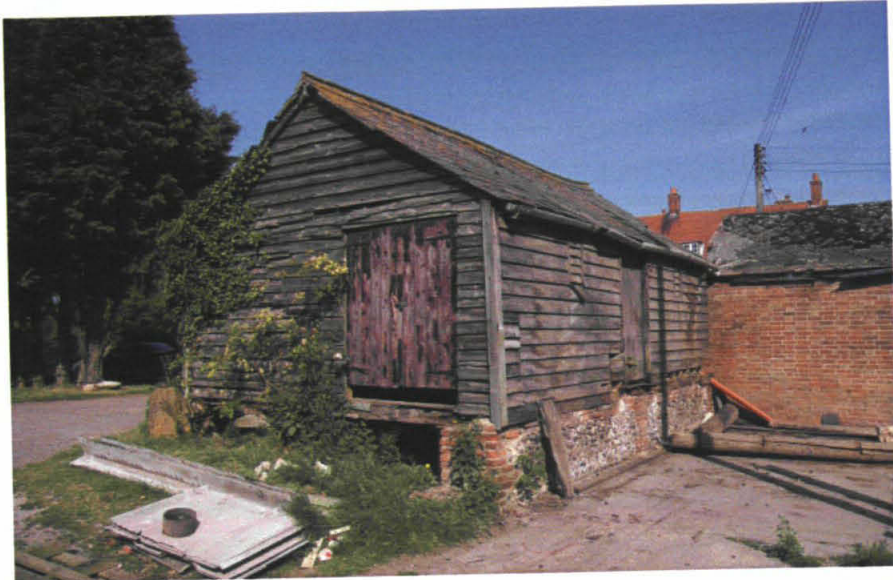
- 4.3.2 The floor of the building is raised above ground level but secondary works have altered the arrangement of primary staddle stones, particularly to the north wall. To this side of the building the staddles have been replaced by a solid plinth comprising three brick piers with flint infill between. The weatherboarding in the north wall shows evidence of patching and alteration. This wall has a central doorway and two small windows, one to each side, which have each been infilled with boarding. The east wall includes a set of double doors at the northern end and there is a single door at the western end of the south wall. The south wall is particularly overgrown and the condition of the weatherboarding is very poor.

Plate 24: Granary from east

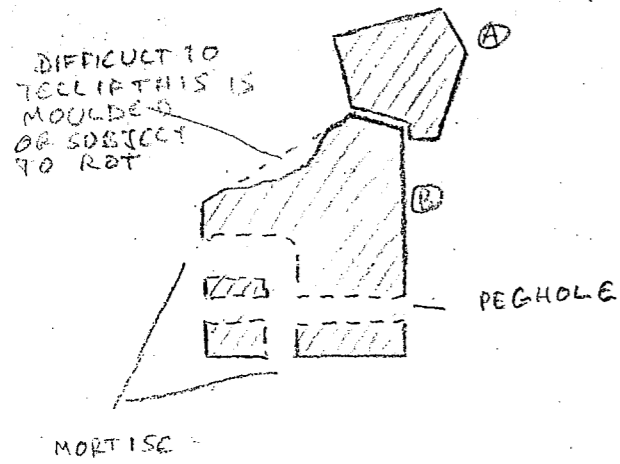
CHURCH FARM - LEWKNOR
 LEWCF
 SECTION - EAST WALL
 PLATE SHOWING MORTISE AND PEG-HOLE
 D.F.
 SCALE 1:20

DIFFICULT TO TELL IF THIS IS MOULDED OR SUBJECT TO ROT

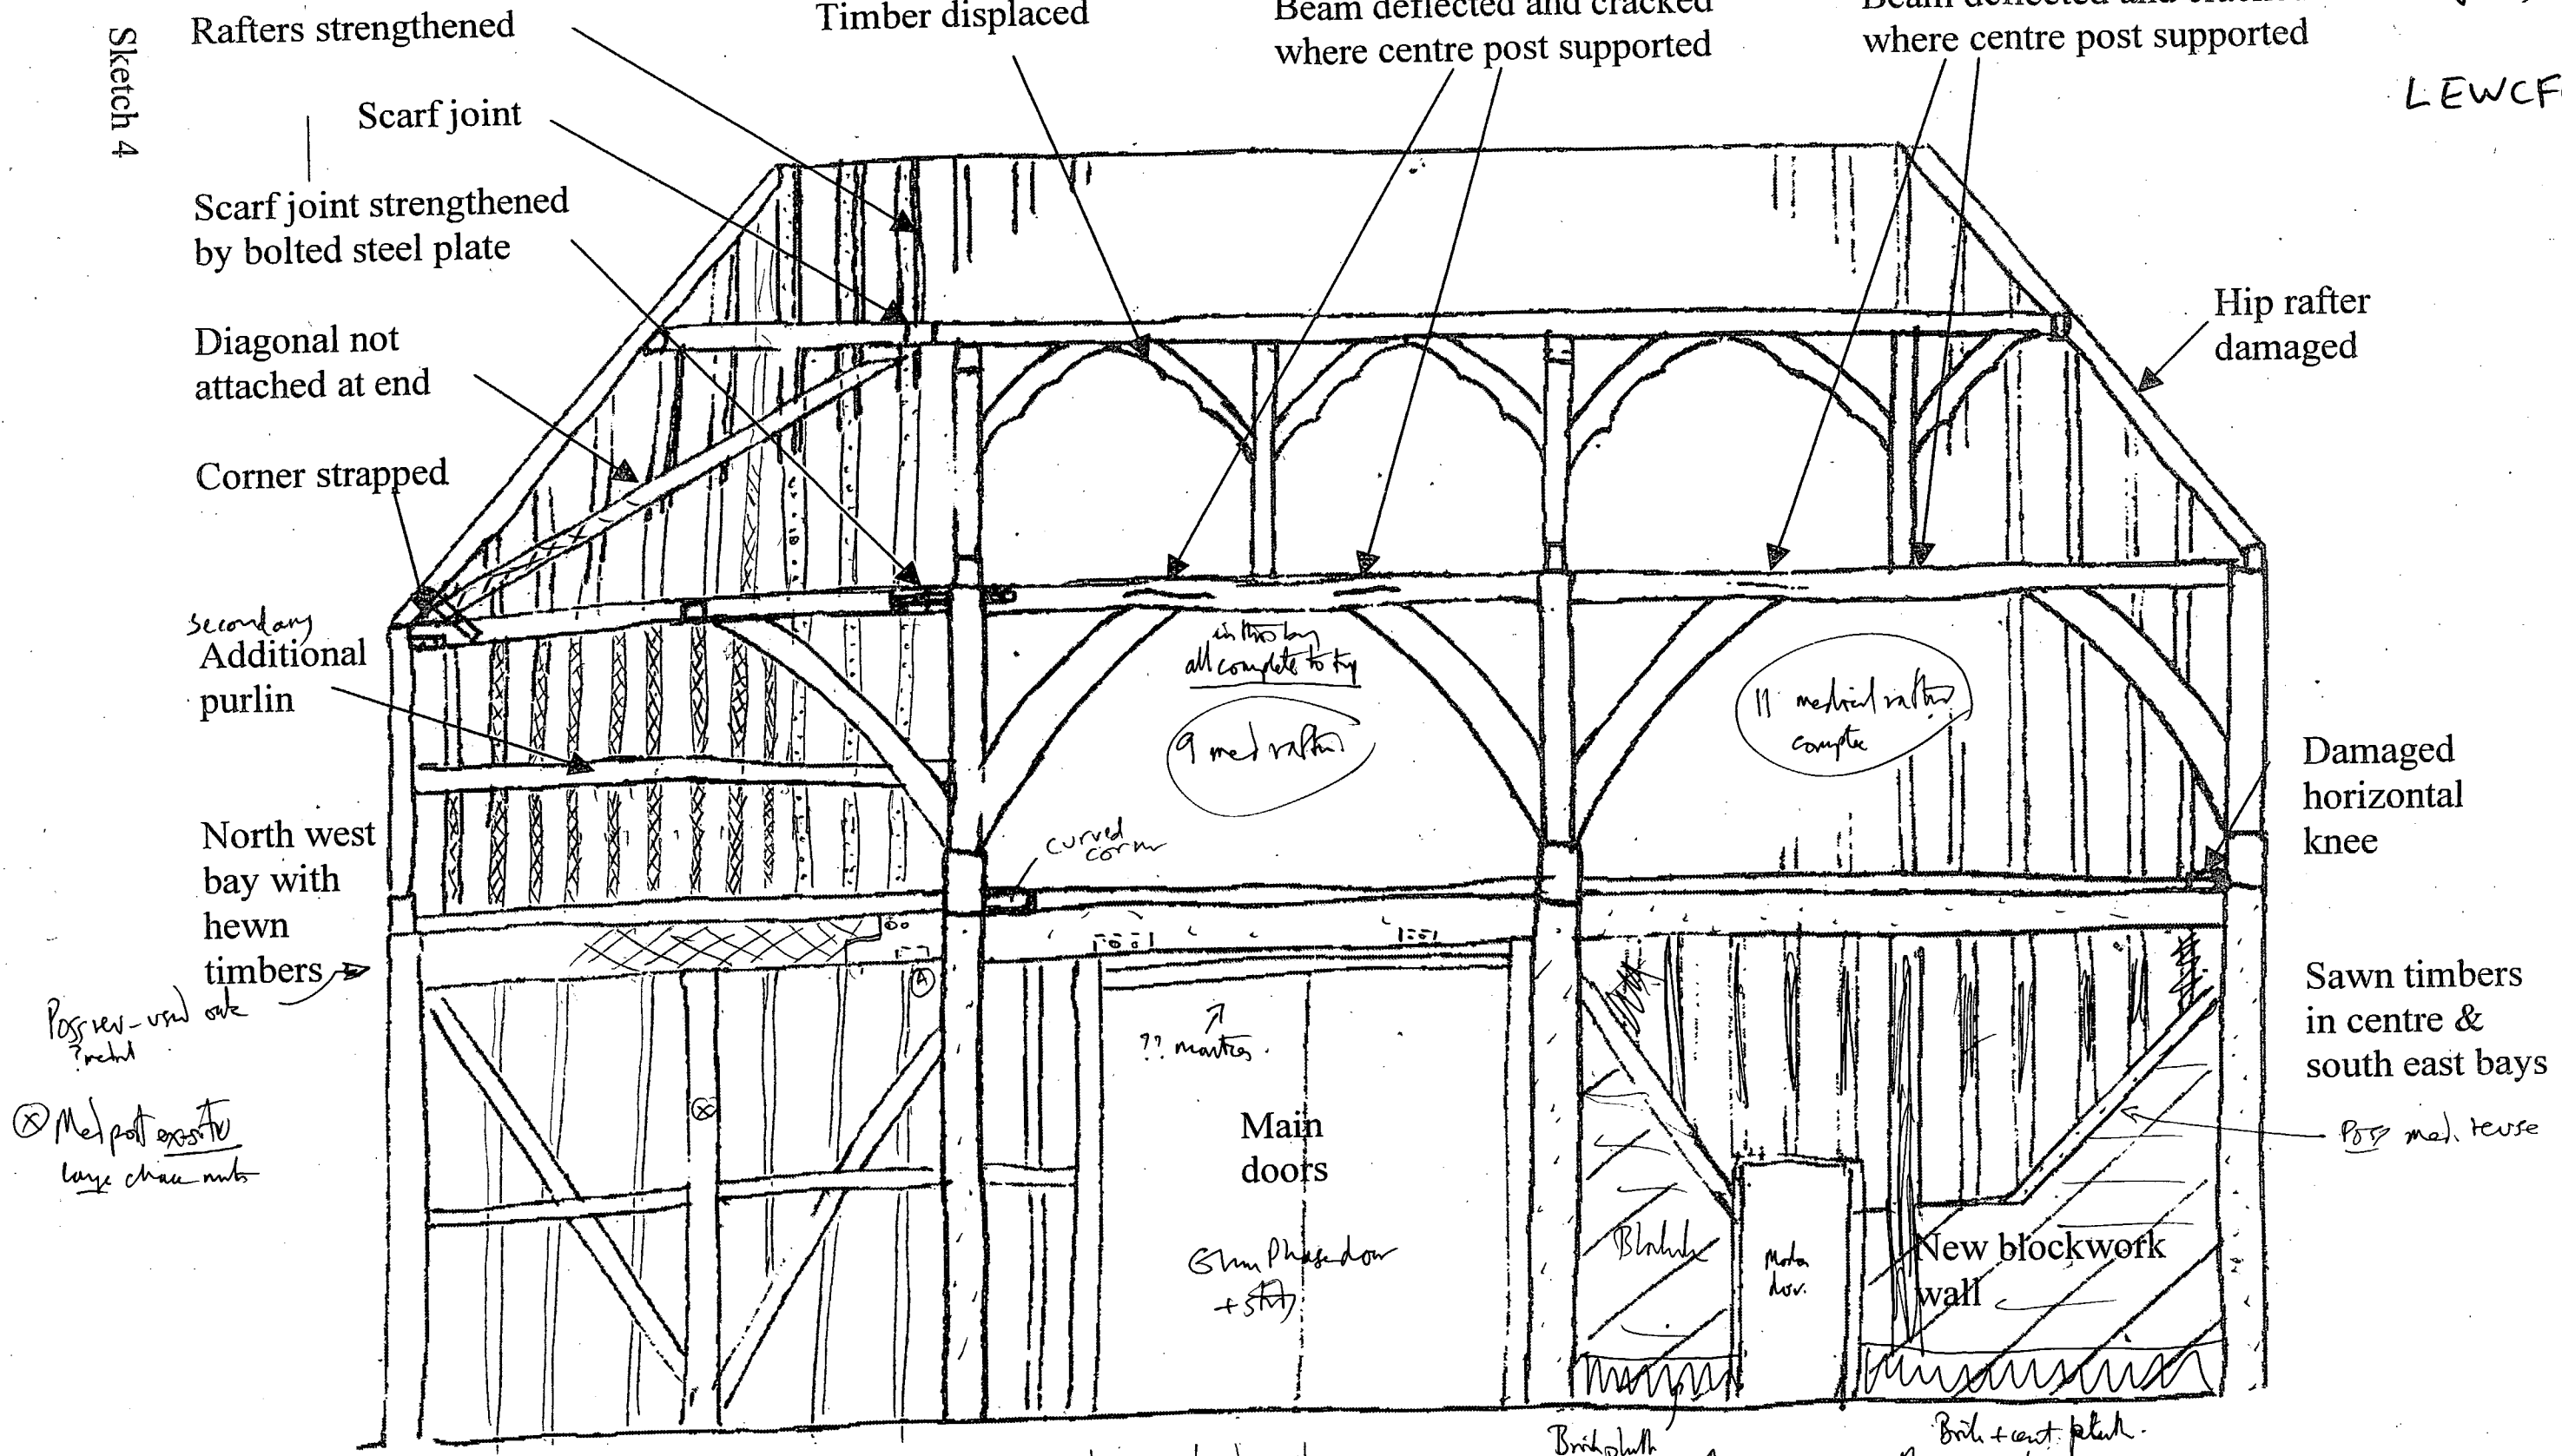
Sketch 4

Rafters strengthened

Timber displaced

Beam deflected and cracked where centre post supported

Hip rafter damaged

Damaged horizontal knee
