MORDEN HALL PARK STABLE BLOCK

Morden, Greater London

HISTORIC BUILDING ASSESSMENT AND SURVEY AND ARCHAEOLOGICAL IMPACT STUDY

Oxford Archaeology
November 2009

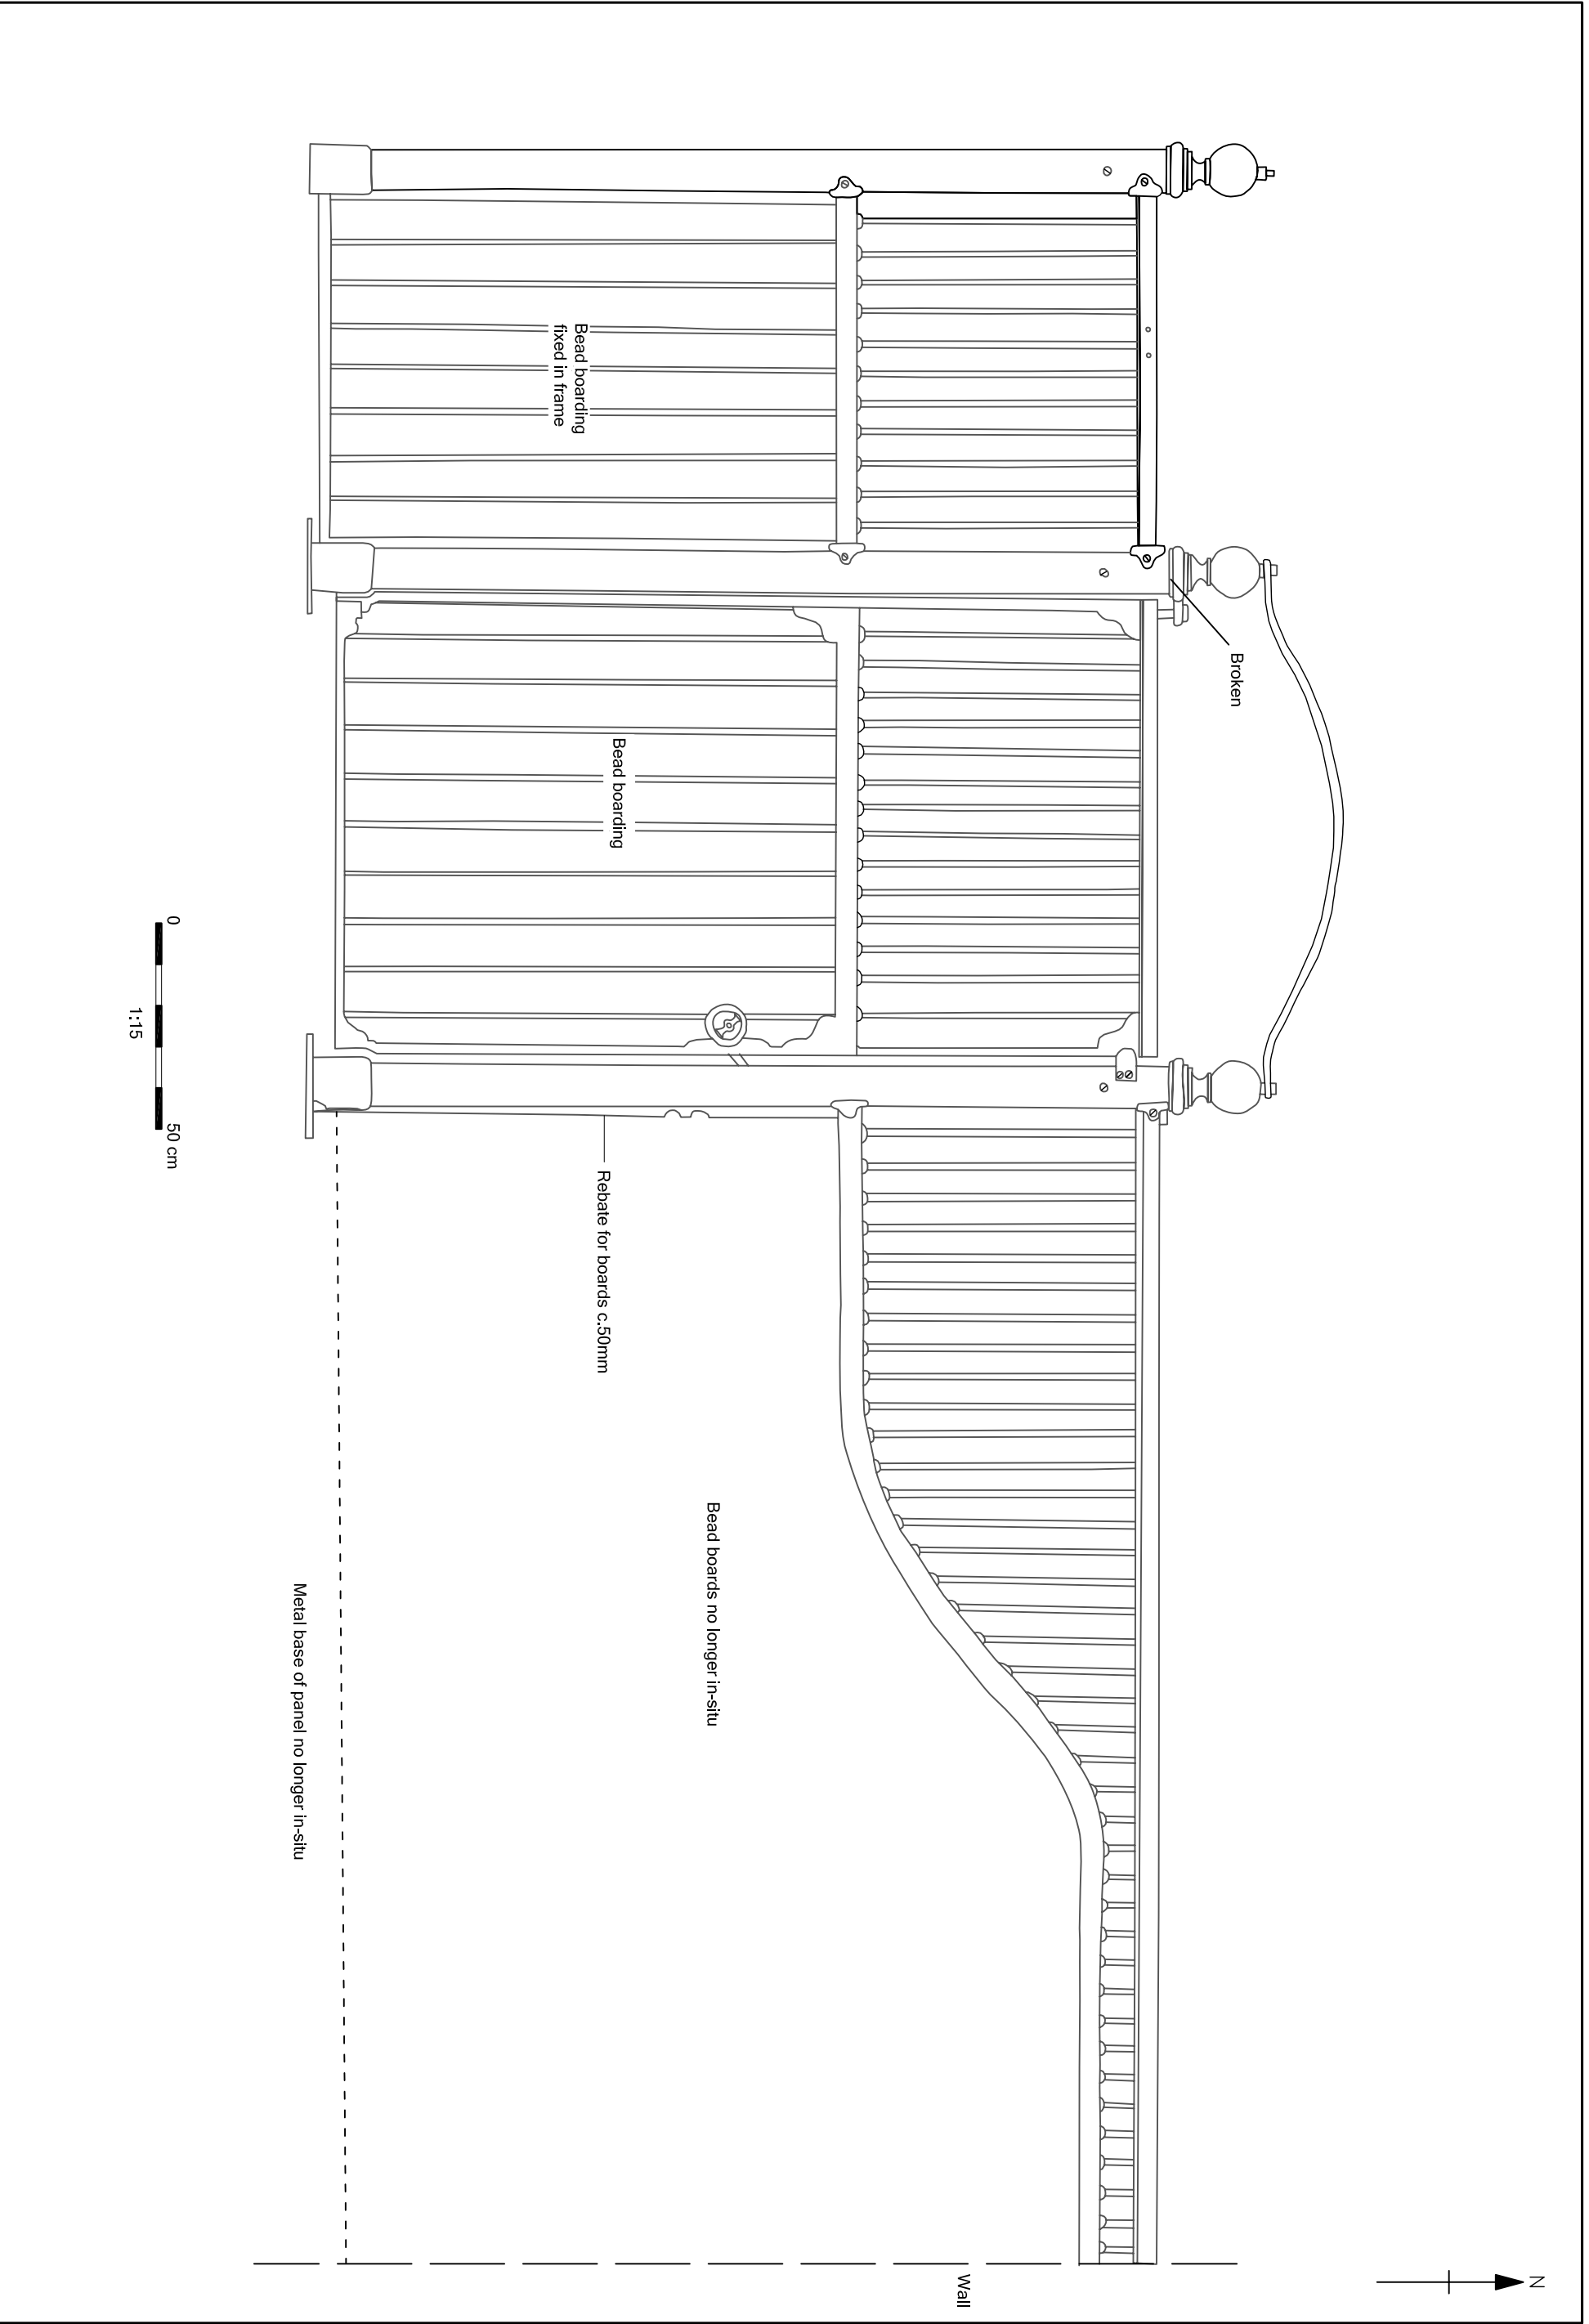
Figure 14: North facing Elevation of Loose Box Division in area 5

- 4.2.26 The southernmost loose box divide is shown as figure 14 and plate 21, and it can be seen that it differs to the other loose box divides as it has a curved central rail. Examples of loose box divides from the same period all feature straight rails and so it is surmised that that one of the rails of the removed stall divides was adapted to form the central rail for this loose box. Each stall retains the primary phase tethering rings but it would appear that within the added loose boxes further rings were added.

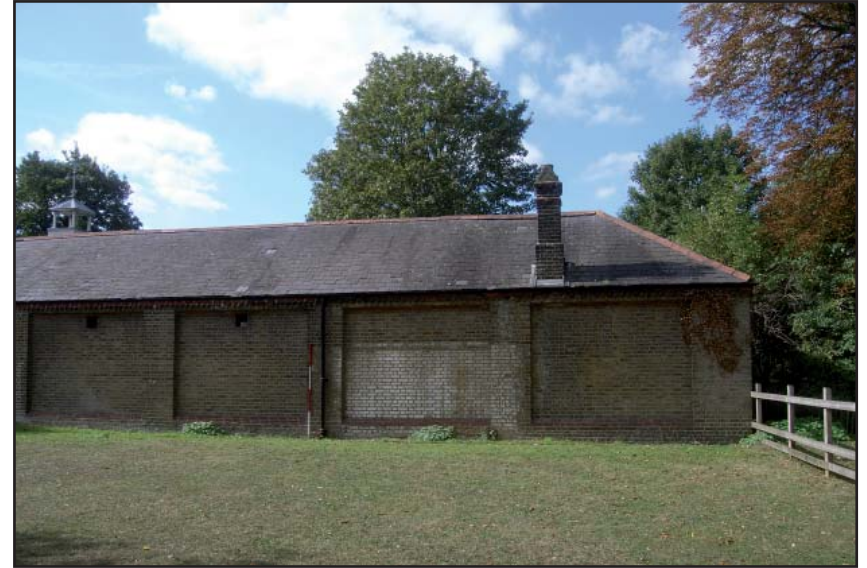
- 4.2.5 The exterior brickwork outside of the courtyard has areas of re-mortaring and repair which all appear to be late 20th/early 21st century in date. The exterior east facing elevation has a section of brickwork which is painted with white paint and adjacent to this is a black mark on the brickwork (Plate 6). This is at the location of the single storey extension shown on the 1932 (Fig 6) OS map which were probably of lean-to construction as there is no significant interference with the existing elevation brickwork. The black mark may also relate to the location of an iron fence which enclosed the adjacent plantation as depicted on the 1879 drainage plan (Fig 5). Running along the ground approximately 760mm away from the base of the wall is a line of concrete 370mm wide and of unknown use which does not relate to any feature shown on 20th century plans.

Plate 6: Detail of external elevation showing location of removed extension

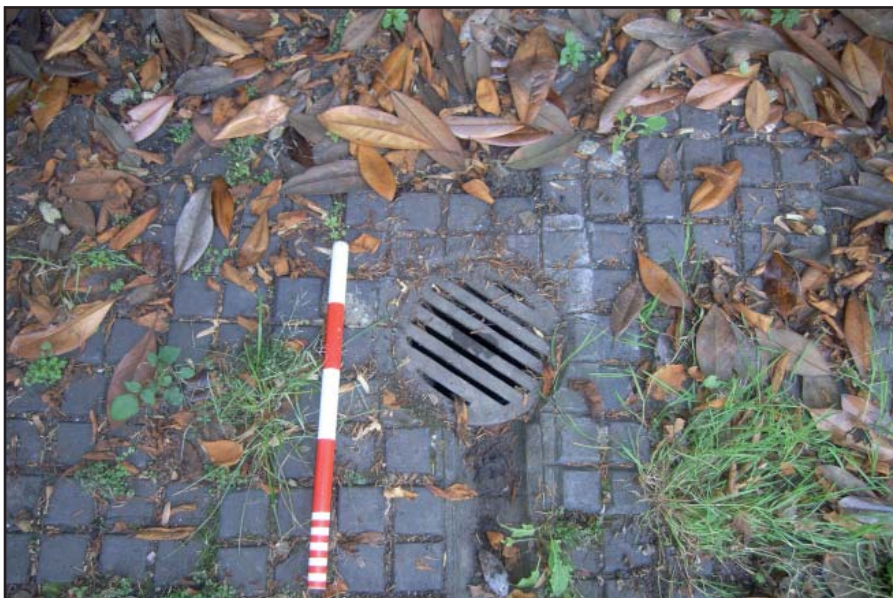
- 4.2.9 The courtyard is covered with black setts measuring approximately 110 x 110mm and which have small chamfered squares providing a decorative surface (Plate 11). This surface is also repeated within some of the internal spaces. Inserted into this flooring are U shaped drainage gulleys which lead to various drains and pots both within the buildings as well as the courtyard. The location of the cess pools shown on the 1879 drainage plan can still be seen although the cover stones have been replaced with 20th century drain covers. The sycamore tree noted on the 1879 plan still remains in situ but the pavours surrounding it have been much lifted by the growth of roots.

Plate 11 Detail of courtyard gulley and drain

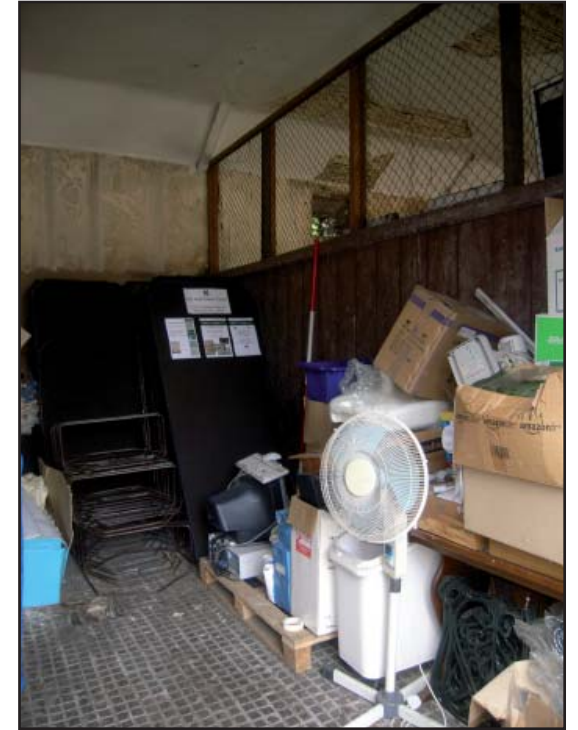
- 4.2.16 *Area 3* – This area was originally divided into three loose boxes as seen on the 1879 drainage plan, each with its own external door and manger. There has subsequently been considerable alterations to the area during the 20th century including the removal of the high wainscot panelling and the blocking and enlarging of doorways. The area is currently divided into two by a primary phase loose box partition (Plate 14).

Plate 14: Interior view of area 3 showing loose box partition

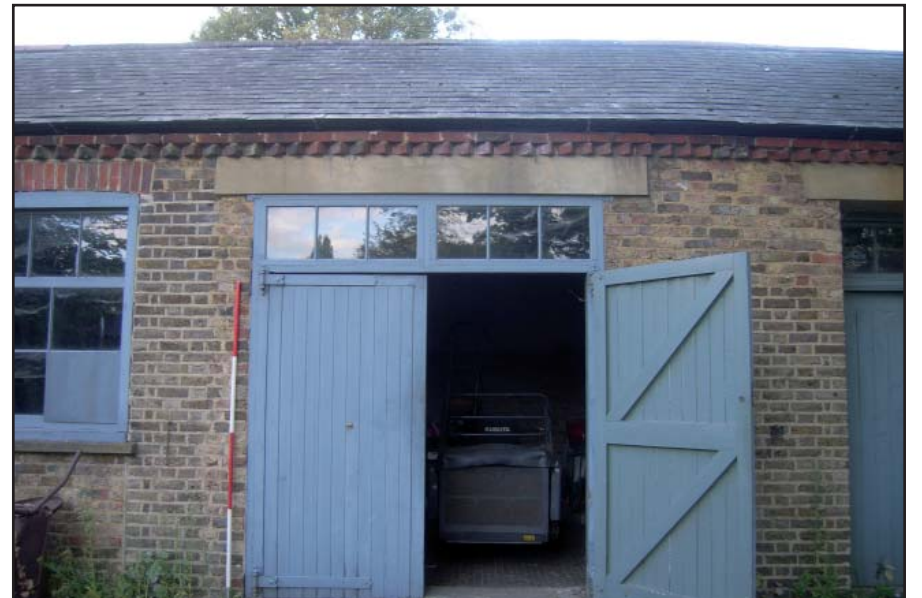
the removed door. The brick arch lintel has been reused. The remaining doorway has been enlarged and features a stone lintel and double plank and batten doors with fittings similar to those seen in area 2. The brickwork adjacent to this doorway has been reset using a sandy coloured mortar and the interior walling at this point does not have render on the upper part. The sill of the door is partly of brick which is probably the lowest course(s) of the wall removed during the enlargement of the opening. There are four tethering rings set within the west wall, two for each loose box, although it is possible that there was originally only one ring for each loose box. Unlike the smaller area, the lower section of the walls have been left as exposed brick following the removal of panelling.

Plate 16: Blocked doorway and adjacent enlarged doorway in area 3

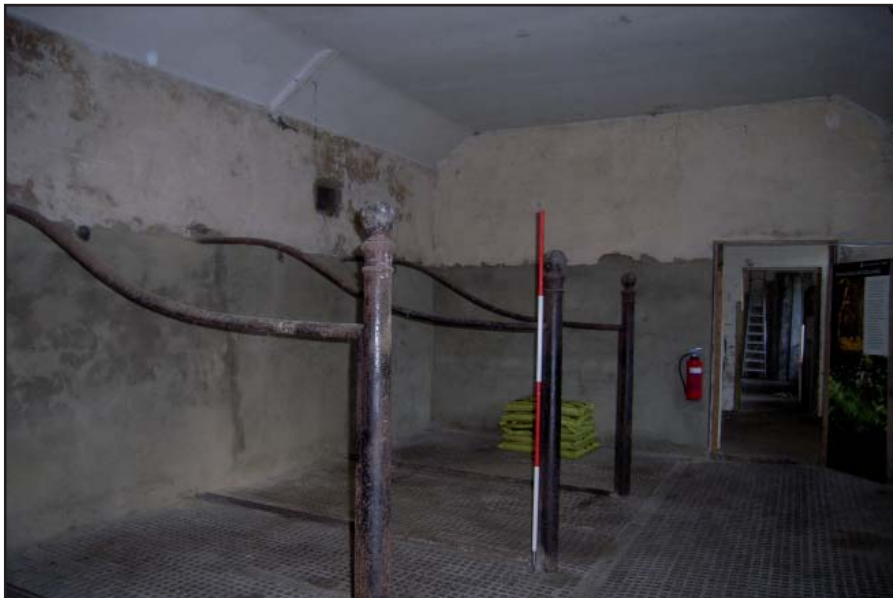
- 4.2.23 The north eastern section retains four of cast iron fittings used to divide the area into five stalls (Plate 19). The cast iron hind posts stand approximately 1.8m high and are topped with decorative finials. The bottom rail is plain and the upper rail has a curved detail as the rail goes into the hind post but is higher and straighter where it is fixed into the wall. Both the rails and hind post have voids where the bead boarding would have been fixed. The stall divides form part of the primary phase fixtures and fittings and remain in good condition however the bead boarding does not survive on any of the stall fittings within the stable block. The stalls retain their primary phase tethering rings.

Plate 19: Cast Iron hind posts in-situ in area 5

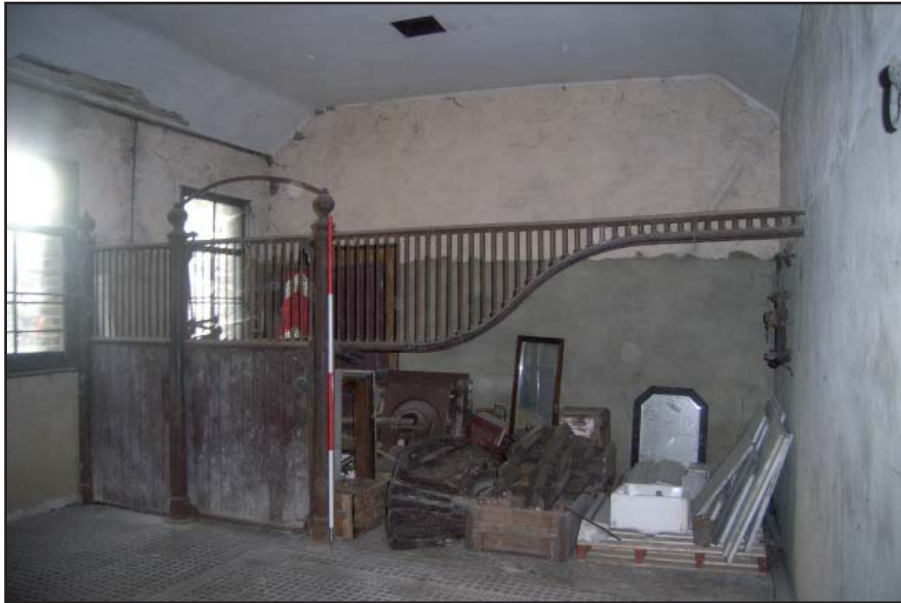
Plate 21: Later 19th century loose box divide in area 5

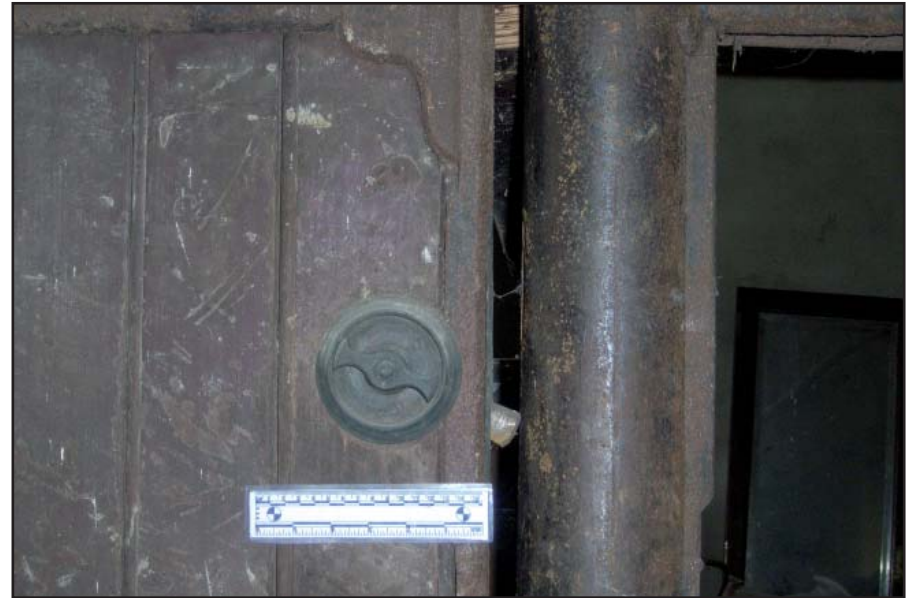
- 4.2.25 The two stall divides previously within this corner have been removed and the area divided into two further loose boxes by the addition of a further partition and two doorways all of which retain the original bead boarding. The additional door sections are the same as the loose box door described above with the exception of the door handles/locks. One of which has a protruding fixed handle set within a circular fitting the other comprises a flush circular fitting (Plate 22).

Plate 22: Detail of door fitting to loose box in area 5

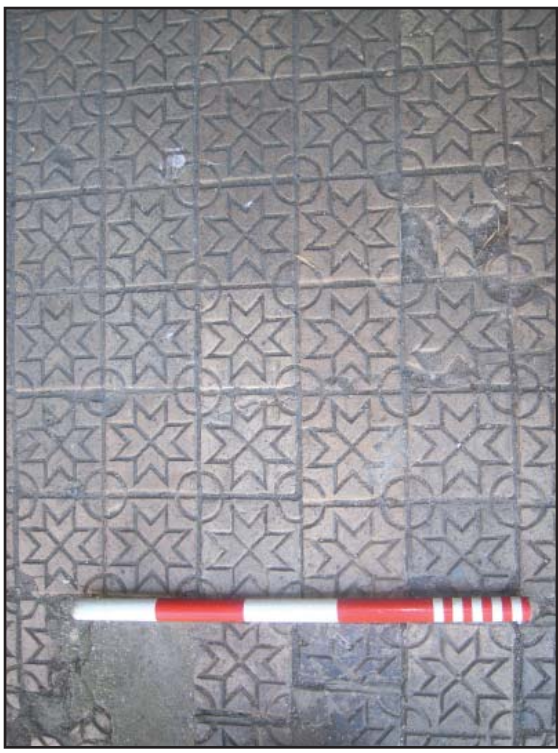
- 4.2.33 The most interesting feature of this area is the floor which is paved with light brown coloured decorative tiles approximately 70mm square (Plate 26). There are areas of broken tiles and some repair patches using concrete and the overall surface is uneven. The area is divided by a low concrete block wall which was probably added during late 20th century works.

Plate 26: Detail of decorative floor in area 9

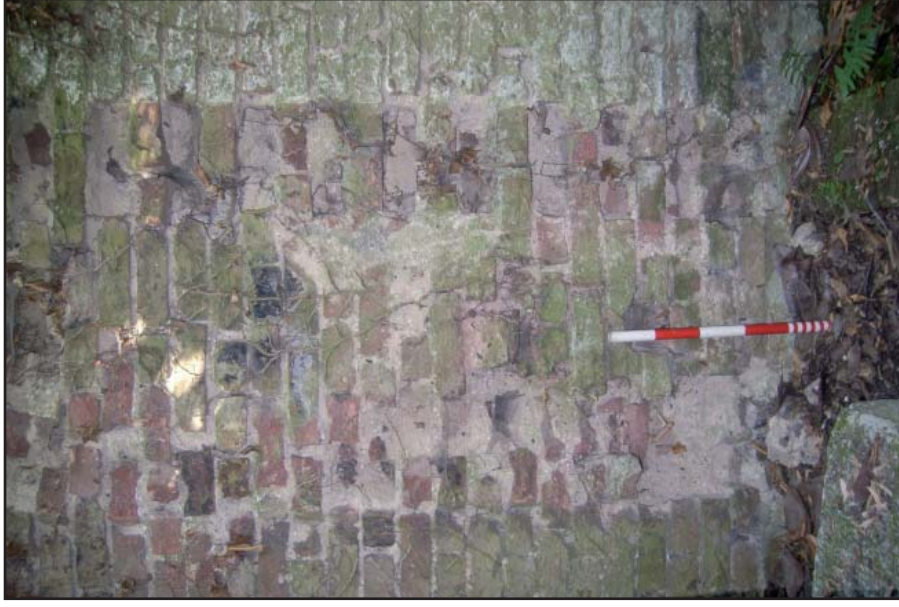
Plate 30: Detail of removed brick feature in former scullery

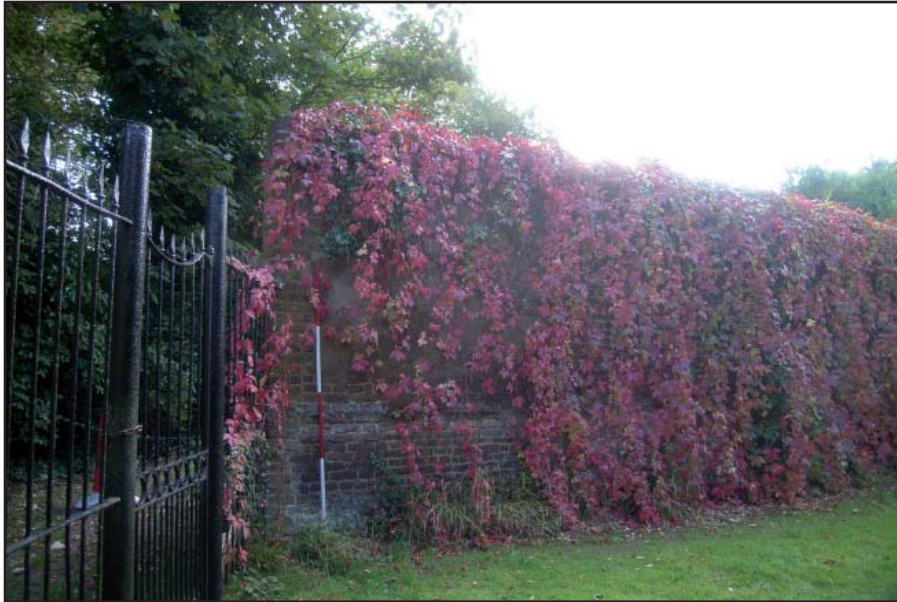
Plate 33: Detail of gate and rebuilt brickwork north facing elevation of orchard and apiary wall
