St Thomas' Church, Simpson, Milton Keynes

ARCHAEOLOGICAL WATCHING BRIEF REPORT

Oxford Archaeological Unit

November 1998

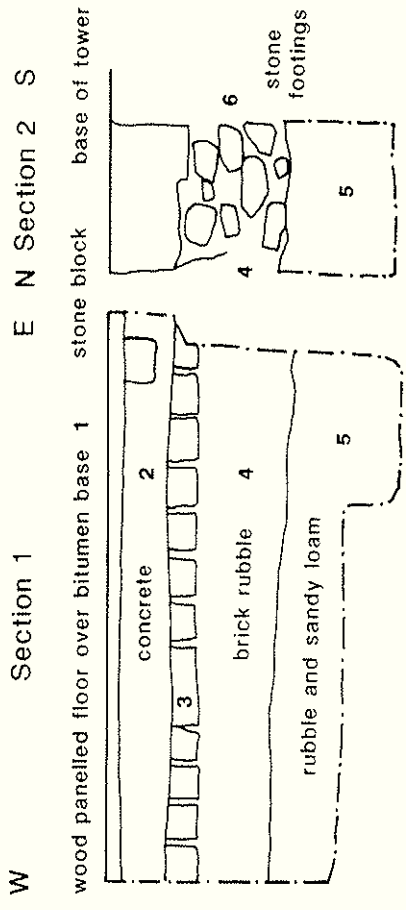
TP 1

- (1) – wooden panelling over a thin layer of bitumen.
- (2) – concrete with occasional medium pieces of stone, possibly disturbed and redeposited structural stone; all pieces were firmly within the cement.
- (3) – one course of modern housebricks; 0.23 m by 0.10 m by 0.07 m, mainly unfragmented red brick with a few broken pieces.
- (4) – mixed grayish brown sandy loam with 15% small-large stone fragments and lenses of mortar.
- (5) – dark gray/brown sandy loam with approximately 30% medium-large angular stone rubble.
- (6) – angular, irregularly placed stone footings of the tower, surrounded by a pale yellow/brown silt loam.

Test pit 1 revealed that the church floor had been removed and replaced with a wooden panelled floor over a concrete foundation, resting on one course of modern housebricks. Disturbance associated with this reached the upper horizon of deposit (5), and was sufficiently invasive to remove any earlier floor layers, if present. Also the stone footings of the tower were exposed and were seen not to be very substantial, at least within the confines of the test pit.

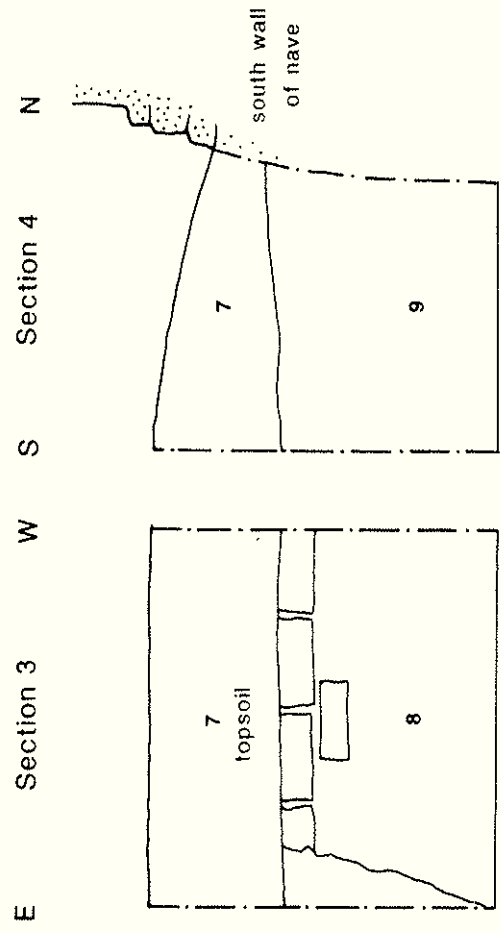
TP 7

- (7) – topsoil; dark brown clay loam.
- (8) – crudely-built red brick wall, approximately 0.35 m below present ground surface. Stretcher-built with bricks circa 0.23 m long by 0.09 m deep, bonded with a pale yellowish gray mortar. The northern face of the wall as exposed within this test pit has mortar protruding from the wall face at the joints, suggesting that this is the back face of this wall. The wall curves gently back into the section, away from the church; no walling was visible in test pit 6, just to the south-east, but a similar structure was seen in the south face of test pit 8, immediately to the west.
- (9) – redeposited, disturbed reddish brown loamy clay with approximately 6% mixed stone, some small pebbles and a small quantity of human charnel.

The wall footings of the standing building remained obscured by deposits (7) and (9).

Test pits 7 and 8 revealed a crudely built brick wall approximately 0.90 m to the south of the church; the upper surface of this feature appeared at approximately 0.35 m below the present ground surface, where it appeared to be vertical, and then curved gently away from the church, disappearing into the section. It was thought likely that this possibly represented a former crypt, or other subterranean graveyard feature, associated with the church as it was before the 1873 restoration work.

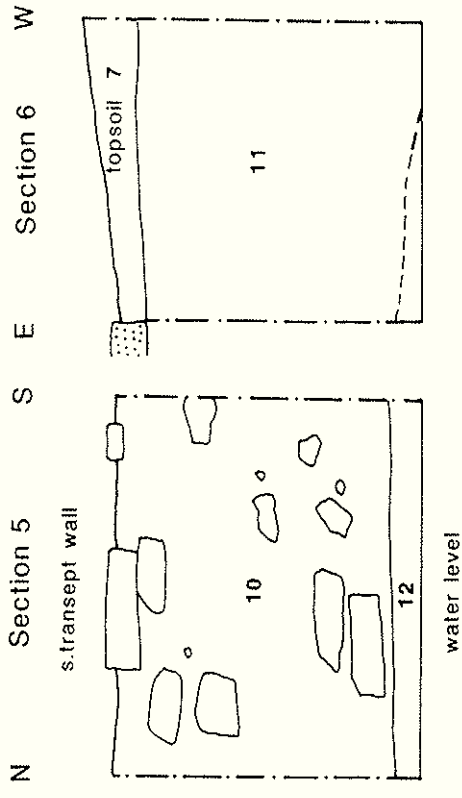
TP 6

- (10) – subangular sandstone footings, protruding 0.20 m from perpendicular, mostly obscured by abutting soil (11).
- (11) – reddish brown loamy clay with occasional redeposited stone pieces.
- (12) – pale yellowish brown clay, mostly obscured by groundwater.

Test pits 2,3,4,5 and 6 revealed the lower wall footings on the exterior of the church, protruding a mean distance of 0.20 m from perpendicular. The squared stone footings were underlain by soil with cobbles and large unworked and fairly random stone pieces. The mortary spread seen in deposits (23), (33) and (16) may be associated with the 1873 restoration work.

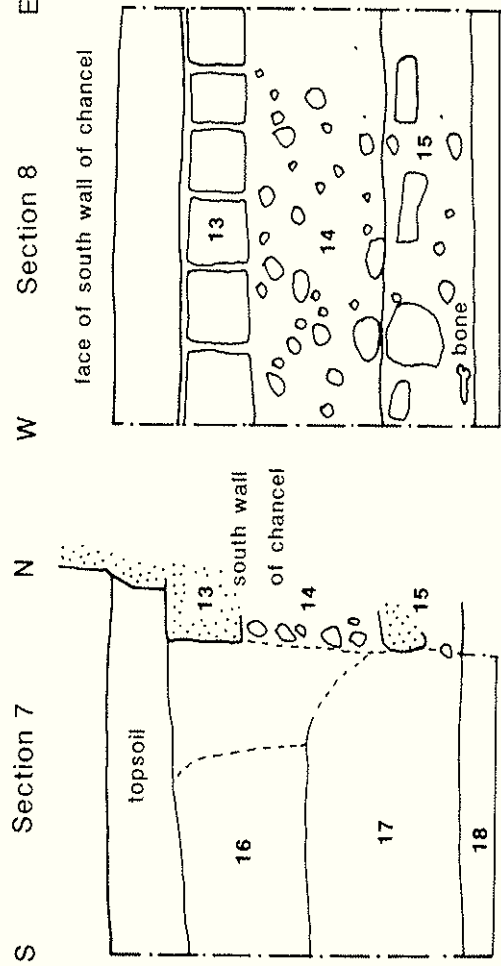
TP 4

- (13) – large, roughly squared sandstone blocks with no apparent mortar bonding, protruding approximately 0.18 m from perpendicular.
- (14) – medium sized rounded and subrounded cobbles, also with broken fragments of same, averaging 0.10 m in diameter, in a reddish brown loamy clay matrix; 60% cobbles to 40% loamy clay.
- (15) – large subangular and subrounded sandstone pieces in a reddish brown loamy clay matrix, in a 50/50 ratio.
- (16) – brown clay loam with a progressively higher percentage of mortar inclusions towards its northern end; the mortar was very powdery, very pale yellowish brown with much small angular stone.
- (17) – brown clay loam with approximately 5% mixed very small stones and pebbles.
- (18) – very pale yellowish brown waterlogged clay, seen just above the level of groundwater.
