Yew Tree Cottage  
Maids Moreton  
Buckinghamshire

Historic Building Recording and  
Archaeological Watching Brief

**Oxford Archaeology**

December 2004

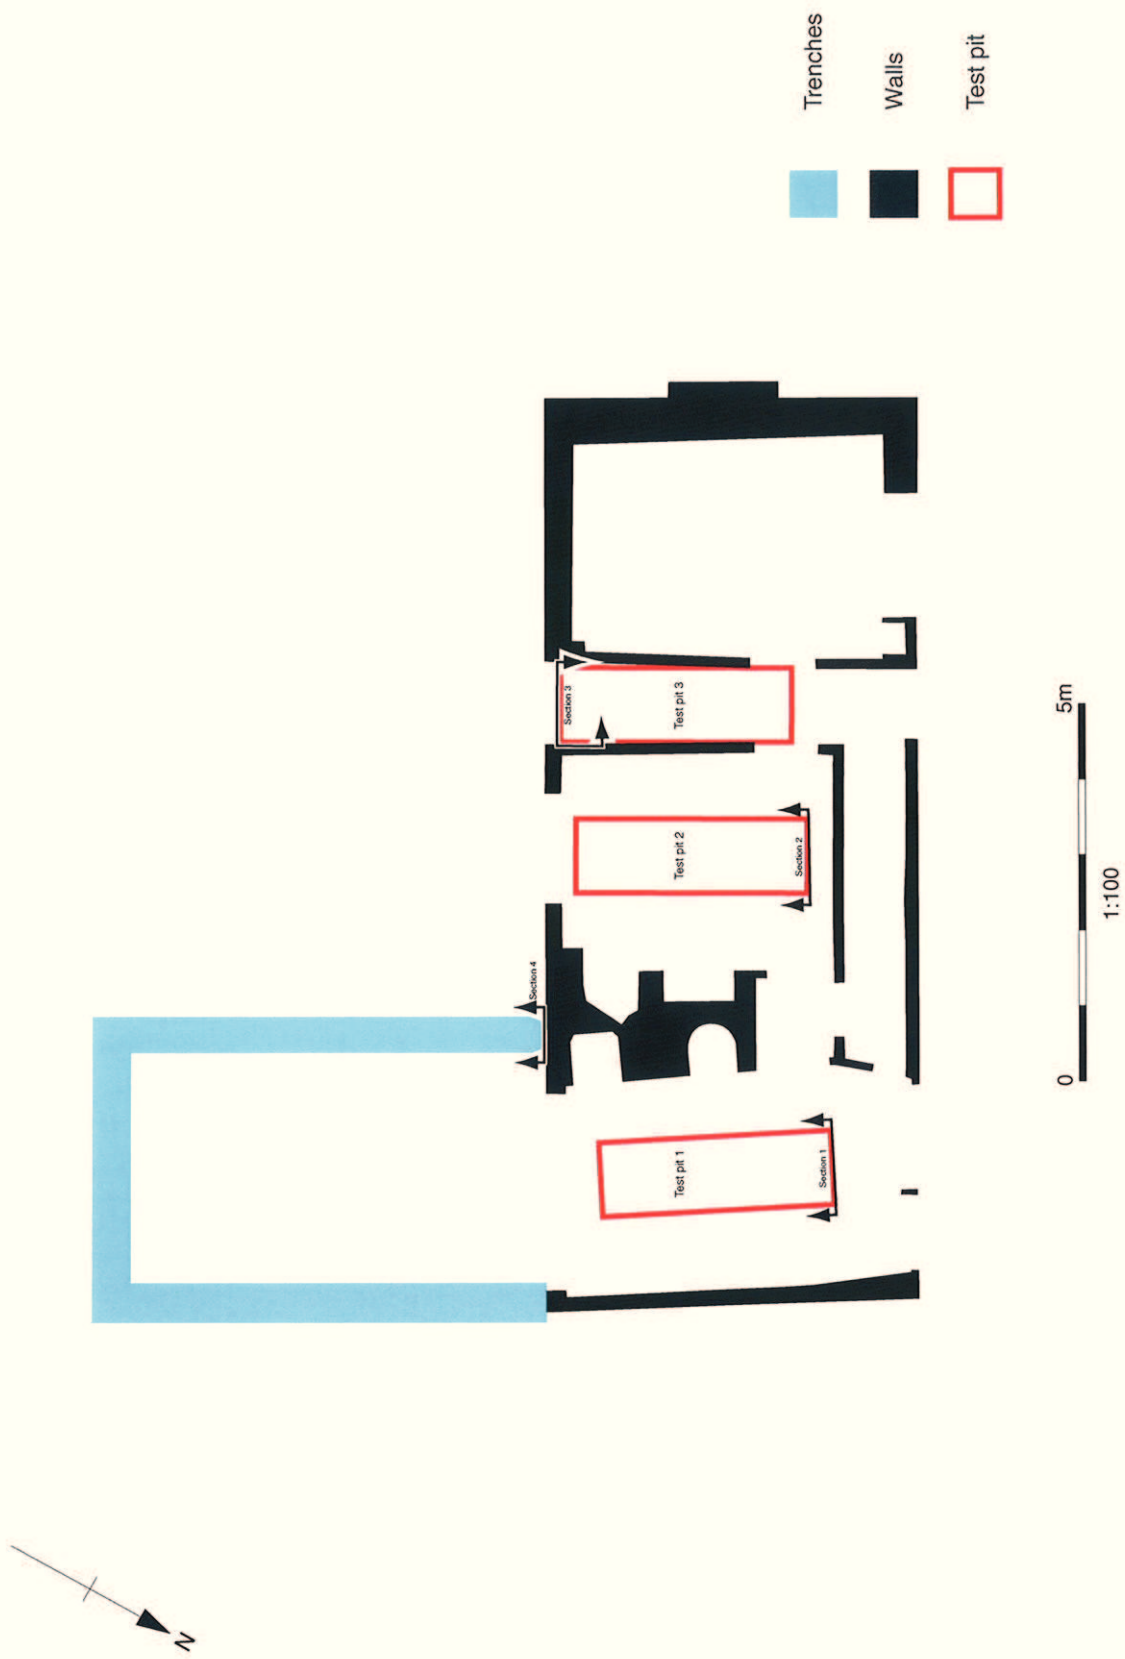
Figure 10: Site plan and location of test pits and sections

- 4.1.1 The three test pits measuring 3 m x 1 m x 0.30 m were to be excavated in the three rooms of the house, but the floor in the south end of the house had been laid in the 1950s and consisted of 0.2 m thick concrete on 0.08 m thick hardcore. This had beams laid in concrete with floor boards fixed to them. The test pit for this room was moved to the hallway of the house. The other test pits were set out in the centre of the other two rooms (See Figs. 10, 11).

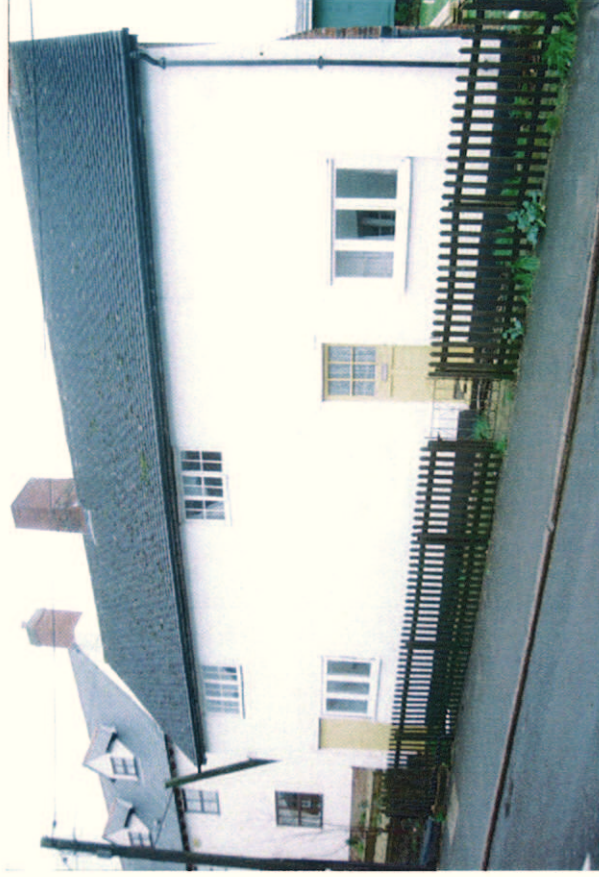
Plate 1: North (front) elevation of house

- 3.2.1 The *north elevation* (front; Plate 1) is of white painted render with a 75 cm tall rubble stone plinth. The lower half of the plinth is painted black but the upper half is covered with the same render as the rest of the wall. The top of the stone plinth is indicated by a distinct shoulder in the western half of the elevation but this gradually disappears in the central part of the elevation and there is no visible shoulder in the east half. Immediately to the west of the westernmost ground floor window the shoulder returns vertically up the elevation to form a vertical step. There are two doors in the elevation: one towards the east end and the other towards the west, and immediately to the west of each door is a three light window (probably 20th century).

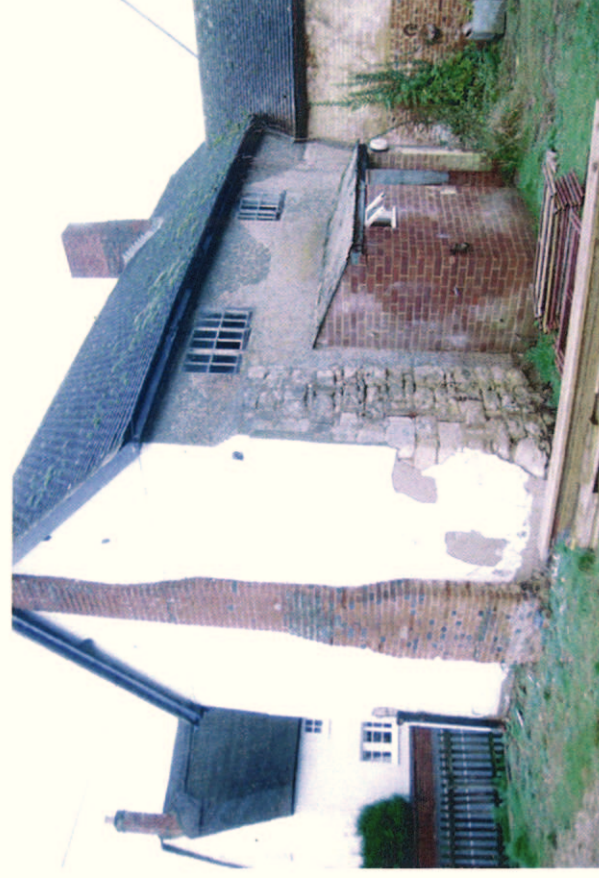
Plate 2: House from south-west

- 3.2.3 The *west elevation* (side; Plate 2) is again covered in white painted render but this has come away in several patches towards the base on the southern side of the elevation to reveal coursed stone blocks. At the centre of the elevation is the projecting stack from a secondary (probably 19th-century) chimney. The west wall is gabled and at the current roof line there is a relatively modern softwood barge board. As detailed above the primary roof was lower than the current roof and the line of this is visible within the elevation. This is shown by the outline of a former gable c.1.2 m beneath the current roofline with the ends of a single purlin to each slope of the former roof *in situ* and visible within the elevation. The end of the primary wall plate from the south elevation is also visible.

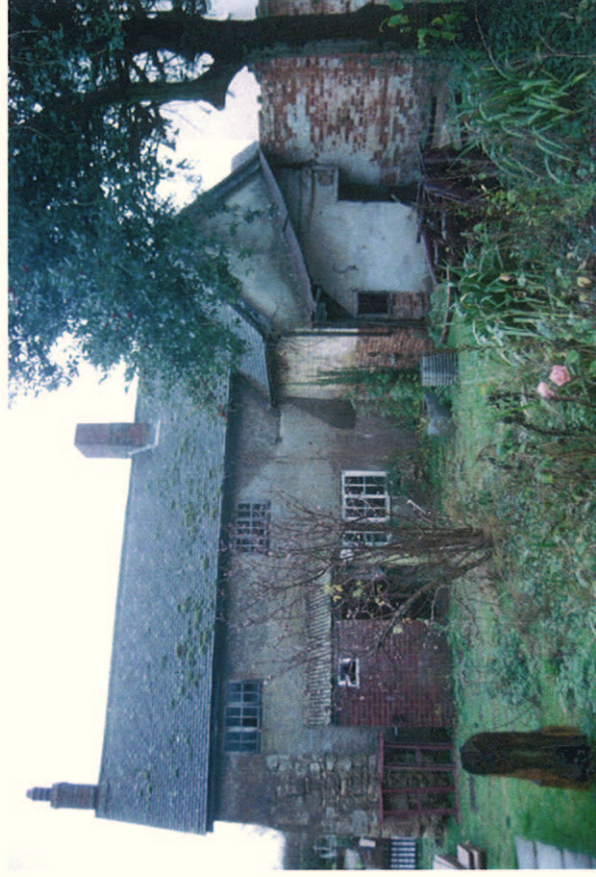
Plate 3: South (rear) elevation of house

- 3.2.5 The *south elevation* (rear; Plate 2, 3) is again largely rendered and it has two extensions: At the east end is the main larger extension (detailed separately below) and towards the west side is a small 20th-century brick porch with WC (Plate 4). To the west of the porch is a substantial coursed stone pier, at approximately three-quarter height, supporting the west end of the elevation. There is a single 3-light mullioned window (19th-century) immediately east of the porch and two similar windows at first floor. The original arrangement at first floor would have been the same as the front of the building with three dormer windows projecting above a roof line lower than the current eaves. The distinction between the two phases of render around the windows is much more apparent than on the front elevation. The two existing first floor windows form the central and western of the three windows, although the windows themselves are replacements (probably 19th century) and where the eastern window would have been is now abutted by the southern projection. The sloped outline of the former lower roof which passed over the windows is visible within the wall.

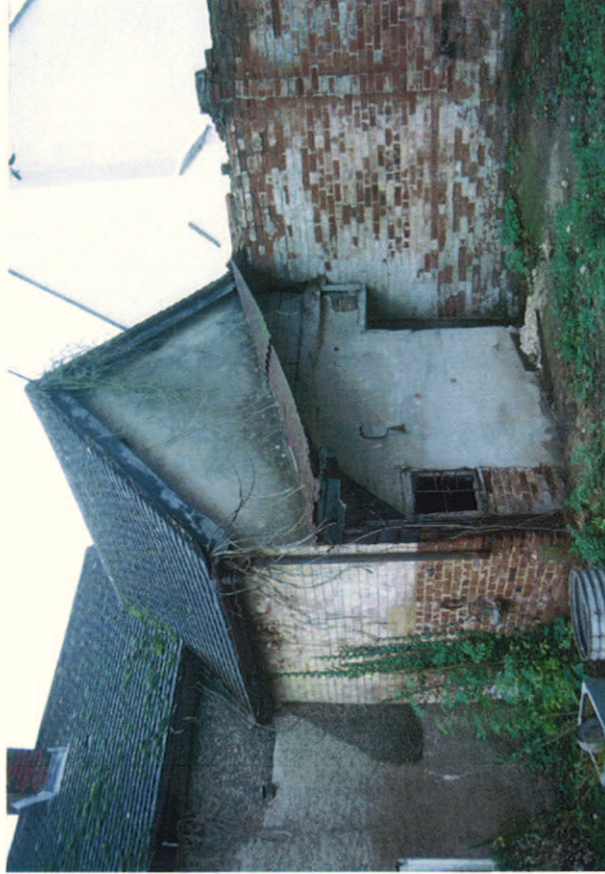
Plate 5: Extension at east rear end of elevation

- 3.2.6 The *southern extension* (Plate 5) projects from the eastern third of the south elevation. It is single storied (with cellar and small attic) and has a concrete tile covered gabled roof. The west wall is of brick (18th/19th century) but the south wall is of a crude timber framed construction clad in lath and plaster and incorporating a small window and door. There was formerly a basic lean-to adjoining to the south of the main extension but this had been demolished prior to the current survey. Evidence survived to show that this had a weatherboarded west wall and in its final form it had a corrugated metal roof, although this probably replaced a previous roof. From the exterior the extension is a lot smaller and

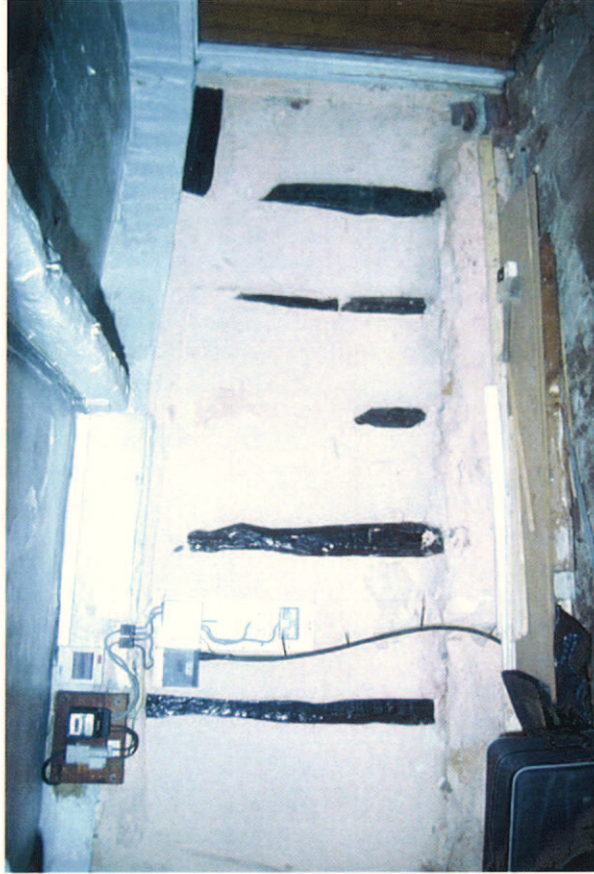
- 3.3.6 The easternmost room (G5) is a scullery and it has a stone flag floor with irregular stones of the same character to those in the cross passage and corridor (Pl. 15). The 3-light mullion window in the north wall is of 20th-century date and beneath it is a shallow trough sink set on a brick (possibly 18th-century) base (Pl. 14). The walls are all plastered but a timber frame is partially visible within the east wall. This frame appears to comprise 6 waney posts set on a brick plinth but the full dimensions of the posts are obscured by plaster (Pl. 13).

Plate 13: Timber framing within east wall of scullery (G5)

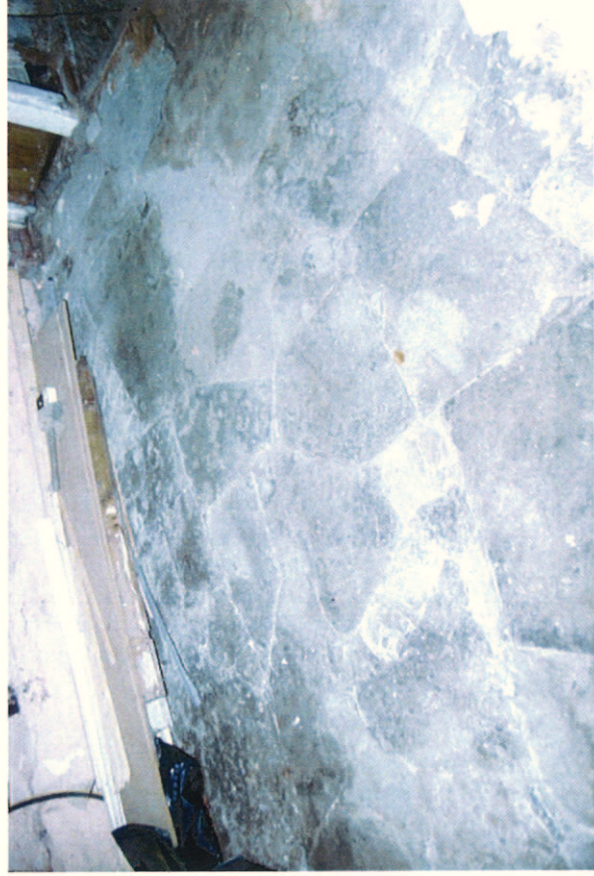
Plate 15: Irregular stone flag floor in scullery (G5)

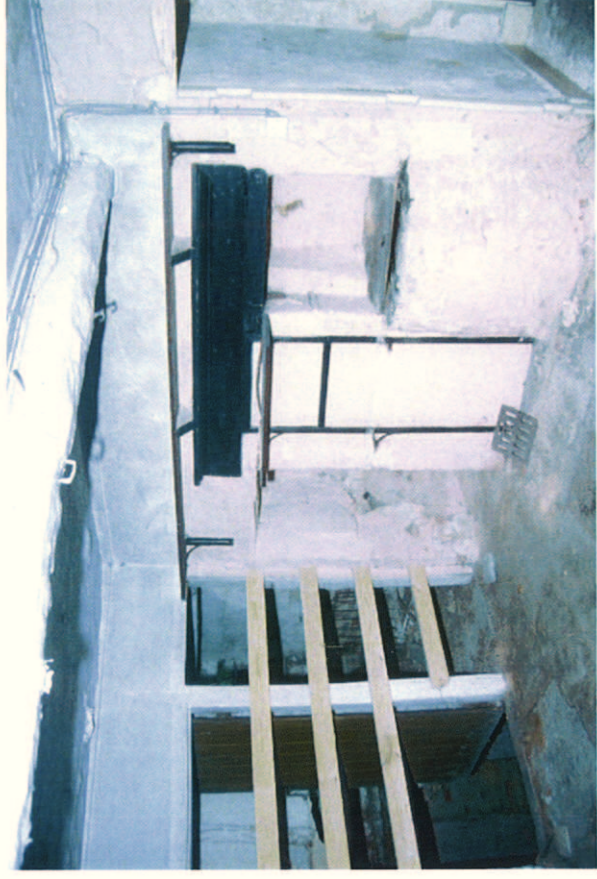
- 3.3.7 The large brick chimney stack within the west wall comprises a washing copper in its north side with a covering board fixed over the top (Pl. 16). The former fire opening itself has also been boarded over. The ceiling is plastered and incorporates a large east-west principal joist with chamfered undersides.

Plate 16: West wall in G5 incorporating fireplace and copper

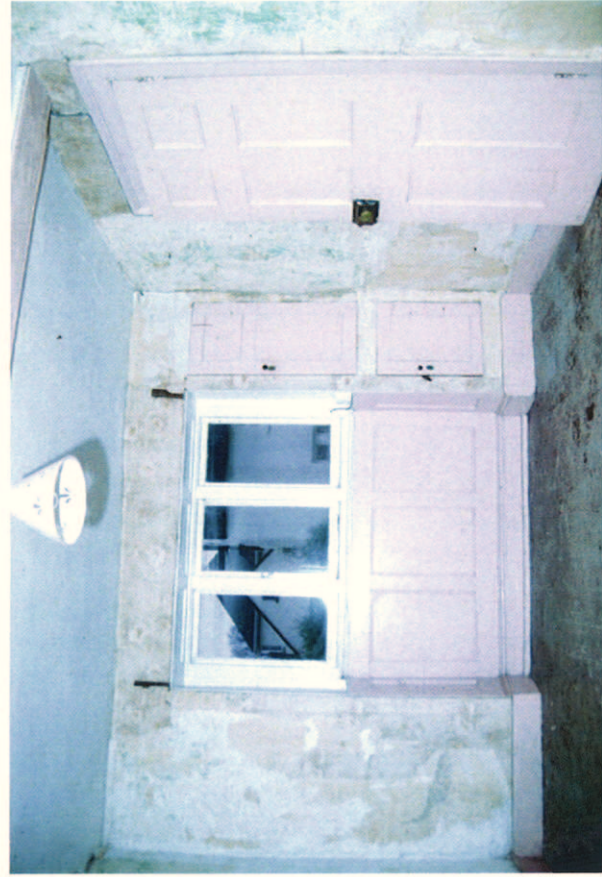
- 3.3.2 The **ground floor** of the primary building comprises three main rooms: between the central room (G3) and the western room (G1) is a cross passage (G2) while between the central stack and the eastern room (G5) is the main chimney stack. **G1** is the living room and the walls are plastered (lime plaster) and painted with a low, plain skirting. A small area of the plaster has been removed from the south wall (c. 15 cm x 20 cm) and this revealed brickwork which appeared 19th-century in date. These may be reused and may relate to the construction of the small 20th-century WC extension on the external face of this wall. The floor has secondary softwood floorboards (late 19th or 20th century) and there is a 1930s tiled fireplace in the west wall. There is 19th-century panelling beneath the window, a built-in cupboard immediately to the east of this and a 19th-century 6-panel door with a plain contemporary architrave (Pl. 18).

Plate 18: North wall of G1

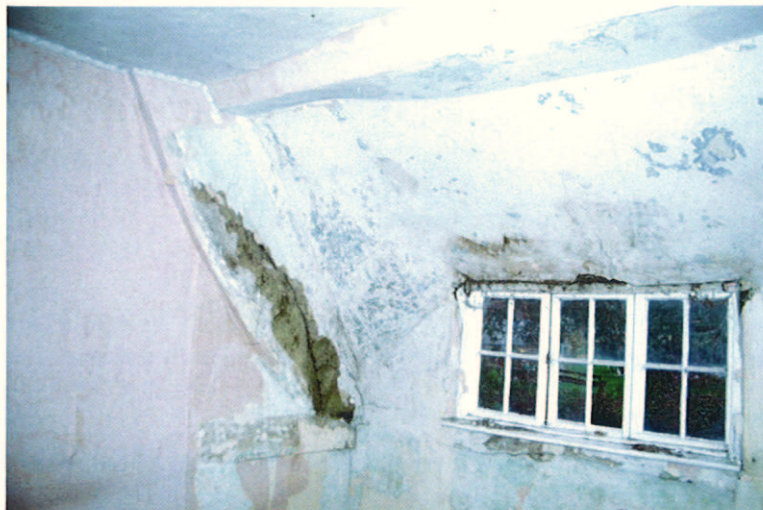
Plate 21: North wall of F1. Note partially exposed cruck frame

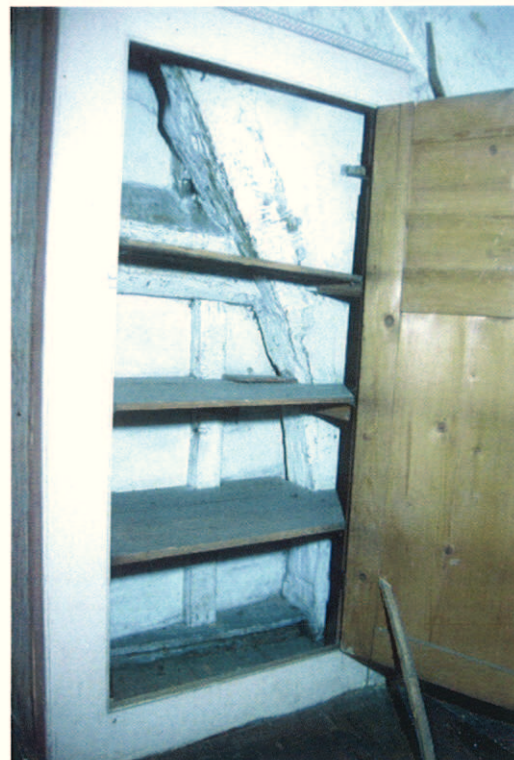
Plate 24: Part of cruck frame visible in first floor cupboard (F2)
