# The Tiltyard Tower Hampton Court Palace

## Historic Building Recording

February 2006

**Client: Historic Royal Palaces**

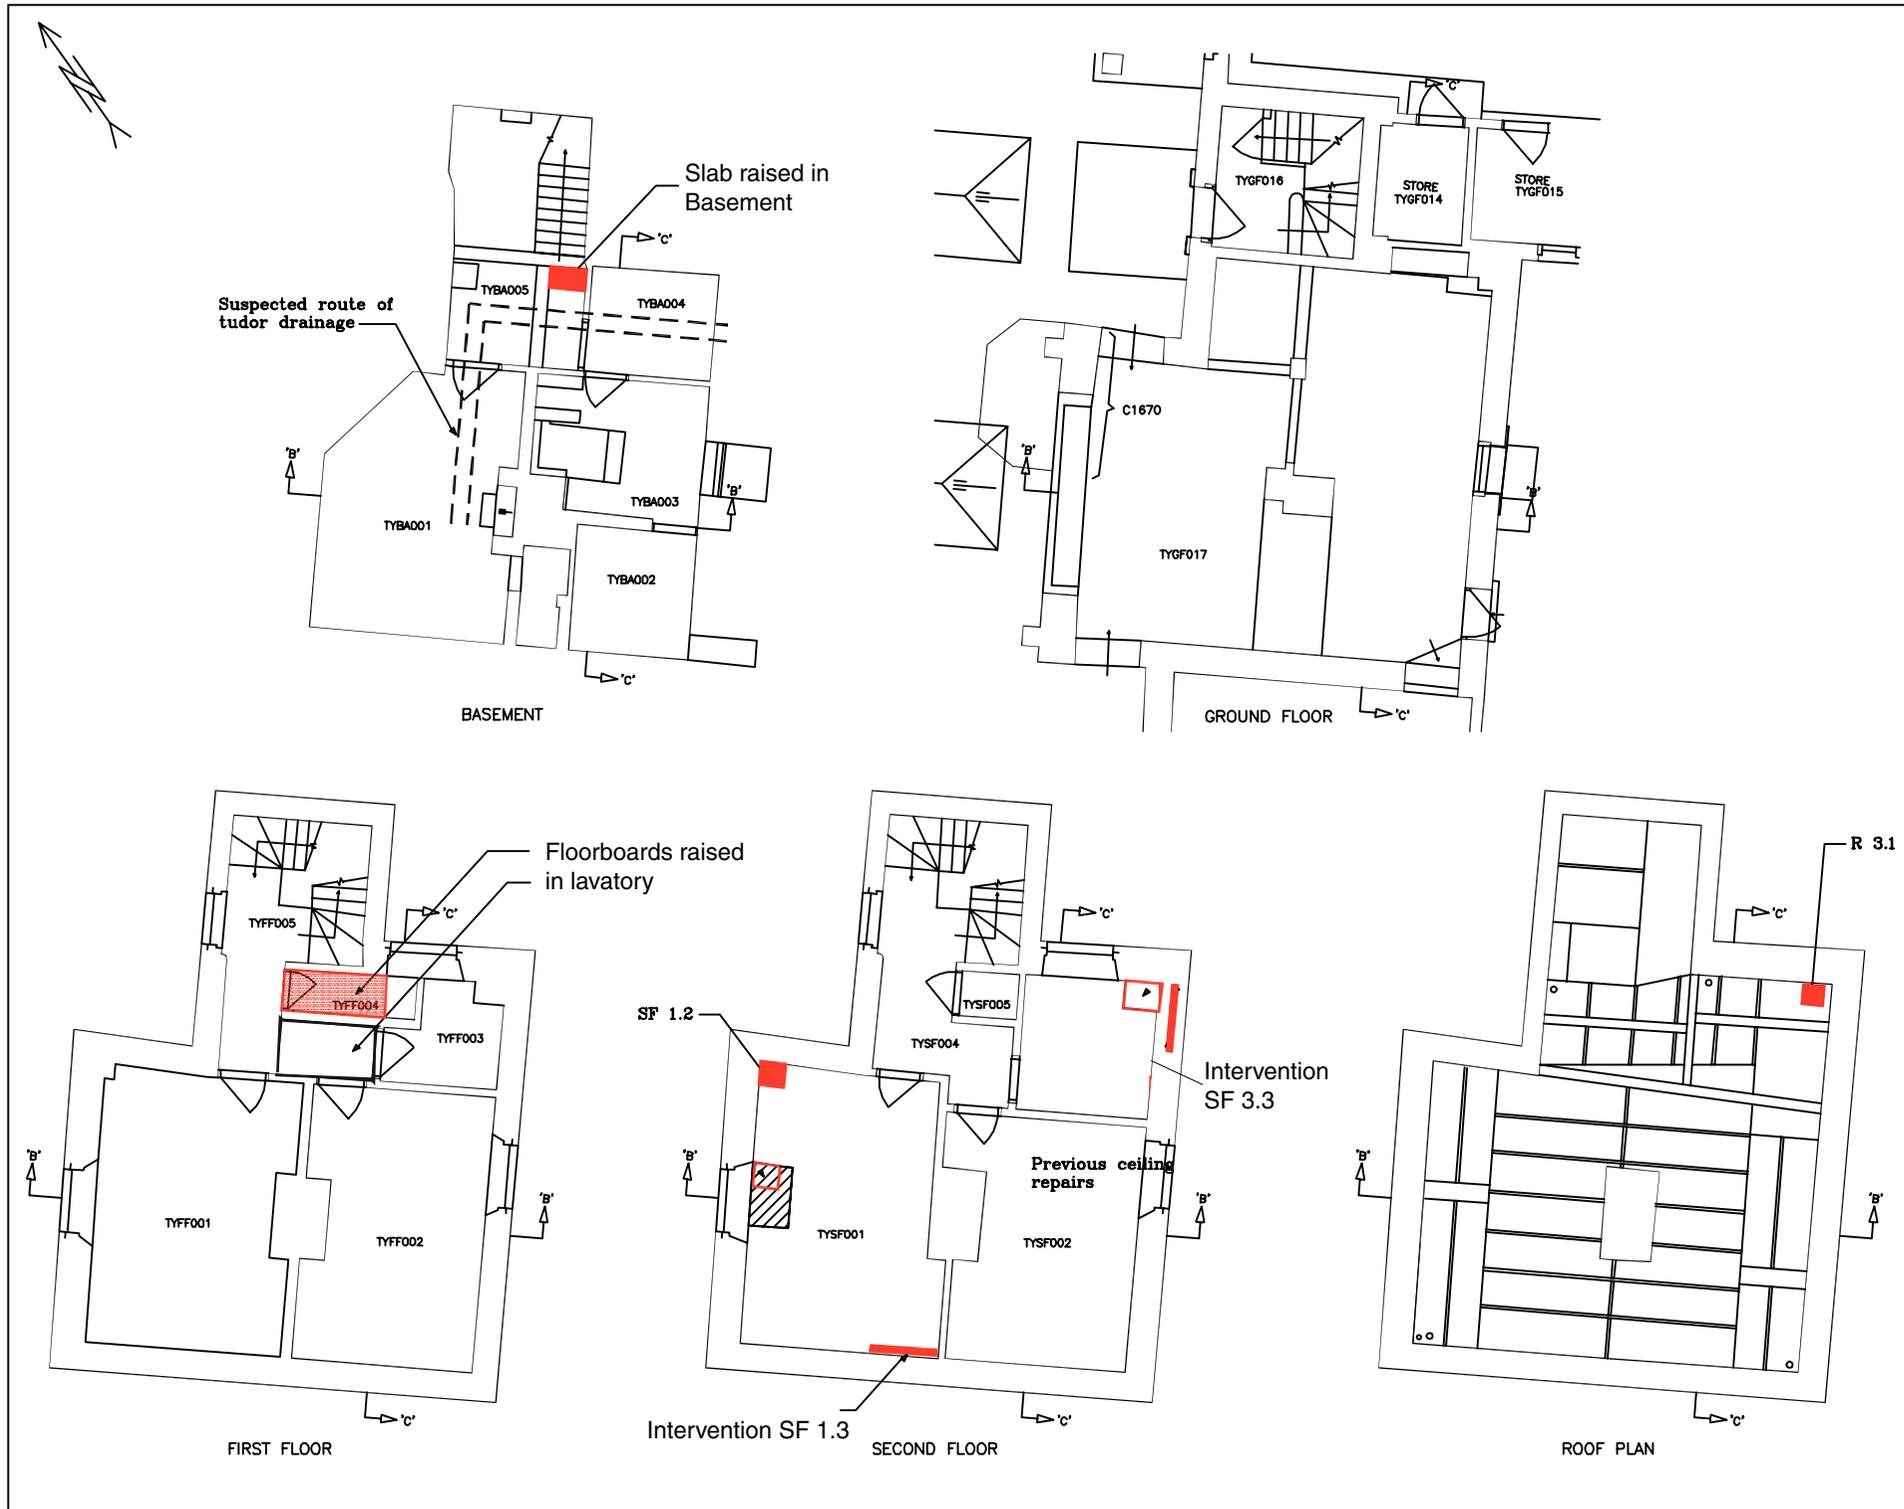
Figure 2: The Tiltyard Tower floor plans

- 3.1.3 As part of the investigations a single paving slab was removed and the void beneath it inspected before the slab was replaced. The slab was sited at the base of the modern stairs on the junction of the stone flooring and the brick flooring (see Figure 2). This flag was lifted to assess the nature of the void which was known to lie beneath it.

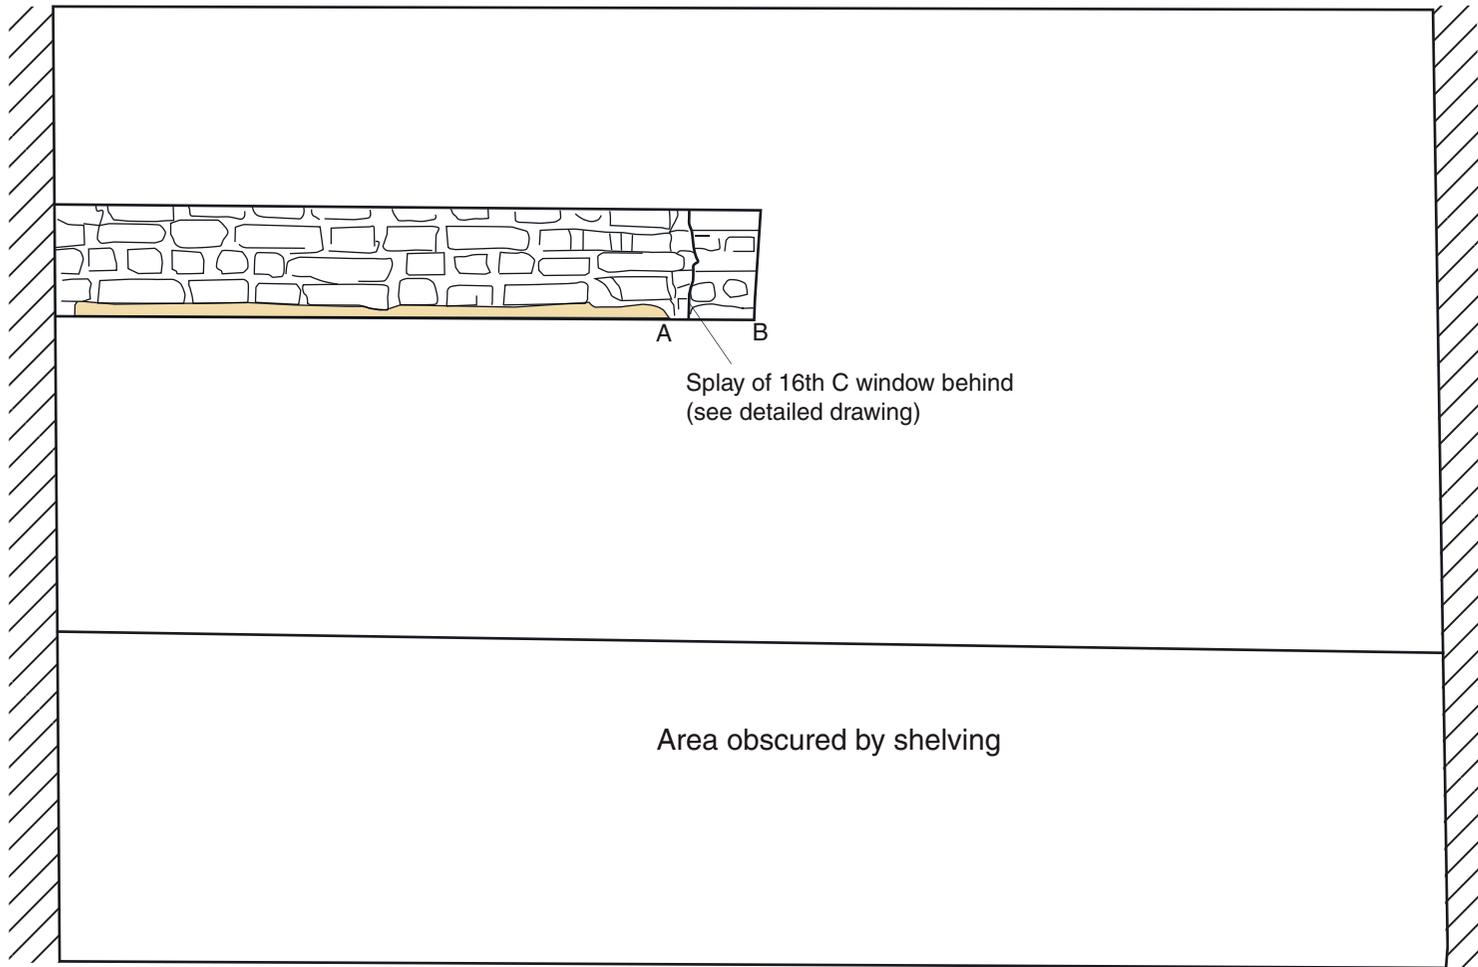
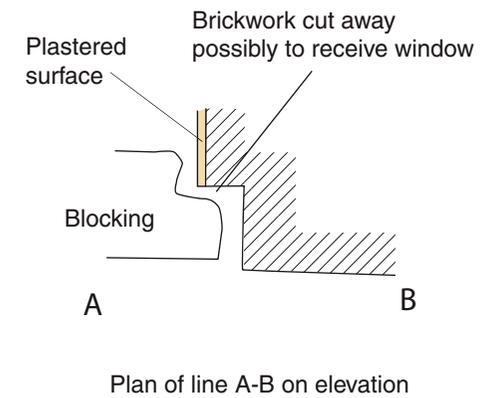
Figure 3: Hampton Court Palace, Tiltyard Tower, Room SF001, Interventions December 2005

3.1.21 As part of the investigations a strip of plaster was removed from the south wall of the locker room (TYSF001). This investigation was designed to pick-up on areas of differing brickwork visually identified by HCP (Foyle 2001). This brickwork had been identified as including primary 1530s work, 17th century blocking and 18th century alterations.

- 3.1.22 Across the whole of the investigated area there were three layers of plaster (all from one phase). This consisted of a scratch coat, base coat and top coat. Paint-work consisted of brown and then white emulsion, overlain by white paper.
- 3.1.23 Although the investigated area was targeted on the three phases of brickwork which are visible on the exterior, there were only two (rather uniform) phases on the interior. The reasons for this are obscure at the time of writing. It is possible that later (now blocked) sash windows on the outside of the wall may have had large external frames and yet small internal ones.
- 3.1.24 The splay of the Tudor window was located and it was noted that it retains its plaster on the jamb. As with the window reveal in the store room the edge had been cut away (perhaps to allow blocking).

Splay of 16th C window behind  
(see detailed drawing)

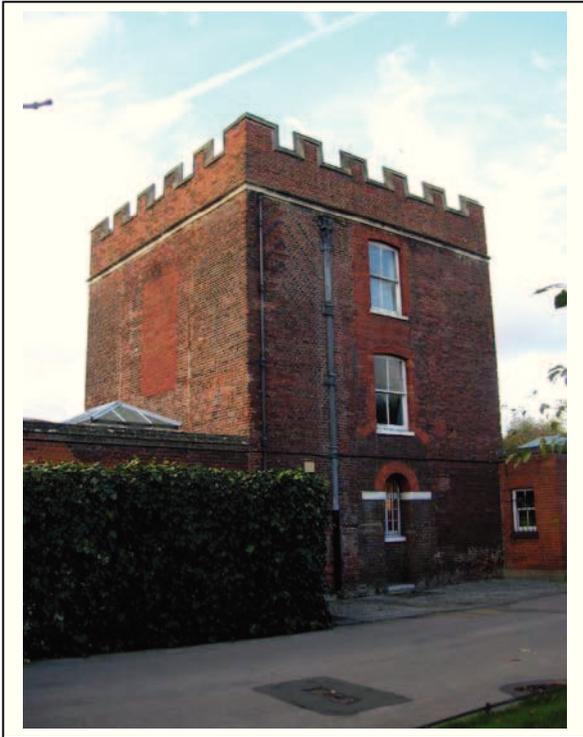
Plate 1: The South and east elevations, December 2005

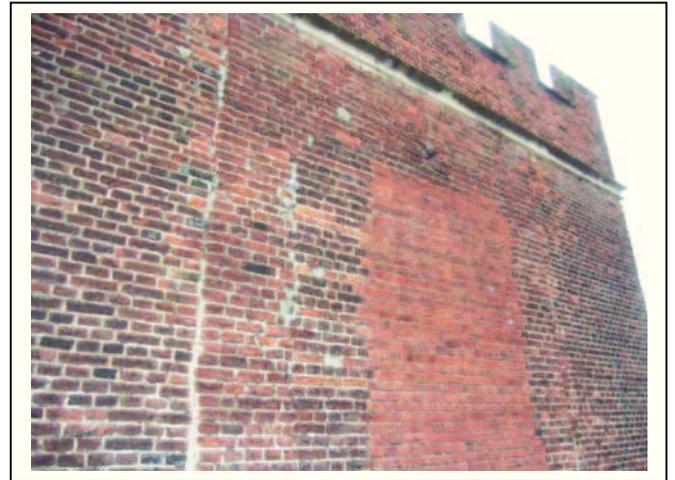
Plate 2: Blocked features on the south wall investigation focused on the area above the large blocked window.

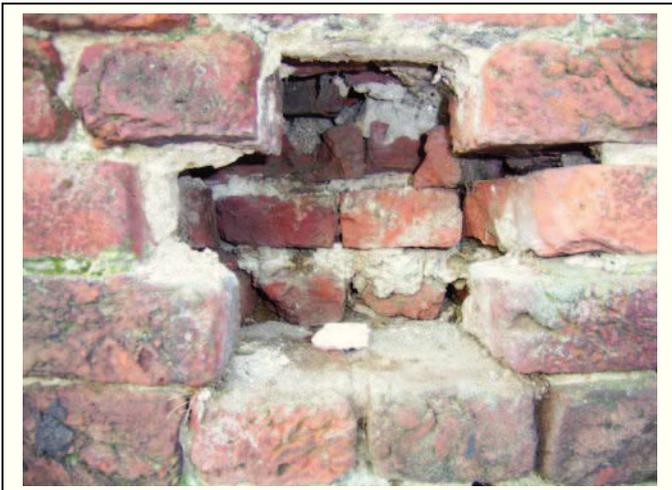
Plate 3 External intervention showing core of south wall.

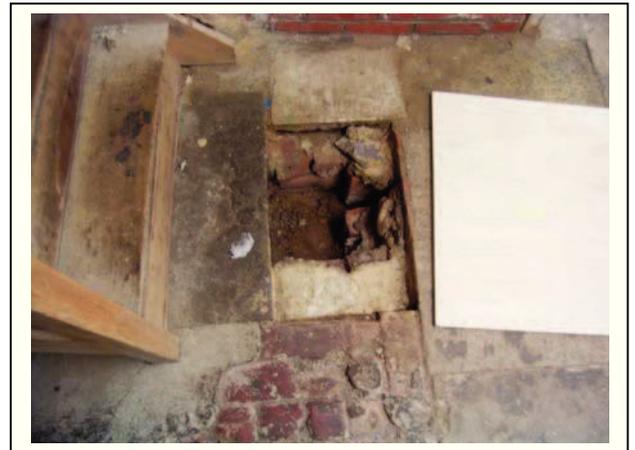
- 3.1.4 Raising of the slab revealed a narrow drain lined with brick and filled with silt. The underside of the slab was levelled with roof tile and slate. It was noted that the drain narrowed considerably on both sides and appeared to be more of a soak-away rather than a main drain. The bricks used in the culvert were of a 16th or 17th century type and were similar to the earliest fabric of the tower's main walls. The drain was almost entirely filled with silt and only a small part of the upper surface was visible. It was outside of the scope to excavate the fill of the drain and therefore recording was limited to photography.

Plate 4: Raised slab in basement showing drain beneath.
