# Privy Kitchen Court Hampton Court Palace

## Archaeological Excavation and Client Watching Brief Report

July 2008

**Client: Historic Royal Palaces**

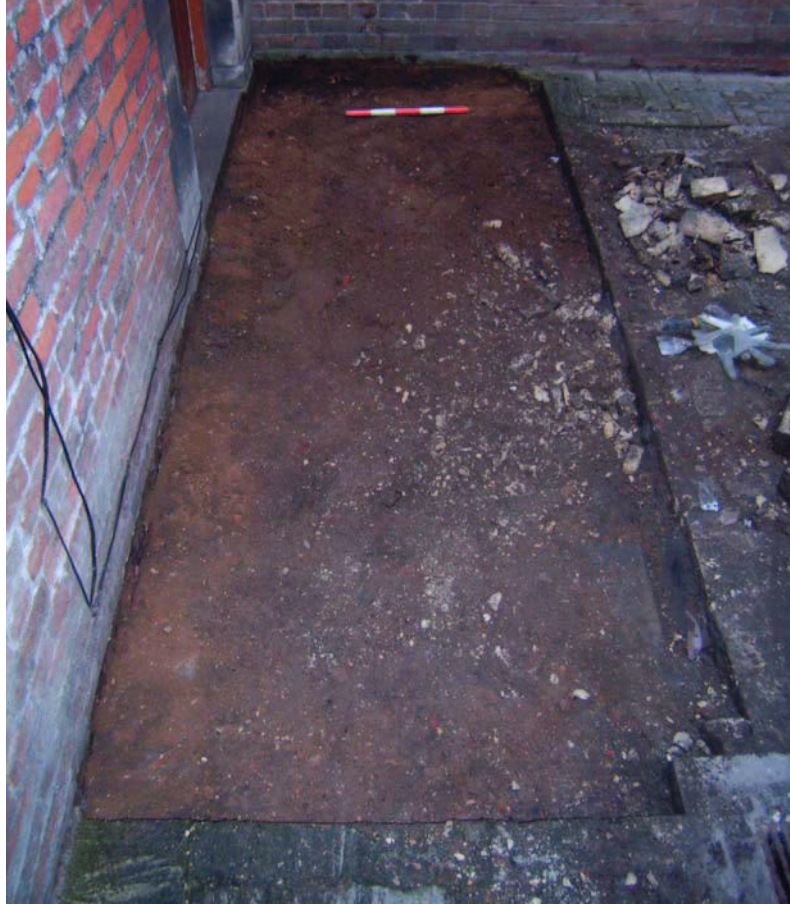
Plate 1: Removal of the pavements

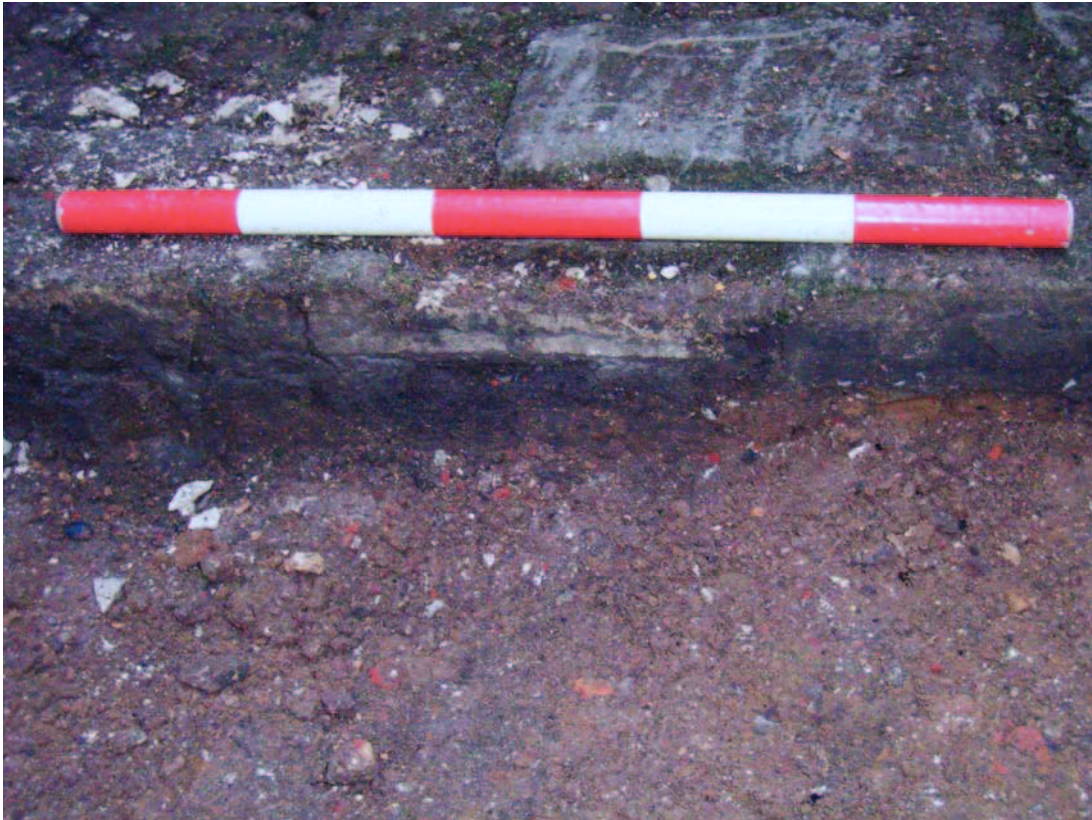
Plate 2: Section of surface during removal of pavements

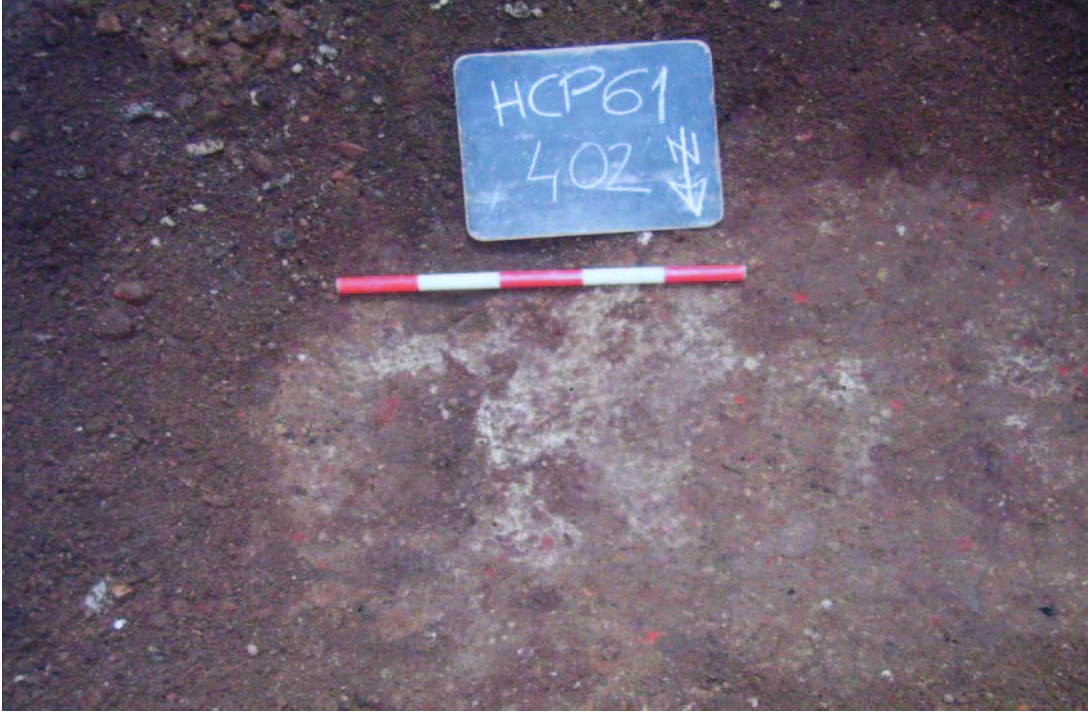
1.1.28 Underneath this context, an irregular portion of an earlier layer was found in the north end of the courtyard (402). It consisted on a very thin deposit approximately 0.02m thick which appeared to have been more extensive but had not been fully preserved. The very low consistency meant that it mixed easily with the context below (403) making it difficult to determine a precise boundary. The layer was composed of a sandy mortar of light colour mixed with very small fragments of ceramic building material.

Plate 3: Context 402 - bedding mortar

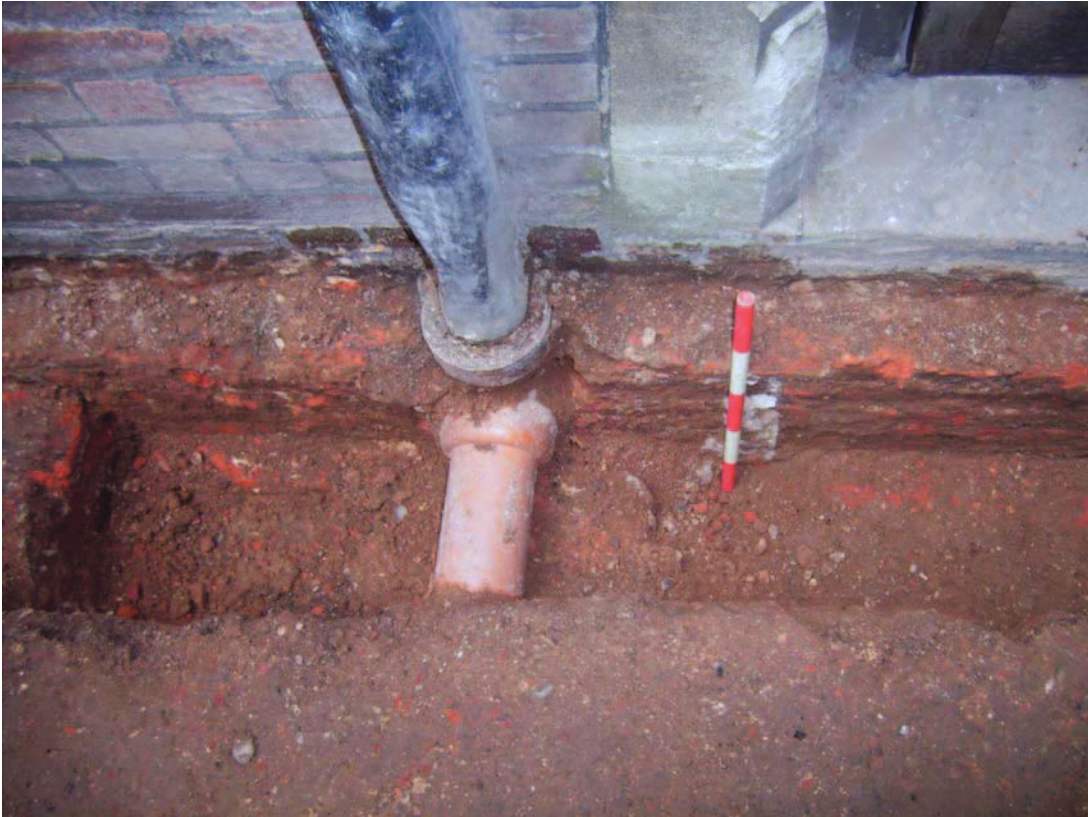
Plate 4: East - brick footing and ceramic pipe

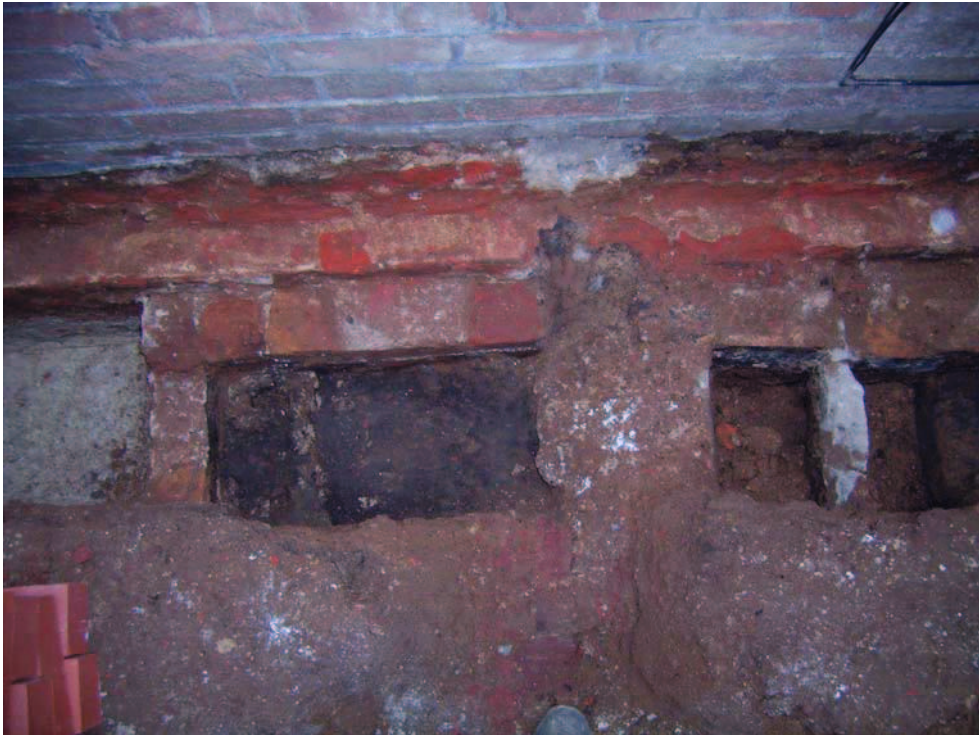
- 1.1.40 The structures (411) and (404) do not have any physical relationship although they seem to have a related functionality. The outer line of (411) is clearly aligned with the outer line of the cavity of (404) and they look like they were part of some system of sinks or deposits for water. However, the few remains unveiled by the works do not give enough information to make a more reliable interpretation.

Plate 5: West - contexts 404, 403 and 411

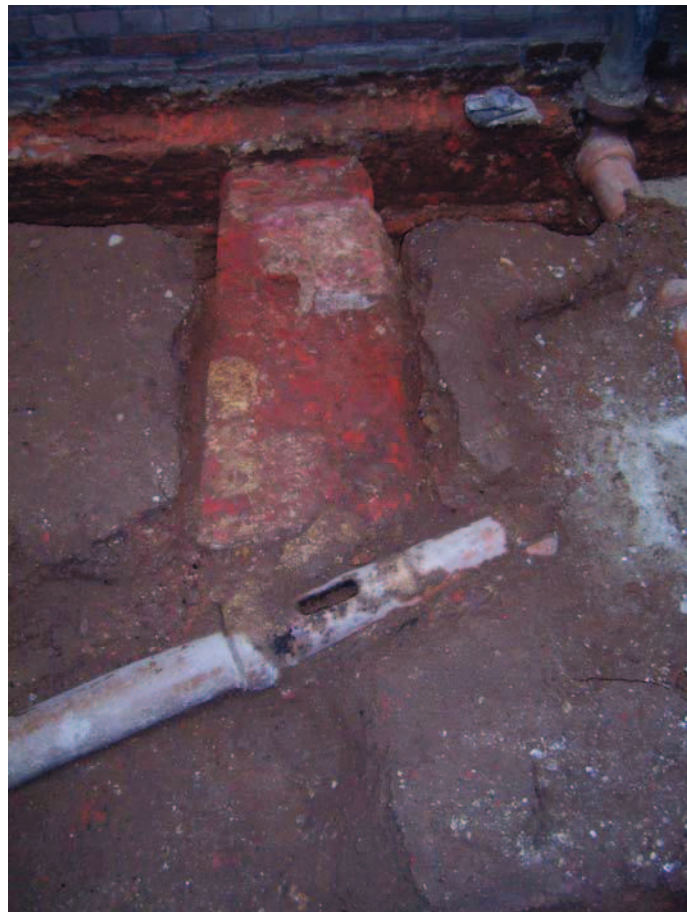
- 1.1.34 Abutting the east wall there was another wall (410) made of red bricks (0.19 x 0.05 x 0.1m) with thin joints filled by a hard yellowish white mortar. The full extent of this feature was not revealed during the course of the works. It appeared to be a solid wall about 1.2m long, 0.3m tall and 0.4m wide. It looked like it had been cut and may have been longer towards the west.

- 1.1.42 The walling (410) would appear to be part of the Late 17<sup>th</sup> early 18<sup>th</sup> century walling

Plate 6: East - brick wall (context 410)

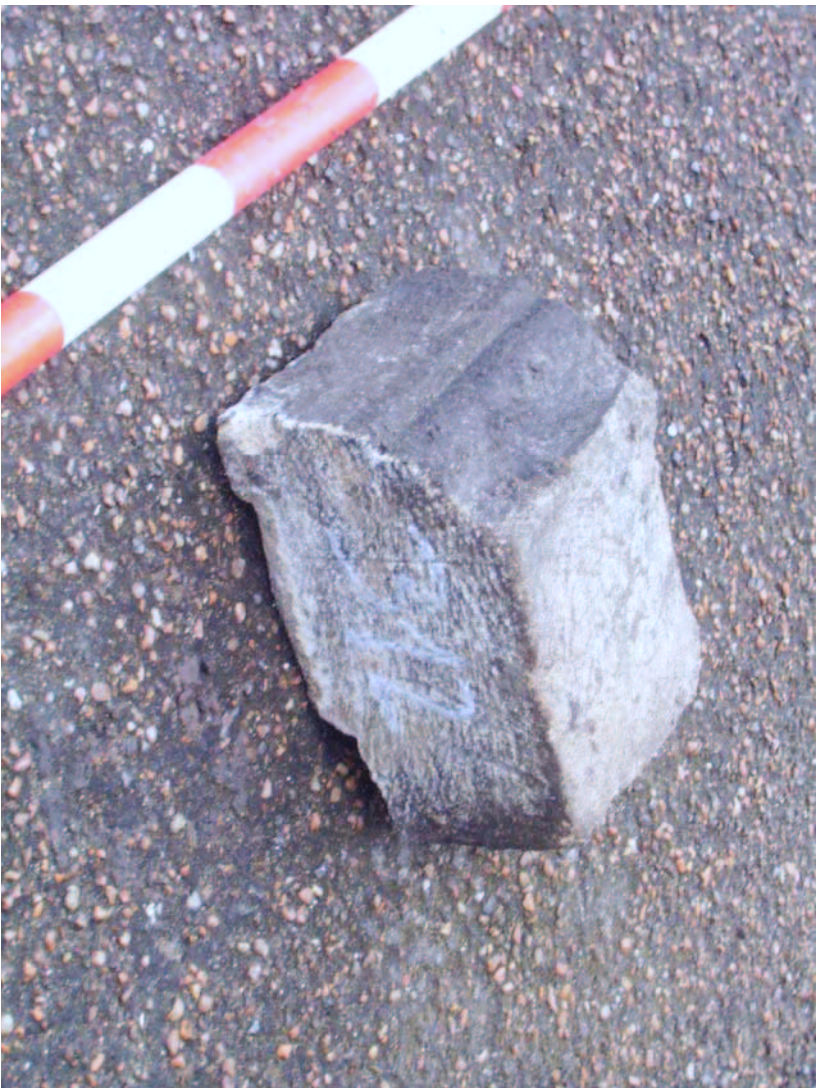
Plate 17: Pavioir 312

- 1.1.43 Some pieces of removed stone (nos. 312 and 324) are possibly reused sections of older stonework which show signs of weathering, whilst the majority of paviments represent off-cuts and/or surplus material from a programme of refenestration undertaken in the 1850s (Colvin 1973, 331). The taking of the moulding profiles of these pieces will enable further studies to be made.
