**ST MARY'S CHURCH, TURWESTON,  
BUCKINGHAMSHIRE  
ARCHAEOLOGICAL WATCHING BRIEF**

**Oxford Archaeological Unit**

**16 September 1994**

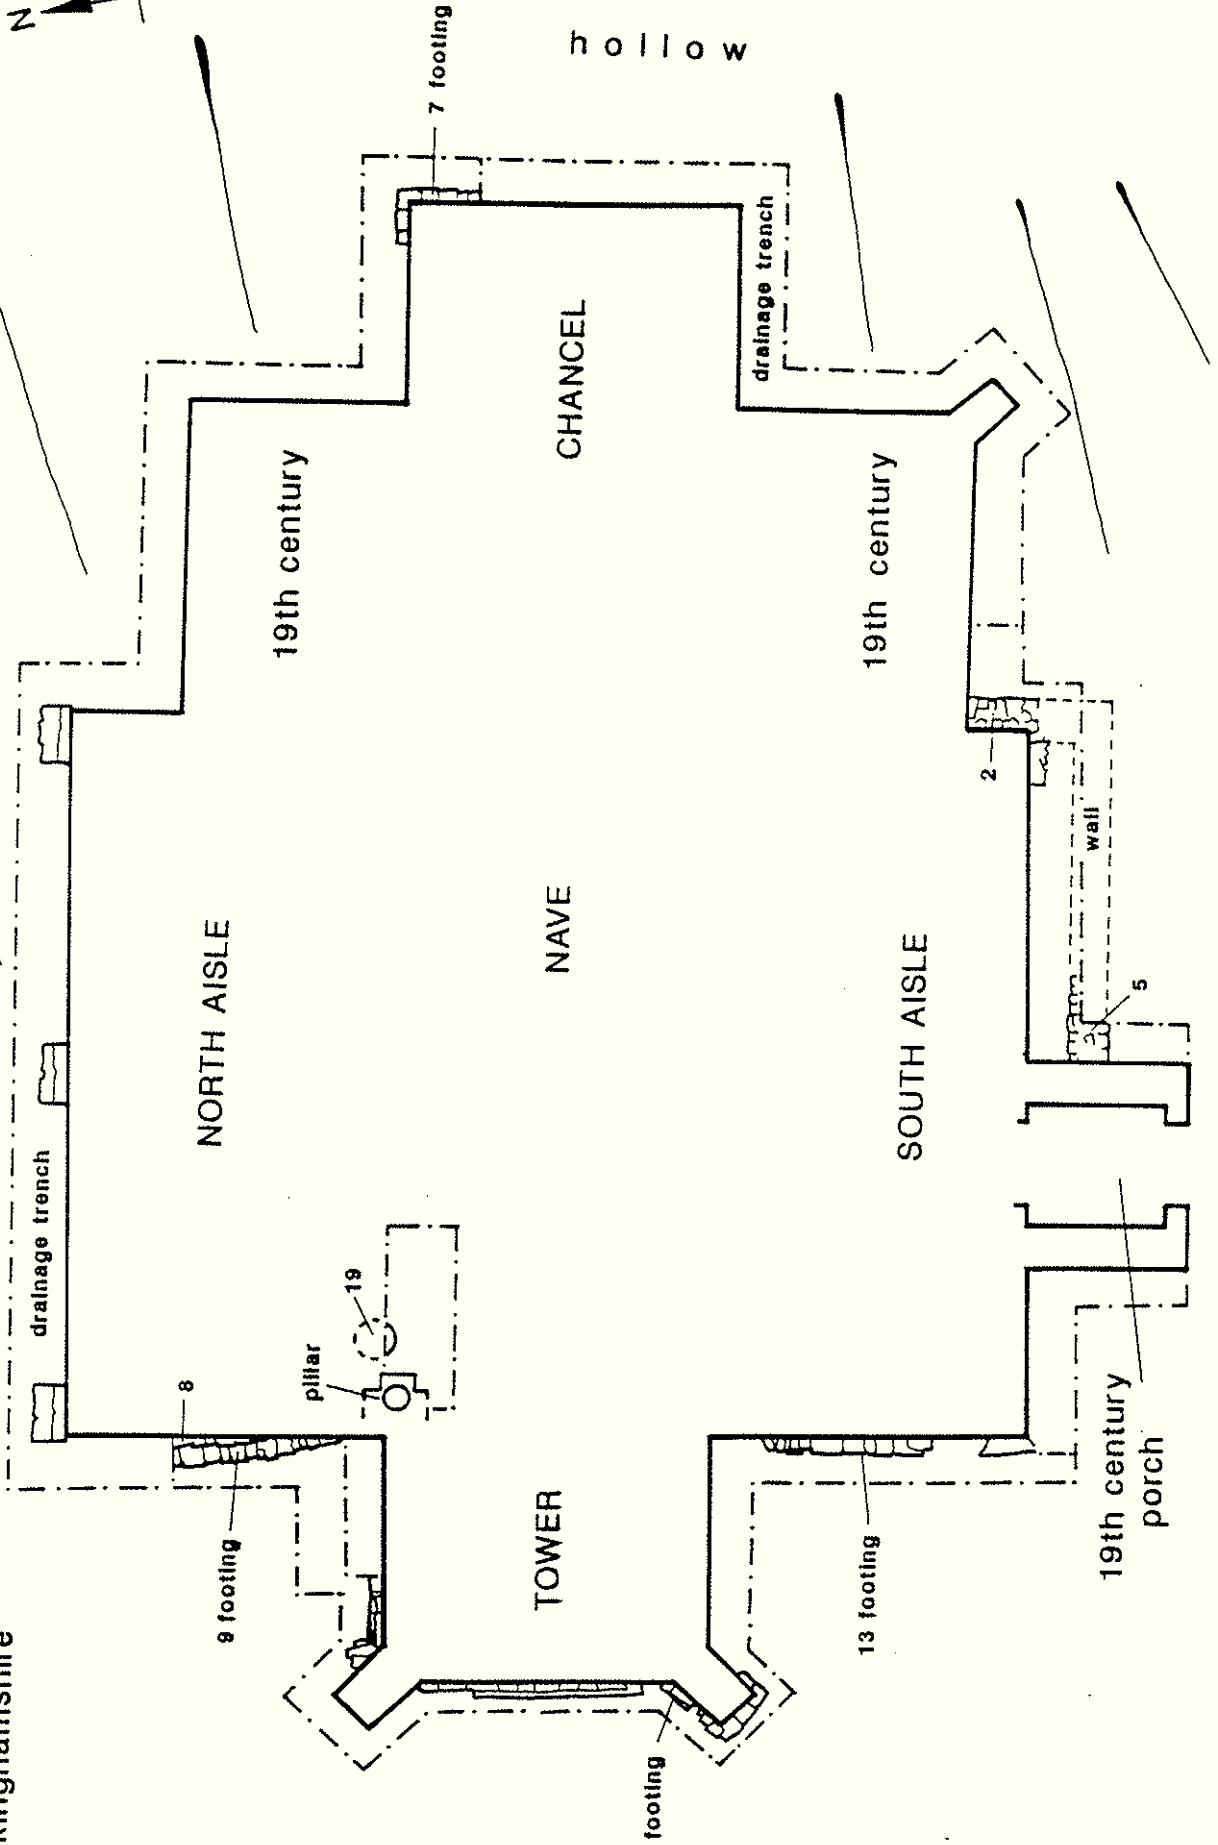
St Mary's Church, Turweston,  
Buckinghamshire

The 0.6 m wide wall (2 and 5) was constructed of unfinished rough coursed masonry held together by a matrix of yellowish brown mortar. It was seen in two places, to the E of the porch and to the S of the E end of the S aisle (Fig.). There were no floor surfaces associated with this wall.

The S aisle has been totally rebuilt by Street on a slightly smaller plan. The wall (2 and 5) to the S of the church suggest that the medieval aisle was wider. The fabric of the wall, seen while plaster was being replaced, was partly brick to a low level, also suggesting a 19th-century date for this construction.
