# Privy Garden Collapse

Hampton Court Palace

## Archaeological Evaluation Report

June 2010

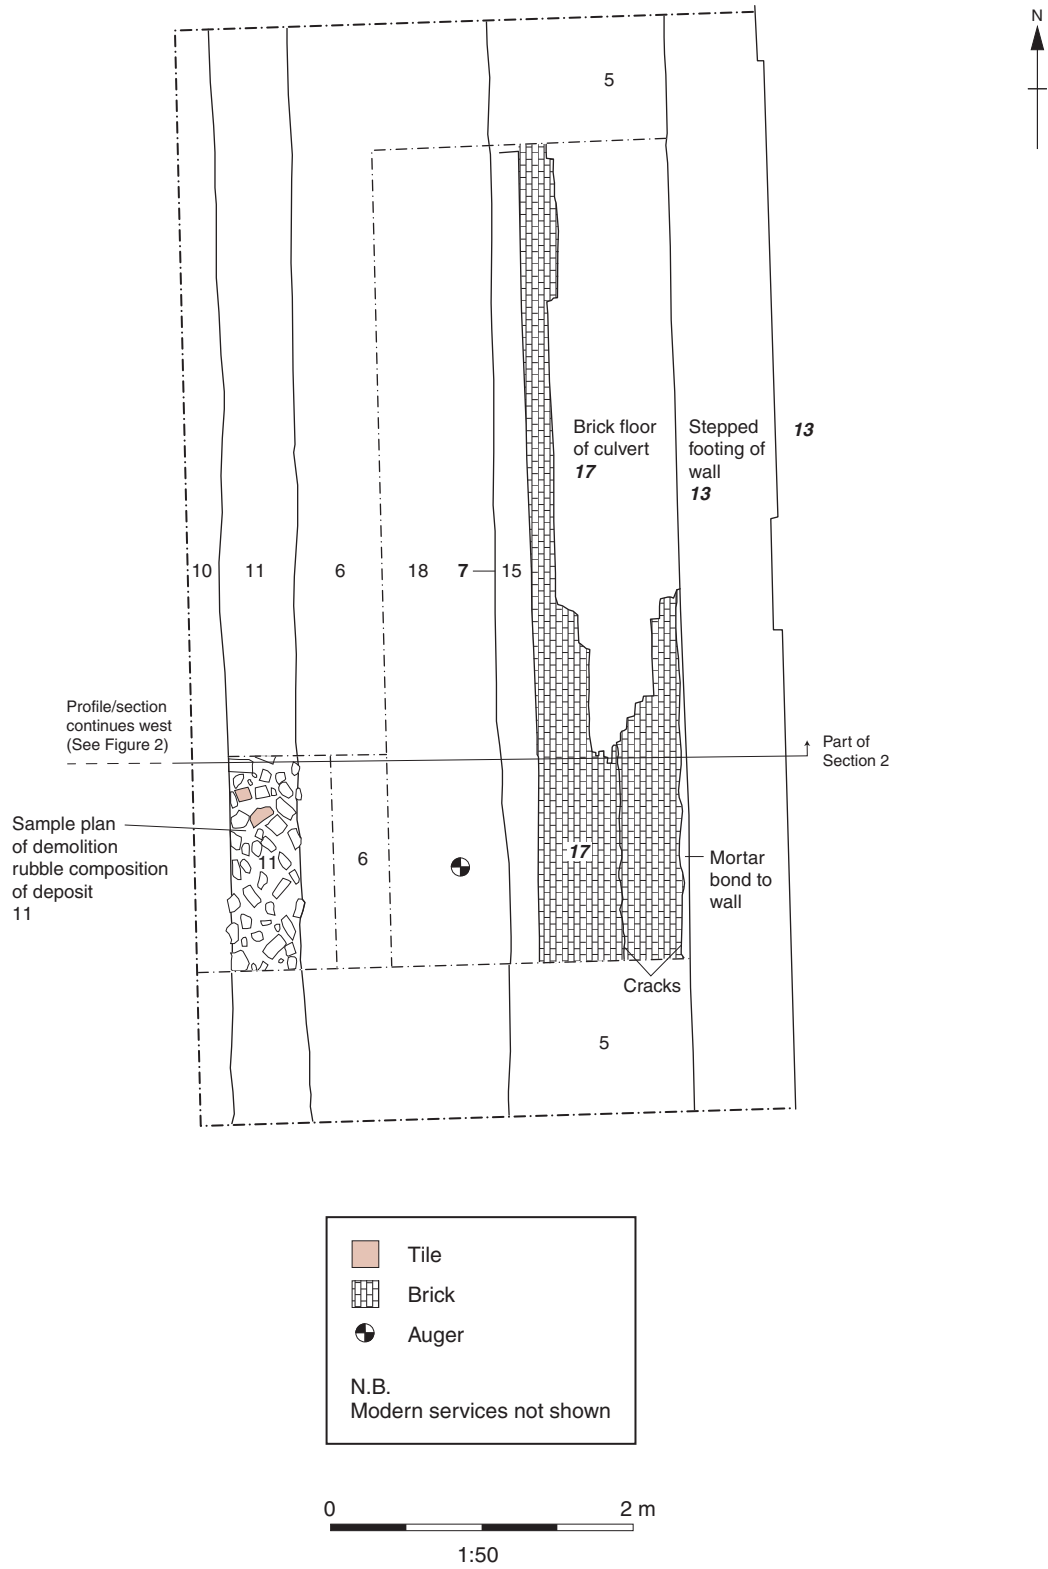
Figure 3: Trench plan

- 3.3.3 These deposits were truncated by the construction cut (7) for the brick culvert (17). The cut was backfilled by a series of deposits, predominantly originating from the re-deposition of the material through which the construction trench cut. The culvert itself was constructed in a stretcher bond with a double skin of brick and a brick base. The bricks are tentatively identified as Type G in the Hampton Court Typology (Ford 1991),

dating to the late 17th or early 18th century, see Appendix 3, Table 3. To the north of the trench, the culvert had been rebuilt using modern brick ("MARSTON BESERES 32"), with a *in-situ* formwork comprising a corrugated tin lining. The inner skin of the collapsed part of the culvert appeared to be overlain by a very fine sandy silt deposit, which was in turn overlain by the collapse of the outer skin. This would suggest that the inner skin of the culvert had collapsed prior to the recent failure.

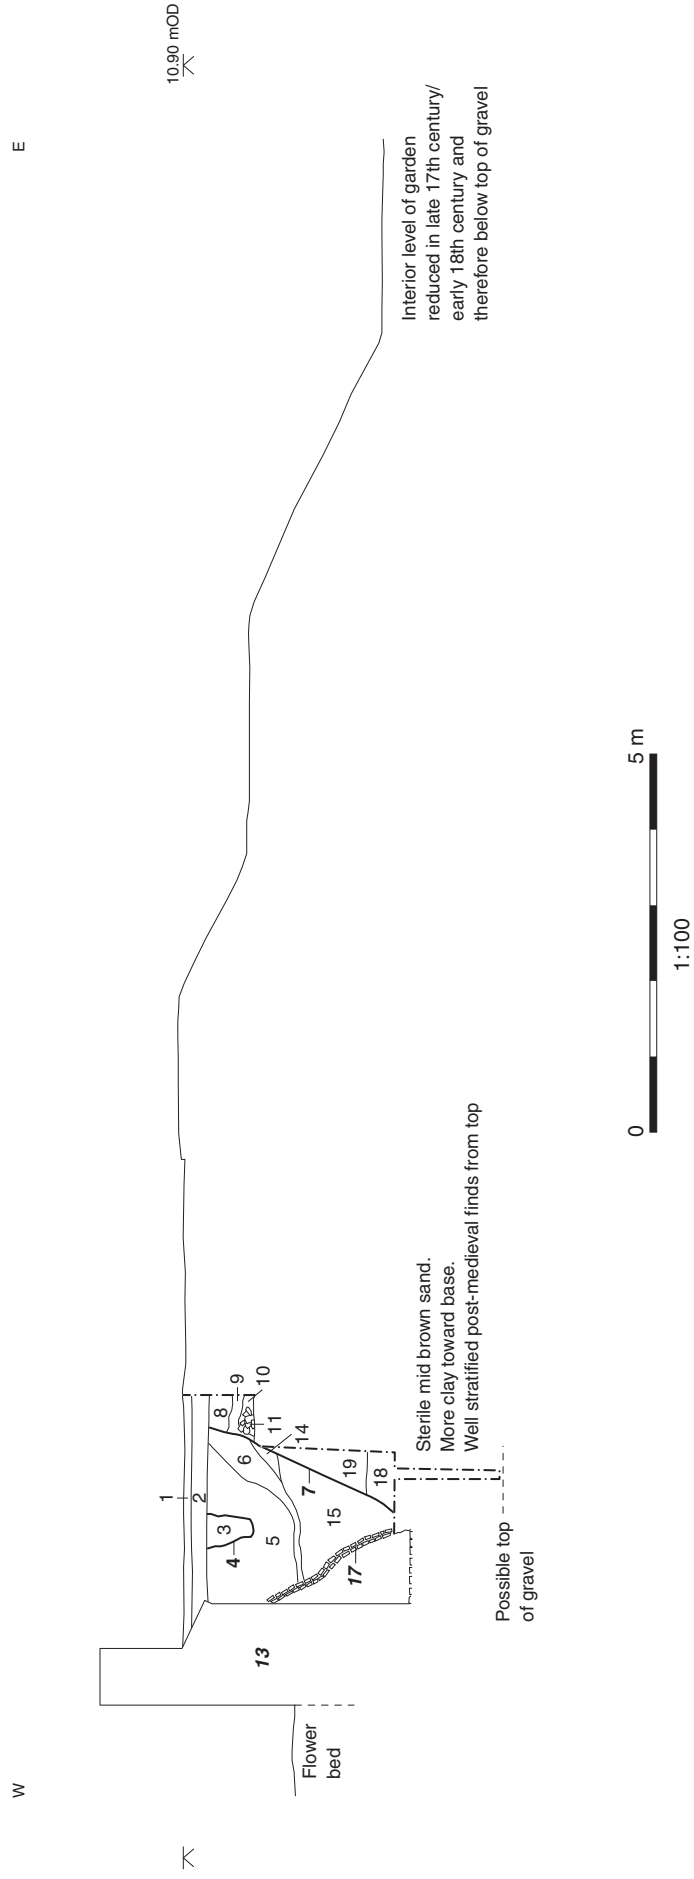
Figure 4: Section 2: Profile showing topography of garden and stratigraphy in trench

- 3.3.2 The earliest deposit, encountered at approximately 8.50m OD, comprised a friable reddish brown sand with little or no variation in composition (18), but with clay pipe throughout. The sterility of this deposit compared with the overlying rubble rich layers (see below), suggested that it may represent a buried soil horizon pre-dating the creation of the existing terrace. This horizon was overlain by a series of deposits (19, 12, 11, 10, 9 and 8) which contained re-deposited 16th century building materials (Sections 3.4.6-10; Appendix C, Table 3), together with 17th century clay pipe and other later artefactual material. It seems likely that these deposits are associated with the landscaping undertaken in the later part of the 17th century or very early 18th century, and that the building material originated from the demolition of elements of the Tudor palace. It is possible that deposit(s) 11/12 - which were comprised almost exclusively of brick/tile and mortar - represent a rudimentary revetment along the eastern face of the mound.

- 3.3.4 At the southern end of the raised walkway, the boundary wall has two offsets on its west side. Within the trench, only the uppermost of these offsets was present, and stepped out approximately 0.6 m at 1.1 m from the top of the wall. The top of the brick culvert corresponded to the top of the lower offset observed to the south of the walkway.
