# The South Terrace Cliveden Taplow Buckinghamshire

## Archaeological Watching Brief

8th November 2002

**Document Type:** Watching Brief

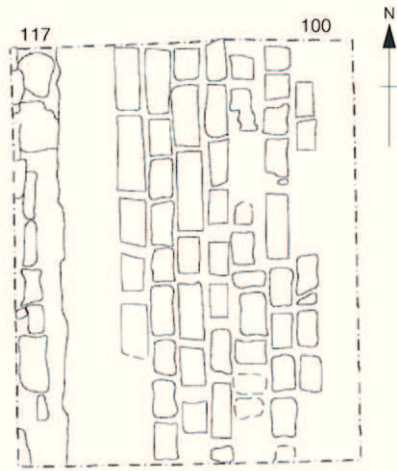
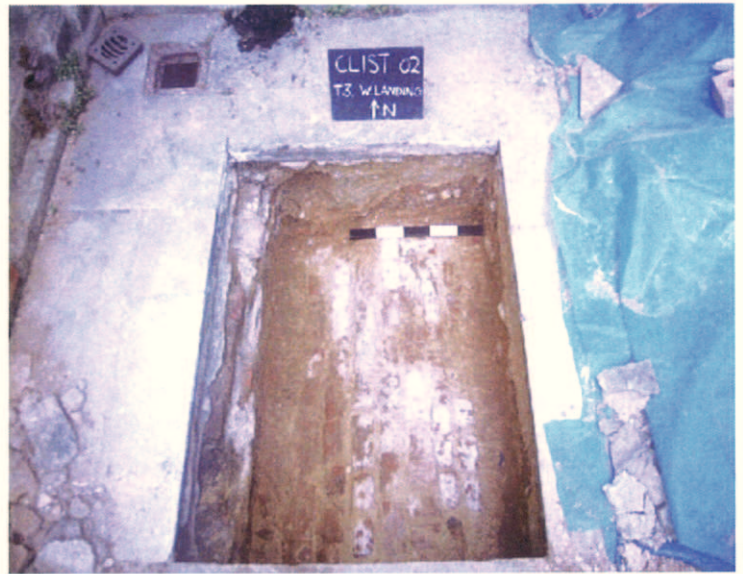
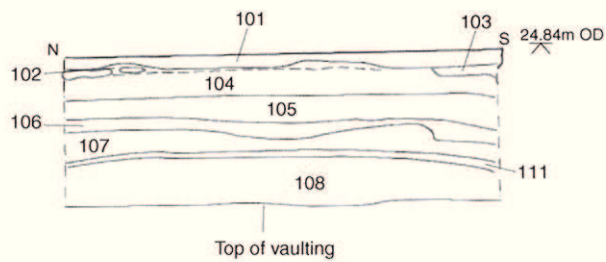
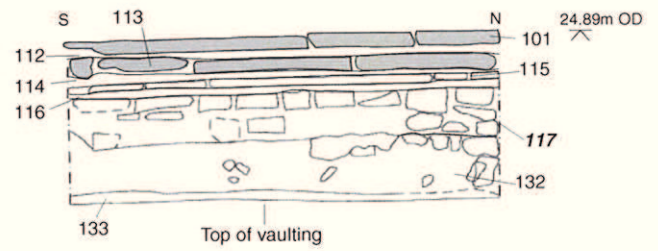
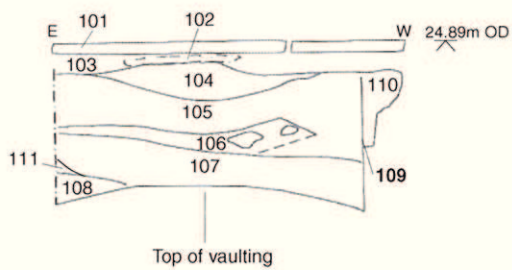
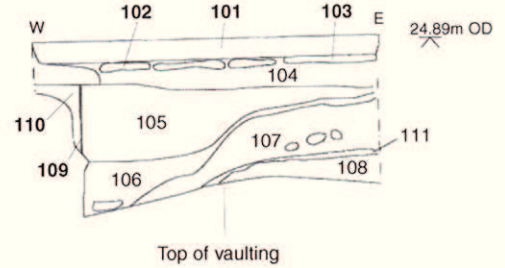
Figure 4: Area 3, west staircase landing

- 3.1.1 On the western staircase landing an area of paving measuring c 1m x 1m was removed and a trench excavated to reveal the top of the vault. The vault (100) was encountered 0.40 m below ground level (bgl) and was overlain by layers of rubble make-up (108 and 111). A layer of silt (107) overlay 111 and was overlain by a rubble layer (106), which was below a deposit of sand and clay (105). A construction cut (109) truncated these layers, which was filled by a rubble foundation (132) below a brick wall (117). The cut was backfilled with 110, a rubbly sand. Over the wall was a levelling layer (116) below a dump of tile (115). This comprised a layer of tiles laid flat. The tiles varied in length from 0.16 m to 0.58 m and were uniformly 0.02 m thick. The tiles had rough edges and were worn, so are presumably reused as bedding material for the terrace. The tile layer was overlain by a further silty make-up deposit (114). A redundant layer of stone floor slabs (113) overlay 114. These measured 0.4 m in length and were 0.03 m thick with no noticeable bonding material. The layer was only noted in section and did not appear to extend of a wider area. It may represent a further levelling/make-up layer rather than an *in situ* floor. A layer of sand (104) sealed the floor/make-up layer 113, and was overlain by a silty layer (103 and 112). Above this was a mortar layer (102) below the present stone surface (101).

- 4.1.1 The trench revealed the top of the vault structure 0.40 m bgl, which was seen to be in a good condition. The vault was sealed by make-up for the landing, which was truncated by a cut for a small wall (117). This would appear to be part of a brick drain to aid run off from the stairway, probably dating from the 1850 rebuild of the mansion. A sealed stone surface (113) is probably an indication of the terrace surface prior to the 1912 resurfacing.

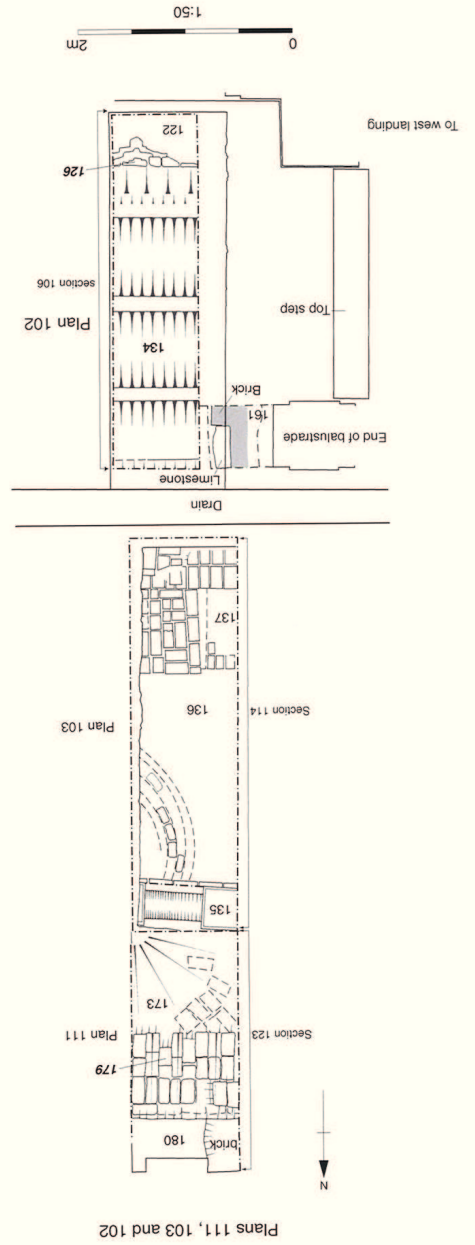
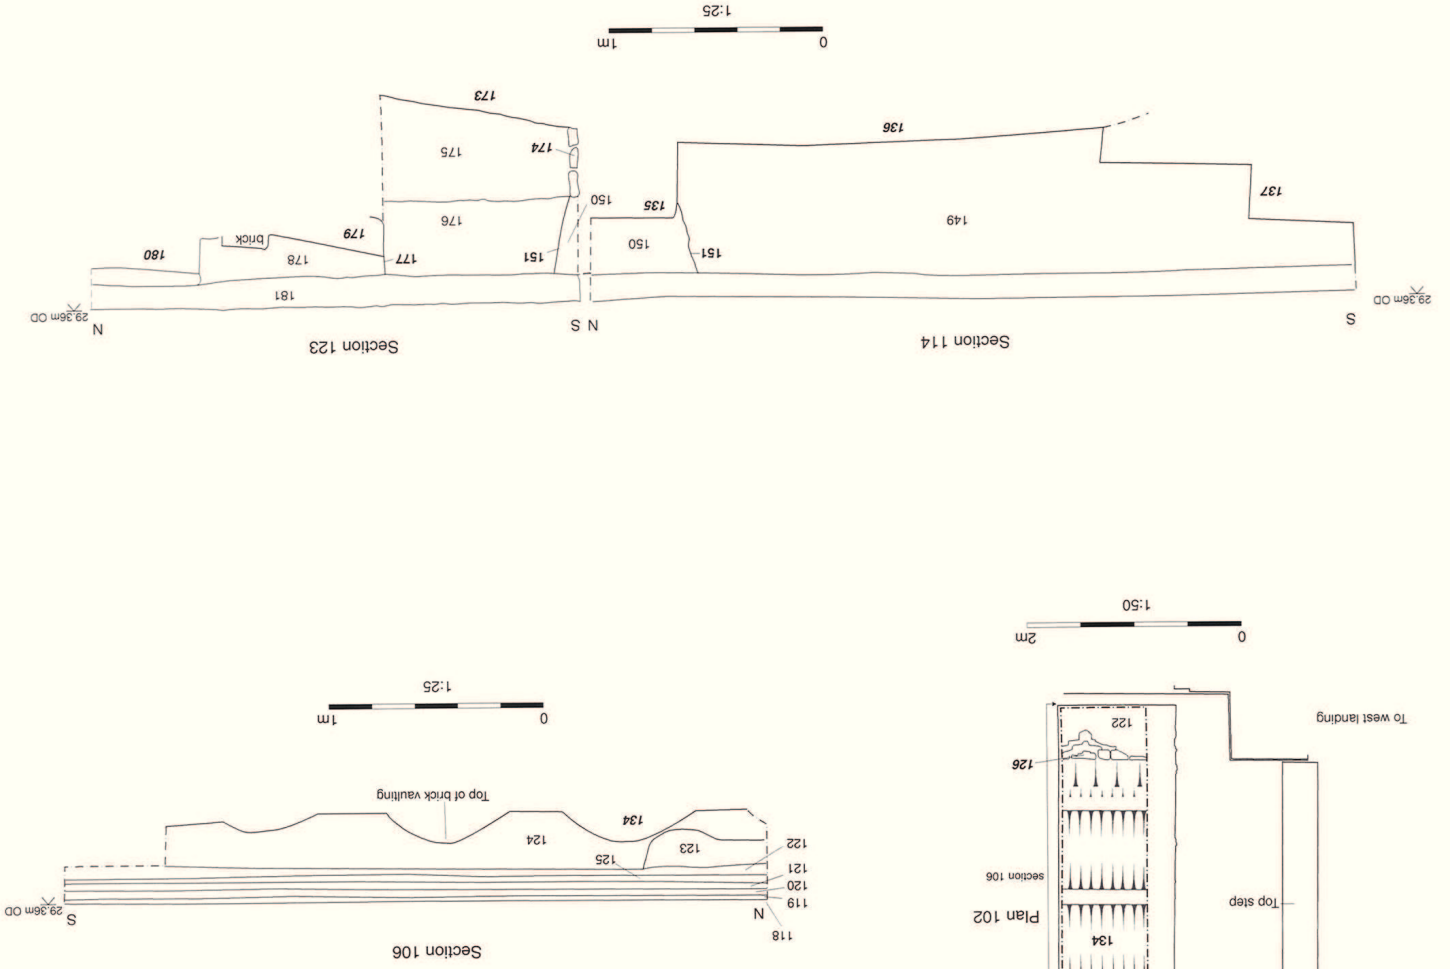
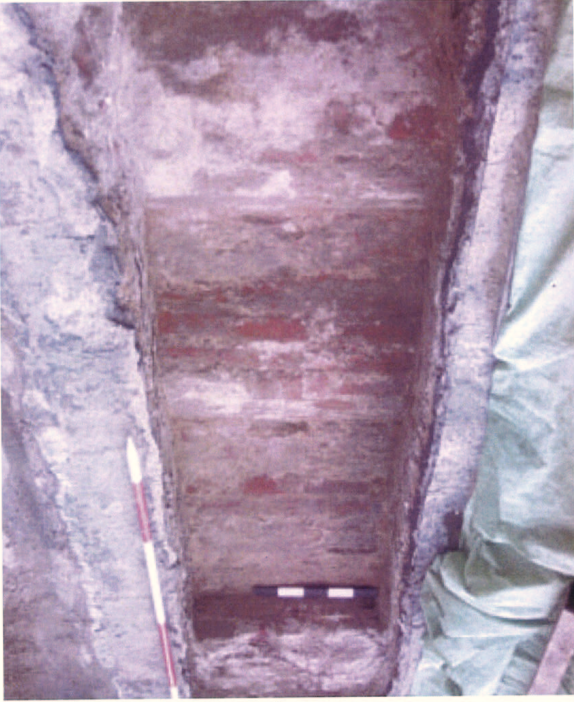
Figure 5: Trench 3

- 3.1.2 A trench was opened through the top of the terrace to investigate the roof of a vault. The trench was aligned north-south and measured 10 m by 1 m. The top of four east west aligned brick arches were seen 0.30 m bgl (134) in the south of the trench. In the north of the trench the vault sloped down to the north to a depth of 0.90 m bgl (136 and 173). Overlying the brickwork in the centre of the trench was a stepped brick structure (137), this was sealed by layers of puddled clay (175, 124, 149 and 176). The clay was overlain by a rubble layer (123), and truncated by construction cuts 177 and 151. Cut 151 was for a brick drain sealed by a stone cap (135) and backfilled with sandy gravel (150). Cut 177 was for an area of sloping bricks (179), perhaps forming a run off area, to the north of the trench and sealed with sand (178). A narrow limestone drain (161) was seen to run north-south along the edge of the trench. In the east section (Fig 5, Section 106) rubble layer 123 was overlain by a sequence of thin layers of make-up material comprising concrete 122, a layer of sandy gravel (125), in turn overlain by a layer of asphalt/bitumen (121). Above this was a thin layer of sand and gravel mixed with ?lime (120) further overlain by two

more bituminous layers (118 and 119). It was noted that these late deposits did not appear in section, where the upper part of the sequence here comprised a layer of concrete (181).

- 4.1.2 The top of the vaulted terrace was encountered between 0.30 and 0.90 m bgl, and was seen to be in a sound condition. Puddled clay had been deposited over the brickwork to act as a waterproof sealant. The clay had been disturbed in places where later drainage facilities had been added. The north of the trench contained a sloping area of brickwork (179), which would have acted as a run off channel for rain water, and the centre of the trench contained a sealed brick drain (135). The brick structure towards the south of the trench (137) did not appear to have a drainage function, but may have added structural support to the vaults. The masonry may have represented the top of the arched entrance into the sounding room below. These features may all date from the mid-19th century rebuilding of the mansion. The numerous layers of make-up for the stone terrace surface suggests that the stone paving may have been replaced periodically.

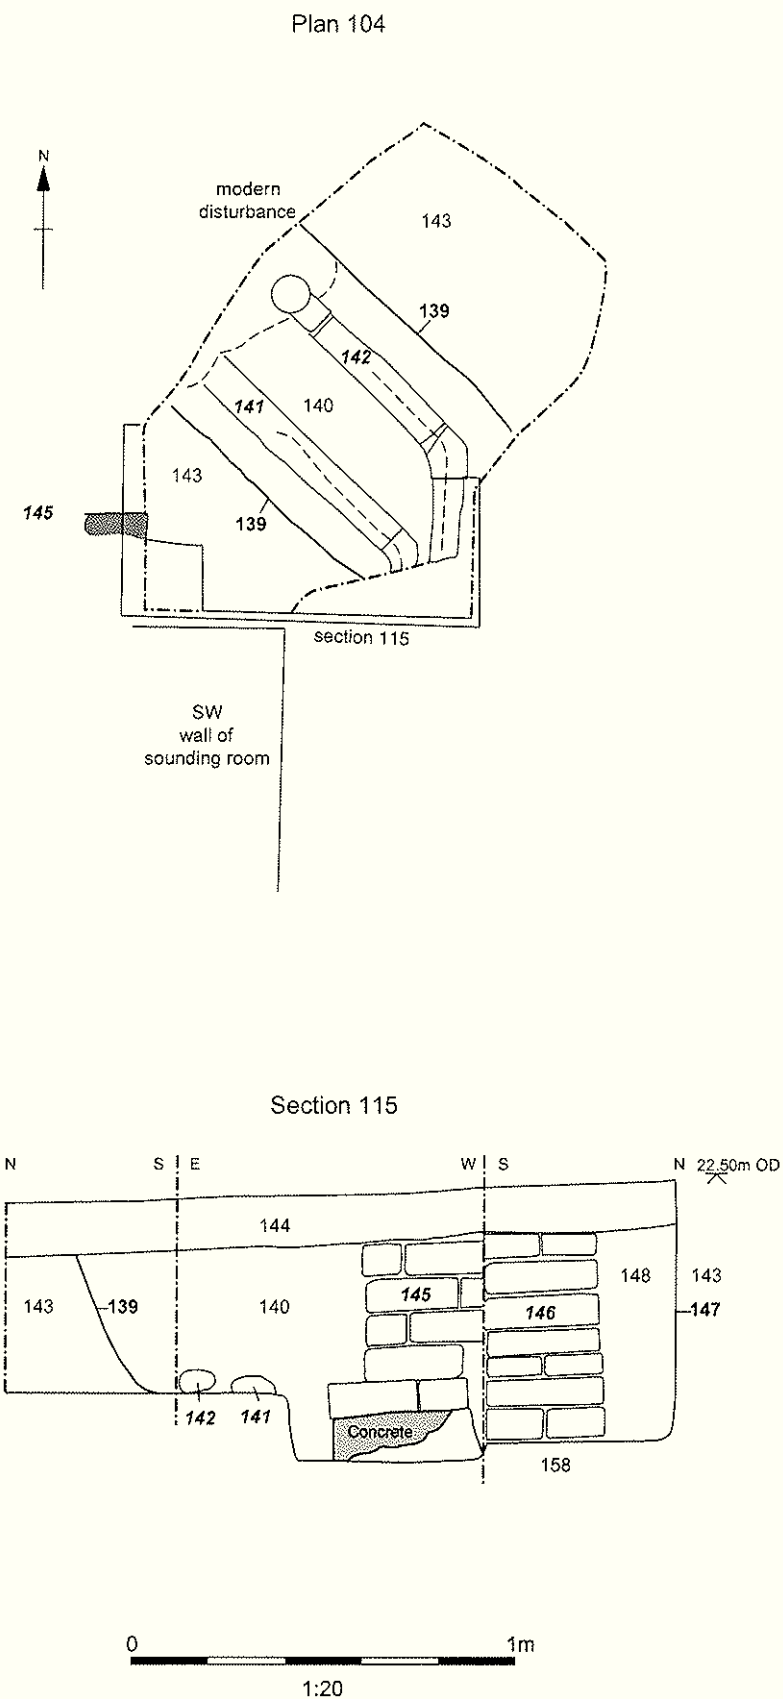
Figure 6: Sounding chamber

- 3.1.3 Broken paving was lifted and a trench measuring approximately 1 m x 1 m was excavated to a depth of 0.6 m bgl. A layer of natural orange sand (158) was sealed by a layer of silty sand make-up (143), which was truncated by a construction cut (147). Within the cut were the brick foundations 145, which had been superseded by the foundations 146 and backfilled with clayey sand (148). A service trench (139) truncated 148 and contained two water pipes (141 and 142) and a sandy silt backfill (140). A stone floor (144) sealed these deposits.

- 4.1.3 The trench in the sounding chamber revealed two water pipes, which would have supplied water to, and taken water from the fountain to the south. The foundations of the vault were seen to be sound and appeared to have been repaired in the 19th century, although it is not known whether Barry altered the internal chambers of the terrace this may be an indication of work he may have undertaken.

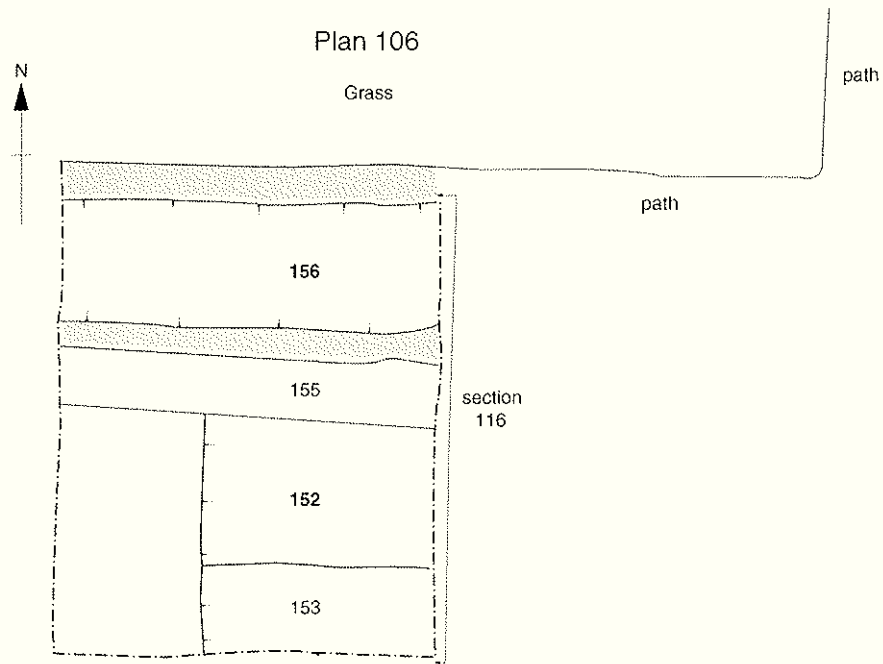
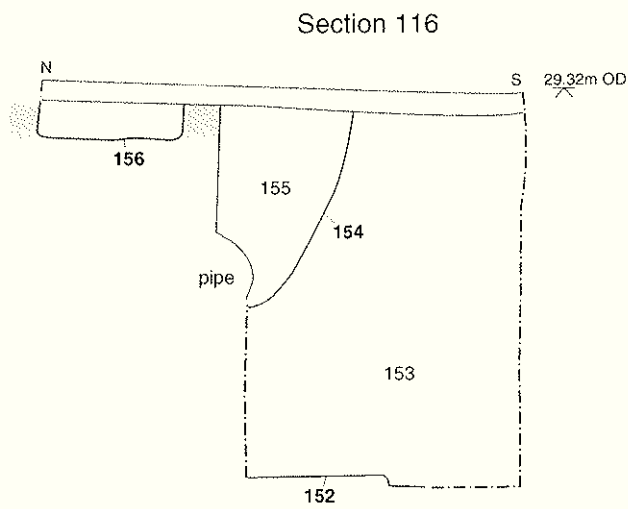
Figure 7: West of terrace

- 3.1.4 A trench measuring 1 m by 1.2 m was excavated toward the centre of the western half of the terrace. A stone covered drain (152) was seen 1.05 m bgl sealed by a clayey sand dump (153). A small brick drain (156) was seen to the north of the trench and, with 153, was truncated by a service trench (154) containing a pipe and a sandy loam backfill (155).

- 4.1.4 The easterly of the two trenches did not reveal the vault roof, but did reveal a stone covered drain (152) assumed to be the same as drain 135 in Trench 3. This was seen at 1.0 m bgl and demonstrated that the drain was dropping off to the west. A curb side drain (156) was also noted which was contemporary with the stone surface of the terrace (post 1912) and used to drain off rain water. The western trench revealed the vault to be 0.20 m bgl and in a good condition.

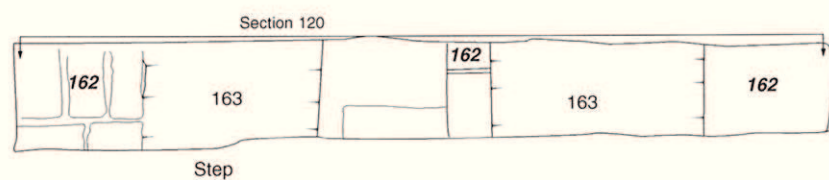
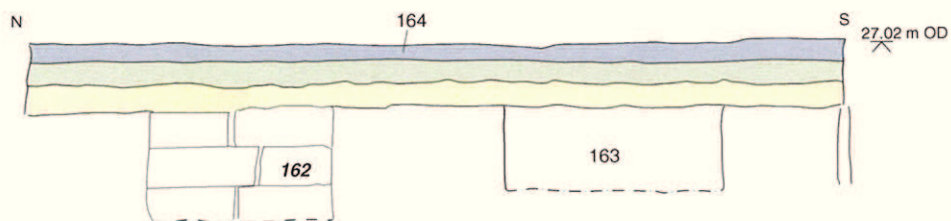
Figure 8: West staircase

- 3.1.5 On the western staircase a stone step was removed and a trench measuring 2.20 m by 0.30 m was excavated. Three brick supports (162) were seen extending to over 0.30 m bgl and were sealed by a silty clay make-up level (163). The stone step (164) sealed these deposits.

- 4.1.5 The trench revealed three brick plinths supporting the step, all of good order, and possibly dating to the mid-19th century building campaign by Barry.

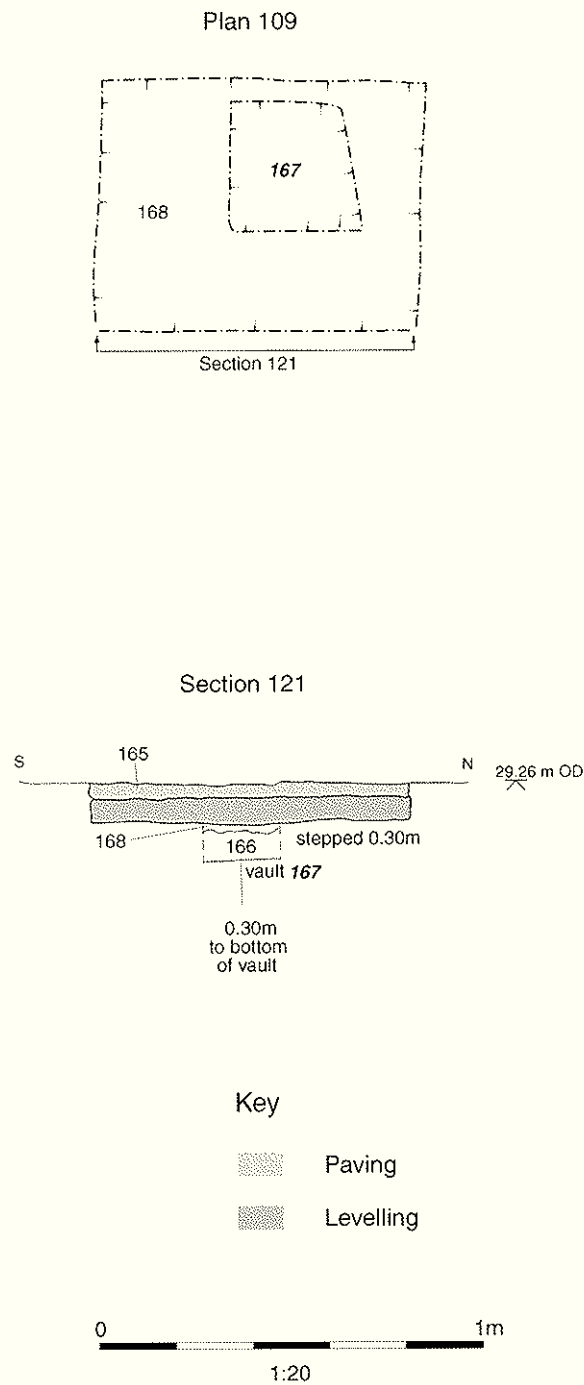
Figure 9: West of terrace

- 3.1.6 To the far west of the terrace a trench measuring 0.80 m by 0.70 m was excavated. The brick vaulted roof (167) was seen at 0.20 m bgl and was 0.30 m thick. It was sealed by a concrete layer (166) and a bitumen deposit (168), the paving slabs (165) sealed these deposits.

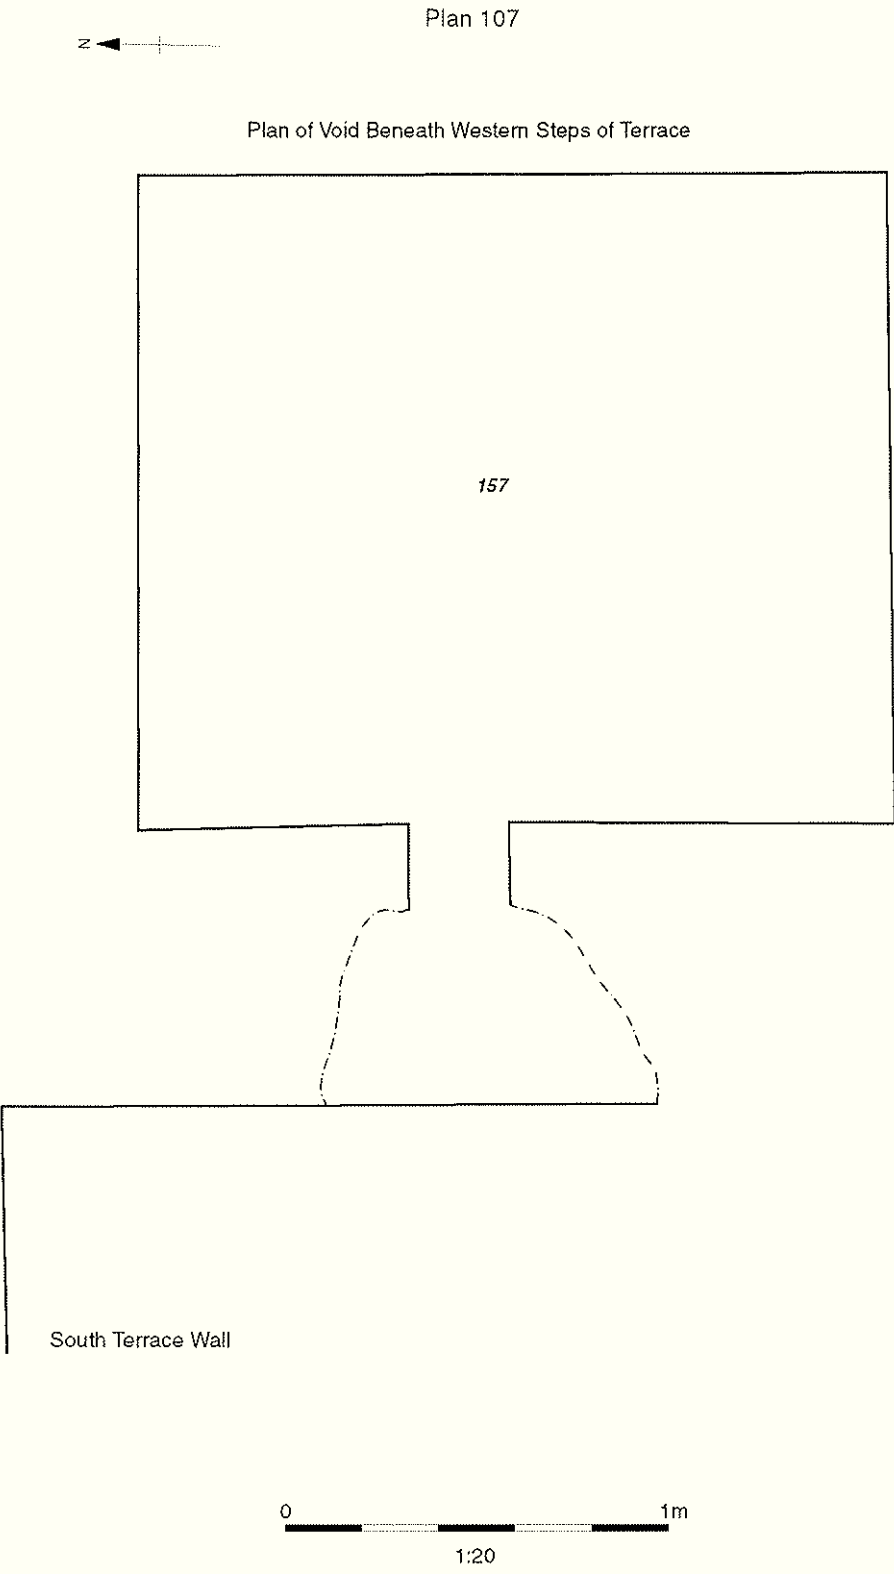
Figure 10: Site inspection Western steps

- 3.1.7 The existing rendered brick to the landing was removed and a hole measuring approximately 1 m by 1 m was cut into the brickwork. The wall was seen to be 0.70 m thick with a void beyond it. The void (157) measured 2.0 m by 1.70 m and was 0.80 m high. Stalactites were observed within the void.

- 4.1.6 The works revealed a brick chamber beneath the stairs acting as a load bearing structure, which was in a structurally sound state. The vault may have been a result of Barry extending the central chamber outwardly.

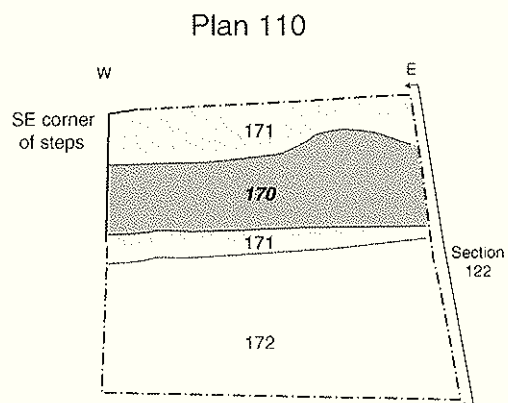
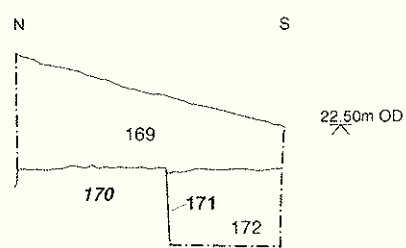
Figure 11: Corner of Eastern staircase

- 3.1.8 Two pits were excavated at the base of the south-east and south-west corners of the eastern landing to assess the wall foundations supporting the landings. The south-east pit measured 0.80 m by 1.0 m and a reddy brown clayey silt subsoil (172) was seen at 0.20 m bgl. This was truncated by a construction cut (171), over 0.40 m wide and more than 0.20 m deep. Within the cut was a concrete foundation with a yellow concrete mortar (170), which was sealed by a topsoil (169).

- 4.1.7 The eastern pit revealed the staircase foundations, and also revealed a concrete footing (170). This may be the remains of garden wall possibly predating the late 19th century balustrade purchased for the property by Astor in 1896 (see 1.3.6 above).

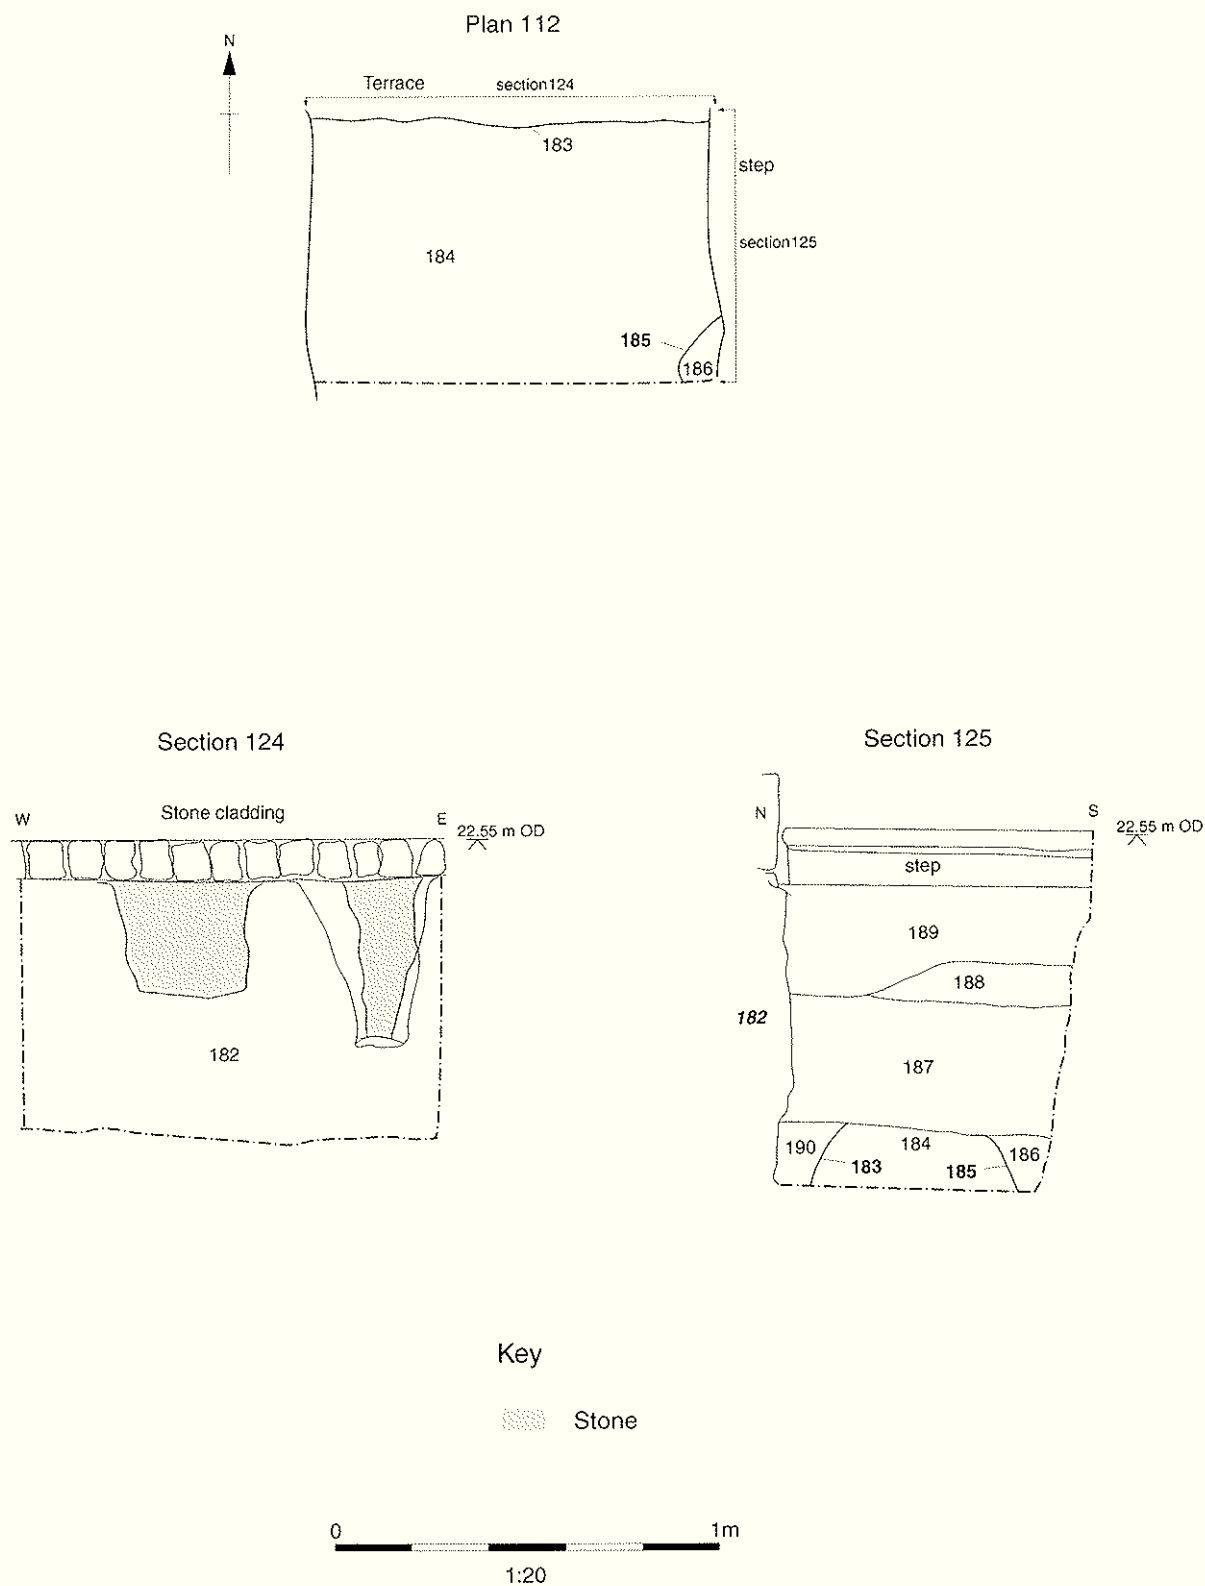
Figure 12: Corner of Eastern staircase

- 3.1.9 The south-west pit measured 0.80 m by 1.0 m and natural sand (184) was seen at 0.80 m bgl. The natural was truncated by a root hole (185), which was filled with subsoil (186), to the south and by a construction cut (183) to the north. Within 183 was the terrace wall (182) extending to over 1 m bgl, and a silty sand backfill (190). Sealing these deposits were two silty sand make-up layers (187 and 188) below a buried topsoil (189) and the staircase.

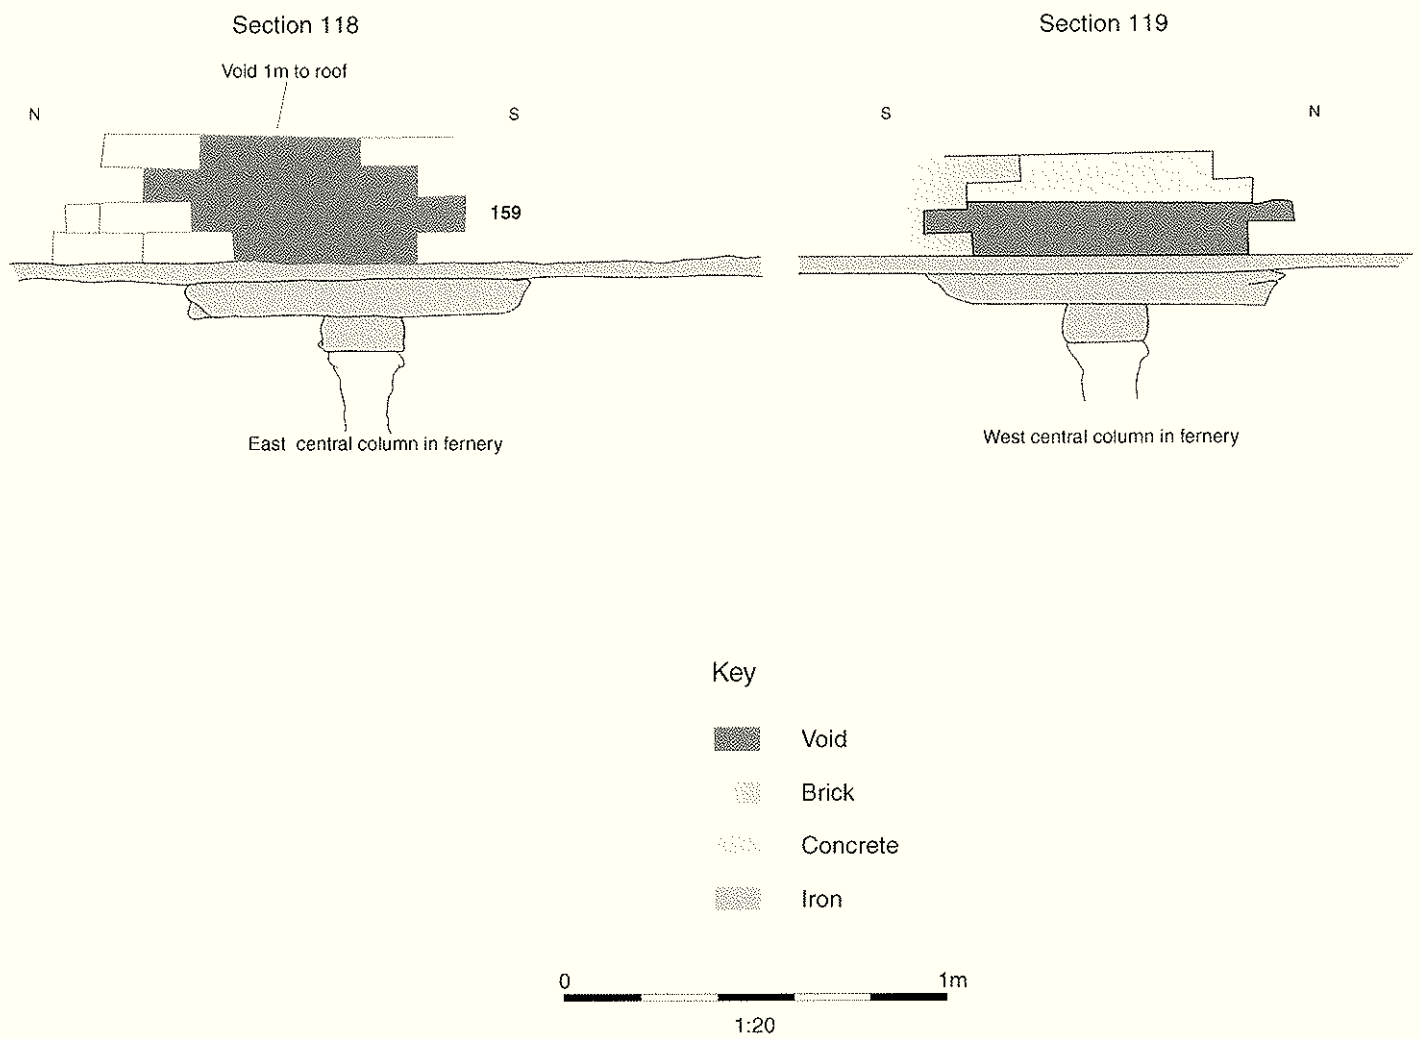
Figure 13: Cast iron capitals in fernery

- 3.1.10 The existing brick vaulting was removed from an area measuring 0.40 m x 0.40 m, to a depth of one brick, to access the cast iron T section girder, on either side of the fernery, for inspection. The access hole to the east of the fernery revealed a void extending 1 m to the vault roof. On the west side a concrete drain (160) was observed behind the single skin of bricks.

- 4.1.8 The inspection holes into the fernery roof revealed the cast iron to be corroded. The vault roof was in a sound state and a concrete drain (160) was revealed to have been added to the western side, perhaps an addition from Barry’s rebuilding of the mansion.
