# CHORLTON FOLD FARM, ECCLES GREATER MANCHESTER

## Archaeological Building Investigation

Issue No: 2006-07/ 614  
OA North Job No: L9779  
NGR: SD 7694 0001

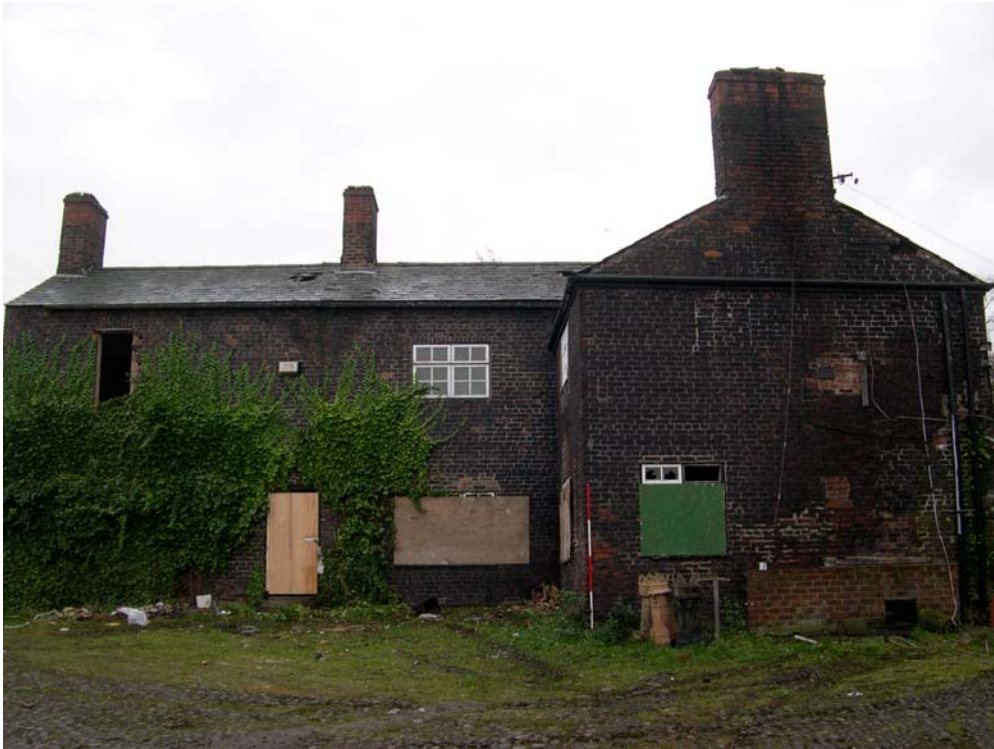
4.2.1 The farmhouse (*Building One*) (Figs 6-9) is constructed from cinnabar red handmade brick (9" by 2½" by 4") and lime mortar (Plate 1), although patches of cement render and wire-cut brick betray later repairs. There would appear to be a discrepancy between the walls of the main part of the farmhouse, which is laid in an English garden wall bond (six to one), and the rear wing, which is laid in English garden wall bond (four to one). Moreover, whilst the majority of elevations are simple bare brick, the front (south) of the farmhouse and the modern, single-storey extension have been pebble-dashed, whilst the west elevation has been hung with slate, painted white in order to match the whitewash of this extension (Plate 2). As the front elevation (south) is heavily rendered, it is difficult to ascertain if the west bay of the farmhouse is original or a later addition. Certainly, it would appear from the pronounced projection that the latter is the more likely of the two.

Plate 1: The rear (south) elevation of the farmhouse, with the rear wing to the right

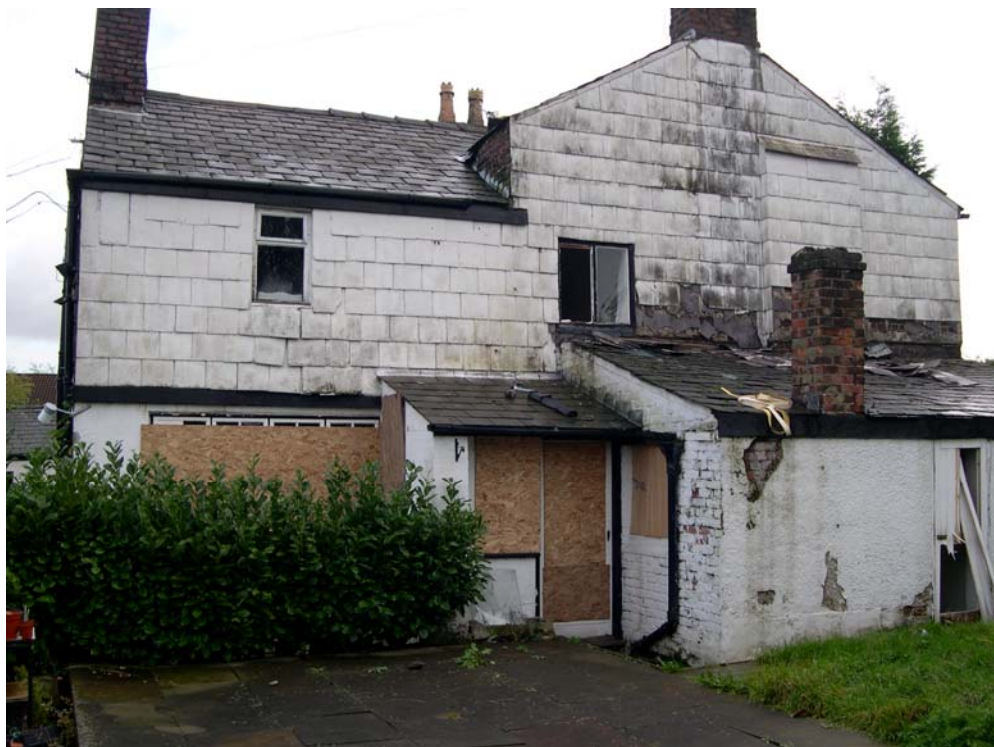
Plate 2: The west elevation of the farmhouse, including the slate-hung walls and the extension.

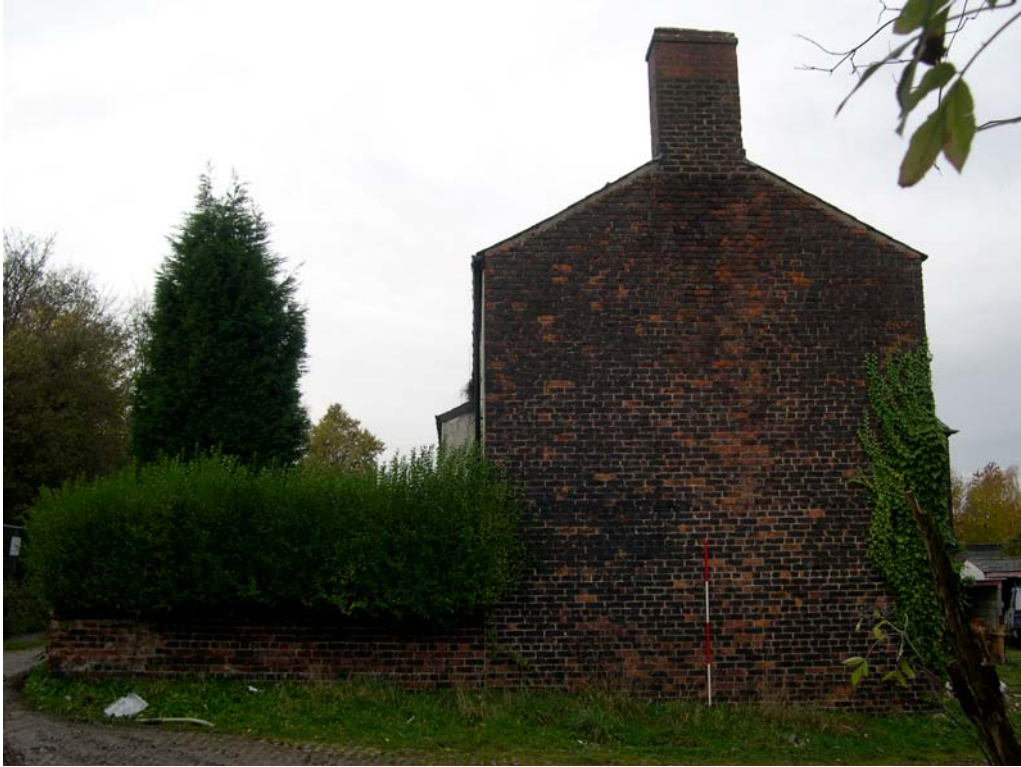
Plate 3: The east elevation of the house, illustrating the rebuild and oversailing of the gable chimney stack

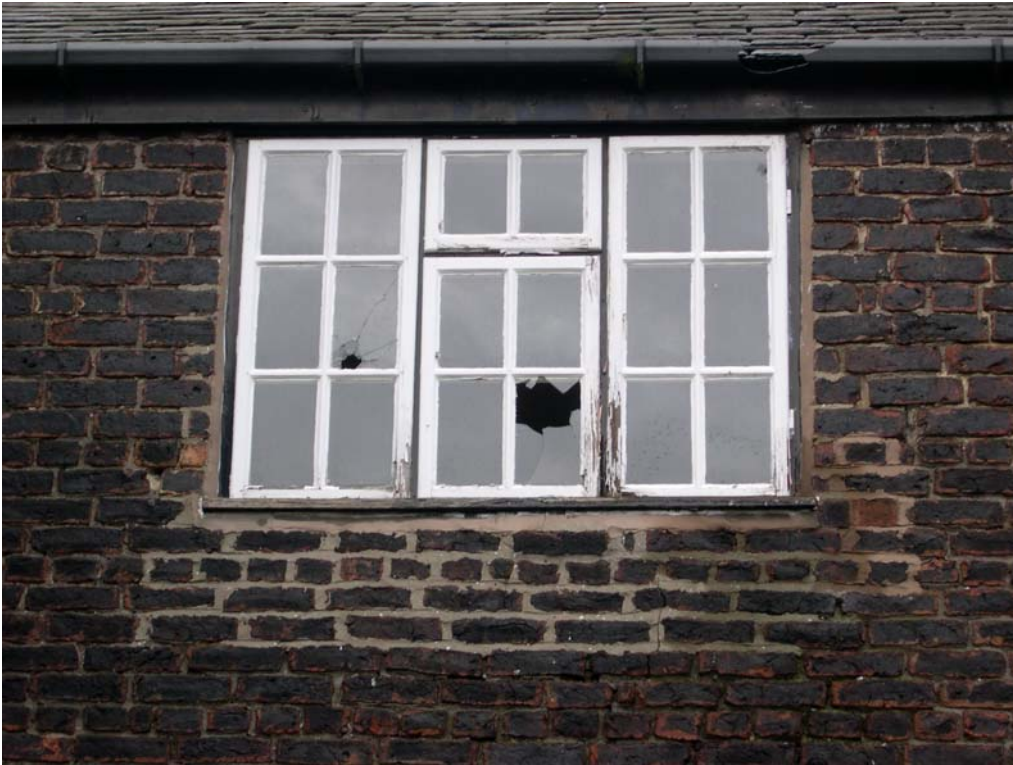
Plate 5: Detail of the rebuild around one of the inserted ventilator casements

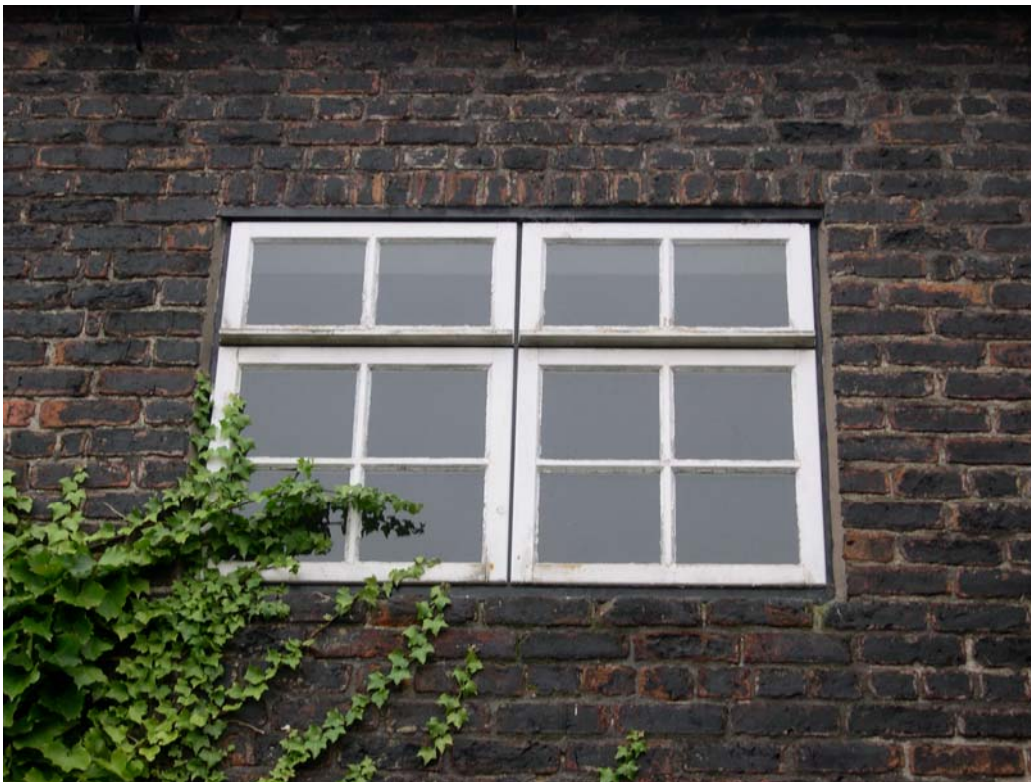
- 4.2.4 All of the windows appear to be mid to late twentieth century replacements, being either side- or top-hung ventilator casements with up to sixteen lights. On the front of the building, the casements of the ground floor are bowed with 'bull's-eye' glass to give an 'olde worlde' effect, whilst a tall narrow casement serves as a stairlight. It is unclear if these or any of the other windows on this elevation have been reduced in height or width, as the brickwork has been rendered with pebble-dash. However, it would seem that the remaining casements are somewhat smaller than their original counterparts (probably sash windows), which is clearly evidenced by the substantial re-build and re-pointing on their surrounds (Plate 5). Despite this, there are still some traces of the original brick rubbers, which are laid as either flat heads (Plate 6) or segmental voussoirs (Plate 7).

Plate 6: Detail of the original brick rubbers, overlying one of the inserted modern casements

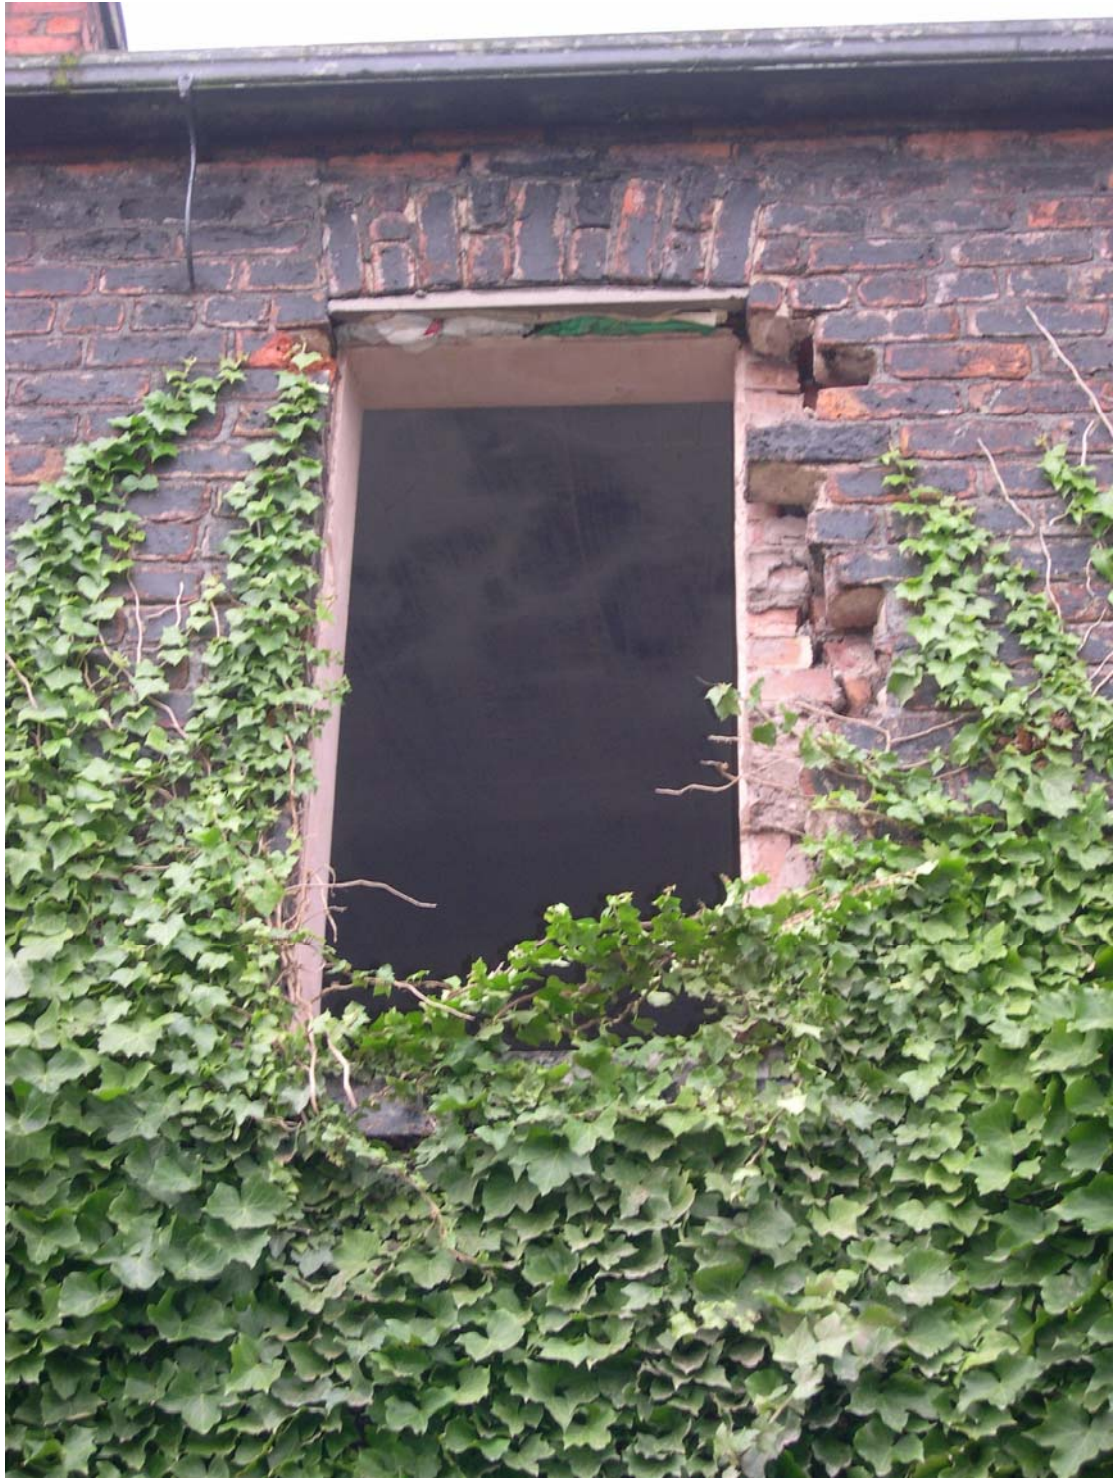
Plate 7: Detail of the segmental voussoir overlying one of the original window apertures

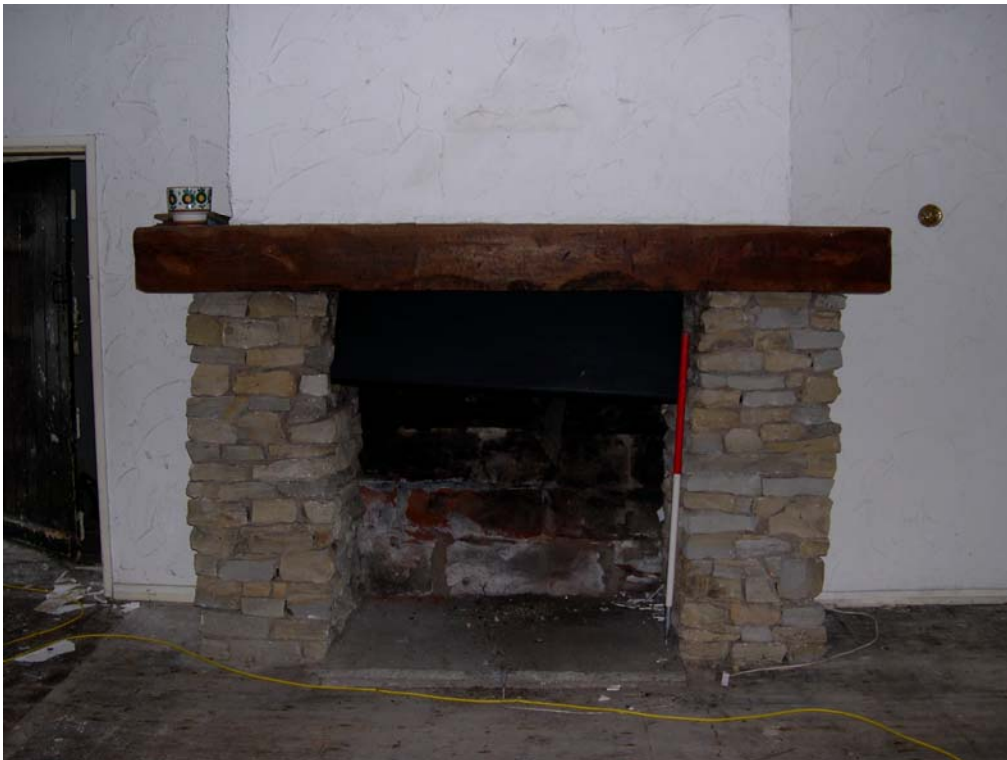
- 4.3.3 The fireplace in Room 2 is a modern addition to the farmhouse, which has been built in a rough manner to affect an antiquated and rustic appearance (Plate 9). It features a roughly-coursed sandstone rubble surround, with a mantle of re-used chamfered oak, whilst a sandstone flag has been utilised as a hearth. In addition, there is a further recent fireplace in the kitchen (room 5), but this is overtly modern. It is constructed from red-brick laid in a plain stretcher bond with cement mortar, and features a segmental voussoir of brick rubbers, two courses high (Plate 10). Within the recess of the fireplace sits a cast iron stove, which is somewhat incongruous, given its contemporary surroundings. In contrast, the fireplaces on the first floor all feature cast-iron nineteenth century surrounds or residual evidence of them. In rooms 10 and 13, the fireplaces have square, fluted surrounds with dentil-effect friezes, bolection-moulded mantels and chamfered firebacks (Plate 11), although neither has retained its dog-grate, nor shows evidence of a hearth. In room 11, the fireplace, which is again cast-iron, features a round arch flanked by rosettes, topped by a rose-motif frieze and a plain mantel (Plate 12). In a similar vein to the fireplaces in rooms 10 and 13, there is again no evidence of a dog-grate or a hearth. Although, the fireplace in room 12 has been removed, the residual scarring would suggest that a cast-iron fireplace comparable with those described above, was once present. However, unlike these other fireplaces, a hearth overlaid with Victorian ceramic tiles depicting lilies, is still present.

Plate 9: Detail of the modern stone fireplace in room 2

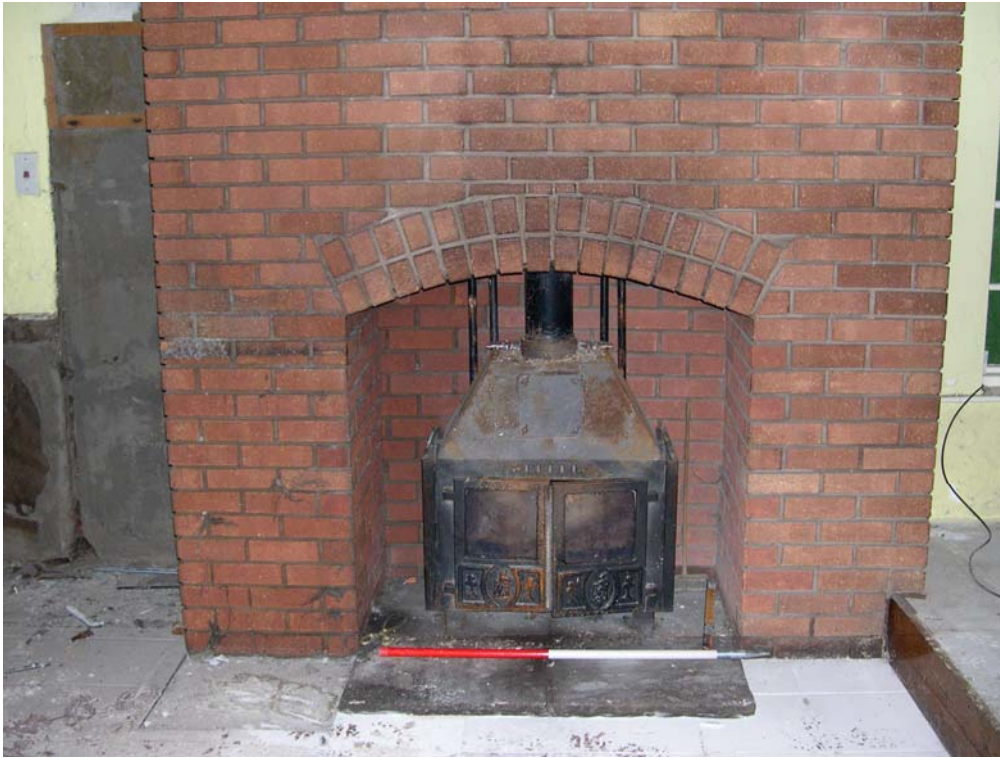
Plate 10: Detail of the modern brick fireplace in the kitchen (room 5)

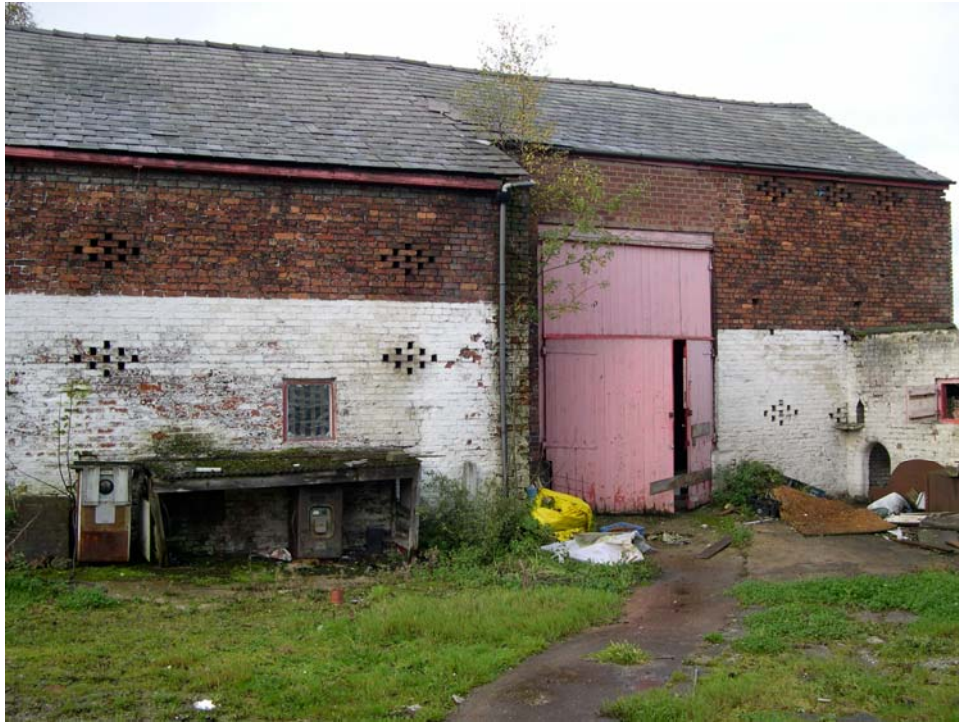
Plate 14: The east elevation of the barn (*Building Two*)

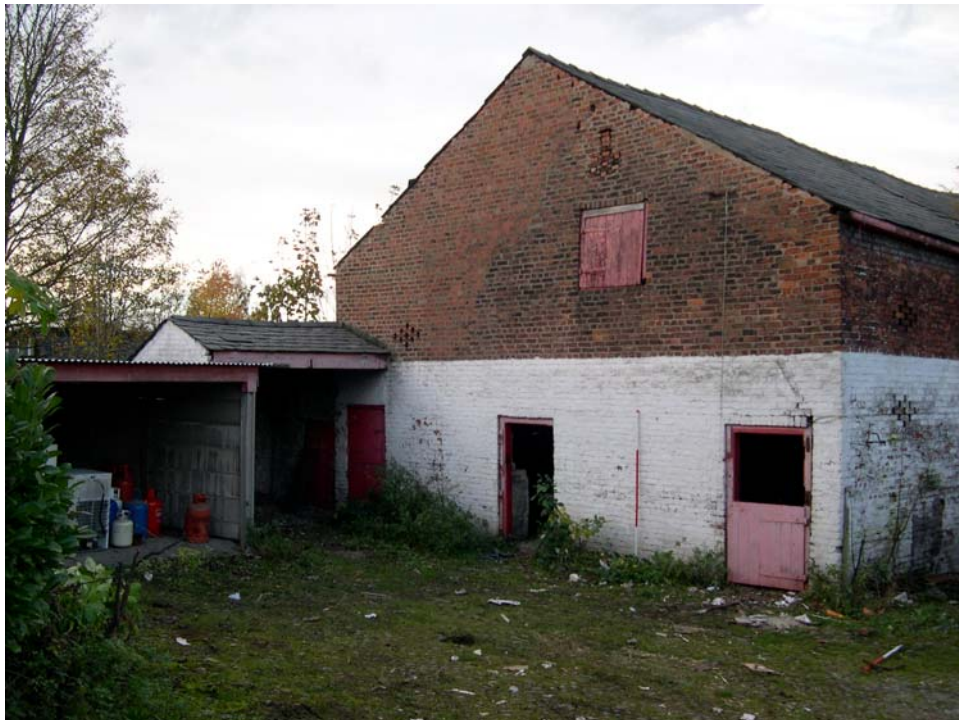
Plate 15: The south elevation of the barn (*Building Two*)

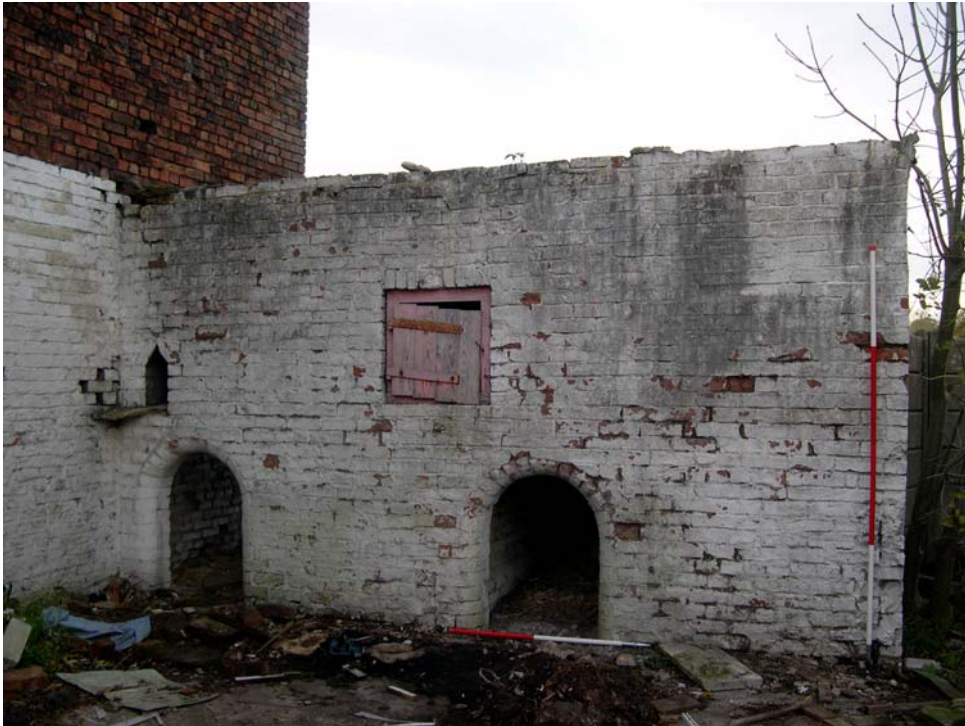
butt-joint some 1.5m high, which would suggest that the south extent of the barn has been extended to create the T-shaped building standing today. On the north-east corner a small red-brick animal pen, probably a hoghouse, has been appended (Plate 16).

Plate 16: The hoghouse on the north-east of the barn

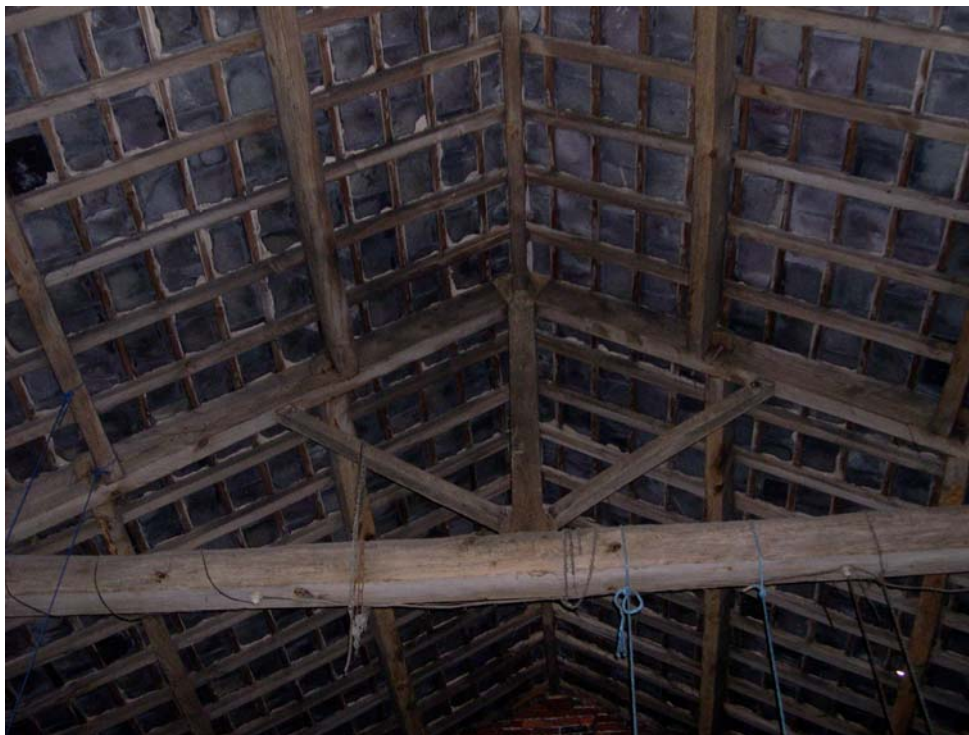
Plate 17: The king-post truss at the north extent of the barn

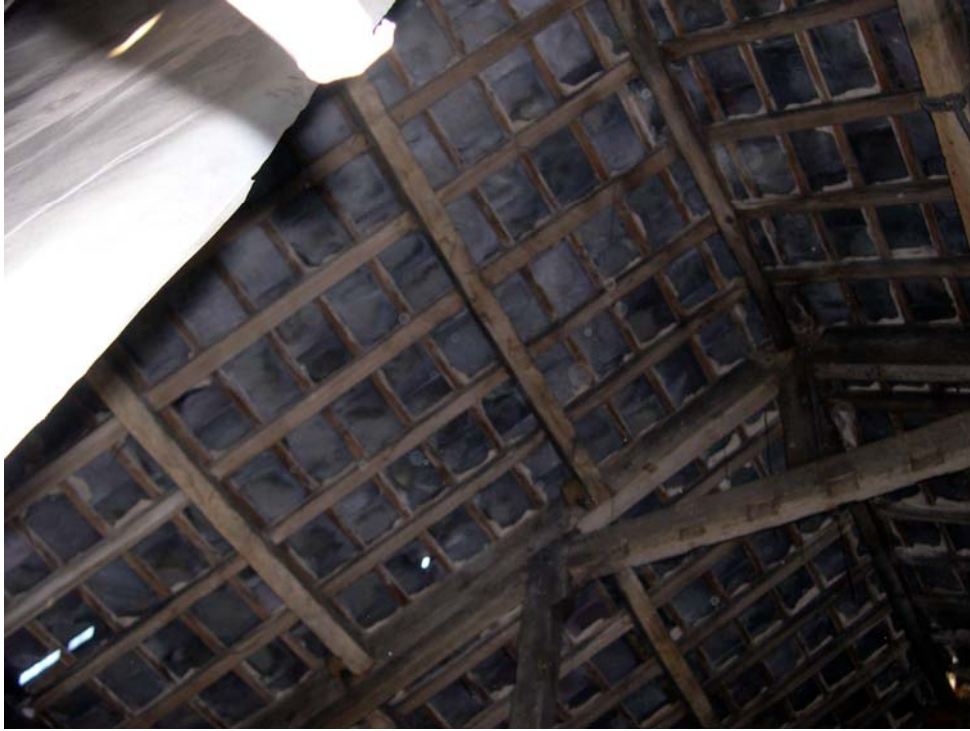
Plate 18: The queen-post truss at the south end of the barn, featuring a king-tie and collar of reused timber

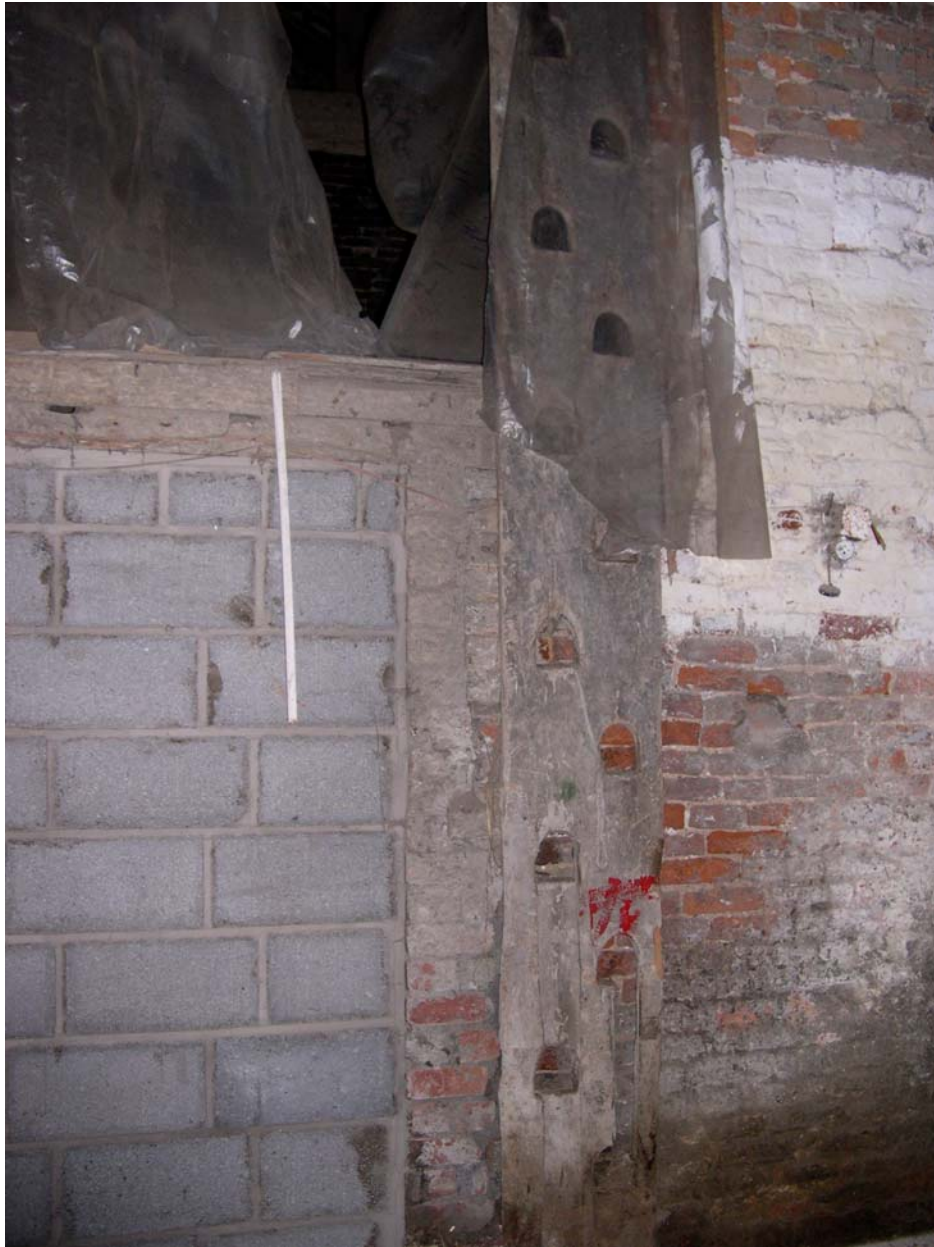
- 5.2.8 Within the barn, the access door between the north end and the south shippens was blocked with cinder blocks, whilst the wagon door on the east elevation was raised significantly, with substantial repairs required to accommodate this alteration.

Plate 19: Detail of the loft-ladder and the blocked access doorway to the shippens

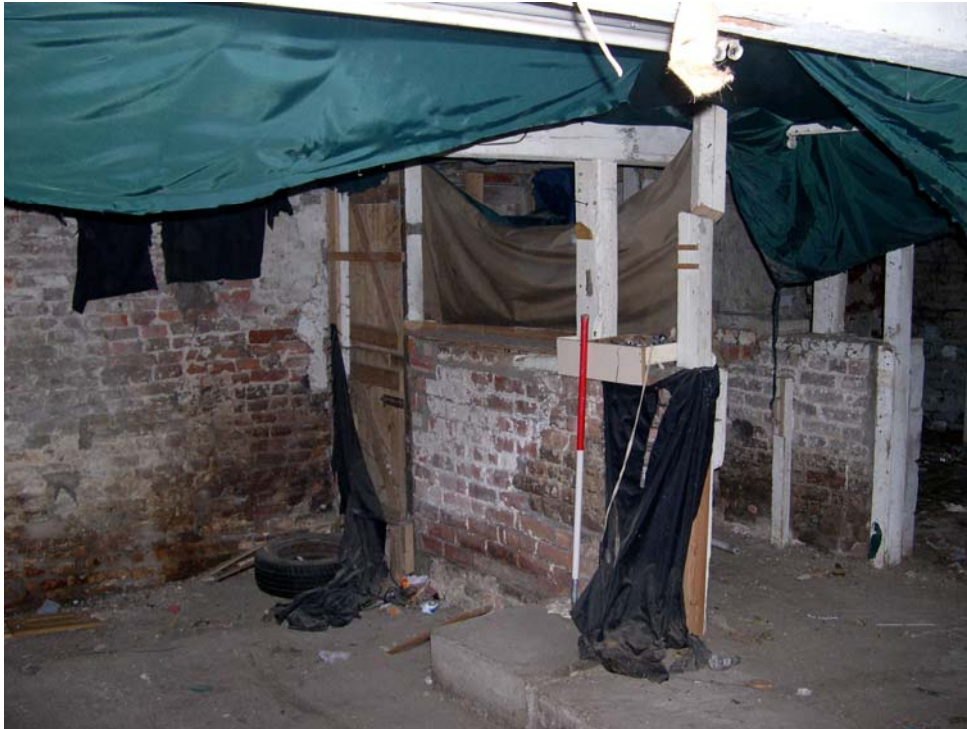
4.5.2 The shippens at the south end of the barn have brick floors, whilst platforms of concrete have been added, no doubt to improve drainage from the stalls, which are constructed from cinnabar red brick laid in an English Garden Wall

Plate 20: The interior of the shippons at the south end of the barn

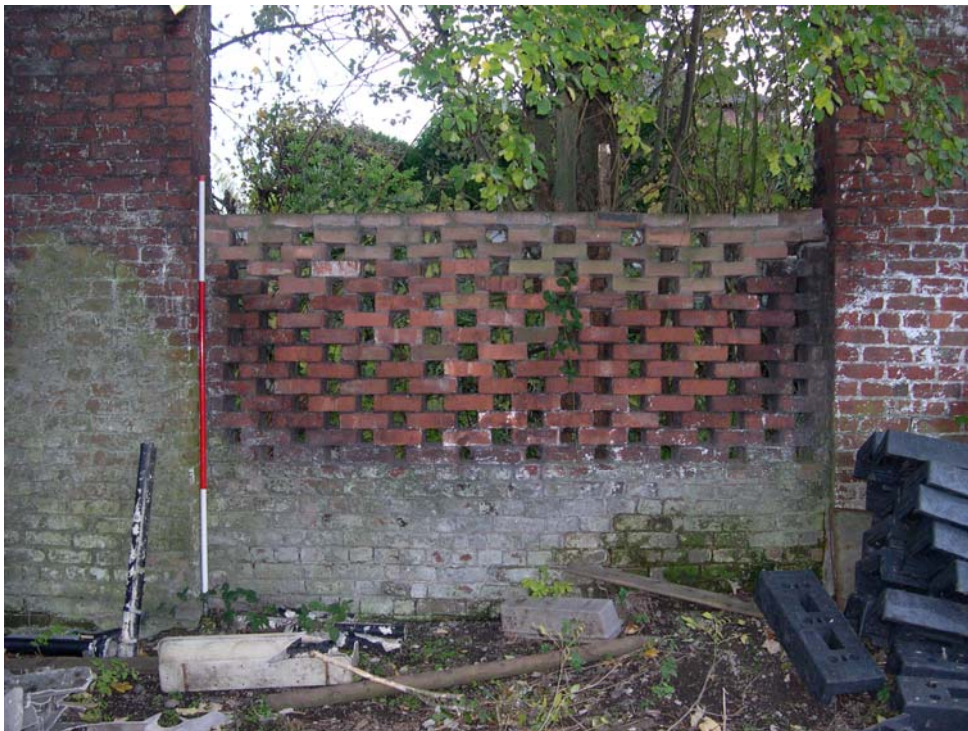
- 4.7.1 The hay barn or Dutch Barn (*Building Five*) to the east of the farmhouse conforms to the classic archetype, in both design and materials (Brunskill 1987: 101) (Plate 23). It is essentially a corrugated tin roof with steel trusses and struts, which is supported by six brick pillars, built from red brick laid in an English Garden Wall bond (six to one) with lime mortar. The barn is open to the elements on three of its sides, whilst the south elevation has a solid brick wall of English Garden Wall bond (six to one), which stands one course thick and up to nine courses high. Situated above this is a further wythe of red brick laid in a ventilator pattern fifteen courses high (Plate 24).

Plate 24: Detail of the ventilator pattern on the south elevation of the Dutch barn
