# TOWNSIDE FARM PILLING LANCASHIRE

## Archaeological Building Investigation

**Document Type:** Archaeological Building Investigation

**Issue Number:** 2005-6/444  
**OA Job Number:** L9614  
**Planning Application Number:** 02/03/00471

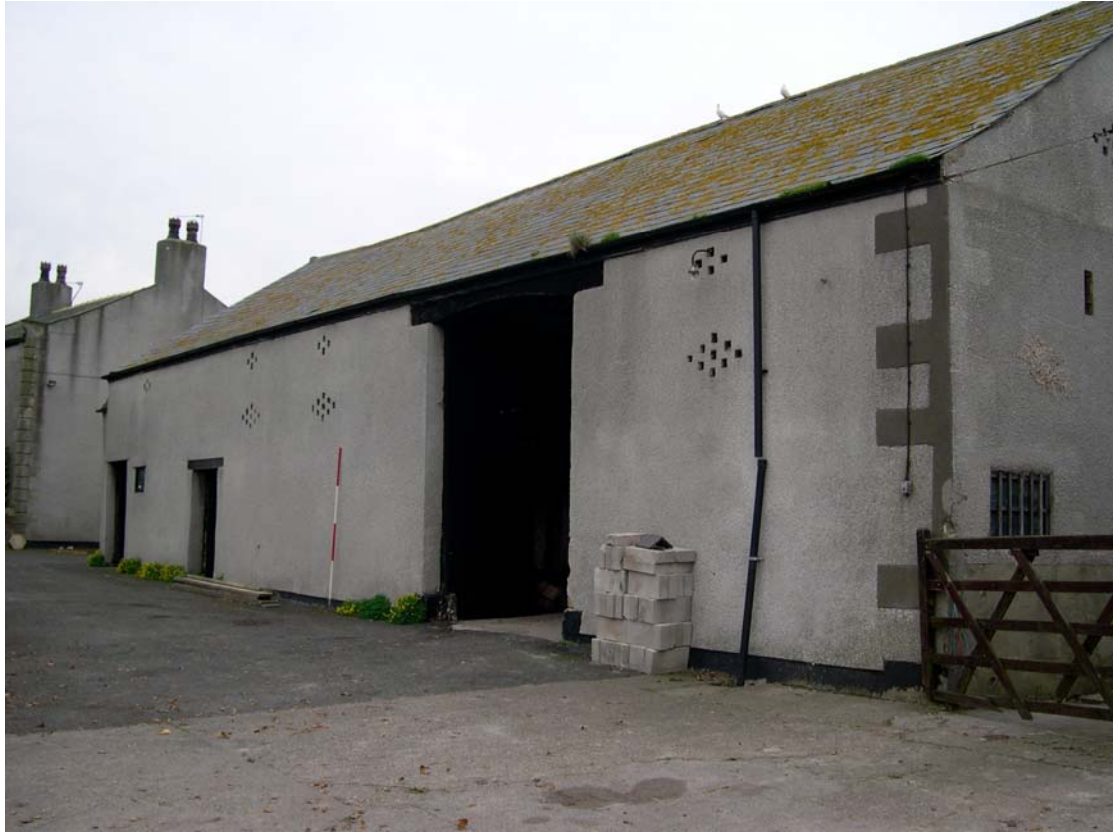
Plate 3: The east external elevation of the barn

- 4.4.1 **East (Front) elevation:** (Plate 3) there are two rows of diaper-pattern ventilation slots across the elevation; the higher level comprising four holes, the lower nine. The north-east corner has ashlar-effect quoins constructed within the render. To the south of this is a large wagon doorway with a timber lintel evidently made of two pieces of re-used timbers: there are groups of relict peg-holes in each piece that suggest these are former cruck blades. To the south there are two pedestrian doorways, the northern one with a stone lintel and the southern, which may be inserted, with a concrete one. At the south end the elevation is continued by a small two-storey outshut. This has a small ground floor doorway in its east elevation, and a partially hipped roof. There is a plastic gutter attached to the whole elevation.

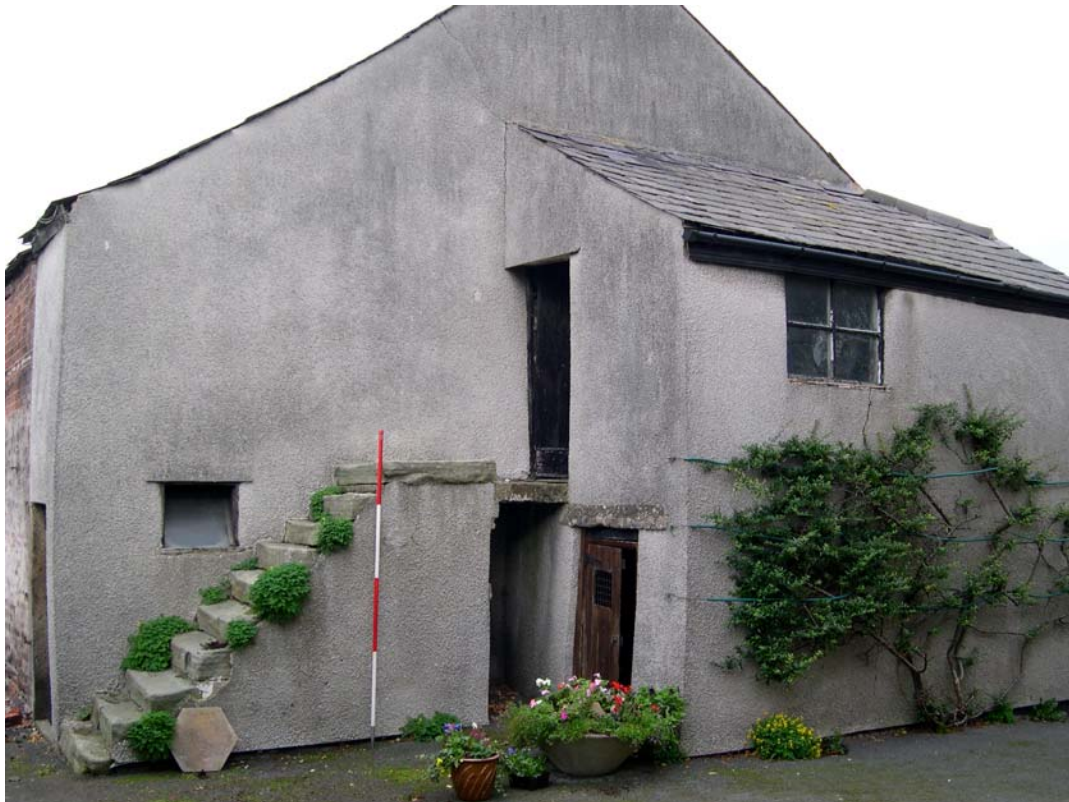
Plate 4: The south external elevation of the barn

- 4.4.3 **South elevation:** (Plate 4) this forms the gable end of the building, to which is attached the two storey outshut. The outshut has a four-light window on the west side, and the west end return has ground floor and first floor doorways, the latter accessed by a flight of yellow sandstone steps attached to the south end of the barn. Above these steps, but on the ground floor is a small window looking into shippon at the north end of the barn.

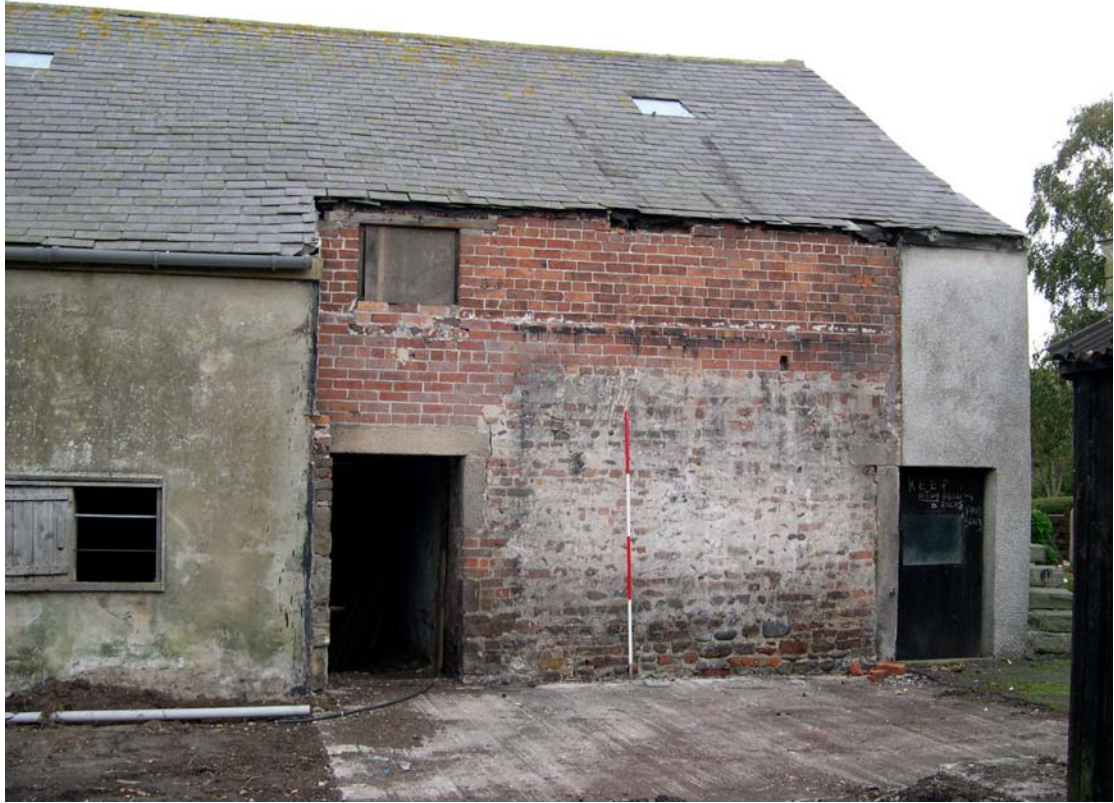
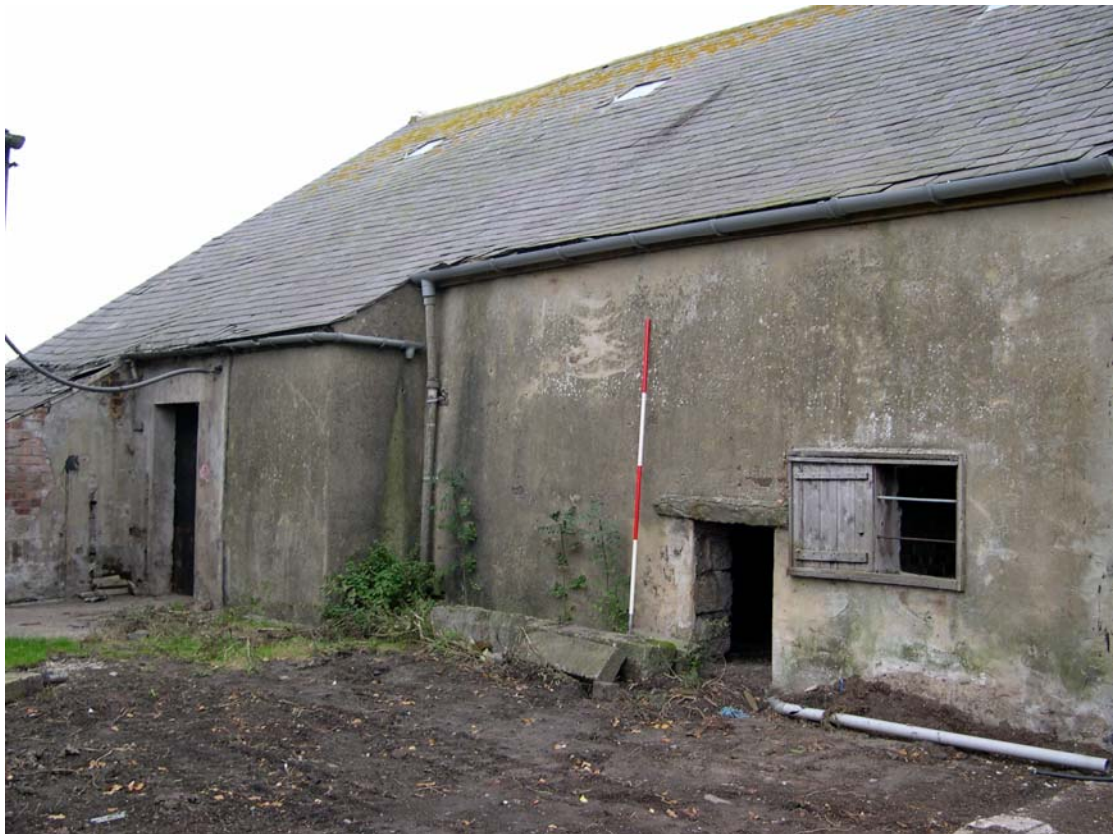
- 4.4.2 **West (Rear) elevation:** (Plates 5 and 6) the majority of this elevation is rendered, mostly with a smooth finish, apart from a small section at the far south end, which is roughcast as per the rest. The exposed section between, which was clearly left unrendered because of an outshut that formerly stood against this part of the wall, is a mix of brick and cobbles, which evidence of considerable rebuilding. A return in stone, with dressed quoins, denotes the north side of a pedestrian doorway at the south end. South of this is another pedestrian doorway and above is a small window. The area between the two doorways has been substantially rebuilt, the original build apparently being a mix of bricks and rounded cobbles, which was built on top of in the standard brick seen elsewhere in the building. North of this is a small low-level window with a sliding shutter, immediately to the north of which is a low doorway with a rough limestone lintel. North of this the wall returns to the west and there is another large pedestrian doorway, the jambs of which are finished with a concrete skim. North of this the wall returns to the west again where there is a small monopitch outshut attached to the north-west end of the barn.

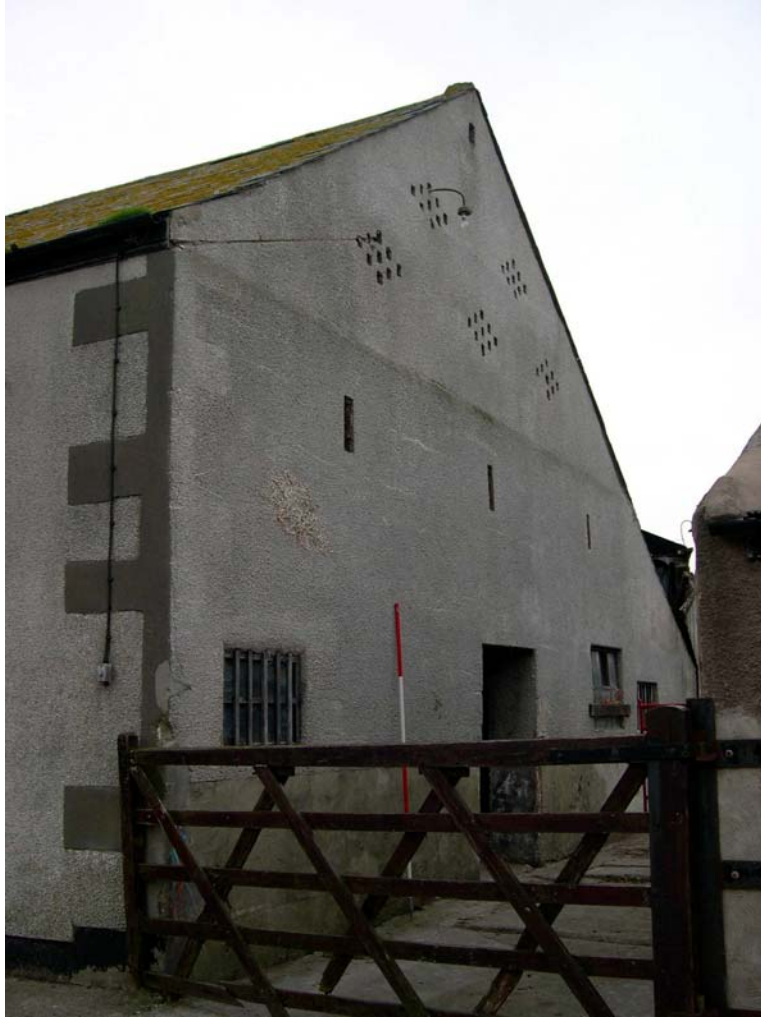
Plate 7: The north external elevation of the barn

- 4.4.4 **North elevation:** (Plate 7) this forms the opposing gable end. The upper part has five diaper pattern ventilation slots, each of nine bricks, in two rows above three. Below these is a shallow plinth, beneath which are three slit ventilators. At ground level there is a central pedestrian doorway, either side of which are small windows. The west end of the gable has been extended by the outshut, which houses another small window. The west end of the outshut is finished with dressed stone quoins that are visible through gaps in the render, while the false quoins of the east elevation continue around the north-east corner.

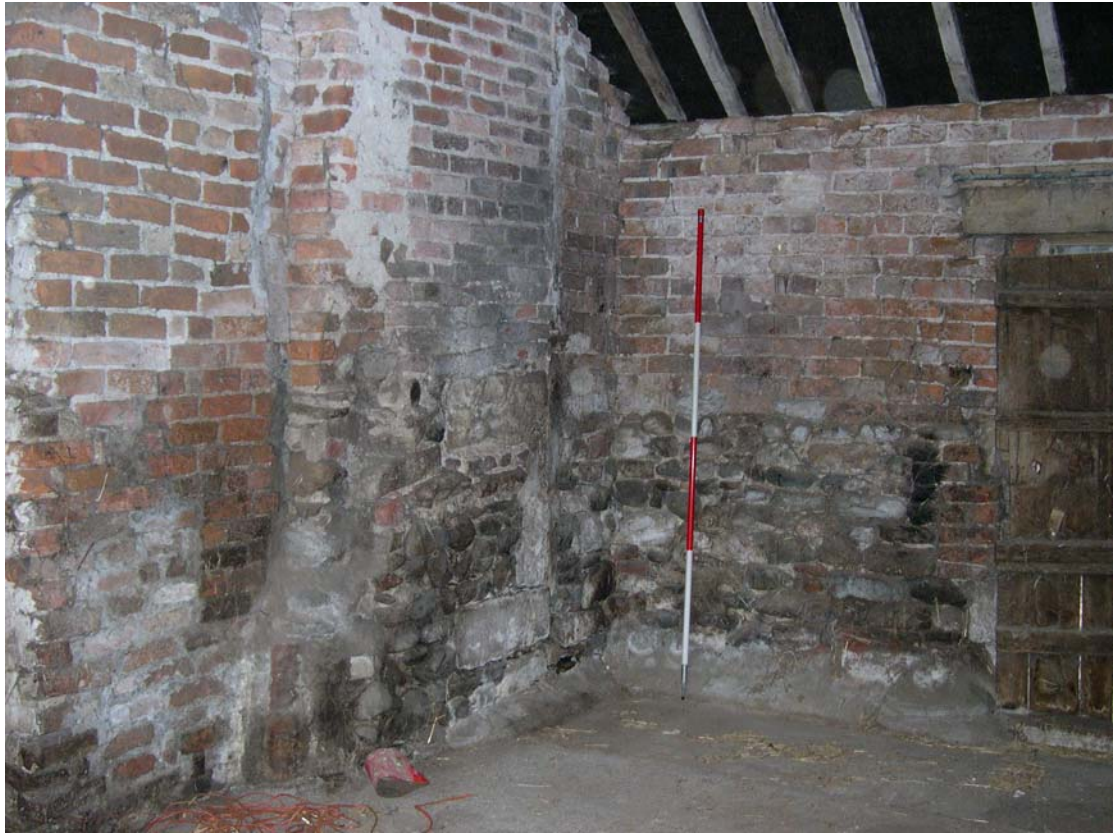
Plate 10: The north-west corner of the barn showing phases of stone and brick building

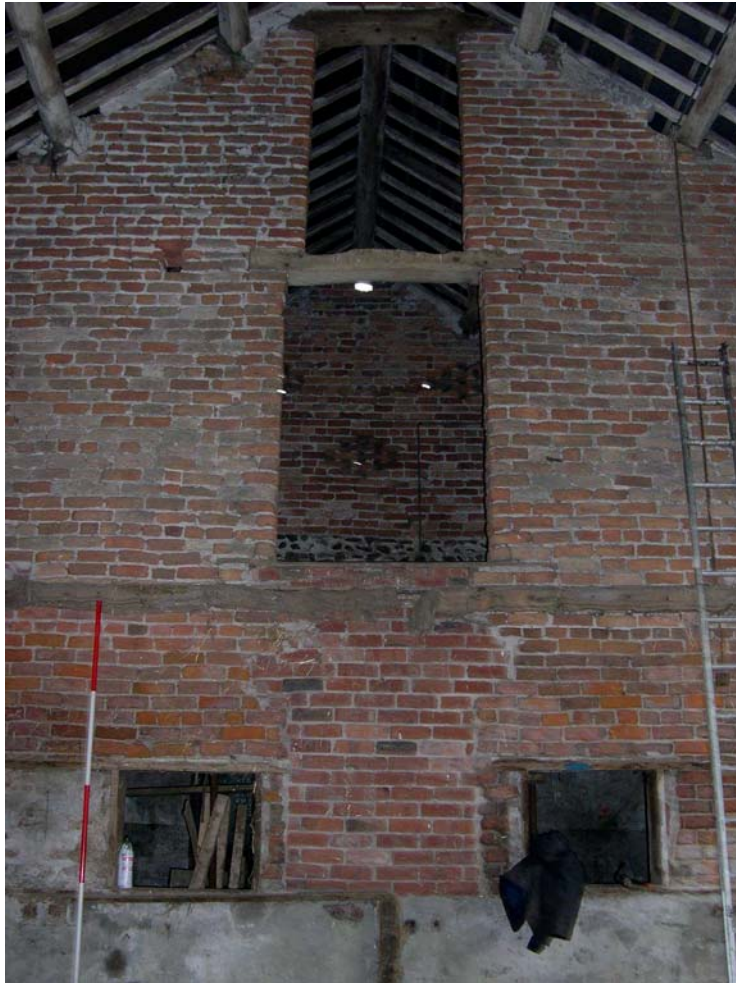
Plate 11: North internal elevation of the barn

- 4.5.3 The north (Plate 11) and south internal elevations of the barn are entirely brick, and both have two large openings (presumably pitching holes for the rooms beyond) at first floor level, one above the other. These both have re-used timber lintels/sills with relict peg holes and joist slots. The north elevation also has four small windows within it at ground floor level, probably inserted, and between the central two an area has been relatively recently rebuilt in modern brick. The east elevation is unremarkable, although the lower c 0.9m is built of cobbles. The lower part of the west elevation is similarly built of cobbles, to a height of up to 1.2m. The wall returns at the north and south ends, at the south end forming the jamb of a doorway, and at the north to form an opening into a short extension, also built of brick on cobbles (Plate 10). The extension butts a quoined jamb, presumably the flanking wall for a former wagon doorway, and there are further quoins forming the inner doorway, although on the south side this has been truncated and rebuilt. A large pedestrian doorway is now situated within this outshut, with dressed stone surrounds.

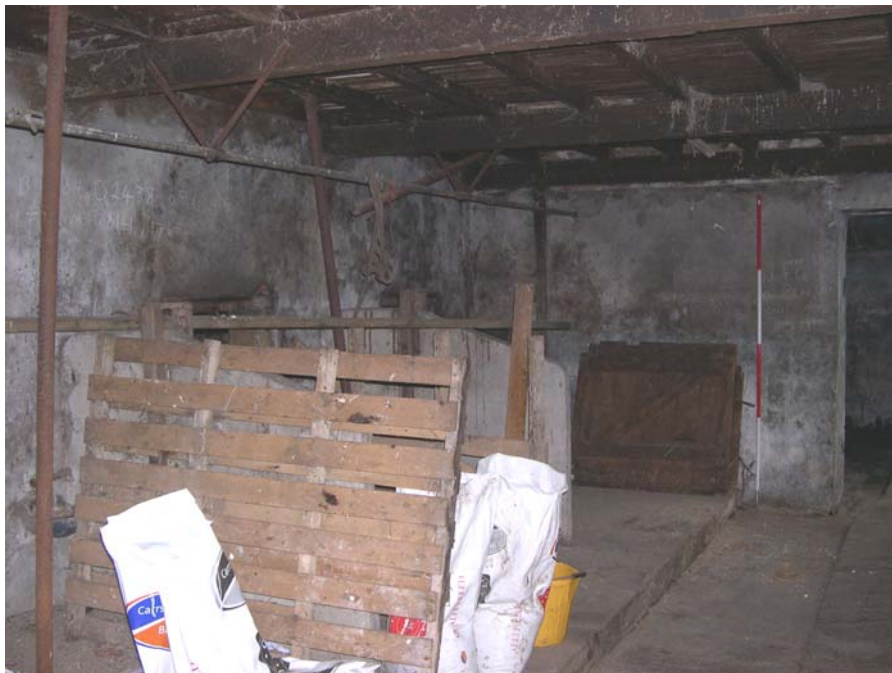
Plate 12: General view of the northern shippon

- 4.5.5 **Northern shippon:** (Plate 12) the single bay to the north of the barn forms a shippon. The floor is finished with a concrete skim incorporating a dung channel, and the walls are finished in a similar manner. The ceiling comprises machine-cut timber joists and floorboards forming the floor of the loft above. There are three concrete stall walls along the south wall. The western end has been extended into a small outshut, which is finished in the same way and continues the same finish, including the dung channel. There are four windows in the south elevation, and two windows and a doorway in the north, all of which appear to have been inserted or rebuilt. Those to the north have concrete lintels.

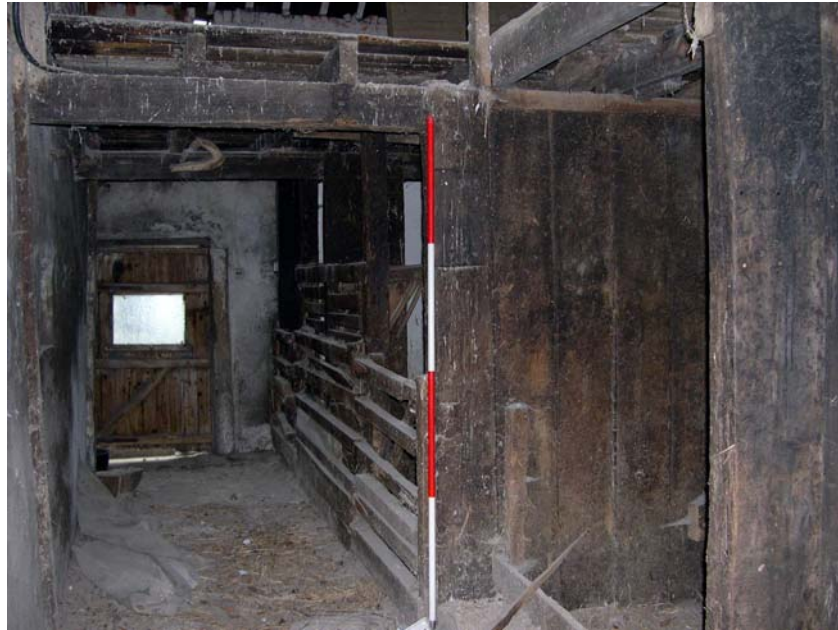
Plate 13: General view of the southern shippon

- 4.5.8 **Southern shippon and stable:** (Plate 13) this is situated within the single bay at the south end of the barn. The floor is part cobbled, part concrete, the ceiling forms a half or three-quarter loft over the shippon and is supported by upright posts attached to which are timber walls of a row of stalls. Both the ceiling and stalls are built of machine-cut timber and appear relatively modern. The walls on the ground floor are finished with a thin skim of concrete. The south elevation, which is mainly built of stone, has two small apertures in the centre, both blocked with stone and with stone and timber lintels. At either end of the elevation the wall is recessed and built of brick; the west end has a small window with a re-used timber lintel. The east and west elevations both have pedestrian doorways on the south side with stone lintels. On the first floor the brickwork of the walls is exposed. There is evidence for rebuilding on the west side of both the north and south elevations; perhaps representing blocked apertures and a possible return for an internal wall.

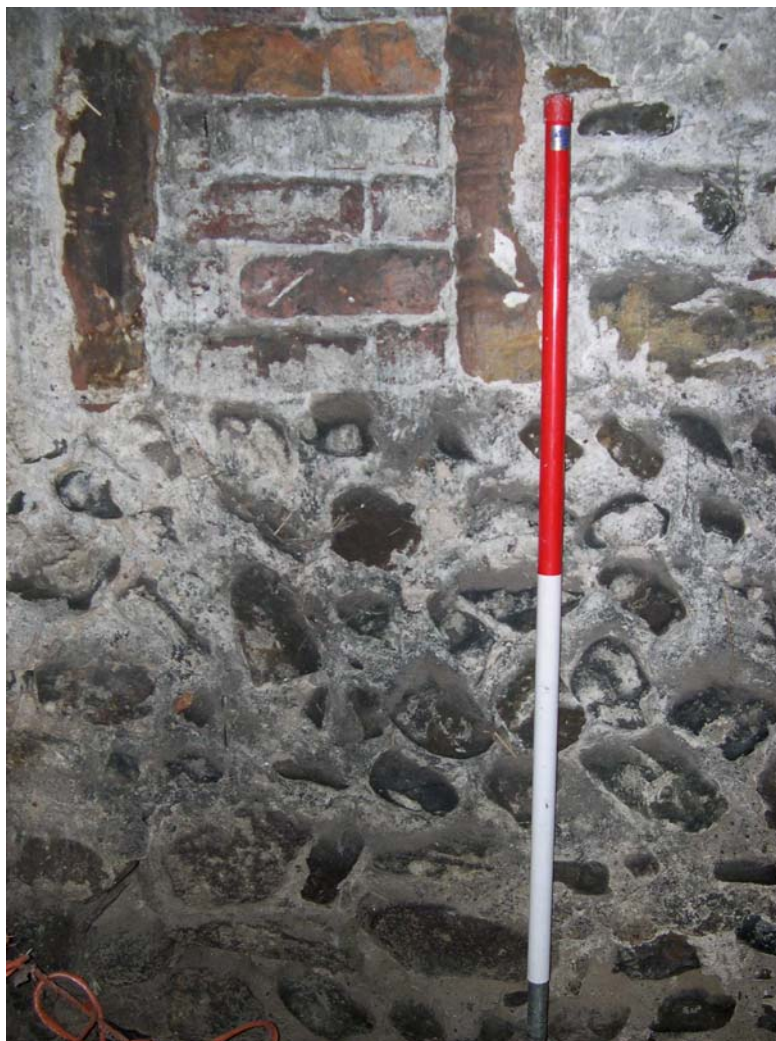
Plate 14: Blocked ventilation slot covered by the granary

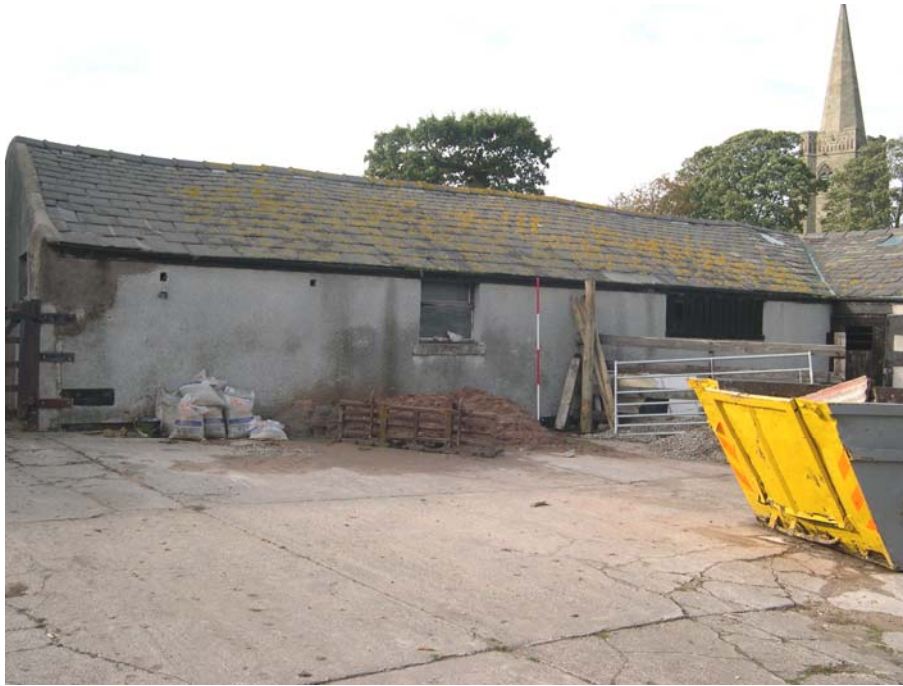
Plate 15: The east elevation of the north/south axis of the cow sheds

- 4.6.1 ***East elevation of the north south axis:*** (Plate 15) the brick wall is finished in a roughcast render and dressed with rough quoins at the north end. There is a small casement window in the centre of the elevation, whilst to the north, there is a large aperture, which has been partially covered with timber slats. The cracks in the rendered wall beneath this opening suggest that this was once a doorway. In addition, there are two small square air vents below the gutter at the south end.

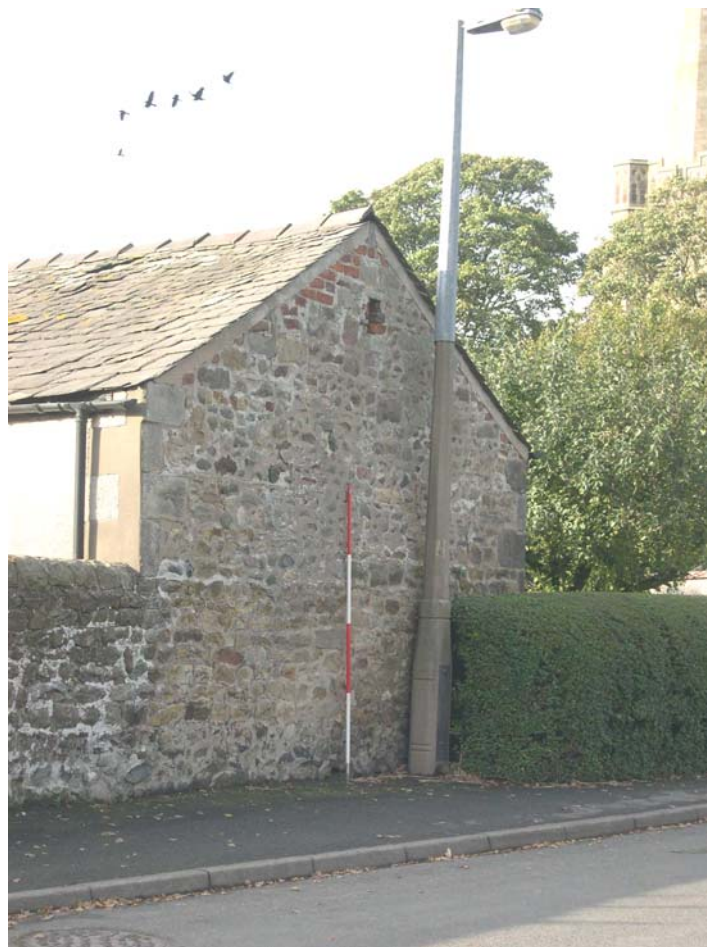
Plate 16: The east elevation of the east/west axis of the cow sheds

- 4.6.2 ***East elevation of the east west axis:*** (Plate 16) this elevation is constructed from rough courses of cobbles dressed with rough quoins. The stonework has been re-pointed with cement mortar and there are brick repairs towards the apex of the gable, within which, there is an air vent or beam slot.

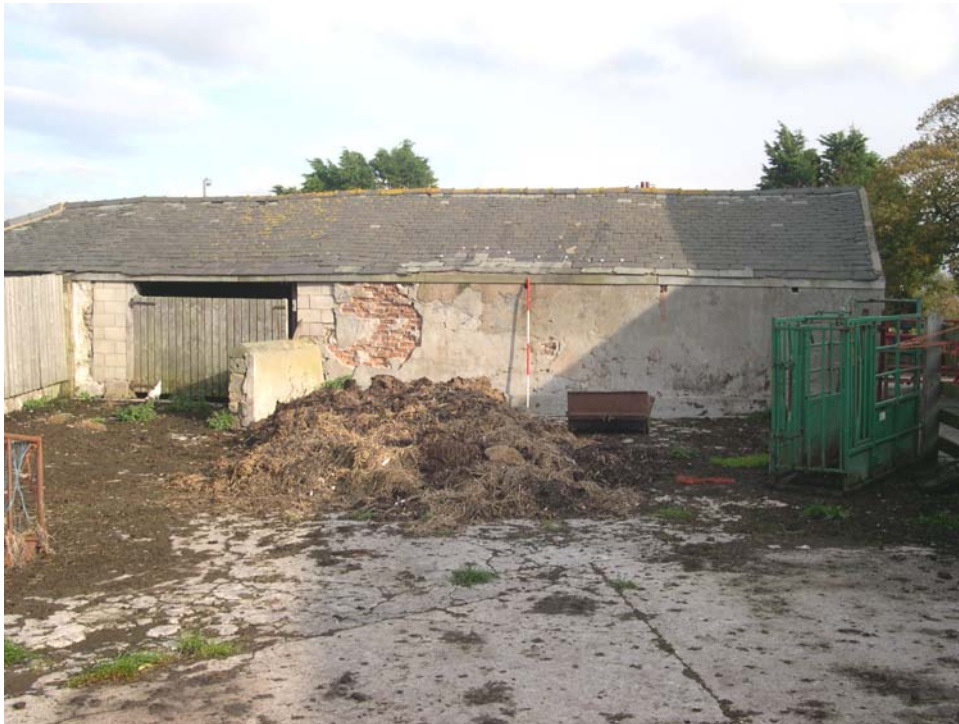
Plate 20: The west elevation of the north/south axis of the cow sheds

- 4.6.6 ***East elevation of the north south axis:*** (Plate 20) the elevation is smoothly rendered, but this is in a poor condition, despite several patches of cement repairs. At the south end, there is evidence of rough courses of the familiar weatherworn cobbles, whilst towards the centre of the elevation, there is bare brick. The north end of the building lies on the adjacent property and consists of unrendered stone dressed with bare quoins. There is a blocked aperture, possibly a hog hole or similar, which features a substantial stone lintel and quoins. Towards the centre of the elevation, there is an inserted or enlarged

gateway, with ash block repairs to the surrounds. In a similar fashion to some of the other elevations, there are four small square air vents along the underside of the guttering.

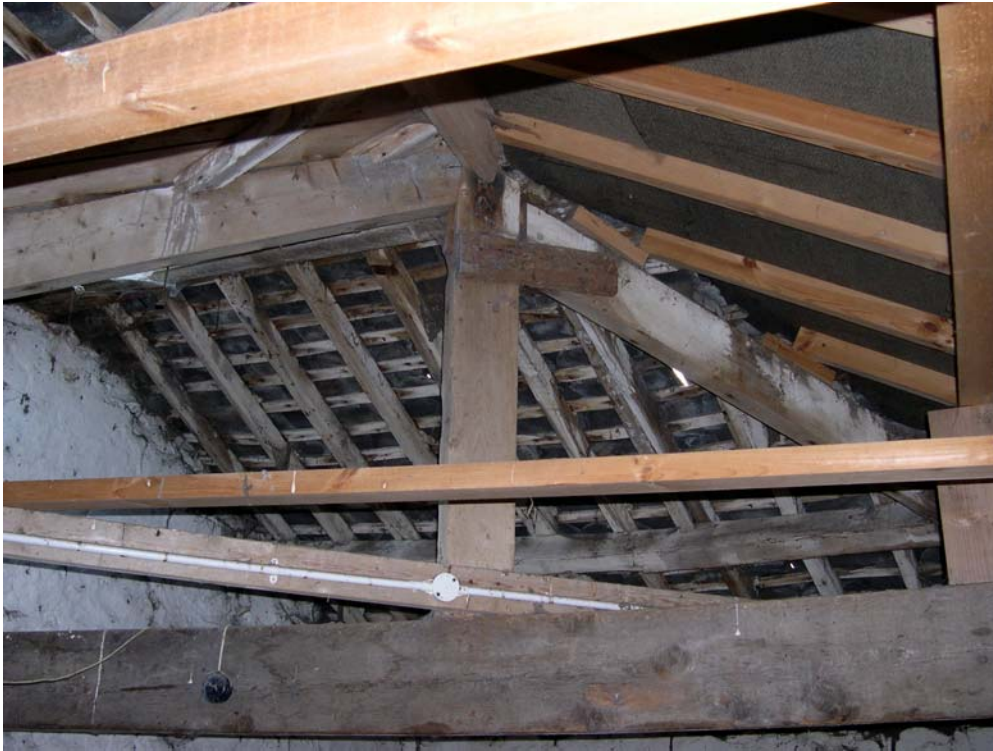
Plate 23 Detail of the recently replaced ceiling in *Box Three*
