The Dye House, Hallthwaites, Millom, Cumbria

Archaeological Building Investigation

Oxford Archaeology North

November 2005

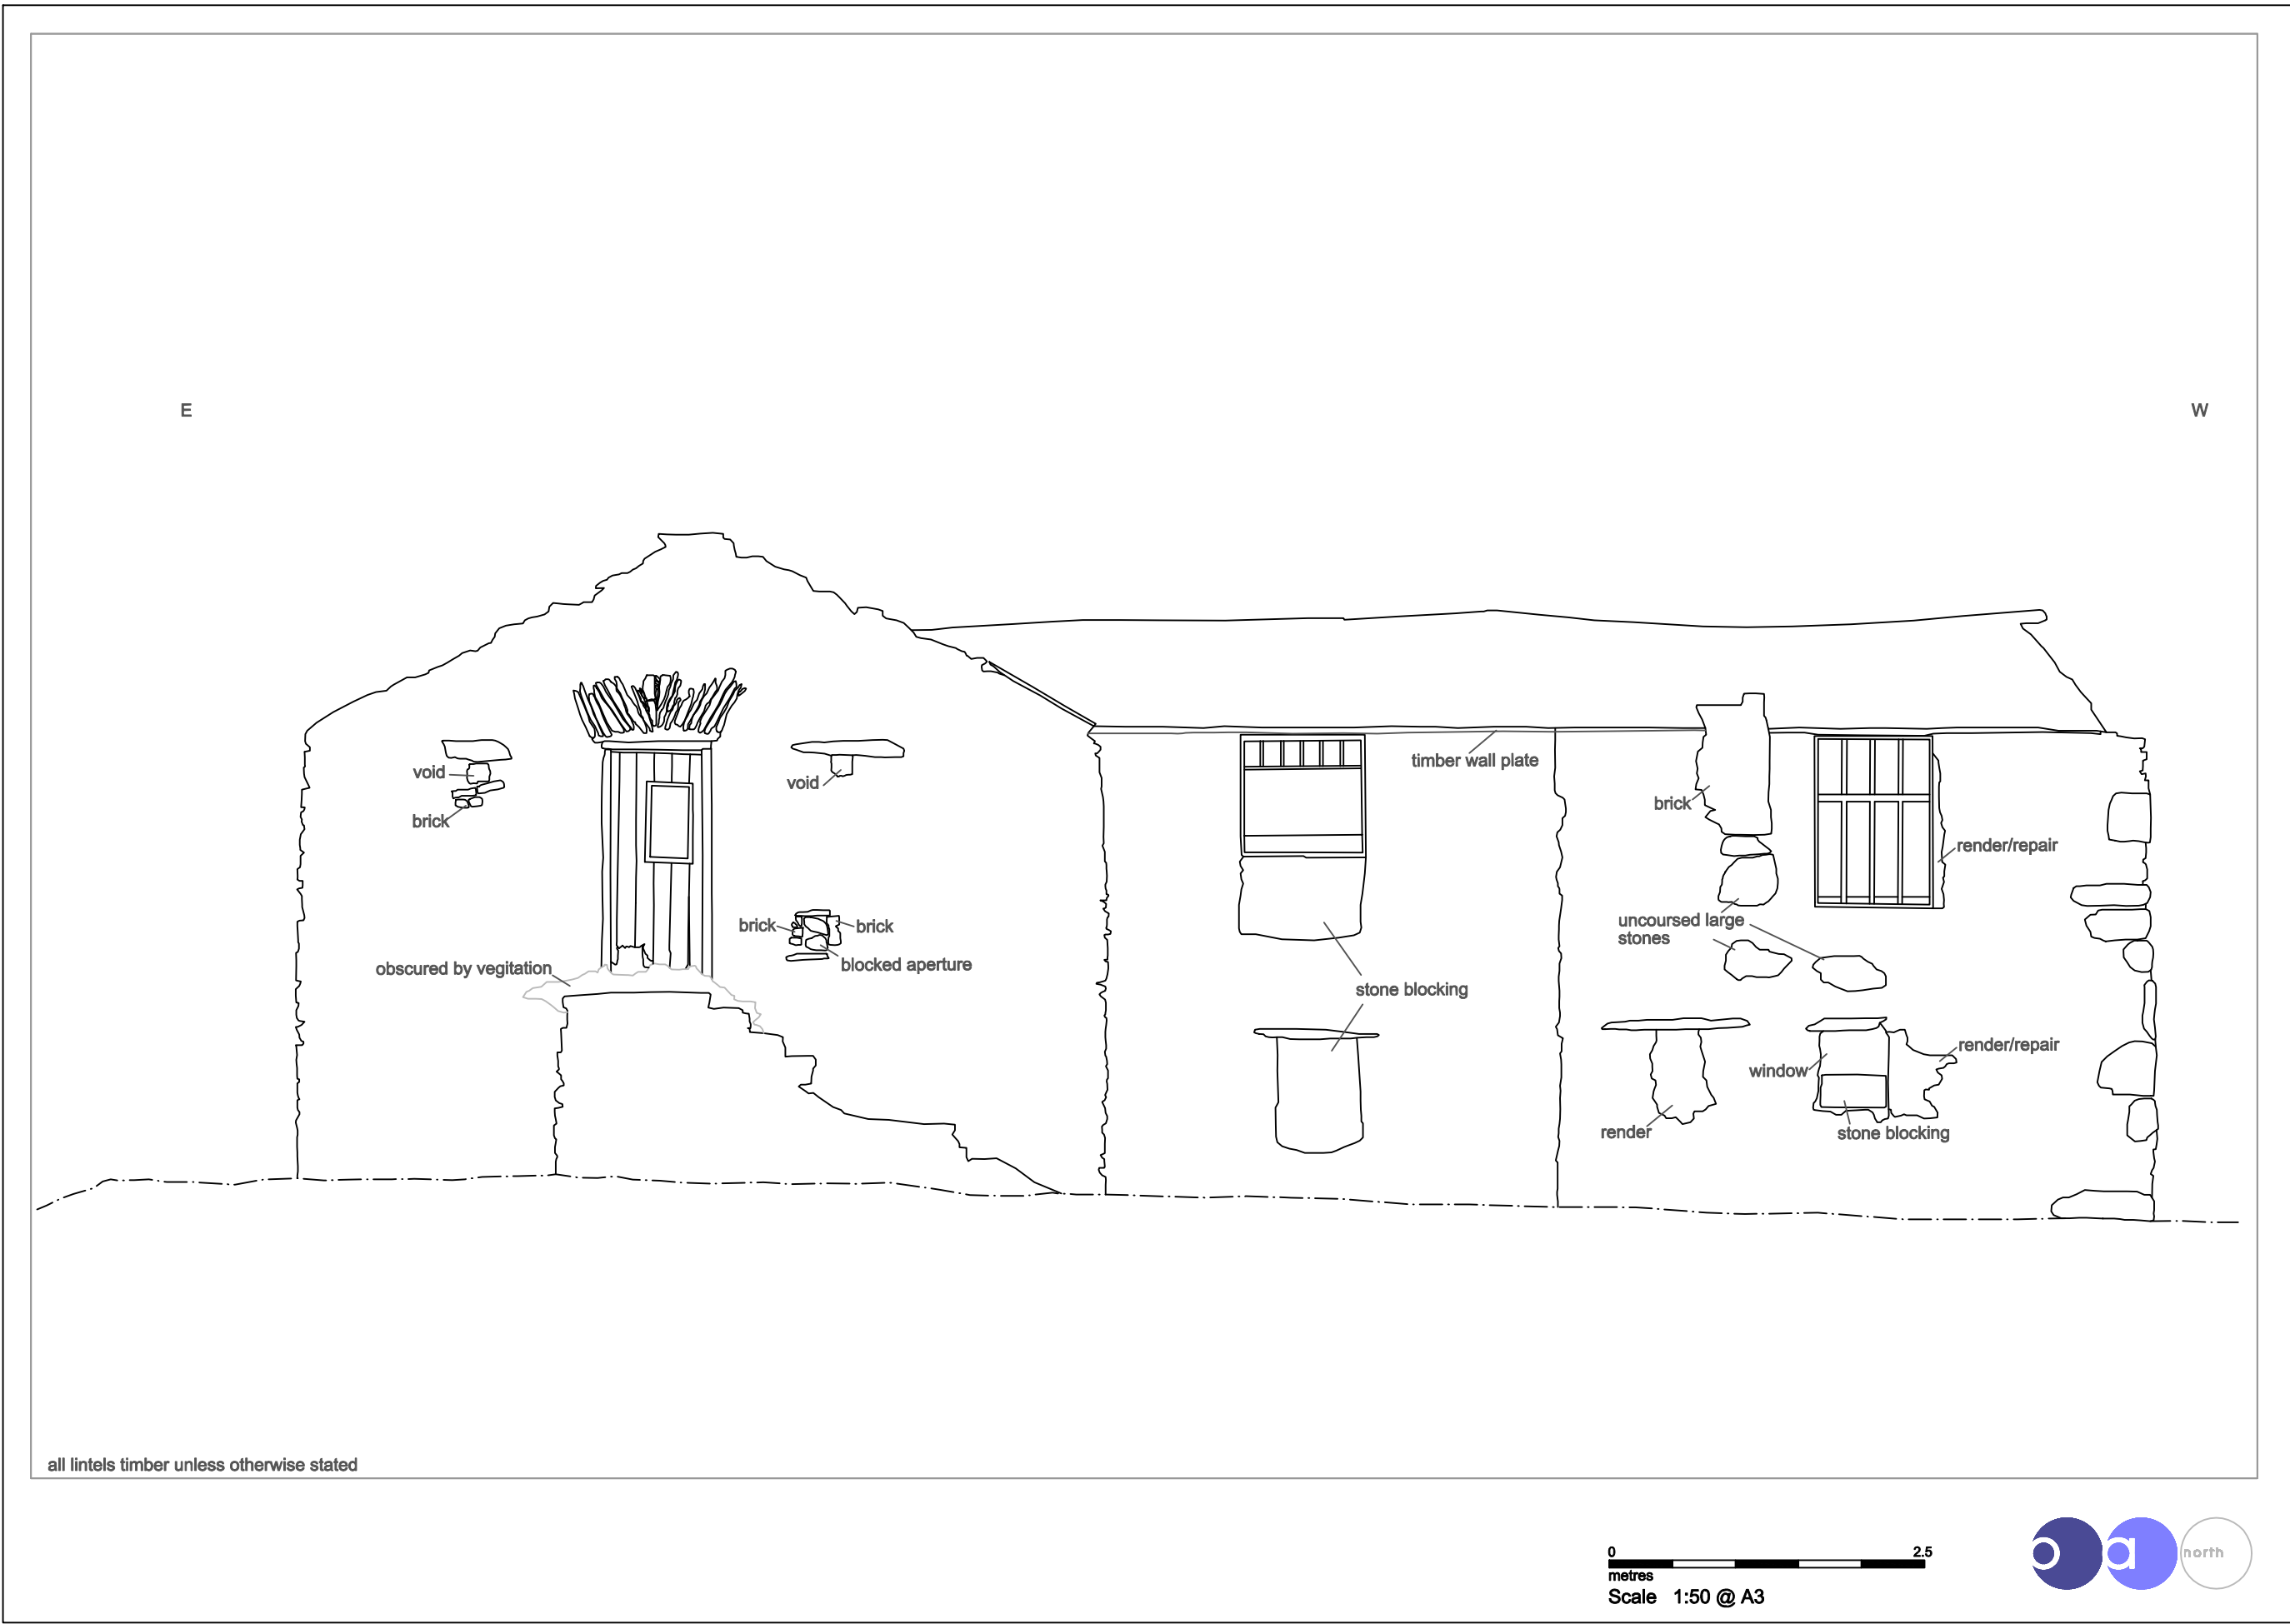
Figure 7: Elevation 1

- 4.4.2 It is evident that the wall was not constructed in a single phase, as shown by the two, very clear, vertical butt joins visible in the elevation (Fig 7). These correspond to the dividing walls between Rooms **1**, **2** and **4**. It would appear that Room **4** was the first to be built followed by Room **2** then Room **1** as Rooms **1** and **2** only have quoins on their western sides. The elevation of Room **1** is quite distinct in that it contains numerous large rounded boulders similar to those visible in the bed of the Black Brook. An inserted chimney (stack missing) constructed from hand-made brick is present just to the east of the western window on the first floor.

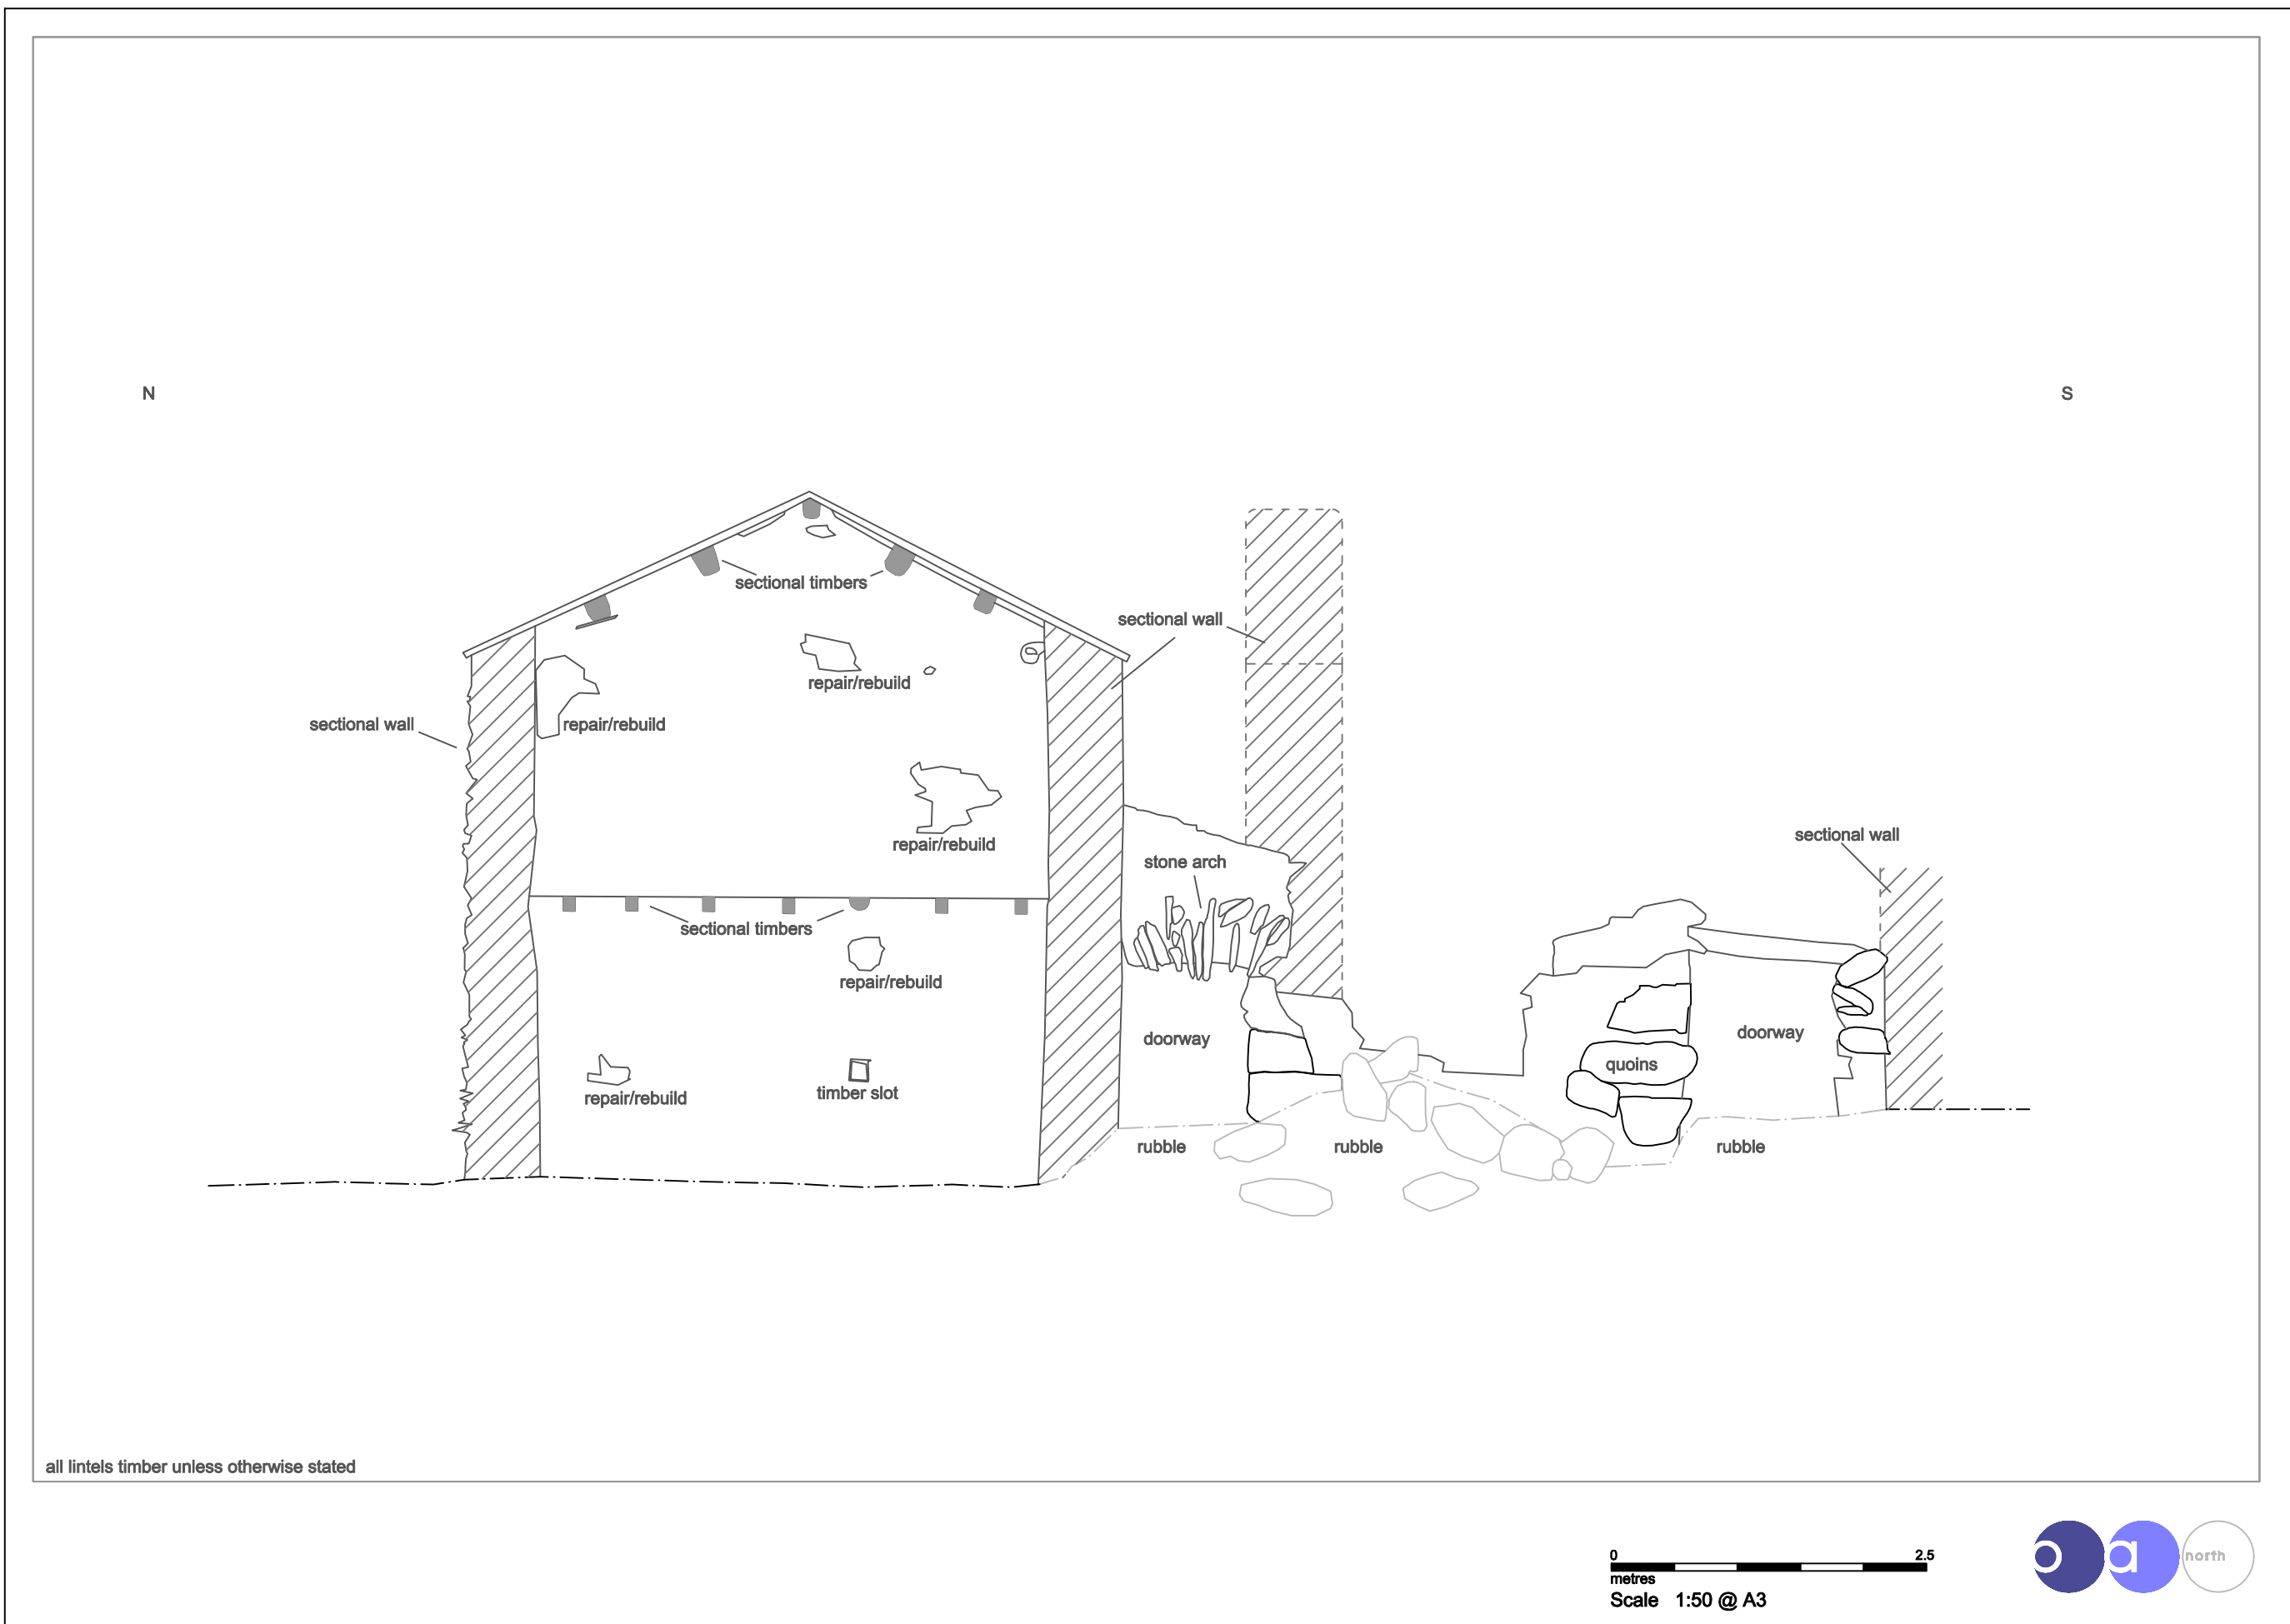
Figure 13: Elevation 7

- 4.4.8 **Elevation 7:** (Fig 13; Plate 9) forming the west external elevation of Rooms 5 and 4 and the east internal elevation of Room 2 (Section 4.5.4), the exterior part of Elevation 7 is much degraded and little survives. At the south end of the wall a doorway allowing access into Room 5 has a surviving timber lintel. The fabric comprises angular and sub-angular split stone and large unworked quoins are present at both ends of the wall. To the north of the elevation a doorway allows access into Room 4. This has a very precarious door head similar to the door on Elevation 1, which allowed access to the upper floor of Room 4 (Section 4.4.1).

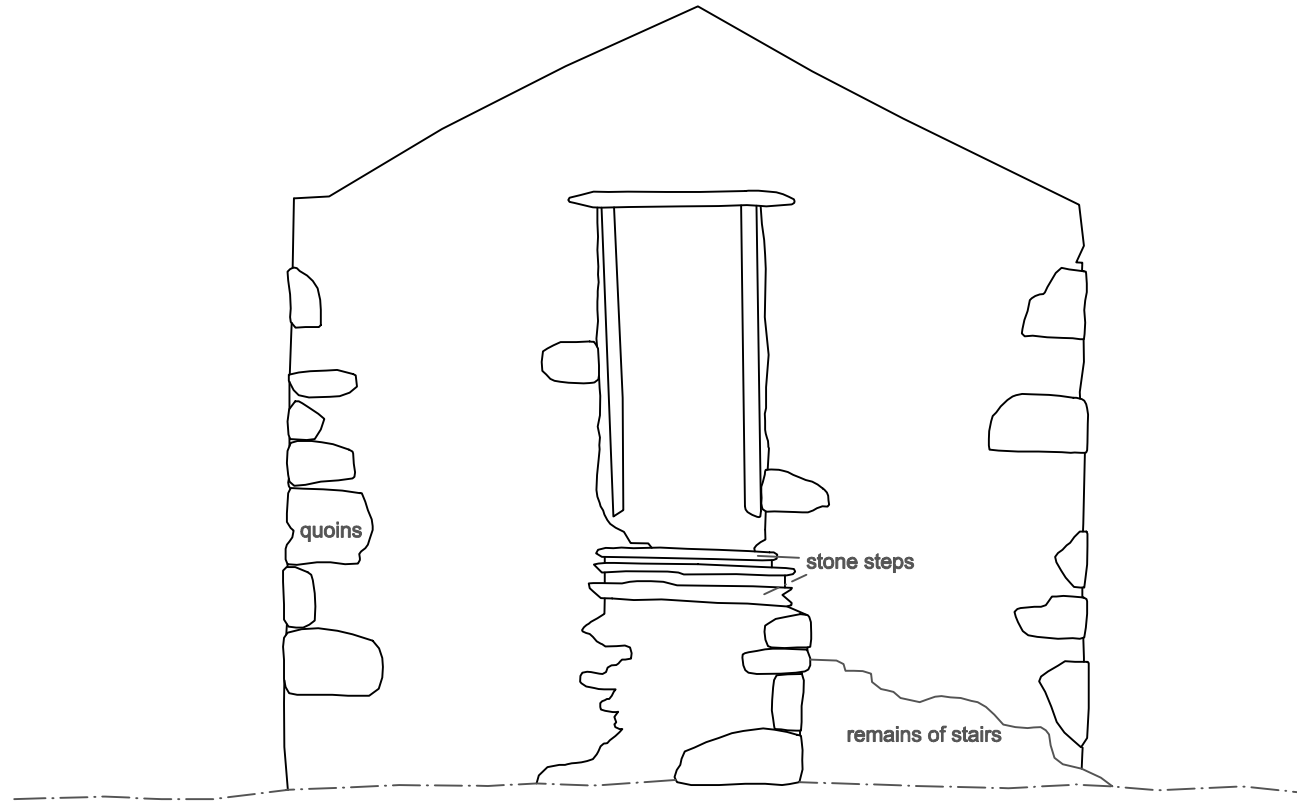
Figure 15: Elevation 9

- 4.4.11 **External Elevation 9:** (Fig 15; Plate 11) this forms the east-facing gable elevation of Rooms 1 and 3. It is constructed from a mixture of varying stone types and sizes which were probably collected locally and has large quoins. A single door with a stone lintel and missing threshold is the only access into Room 3, and is reached via a flight of semi-collapsed stone steps (similar to those described in *Section 4.1.1*). There is a small flagged landing at the top of the steps and, unlike those steps described in *Section 4.4.1*, there is a storage space beneath. The steps contain possible evidence of a handrail in the form of leaded holes in the steps (R Newman *pers comm*). The door is side-hung and of battened construction similar to that in Room 1. There is a simple timber surround and the whole assembly is in very poor condition. Above the door is a slate drip course below which are two square holes that may have held a timber for a porch (one of which still contains a timber).

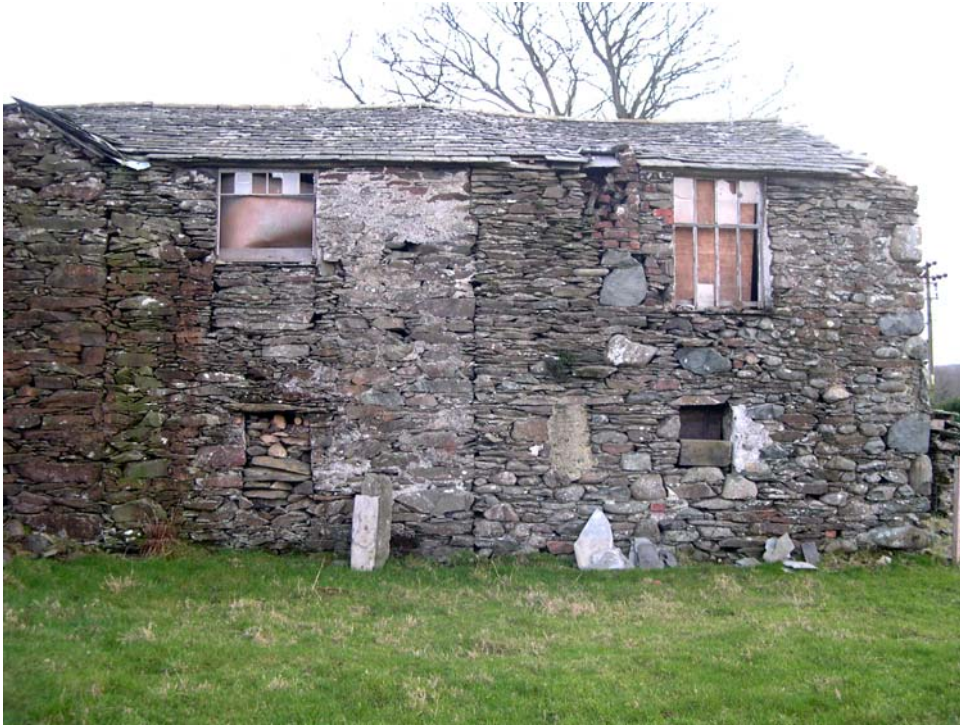
Plate 4: West end of Elevation 1

- 5.2.7 **Phase 6:** the Phase 5 extension was later extended further to the west with the addition of Room 1 and the associated steps. A vertical build line can clearly be seen in Elevation 1 (Plate 4). Room 3 was evidently also created at this time probably by removing the upper part of the east gable wall. The roof was also modified with the addition of new purlins and a truss was obviously required to compensate for the missing cross wall. The roof appears to have been re-covered some time later.

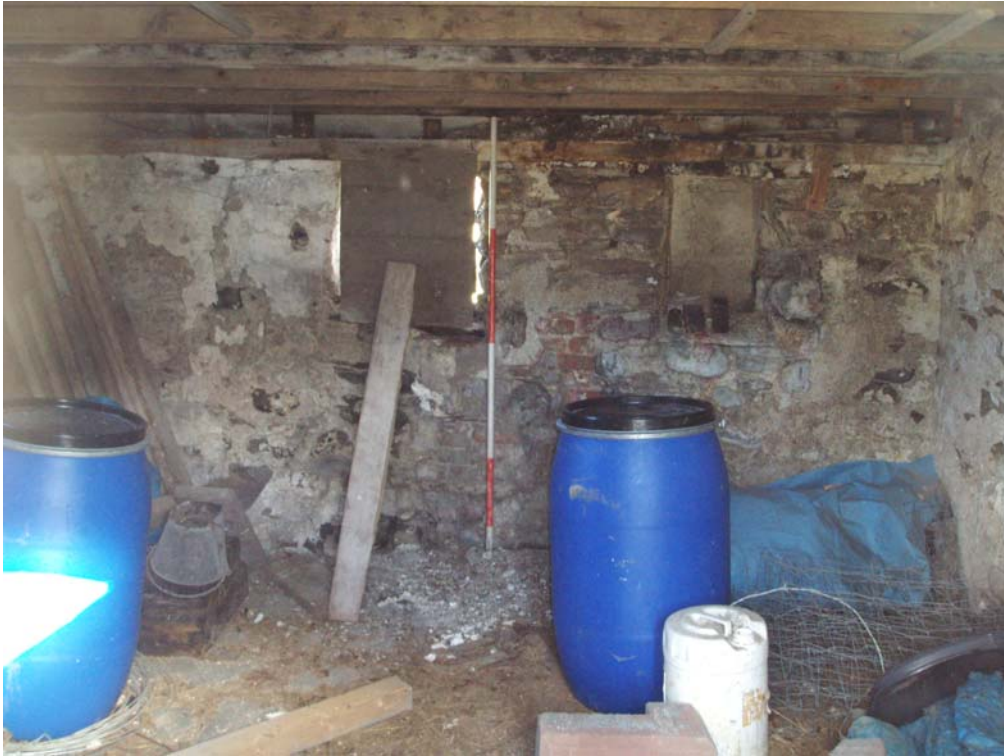
Plate 12: North-facing view of Room 1

- 4.5.2 There are two windows present on Elevation 10 as described in *Section 4.4.1* one of which is boarded and the other has been permanently blocked and rendered with cement (Plate 12). Both windows have timber lintels and sills and appear to be fire damaged. The area between these windows has been partially rebuilt in brick. The east wall (Elevation 22) contains a further

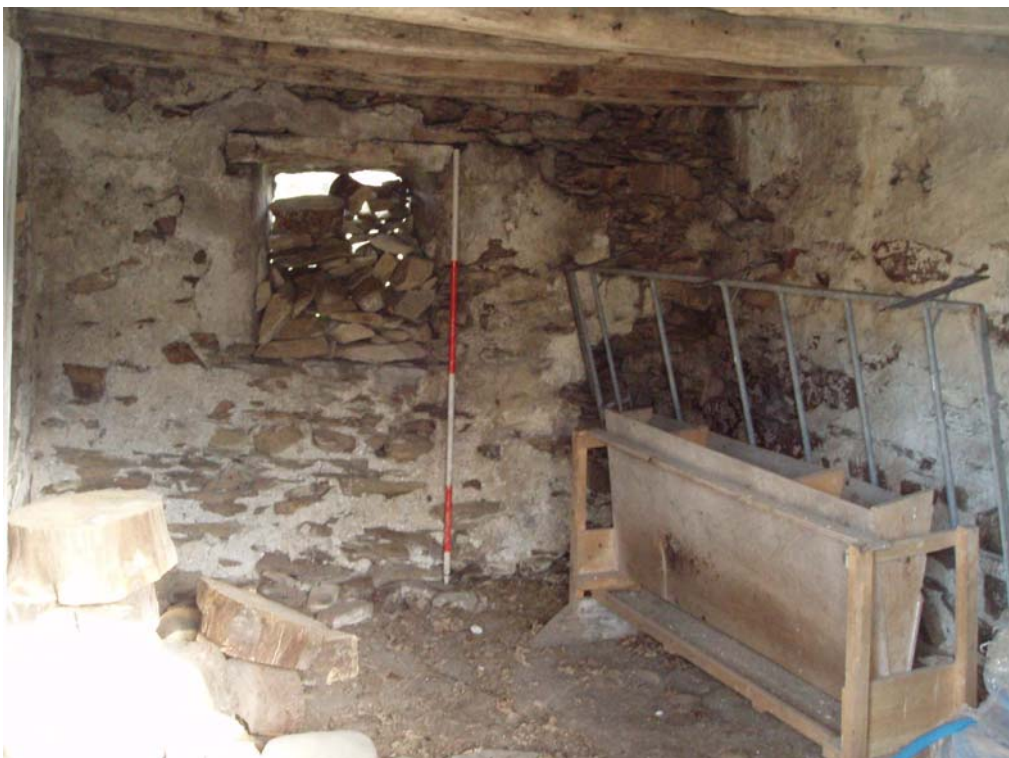
Plate 13: North-facing view of Room 2

- 4.5.4 **Room 2:** (Fig 3; Plate 13) (Fig 13 Elevation 7; Fig 16 Elevation 10; Fig 25 Elevation 20 and Fig 28 Elevation 23) east of Room 1, this room is of similar appearance and is also being used as a general store room. It is accessed via a single door located in Elevation 8 (Fig 14 *Section 4.4.9*). In common with Room 1, the walls have the remains of lime plaster/limewash present and are constructed from coursed small-to medium-sized sub-angular and sub-rounded stones. Larger ‘pad stones’ are to be found at the base of each wall.

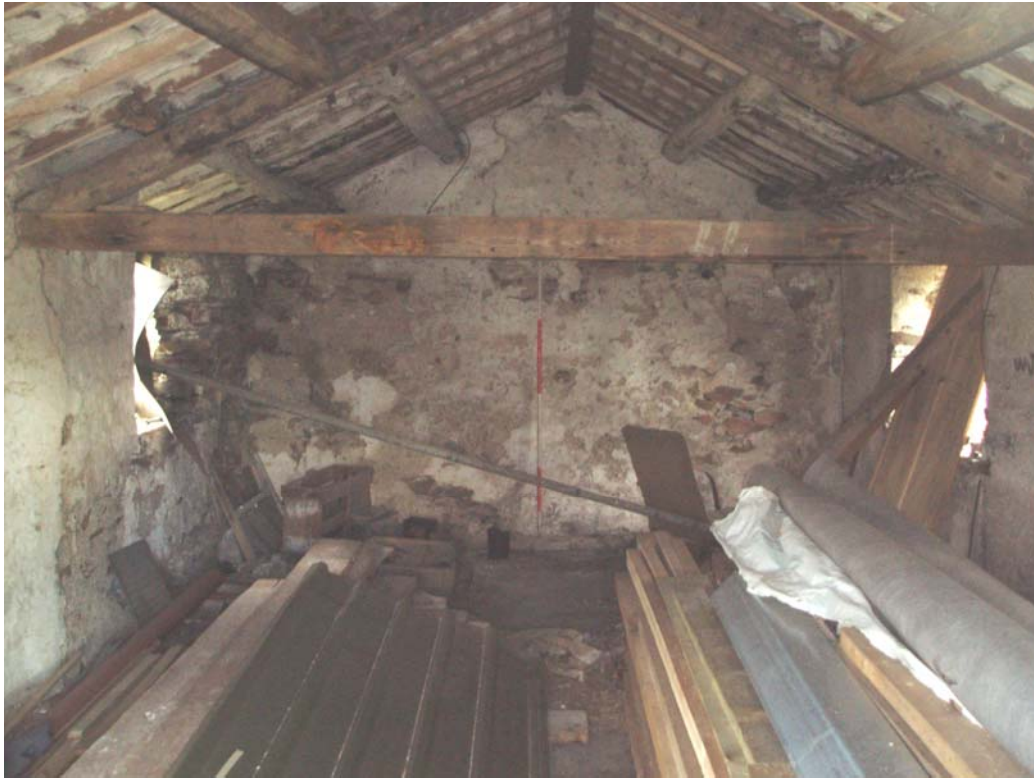
Plate 14: East-facing view of Room 3

- 4.5.7 **Room 3:** (Fig 4; Plate 14) (Fig 13 Elevation 7; Fig 16 Elevation 10; Fig 25 Elevation 20 and Fig 26 Elevation 21) comprising the first floor of the roofed section of the complex, above Rooms 1 and 2, this rectangular room is accessed via the doorway described in *Section 4.4.11*. There are four windows (*Sections 4.4.1 and 4.4.9*) both with splayed reveals. The walls are of similar appearance to both Rooms 1 and 2 and are mostly lime-plastered or limewashed with some brick patching and repair. There is a butt join visible in the south wall (Elevation 20) 1.2m east of the west window. The wall which divides Rooms 1 and 2 does not continue up into this room but there are slight bulges on each of the long walls in the area where the wall would have been. It is possible that the wall has been removed to create a larger space.

- 4.5.8 The floor is laid down to 10 inch wide timber boards on the east side and 6 inch wide boards on the west. The roof is supported by a single principal rafter truss located in the centre of the room (roughly in line with the butt join noted from Elevations 1 and 8 (*Sections 4.4.1 and 4.4.10* respectively)). East of the truss there are four purlins (carried on the back of the principal rafters), together with a ridge purlin. West of the truss there are only two, higher quality (and probably later) tenoned purlins. The opposite ends of the purlins rest on the gable walls. The remainder of the roof comprises common rafters and battens, the spaces between which are lime plastered. It is probable that the truss was inserted when the room was enlarged.

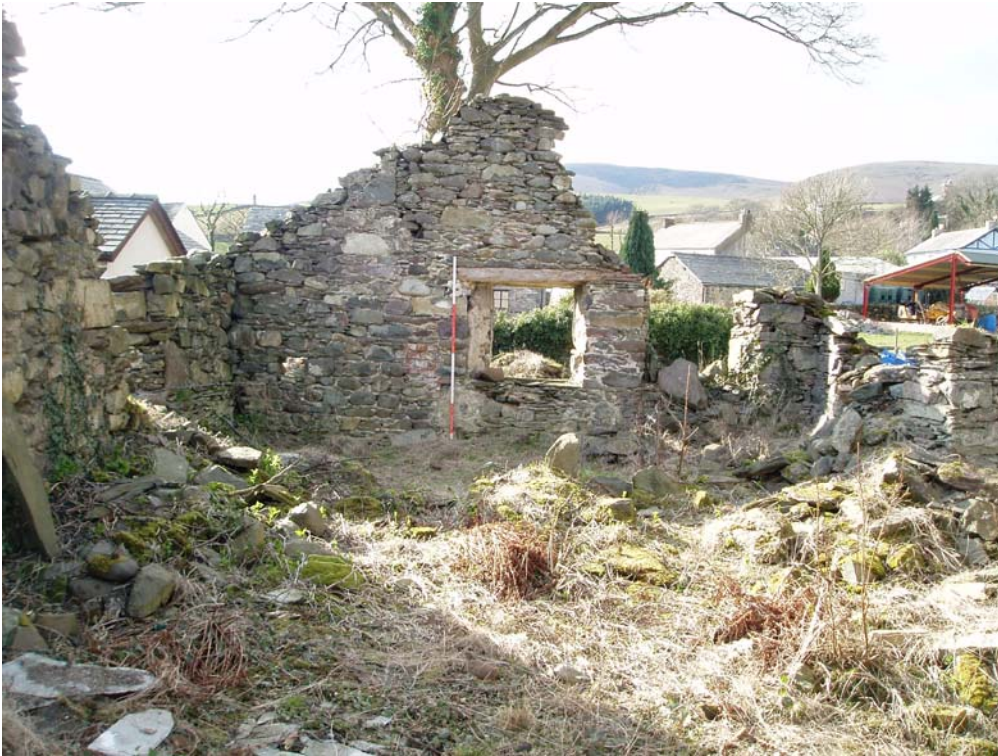
Plate 18: West-facing view of Room 7

- 4.5.20 **Room 7:** (Plate 18) (Fig 18 Elevation 13; Fig 19 Elevation 14; Fig 20 Elevation 15 and Fig 21 Elevation 16) this is the largest room of the complex and is constructed from a mixture of coursed angular, sub-angular and sub-rounded stone with lime mortar. There are areas of brick patching and repair above the doorway in to Room 6 in Elevation 16 (Fig 21), next to the window in Elevation 15 (Fig 20) and next to the window and doorway and gable on Elevation 14 (Fig 19). The butt joint between Rooms 6 and 5 can clearly be seen to the west of the door in Elevation 16 (Fig 21).

- 4.5.24 The floor although obscured by large amounts of collapsed wall material was observed to be stone-flagged in places. Also visible were some internal structures which consist of othostats – probably a tank of some description.

- 6.2.1 As the floors within the ground floor rooms were obscured by collapsed wall material, the identification of any internal structures was impossible during the building survey. Room 7 in particular contains features that may help to identify the industrial processes carried out on the site. It is recommended therefore, that a watching brief or further building survey should be carried out when debris is cleared from the floors. Similarly, any excavation of new services or foundation trenches should also be monitored by watching brief in order to identify earlier features or to collect dating material. Any identified features of particular architectural/historical importance, such as tanks or hearths, should be conserved *in situ* as far as is practicable.
