# BRAIDES FARM, COCKERHAM, LANCASHIRE

## Archaeological Building Investigation

**Jacksons Ltd**

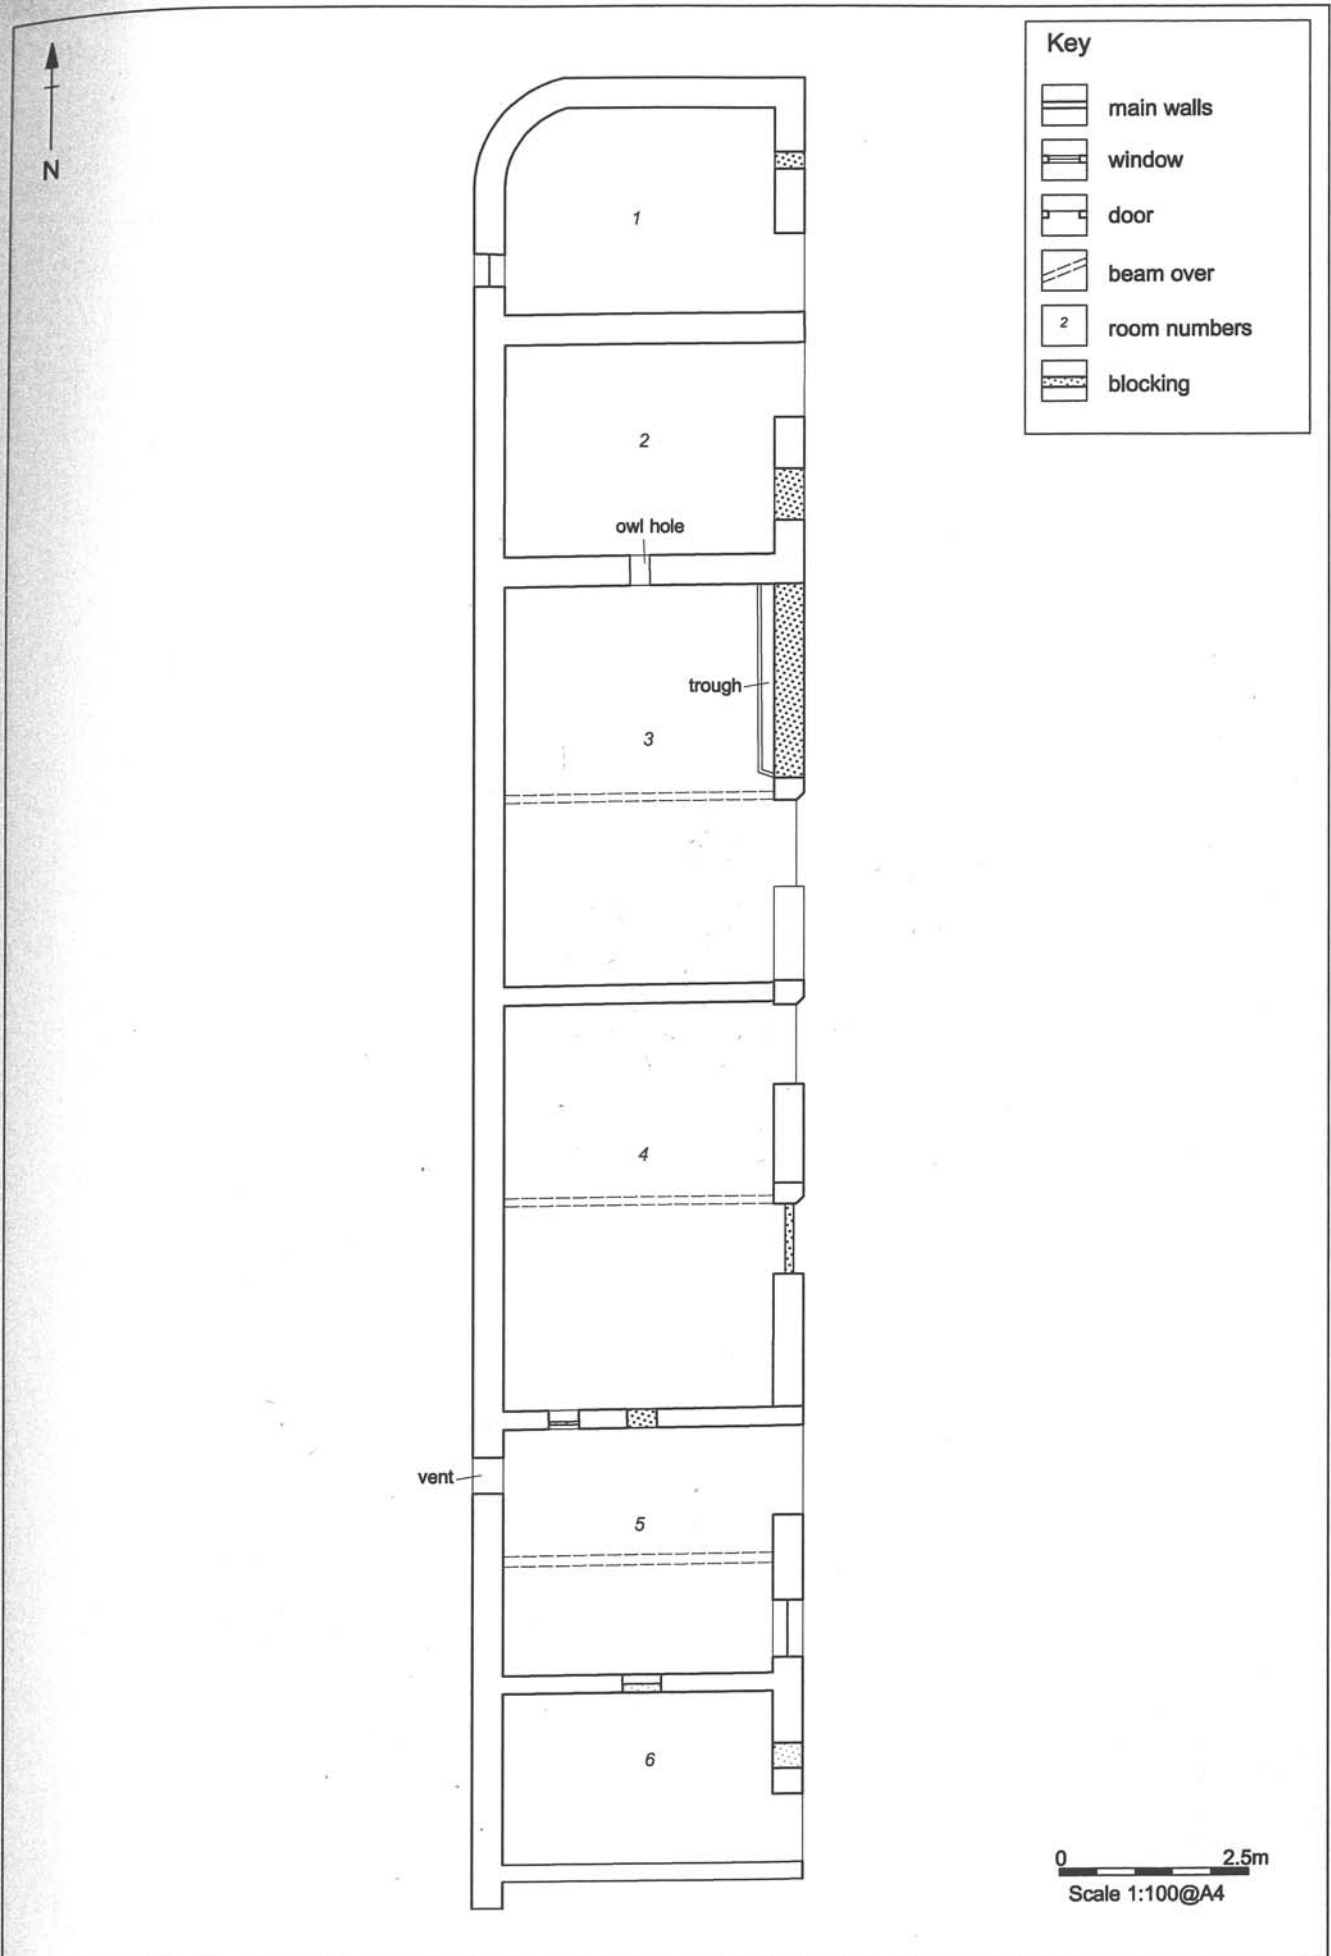
Figure 3: Plan of the Cow Shed

4.2.1 The west shed is a single-storey, rectangular building which is divided into several livestock stalls (Figs 3 and 4). It is built from a single phase of coursed red sandstone rubble (Plates 1-4), but the front (east) elevation of the building has undergone a considerable amount of alteration, with various materials including concrete, stone and timber being employed. The roof is of shallow to moderate pitch, laid with diminished courses of Welsh slate, and supported by waney-edged tie beams with trenched purlins. The upper face of the trusses is on the north side and carpenters' assembly marks are clearly visible (Plate 5).

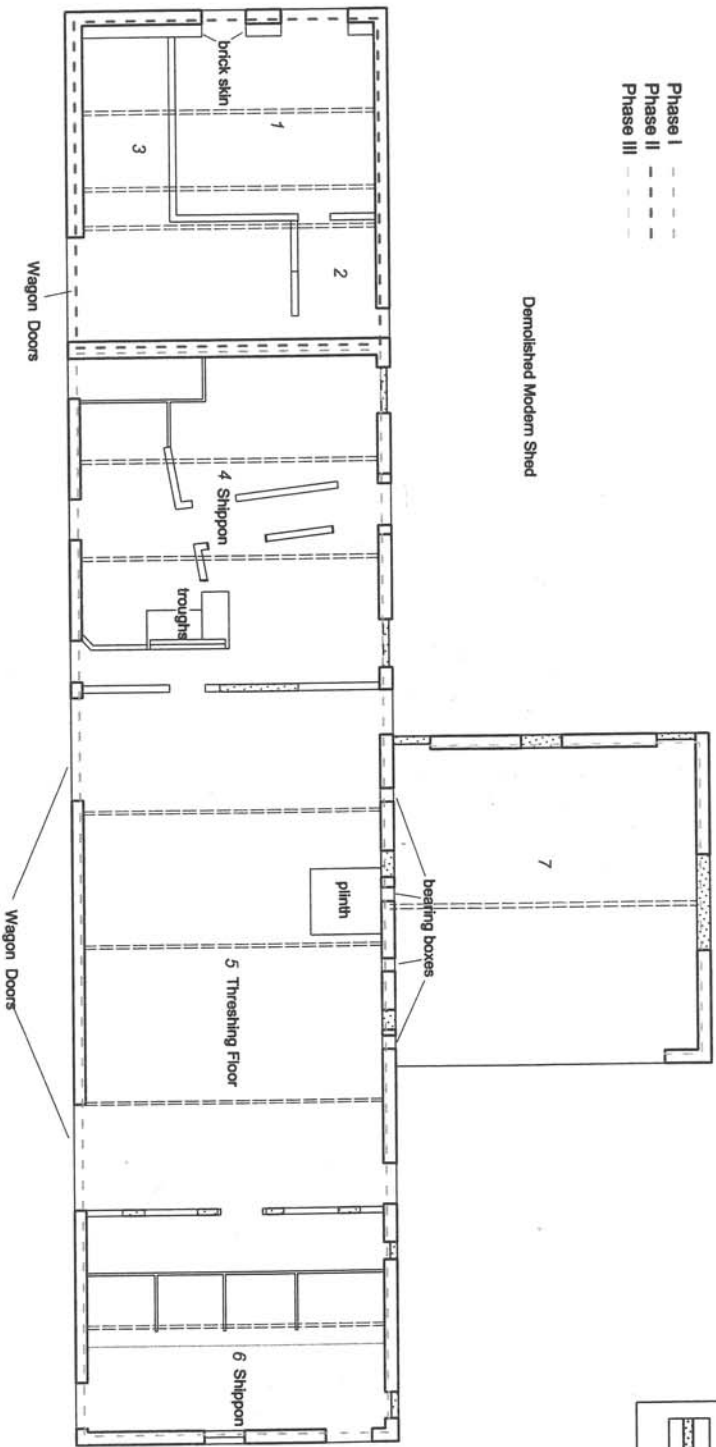
Figure 5: Plan of the North Barn

- 4.3.1 The barn comprises several phases of build forming an inverted T-shape (Figs 5 and 6). The earliest phase features foundations of limestone and sandstone, which are overlain with handmade brick laid in English Garden Wall (four to one), whilst the margins and dressings are detailed with well-cut, rock-faced stone (Plate 7, 11-12). To the west of this is an extension of coursed red sandstone rubble, with well-cut quoins on the dressings and margins featuring pronounced furrowing (Plate 8). Additionally, there is a second extension at the rear (north) of the building, which features well-coursed rubble with similar furrowed quoins (Plate 9). This is now housed within a modern extension of klinker block and corrugated iron, but being modern, this later structure has been omitted from the survey.

- 4.4.1 As noted above, the barn comprises several phases and, subsequently, to facilitate ease of reference, the division of space within it has been numbered (Fig 5). The original phase at the east end of the barn consists of the 'threshing floor' area (5), with a shippin to both the west and east (4 and 6), both of which are overlain by haylofts. The west elevation has been partitioned into three with modern materials and comprises an L-shaped room at the front (south) (3) and two smaller rooms to the rear (1 and 2), whilst directly to the rear of room 5, is the north extension comprising a single open shed (7). The east wall of this shed has been demolished and it now forms part of the modern shed, but this has been excluded from the survey, because of its lack of architectural or historical significance.

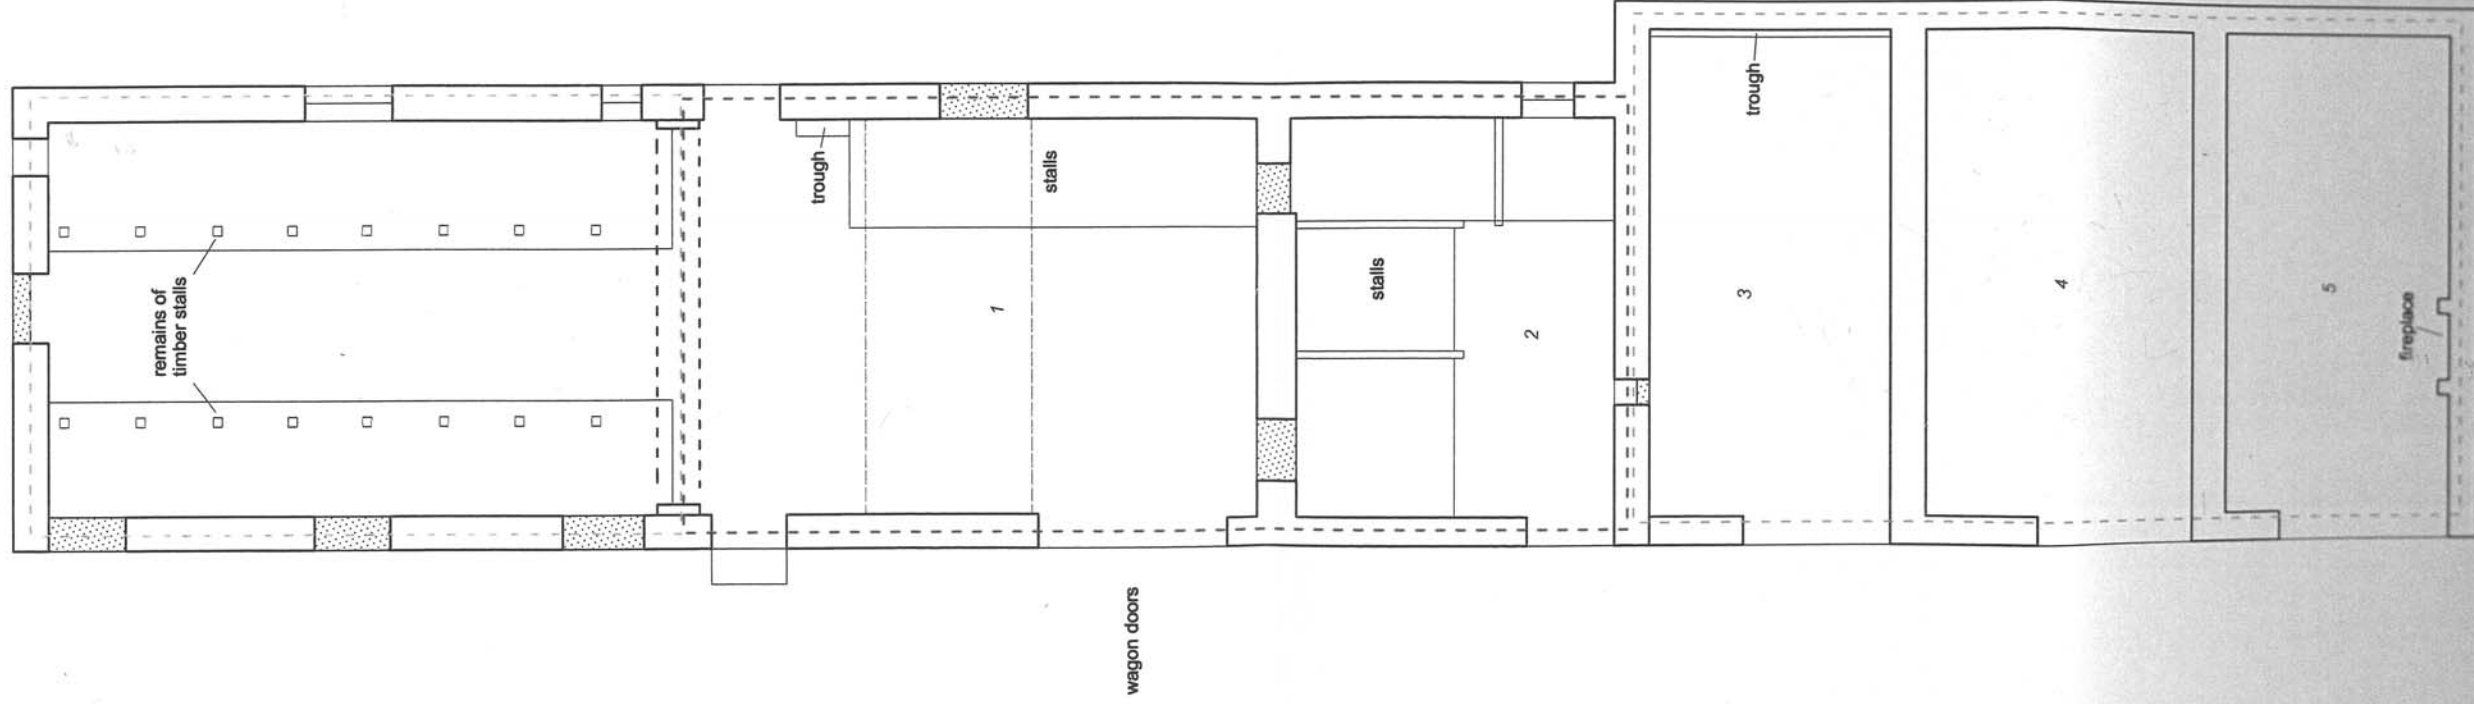
Figure 7: Plan of the East Barn

4.5.1 As was the case with the north barn, the building consists of several distinct phases of construction (Figs 7 and 8). The original build appears to be located at the north end of the elevation and is constructed from coursed squared rubble with rock-faced quoins on the dressings and margins (Plate 17). On the east elevation, there is a change in build from this ordered bond towards a more roughly-coursed build featuring sub-rounded and sub-angular stonework. Directly to the south of this original structure, there is a sympathetic extension, featuring extensive cobble repairs on its south-east corner (Plates 18 and 21), whilst additional repairs appear to have also been made to the uppermost courses, and in particular, above the wagon doors. The east elevation of this extension is now part of a modern shed, but it appears to be built with the same squared rubble, albeit with a coarsely-applied cement pointing. At the south end of the barn, a single-storey extension has been built in coursed rubble with rock-faced stone on the dressings and margins, whilst in the centre, there are klinker block repairs or infill (Plate 19).

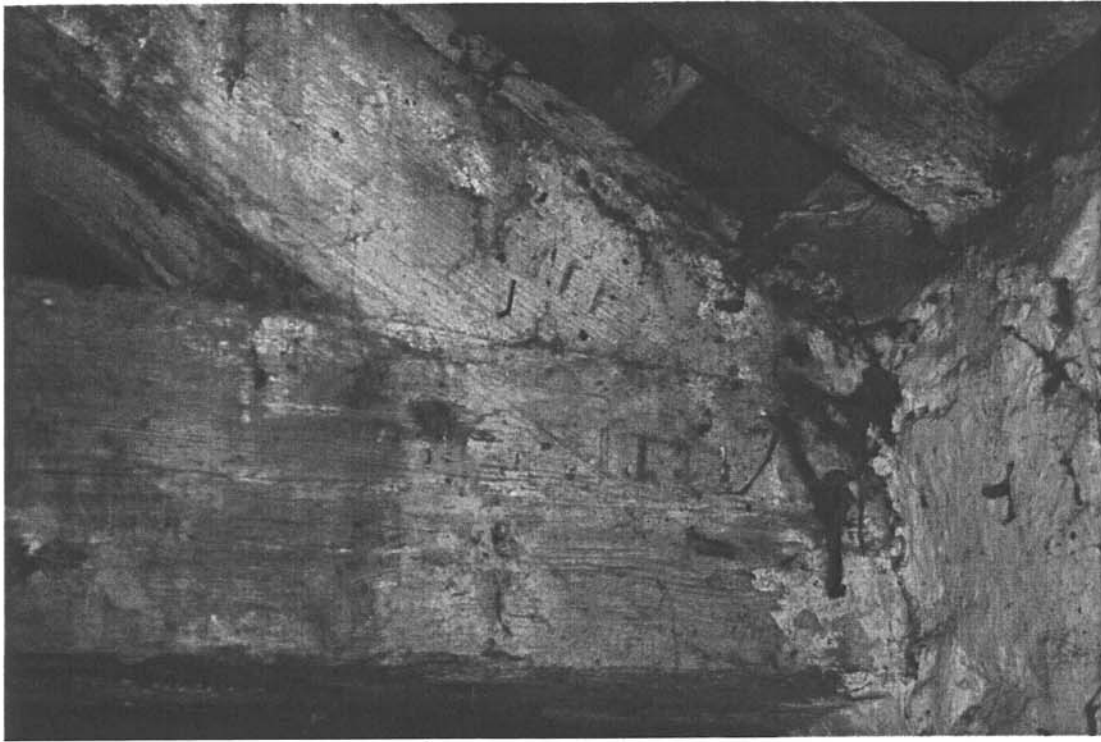
Plate 5: Detail of the carpentry marks on one of the trusses within the West Cow Shed

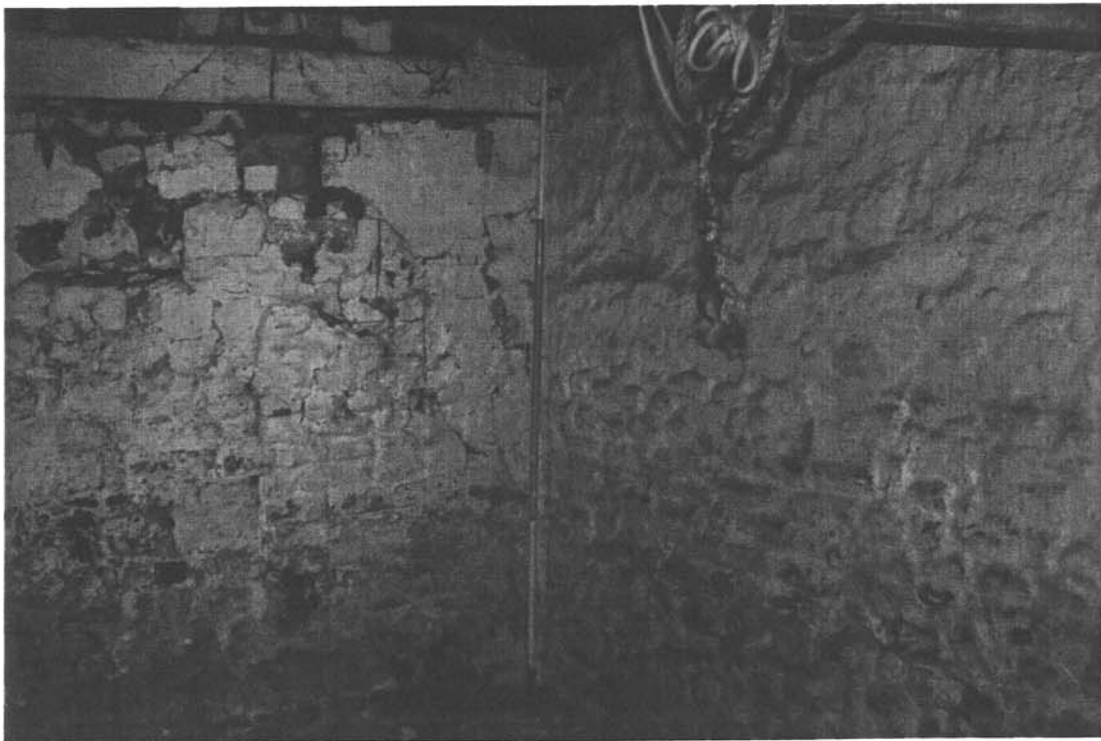
finished with a thick limewash, with occasional brick repairs/insertions (Plate 6).

Plate 6: General view of one of the stalls within the West Cow Shed

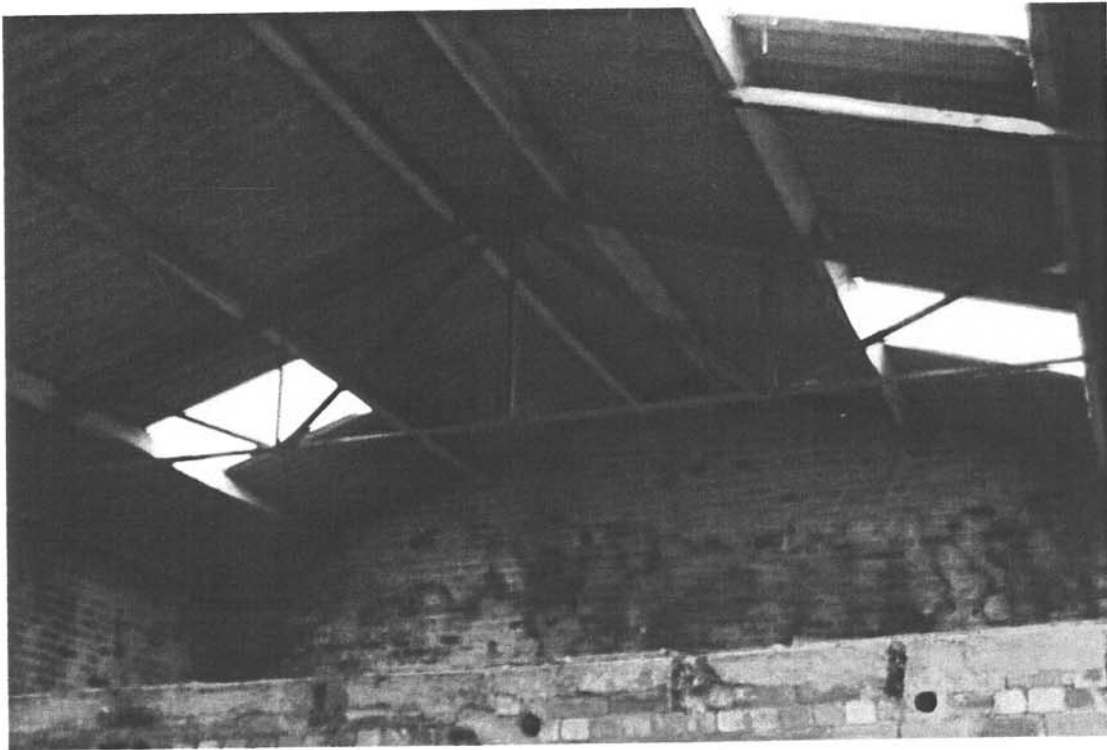
- 4.3.2 The roof of the long axis of the barn is laid with corrugated asbestos cement supported by three pairs of machine-cut purlins overlying L-section steel trusses (Plate 10). These modern trusses feature three vertical braces and two pairs of diagonal supports. The roof to the rear extension, being now part of the modern shed, is laid with corrugated iron sheets supported by iron beams trenched within the north and south walls.

Plate 10: Detail of one of the modern trusses within the North Barn

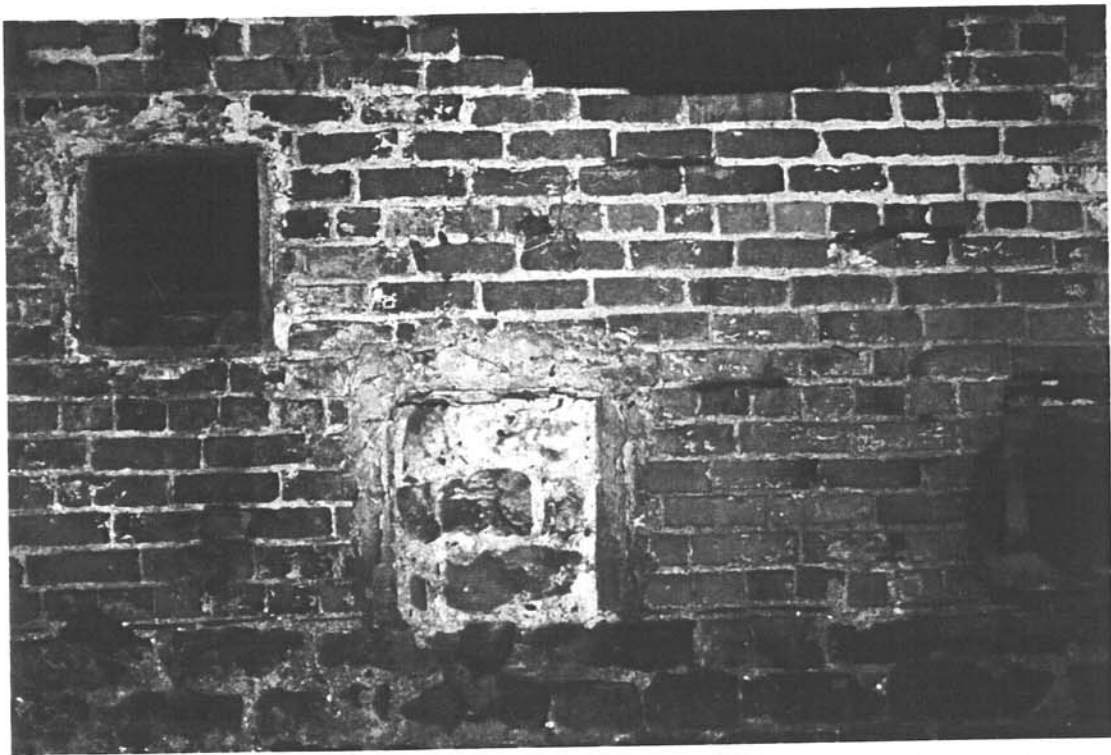
- 4.4.3 The floors throughout the building are laid to concrete, with the exception of the threshing area (5), the rear extension (7), and the L-shaped room to the south-west (3), which are all bare earth. Of particular interest is the sub-rectangular concrete plinth lying within the main threshing barn area, which appears to be some form of machine base. Certainly, the adjacent north wall would appear to have several bearing boxes associated with it (Plate 16).

Plate 16: Bearing Boxes on the north wall of the main threshing area, within the North Barn

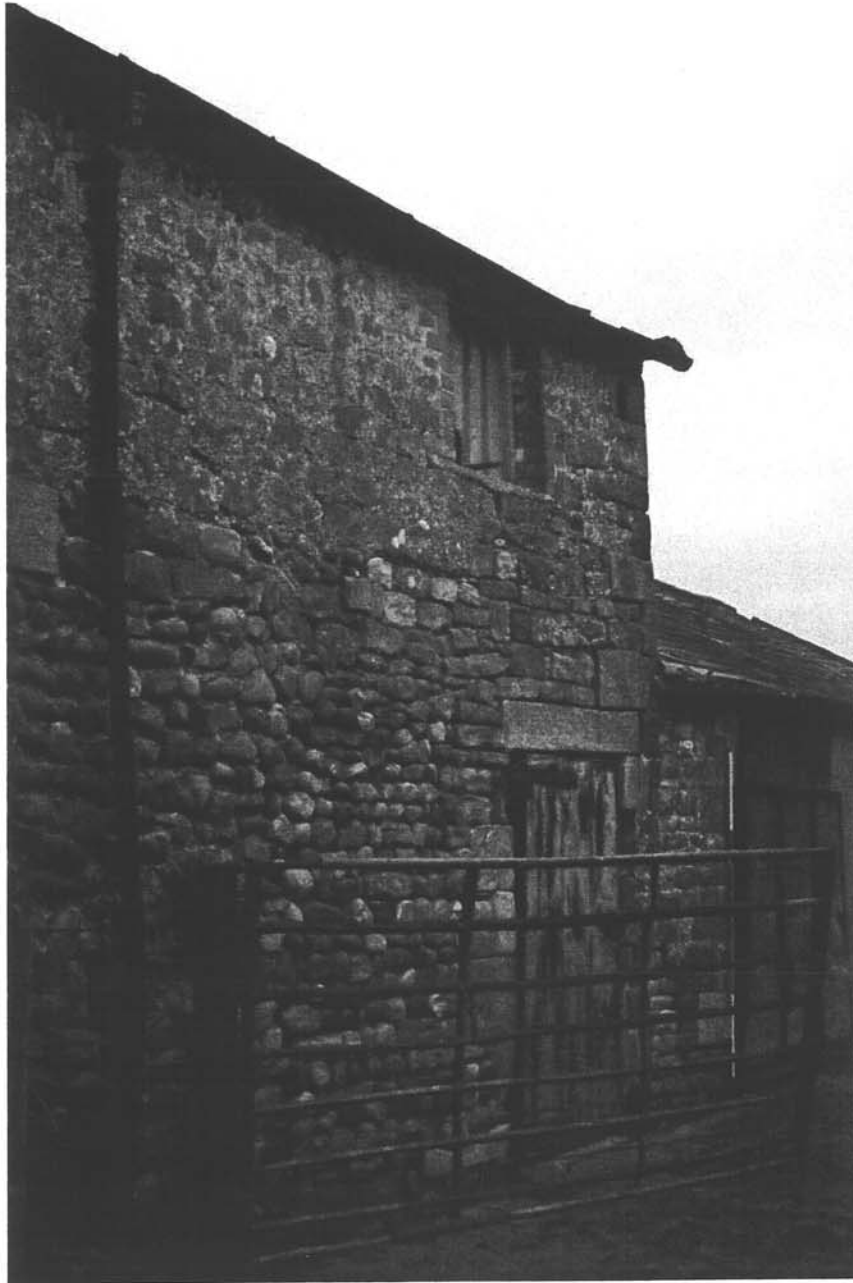
- 5.4.3 At the south end of the west elevation, there is a mixture of builds, which creates something of an imbroglio. Whilst the upper reaches of the elevation appear to be comparable with the rest of the elevation, there is a substantial patch of rough sub-rounded stone or cobble beneath. This cannot be later repair or infill, because the structural integrity of the south-west corner of the building would have been compromised. Thus, it may represent an earlier structure, which has been partially incorporated into this late development.

Plate 18: Detail of the west elevation of the East Barn featuring rebuild at the south end of the second phase, with the later single-storey phase in the background

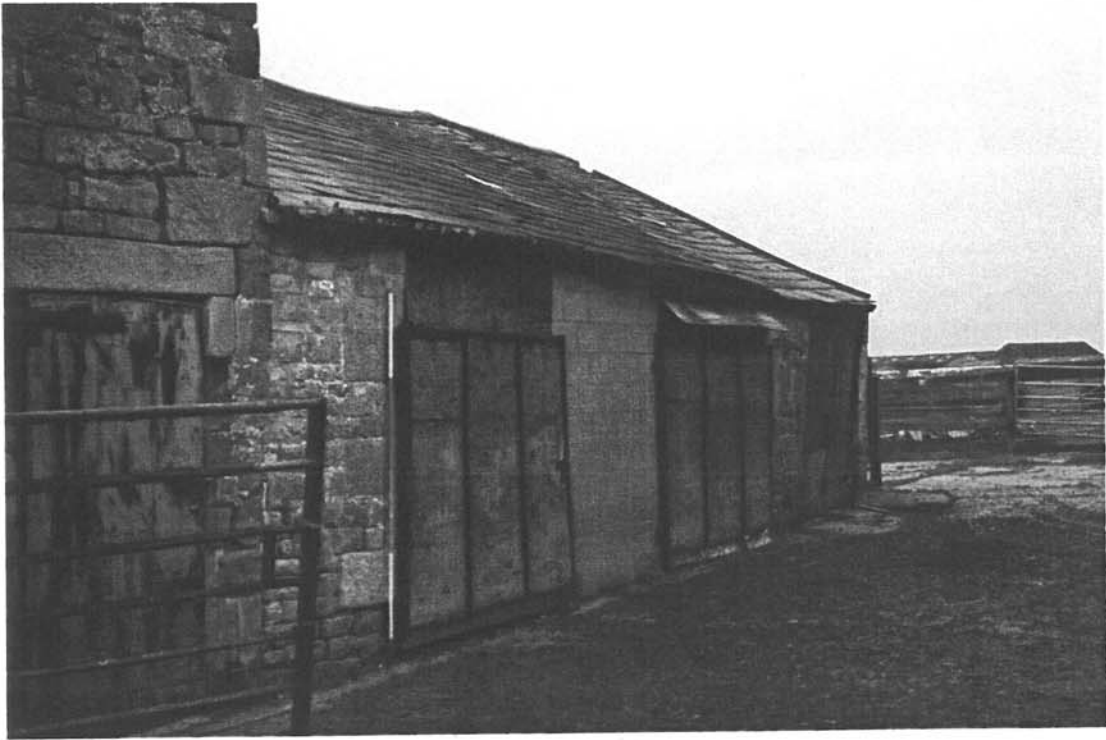
Plate 19: The single-storey extension at the south end of the East Barn

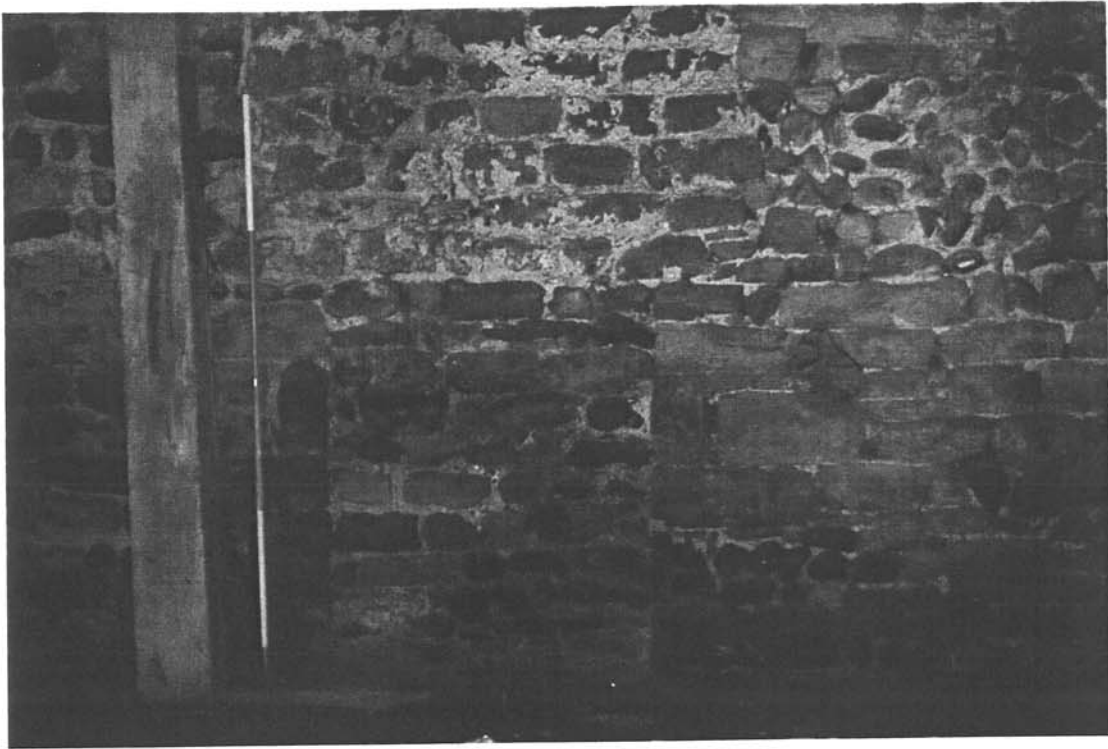
- 4.5.4 The windows are a similarly diverse mix of sizes and styles. On the front (west) elevation, there is a first floor casement with well-cut rock-faced quoins and lintel, whilst at the other end of the barn, there is a small first floor window, featuring brick repairs on the jambs and a perspex window. On the north elevation, there is a stone-blocked window, with a small casement to the left, whilst on the rear (east) of the building, there are a further pair of casements. Of these, the window to the right of the elevation is a top-hung ventilator casement with a chamfered lintel (Plate 23), whilst the remaining window has a narrow timber lintel and rough stone jambs. Additionally, there is a further pair of casements, comprising a plain casement and an ephemeral stone-blocked window within the modern extension (Plate 21).

Plate 21: Detail of a blocked window within the two-storey section of the East Barn

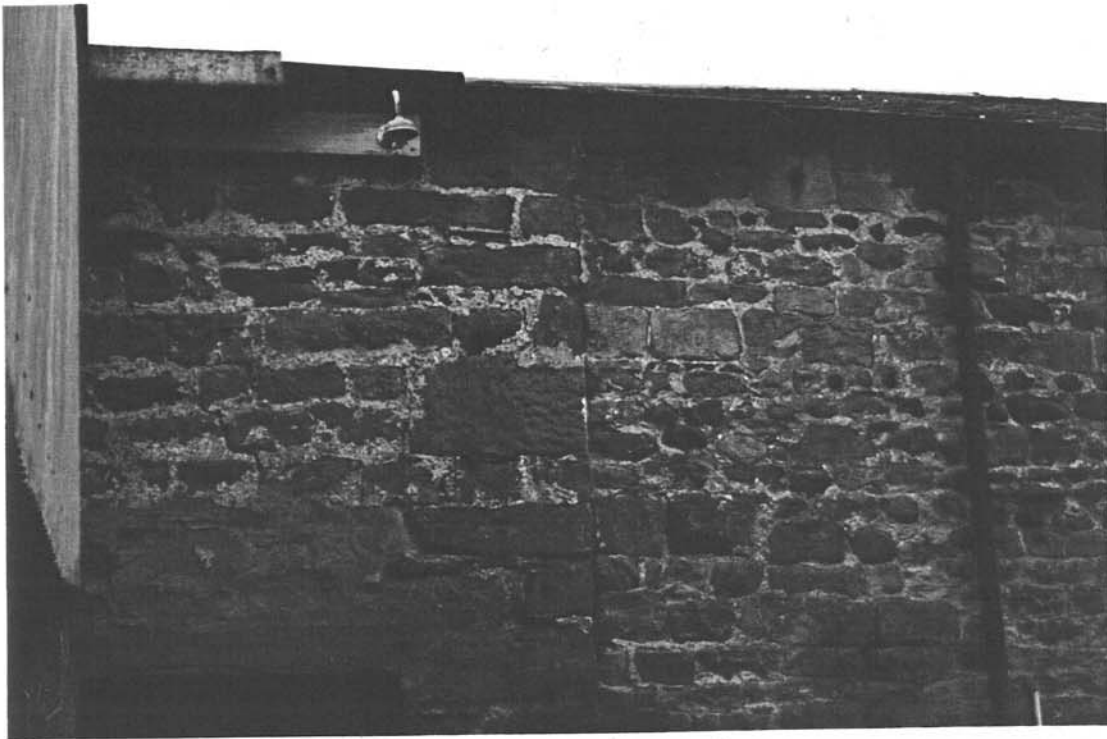
Plate 22: The butt-joint between the original and secondary builds on the east elevation of the East Barn

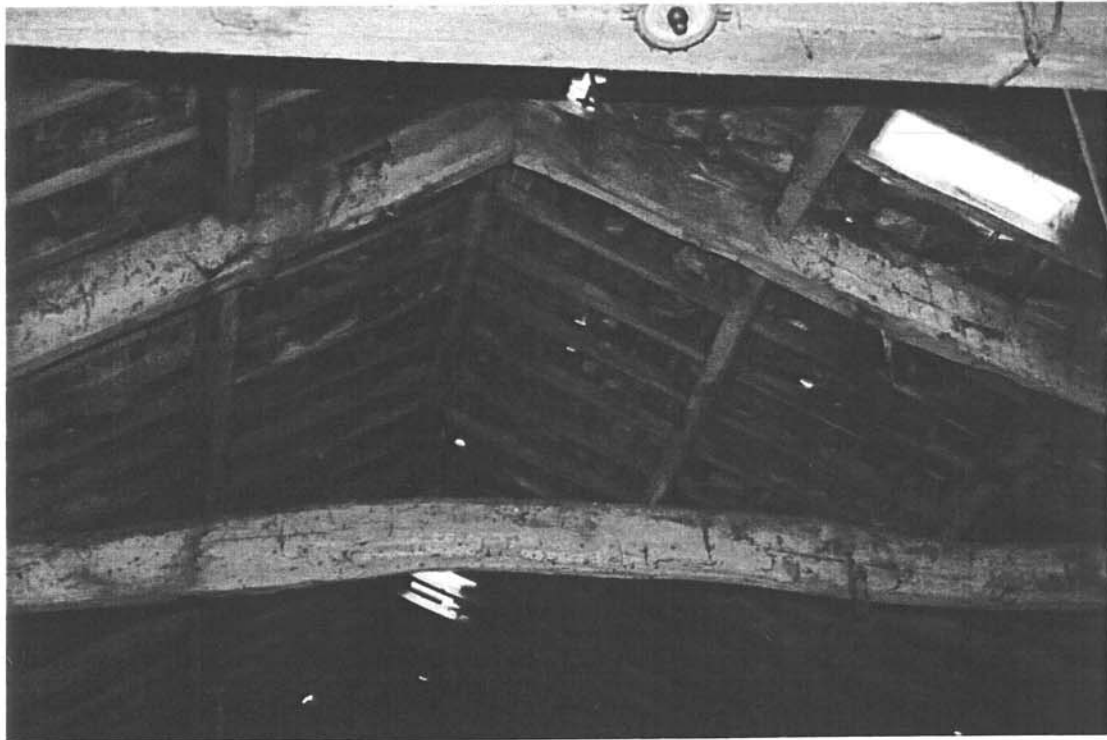
Plate 24: The waney-edged truss within the original phase of the East Barn
