MERLEWOOD, GRANGE-OVER- SANDS, CUMBRIA

Historic Building Investigation, Topographic Survey and Archaeological Evaluation

Oxford Archaeology North

March 2008

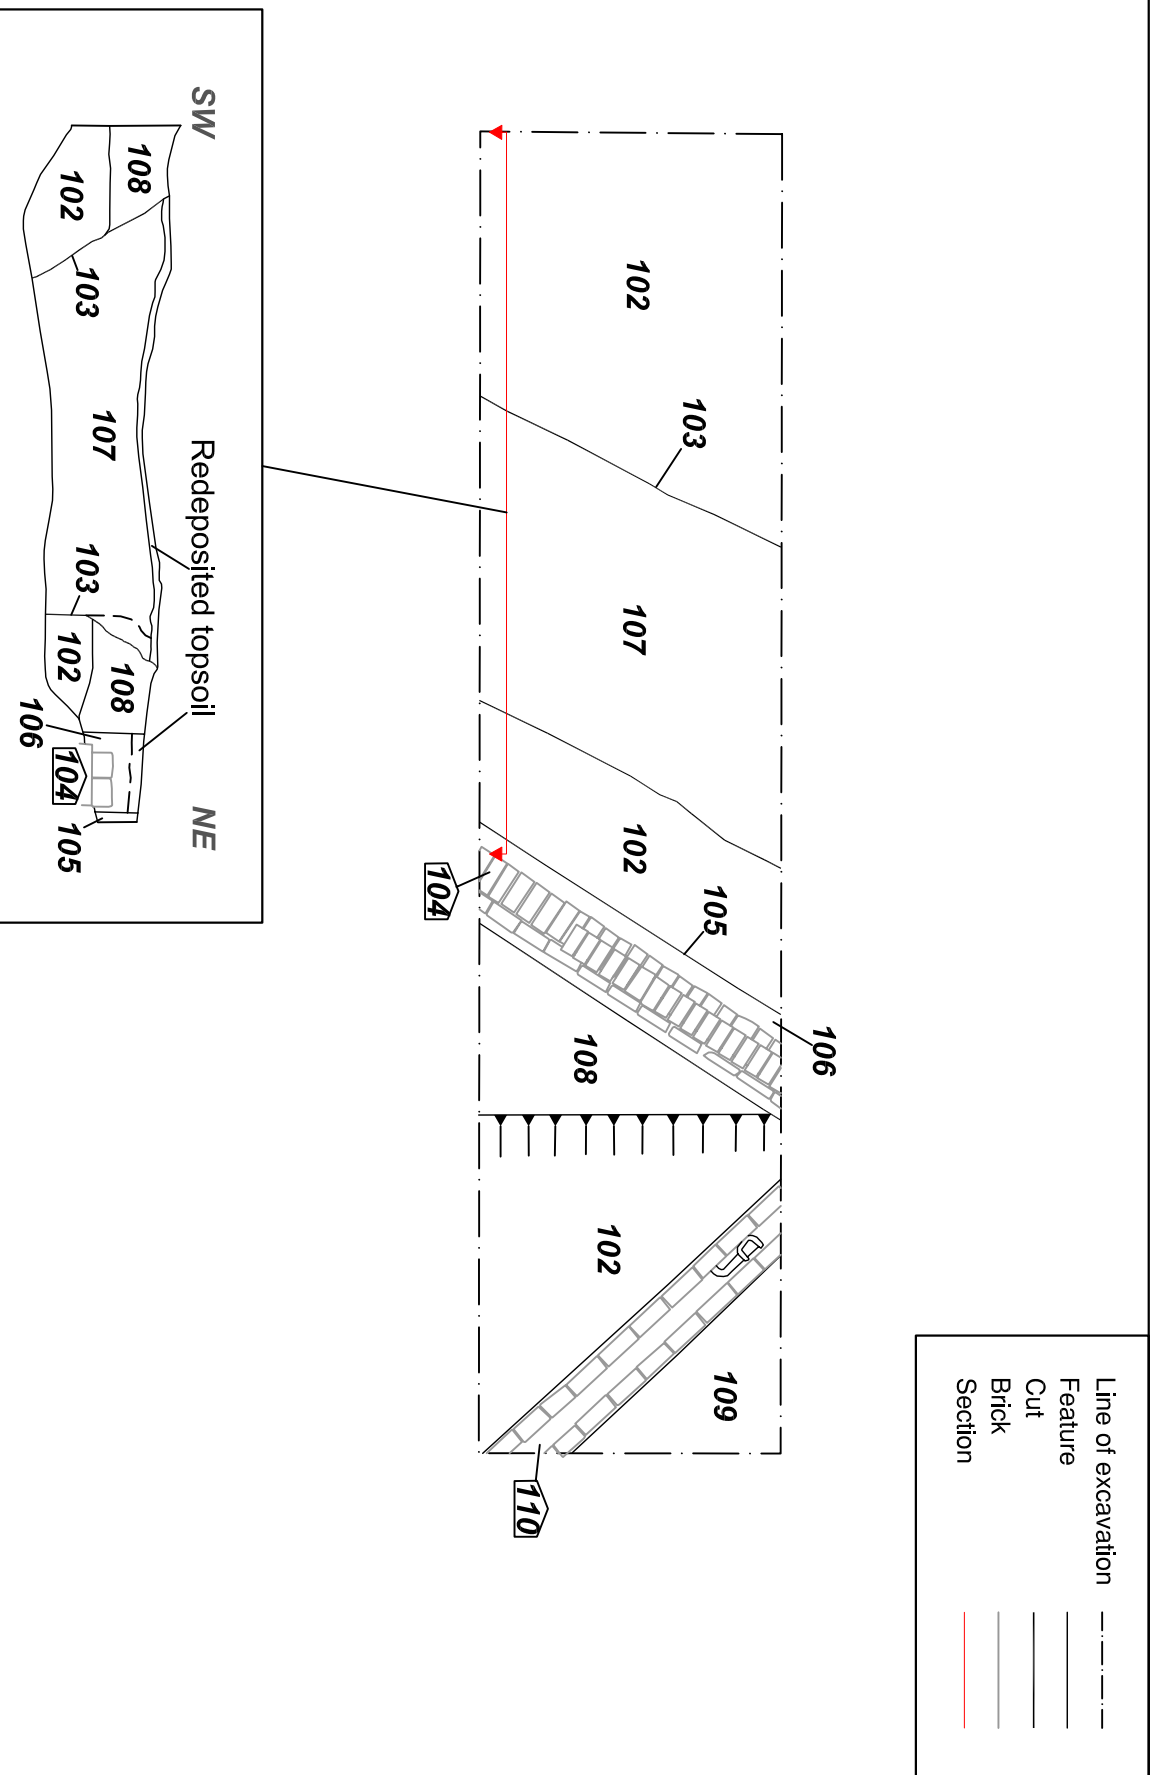
7.3.2 Trench 1 contained two modern redbrick walls, **104** and **110**, which most likely related to a former glasshouse or garden feature. The Ordnance Survey of 1891 illustrates a glasshouse on this spot; the two walls observed may be the north-east corner of the structure. The linear feature that runs across the trench, **103**, was a continuation of the modern timber-lined trench which remains extant to the south. Containing rubber tubes, this feature was probably

related to activities of the research station. The remaining dump of material, **109**, was most likely garden refuse and demolition material. None of the material seems to pre-date the mid-twentieth century. To the south of Trench 1, Trench 2 also exhibited extensive modern disturbance. Much of the trench comprised a large pit containing modern garden refuse, and was very similar to the material identified in **103** (Trench 1). Trench 5, situated to the east of the main house, had two services along each end of the trench. Although no actual features were observed across the majority of the trench, the south-west end clipped the estate road, **111**. This was most likely established during the mid-twentieth century, when the estate was either a WWII training centre or the later nature research facility.

Figure 18: Plan of Trench 1, with section inset showing twentieth-century garden features 104, 110, and 103

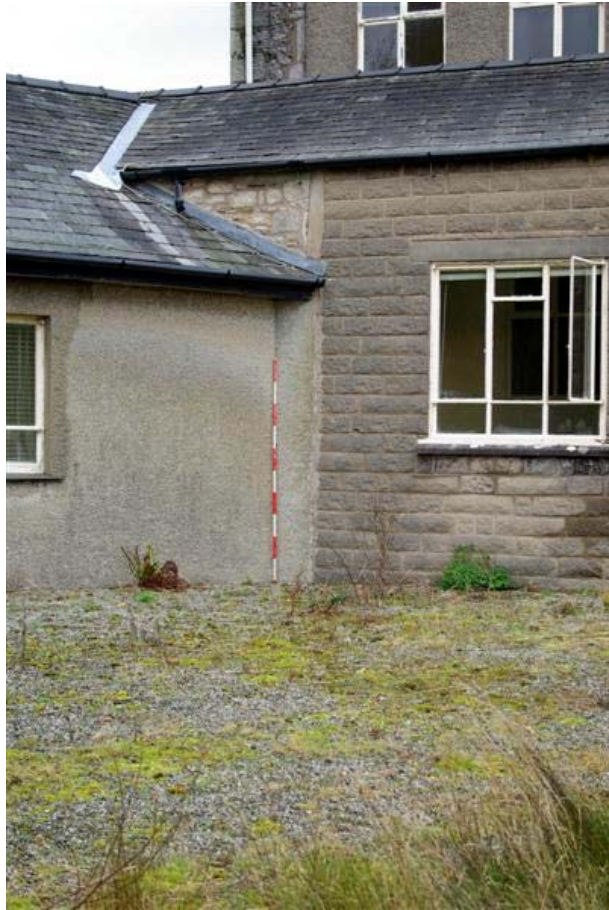
Plate 3: Join between canted part and northern part of Building 1

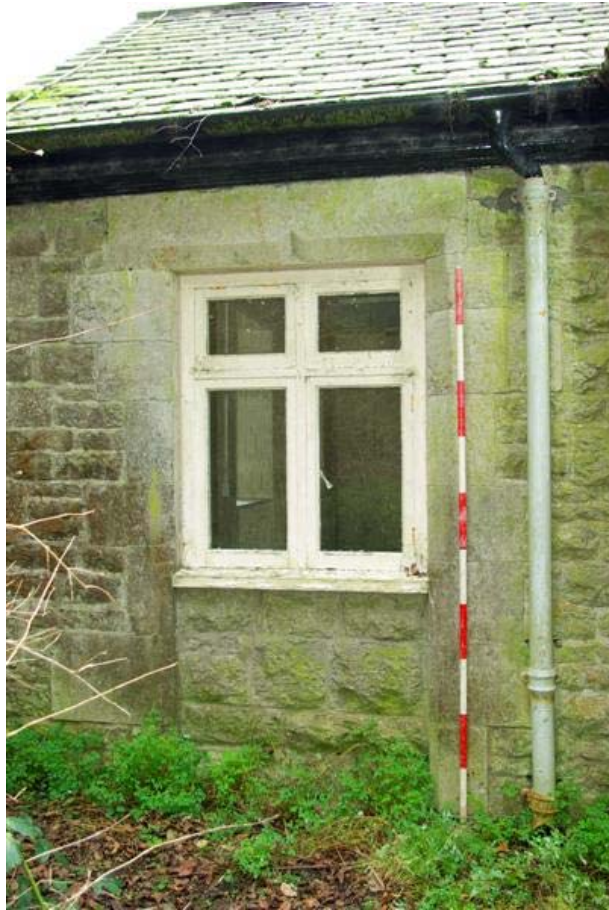
Plate 5: Partially blocked doorway on the south-west elevation of Building 1

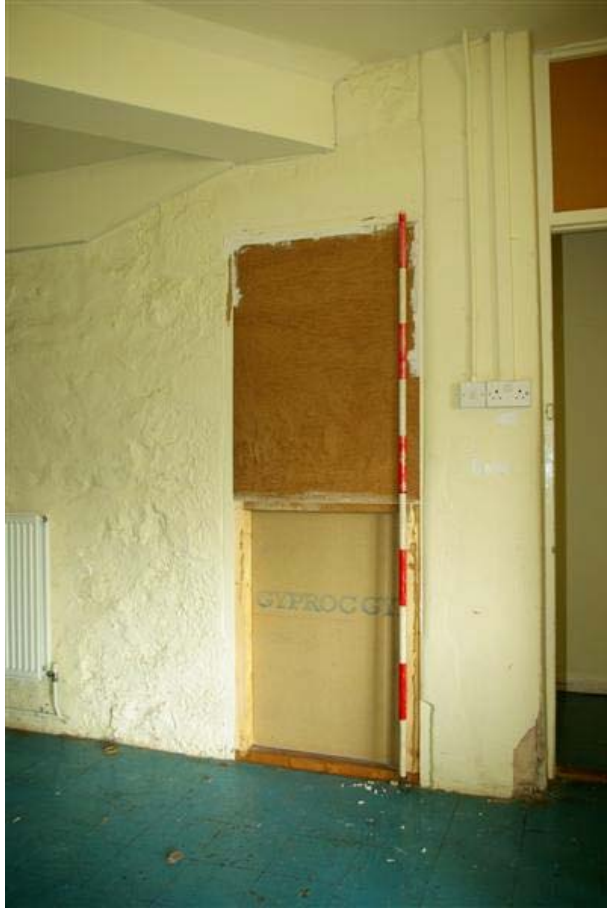
Plate 9: Blocked door between Rooms **B1-5** and **B1-7** (from Room **B1-7**)

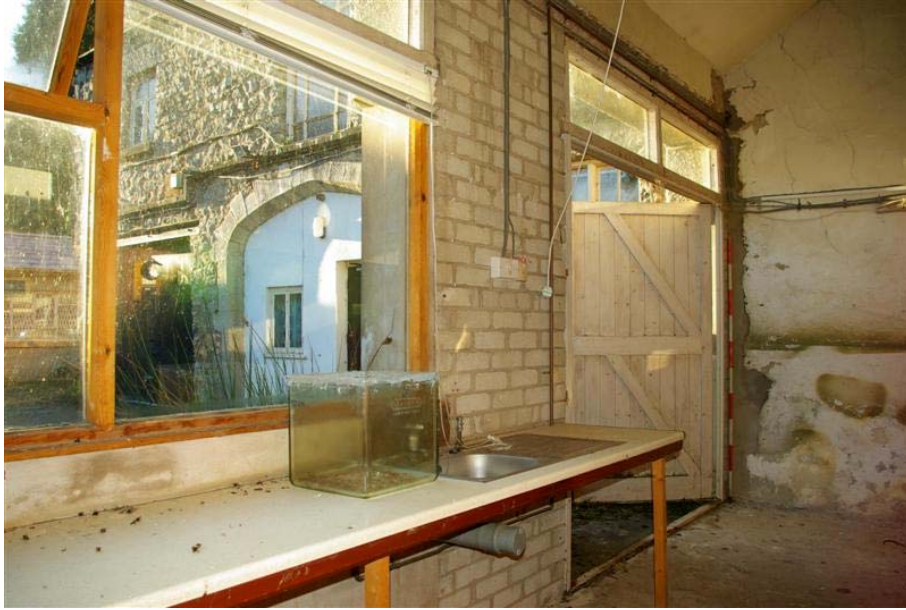
Plate 39: Rebuilt south elevation of the 'Growth Rooms', Building 3

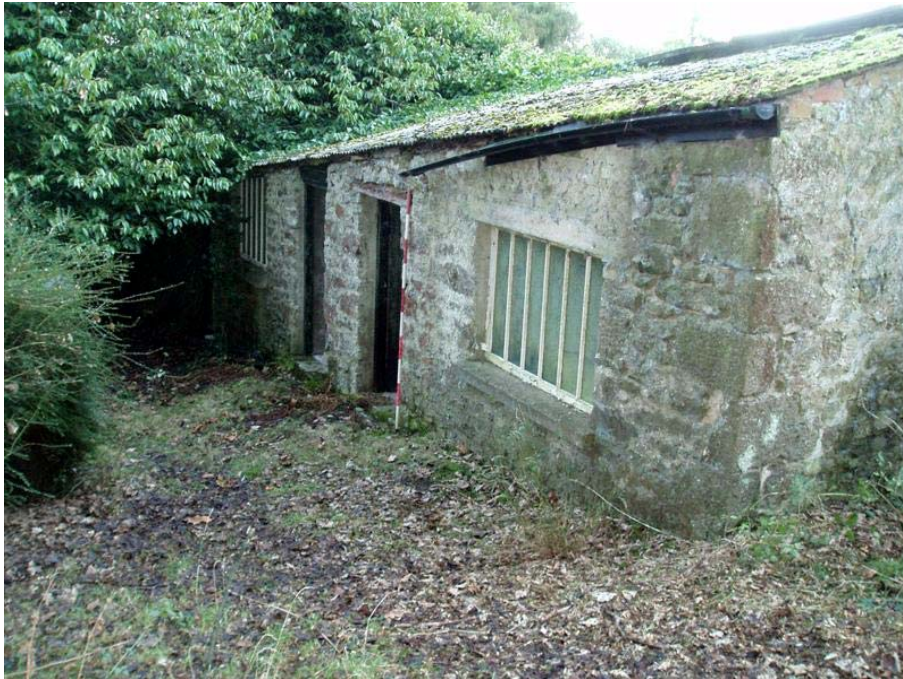
- 4.5.7 A more substantial structure (Building **4J**) is located at the north-east corner of the garden where it is built against the external face of the north wall (Plate 43). It is of random rubblestone construction and has three rooms, each with its own separate access (Fig 10). Each room has a braced and ledged door and a small window with reinforced glazing. Rough limestone quoins are present framing each doorway and the corners of the building. The pent roof is of corrugated asbestos. Internally, each room is basic, with concrete floors and roughly-plastered walls (degraded). Some rebuilding and repair with modern brick has been carried out.

Plate 43: Building **4J** at the north-east corner of the walled garden

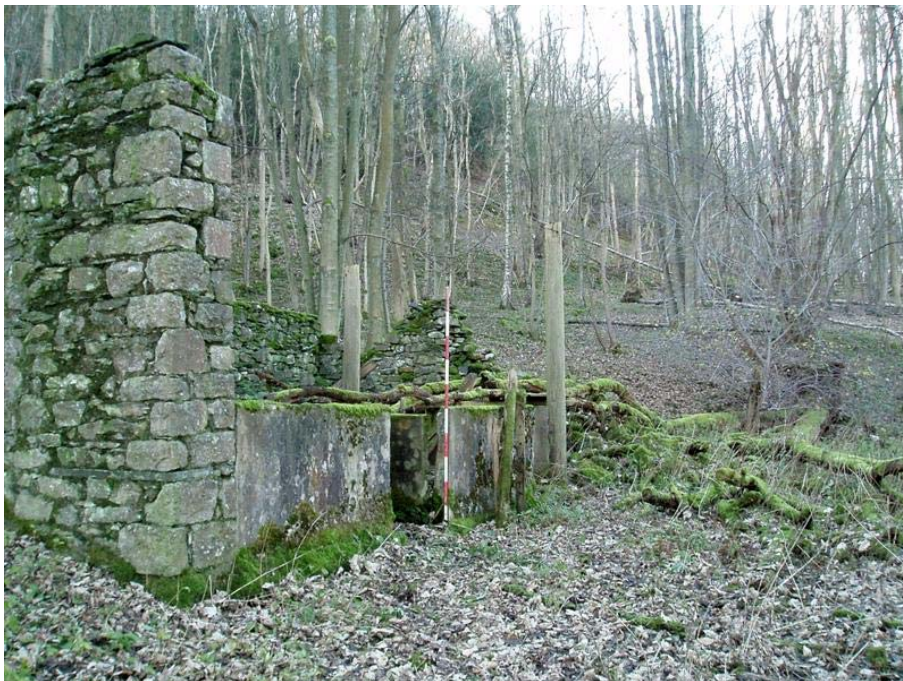
Plate 44: Derelict structure (Building **5**) at the northern limit of the development area

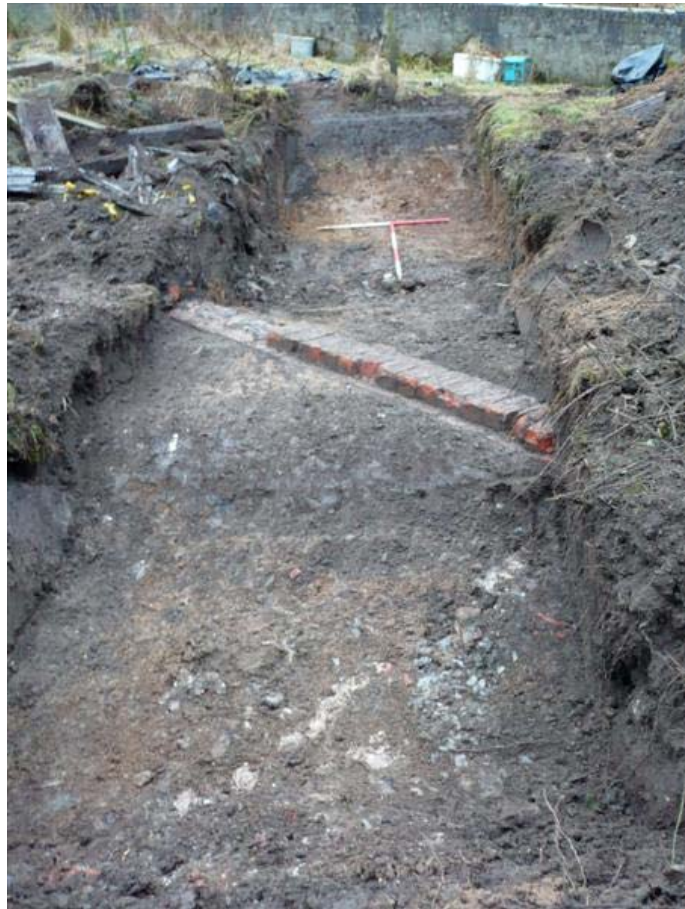
Plate 59: Trench 1, looking south-west
