The Lumley Chapel Cheam South London

Historic Building Analysis

November 2004

Document Type: Building Analysis

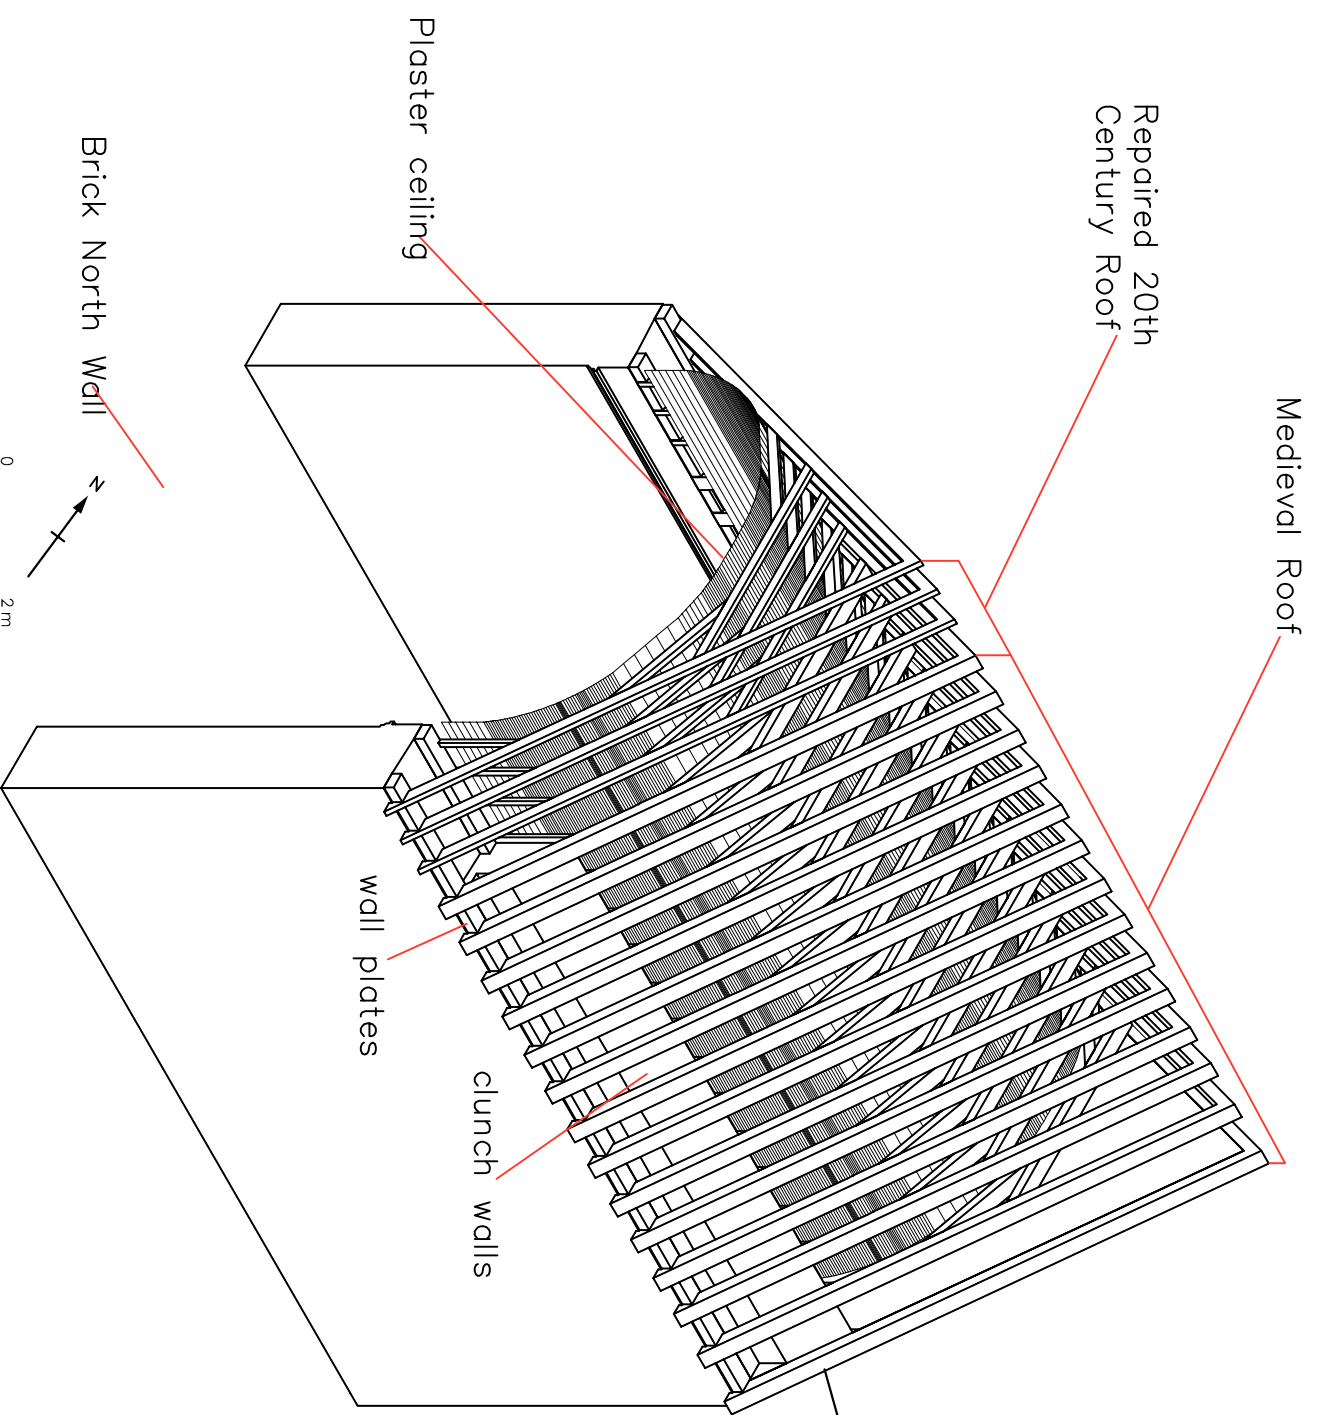
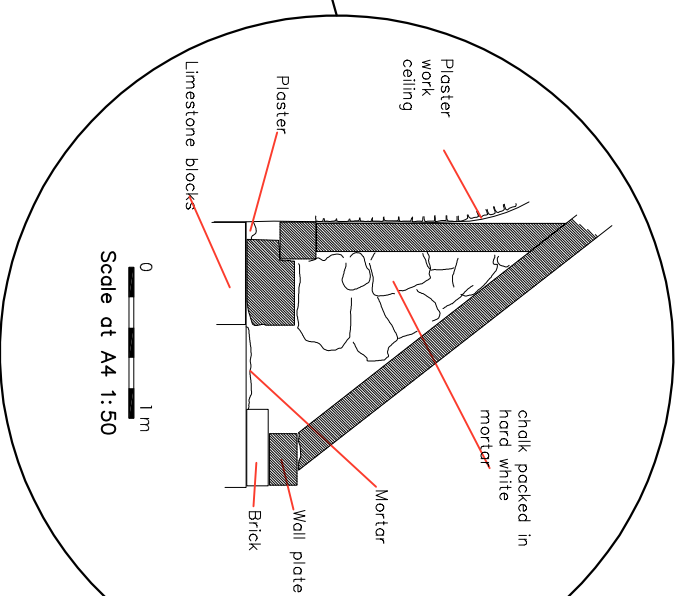
Figure 3: Rafters and wallplates

5.2.1 The most unusual feature of the roof are the small flint and chalk walls in the eaves (see Fig. 3). These sit on top of the main north and south walls above the wallplate level. These are roughly built of flint and chalk nodules set in a hard white mortar. They do not appear at the west end (which has been substantially repaired). These walls appear to have been cut away to accept the rafters (although their crude make up makes this ambiguous). The walls mostly rest on large crudely dressed timber beams (c130 by 200mm). These are not visibly connected to the rest of the roof structure. On the inner face of each wall a smaller beam has been inserted which holds the uprights supporting the roof and the plasterwork and lath barrel vault. On the north side this wall is wider and sits flush with the wall plate, while on the south there is a gap between wall plate and wall.

5.4.1 The wall plates appear to have been more altered than any other part of the roof structure and a number of plates are clearly repairs and interventions replacing earlier decayed elements. each wall plate has been allotted a letter (see Fig 4). The differing wall plates are described individually below;

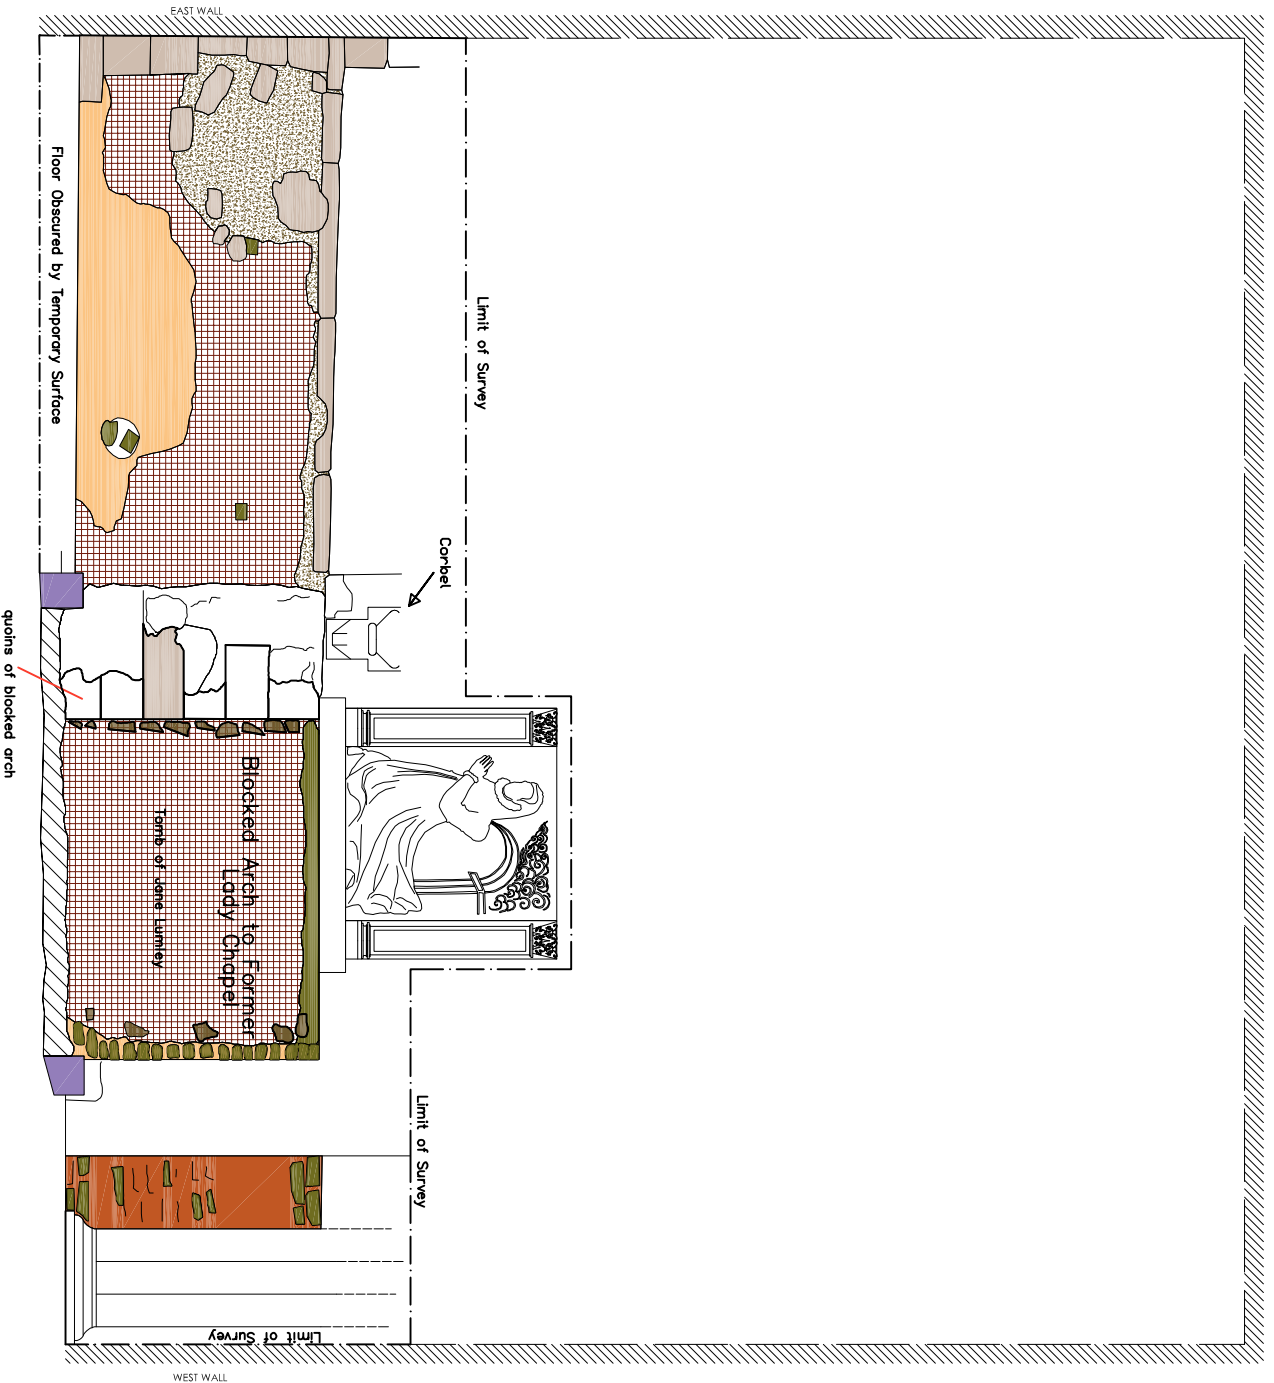
Figure 4: The Church Interior: The South Wall

- 6.1.1 Parts of the interior of the south wall were exposed during restoration. The plaster and monuments were removed from the lower part of the wall along most of its length. Only the small area to the west of Jane Lumley's tomb remained unaffected by the repairs. Apart from minor constructional details few new features were noted and the main focus of investigation was the tomb of Jane Lumley.
- 6.1.2 In the 1580s John Lord Lumley converted the building into a memorial chapel for himself and his two wives (Jane Fitzallen and Elizabeth Darcy). Although the tombs vary in style they must all have been commissioned by Lumley before 1590 as they are shown in the Red Velvet Book which contained an illustrated inventory of his most choice possessions.

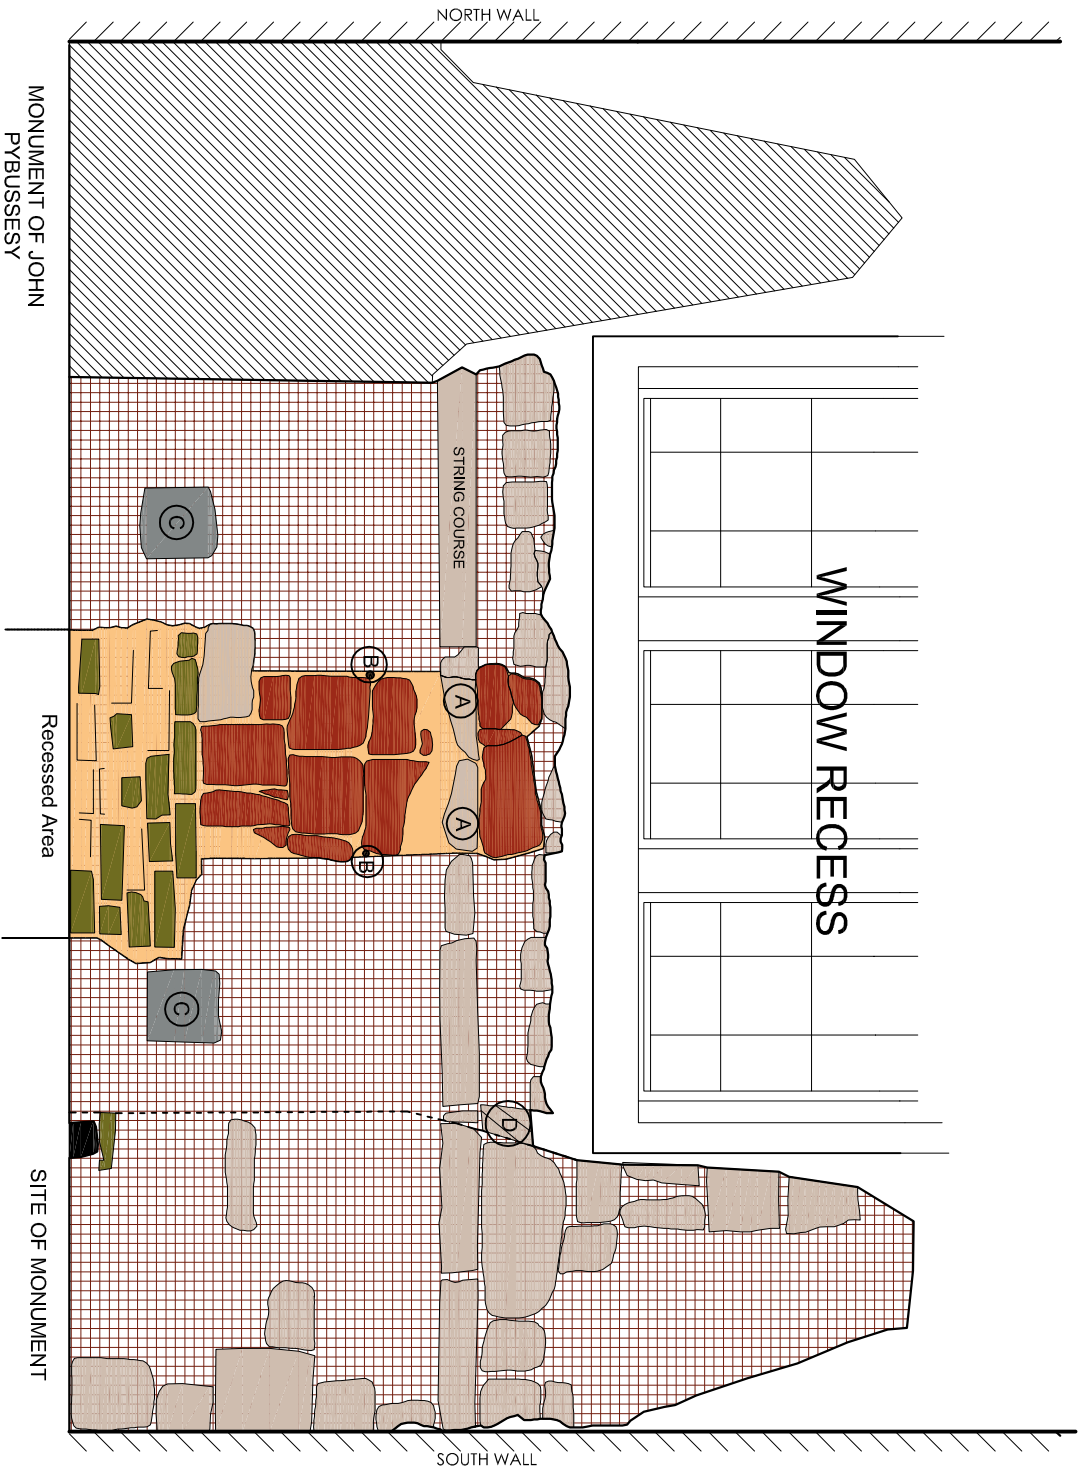
Figure 5:
 The Church Interior:
 East Wall

- 6.2.2 The exposed walling was mostly made up of rough flintwork set in a grey lime-mortar. A string course of limestone blocks was noted some 50cm below the window sill. This was made up of long thin dressed blocks and may represent a levelling course or a break in construction (it serves no clear structural function). Above this (beneath the sill) lies a course of small limestone and clunch blocks. Part of the quoining of the south wall and the quoining of the east window were exposed. These were made up of dressed limestone blocks.

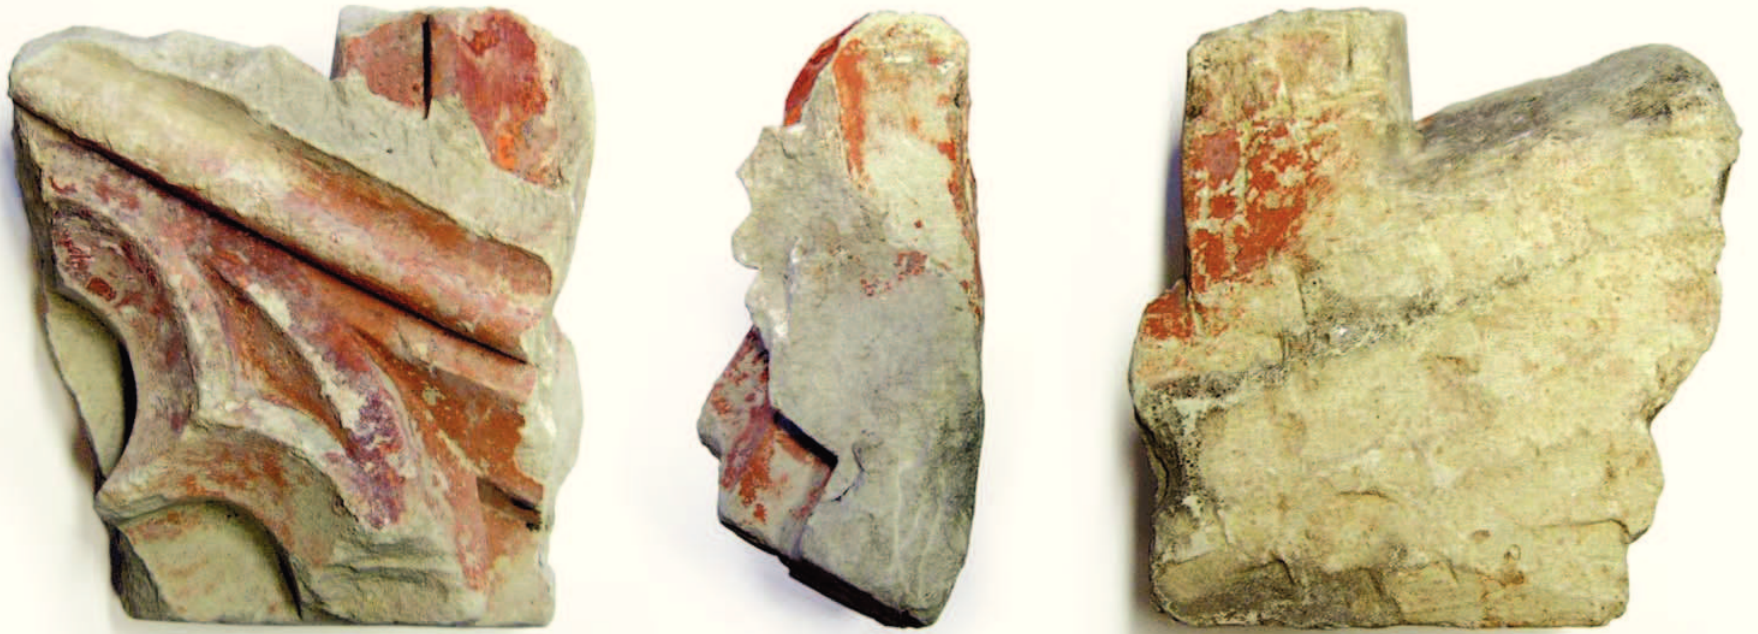
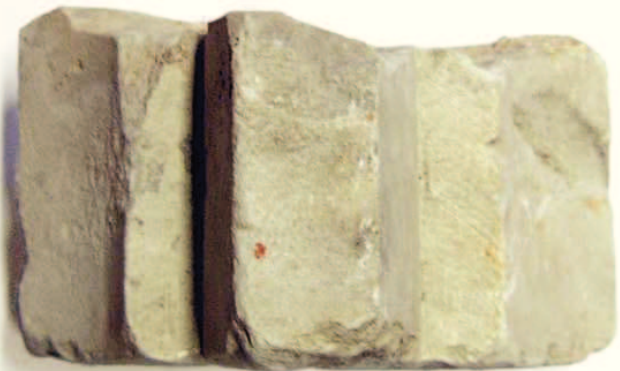
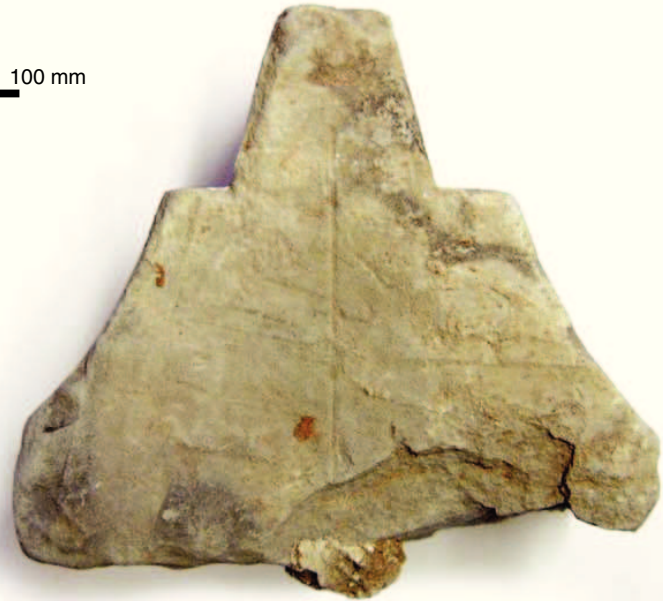
Figure 6: Stone from north wall

7.2.1 Two fragments of dressed stone were recovered from the small brick projection on the north wall. This projection sits immediately behind a large monument and is filled with rubble. Amongst this rubble was a single fragment of moulding and a fragment of tracery. The tracery was brightly painted in a dark red and was in remarkable condition. The tracery is perpendicular in style and may have belonged to a now vanished monument, almost identical tracery was found in the tomb of Jane Lumley on the opposite wall.
