Valentines Park Ilford

London Borough
of Redbridge

**Historic Building Recording and
Archaeological Watching Brief**

April 2009

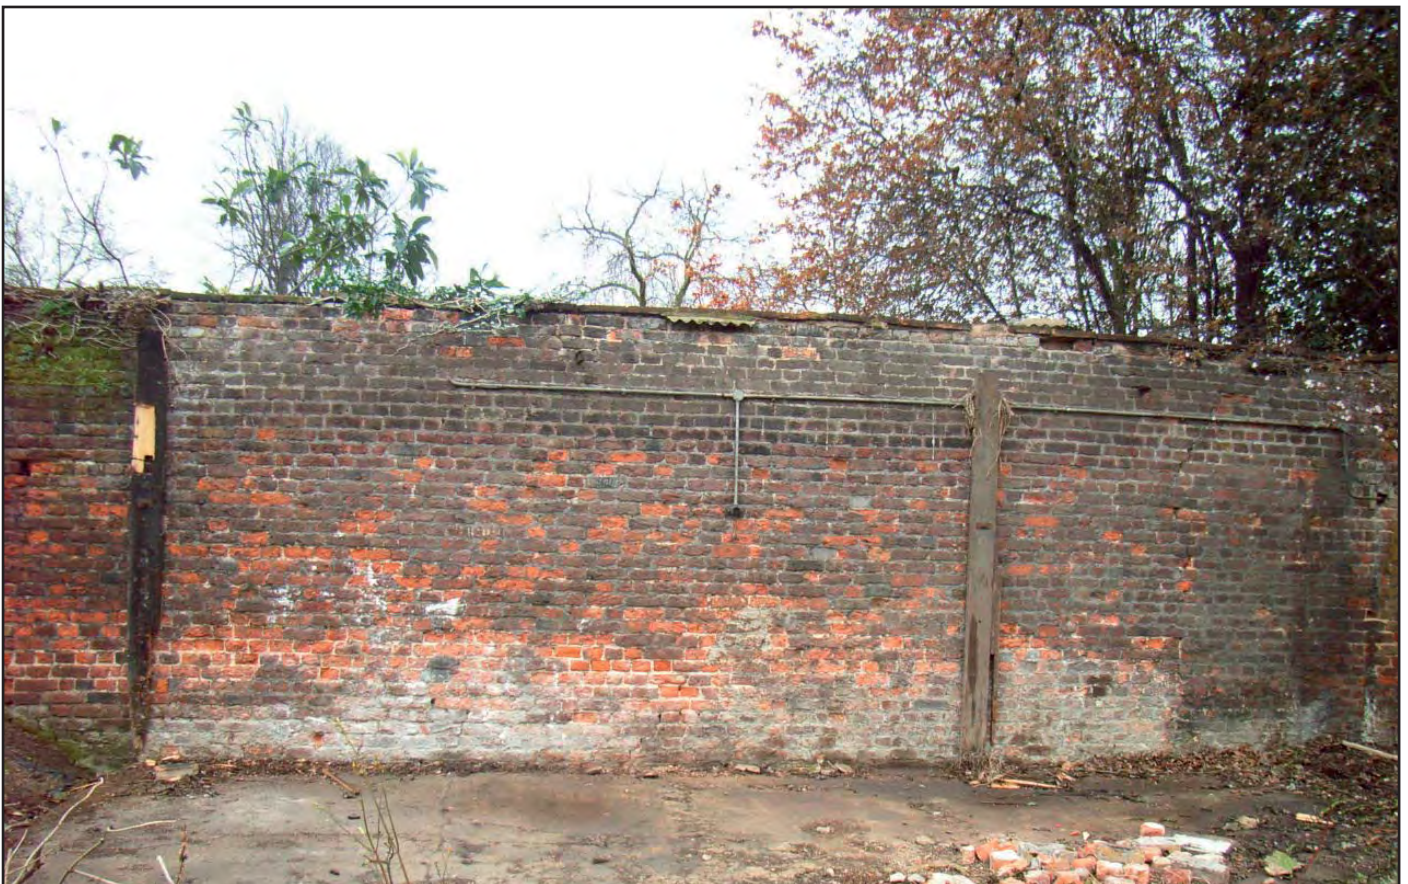
- 5.3.6 **Wall 2** forms the south-east side of the Kitchen Garden, adjoining the Parterre Garden, and both its form and condition are broadly similar to Wall 1 (Pl. 2-4). The north-eastern end of the wall was taken down in the early 20th century to allow the creation of a new path parallel to the Long Water which truncated the north-eastern end of the Kitchen Gardens. This path is shown on the 1939 OS map (Fig. 7). There are also other sections in poor condition but the main c.65 m remains intact. The primary fabric largely survives and it is formed from irregular, soft, handmade bricks without frogs. The bricks are a red/maroon colour on the outer face but an orange colour on the inside (where some have lost their face) and they measure 19.5-23 cm x 10-11 cm x 5.5-7 cm. There is no consistent brick coursing used; there are patches of English Garden Wall bond but in other areas there are whole header courses and many half bricks.

Plate 2: NW side of Wall 2a showing evidence of former lean-to's

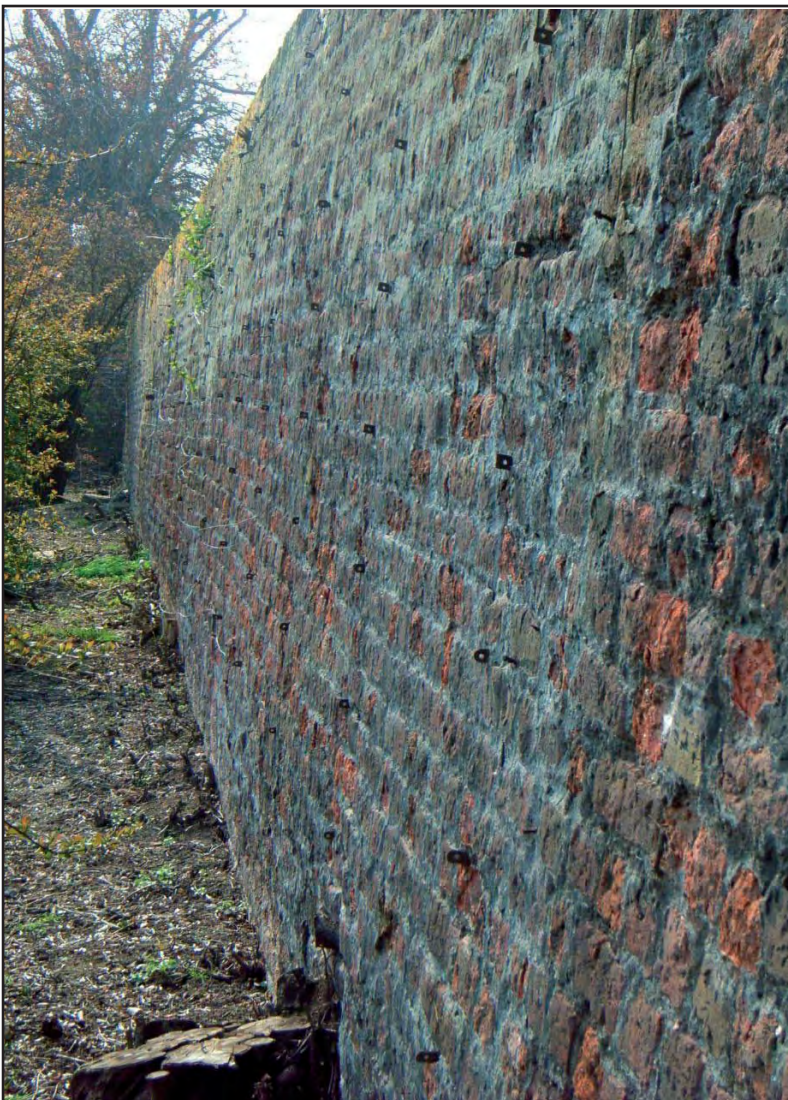
Plate 4: SE side of Wall 2 showing ash-rich repointing

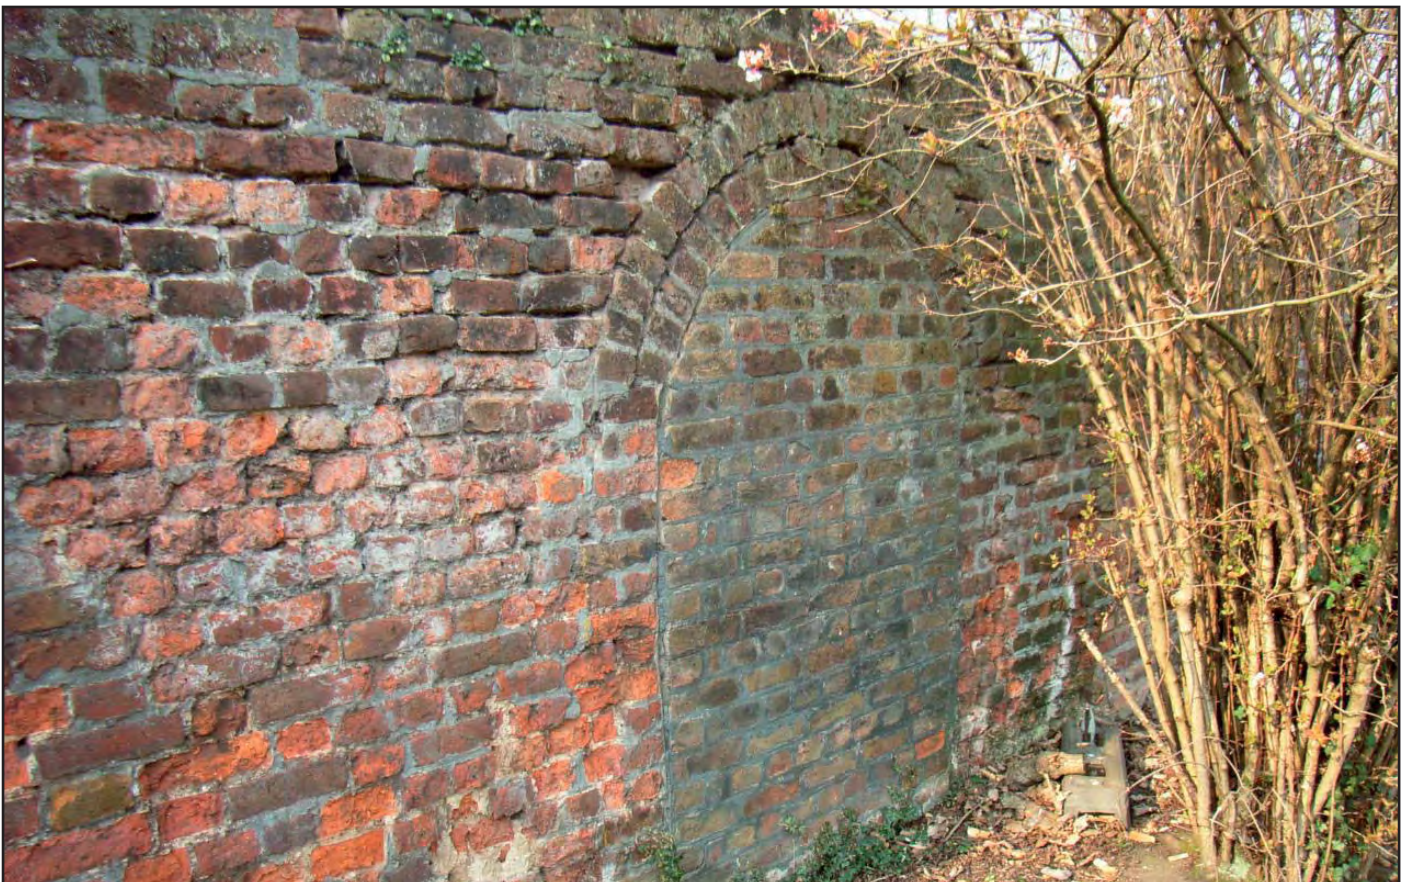
- 5.4.2 **Walls 4 and 5** are 35.5 cm thick, largely constructed of primary (1720s) soft red bricks and they form the south-west and south-east sides of the Parterre Garden (Pl 6 – 7, Fig. 9). The bricks measure 23 x 10-11 x 6-7 cm and the mortar is pale, creamy and relatively coarse with substantial grit inclusions. The bond is largely a Flemish variation bond and at the south end, where it appears to be full height, the wall is c.2.9 m tall. The upper courses of Wall 4 represent a secondary raising or repair of the structure and the brick is slightly yellower and slightly harder than the primary fabric. The join between the two phases of wall is clear at the north-east end but at the southern end it is hard to distinguish, possibly because some early bricks were also used in the later raising/repair. At the southern end (over the door) the later brickwork is only 4 courses high but at the mid wall it extends to seven courses and then reduces again to five courses towards the canal. This brickwork appears to be contemporary with four 19th-century buttresses on the south-east face of Wall 4 and both the buttress and the upper courses may all represent alterations undertaken in c.1870 when the Rose Garden was added by Sarah Ingleby.

Plate 6: Infilled doorway in Wall 4

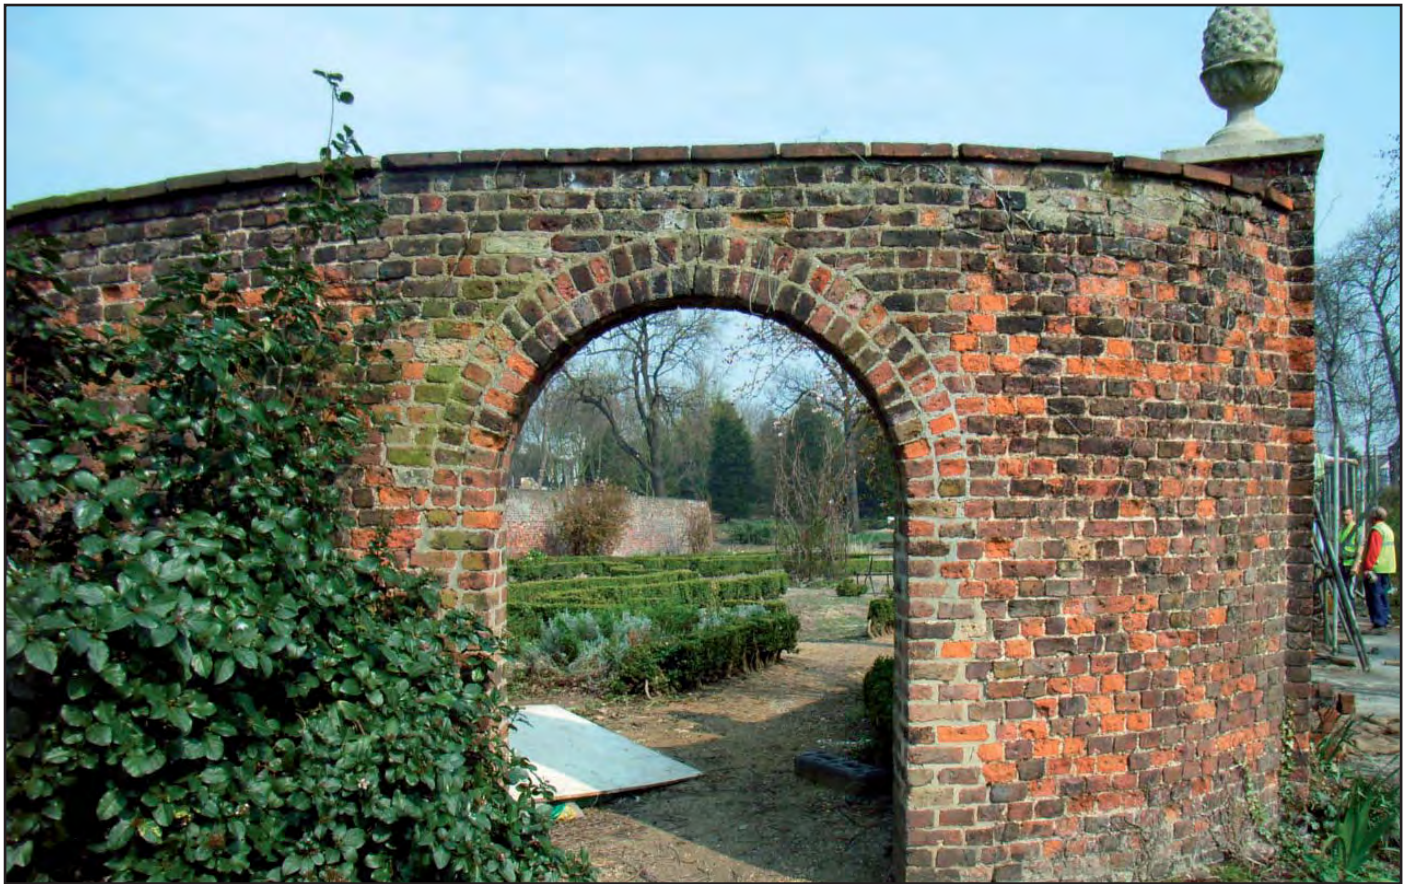
Plate 7: Secondary (early 20th century) doorway at corner between Walls 4 and 5

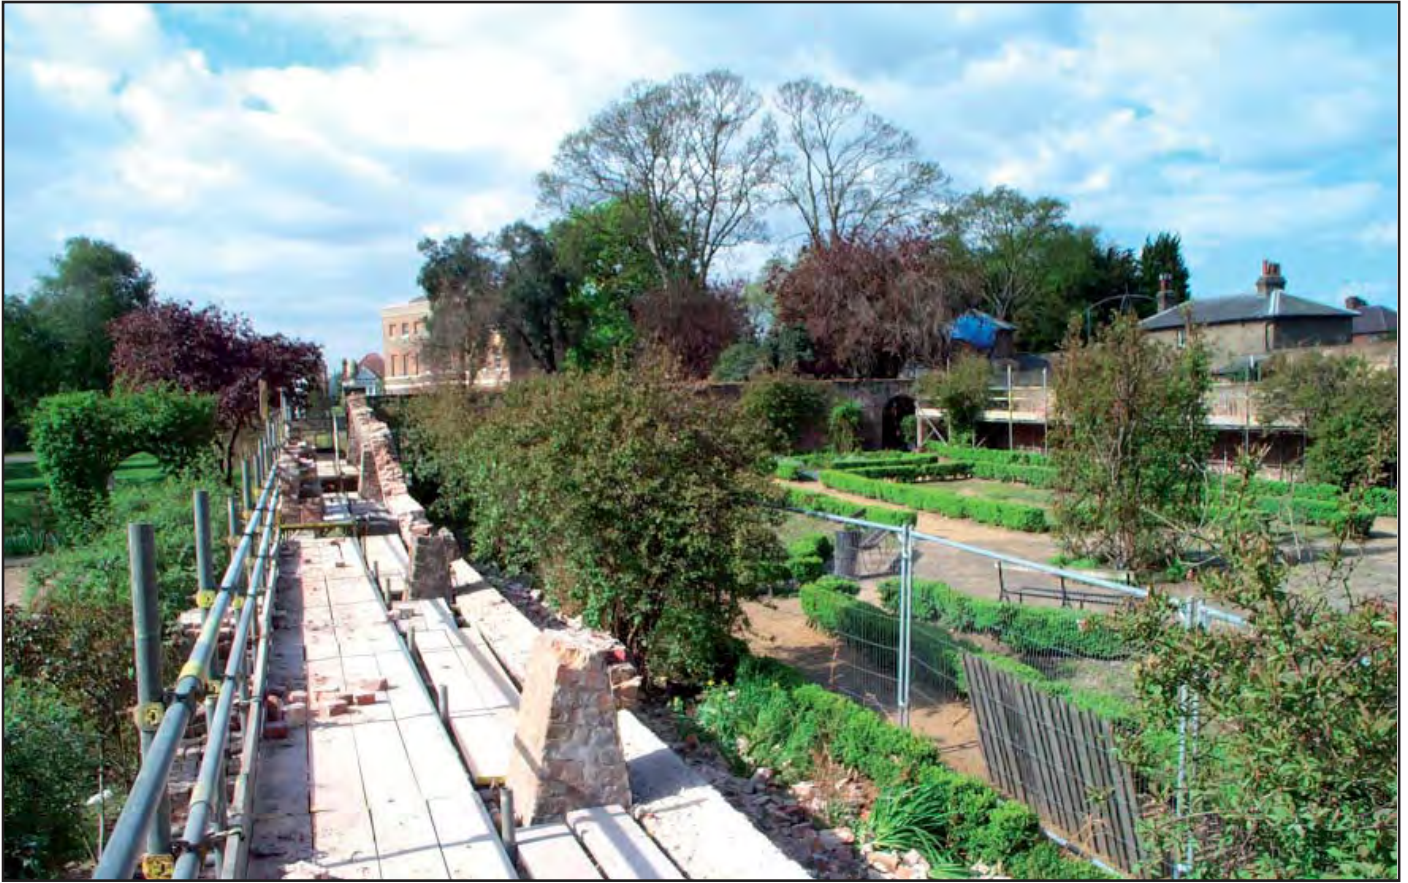
- 5.4.1 The Parterre Garden is a rectangular formal garden immediately to the south-east of the Kitchen Garden with brick walls, gravel paths and box-edged planting beds. It remains as a formal garden and is in much better condition than the Kitchen Garden (Pl. 9).

Plate 9: General view of Parterre Garden from east during works

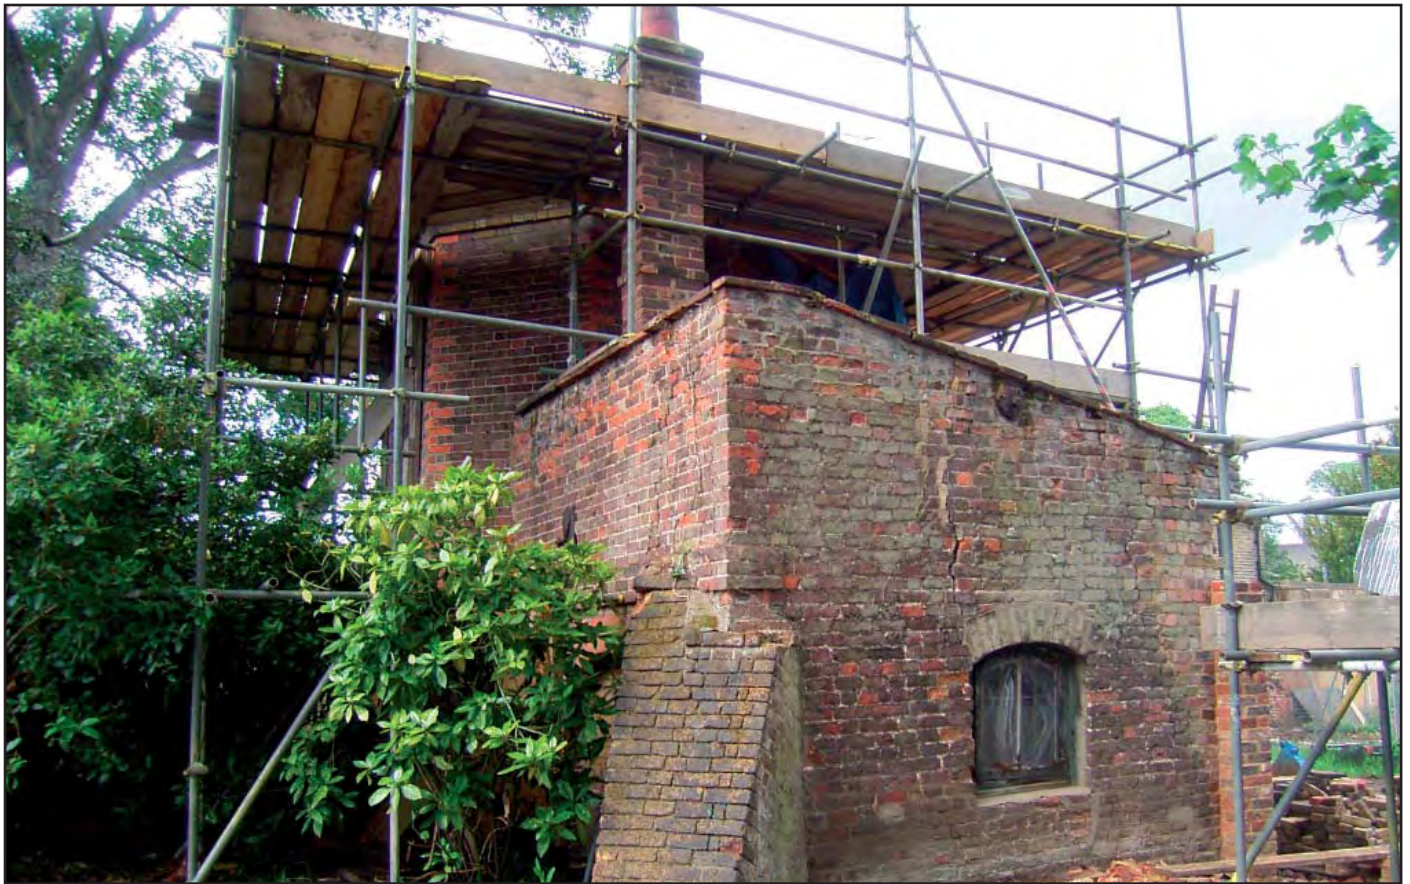
- 5.5.4 The south-east elevation is constructed from plain brickwork of a rough character, without any systematic bonding and with substantial cracks (Pl. 11). There is an iron tie-plate towards the roof ridge, many areas of patching to the wall and a low, thick buttress has been added to the western corner of the building (Pl. 12). This buttress uses hard yellow bricks and is probably of later 19th century date. The brickwork in the main south-east wall appears of 18th-century date and its poor quality is suggestive of a utilitarian garden building where appearance or longevity would not be principal concerns. The elevation incorporates a 2-light window beneath a segmental brick arch.

Plate 11: SE elevation of Dovecote with 18th-century brickwork at ground floor

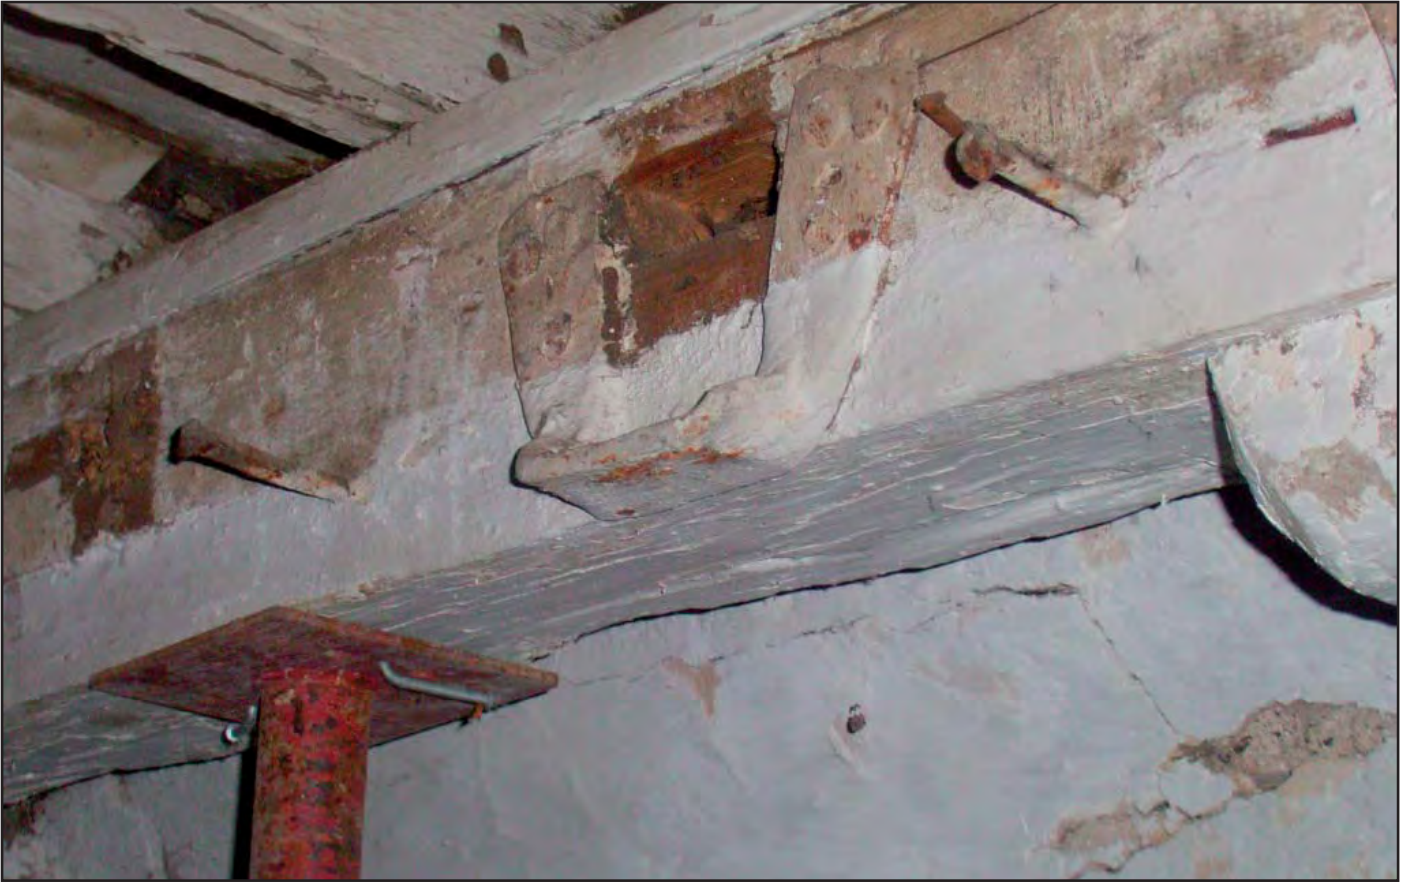
principal joist and an iron strap has been nailed beneath one of the holes to add additional support. The principal joist is now supported by two corbelled timbers set into the wall. This structural re-arrangement may have been a rather crude temporary solution to structural failures or it may relate to the creation of former openings between this area and the secondary lean-to. The north-west and south-east internal walls of the Dovecote's ground floor each comprise a wide semi-circular arch which support the octagonal first floor structure. The arches measure approximately 2.85m wide and 1.95m high although that to the SE has been partially infilled with a central doorway. The walls are plastered and painted white. The ground floor has a concrete, brick, and flagstone floor and a trench dug by contractors through the floor of this structure made visible foundations of soft red/orange brick with cream coloured lime mortar approximately 0.5m down from the existing floor level.

Plate 21: Sockets in principal joist of Dovecote central room

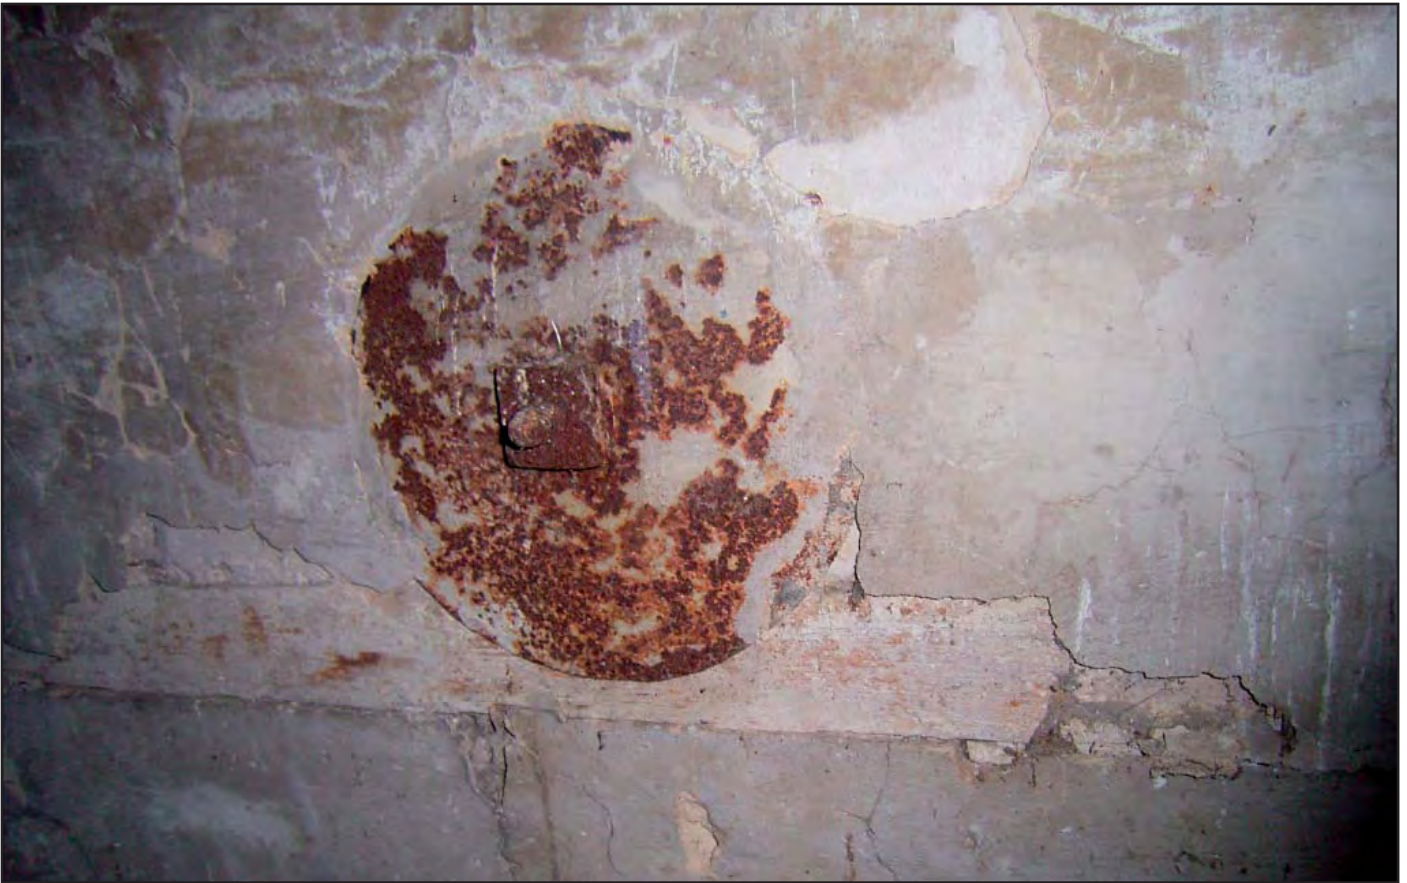
Plate 22: Tie bar plate in Dovecote

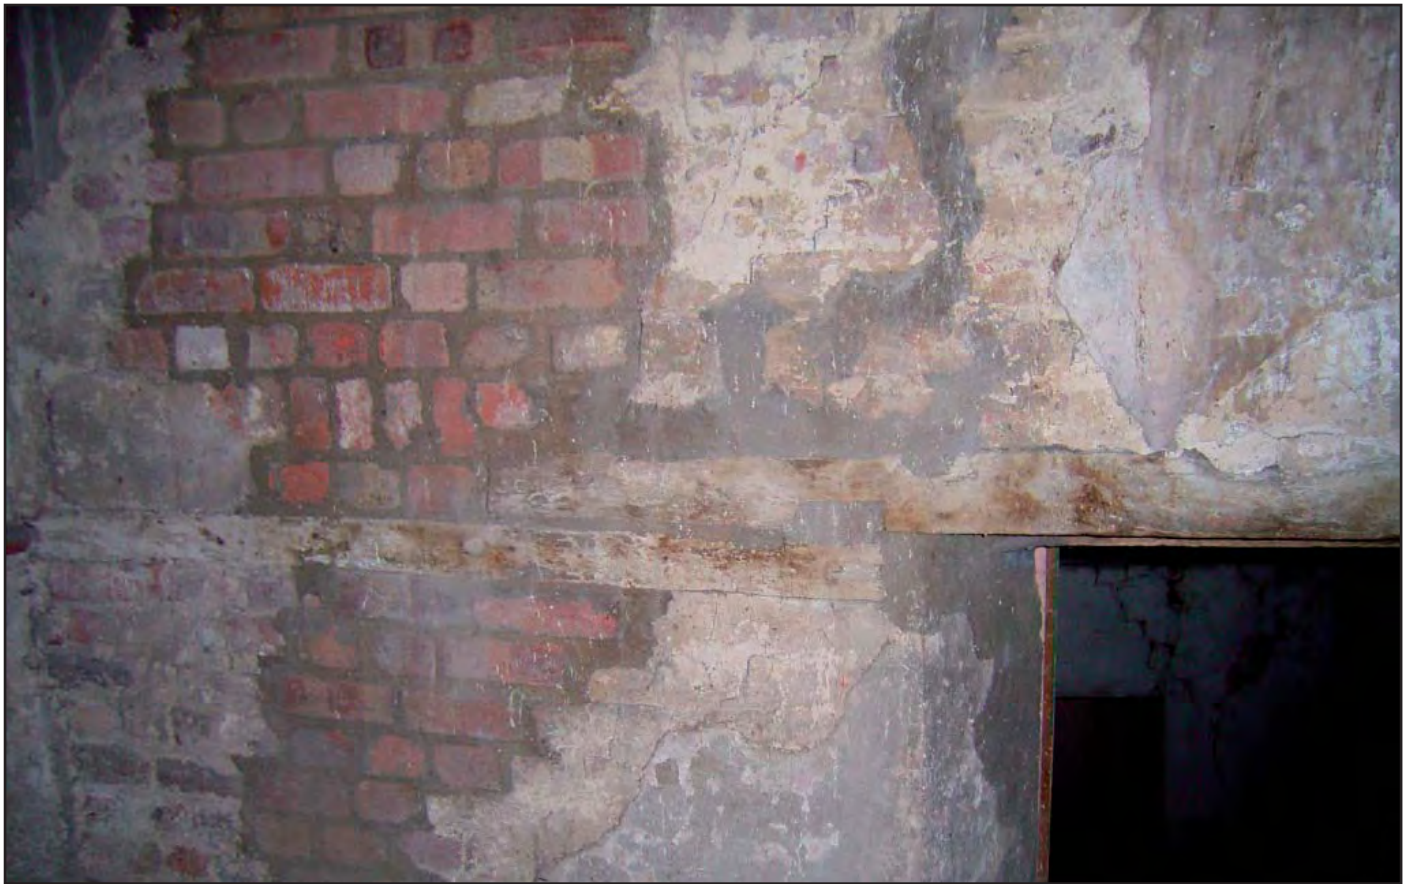
- 5.5.12 The walls are all plastered although this has come away in limited areas to show that a lower quality of brick was used on the internal faces than the external. There are some patches of repair including a large area of modern brickwork in the north-west wall, adjacent too the hatch, which rises in an irregular 'pier' towards the wall-plate (Pl. 29).

Plate 29: Repairs in internal walls of Dovecote

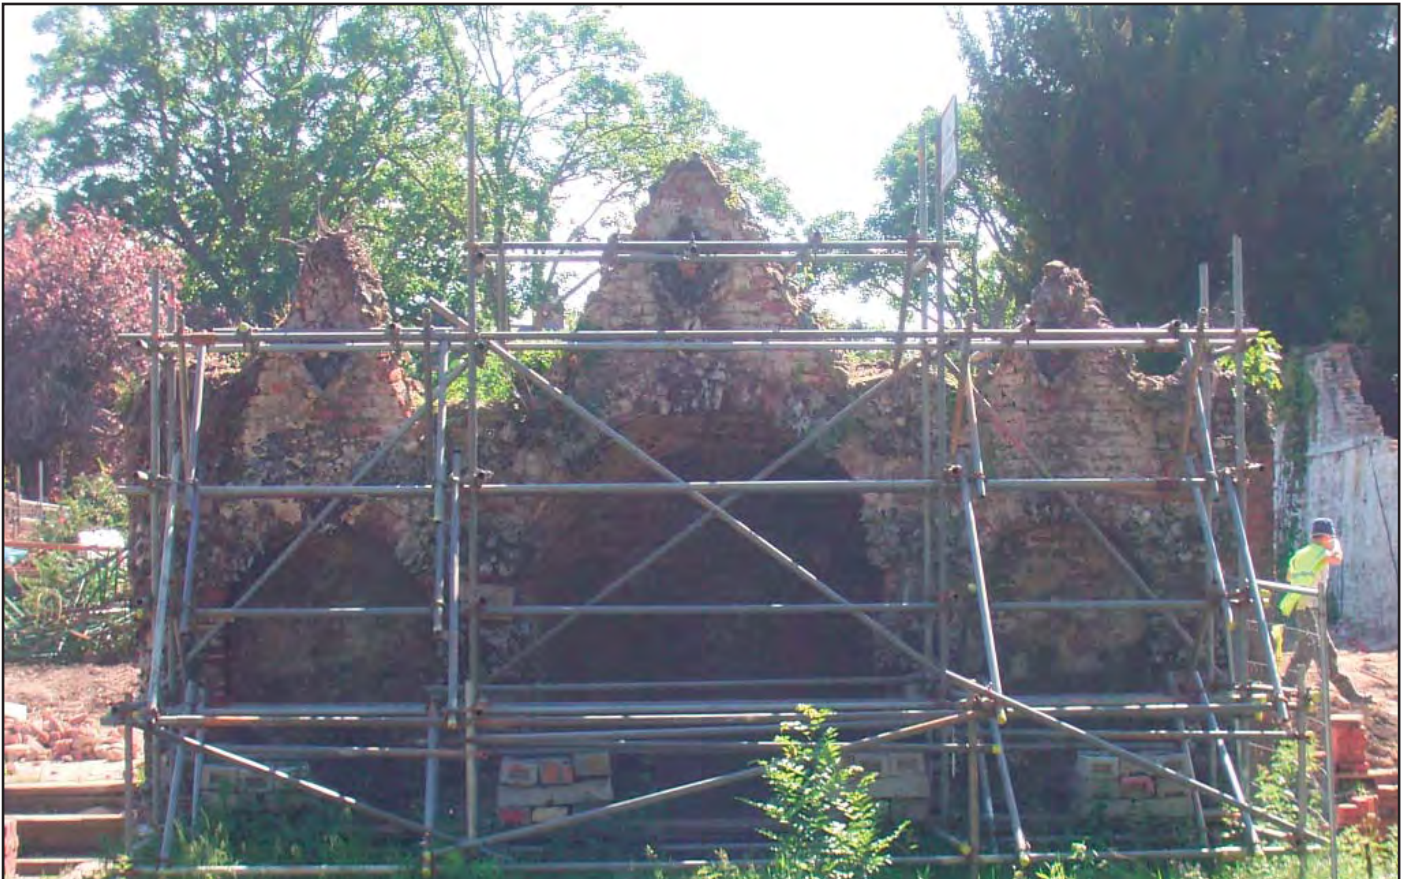
- 5.7.1 The Alcove Seat forms part of the early 18th century designed garden and is located at the north-east end of the Kitchen Garden within the largely collapsed Wall 6 (Pl. 40-42, Fig. 12-13). The structure would have formed a romantic eye-catching folly facing onto the Long Water and forming part of a group of similar, probably contemporary structures with the two grottoes and Jacob's Well.
- 5.7.2 Prior to the current restoration works the structure had become isolated due to the collapse of the surrounding walls and its condition had deteriorated severely by neglect and ill conceived 20th-century restoration works. The structure has a serious lean towards the north-east and scaffolding supports its north-east face.

Plate 40: Alcove Seat from NE before start of works

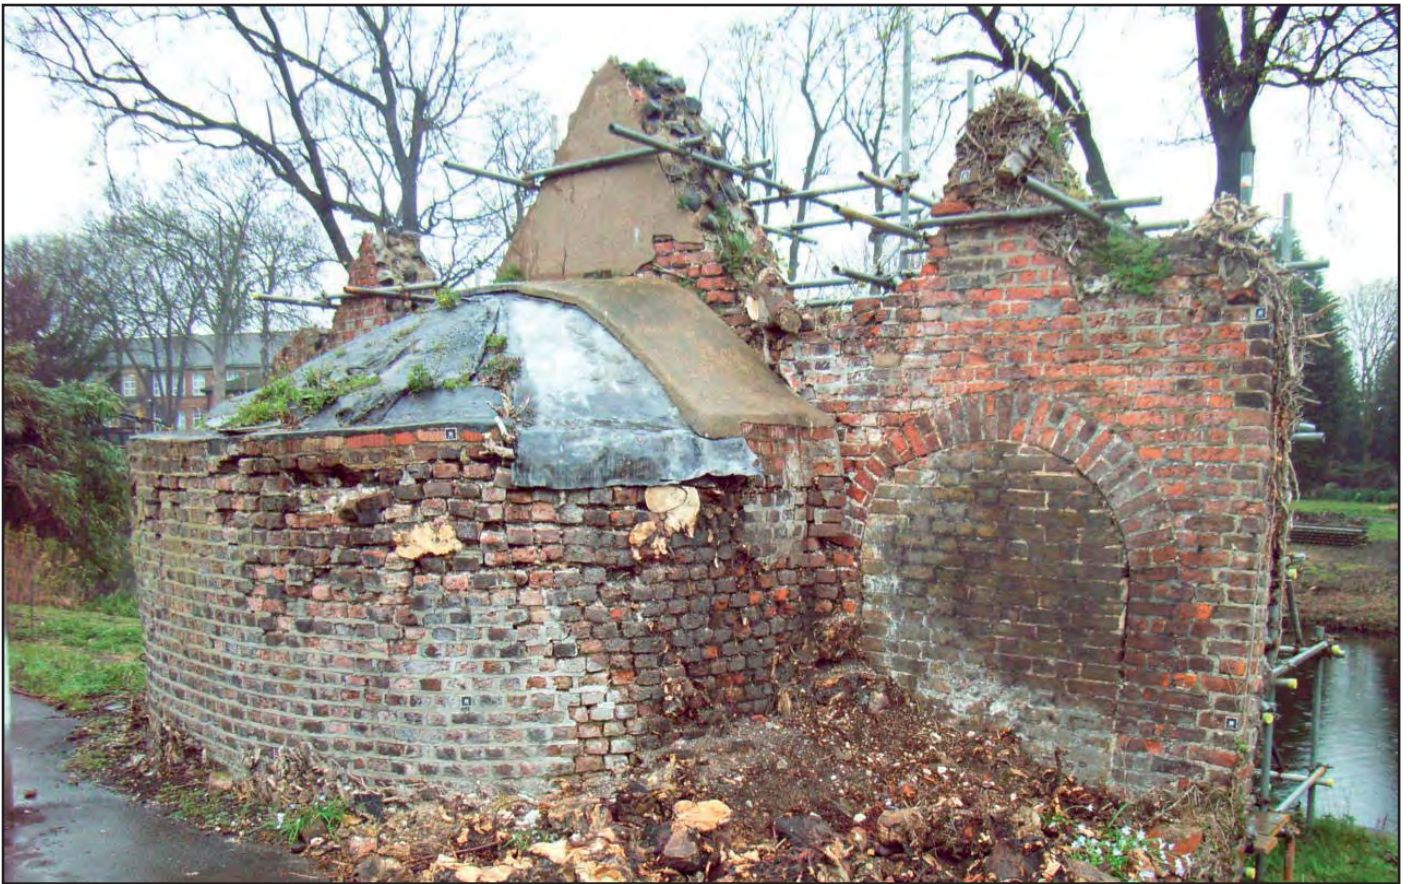
- 5.7.6 The south-west rear side (facing the walled garden) is very plain in comparison with exposed brickwork and no romantic decoration. The brickwork appears to be largely primary although there have been repairs in patches and the rear of the main 'gable' is rendered. At the top of the main section of wall, but below the height of the gables, is a soldier course. The north-west end of the wall is capped with secondary brickwork presumably dating to when the main wall collapsed and the general condition of the wall is very poor, partially resulting from vegetation which covered the structure prior to the current works. There has clearly been a fire against the south-east side of the recess and there is much charring against both this wall and the adjacent section of the main wall.

Plate 41: Rear SW face of Alcove Seat

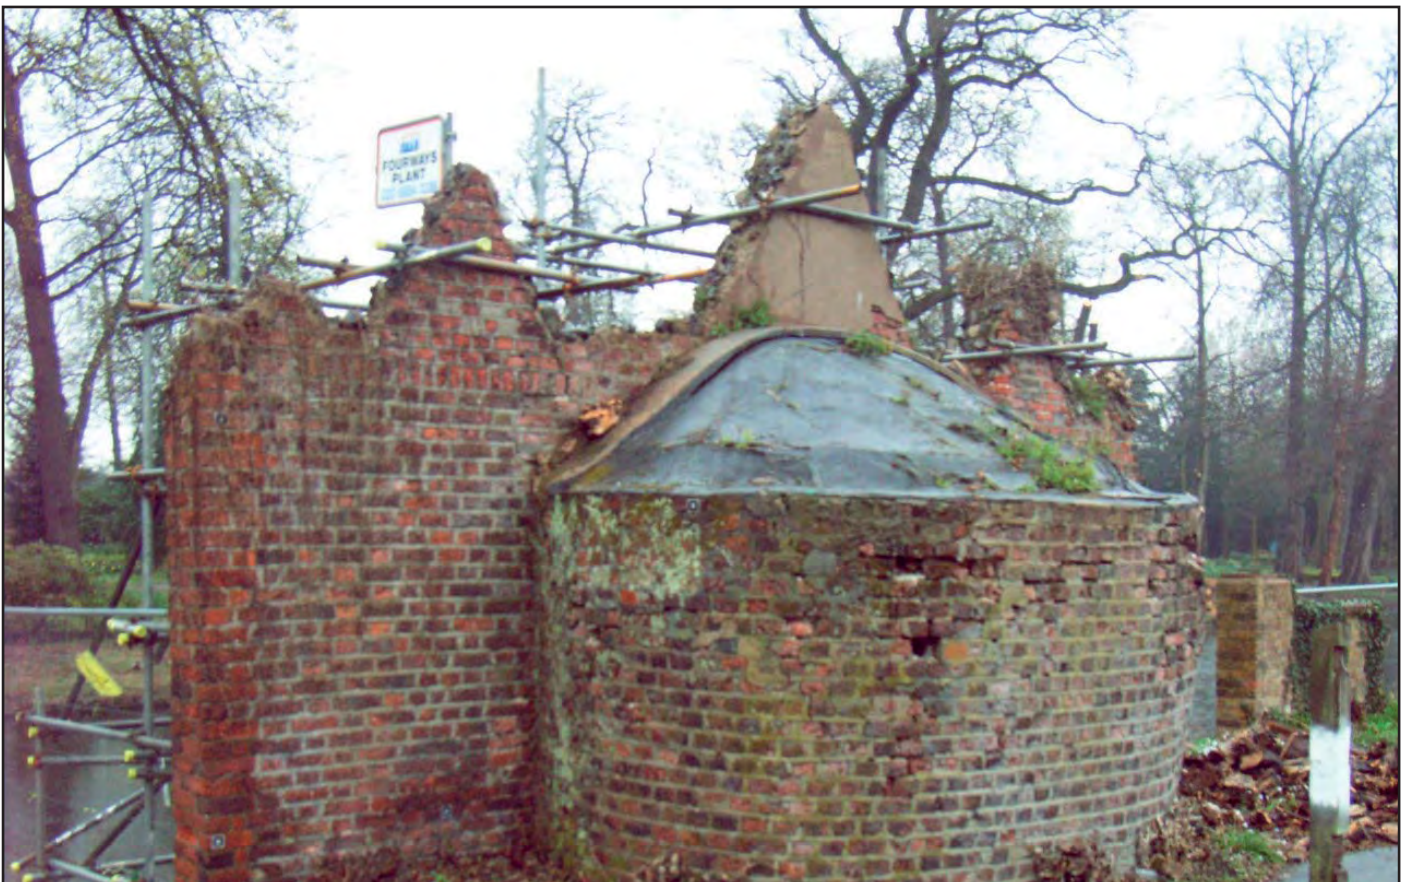
Plate 42: Rear SW face of Alcove Seat
