Priory Wall Ham Lane Lewes East Sussex

Archaeological Recording

Oxford Archaeology

October 2004

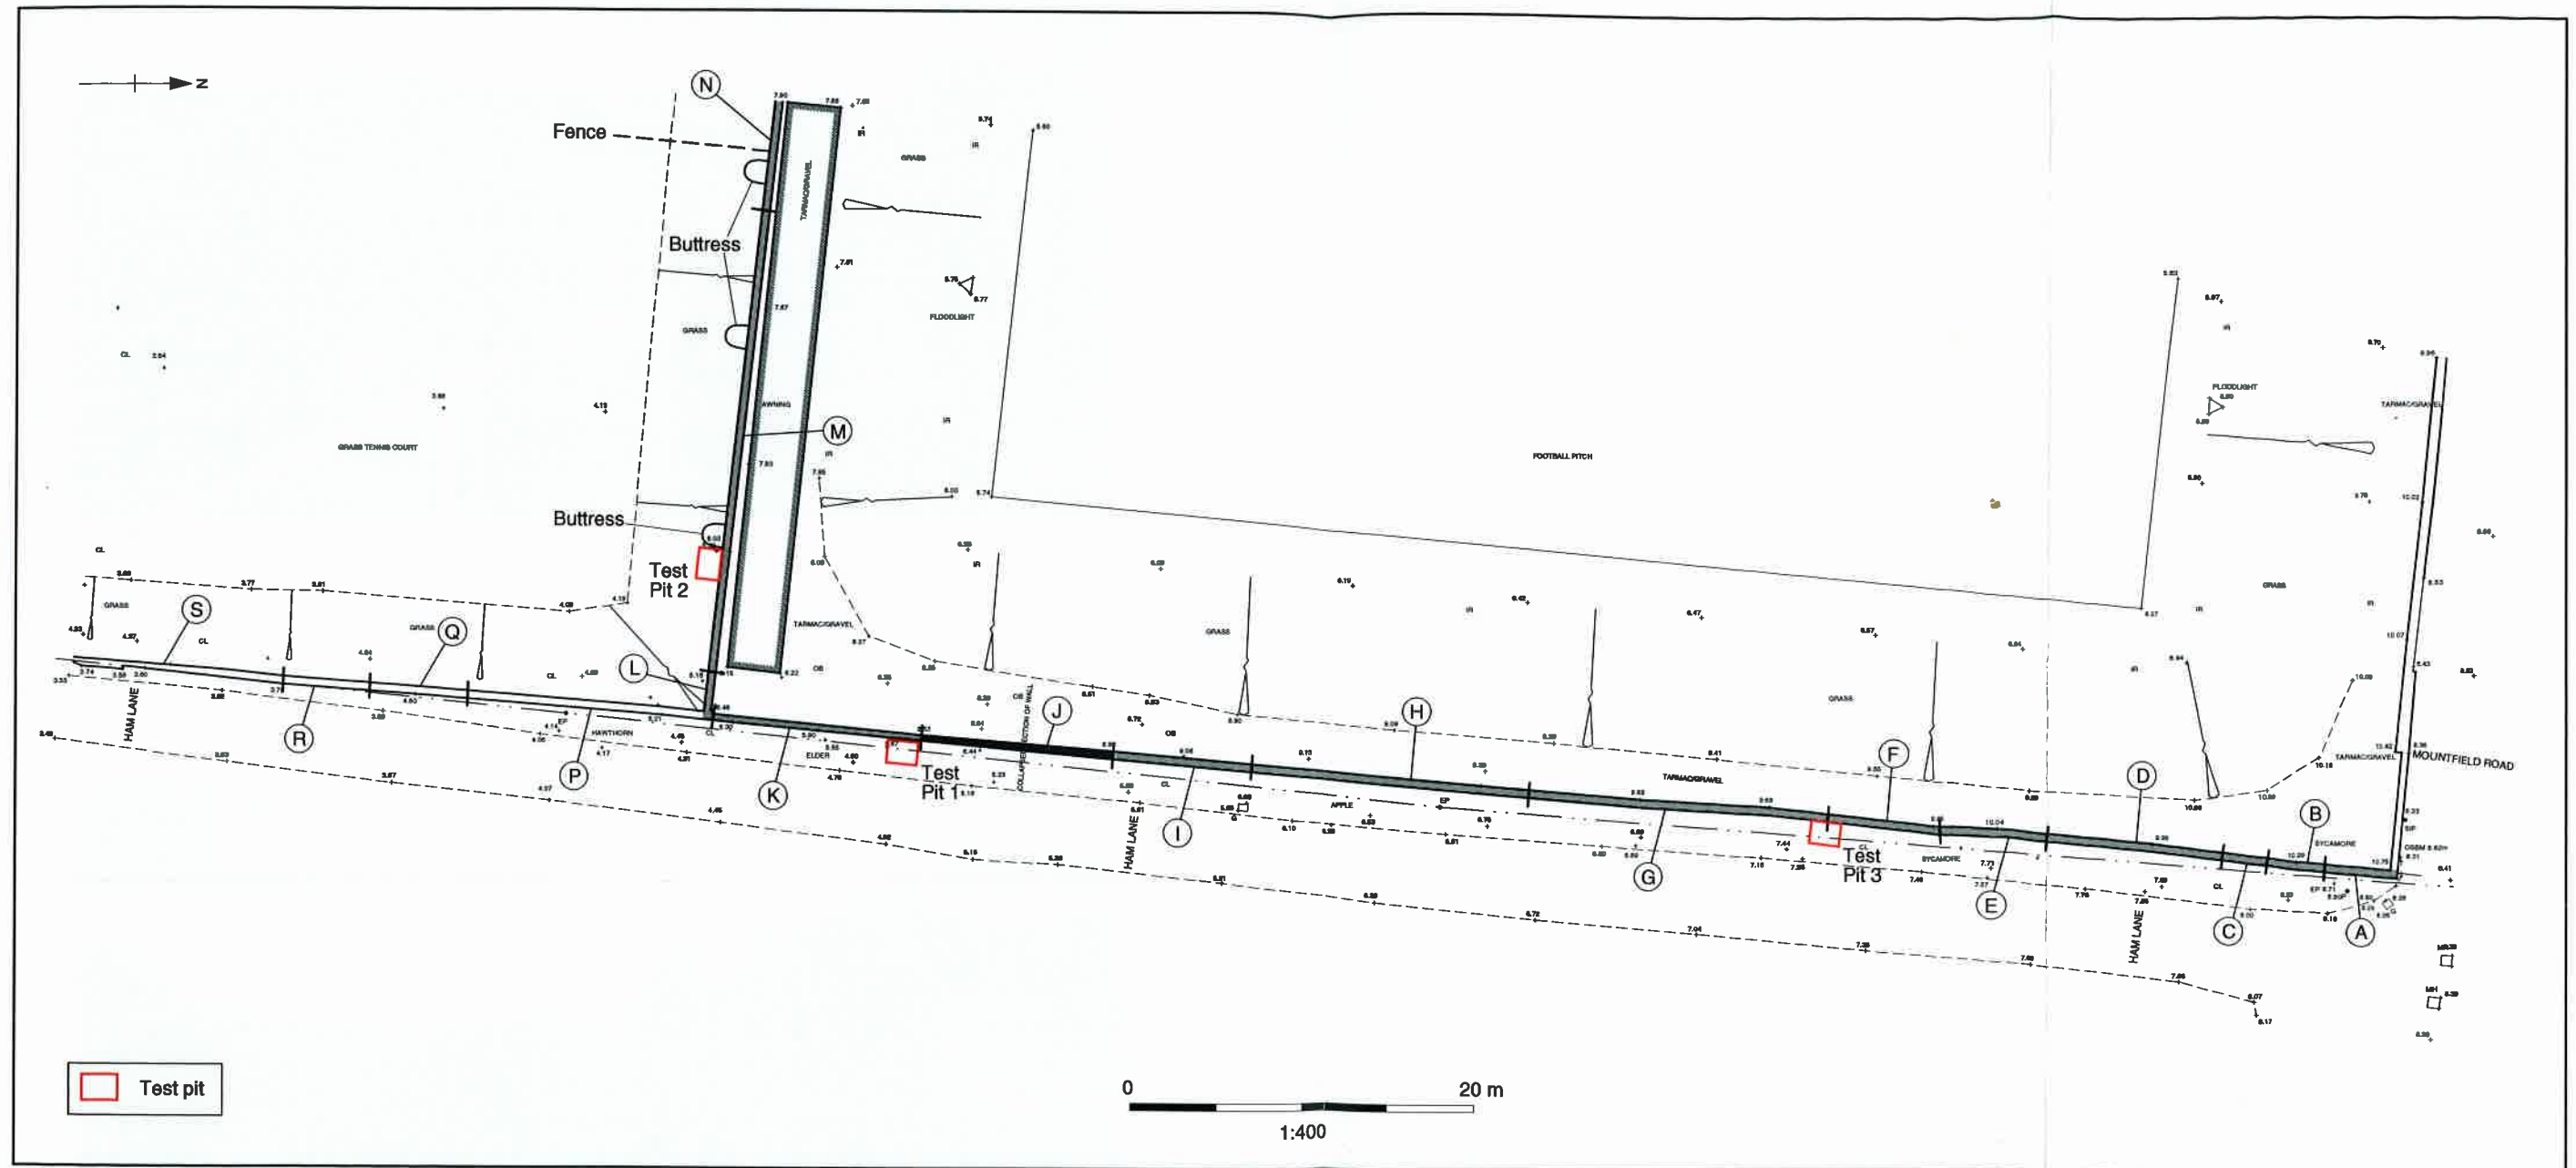
Figure 9: Plan of wall included in assessment showing constructional phases

- 3.1.4 Some parts have squared stones incorporated (presumably old stones reused) and some have bricks mixed in. The flints are largely cut to form a rough face. To aid the understanding of the structure the description section below divides the walls into each distinct constructional phase or context. In addition to these main phases there are also many smaller areas of patching or repair within the larger distinct sections. Those parts of the wall that the descriptions relate to are shown on Figure 9.

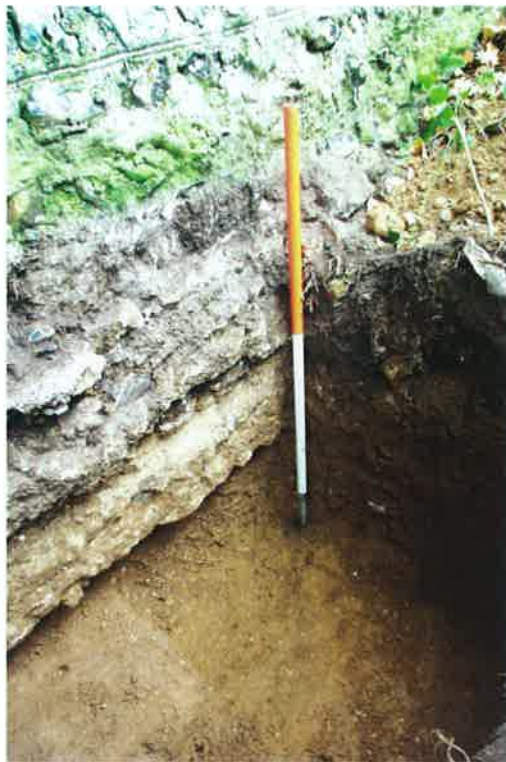
Plate 3: Test Pit1

- 3.2.2 **Test Pit 1:** Located towards the south end of the main wall flanking Ham Lane, immediately to south of area of collapsed wall (in Section K). This showed that the wall in this location was built directly onto a clay deposit c.76 cm below the current surface of the bank and there was no trench cut for a foundation. Above the top of the current bank the flints are cut to form a face while below the surface they are un-faced.

Located on east side of north-south stretch of wall flanking Ham Lane, c. 12 m from south corner of the wall and c.82 m from south corner. c.1m x 1 m. The pit was located immediately to the south of the area of collapsed wall (Section J) which will have to be rebuilt. Location chosen partly to allow structural engineers to assess the depth of the foundations in this area.

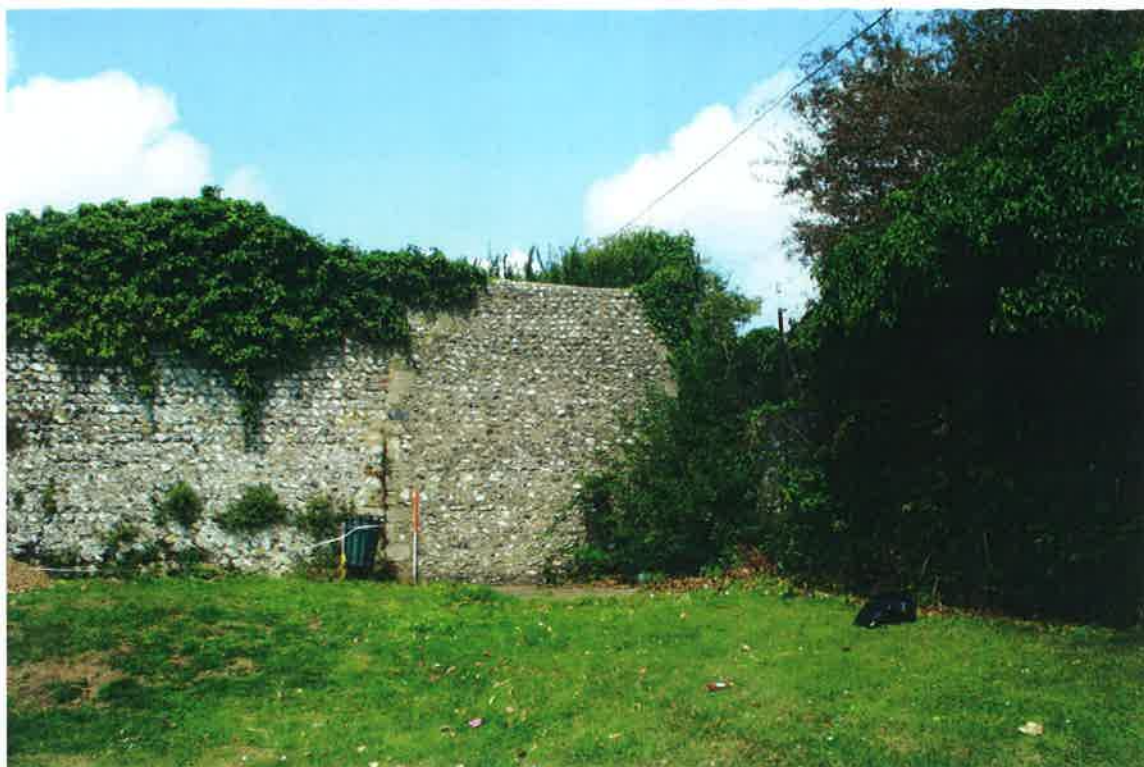
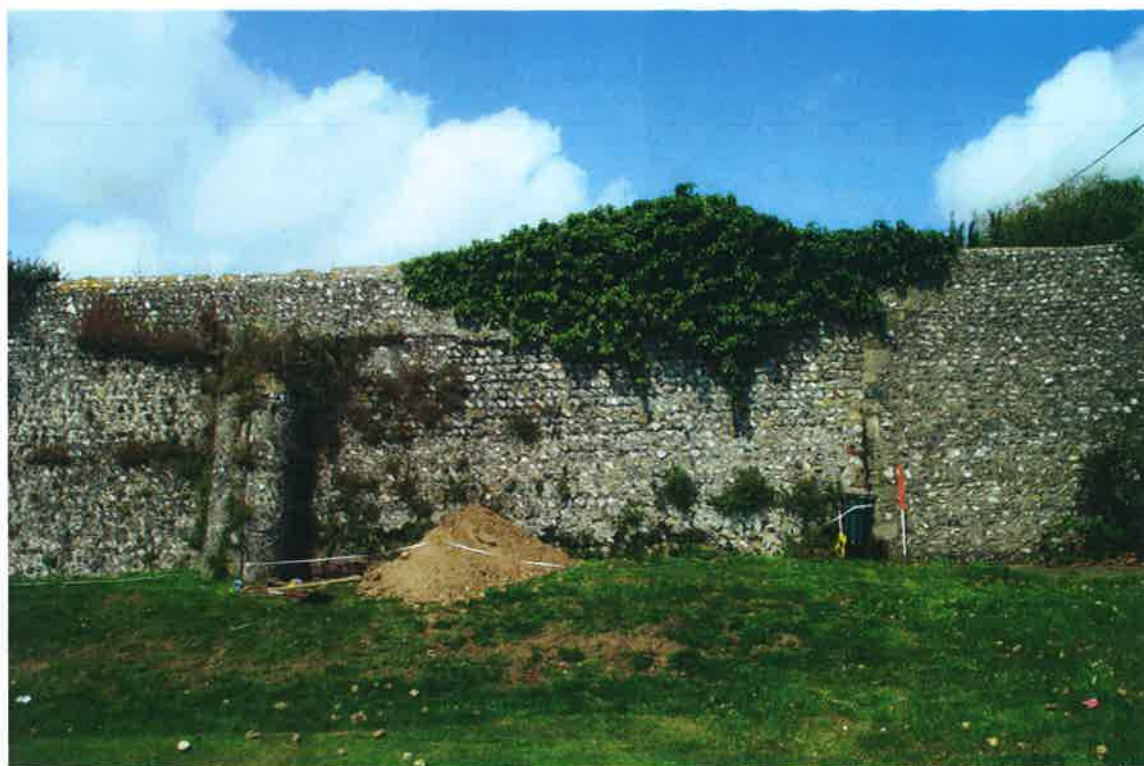
- 3.1.17 **Section M:** c.24 m. Flint faced with regular coursed construction. Hard cementitious mortar with decorative double groove between each course. There is a large crack running along the upper section of the wall, probably indicating the top of the bank on the north side of the wall. Three evenly spaced buttresses support the wall with rounded southern faces (Pl.12, 13). Each buttress is c. 2 m tall, of flint construction and with distinct vertical line of stones at central line of southern face. Two buttresses are shown in this general location on Budgen's view of Lewes (1724) but two later plans (1799, 1824) show a fence in this location so the buttresses are unlikely to be those on the 1724 view. However, there is evidence to suggest that the previous buttress foundations may have been reused for new buttresses when the wall was rebuilt (detailed below in Appendix 2).

Plate 5: Sections L and M

Plate 6: Sections L and M

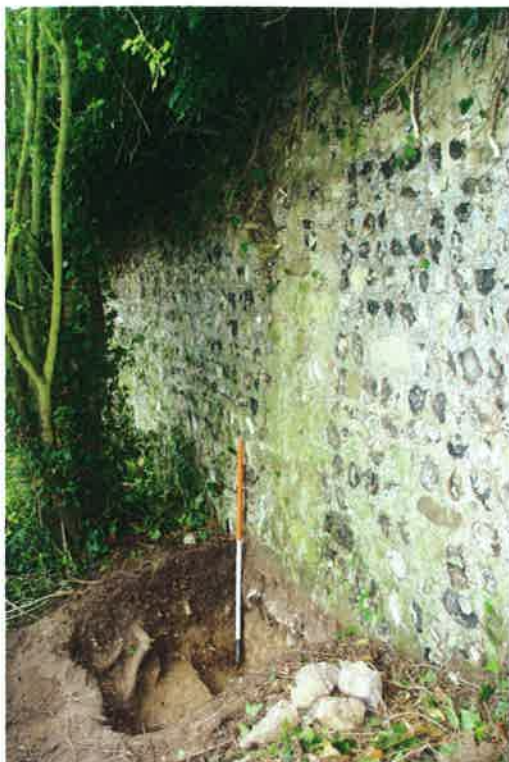
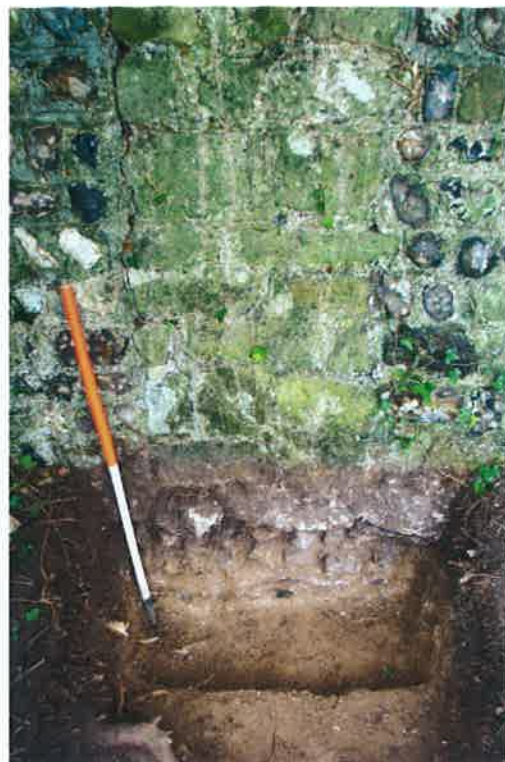
- 3.2.4 **Test Pit 3:** Located against north-south wall facing Ham Lane, c.33 m from north end (In section G/F). Intended to investigate the buried section of a stone 'pier' within the largely flint wall which extends c.1.2 m above ground at this point. The test pit revealed that the stonework of the 'pier' only extended for a single course below the top of the bank and then sat on a coursed flint foundation. Although the pit straddled Sections G and F no clear distinction was noted in the construction of the foundations. The bank contained a high content of dumped 19th and 20th-century waste suggesting that the bank is of relatively recent origin and the fact that the bottom of the 'pier' and foundations only extended just below this height suggests that this part of the wall is probably no older than the bank.

Plate 7: Pier of stones directly above Test Pit 3

Plate 8: Pier of stones Directly above Test Pit 3

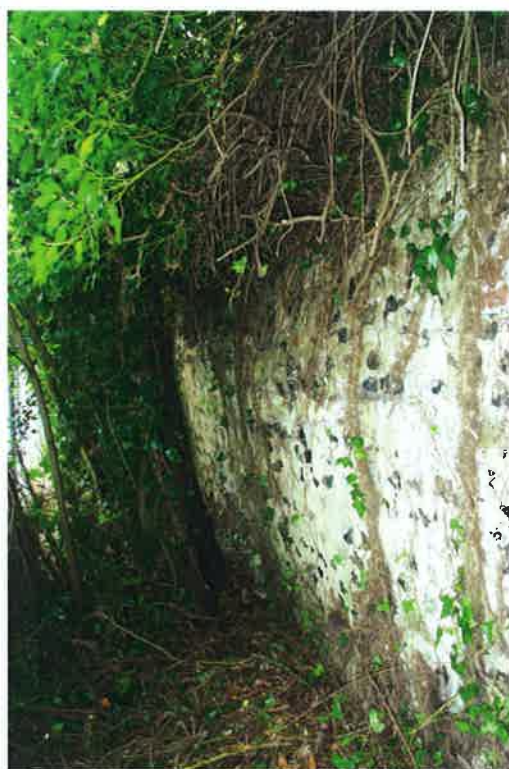
Plate 9: Bowed section in E

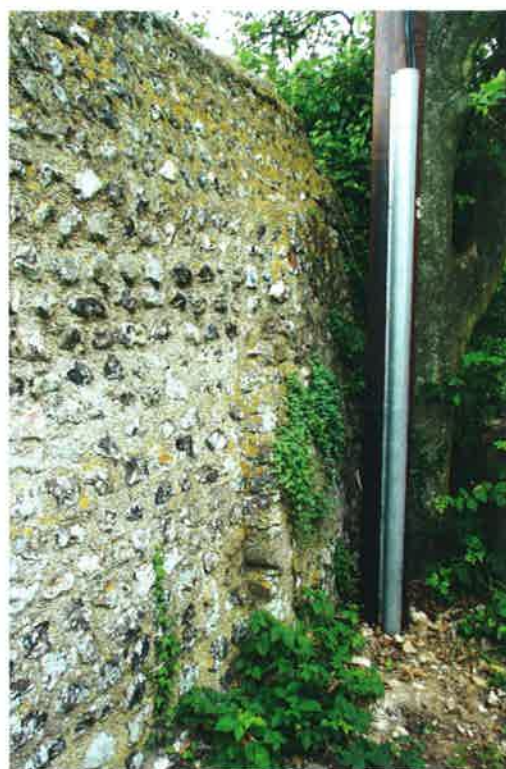
- 3.1.5 **Section A:** northern 4.5 m of wall. Very rough construction with flint and a relatively high number of bricks (probably 19th-century) mixed in. Well constructed stone quoin at north corner. Several areas of patching and later render (heavy cement render) over parts of A. At its southern end Section A steps down and section B is constructed over it. Clearly Section A has partially collapsed in the past and then the wall has been rebuilt with Section B on top of the collapsed part. Section A is likely to be of 19th-century date. The condition of A is moderately good and it does not appear to be close to collapse (Pl. 10).

moon brick coping. Section B is of relatively recent date (20th century) and its condition is moderately good (Pl. 10).

Plate 10: Sections A and B

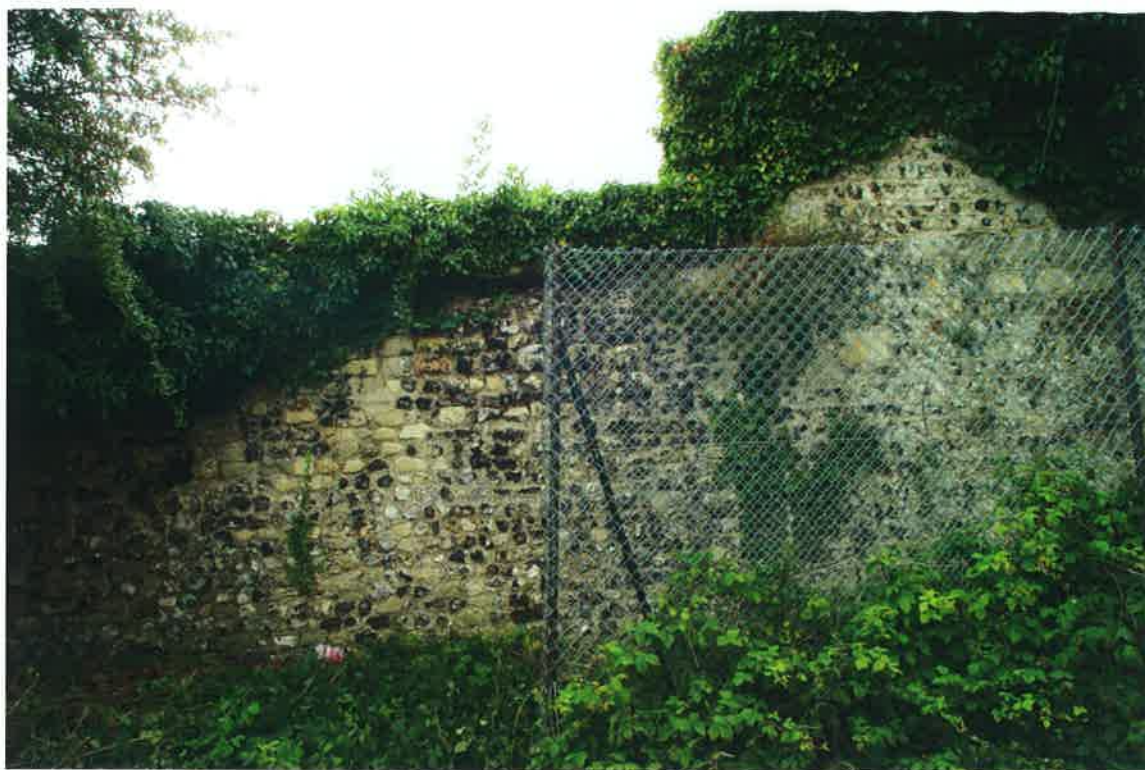
Plate 11: Section K behind wire fence

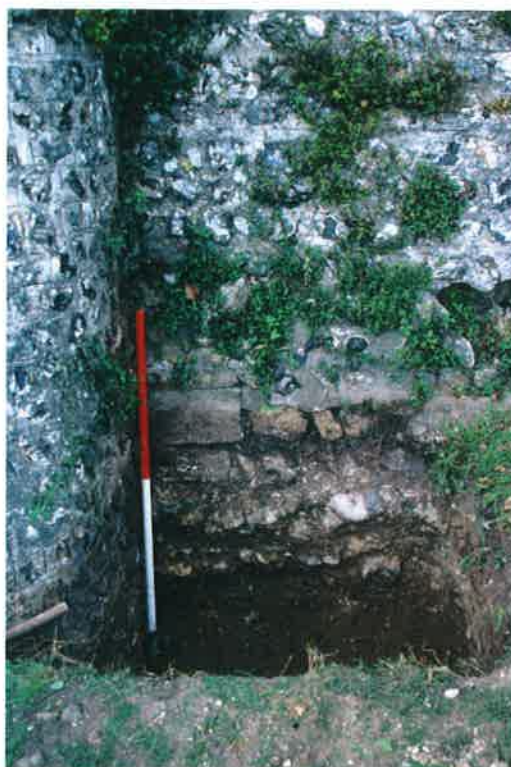
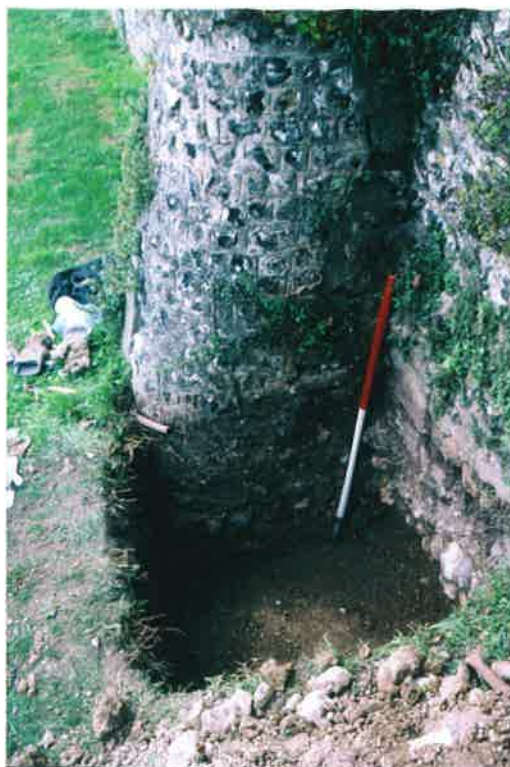
- 3.2.3 **Test Pit 2:** Located against buttress in western 'spur' wall (in Section M). Evidence revealed in the test pit suggested that the buttress pre-dates the adjacent wall. This corresponds with historical evidence (detailed above) which suggests that there was a wall with buttresses in the early 18th century (shown on Budgen's 1724 view) but that the wall had been replaced by a fence by 1799. It may be that the current buttresses were rebuilt in the 19th century, when the wall was rebuilt, on the base of the older buttresses shown in the view.

It is difficult to ascertain whether the buttress is keyed into the wall as it has been repaired at the join and thick cement covers this area. The foundations to the buttress are deeper and the stone coursing continues to the depth of the pit. The foundations are very solid, square with the rounded buttresses sitting on top of the foundation. The pit shows coursed flint foundations that are bonded with mortar. It appears that the buttress was built first and that the wall was constructed against it. There are large worked blocks of stone at the base. The fill of the wall cut butts the buttress foundations also showing it is probable that the buttress pre-dates the wall. This corresponds with historical evidence (detailed above) which suggests that there was a wall with buttresses in the early 18th century (shown on Budgen's 1724 view) but that the wall had been replaced by a fence by 1799. It may be that the current buttresses were rebuilt in the 19th century, when the wall was rebuilt, on the base of the older buttresses shown in the view.

Plate 12: Test Pit 2 adjacent to buttress

Plate 13: Test Pit 2 adjacent to buttress
