HEST BANK JETTY, LANCASHIRE

Archaeological Survey Report

Oxford Archaeology North

July 2010

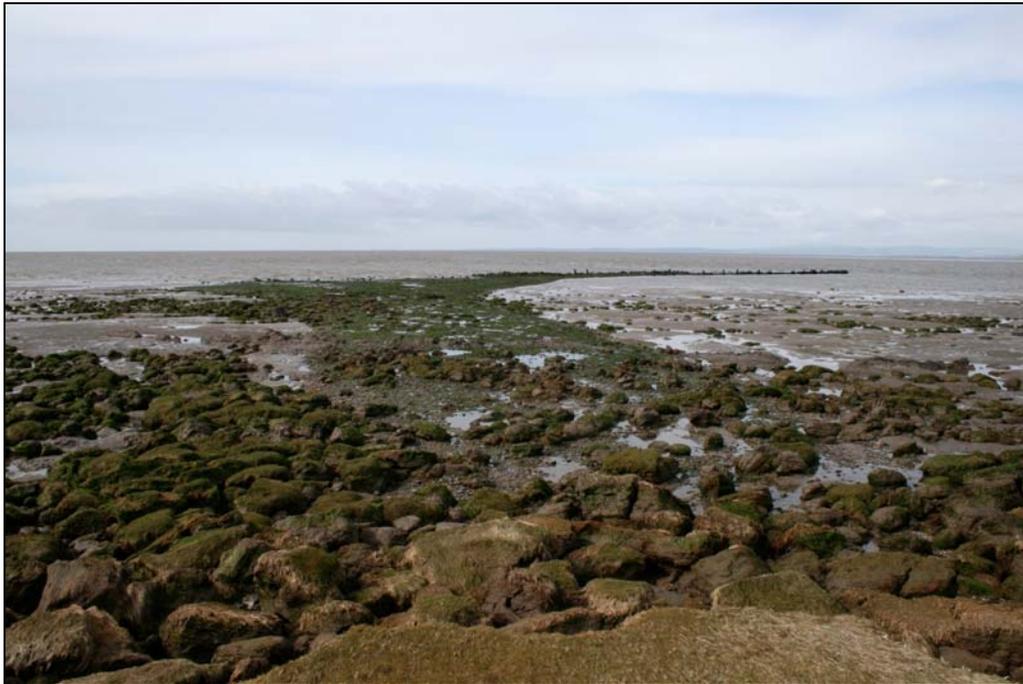
Plate 10: General view of Hest Bank Jetty looking north-west

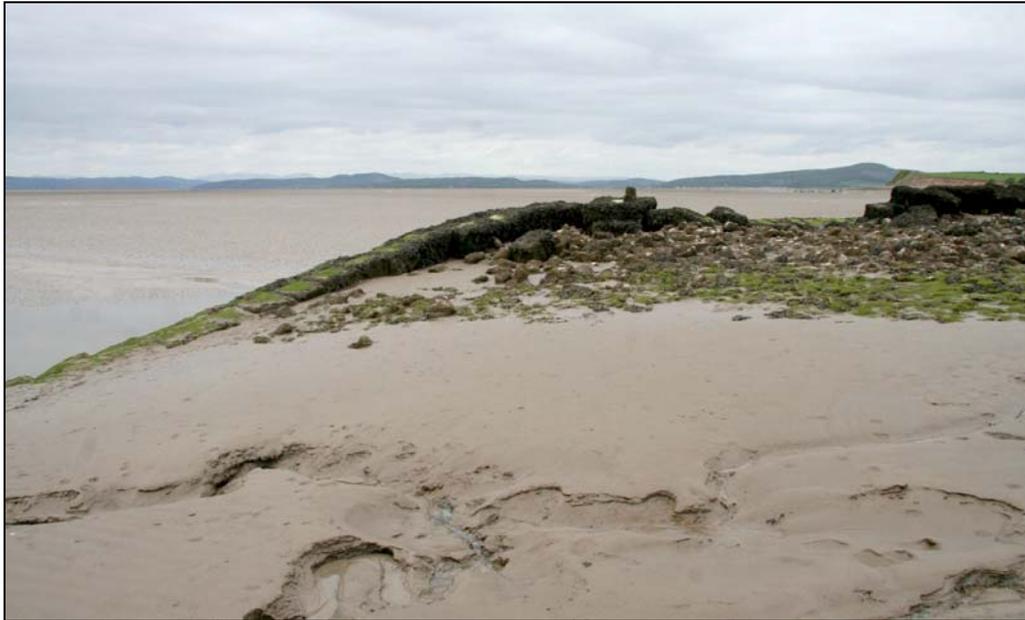
Plate 11: Area of cobbled floor on the northern end of the south-west facing side of the jetty

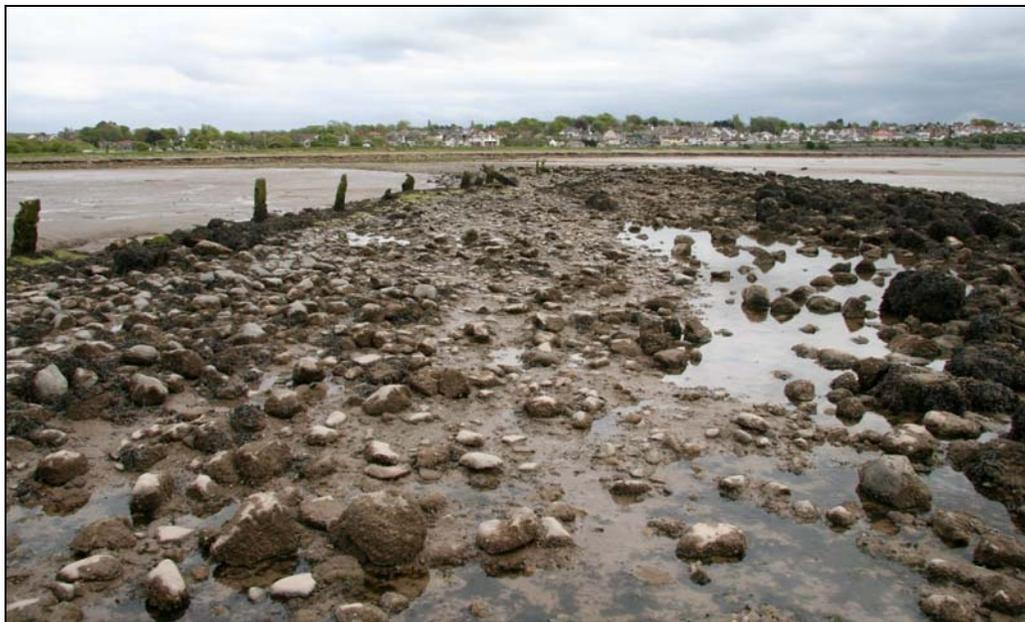
3.2.1 The jetty consists primarily of a linear cobble-constructed, relatively flat, platform running on a diagonal angle (orientated north-west/south-east) at a little distance from the present coastline forming what would have originally been an isolated breakwater (Plate 9) (Fig 3). The southern end of the structure is less well defined and consists of a curvilinear bank of cobbles that run to the shoreline and would have originally formed an access causeway at low tide (Plate 10). The main part of the structure has a shallow-sided, curved profile on its seaward side in order to dissipate the effects of storm waves, and there is evidence of partially surviving elements of a layer of densely-packed set cobbles (Feature 1) forming the northern end of the outer seaward face of the jetty (Plate 11). The inner construction of the jetty is of large beach cobbles with a packing of smaller cobbles on the outer surfaces, much of the latter has been eroded away over years of storms and tides leaving a slightly uneven upper surface with much of the finer material having been stripped away (Plate 12).

Plate 12: Disturbed cobbled construction in the centre of the jetty

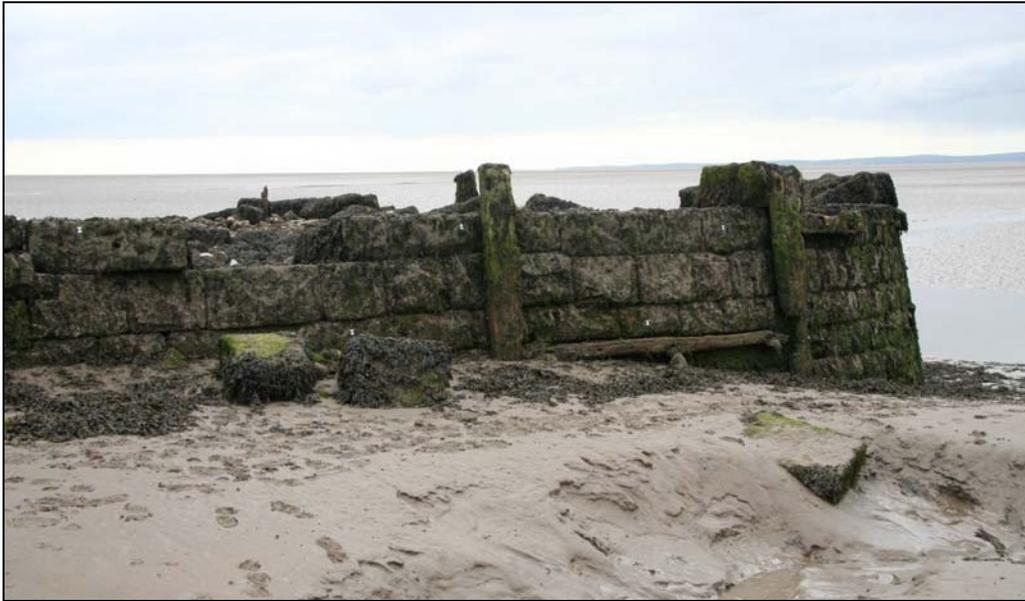
Plate 13: North-eastern end of the north-east-facing dressed jetty wall.

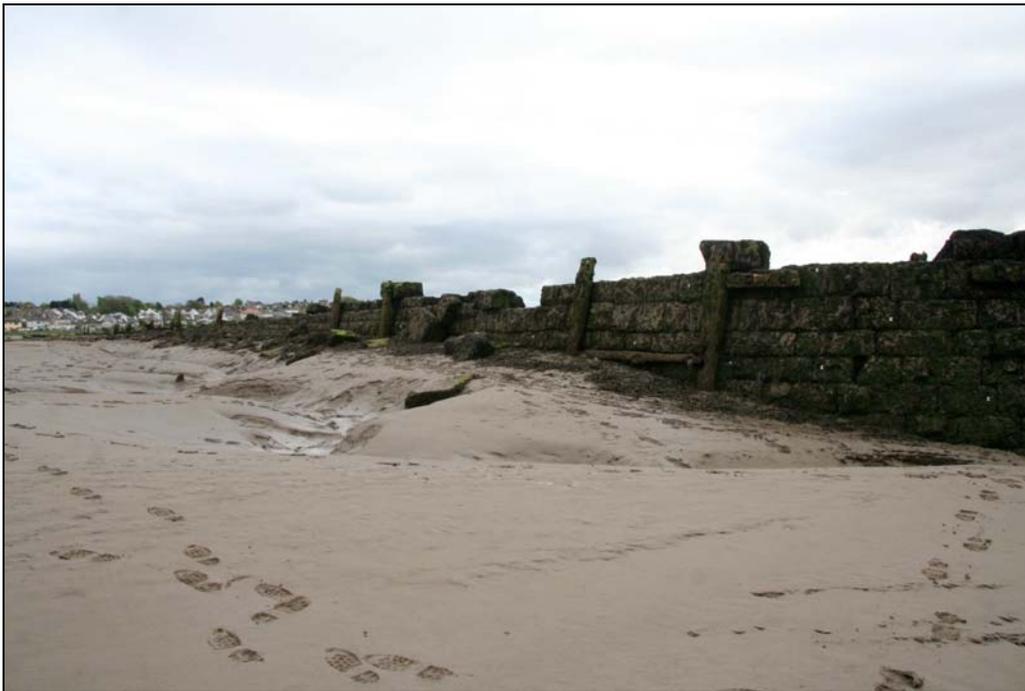
Plate 14: Mid-section of the north-east-facing dressed jetty wall

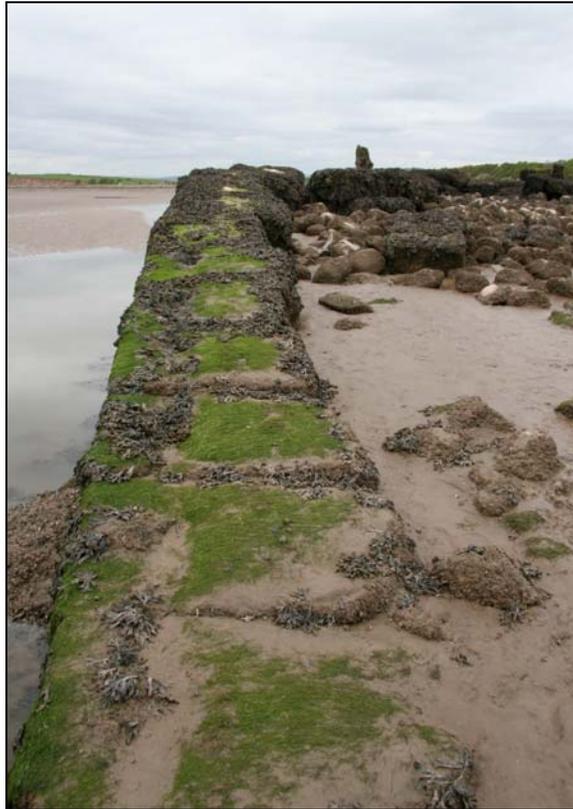
Plate 15: Surviving outer edge of facing stones on the northern end of the jetty

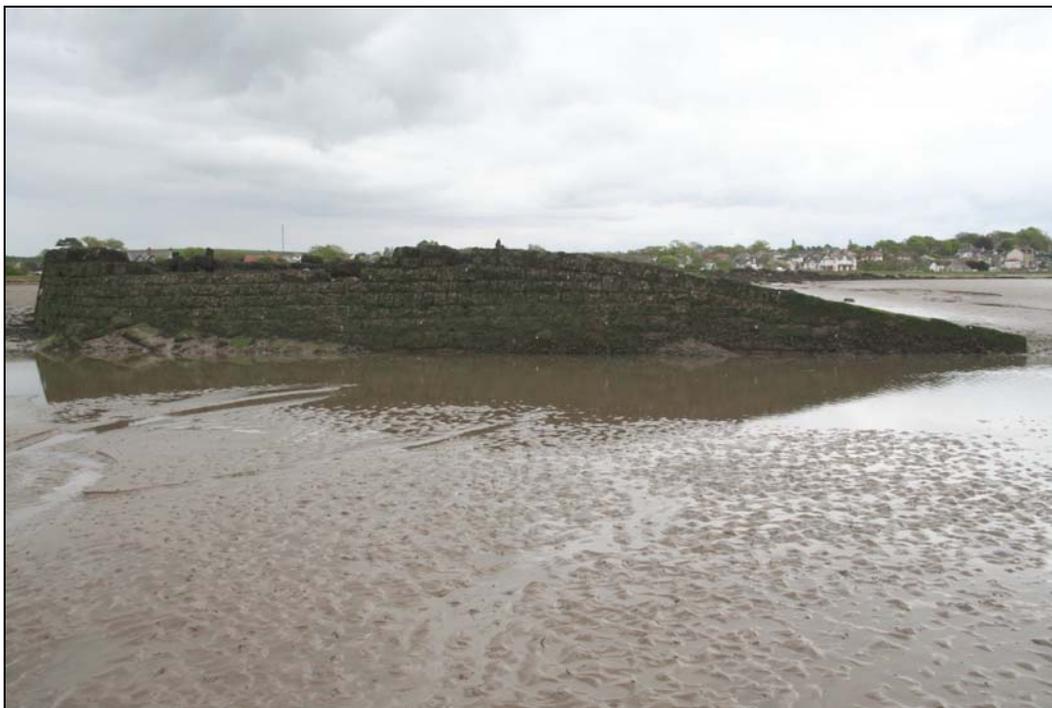
Plate 16: Profile of the northern end of the jetty walls

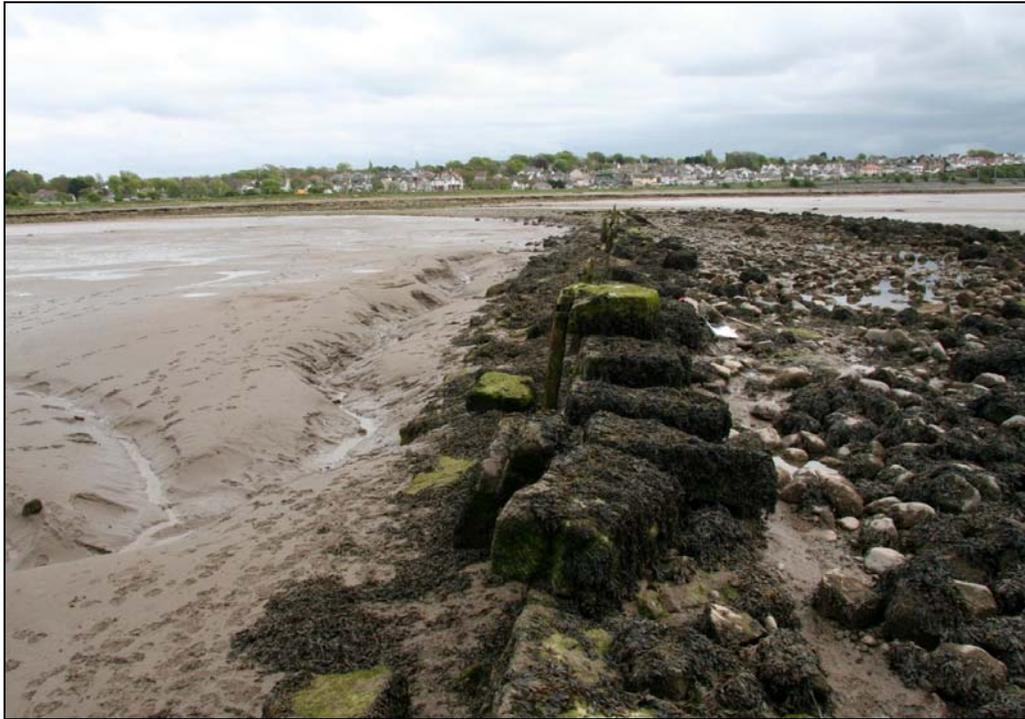
3.2.3 The north-east face of the jetty wall has surviving, fragmentary, elements of at least nine squared, vertical wooden posts (Feature 3) (Figs 4-6, 10-12), with an iron-bracketed framework, and there were originally two horizontal rows of wooden timbers dovetailed between them (Feature 4) (Figs 10 and 11; Plates 13 and 14). The structure would have run the entire length of the wall, judging by the extent of the surviving iron brackets and/or socket holes and would have acted as fenders or rubbing strip to stop vessels damaging the structure. The posts on the southern half of the jetty wall extend above the current upper surface of the wall, suggesting that the wall has been eroded or scavenged of stones in this location (Plate 17). The

Plate 17: Disturbed edge of facing stones and wooden fenders on the north-east side of the jetty
