South Hill Park Bracknell Lake Dam Culvert Investigation

Archaeological Watching Brief Report

South Hill Park, Bracknell: South Lake Sluice Investigation

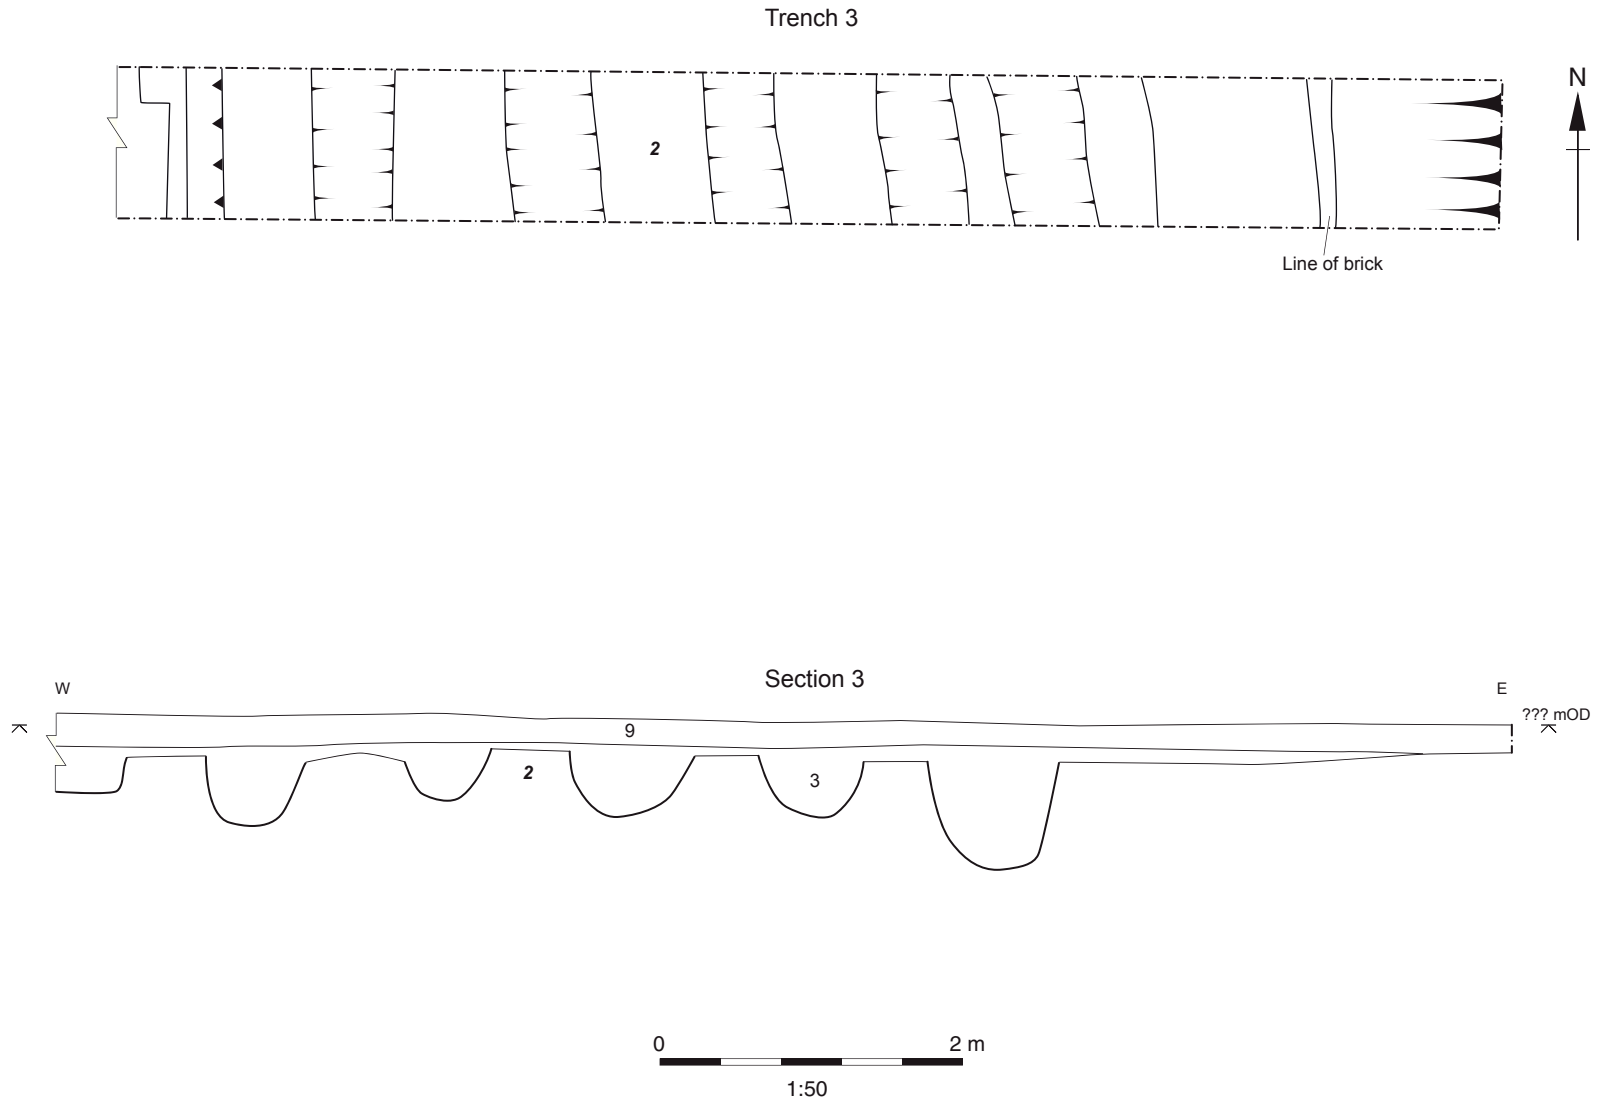
Figure 3: Plan and section of Trench 3

- 2.1.5 **Trench 3** extended for a distance of 13m in an easterly direction from Trench 1, along the top of the upstream side of the dam. It was excavated to a maximum depth of 0.74m. The trench was excavated through the modern path surface (context 9), which comprised a very dark grey pebble and sand mix with a surface of yellow sand. This overlay a loose, mixed soil (context 3) which covered and infilled a series of parallel brick channels (context 2). Context 3 produced a single sherd of red border ware pottery, which has a date range of c 1700-1850.

- 2.1.6 The brick channels (context 2) had an approximately U-shaped profile up to 0.8m in diameter and 0.75m deep. They all appear to be of the same period and the unfrosted bricks are consistent with a late 18th century date. The channels appear somewhat irregular in their spacing and dimensions, possibly as a result of subsidence (Fig.3, Plates 5, 6 and 7). They were generally constructed in English style bonding although the uppermost layer was in headed bond. The mortar was somewhat degraded.

- 3.1.3 The parallel brick channels in Trench 3, when overlaid on the Ordnance Survey map of 1871, clearly lie along the upstream edge of the dam separating South Lake from the (now infilled) lake to the north (Fig. 2). They are presumed to be inlet channels to carry overflow from the South Lake into the northern lakes, thus preventing the water in South Lake from rising above the desired level. The structure as a whole is described as a 'sluice' on the 1871 map, which if correct would imply the presence of one or more gates on the upstream side. This could refer to the brick culvert in Trench 1. Certainly no traces of gates were found in Trench 3, but if present they could have been positioned slightly further to the south, beyond the limit of excavation. Given the comparatively small scale of the lakes and limited flow of water from the Gormoor Brook it is possible that the parallel brick channels had no associated gates and rather served as a weir, channelling excess water over the clay bank and underneath the path.

6. The sluices will be filled with small mixed aggregate, 10mm down, and then compacted as far as possible, possibly by overfilling and using a wacker plate.

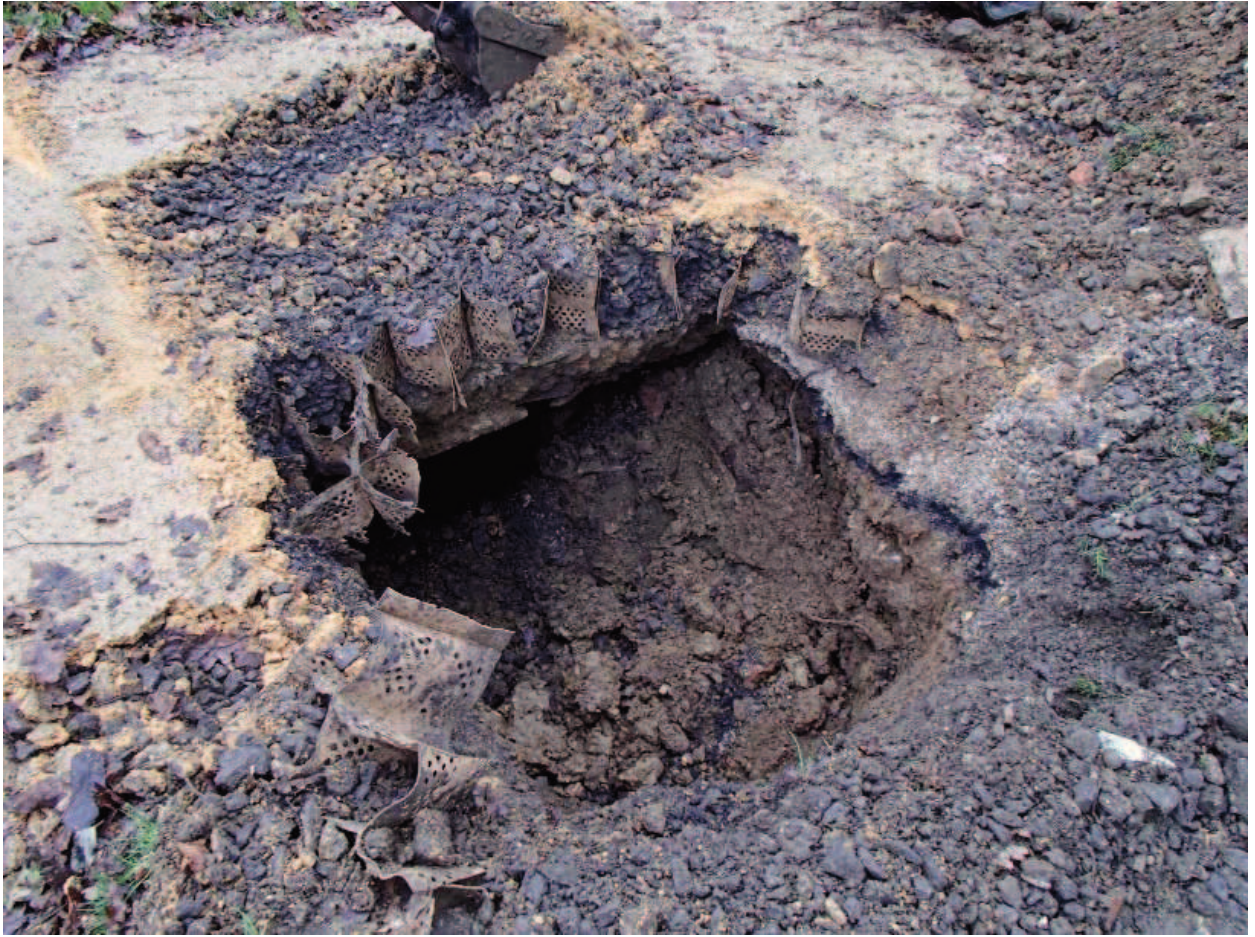
- 3.2.1 The collapsed section of path coincides with both the original collapse in the culvert arch and the subsequent modern repair. There appears to be evidence of water getting past the metal seal of the culvert and into the cavity under the concrete slab, which in turn may have affected the supporting material for the path. The condition of the metal (both sheeting and supports) within the capping structure was found to be badly degraded, with the metal sheeting providing almost no support to the concrete.

Plate 1: Showing collapse of path

- 3.2.6 Because the path is used to allow trucks, as well as pedestrian traffic, into the grounds, the engineer recommends that the collapsed inspection manhole is not reinstated. The following repair method will be followed:

1. Remove, completely, the concrete and steel supports over the upstream end of the culvert. Take additional photos of the exposed upstream end of the culvert behind the headwall.

2. Move the rubble which is currently filling the excavation up towards the headwall to expose the collapsed end of the culvert. Take a downstream photo of the inside of the culvert.

3. Protect the top of the culvert by laying a sheet/sheets of Richard Lees Holorib over the top, supported on either side of the culvert by carefully graded hardcore.

4. Pour concrete grade GEN 3 on top of the steel sheet to a depth of 150mm. This will protect the culvert from further collapse.
 5. Once the concrete has gained sufficient strength, after approximately 14 days, the excavation will be backfilled with the material which was removed, and compacted in 150mm layers using a wacker plate.

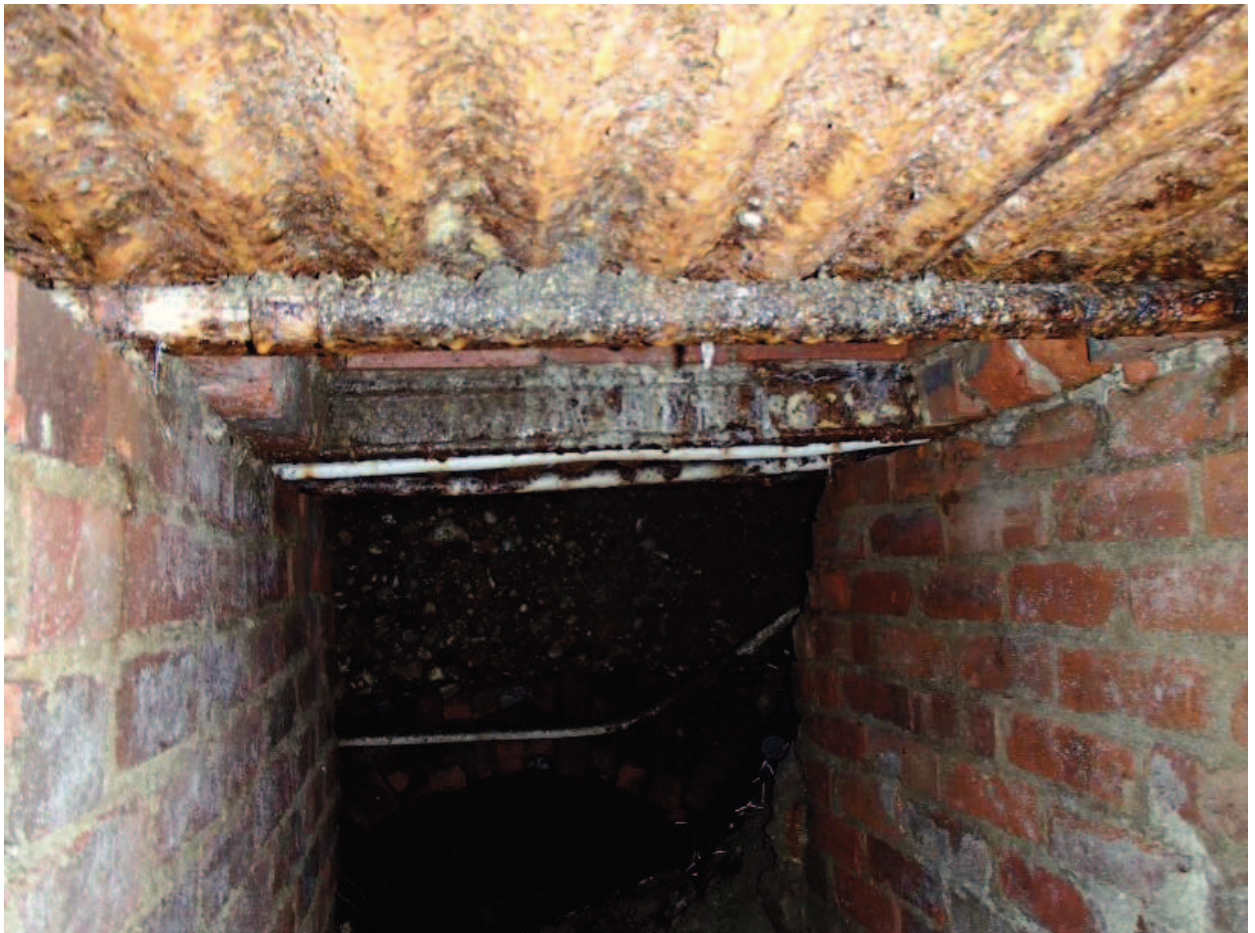
2.1.2 A section of the culvert adjacent to the headwall had collapsed previously and been repaired in recent years with a pair of parallel, single skin brick walls, constructed with modern frosted bricks. Steel support bars and metal pipes were placed across the gap between the walls, supporting a roof of corrugated metal sheets, which were in turn covered with a 0.20m thick layer of poured concrete. An inspection hole had been built into this structure.

Plate 2: State of corroded concrete slab

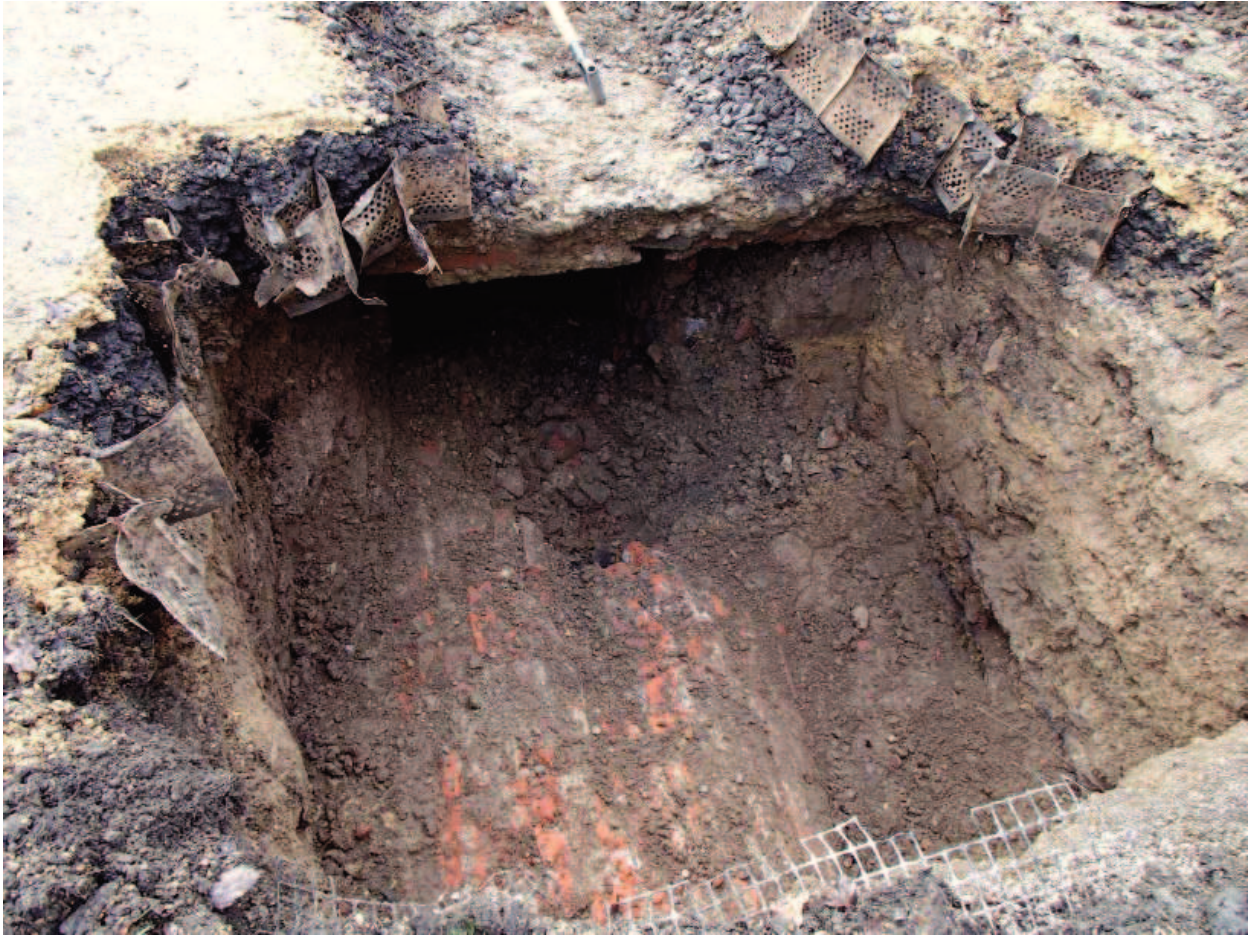
- 3.2.3 The base of the original culvert was largely obscured by a build up of mud/silt, to the extent that the full depth could not be established. The top of the culvert arch was 1.06m below the path surface.

Plate 3: Showing state of condition of culvert

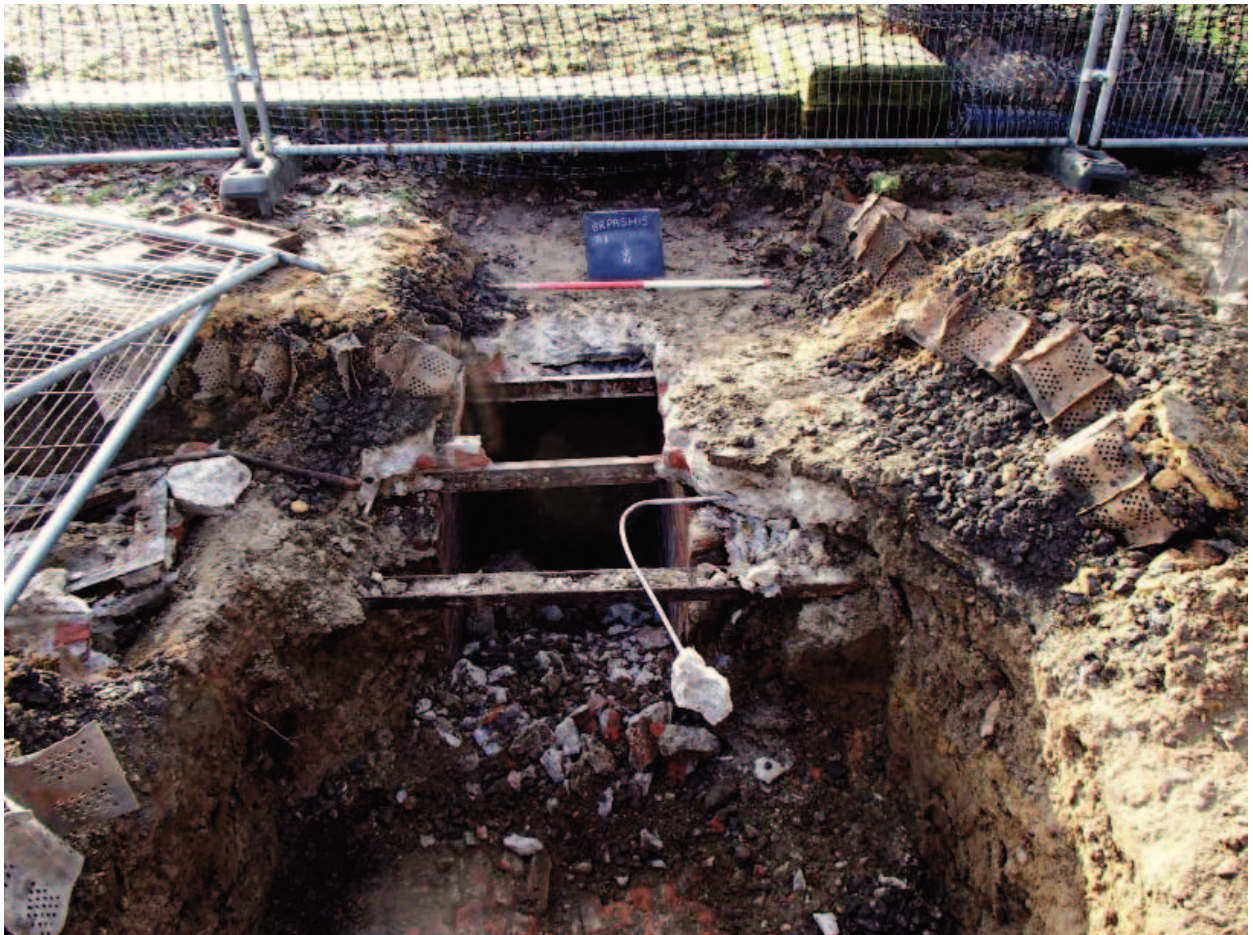
Plate 4: Concrete slab and inspection hole
