**ROYAL VICTORIA & BULL HOTEL, DARTFORD**  
ARCHAEOLOGICAL AND PHOTOGRAPHIC RECORD DURING REFURBISHMENT

OXFORD ARCHAEOLOGICAL UNIT  
SEPTEMBER 1998

NMR DATA	
SITE NAME	ROYAL VICTORIA & BULL HOTEL
ADDRESS	HIGH STREET
TOWN	DARTFORD
COUNTY	KENT
NGR	TQ 5415 7402
LISTED STATUS	GRADE II *
VISIT/SURVEY DATE	AUGUST - SEPTEMBER 1996
OAU SITE CODE	DARVB 96

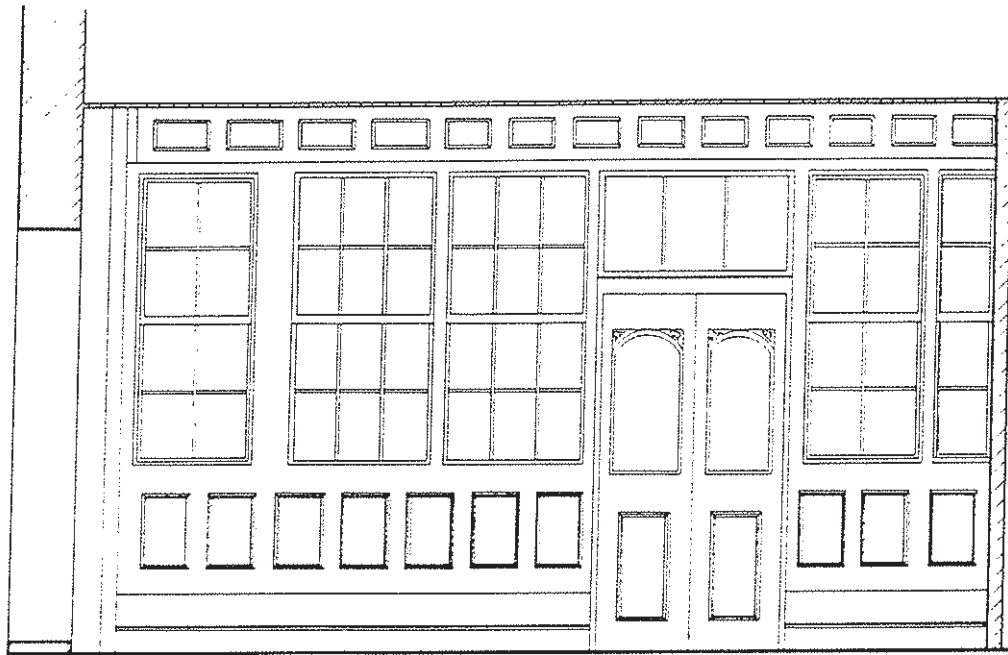
Figure 5 1920's glazed screen, 'Bottle bar', east facing elevation, (1:50)

3.3.1.3 On removal of the modern panelling in the SE corner of the bar a classic, aediculated, Victorian door with acanthus brackets and glazed panelled architrave was uncovered (Plate 9). The door had been blocked to the south with modern 20<sup>th</sup>-century wire cut bricks and cement. It was framed by a pilaster to the east and the central column of the former carriage way to the west. The door formed part of the blocking of the abandoned eastern side of the main entrance, with further brick blocking to the east. The partition wall to the west of the room was seen to post date the uncovered door as it was built against its west panel (Figure 5).

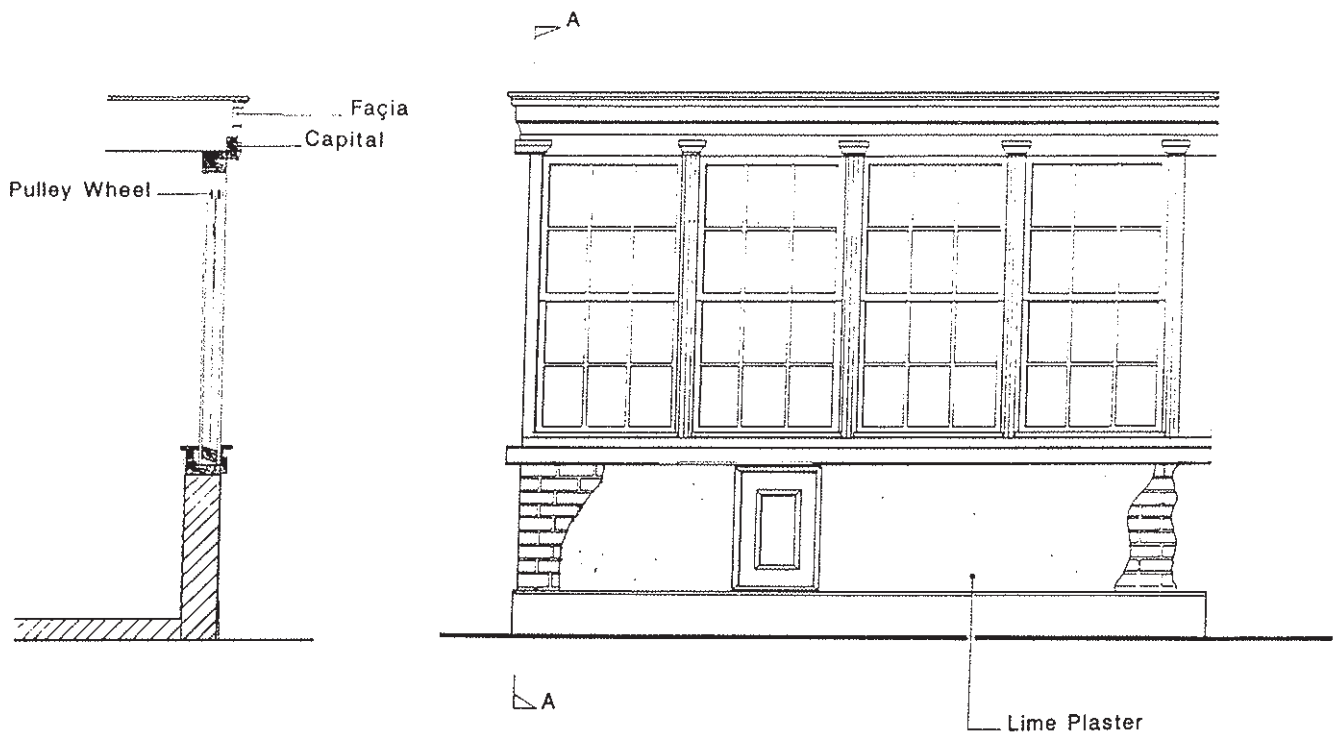
Figure 7 Section A-A, through the historic bay, showing evidence of previous window fittings, (1:50)

3.3.7.2 During the 1996 refurbishment work the modern screens were entirely removed leaving the historic bay and enabling some structural observations. The sleeper wall of the historic bay is built of a combination of primary phase brick and a wire cut yellow brick with dark inclusions. The fenestration is made up of 4 six-paned vertical sash windows with a door in the north end of the bay (Figures 6 & 7). The door opening retains fittings and a pulley wheel indicating that it was previously a sash window. The architraves, flanking the door and windows, are in the form of fluted pilasters topped with a simple Doric capital. The bay was obviously intended to light the bar and is likely to date to the first half of the 19th century, and may have been contemporary with the fitting out for the Corn Market in c1820, though it could also be older. Cast-iron brackets supporting the tongue and groove clad soffits of the galleries are shown in the photographs and during the refurbishments were uncovered. Within the area created by the historic bay a horizontal sliding sash window was uncovered, as reported on above (§3.3.4). Under this window a small cupboard of uncertain date, but lined with softwood tongue and groove was built into the wall (Plate 10). Various patches of repair work in yellow brick was also noted and recorded around the door to the south of the bay. During the course of the works no evidence of the original courtyard surface was observed. In the mid-19<sup>th</sup>-century photographs the floor is paved with bricks, replaced by a screed concrete floor by the Edwardian period. Small excavations in the yard at the time of the survey indicate that the earlier flooring materials

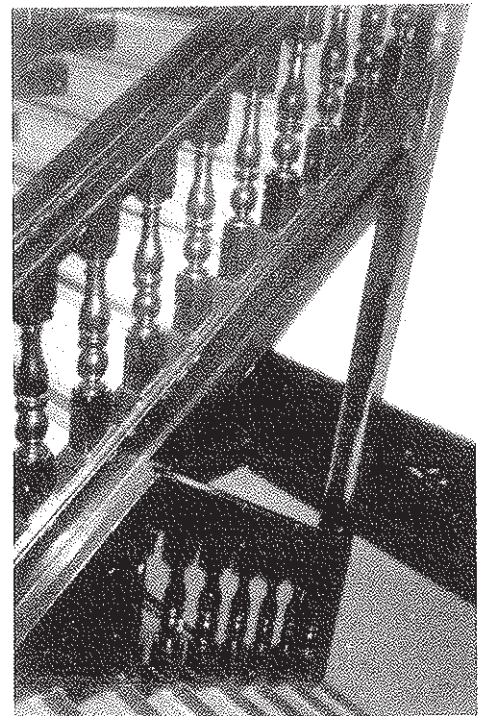
Plate 12: Original 1703 stair

The main staircase, situated in the north-east corner of the courtyard and leading to the first floor gallery and on to the attic storey, is a fine piece of joinery. It has all the appearance of being original work of 1703, with its heavy turned balusters and newel posts (Plate 12). From ground floor to first floor it is of dogleg type and from first floor to attic level the stair spirals around a newel post. The bottom flight of stairs has clearly been altered during the 19<sup>th</sup> or 20<sup>th</sup> centuries and currently projects beyond the line of the blocked eastern carriageway suggesting that it replaced an original steeper pitched flight.

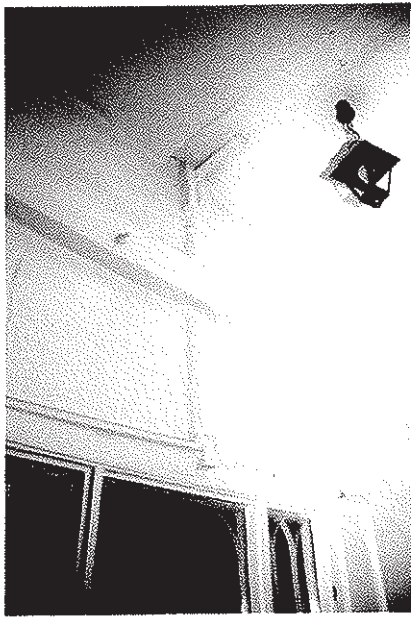
Plate 14: Sawn off column,  
north gallery

3.4.2.1 The first floor has galleries overlooking the courtyard around all four sides. The southern side is of 20<sup>th</sup>-century date as demonstrated by historic photographs. The northern side is walled off from the courtyard area with a mid-19<sup>th</sup>-century gothic window lighting the enclosed corridor. The current roof was constructed in 1826 by the incumbent landlord W.T. Bray. The glazed covering is supported on timber queen post trusses. The building of this roof has almost certainly truncated the earlier roofs of the side wings, which would have come forward to cover the gallery on the first floor, leaving the courtyard below open to the elements. The earlier roof would have been supported on columns rising from the hand rail of the surviving balustrade. The sawn-off footings for the columns are visible spaced at approximately 2.5m intervals with two complete examples remaining in situ in the NE and NW corners of the gallery (Plate 15). In the centre of the north side the upper section of a third column survives above the head of the window, supporting the soffit of the second floor gallery (Plate 14). The window presumably was cut through the column at a later date, and it is unclear whether this covered walkway was open at the side to the elements or glazed. The balustrade itself has the same heavy turned balusters as the original stair in the front of the building, which fit with the 1703 date of construction. The balustrades of the south gallery are modern lathe-turned copies.

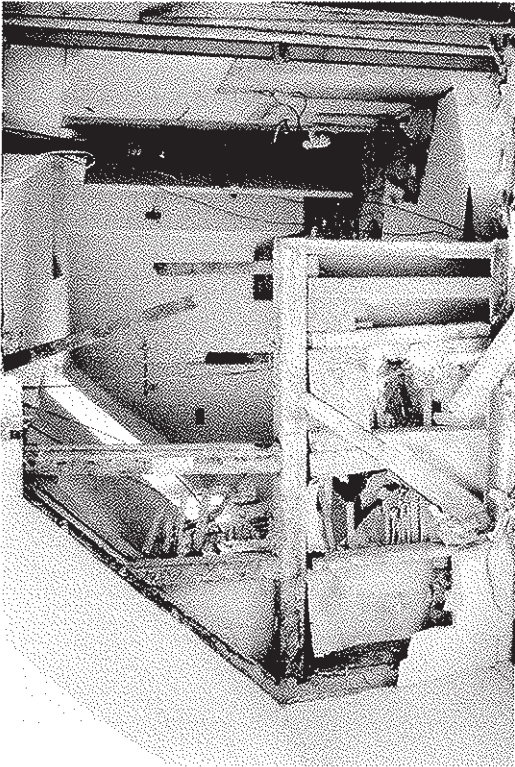
Plate 16: Stud partition in east attic

3.4.3.1 The southern end of roof space of the east wing was converted in the late 19th century or possibly early 20th century in to an attic or store (Plates 17-19). The original roof trusses have been drastically altered to the south of the attic and the truss in the middle of the void is a Victorian replacement. The southern half of the attic was lined with softwood tongue-and-groove and electric light fittings were put in; a large lead water tank was also inserted. The north end of the wing was seen to contain some original partitions, including a closed truss stud and lath partition which was partially demolished (Plate 16).
