Harts Hill Farm Thatcham Berkshire

Historic Building Investigation and Recording

January 2006

HISTORIC BUILDING INVESTIGATION AND RECORDING

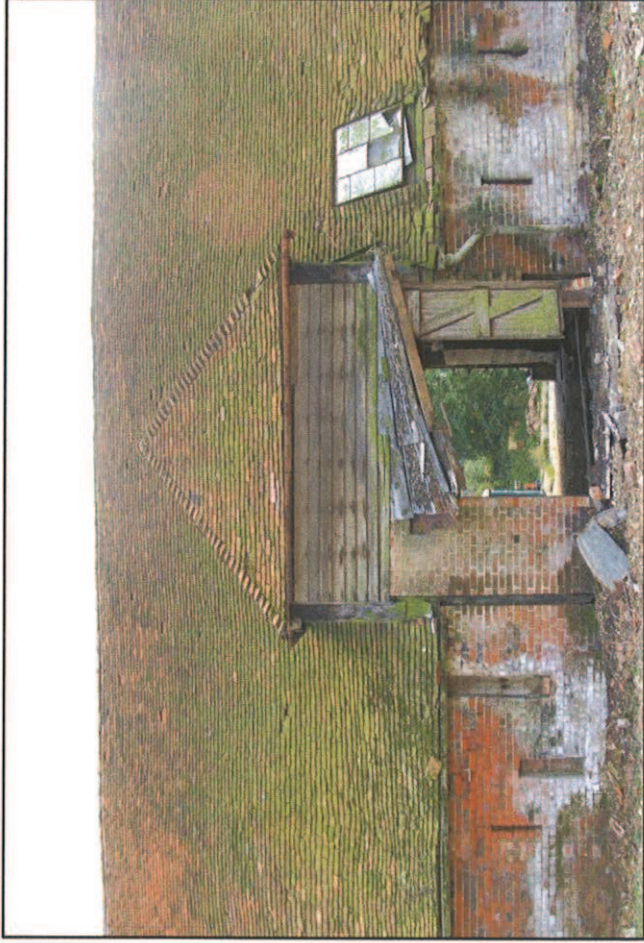
- 3.2.1 The most distinctive feature of the north elevation is the central wagon porch with hipped roof (see plate 2). Internal evidence shows that this porch is a later, probably 19th century addition to the barn and some modern brickwork survives where the porch was connected to a later now demolished structure.

Plate 2: North elevation of barn; central section and porch

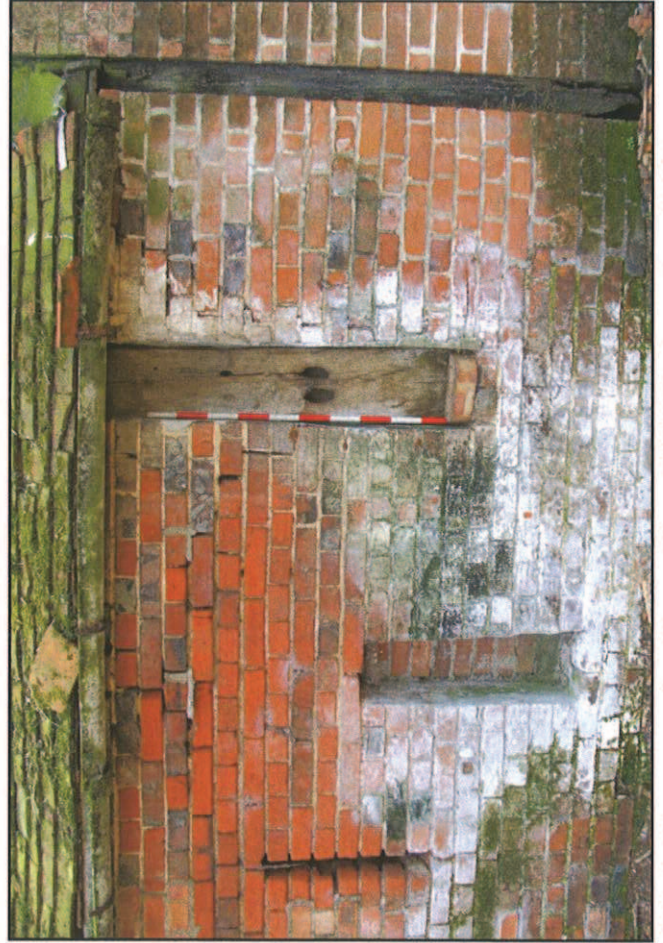
- 3.2.3 Just east of the door are two wide slit openings in the brick wall placed about 0.7m apart and both are approximately 0.2m wide (plate 4). That on the west is 1m high and extends from about 0.5m above ground level to the eaves whilst the smaller one on the east is 0.6m high from about 0.25m above ground level. The smaller slit is blocked by brickwork leaving an external recess and the larger is blocked by a single timber also leaving an external recess.

- 3.2.4 The most likely explanation for these former openings is that they were for belt drives from an external power source to enter the barn to drive machinery such as a threshing machine. The OS map of 1911 (fig 4) shows a small rectangular building attached to the north side of the barn exactly where these openings are located just east of the central bay, this was probably an engine house, housing the power source which may have been a steam engine originally and later replaced by oil. It is unlikely that the building housed a horse engine as these were more often round or round ended and would almost certainly have been larger than the structure shown on the map and also used a shaft drive which the horse could step over or under and which would require a much smaller hole through the barn wall.

Plate 4: Former openings for machinery belt drive in north wall of barn

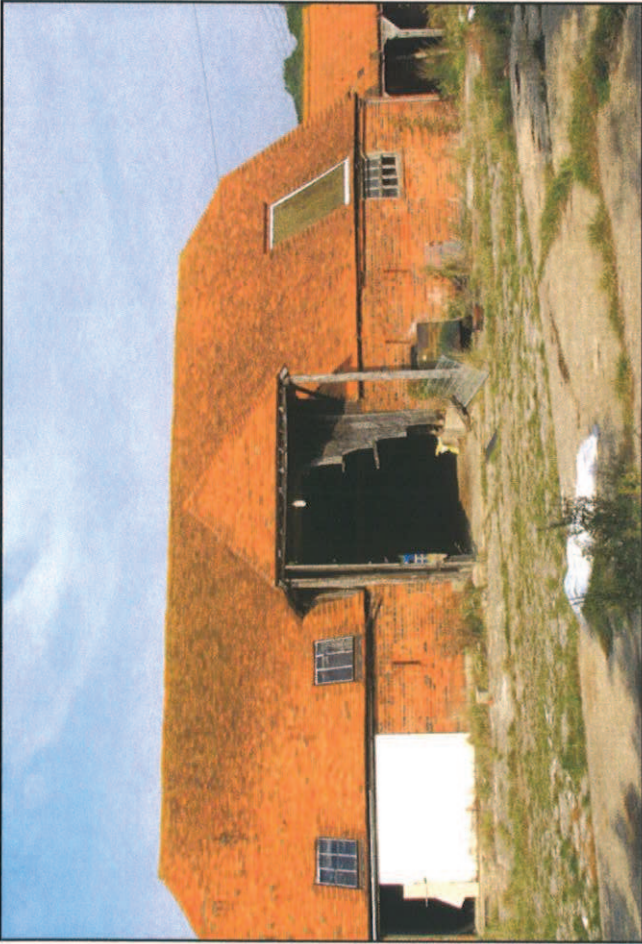
- 3.3.1 The south elevation has a projecting central porch canopy with a hipped roof, this was originally supported by angled struts and these have been supplemented by round posts on concrete plinths added at the corners (plate 6). The south wall has three ventilation slits east of the porch, two are blocked

Plate 5: South elevation of barn looking north

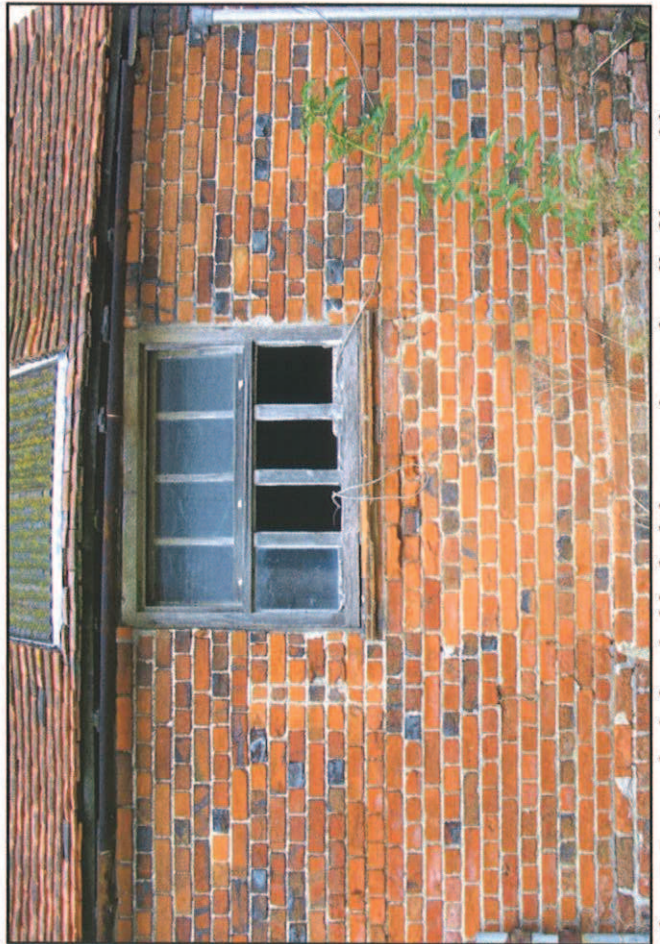
on the inside and one is fully blocked in brick. Towards the east end a later window has been inserted in the top of a former doorway the lower part of which is blocked in brick laid in English bond to blend in with the main wall (plate 7). Above this a long opening has been inserted in the roof, which is now covered in corrugated iron and was probably originally used for pitching sheaves of corn into the barn.

Plate 7: Inserted window in blocked doorway in south wall of barn with blocked ventilation slit to left

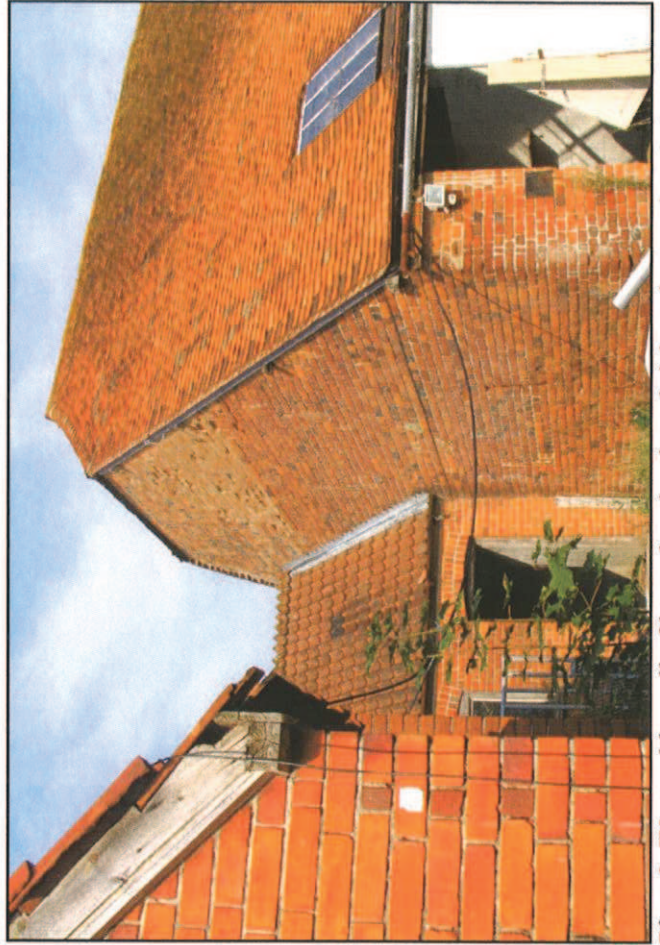
Plate 8: West gable wall of barn showing later brickwork covering timber-framed section, looking north-east

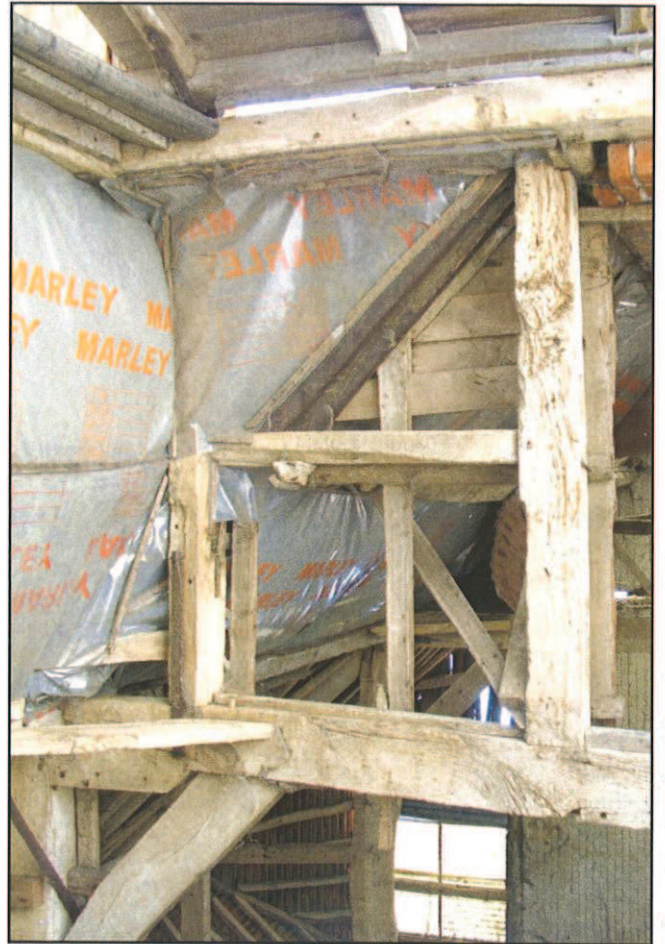
- 3.5.4 Trusses 2 and 3 vary from the general form on the south side to accommodate the projecting porch canopy which is an original part of the construction (plate 12). Here the curved lower principals are absent and a vertical strut rises from each aisle tie to support plates which extend from the back of the posts below arcade plate level. A pair of short posts rising from the ends of the wall plates support the centre of the plates which project about 1.6m beyond them. Angled struts from these short posts and a later pair of external posts at the corners support the projecting plates and longitudinal plate which support the ends of the porch rafters. Posts either side of the doorway rise up to a bridging plate over the entrance.

Plate 12: South side of truss 2 below south porch, looking east

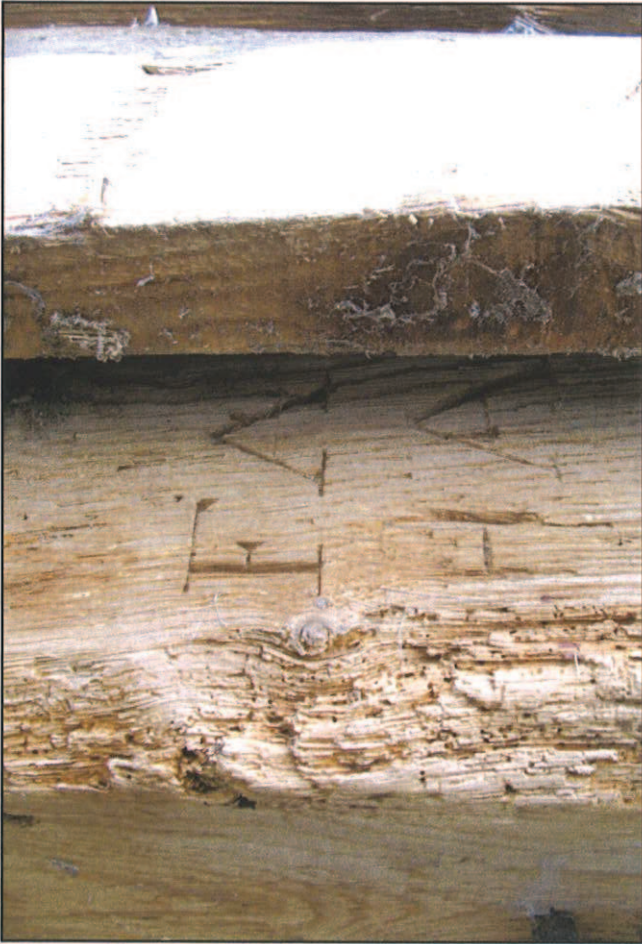
- 3.5.5 The door posts have inverted L-shaped slots midway up their opposing faces to support a removable rail for fastening the doors. The eastern post has some neatly incised initials with serifs just below the slot; FA, HA (plate 13).

Plate 13: Incised initials on south-east door post

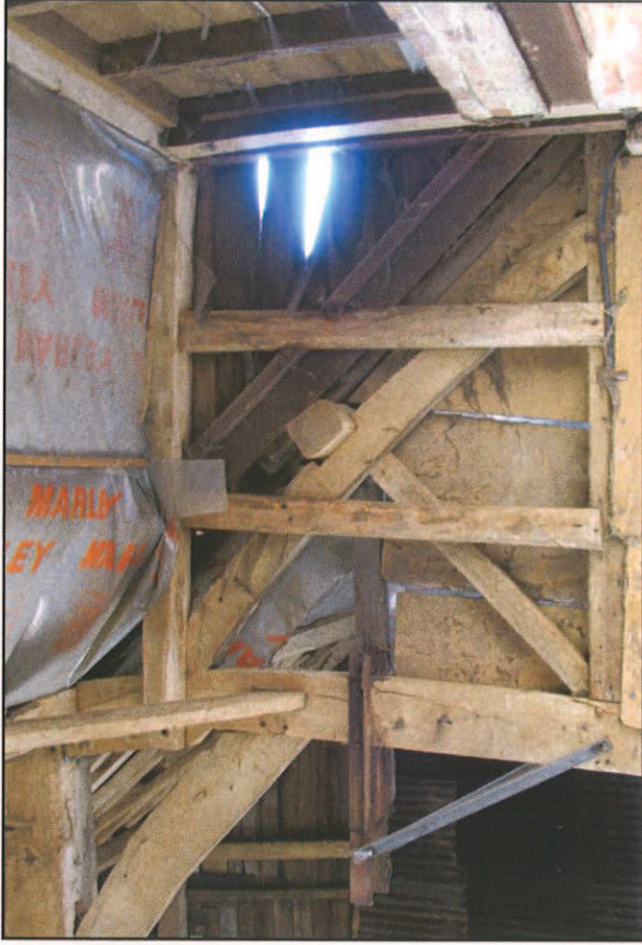
- 3.5.6 The north porch is a later addition, it has a hipped roof which does not project beyond the line of the barn wall. The porch roof is supported by transverse plates which are lapped and nailed onto the truss posts at their southern ends and supported by a short post rising from the ends of the wall plate and by two vertical struts tenoned into their lower faces. These rise from the original aisle ties to which they are lapped and nailed (plate 14). A longitudinal plate extends across the opening and is supported by two additional longer posts positioned against the ends of the barn wall just inside the two short posts rising from the wall plates. The opening has been lowered and narrowed later by studwork and weatherboarding across the top and modern brickwork to the sides.

Plate 14: North side of truss 3 showing addition of later porch timbers, looking west

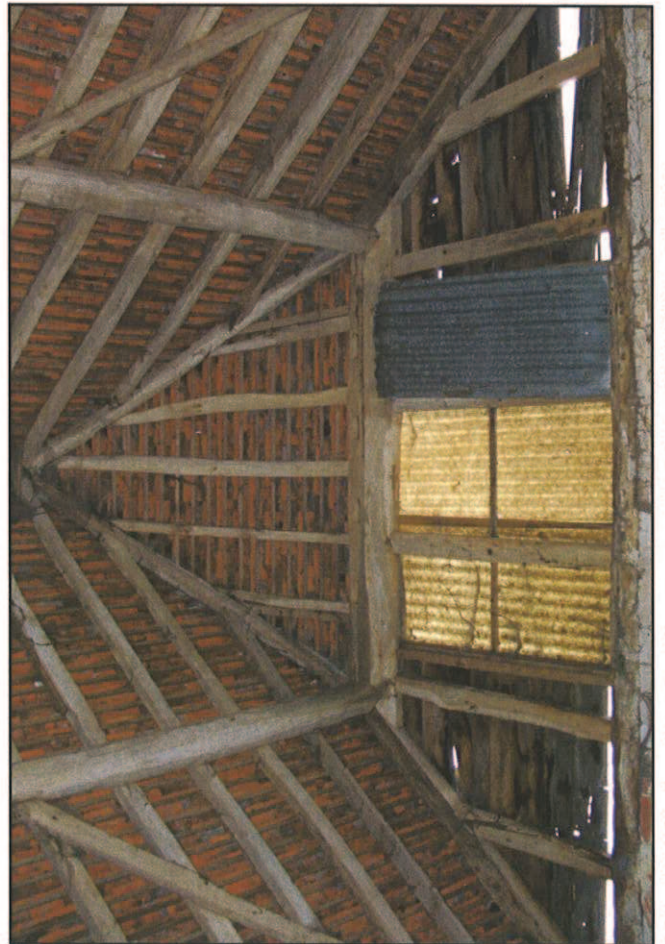
- 3.5.8 The timber-framing of the west upper gable which extends from the tie beam up to the base of the hipped section of roof is still in-situ on the interior, inside the later brickwork and can be seen from inside bay 5, the construction mirrors the corresponding section of the east gable and consists of posts rising from the tie beam to the collar and short principal rafters (plate 15).

Plate 15: Timber framing in upper east gable and half-hipped roof

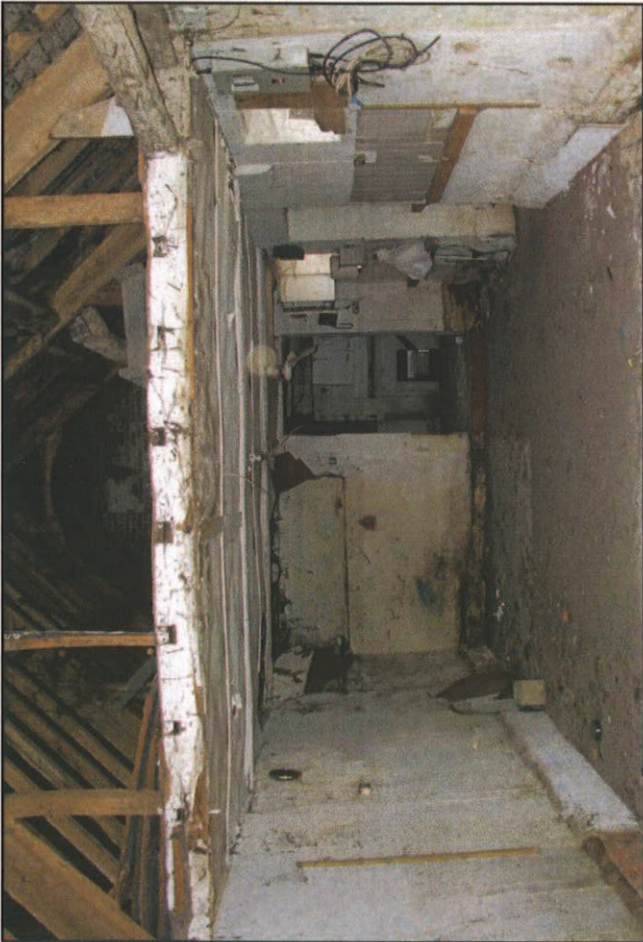
- 4.1.3 The interior (plate 17) is whitewashed and the roof consists of four trusses with tie beams which double as main joists and support the loft floor. The northernmost tie beam has been cut and removed for some reason and there is consequently no floor in the northern two bays.

Plate 17: Interior of Block B looking south

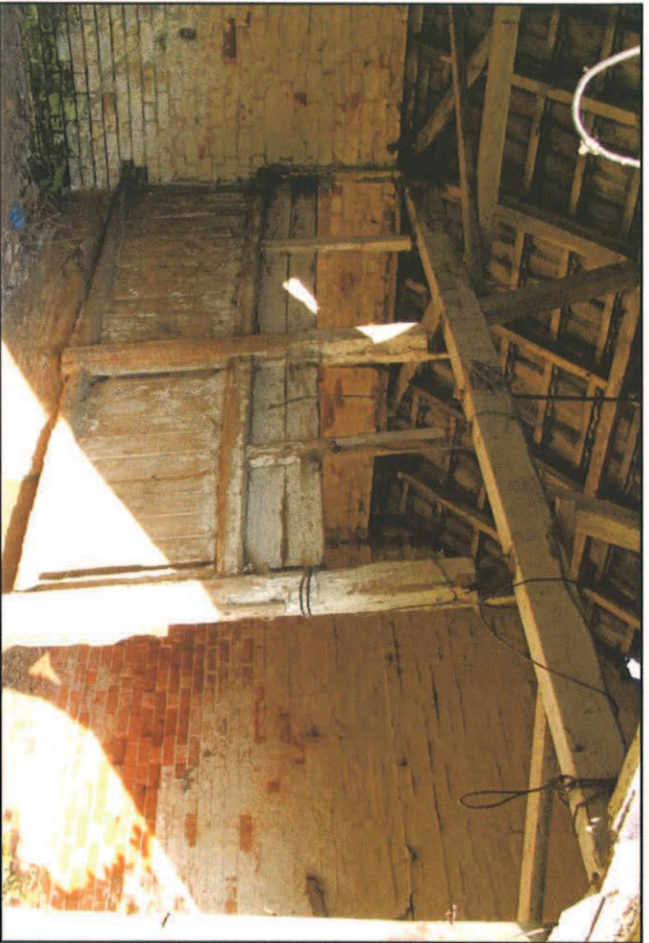
5.1.5 There are two wooden partitions separating the bays which are made of posts and rails with tongue and groove boarding. The posts are half lapped to the tie beams. These were probably inserted soon after the initial construction of the building (plate 21).

Plate 21: Timber partition within shelter shed, looking north-east

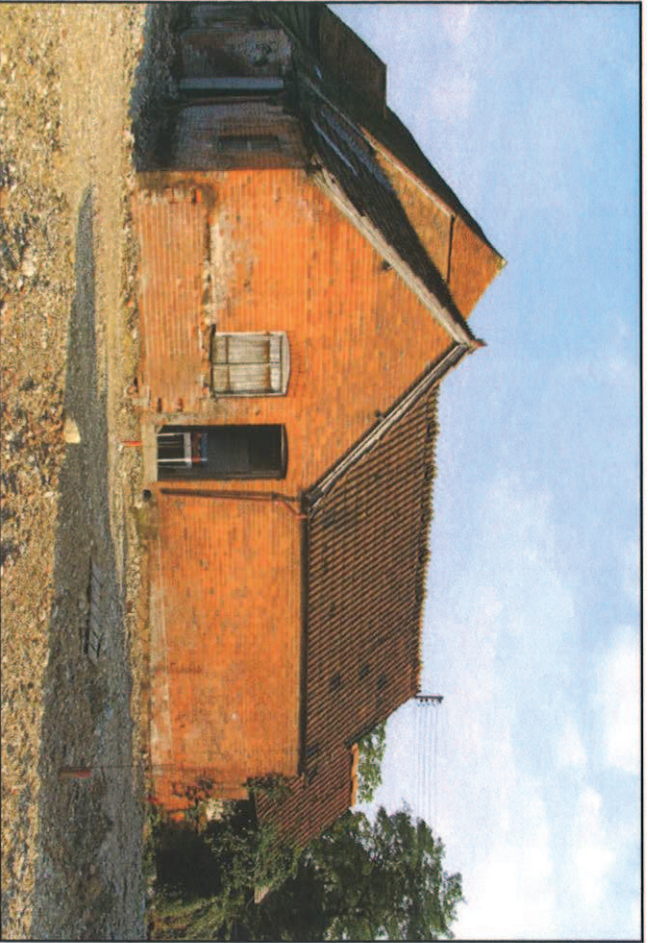
5.1.6 **Block D.** The building on the west side of the barn consists of an L-shaped block of one phase with a small later extension built onto the south wall (plates 22-3). The original block consists of a large three bay east-to-west aligned rectangular room abutting the barn with a smaller north-to-south aligned two bay room extending south on the west side. This is constructed of red brick laid in monk bond as the eastern building and with a pitched roof clad in the same original tiles excepting on the north facing slope where they have been replaced with more modern tiles similar to the originals.

Plate 23: Block D looking east
