# SSP Trench Cliveden Buckinghamshire

## Archaeological Watching Brief Report

southsouthsouth  
November 2016

**Client: National Trust**

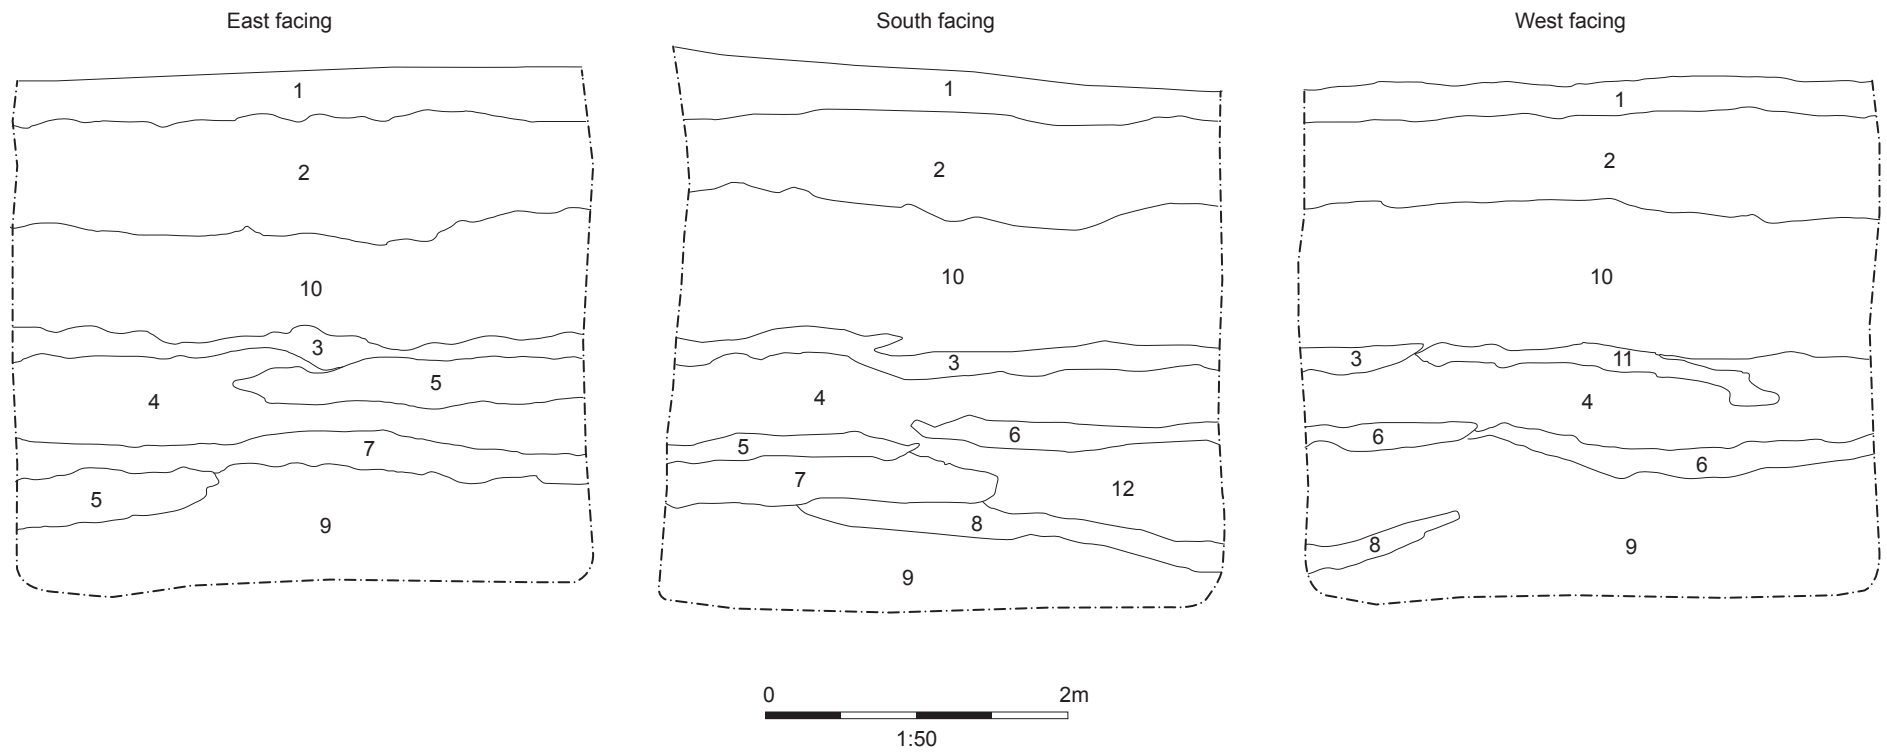
Figure 9: Sections through soakaway pit

- 3.1.13 The four sides of the soakaway pit had a similar series of geological layers but without any archaeological features (See Fig 9, Appendix B, Plates 12-18). The pit contained a dark topsoil above a deep, ochre coloured sandy deposit, above a similar but slightly more henna-coloured loam. Beneath this were various other gravel layers.

Layer No.	Description
[1]	Top soil and subsoil. Dark brown loam with stones inclusions.
[2]	Deep, ochre-coloured stoney/sandy loam
[3]	Thinner darker stoney layer. Loam.
[4]	Ochre loam with gravels and stones mixed in.
[5]	Finer sandy layer. Few stones
[6]	Dark loam layer.
[7]	Light coloured layer. Stoney clay. Light grey.
[8]	Dark loam/silt layer. Fairly fine and with few stones.
[9]	Gravelly ochre loam.
[10]	Similar to 2 but slightly more henna coloured. Brick red patches and with patches of grey clay mixed in.
[11]	Distinct layer in east side. Pure gravel without any sand mixed in. Small gravel stones quite different to other layers.
[12]	Grey/ochre coloured layer. Generally with large stones mixed in.

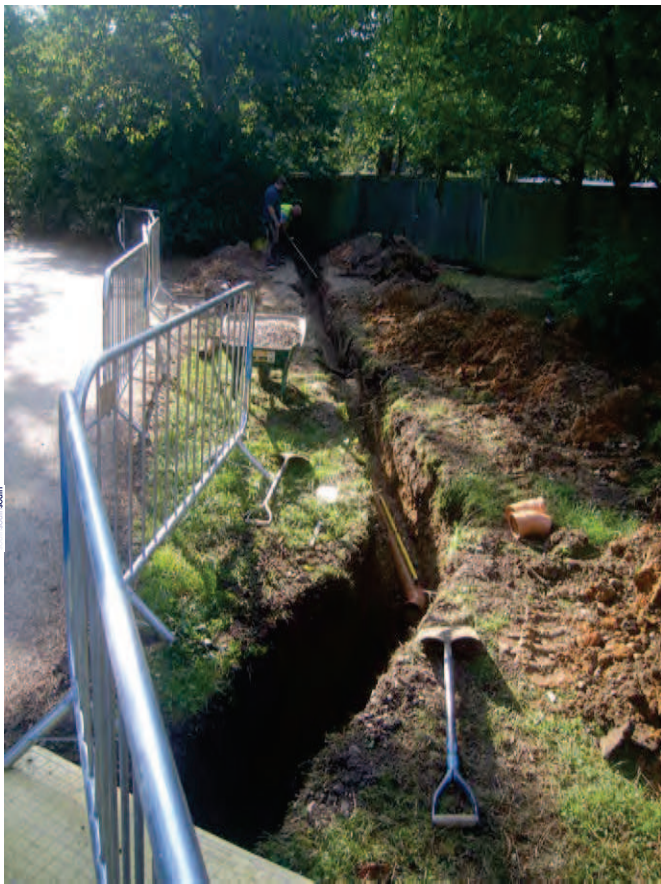
- 3.1.6 The south-eastern section of the trench, on the south side of the road was c.13 m long (Pl 1-5). The surface of this section was a modern, light grey compacted screed layer and below this, in the south-eastern half of this section there was a distinct layer of terracotta coloured ballast, c.15 cm deep. Beneath the ballast was a 20 cm deep layer of hard-core formed from broken bricks, small stones, ash etc and below this was a darker chocolate-brown loam which may have been a topsoil layer before the later deposits were added on top. The base of this section of the trench was formed from an ochre coloured sandy-silt which was interpreted as natural.

Plate 1: South end of SSP trench in overflow car park (looking S)

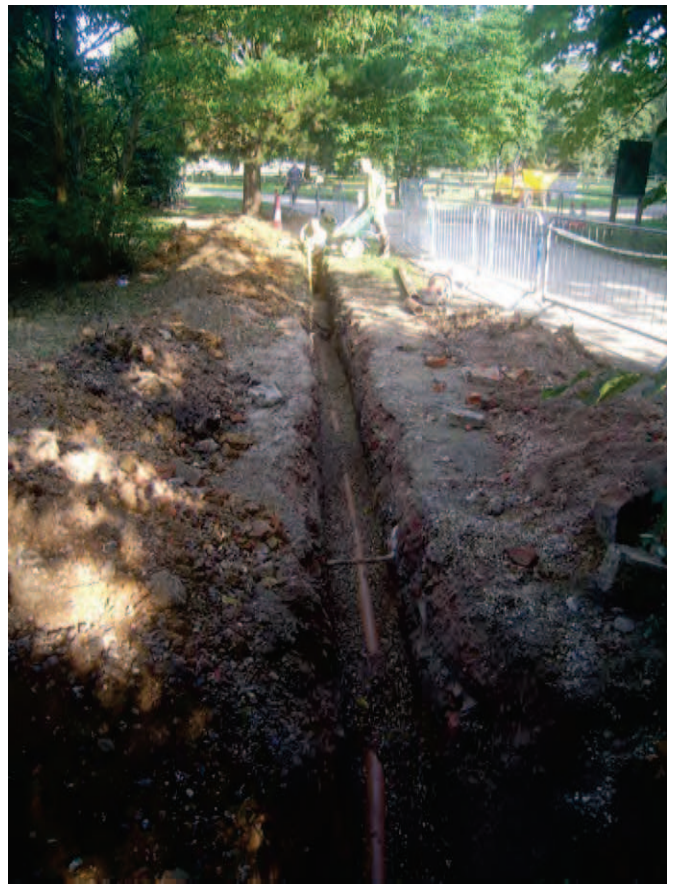
Plate 2: South end of SSP trench in overflow car park (looking N)

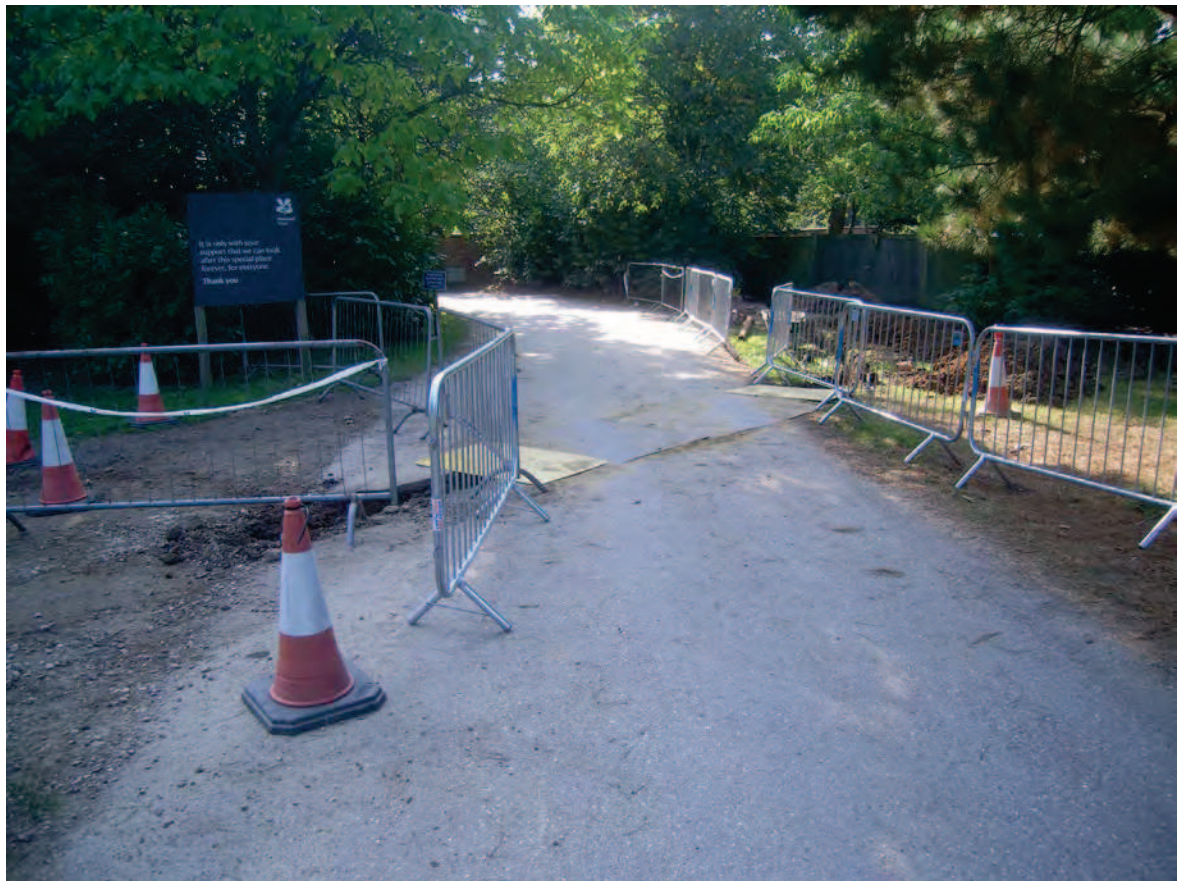
Plate 3: Trench crossing road at south end of overflow car park, looking south

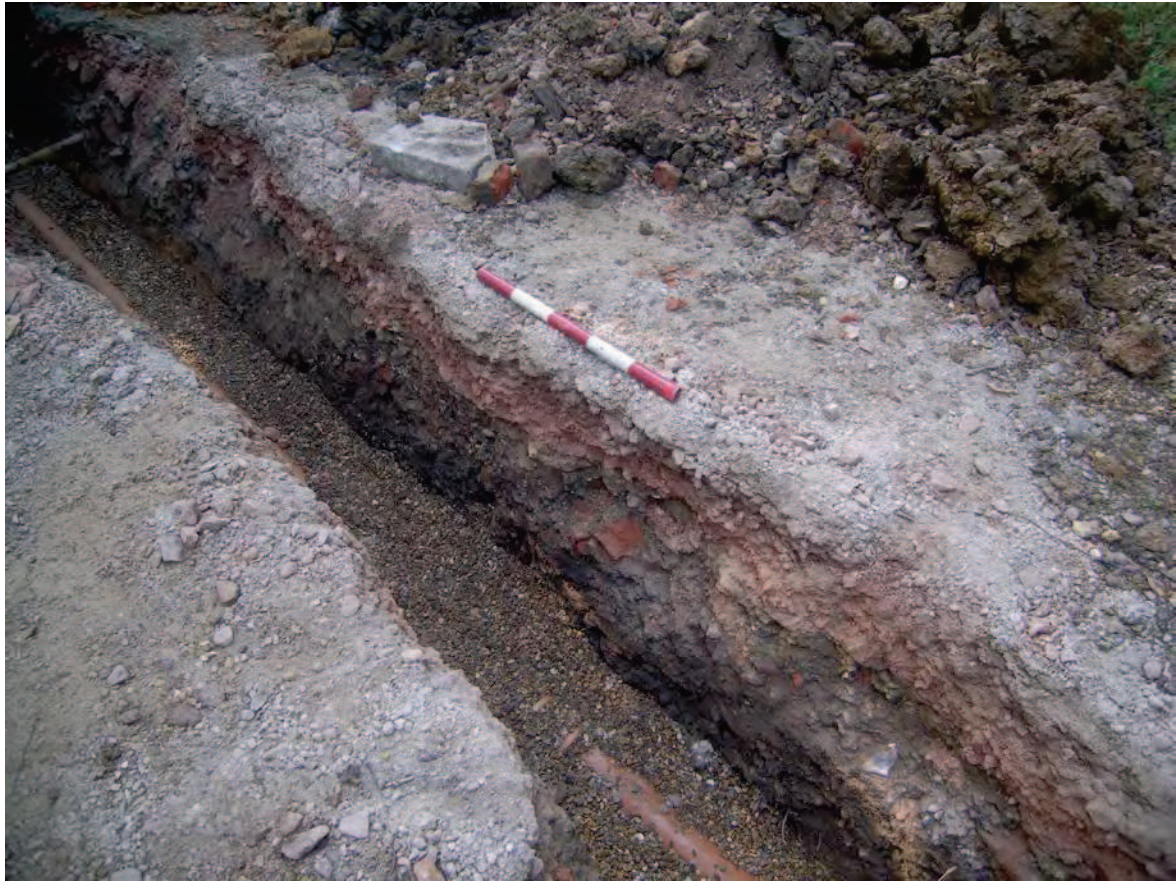
Plate 4: Southernmost section of trench in overflow car park, looking south

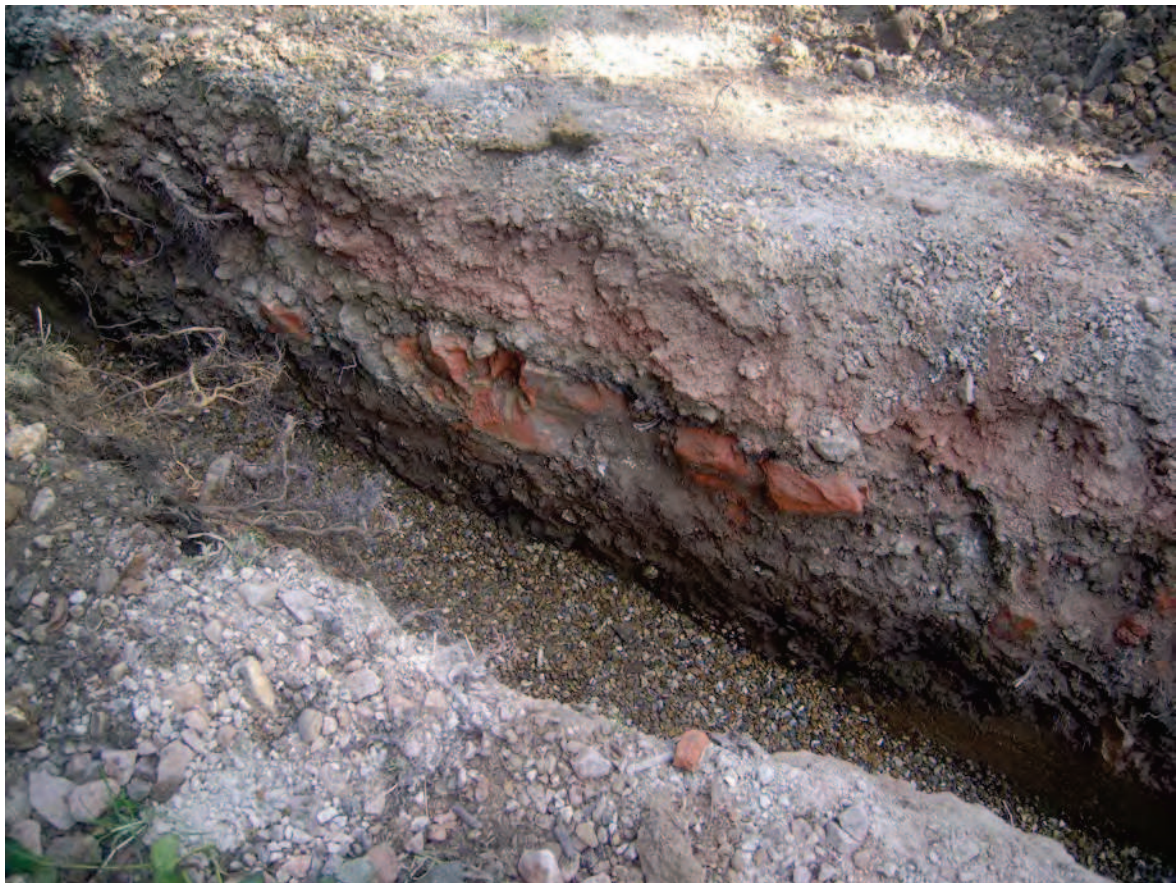
Plate 5: Brick rubble in southernmost section of trench, looking north

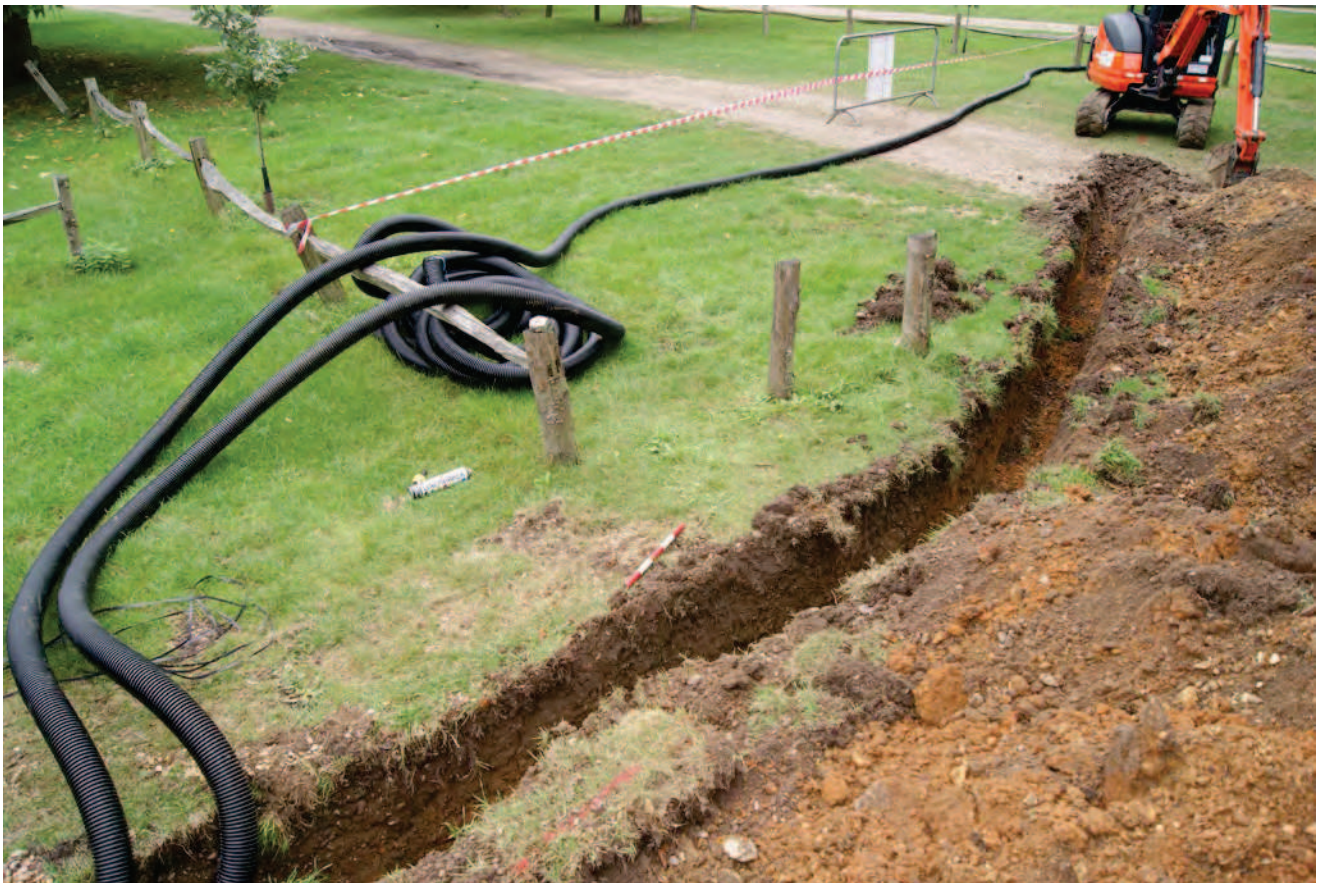
- 3.1.9 Through the central part of the overflow car park the trench was found to contain a dark brown top soil with a light brown loam beneath and then a darker ochre-coloured stoney loam beneath this (Pl. 9-11). This loam was interpreted as natural and this section did not have the same modern layer as the section further to the south.

Plate 9: Trench towards centre of car park (c.50 m N of S end), looking north

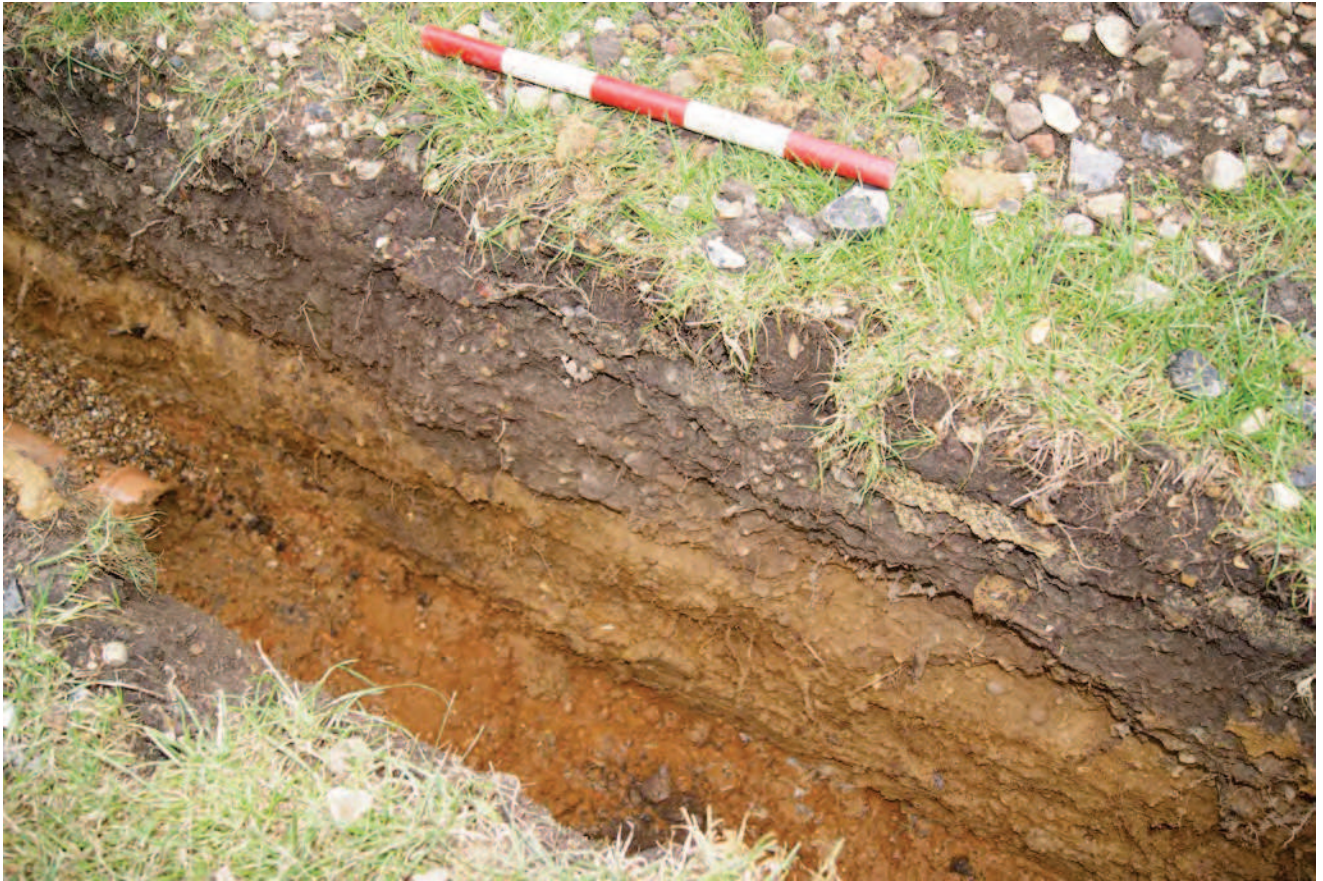
Plate 10: Trench section towards centre of car park (c.50 m N of S end), looking south west

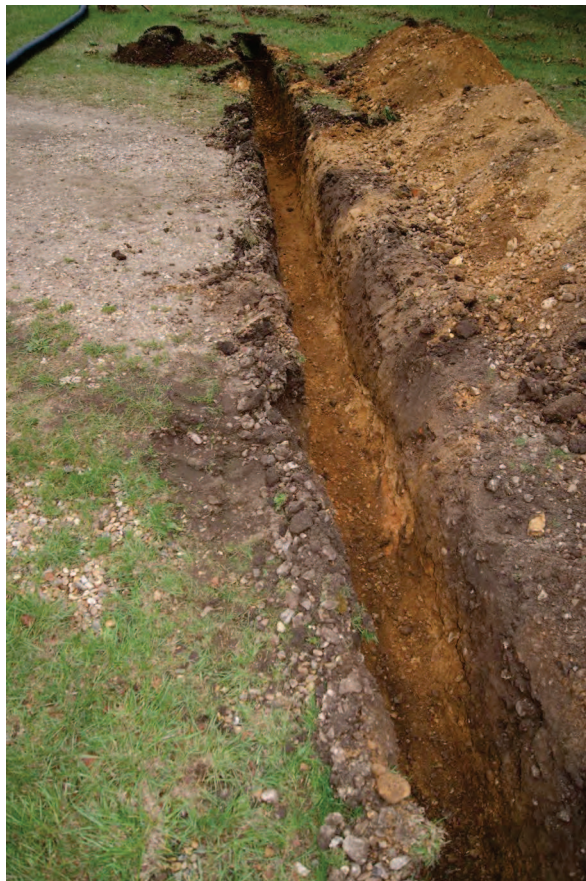
Plate 11: Area c.55 m to north of south end of trench in car park, looking north

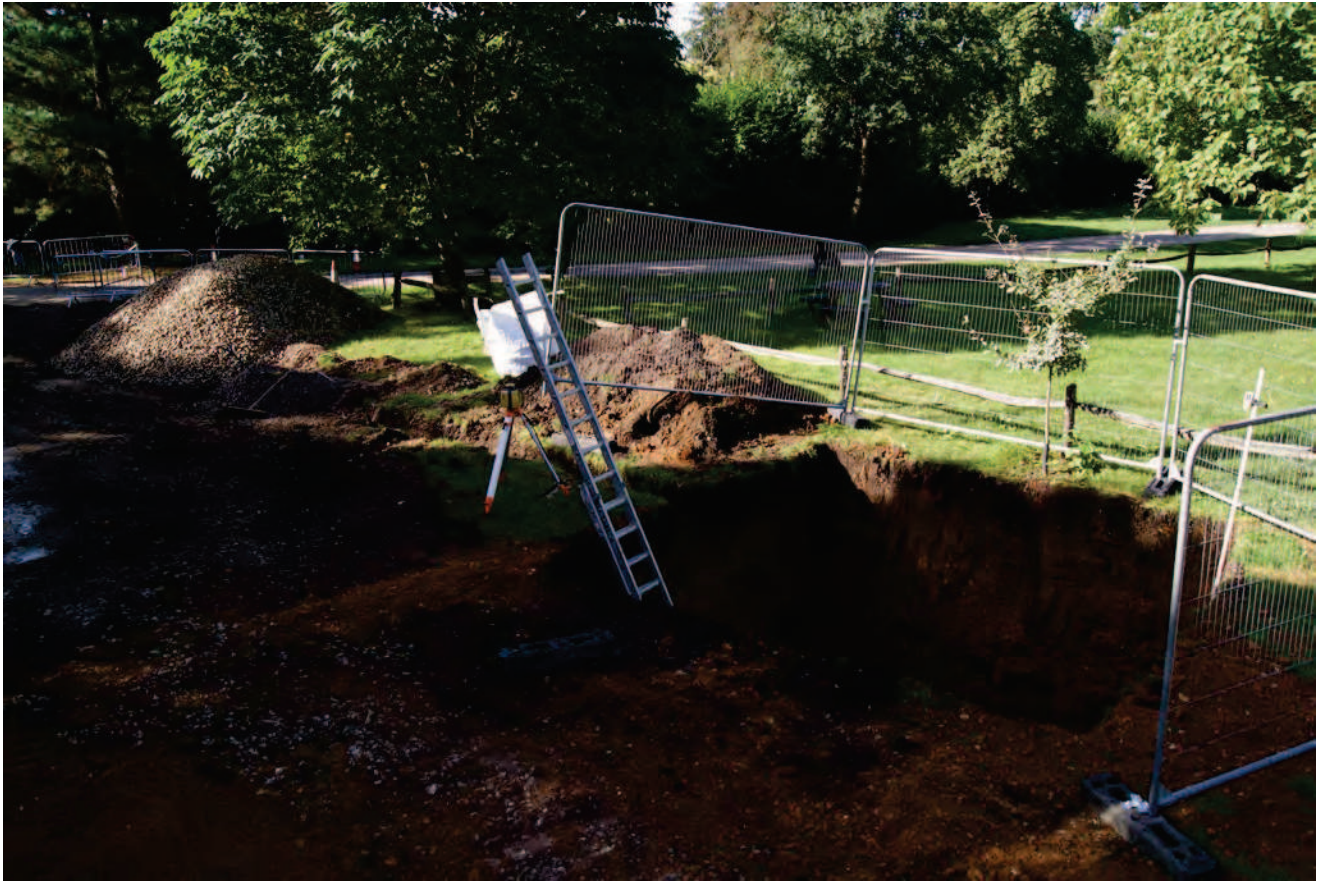
- 3.1.12 The soakaway itself was by far the deepest excavation in the current investigation. It was located just to the west of the north-to-south track on the east side of the car park and it was c. 4 m deep by 4 m by 4 m.

Plate 12: General view of soakaway hole (c.35 m to N of S end of trench), looking south west

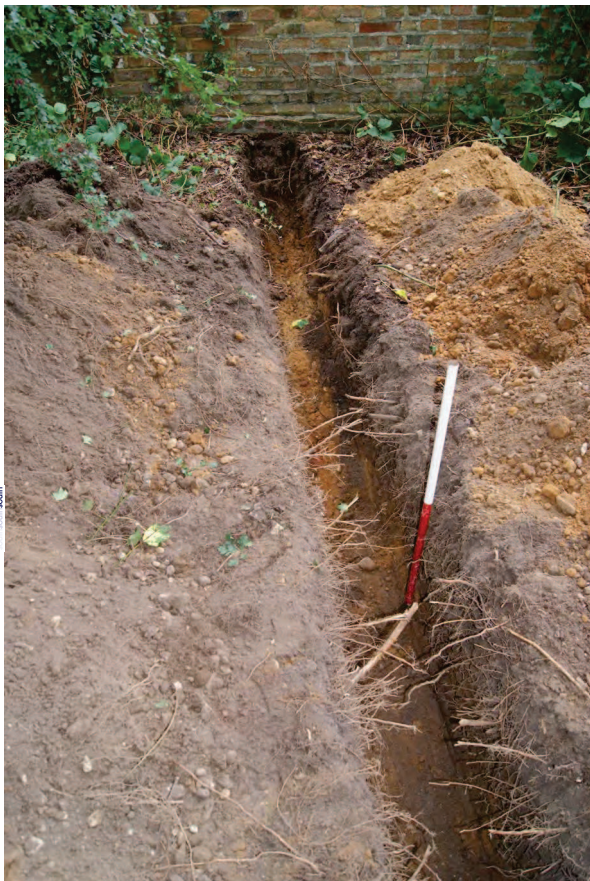
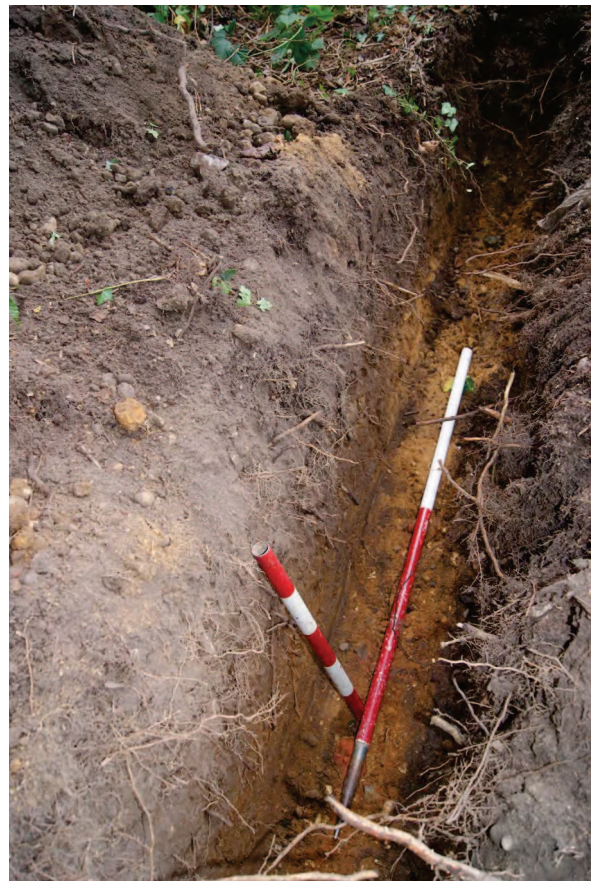
- 3.1.10 The northern section of the trench, up to the boundary wall, was similar, again with topsoil and an ochre loam beneath (Pl. 19-20).
- 3.1.11 The branch trench to the soakaway was c.1.1 m deep and therefore slightly deeper than the main trench. Beneath the topsoil the uppermost c.30 cm of the trench was formed from a stoney chocolate brown subsoil and below this was an ochre colour, stoney/sandy layer (natural). There were no archaeological features present.

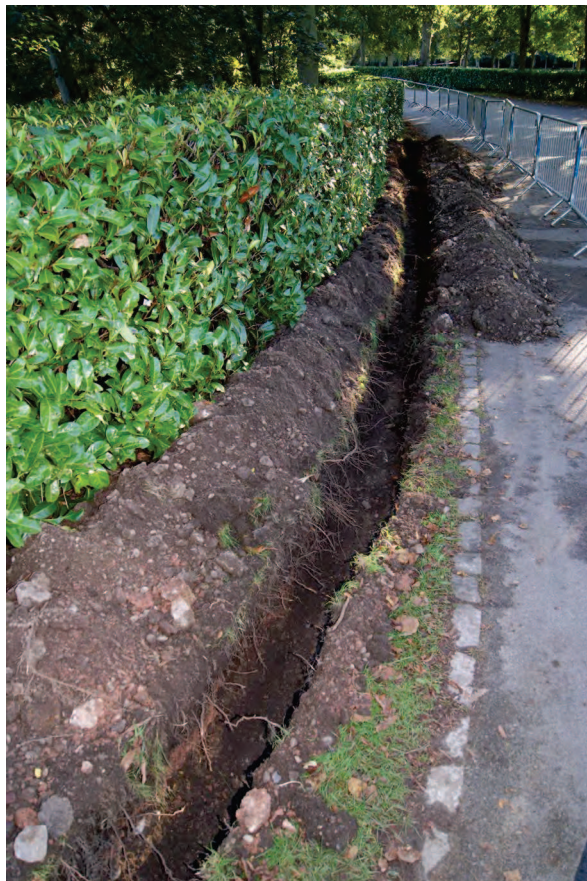
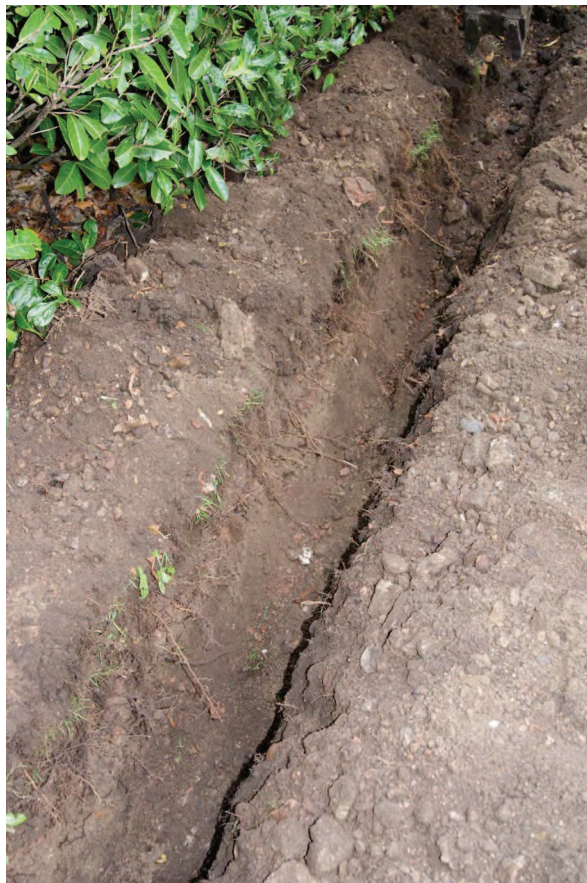
- 3.1.17 The northernmost 50m of the trench was found to almost entirely comprise top soil and a subsoil for its full depth (Plate 21, 23). Approximately 14 m from the north end of the trench there is a slight hump in the road, edged in cobbles across the road, and this hump appeared to comprise four thin layers on top of the subsoil (Pl. 22- 25). In total the four layers were c.25 cm in depth. The uppermost layer was a soft, sandy, ochre colour layer while beneath that there was a stoney grey layer, then beneath that it was brown soft soil then at the bottom it was a soft salmon pink layer. There are also several other areas nearby where the salmon pink layer is found in patches near to the surface (beneath top soil) as if some waste material has been dumped. Similarly there are also some thin patches of a grey material. It is unclear what the function of the hump is. It could be there are (or were) service pipes extending beneath the road but no pipes were seen in the trench by the side of the hump. There is a drain pipe to the north of the hump and although this is outside the line of the hump it may be that the slight rise was intended to guide rain water running along the northern part of the track into this drain.
