The Stables Coleshill Estate Oxfordshire

Historic Building Investigation and Recording

May 2017

Client: National Trust

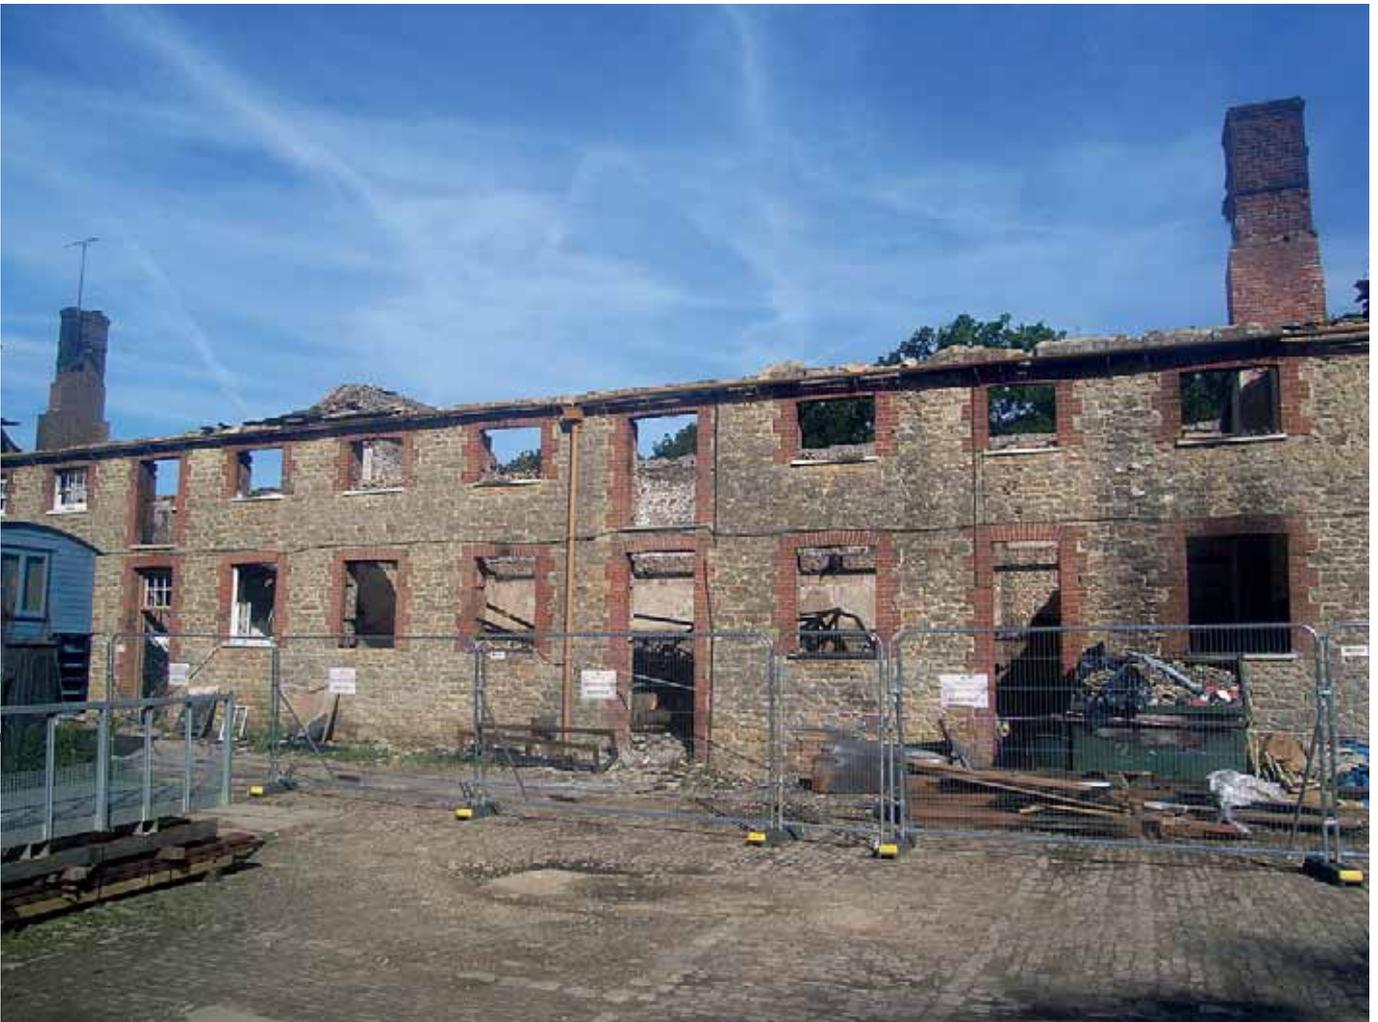
Plate 1: South elevation of fire damaged range before erection of scaffolding

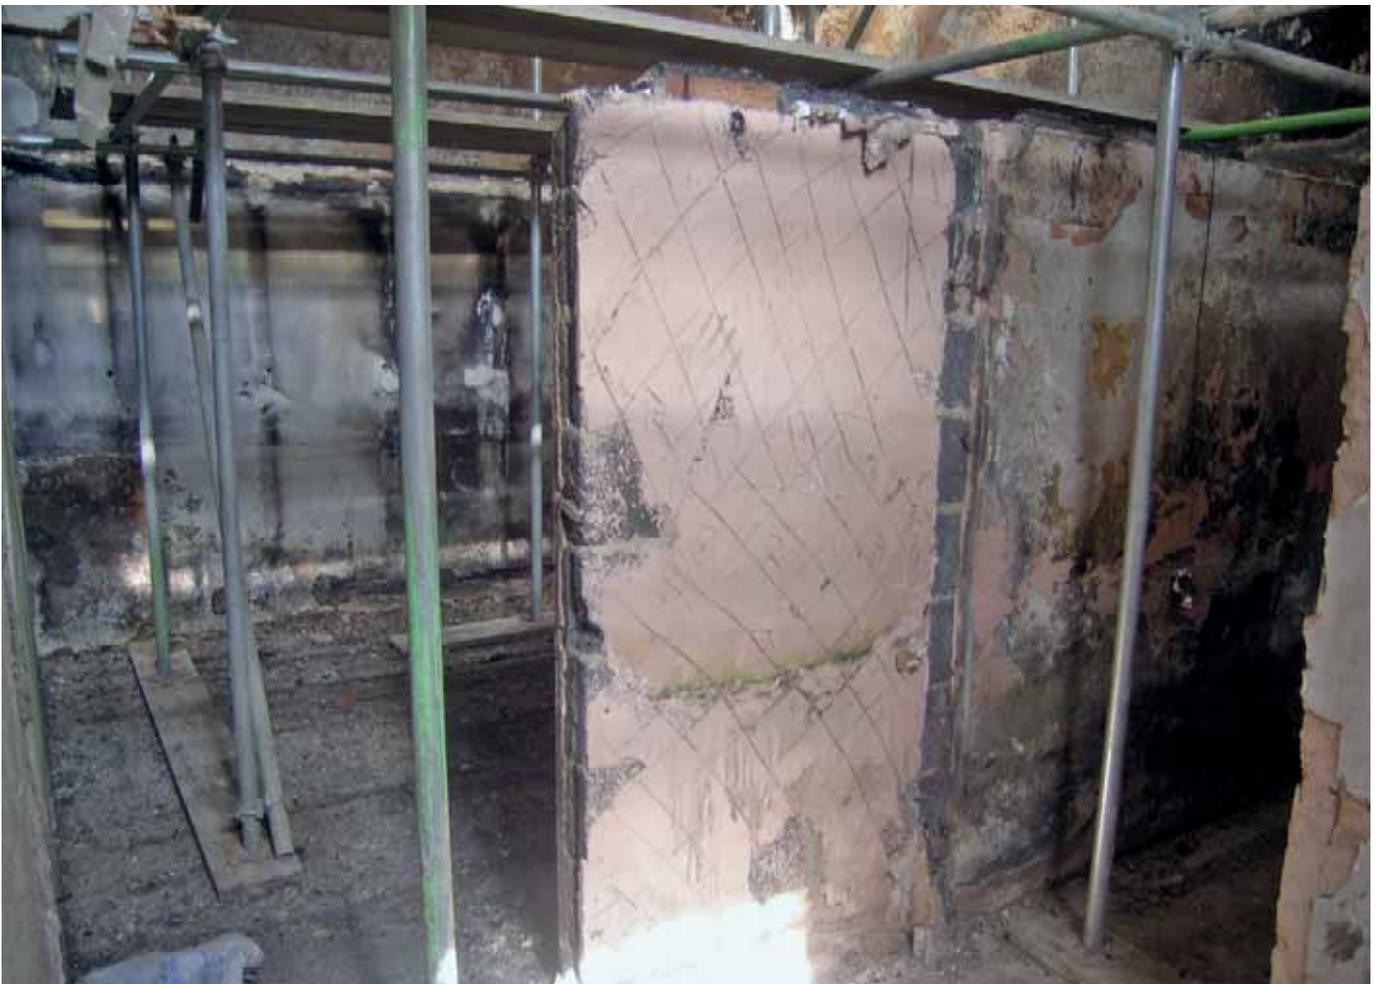
Plate 45: Concrete blockwork forming south wall of G4

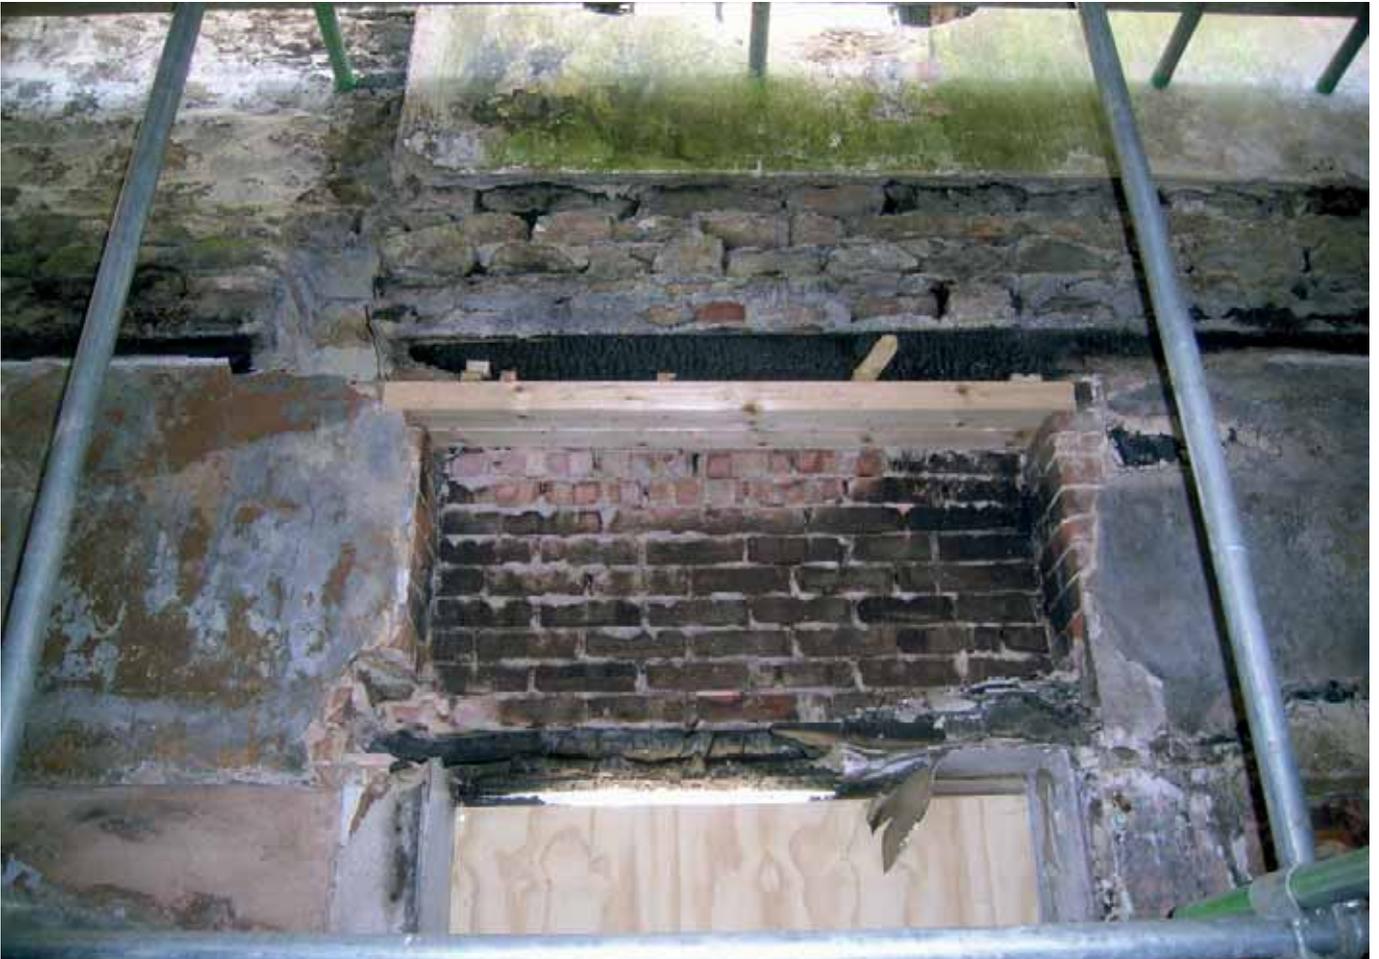
Plate 49: Blockwork above window in G5

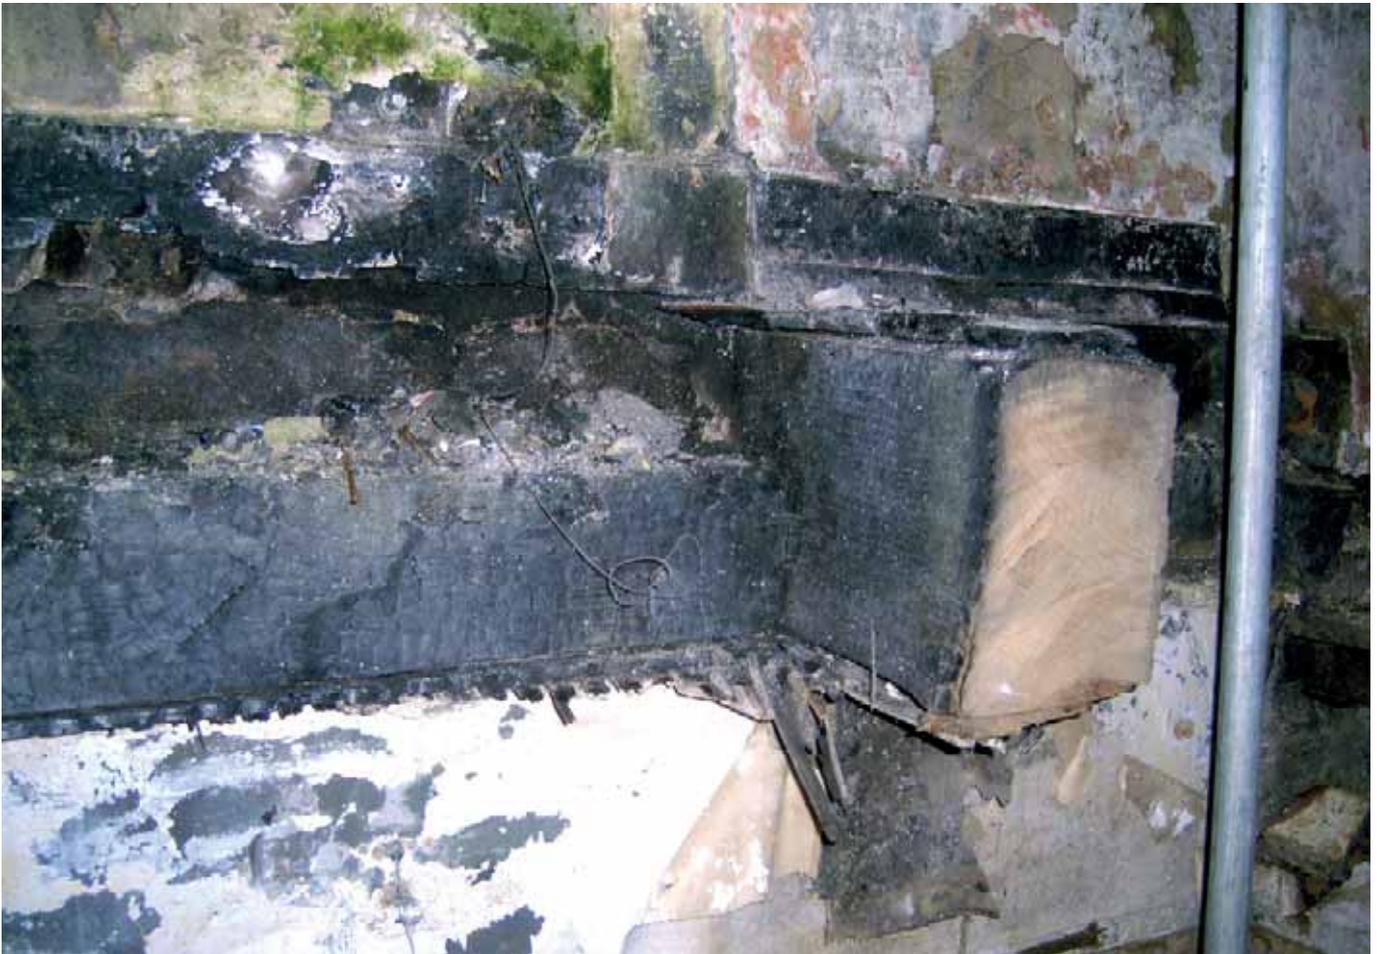
Plate 65: Truncated principal joist in north wall of G7

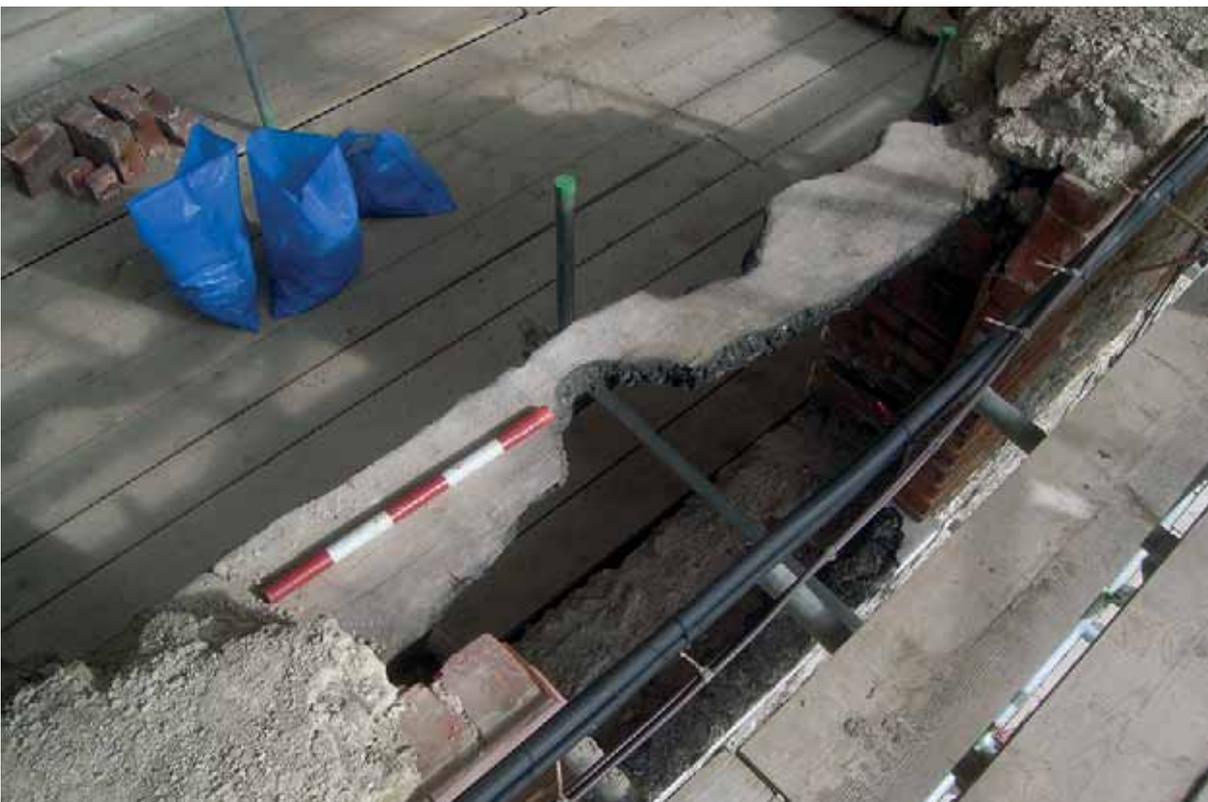
Plate 91: Fire damaged timber lintel in F4

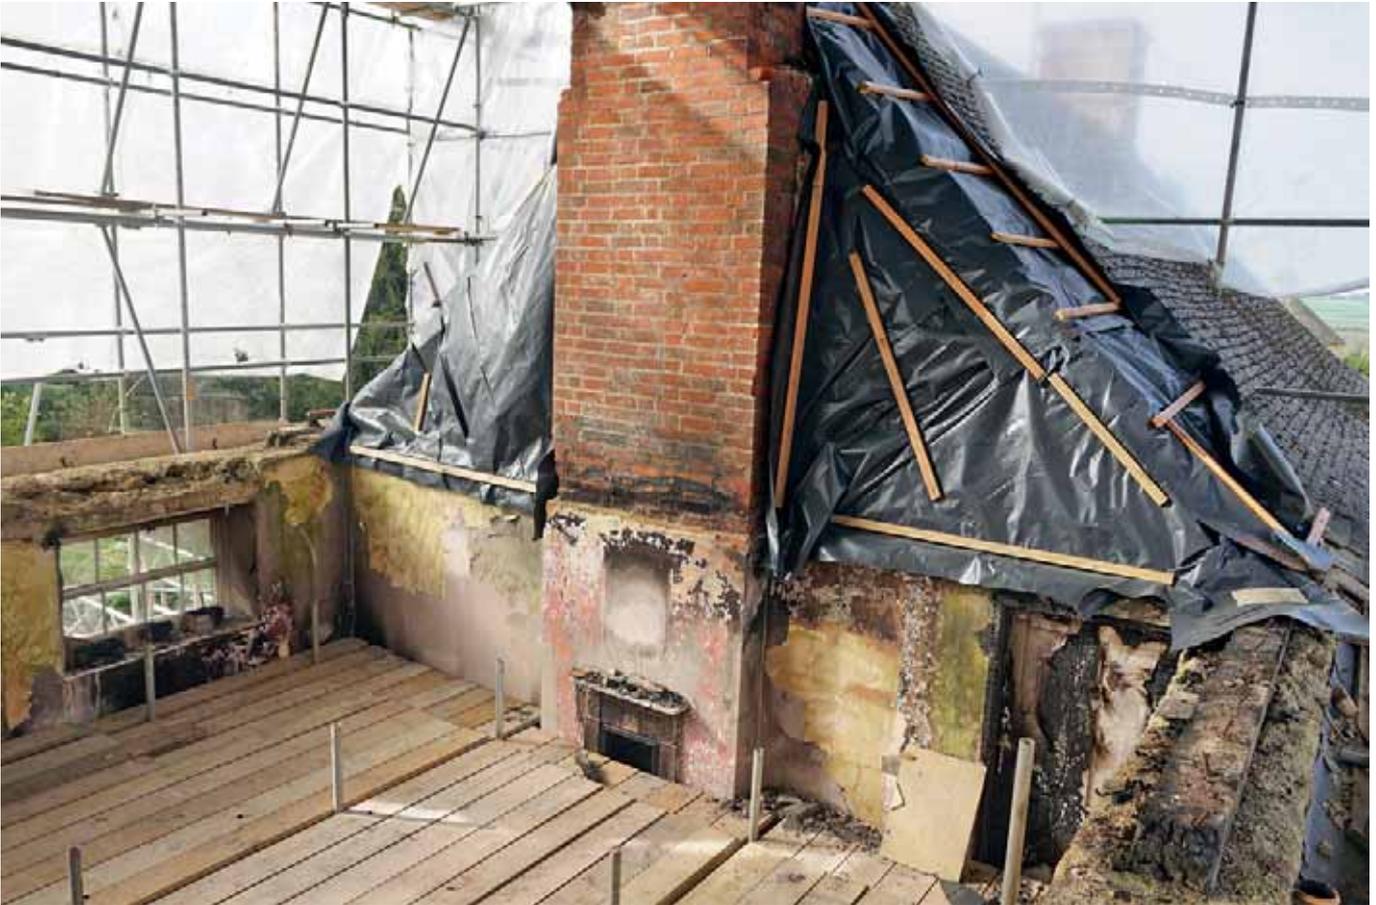
Plate 101: West end of fire damaged area at first floor level (F6)
