LOWER FARM BARN  
WASING  
WEST BERKSHIRE

HISTORIC BUILDING RECORDING

OXFORD ARCHAEOLOGICAL UNIT

October 1999

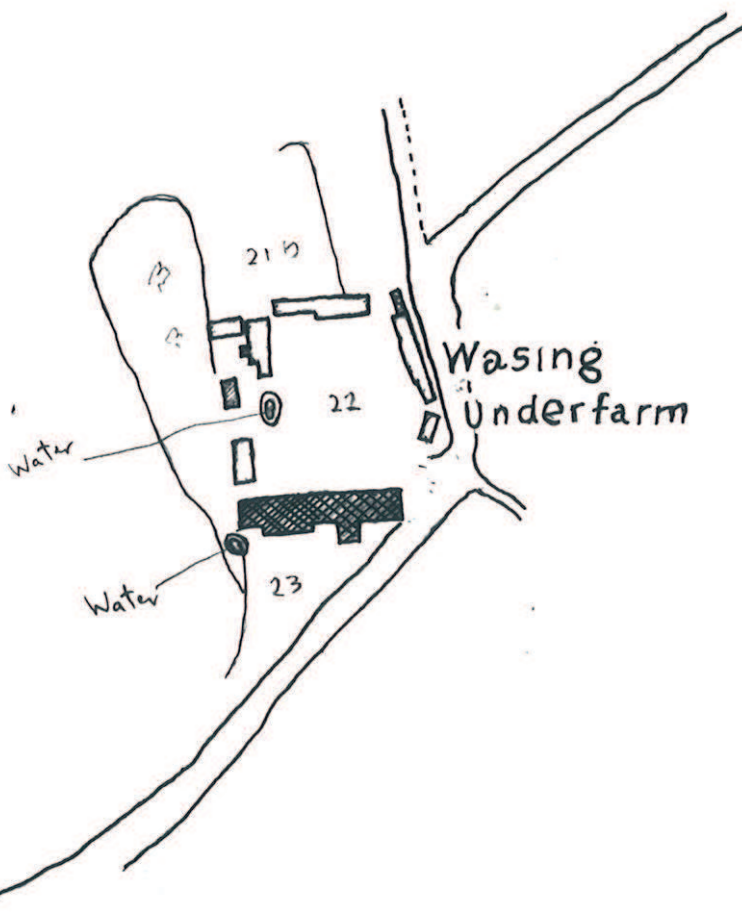
**FIGURE 5** From 1849 Tithe map.  
(Barn shown hatched)

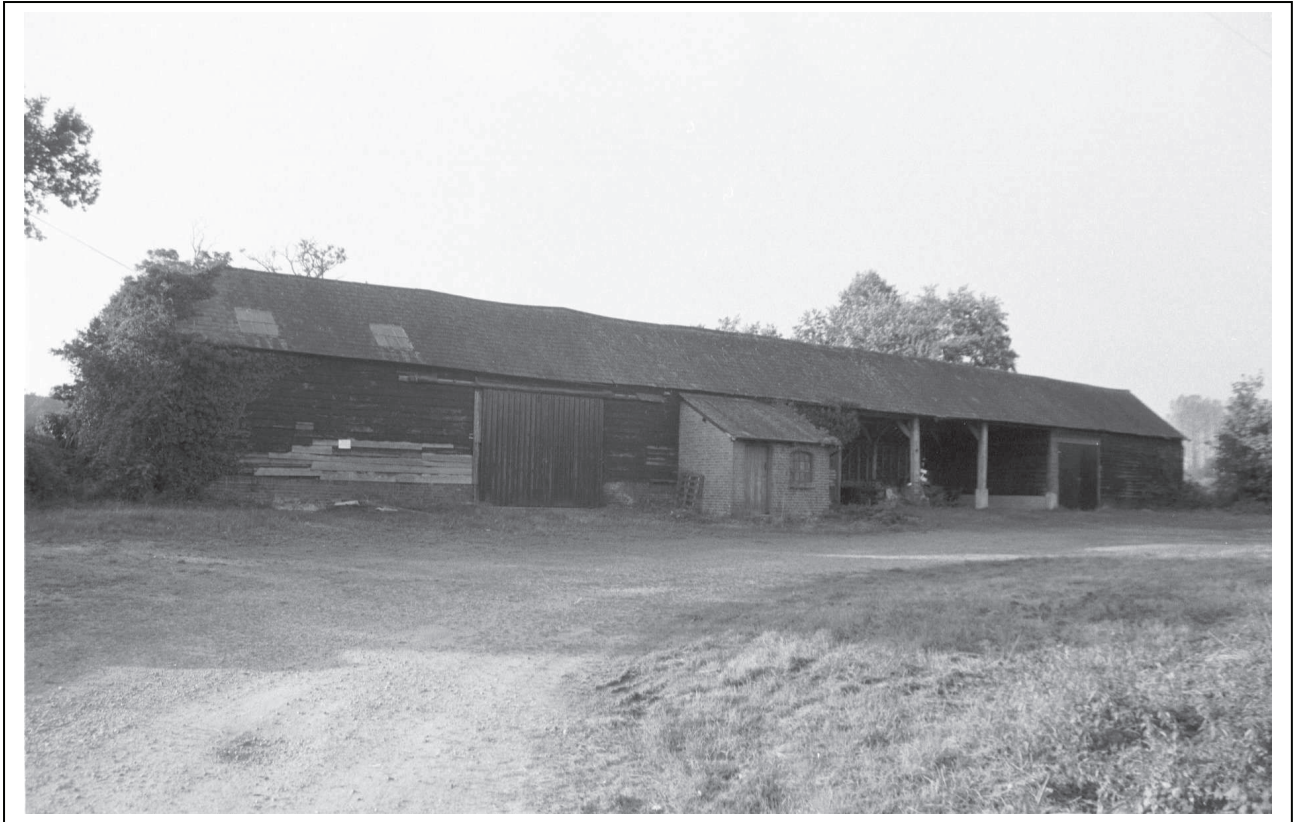
Plate 1: View of barn from north-east

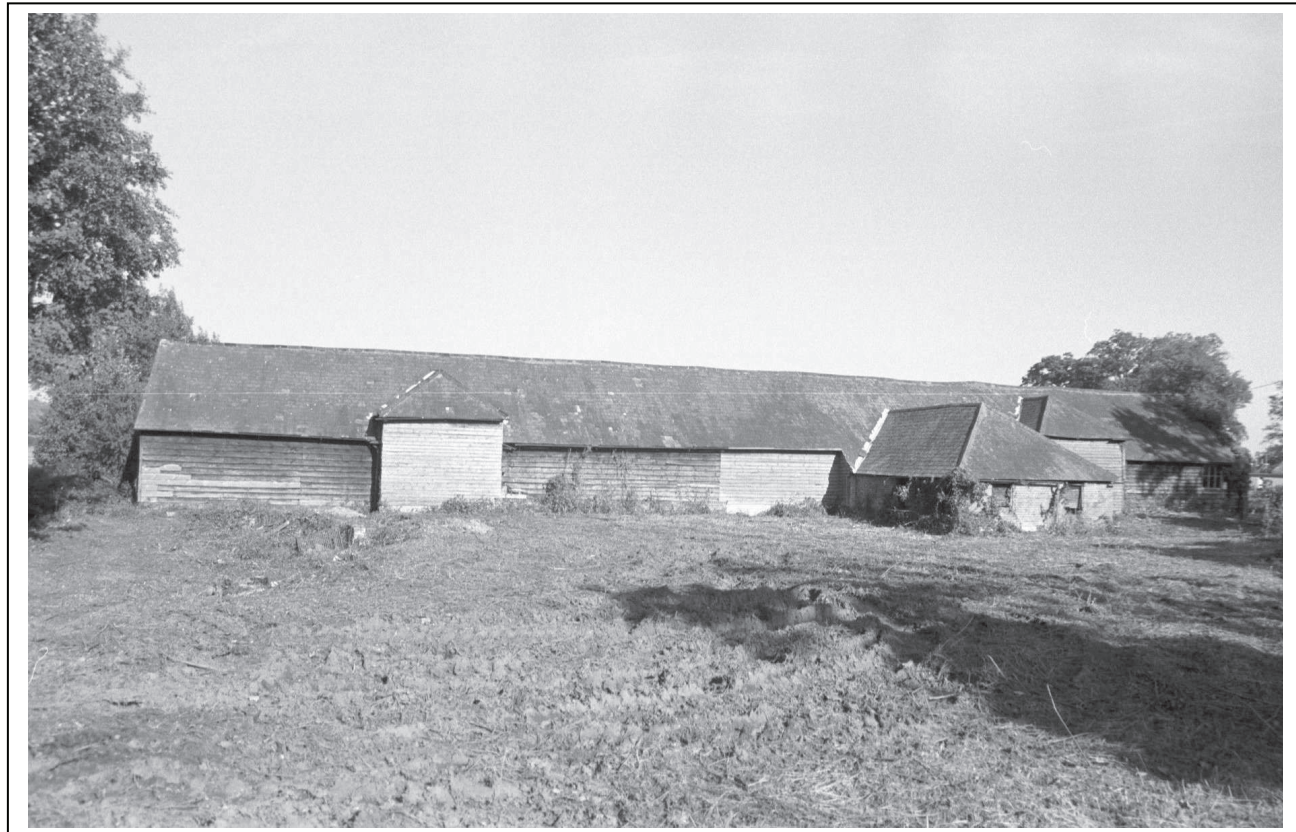
Plate 2: View of barn from south. Note outline of former projecting porch to central bay and partially visible outline of mill pond to left.

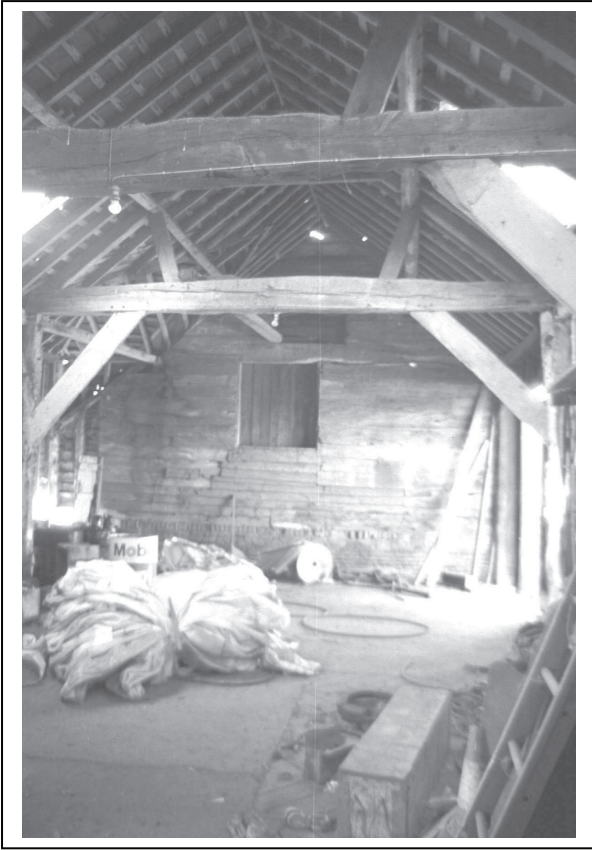
Plate 3: Area 1 viewed from east

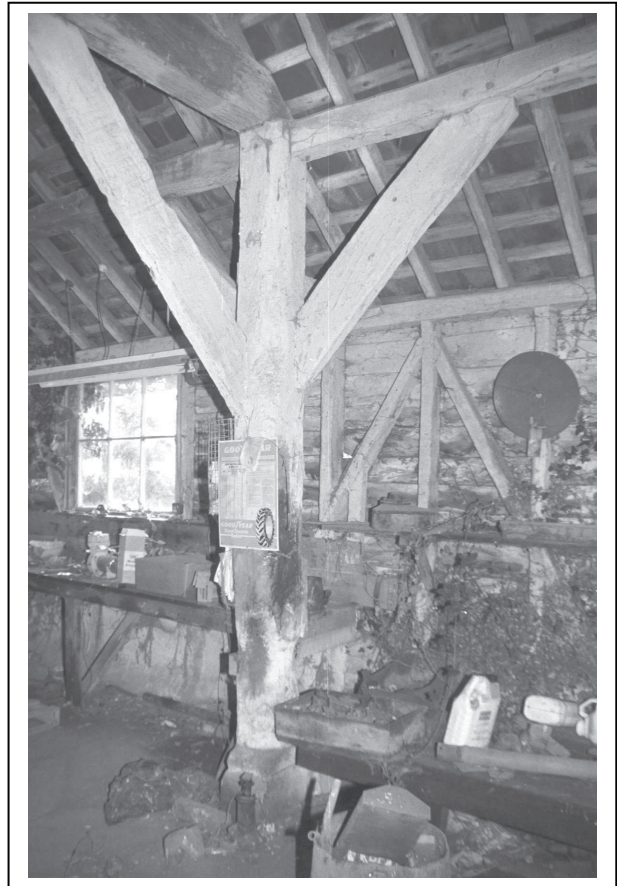
Plate 4: Southern post of Truss 1

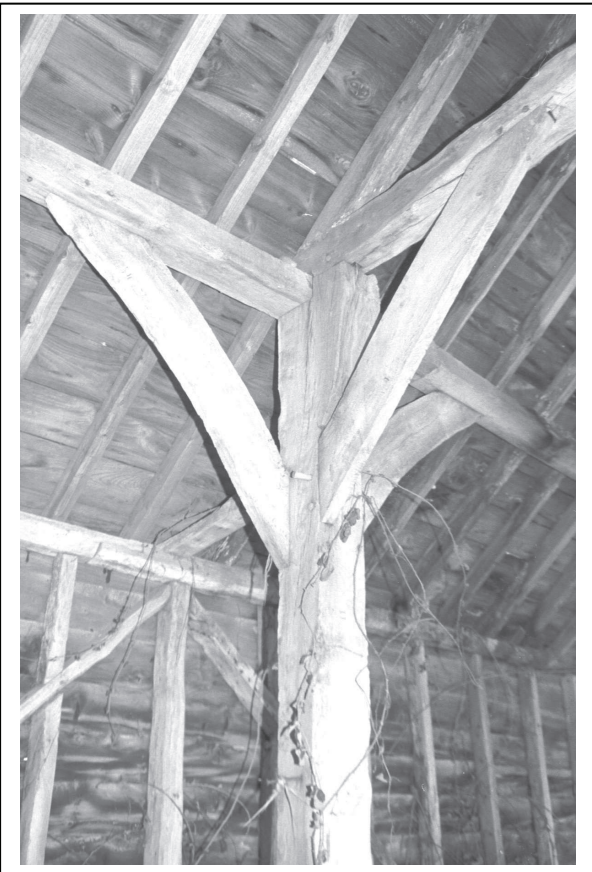
Plate 6: East side of porch in Area 3

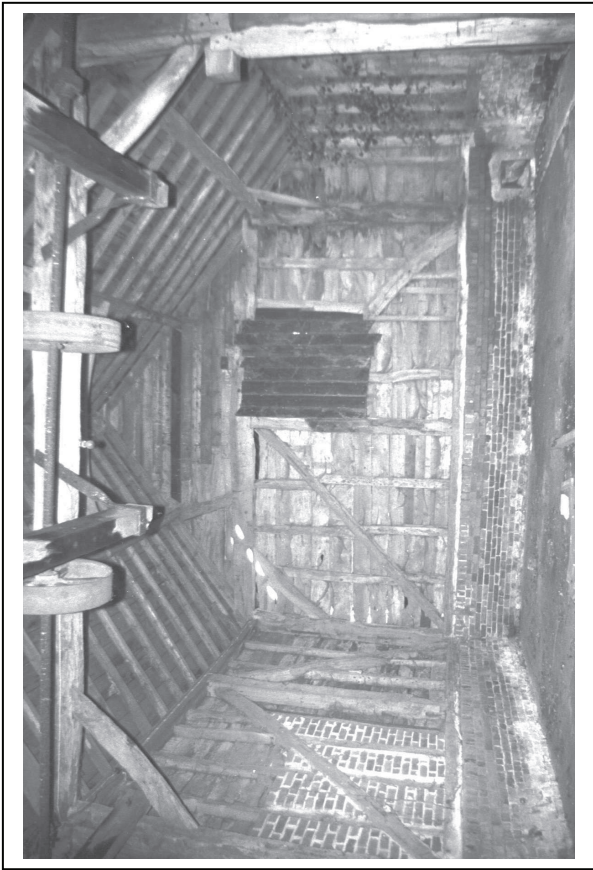
Plate 7: East end of Area 2

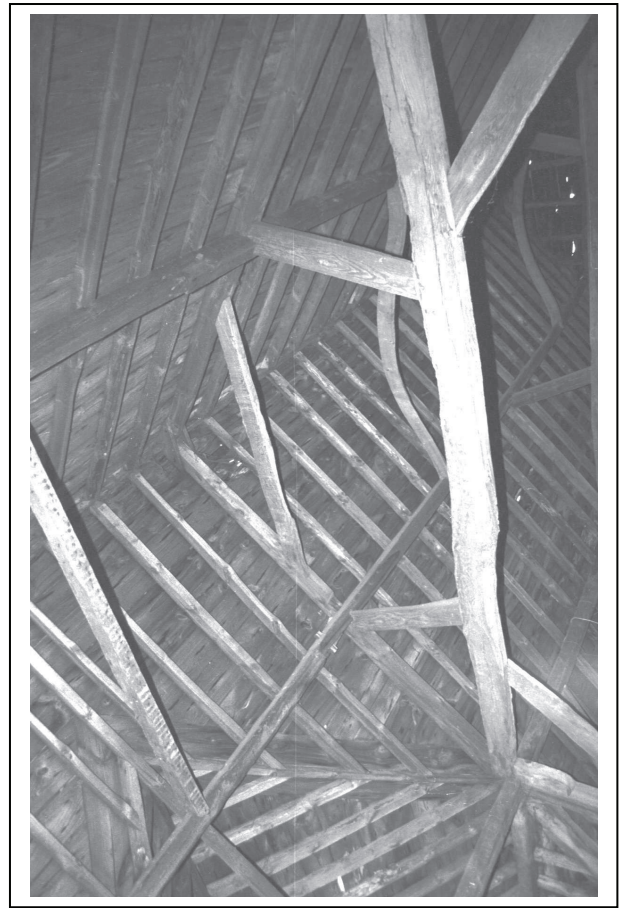
Plate 8: Roof within Area 3

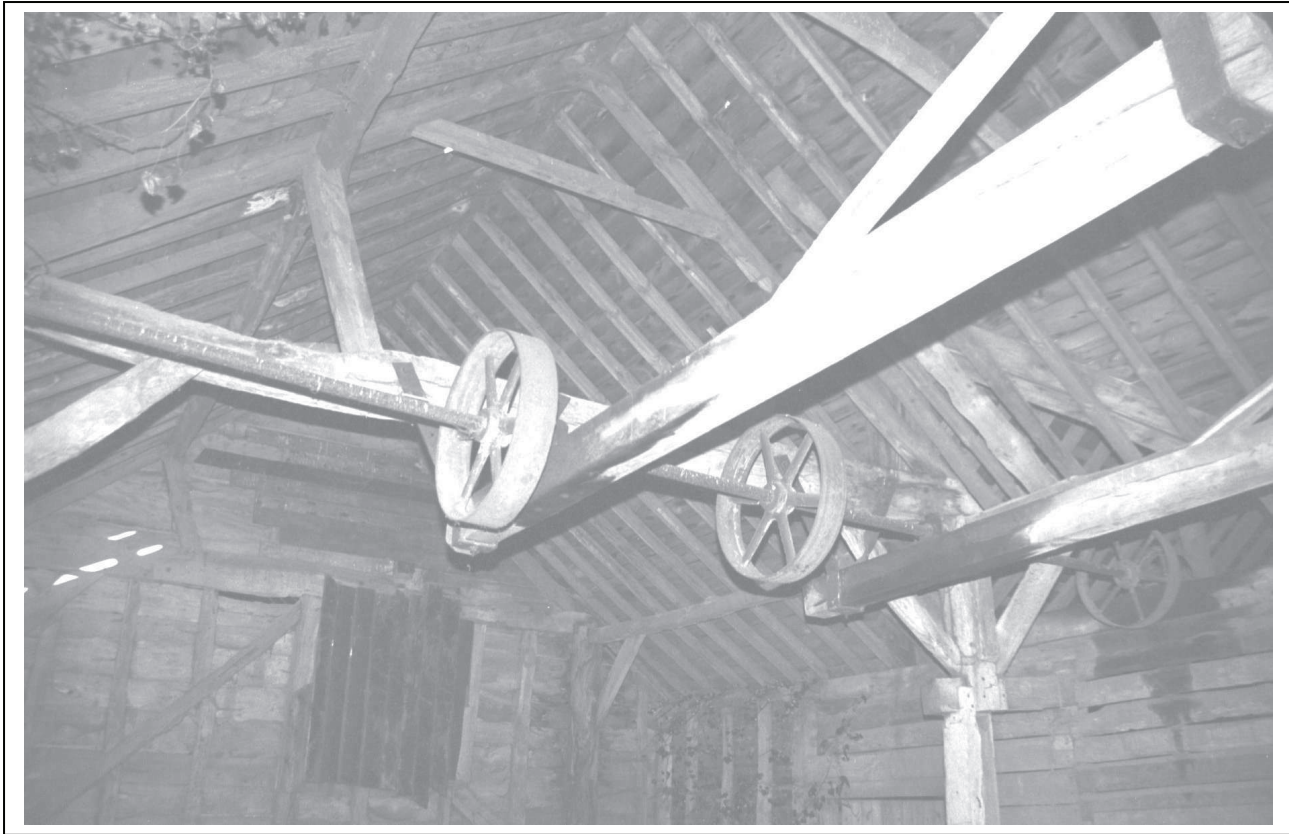
Plate 11: Overhead power shaft within barn. Wheel house to right.

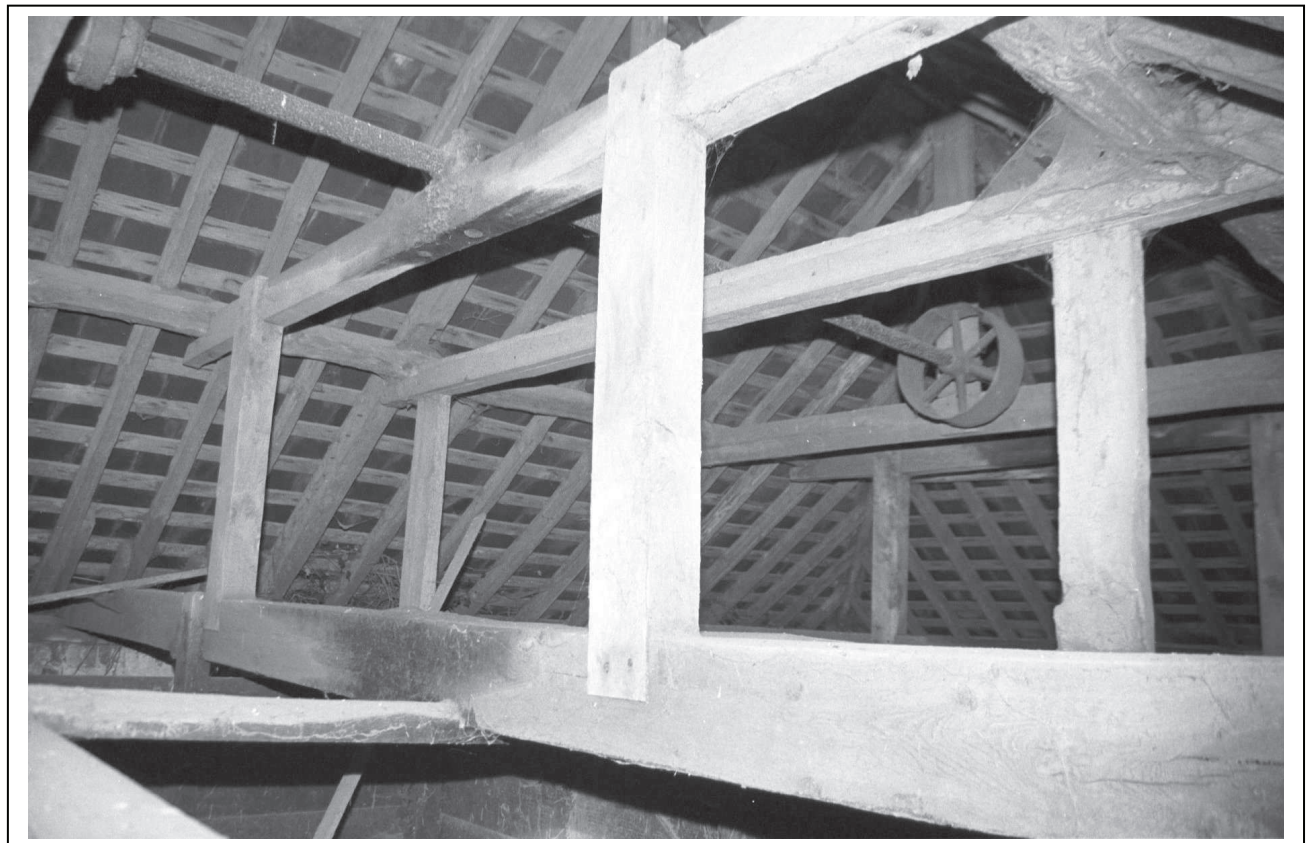
Plate 12: Power shaft and roof structure within wheel house. Looking towards south-east.

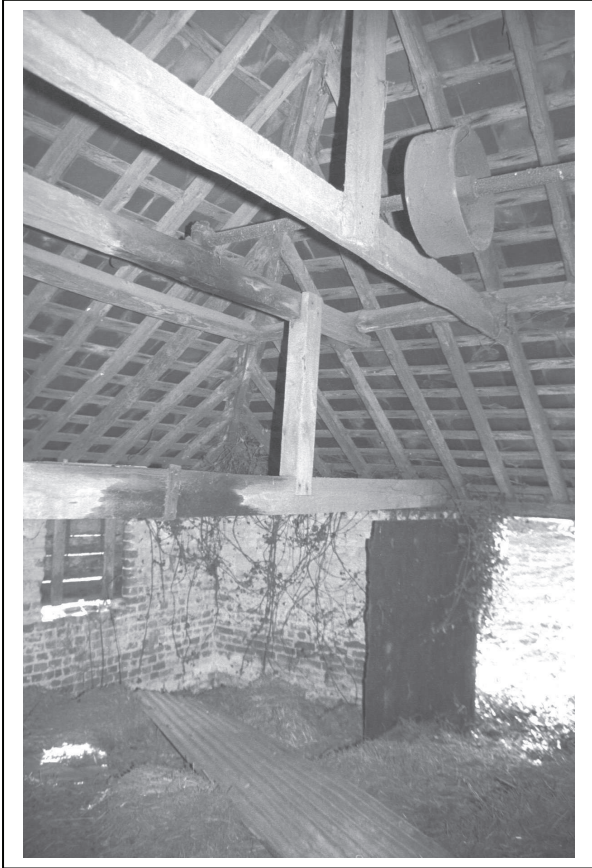
Plate 13: Wheel house looking south-west

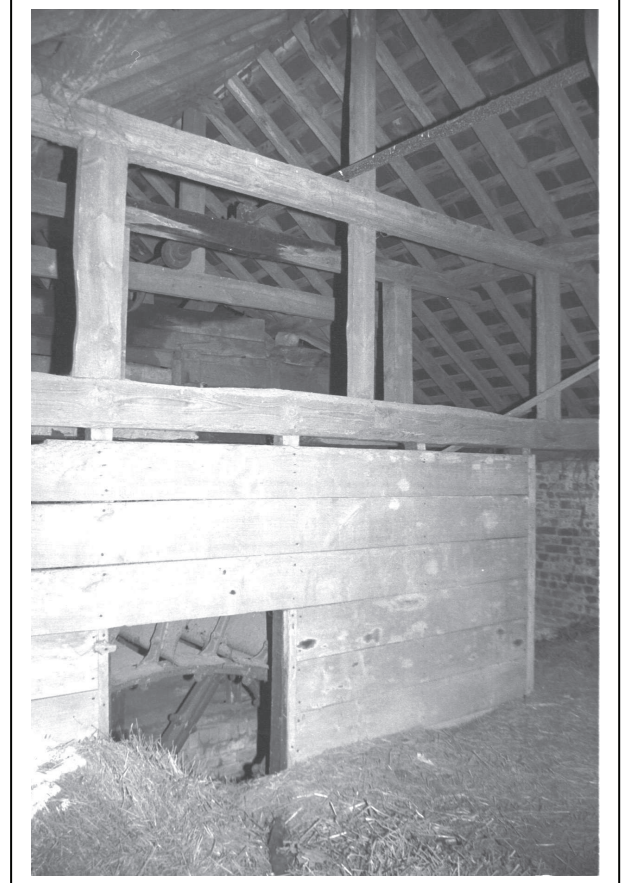
Plate 14: Frame surrounding waterwheel from south-west

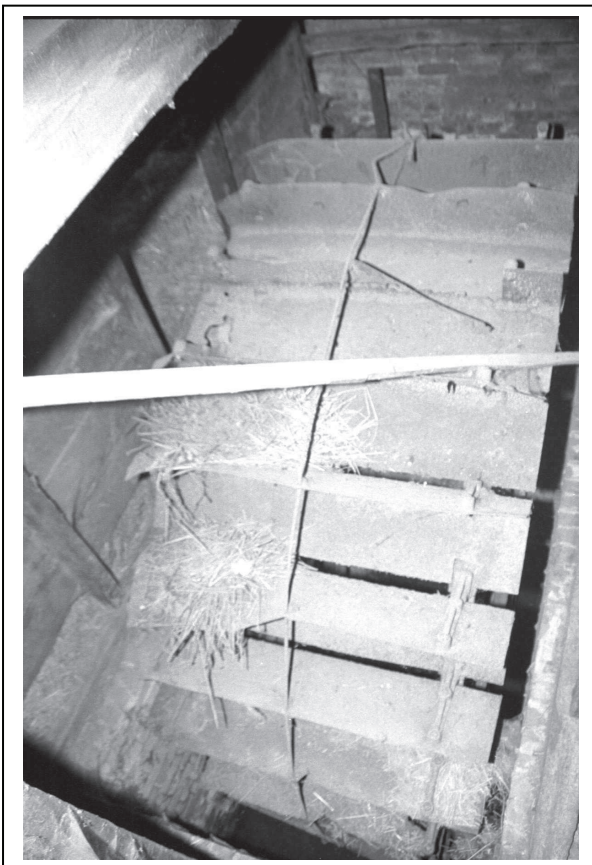
Plate 16: Axle and southern wall of wheel pit

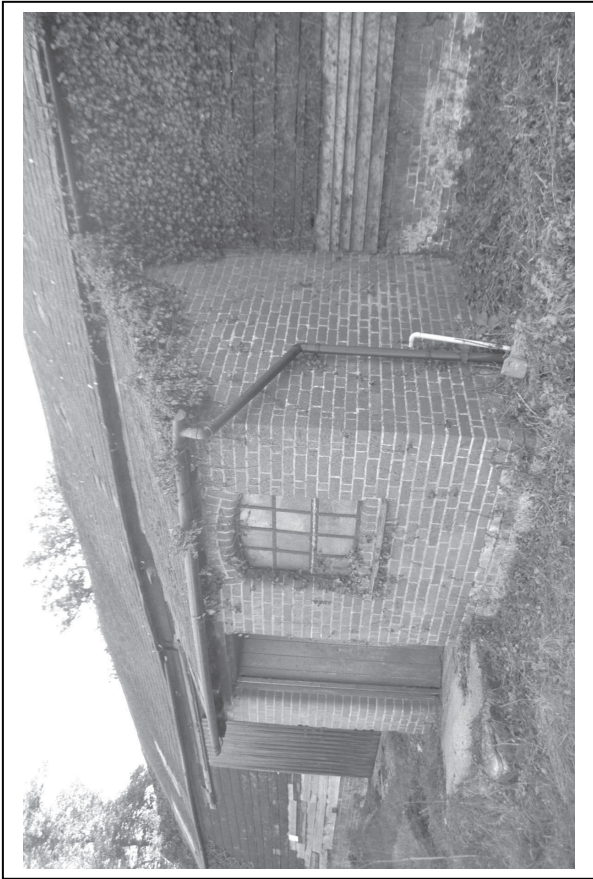
Plate 19: Projection to north of barn

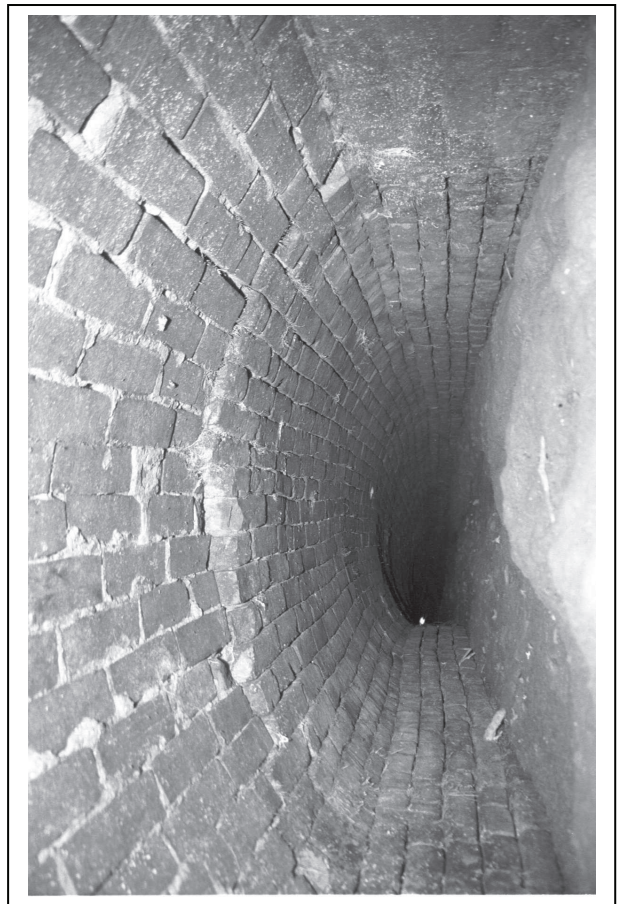
Plate 20: Culverted leat viewed from wheel

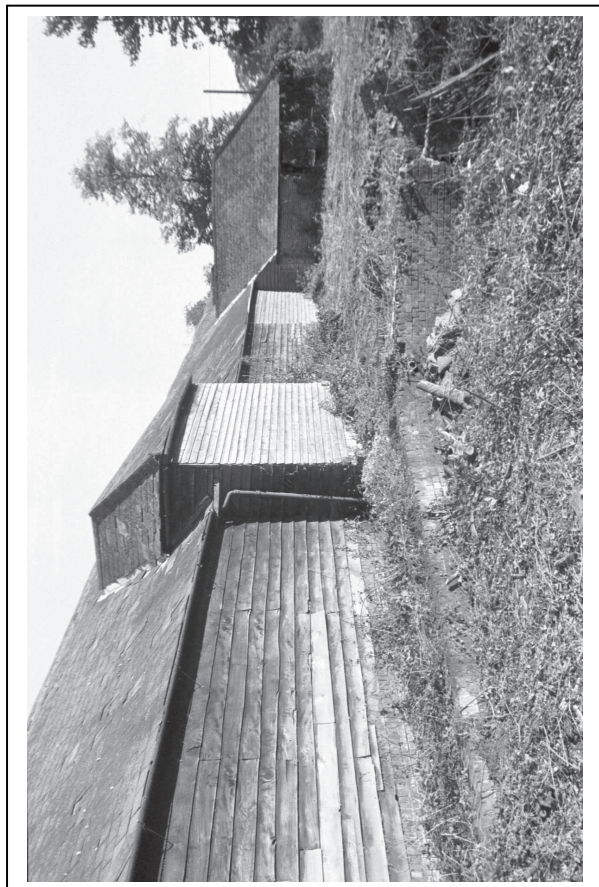
Plate 22: Wheel house viewed from SW

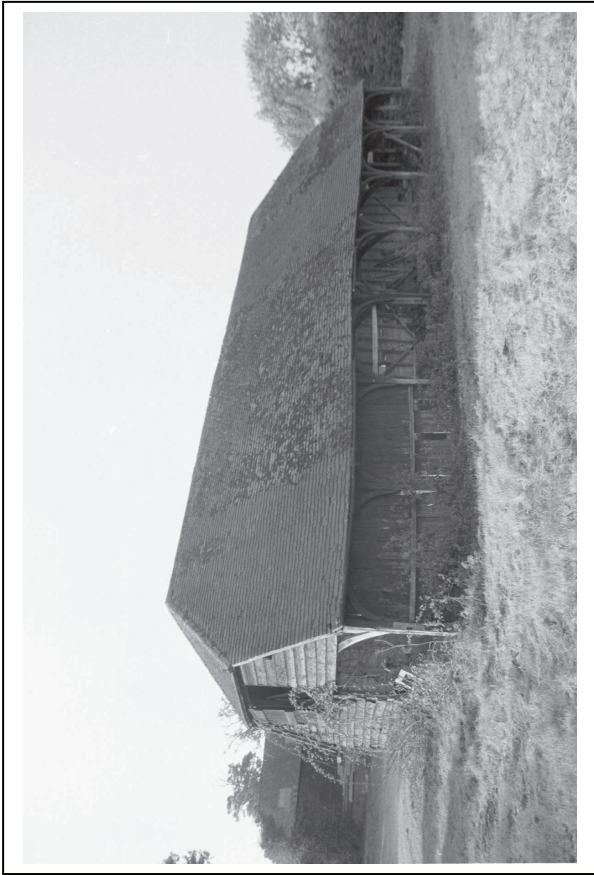
Plate 23: Cart shed viewed from south-west

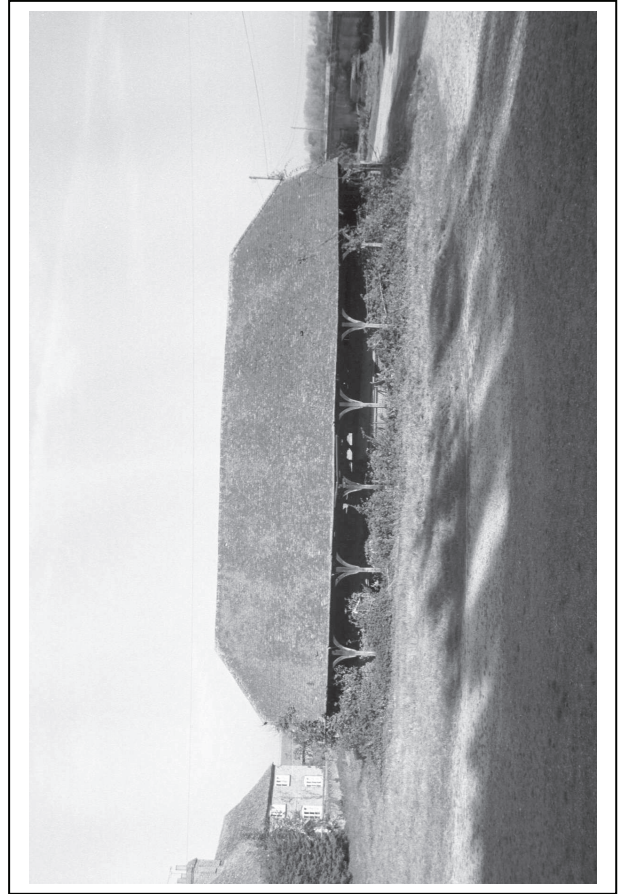
Plate 24: Southern face of cart shed

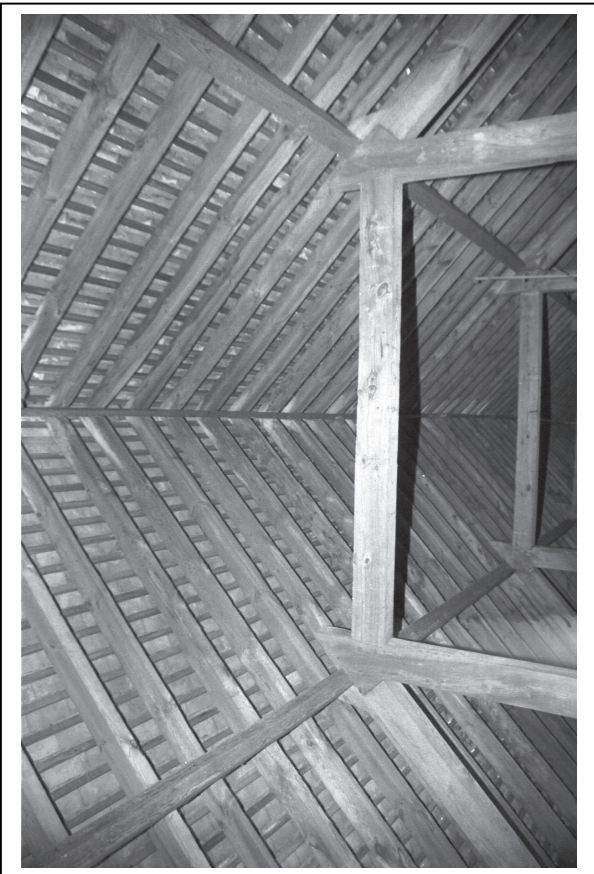
Plate 26: Interior of cart shed from west
