# THE WHITE HOUSE MAIDSTONE KENT

HISTORIC BUILDING RECORDING  
AND ARCHAEOLOGICAL WATCHING BRIEF

OXFORD ARCHAEOLOGICAL UNIT

September 2000

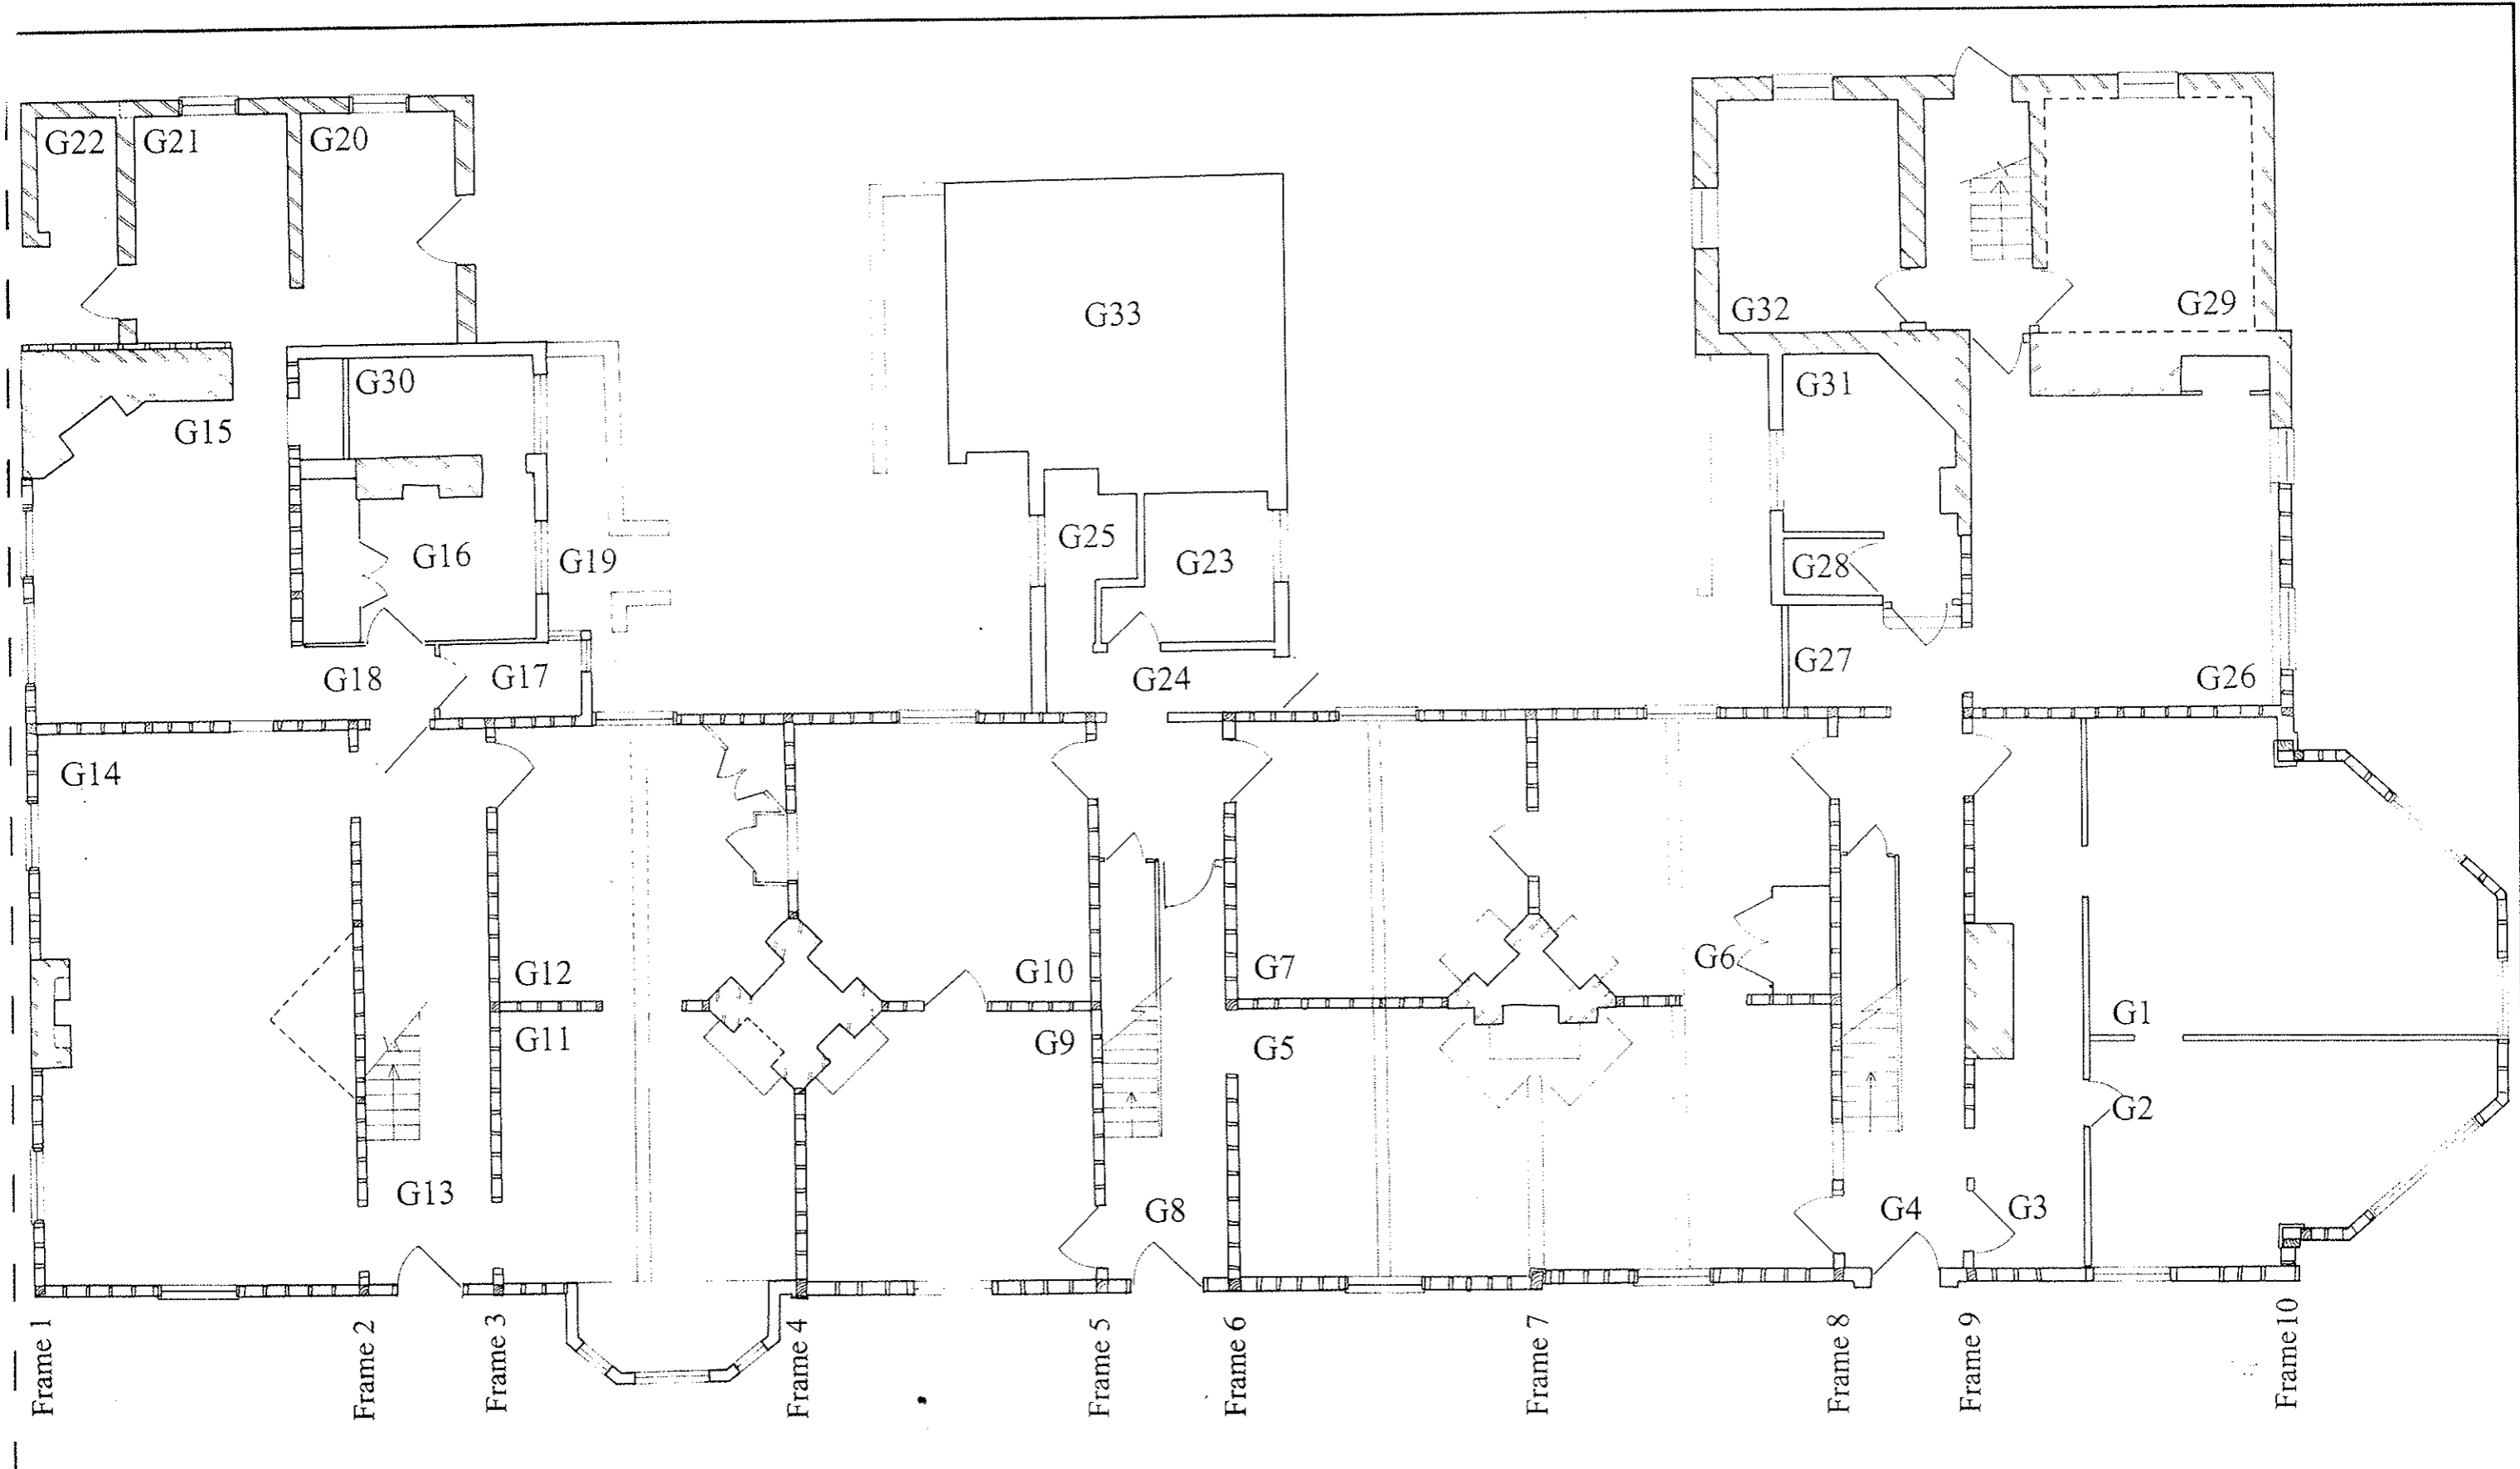
Oxford Archaeological Unit  
THE WHITE HOUSE, MAIDSTONE  
**FIGURE 3: Ground floor plan**  
Survey: Feb 2000. Scale: 1:50 at A1

- 2.6.1 The only one of the four divisions at ground floor which appears to retain its original layout is the one immediately to the north of the central staircase. There is a square plan, diagonally-set brick chimney stack at the centre of the area with timber-framed partitions radiating out from it and forming small rooms. The area to the south of the central staircase originally shared the same plan but the two rooms to the west have been combined by the removal of the partition and half the chimney stack. An iron joist supported by an iron post at its west end has been inserted spanning the new opening. The two fireplaces, which would have projected into this room, have been replaced by a single fireplace along the same line as the partition but when the survey was undertaken much of the ground floor within G5 had been removed to reveal the foundations for the hearths of the former angled fireplaces. The removal of the floor also revealed three east-west brick footings. The central one would have been beneath the partition dividing the two rooms and the other two would have supported the ground floor common joists at the mid-point of each room. The ground floor had also been largely removed within G6 and G7 to confirm that each foundation extended across the building and a similar brick feature was visible within G11 beneath the largely collapsed floor.

- 2.6.2 As referred to above it appears that the northernmost division (G14) of the ground floor was originally divided into two rooms. The two larger-section posts set apart within the cross-frame strongly suggest that there was formerly a chimney stack within this wall and the first floor construction, visible from

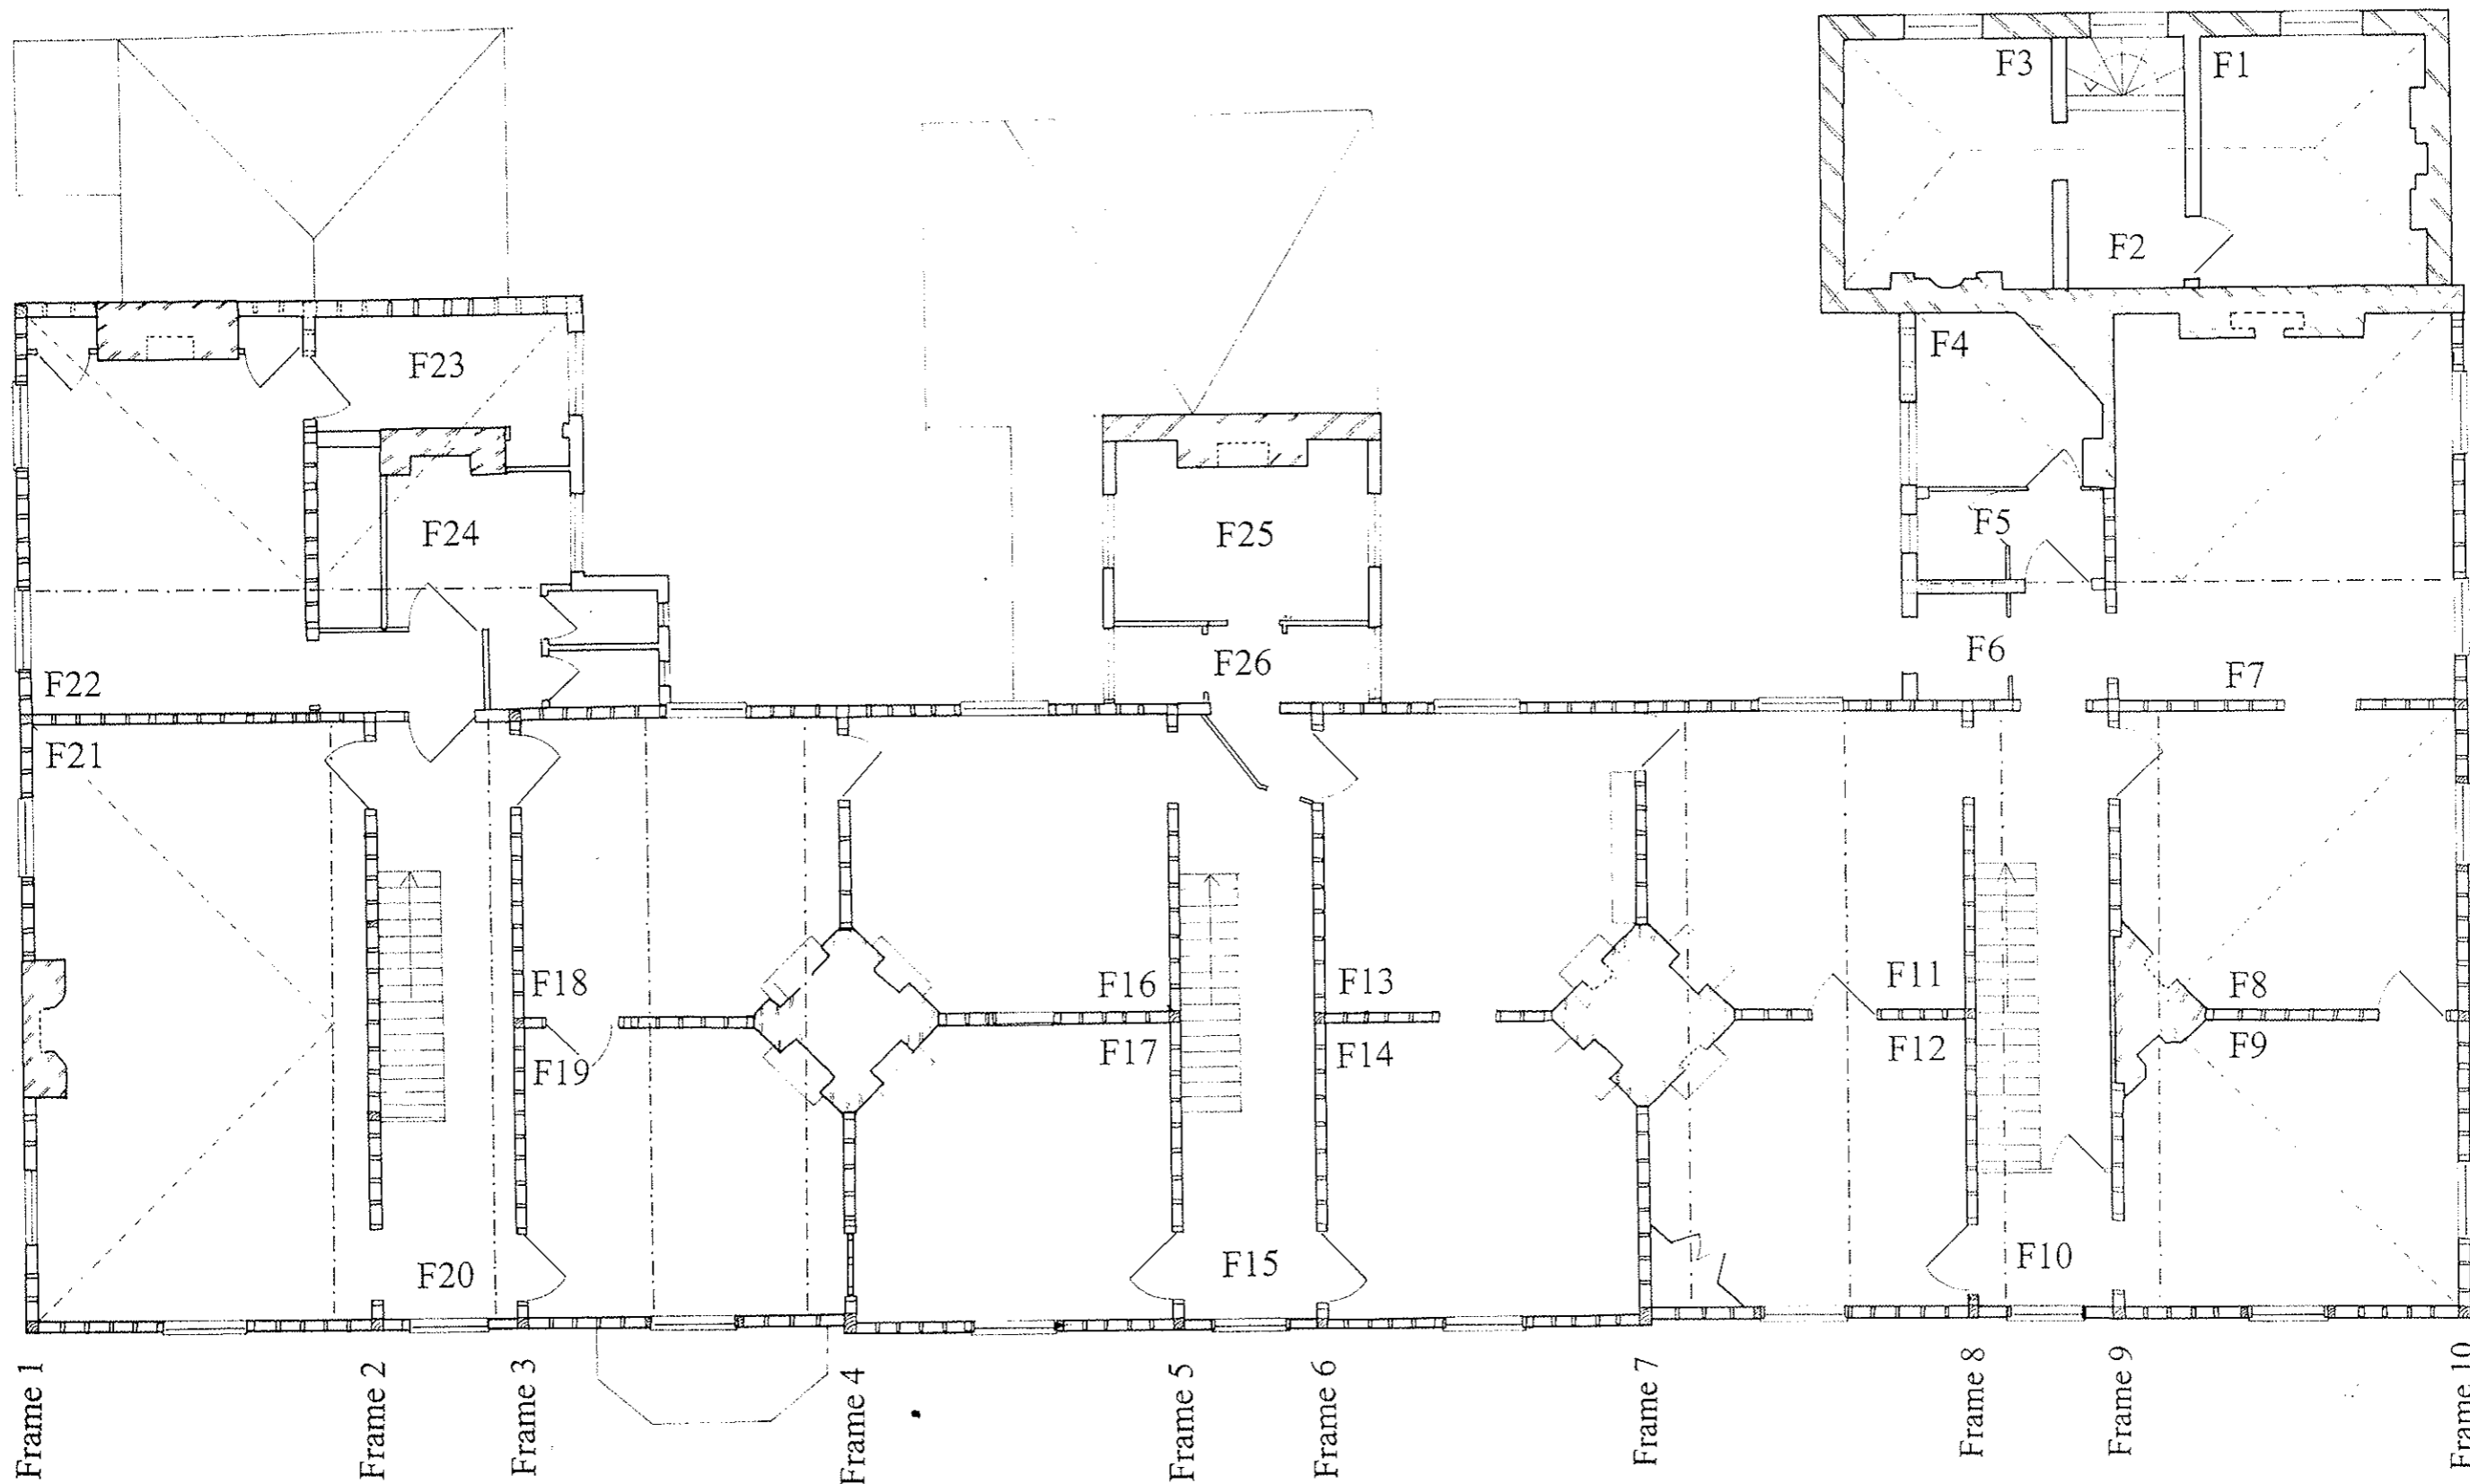
Oxford Archaeological Unit  
 THE WHITE HOUSE, MAIDSTONE  
**FIGURE 4: First floor plan**  
 Survey: Feb 2000. Scale: 1:50 at A1

- 2.7.1 The first floor largely retains its original layout with each of the two sections either side of the central staircase divided into four square rooms utilising a shared, diagonally-set brick chimney stack. The area to the southern end of the building is divided into two rooms by a partition along the spine of the building with diagonally-set fireplaces. The northern end of the building would originally have been similarly divided into two rooms and there is evidence of a former diagonally-set chimney at the southern end of this room, similar to that at the opposite end of the building, which was replaced by the existing chimney breast serving the larger unified room (F21). Some evidence of this has been referred to above in the section on the ground floor but there is further evidence visible within F21 such as the fact that the uppermost horizontal within Cross-Frame 2 does not span the building. The beam is only

- 2.7.2 One feature of some archaeological interest within the first floor is the fact that the window within F18 appears to have been moved slightly to the south. Unlike all the other windows to this elevation it is not above that at ground floor level and it cuts through the diagonal brace within the wall-frame (Fig 8). This is explained by the small secondary toilet block (F24 a + b) constructed at this point which would have overlapped the window. Due to the timber-framed construction of the building it would have been relatively easy to cut out the window, form a new opening in the frame and reinsert it.

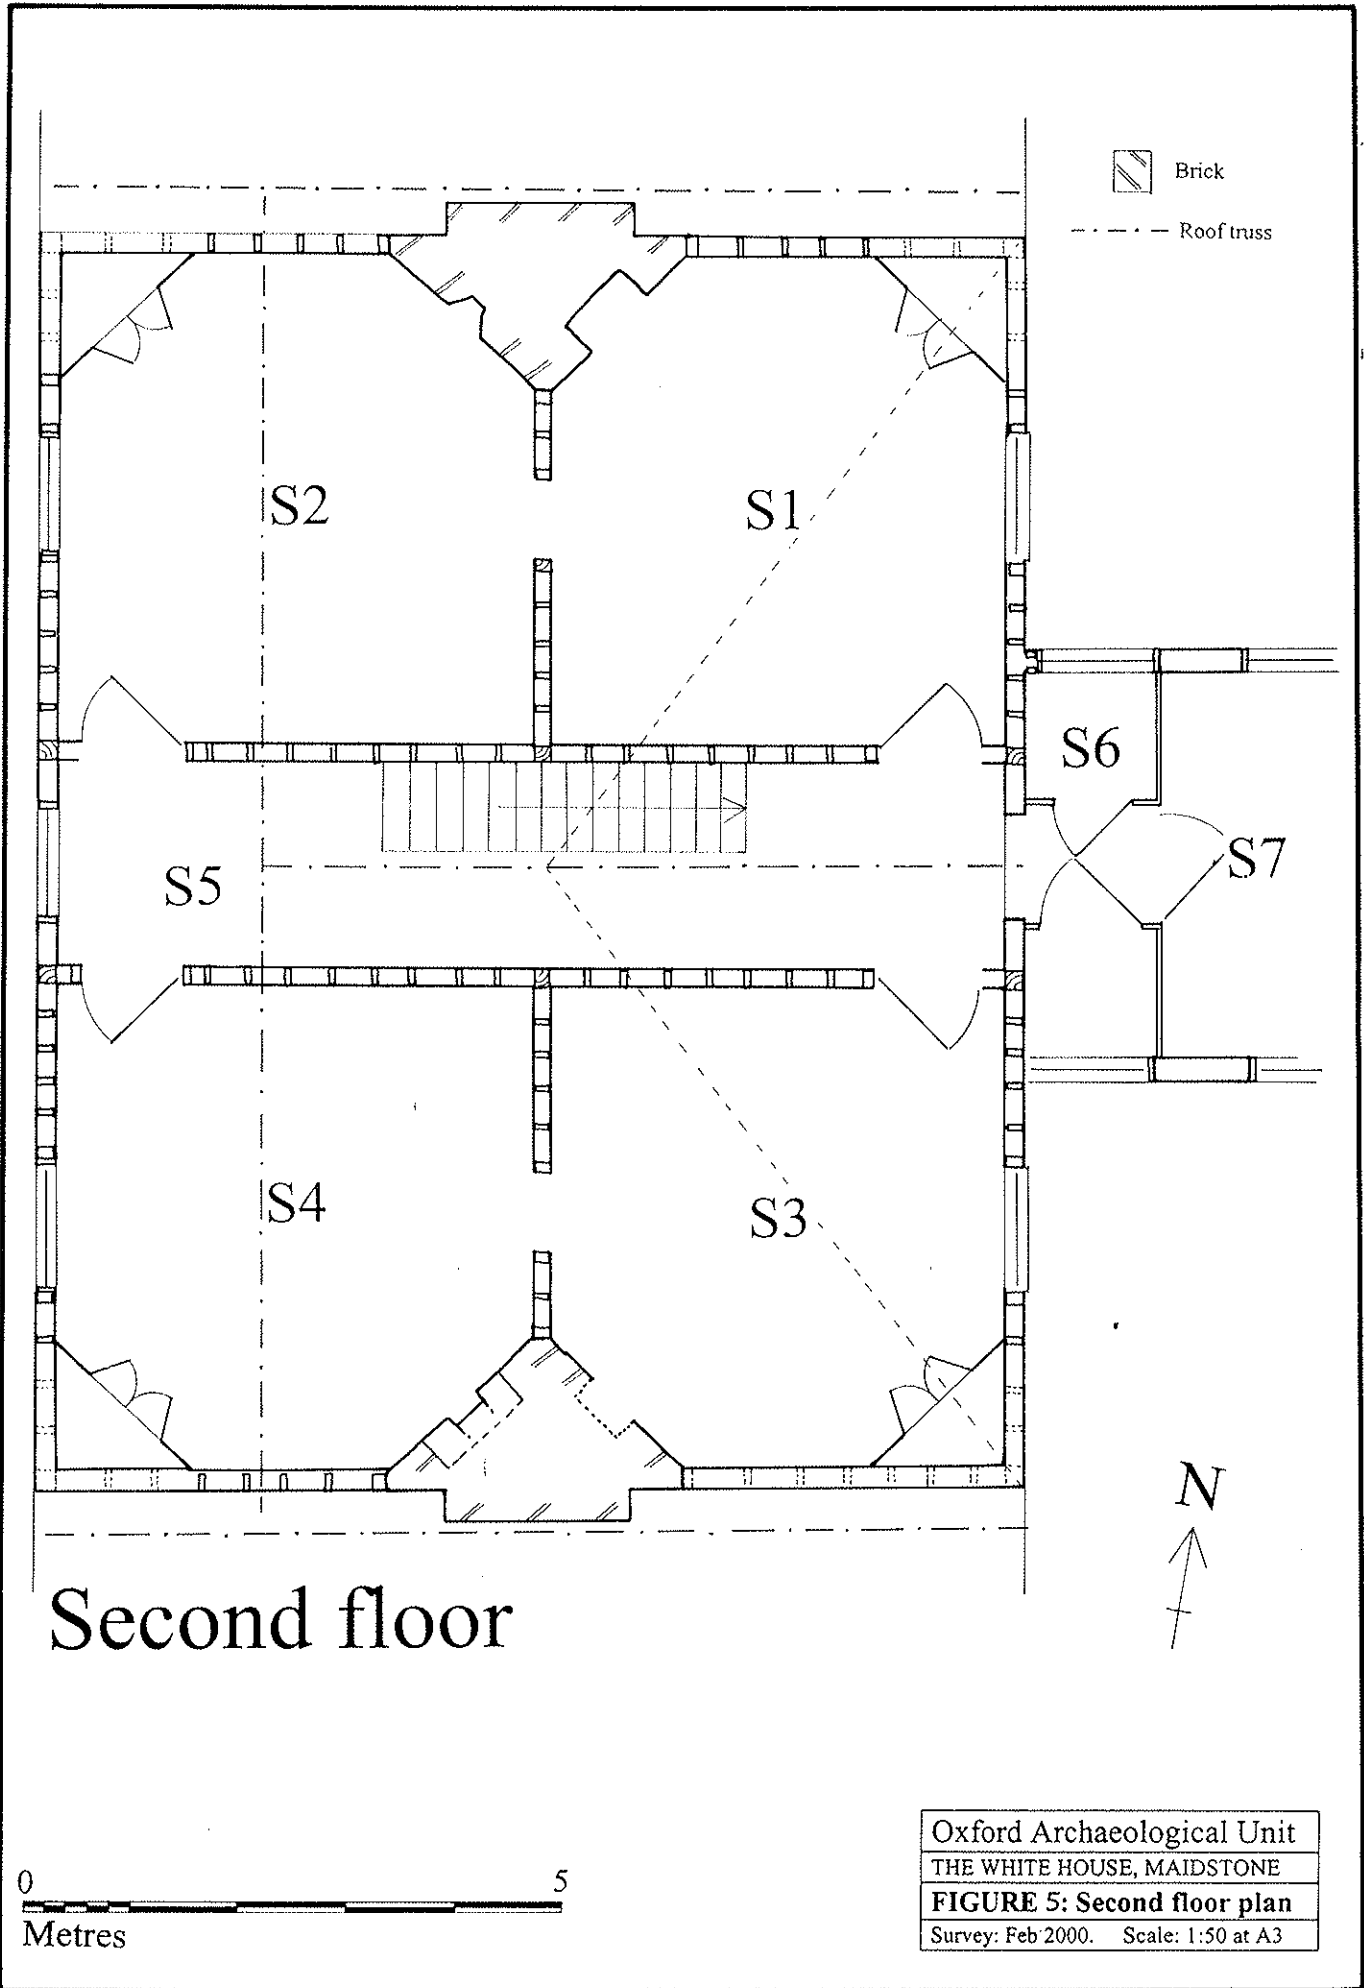
Oxford Archaeological Unit
THE WHITE HOUSE, MAIDSTONE
<b>FIGURE 5: Second floor plan</b>
Survey: Feb 2000. Scale: 1:50 at A3

- 2.8.1 There is a second floor within the central third of the main body of the building and the central eastern projection. It consists of four regular bedrooms each one the same size as those on the floors below, a central hall housing the staircase, and three rooms (S6, S7, S8) within the projection.

- 2.8.2 Each of the four bedrooms retain many of their original features form with each of the two pairs of room either side of the hall sharing a triangular plan chimney stack at the outer (north and south) faces of the storey. Each of the chimneys appears to have been rebuilt or extended just above eaves level with a yellow brick above the primary red brick. Each room also retains an angled corner cupboard similar to those partially surviving on the floors below.

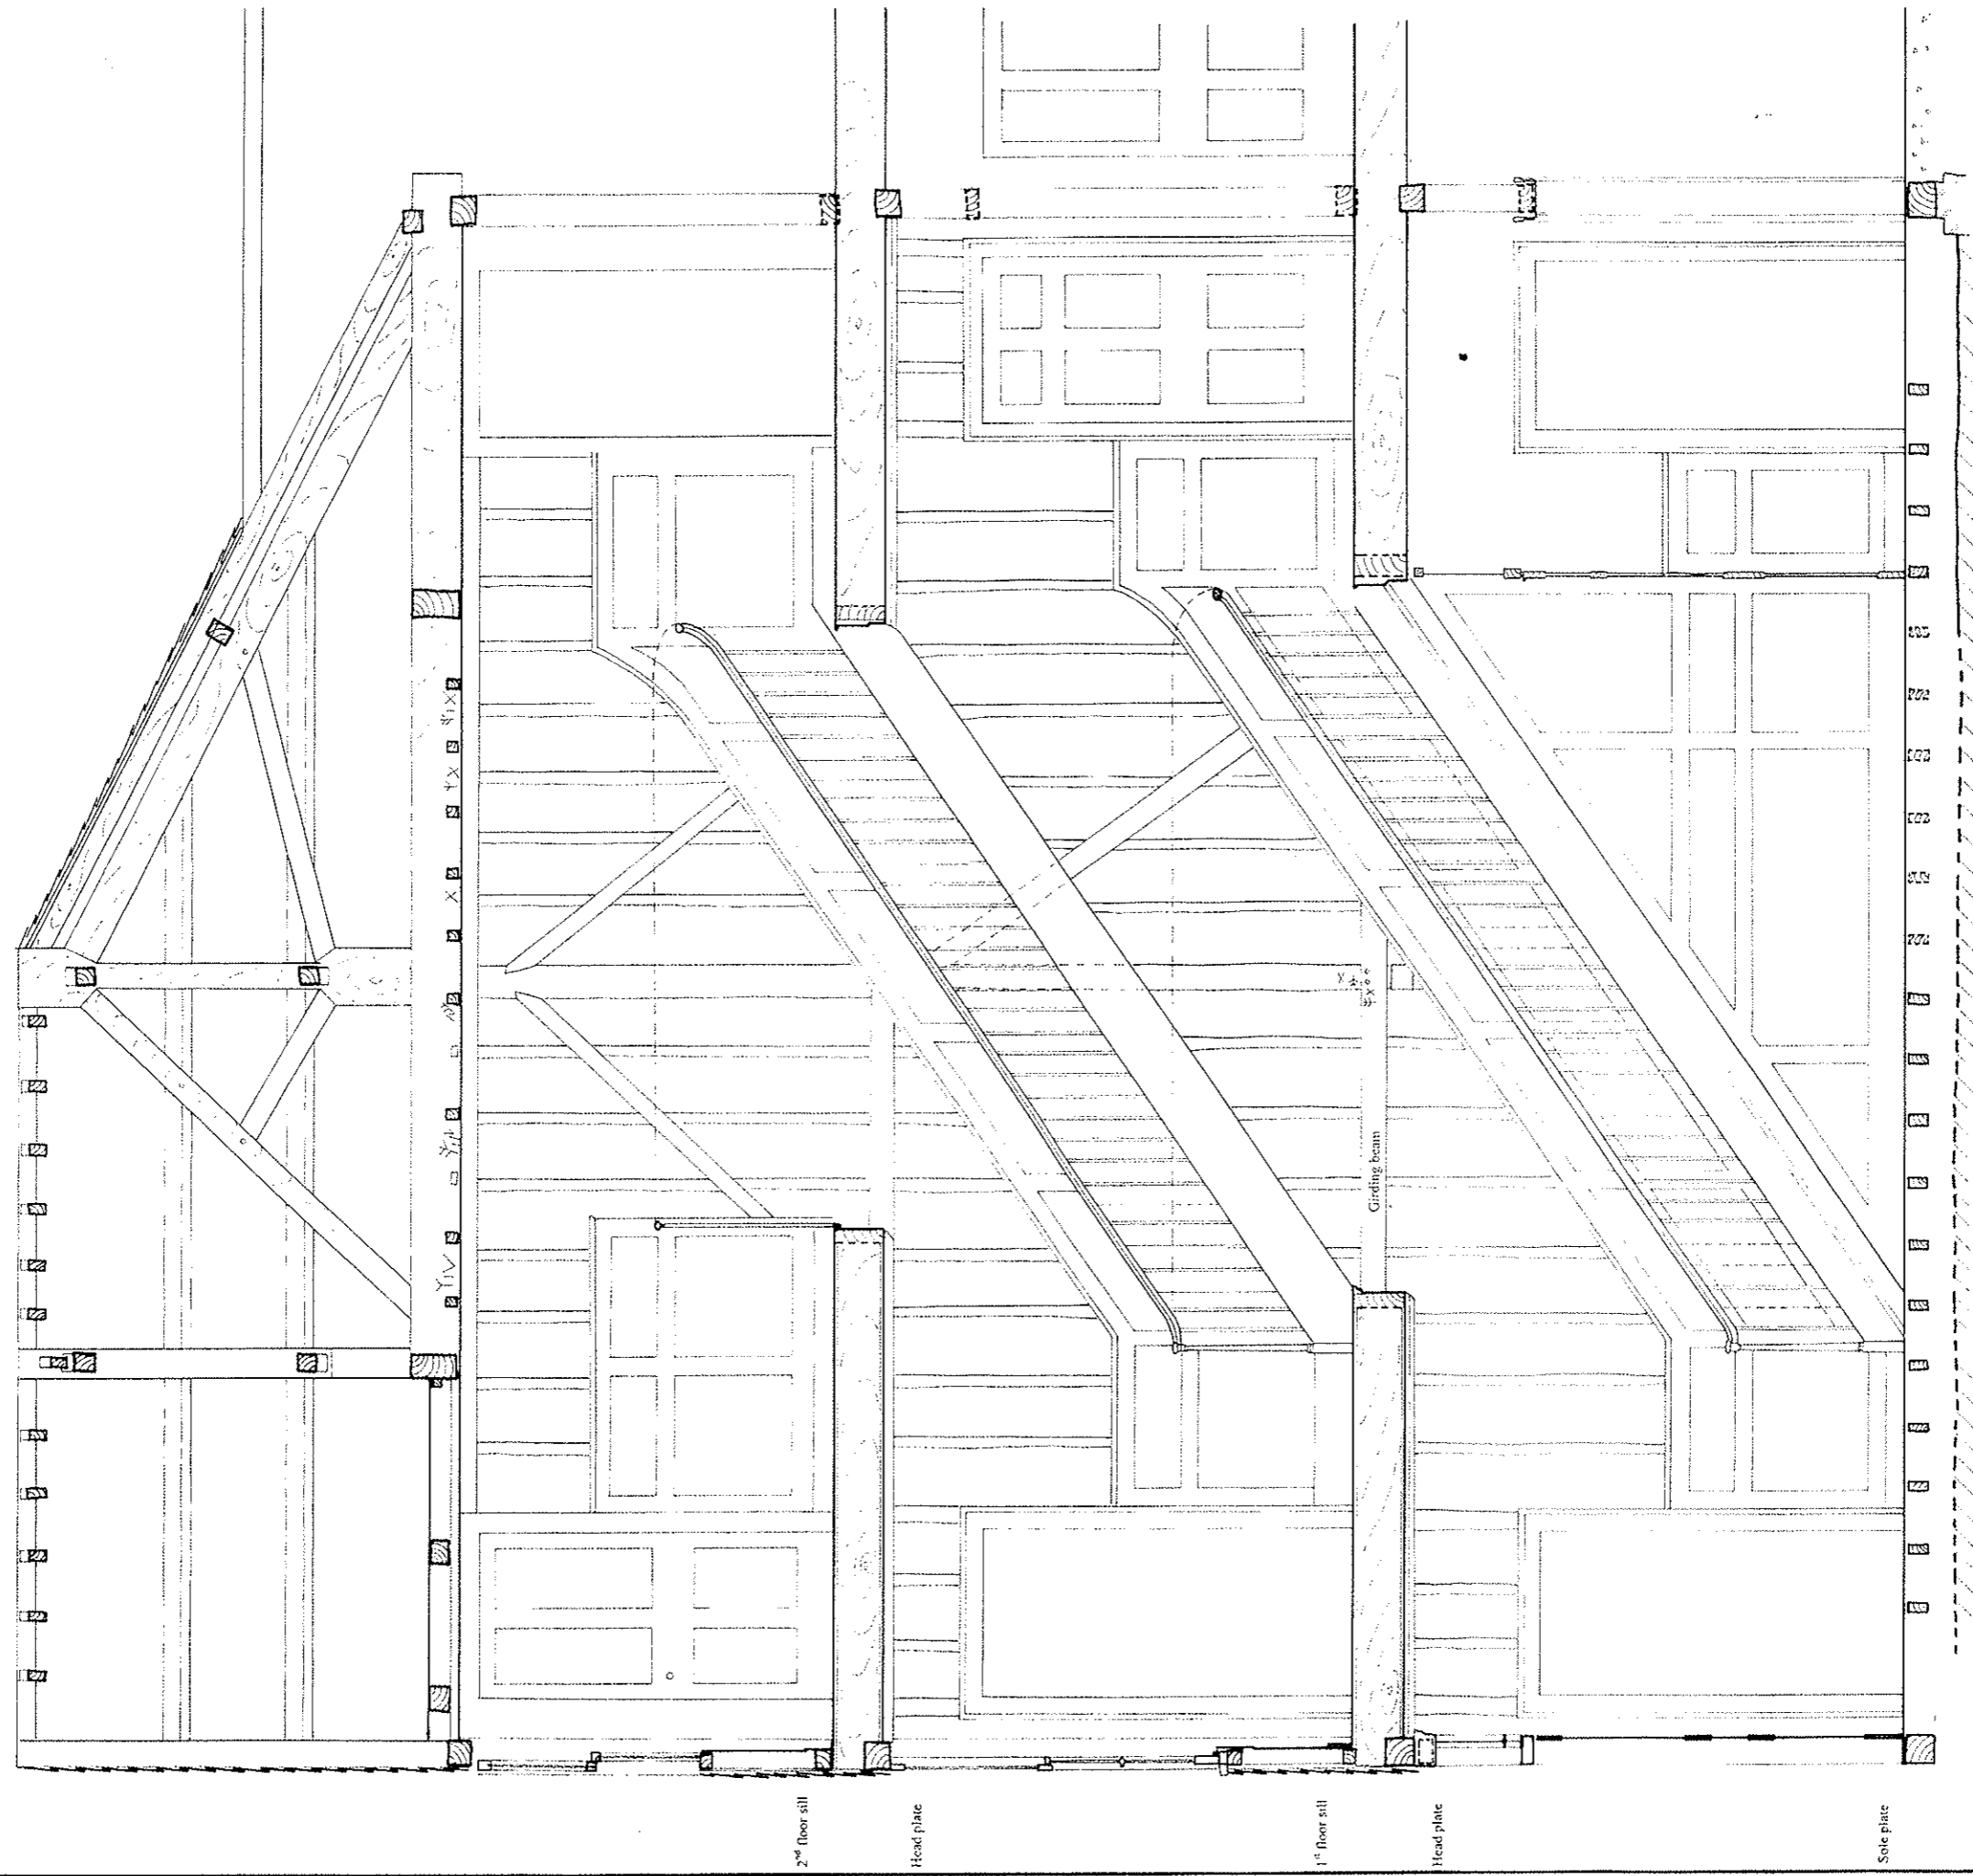
Frame 5 (looking north)

- 2.3.3 There are essentially two types of cross-frame: those which coincide with a chimney stack (Frames 2, 4, 7, 9) and those which do not (Frames 3, 5, 6, 8). Those not in line with a chimney have a large central post (14 cm x 14 cm) which supports the abutting partition along the spine of the building and a diagonal brace to each side which strengthens the cross-frame. Those which are in line with the chimney stacks also have two diagonal braces but due to the stack they are spaced further apart. The braces are spaced apart within Frame 2 which confirms other evidence (see below) suggesting that there was formerly an diagonally-set chimney within this frame.

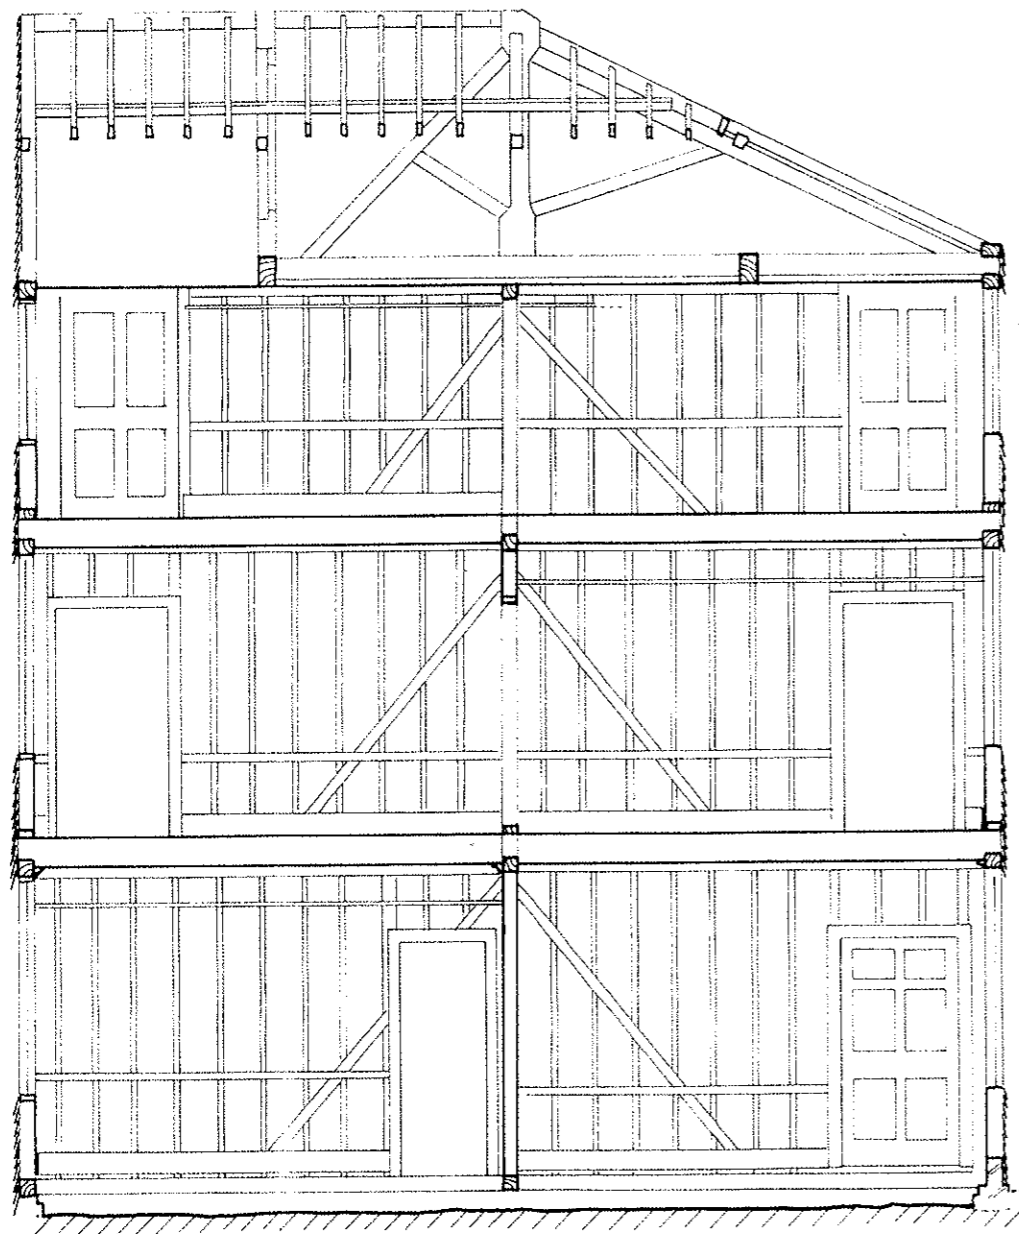
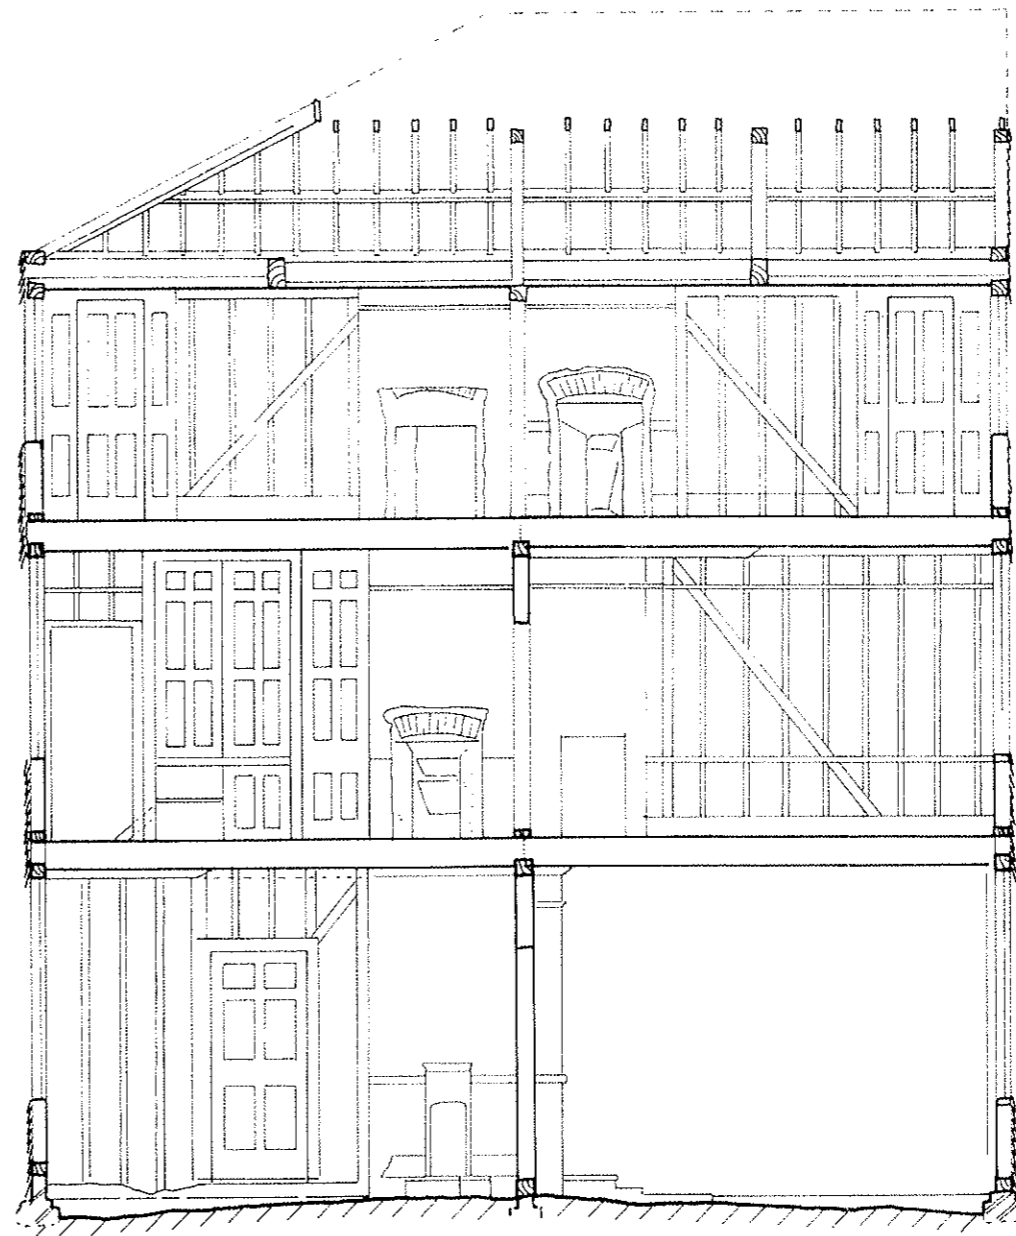
Oxford Archaeological Unit  
 THE WHITE HOUSE, MAIDSTONE  
**FIGURE 8: Cross-frames 6 + 7**  
 Survey: Feb 2000. Scale: 1:50 at A2

- 2.4.1 The primary roof divides into three sections: that above the 2-storied, L-shaped section at the northern end of the building, the very similar structure above the southern end of the building and that above the three-storied central section of the building (Fig 8).

- 2.4.3 The roof above the taller central third of the building is hipped to the rear and gabled to the front. It is supported by two king-post trusses, one orientated north-south and inset c.2 m from the front (west) of the building and the other orientated east-west and spanning from the N-S truss to the east wall (Fig 7). The eastern principal rafter of this truss has a shallow pitch and supports the rear slope while that to the west does not directly support a roof slope and has a steeper pitch. The E-W truss not only supports the rear slope of the roof but also the rear sections of the two side slopes with struts and principal rafters attached to the side faces of the king-post (shown in outline on Fig 8).

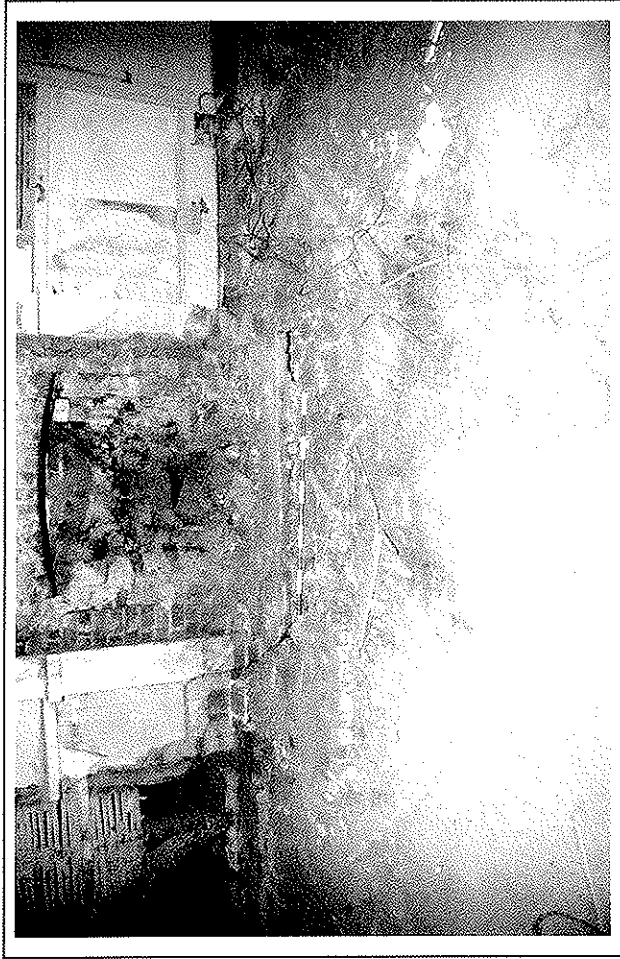
Plate 3: Foundations of corner fireplaces removed when G5 created

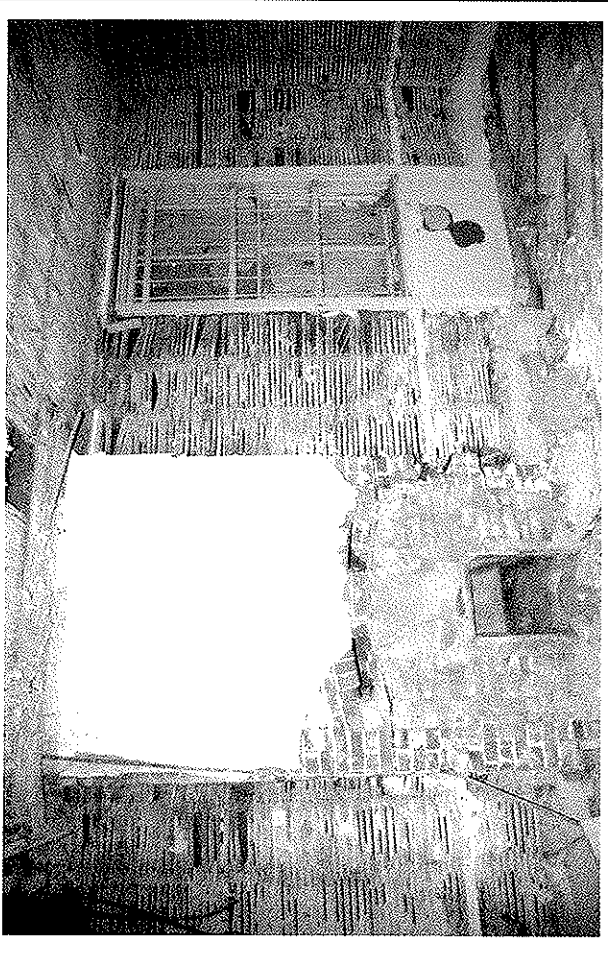
Plate 7: General shot within G14 showing secondary chimney breast

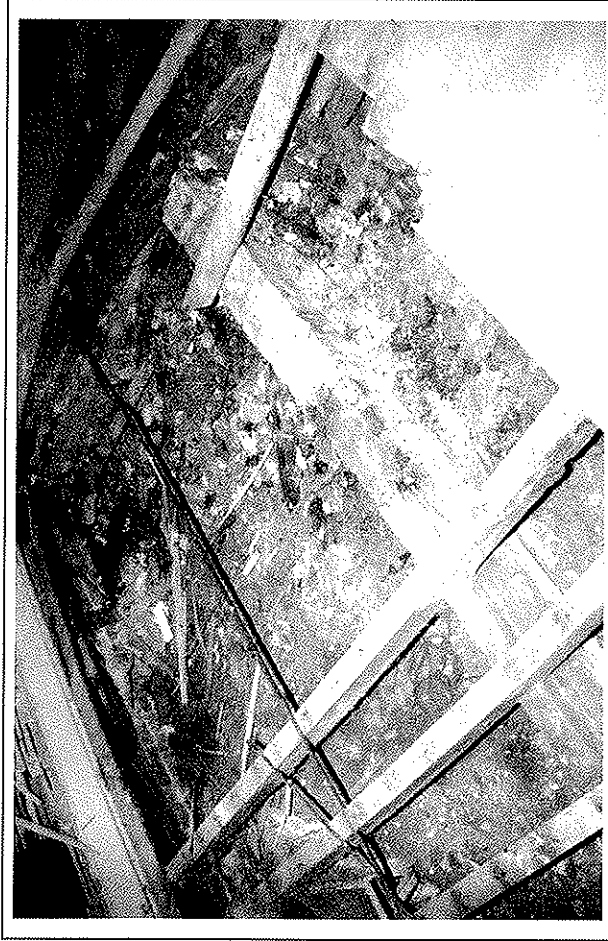
Plate 8: Exposed floor within G11

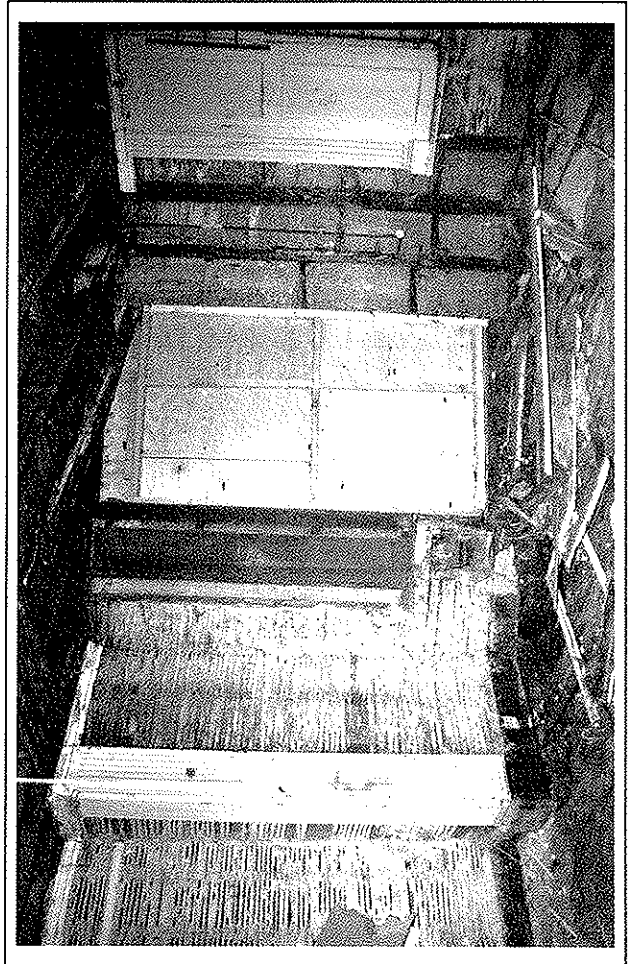
- G1** Divided from G2 and G3 by modern stud partitions. Previously a single large room with semi-octagonal secondary projection. Three tri-partite windows survive two of which within projection. Fourth window lost. Each has 4-pane timber-framed sash windows to central section and flanking timber pilasters. Windows to S and W non-glazed to sides panels. Tall skirting survives. Softwood cornice largely survives (see Fig 10). Parts of south-east wall fire damaged and lumpy concrete apparently poured and set between damaged posts.

Plate 9: General view within G1

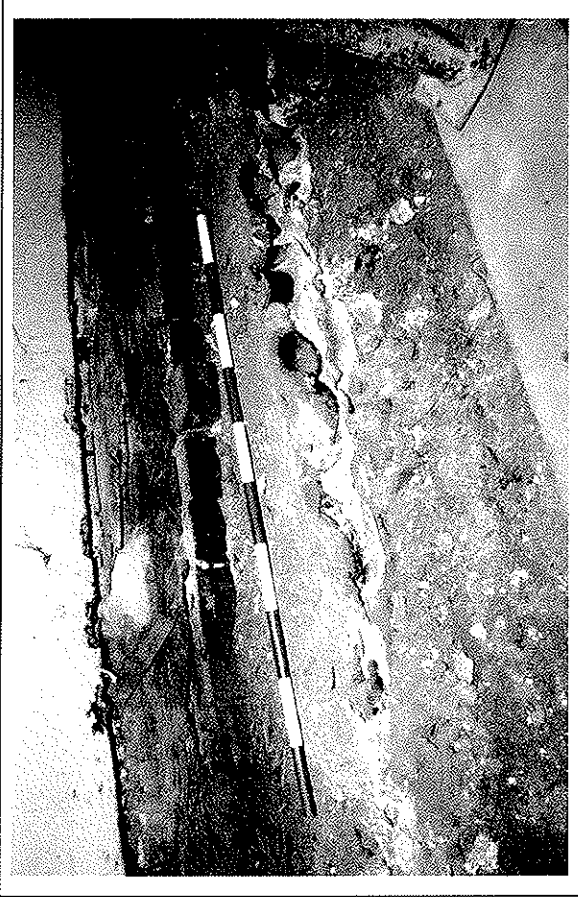
- 2.3.7 Another feature of interest revealed by the works is that the foundation of each of the four walls of G14 at the north end of the building are extended into the room by a shelf of dark green/blue bottles laid horizontally so that only the base is visible within the room and set within a white mortar (Plate 31). The bottles are set against the internal wall of the foundation and they extend between 20-30 cm into the room. Their depth varies between 15-30 cm above the ground surface.

Plate 31: Bottles laid against foundation within G14

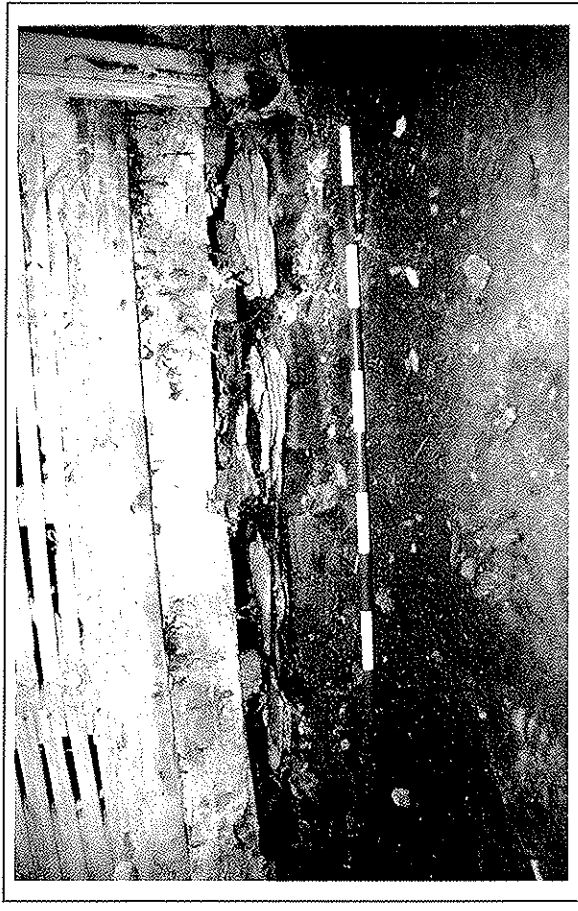
- 2.3.6 The sole plates of the cross-frames and wall-frames as well as the intermediate supporting joists, rest on stepped brick foundations. It appears that there may originally have been a slate damp proof course constructed between the brick and the sole plates but only a few small sections of this survive. The two areas in which this is most obviously apparent are within the north wall of G11 and the east wall of G10. Within each of these areas there are about five or six courses of slate laid directly on top of one another beneath the sole plate and above the brick foundation (Plate 32). The slates were only exposed by the development works and although when the site was visited these were the only two areas where the feature was obviously apparent it was also encountered elsewhere during the works. It may be an original feature although it alternatively have been a secondary insertion in areas where damp became a particular problem. This is suggested by the fact that the sole plate were particularly rotten in the areas with the slate damp proof course and they had been partially replaced in some areas with concrete poured in-situ.

Plate 32 : Slate damp proof course between sole plate and brick foundation within G10
