THE WHITE HOUSE  
MAIDSTONE  
KENT

HISTORIC BUILDING ASSESSMENT

September 1999

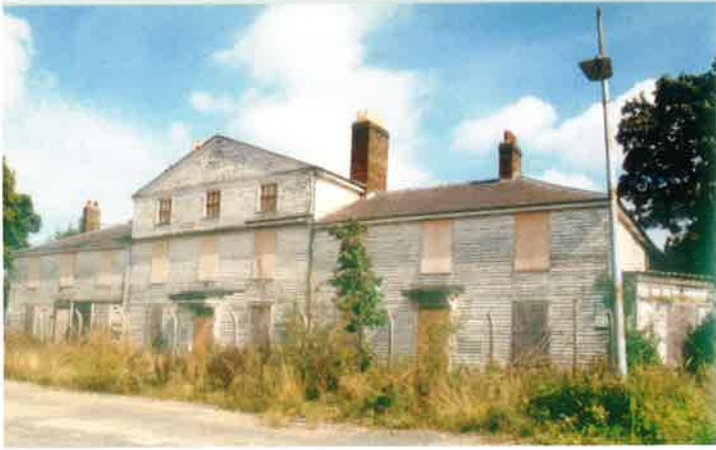
1

- 2.1.1 The White House is a striking and unusual landmark within Maidstone a short distance to the north of County Hall and the town centre (pl. 1). With its simple classical design and weatherboarded skin it is more reminiscent of an early nineteenth century mansion in the southern United States than a part of an army barracks in Kent.

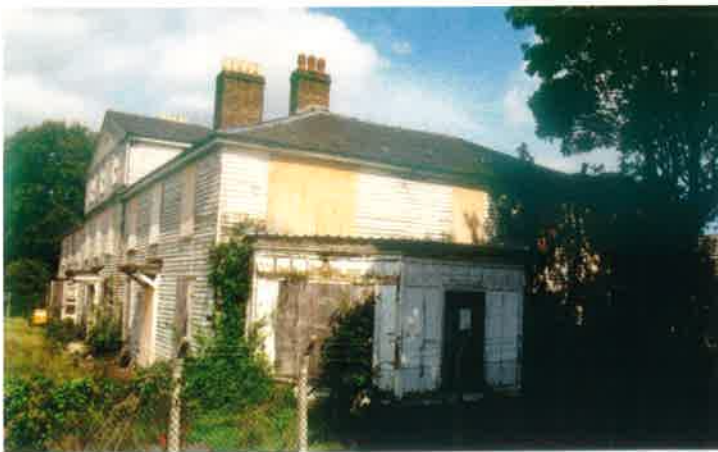
3

- 2.1.2 Structurally the primary building has a pine balloon frame and is clad in weatherboarding. It is orientated north-south in an E-shape with three primary service wings extending to the east and two further secondary projections extending the northern and southern wings (fig. 3). The building is two storeys tall with three storeys to the central third and three small individual basements beneath each of the eastern projections. The main elevation (west) is nine bays wide with the raised central three bays beneath a pedimented gable. The north elevation, including the primary projection, is four bays deep and the southern elevation is similarly four bays deep with a secondary semi-octagonal projection (pl. 3).

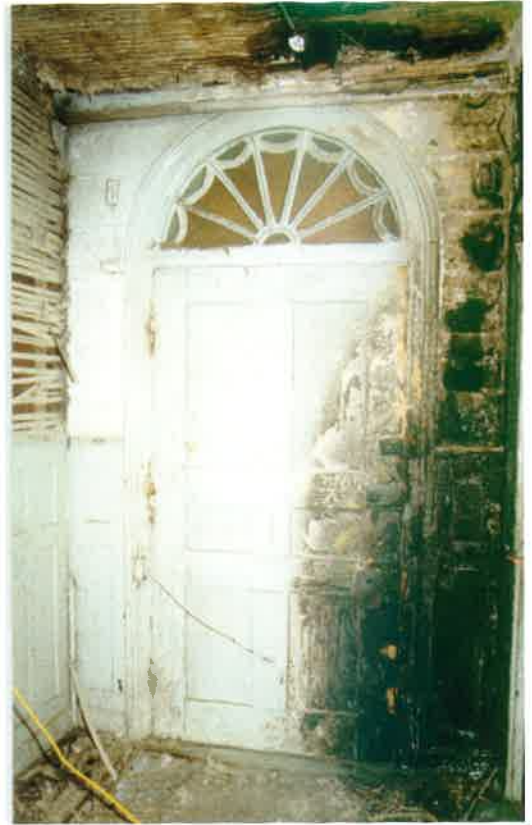
4

- 2.3.2 The architectural detailing of the building is also of considerable interest denoting the high status of the cavalry officers. Externally this is reflected in the fanlights above each of the doors and in the pediment above the central third of the building. It is interesting to note the subtle differences in the fanlight above the central doorway and those to each side (pls. 4-5).

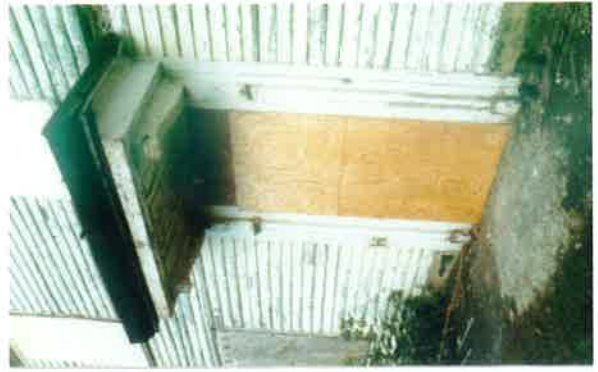
11

- 2.1.6 The building is divided into three sections, each one with a front door with bracketed doorcase (pl. 11) (doorcase to north lost) leading into an entrance

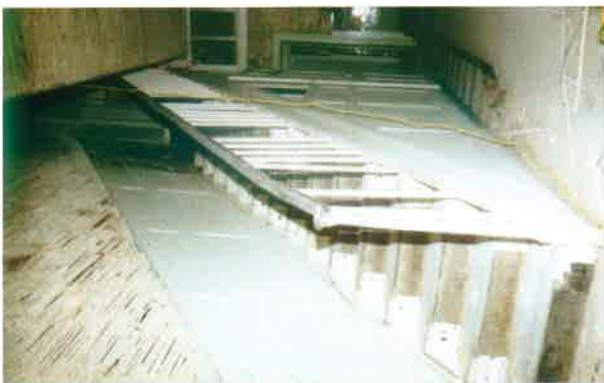
6

- 2.3.4 The central staircase is of particular interest (pl. 6), rising two storeys with very slender newel posts and hand rail strongly appearing to be primary. The northern staircase, rising a single storey, has similarly slender detailing (pl. 7) although it has lost its button-head to the ground floor newel post. In contrast the detailing to the southern staircase is more solid in form (pl. 8) and this, together with its generally better condition than the other staircases suggest that it was inserted in the latter part of the nineteenth century. Each of the staircases have lost some of their square-section balusters.

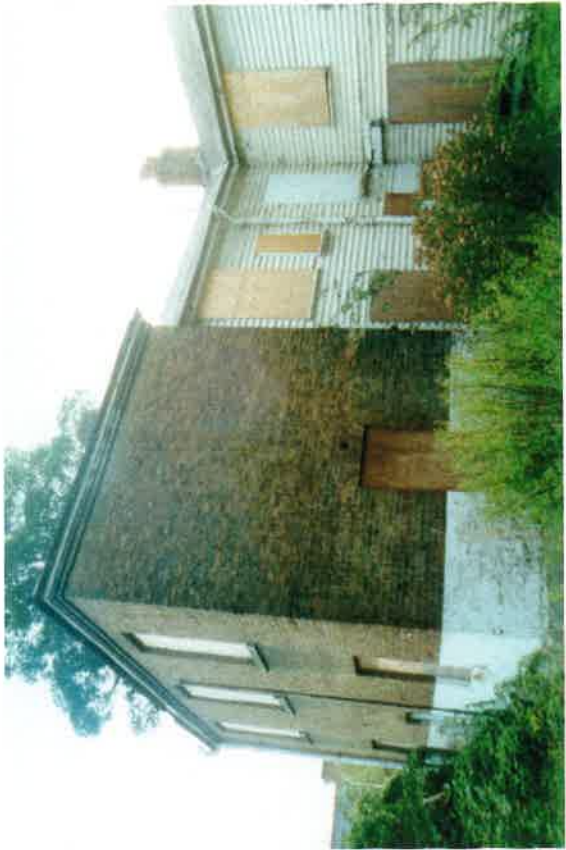
13 15

- 2.1.4 The secondary projection extending the southernmost wing (pl. 15) is two storeys tall and is constructed in a light brown stock brick with a slate-covered hipped roof. The window openings have gauged brick heads which match those to the single storey extension to the northernmost wing, also of a similarly coloured stock brick.

- 2.2.3 The two outer brick projections to the other two wings are secondary. The eastern end of the primary section of the southernmost wing is of a brick different to (and abutting) the adjacent extension, thus confirming that this must have been secondary. The similarly constructed, single storey extension to the northern wing is shown to be secondary by the fact that it abuts the formerly external weatherboarding on the eastern end of the primary wing. These extensions are not however substantially later than the primary building and probably date to the early-nineteenth century. The button-headed newel post and swan-necked handrail of the staircase within the southern wing (pl. 10), together with the gauged brick-headed window opening to both wings are suggestive of the first half of the nineteenth century.

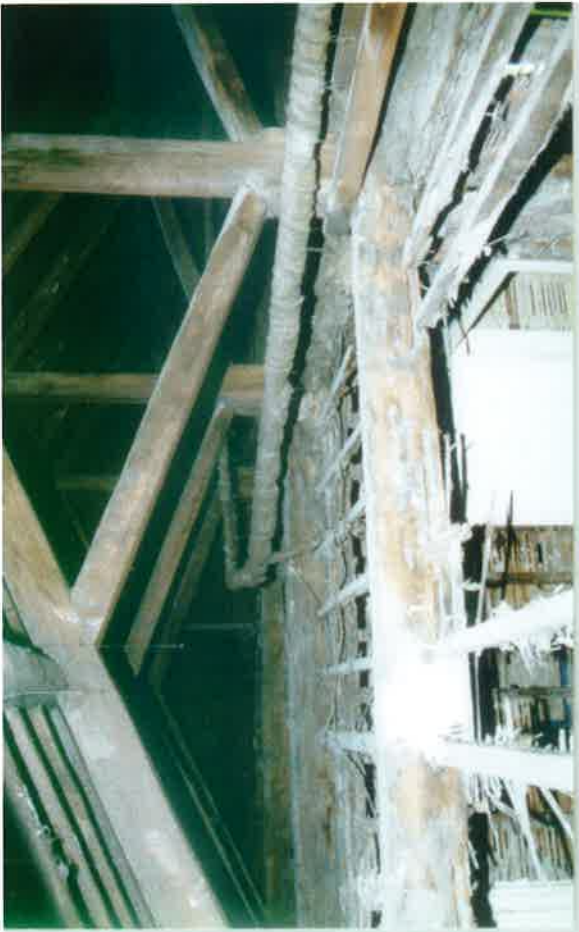
12 14

- 2.1.3 The hipped roof is slate-covered and is supported by king-post trusses (pl. 12). There are four trusses above the main two-storey sections of the building with a further similar truss above the main primary eastern projections. The roof structure above the three-storey central section consists of two king-post trusses orientated north-south and a single truss orientated east-west.

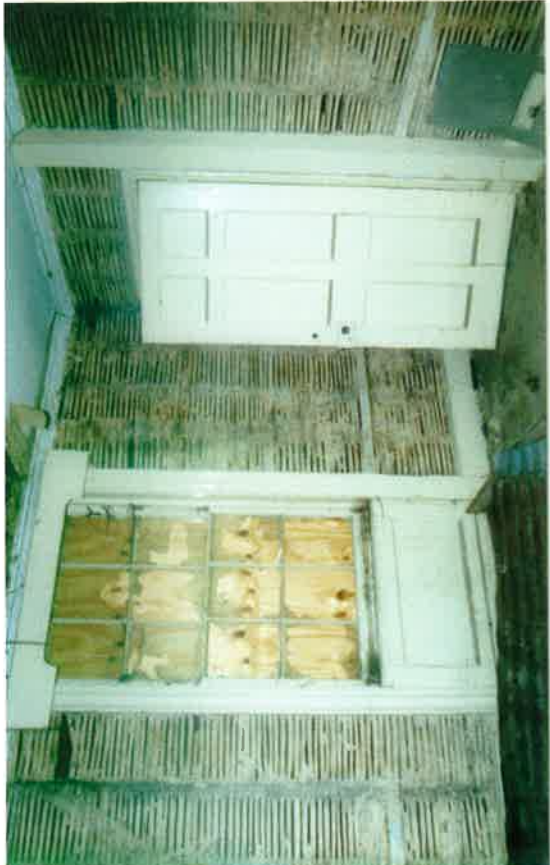
- 2.1.5 There are three main sorts of windows within the building. The predominant sort is the 12-light sash (pl. 14), in both the primary building and in both of the main secondary brick projections. There is a wide variety of subtle differences in the ovolo-section glazing bars suggesting that many have been replaced at different stages, largely in the nineteenth century. Some glazing bars and entire sashes are clearly secondary, probably having been inserted in the early twentieth century. The other main window type is the large-paned 4-light sash, with ovolo glazing bars, probably of mid-late nineteenth century date. All the windows to the north elevation of the building are of this type along with about half the window to the front (west) elevation. All the windows to the second floor are the third type of window: the 6-light sash.
