**SALTER'S BOATYARD, FOLLY BRIDGE
ABINGDON ROAD, OXFORD**

ARCHAEOLOGICAL INVESTIGATIONS DURING DEVELOPMENT

OXFORD ARCHAEOLOGICAL UNIT
DECEMBER 1999

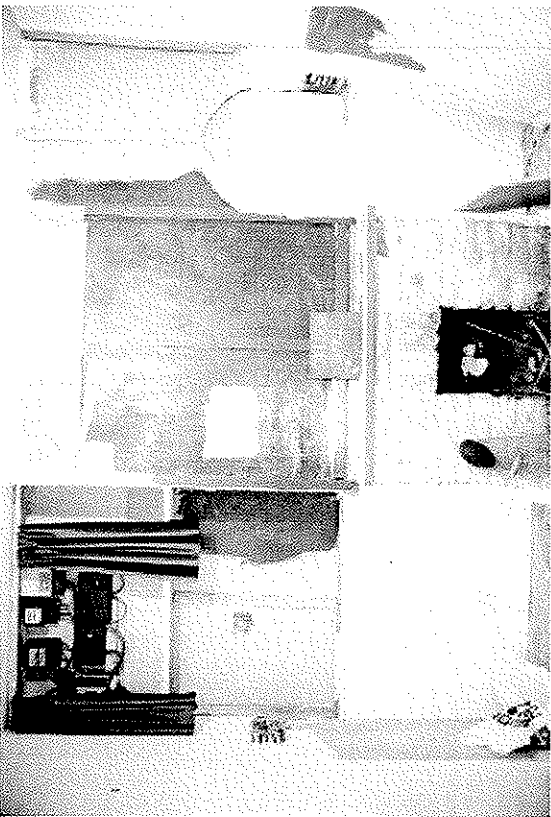
Plate A4: GFR1 – West Wall

2.2.3.1 The ground floor had two rooms. GFR1 (Openings 24 - 32) had recently been in use as a living room (Plate A4). The *west wall* was the limestone rubble wall, as seen from the exterior. Its eastern surface viewed via openings 20 and 28 was weathered demonstrating its previous function as an exterior boundary wall. The wall had been refaced twice with grey plaster board and subsequently modern sterling board. The fireplace was a modern replacement presumably built in the original location of a hearth. The red brick chimney stack had been disguised by modern boxing and coving. Dimensions of the bricks were investigated in every room in the building (Openings 8, 11, 21 and 27) and were of a consistent type throughout measuring 22.5 x 7 x 11 cm. The lime mortar binding the bricks was also similar throughout being light beige in colour with inclusions of grit.

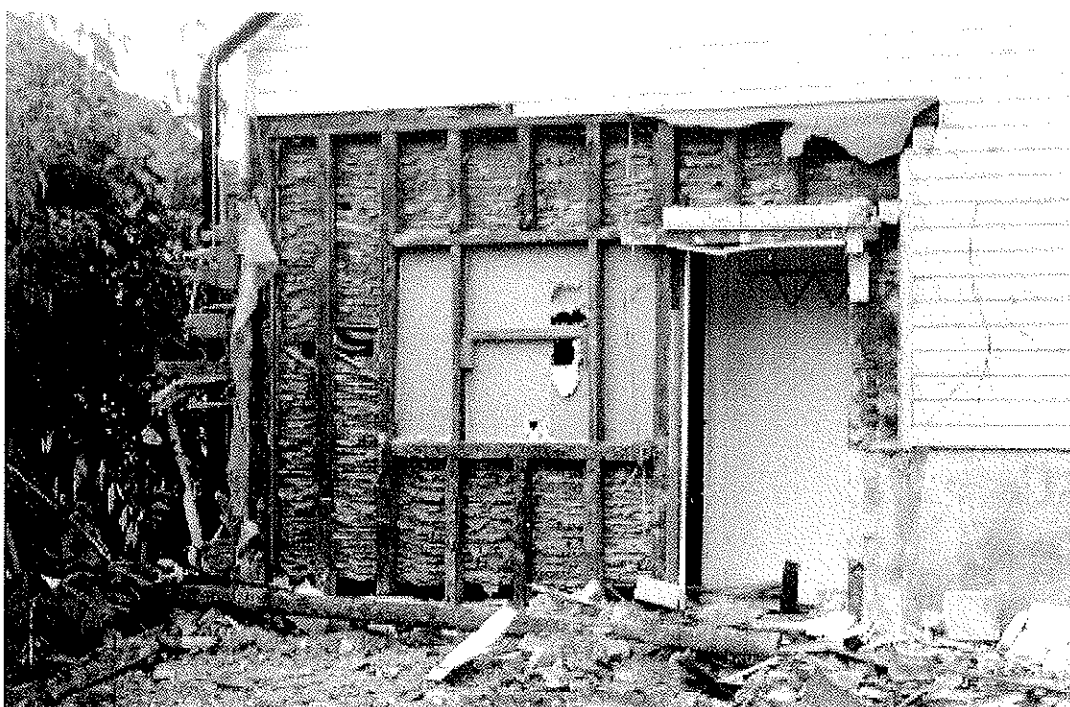
Plate A8: East elevation: Timber framing exposed during demolition, note original window and door openings

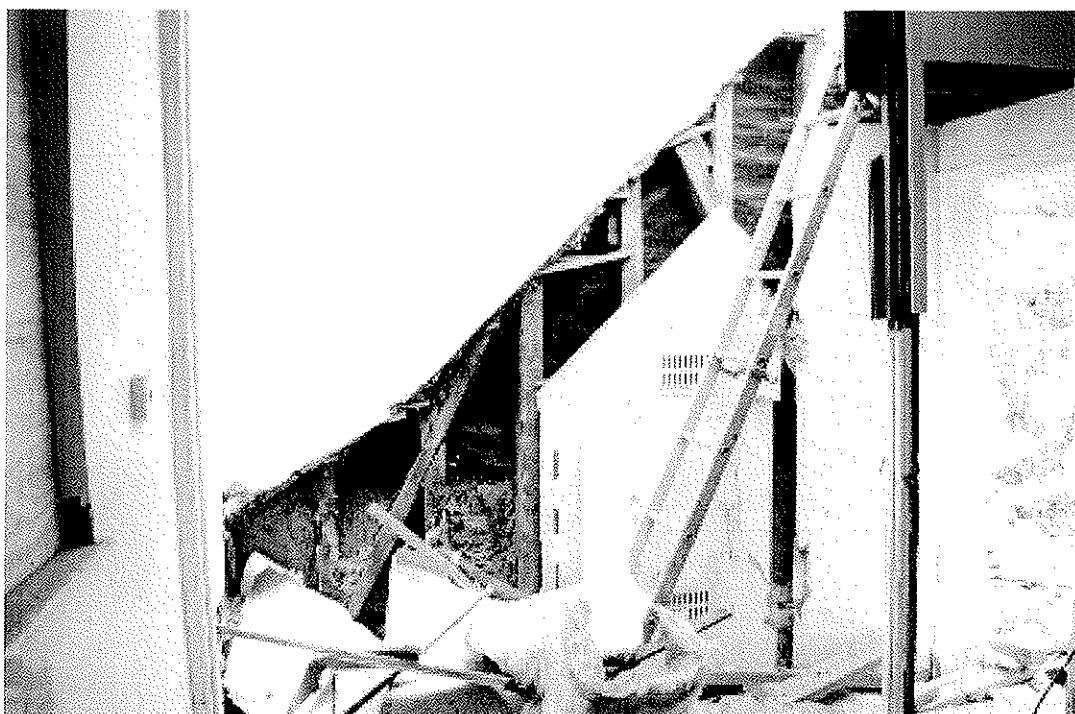
Plate A9: East wall – north end, internal view following the removal of the stairs, timber framing with diagonal bracing exposed

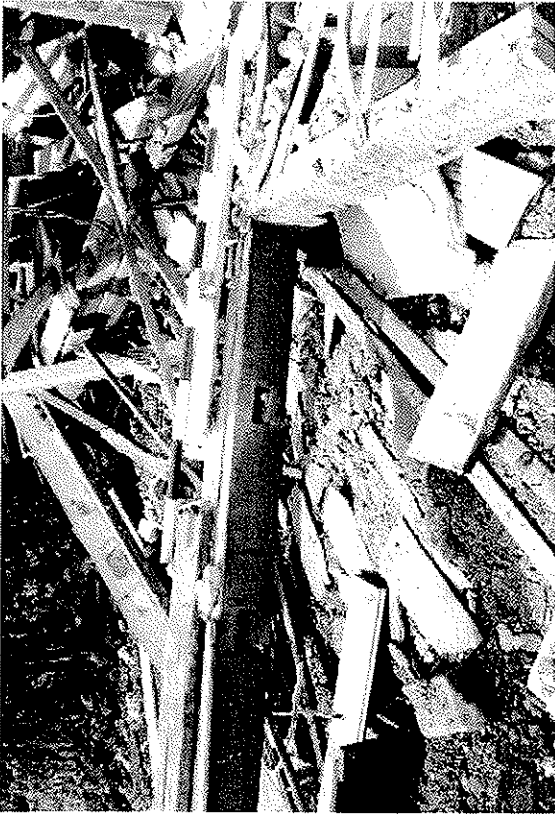
After total demolition of the building the softwood framed panels of the building were observed on the ground (Plates A10-12). The wall plate of the frame was 9 x 9cm and had a lapped joint at either end, 11 x 4cm. The joint was secured with nails. The jointing technique between studs and wall plate and cross rail was seen to be a shallow mortice and tenon joint. The tenon of the studs measured 5.5 x 1.5cm and was flush to one face of the stud, rather than being central. The diagonal braces and the studs were nailed together, although a similar shallow mortice and tenon joint seems likely. The struts were framed into the diagonal timbers. Generally throughout the constructional timbers some evidence for reuse was seen in the form of additional peg holes and occasional mortice holes which were not necessary in the construction of the building. A scrap of 19th-century wall paper was removed from the first floor debris. It is of a vertically banded design with columns of pink roses and a trellis work of leafed foliage in greens and greys and is block printed.

Plate A:10: Mortise holes of timber framing after demolition

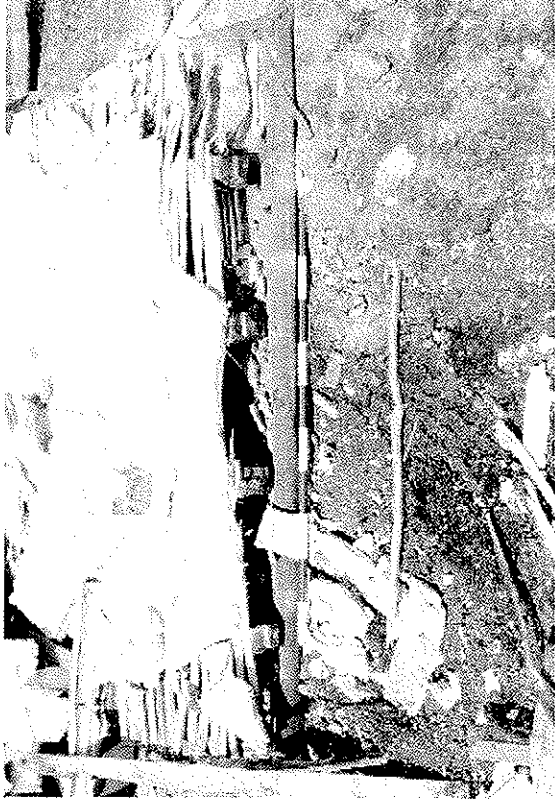
Plate A:11: Tenons of timber framing after demolition

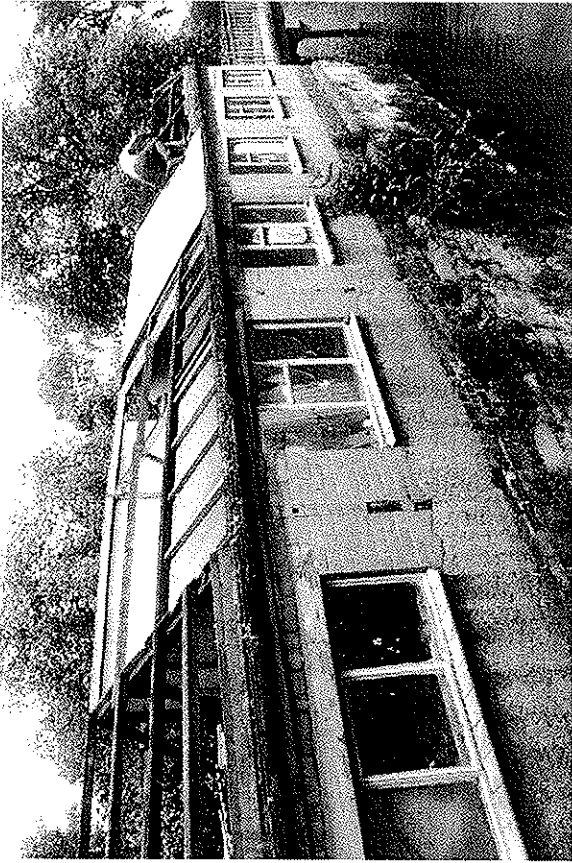
Plate B1: Building B/1.1-1.2 from the south-west showing primary roof structure and timber posts set into secondary beton-pisé and concrete brick walls. Note historic stone walling of wharf side beneath.

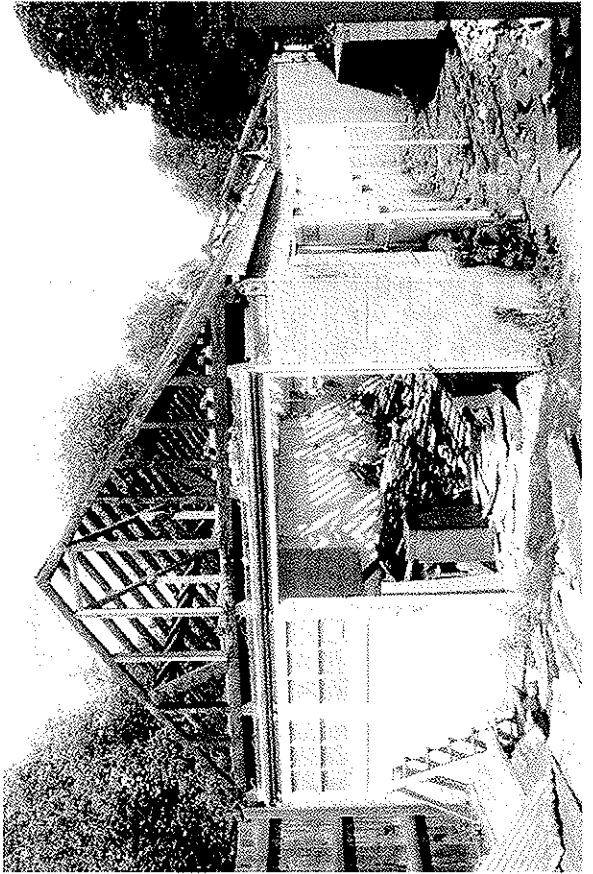
Plate B2: Interior of building B/1.1-1.2 from the west showing primary roof structure and timber post set into walls. Note hardwood off-cuts from machine sawing operations.

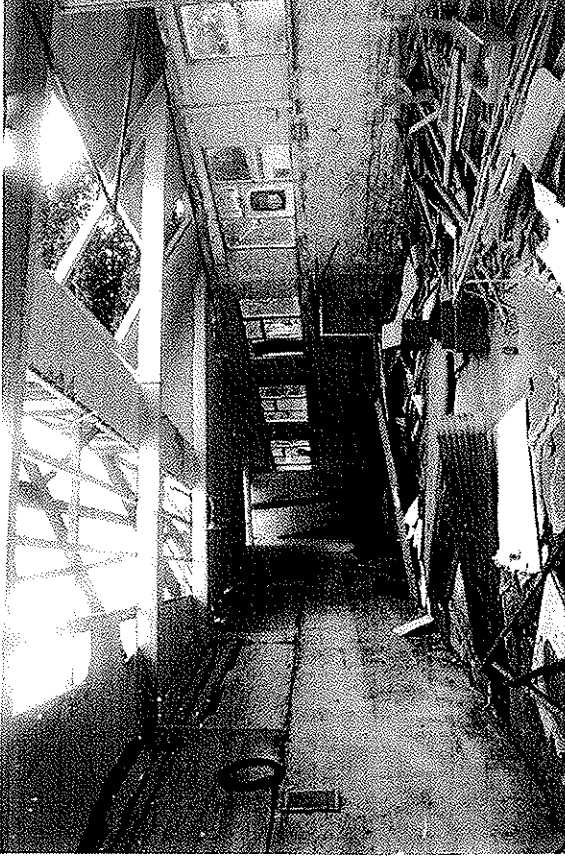
Plate B4: Building B/1.3. Interior detail showing underside of primary northern wall plate with typical mortice showing site of former wall stud.

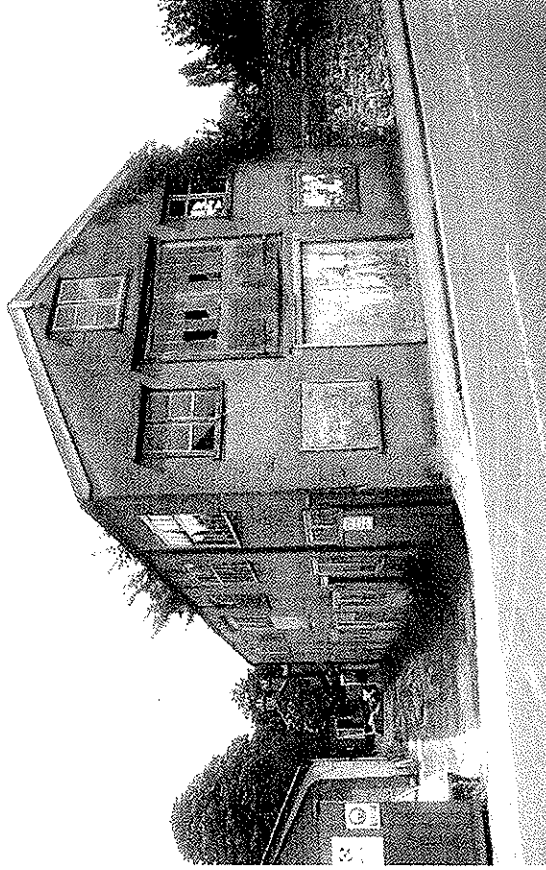
Plate C1: Building C/1.1-1.2 from the north-west. Note taking-in doors on both storeys an north and west elevations.

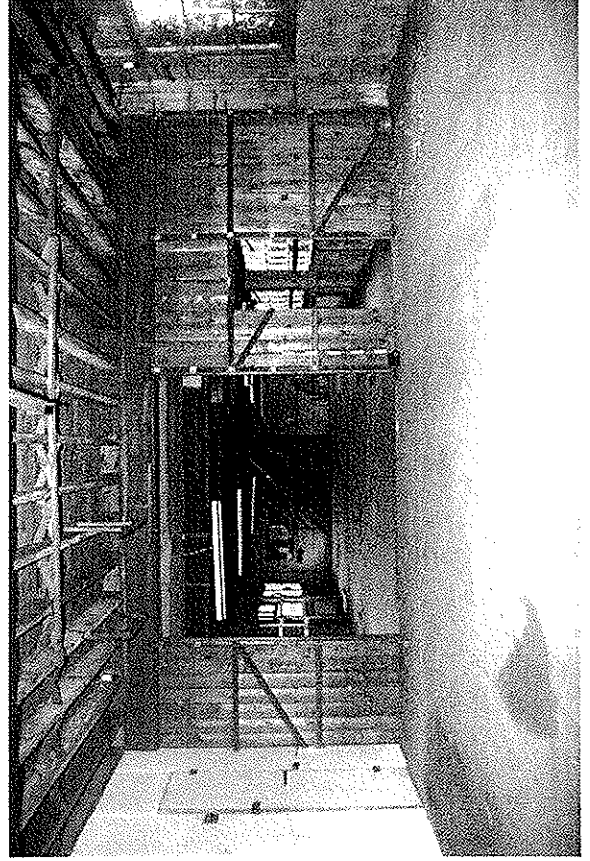
Plate C3: Building C/1.1-1.2. Ground floor from the west showing raised floor of C/1.1 in foreground. Room C1.2 visible beyond. The large square hole cut from the studded and boarded wall is not a historic feature but was cut out shortly before survey.

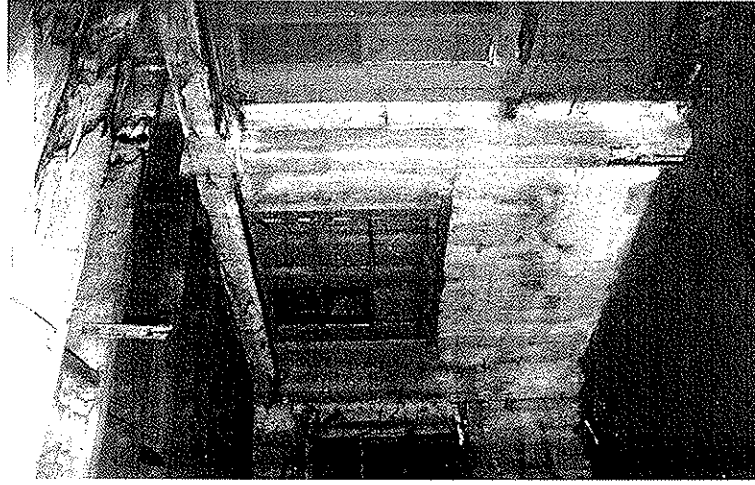
Plate C8: Building C/1.4. Detail showing former east gable from the north-east. This early wall clearly pre-dates the collapsed adjacent building D (on left).

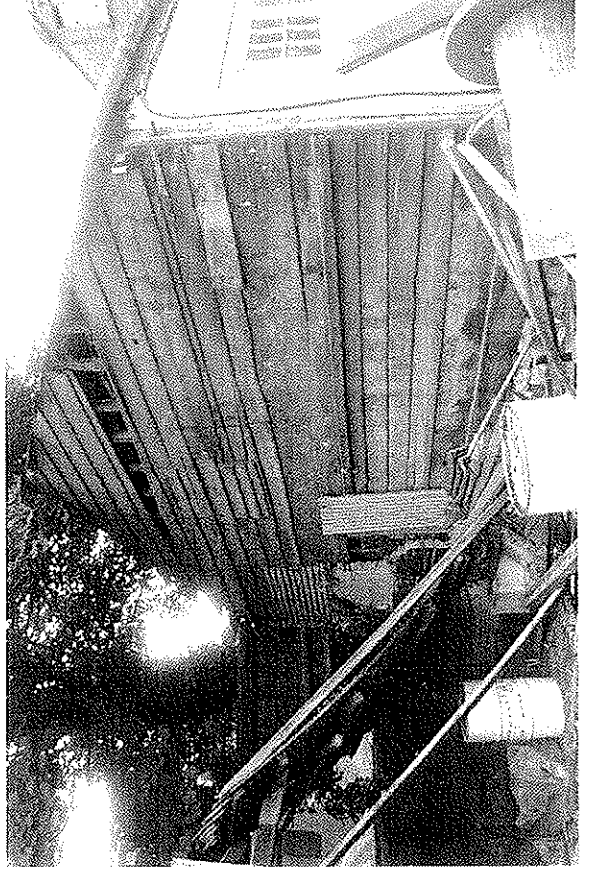
2.6.1 Abutting the eastern end of building C/1.4 was a partially collapsed four bay open-fronted shed with a slate roof, hipped at the east end (Plate D1). The roof profile and construction of this building were very nearly identical to that noted in building C/1.4 that it is presumed that these

Plate D1: Building D from the north-west showing the collapsed state of this former mid 19th-century open-fronted timber storage shed at the time of survey

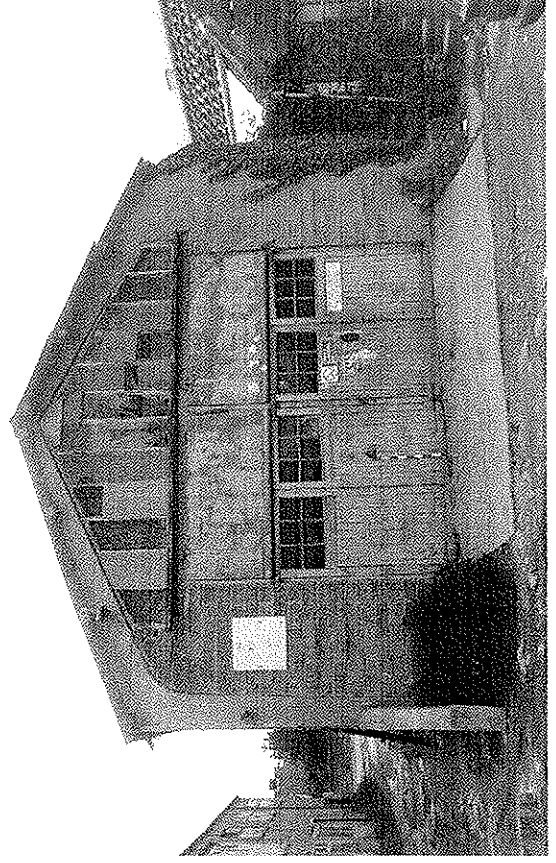
Plate F1: Building F from the south-west showing the truncated roof and cast in-situ concrete north wall.

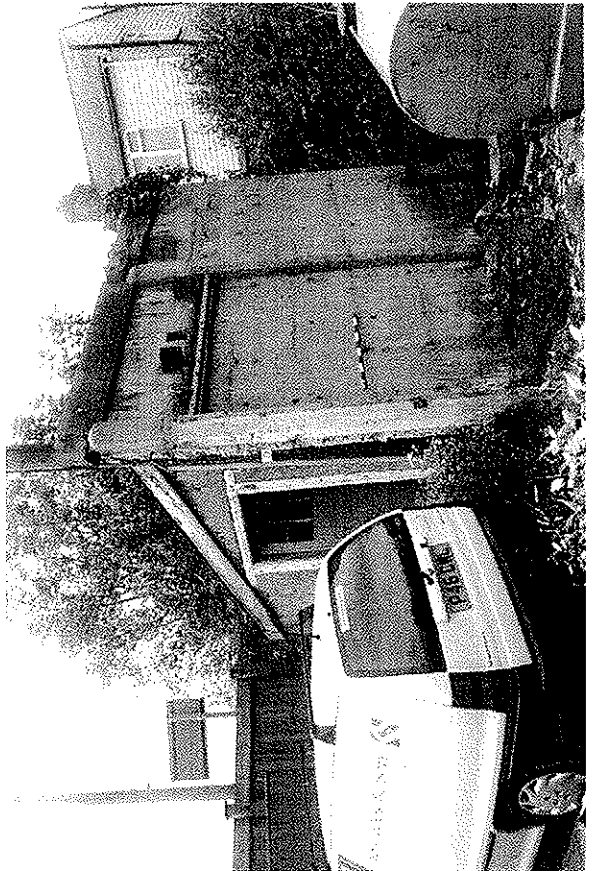
This wall, which formed the northern boundary between the development site and the towpath, from Folly Bridge to building B/1.3, was constructed of cast *in-situ* concrete posts and panels (Plate 2.1). Cast-in softwood spacer blocks were noted, identical with those noted in the walls of buildings C/1.1-1.2 and the small remaining stub of a building adjacent to bridge L. This wall was doubtless built during the same phase as these structures.

Plate 2.1: Northern boundary wall (other features 2) showing cast-in-situ concrete construction matching other structures on site.

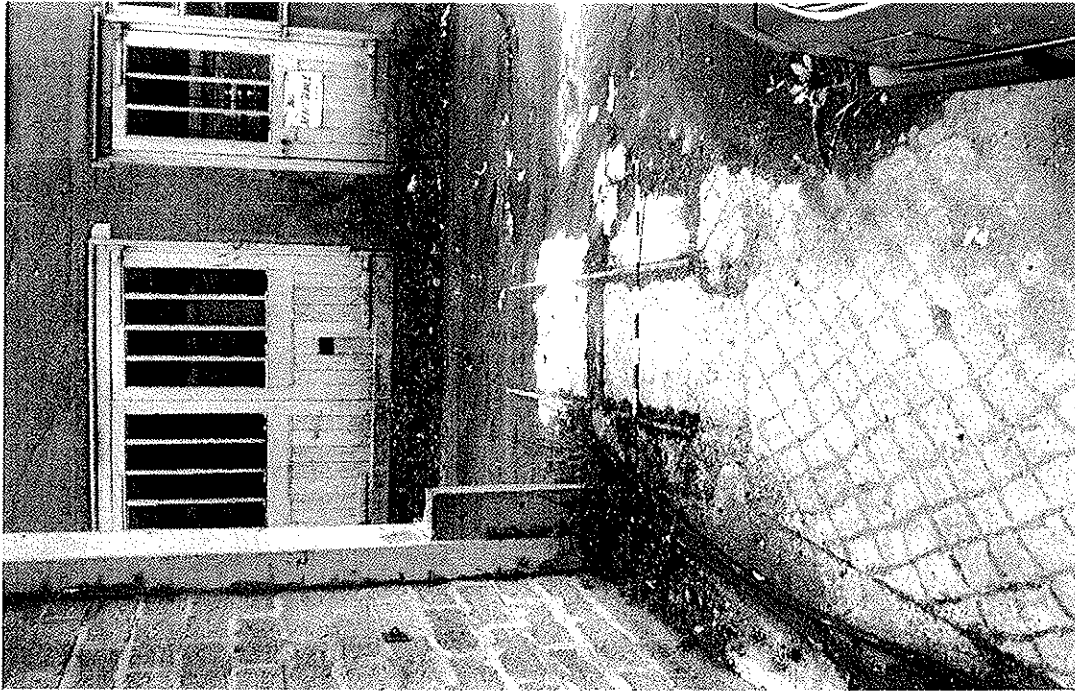
Plate 3.3: The length of embedded railway track adjacent to the west end of building E. It seems probable that this was used for transporting very heavy objects (possibly un-sawn logs) into the lost building of which feature 3 was the only remaining part.

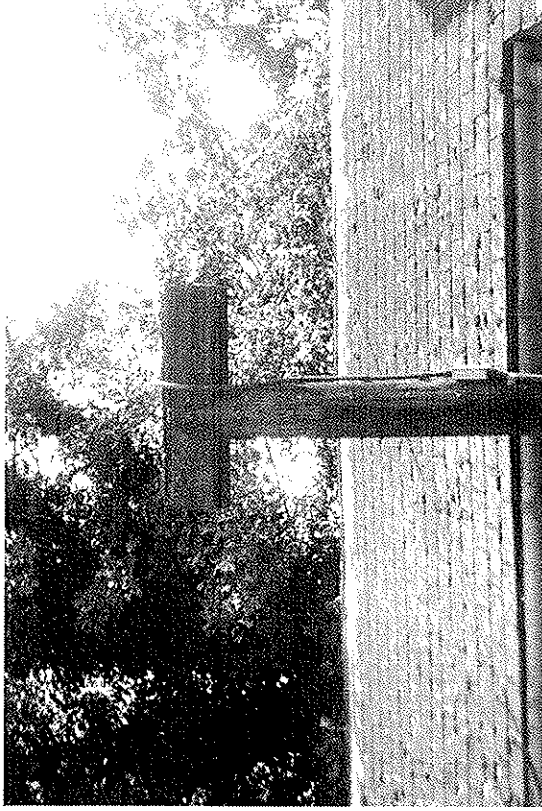
Plate 4.1: Post by building C (other features 4) interpreted as a former support for an elevated mobile gantry crane. Such a structure, if correctly interpreted, would indicate that the site was equipped for moving substantial objects, most probably heavy baulks of sawn or un-sawn timber.

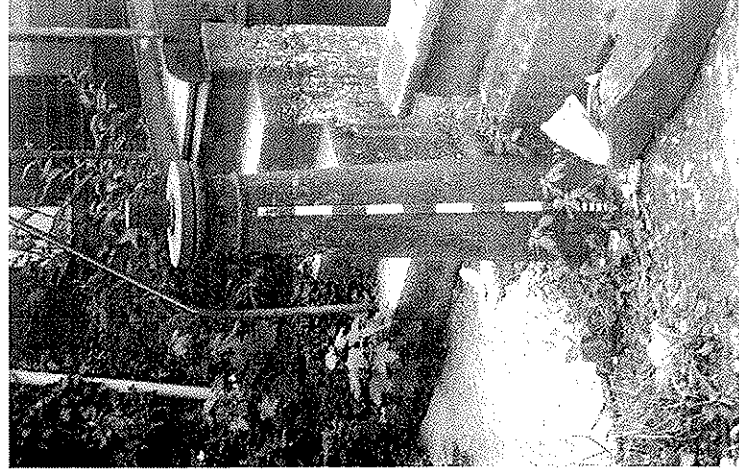
An attractive iron casting resembling a decorative bollard with a spigot projecting from its flat top remained in-situ adjacent to the channel dividing the north and south islands (Plate 5.1). This was clearly the base of a crane noted on the maps from 1844 to 1939.

Plate 5.1: Cast-iron crane base adjacent to bridge K (other features 5). This was clearly the base of a crane noted on the maps from 1844 to 1939.

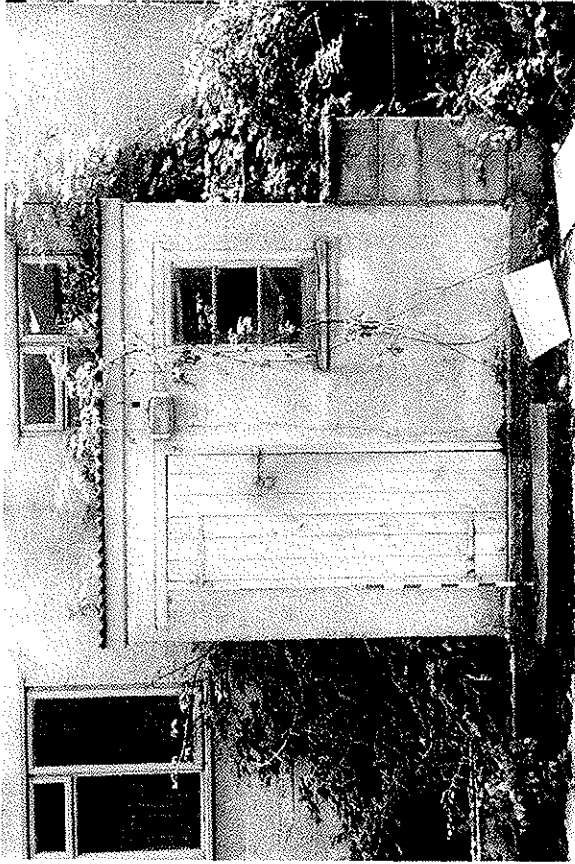
Plate 6.1: Flat-roofed store adjacent to workshop G (other features 6) This small building was also of cast *in-situ* concrete constructio. It was located facing onto the inlet dividing the north and south islands and appeared to have been associated with pumps for refuelling boats.

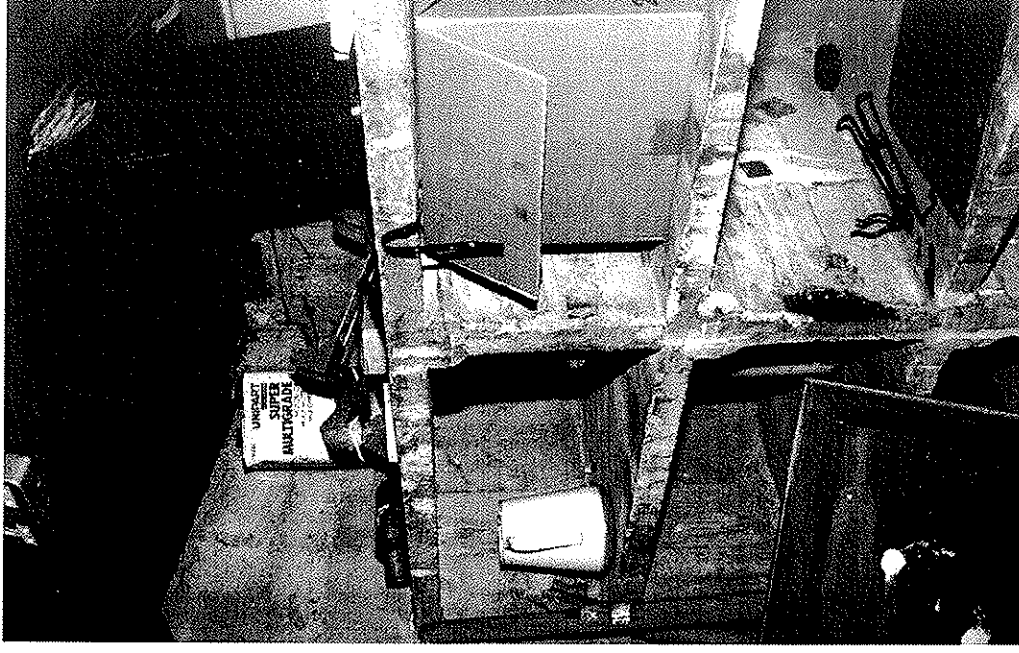
Plate 6.2: Interior detail of the flat roofed store showing cast *in-situ* concrete shelves.
