**Church of St Mary the Virgin
Long Crendon, Buckinghamshire**

NGR SP 697 091

Archaeological Watching Brief Report

Oxford Archaeological Unit
April 2001

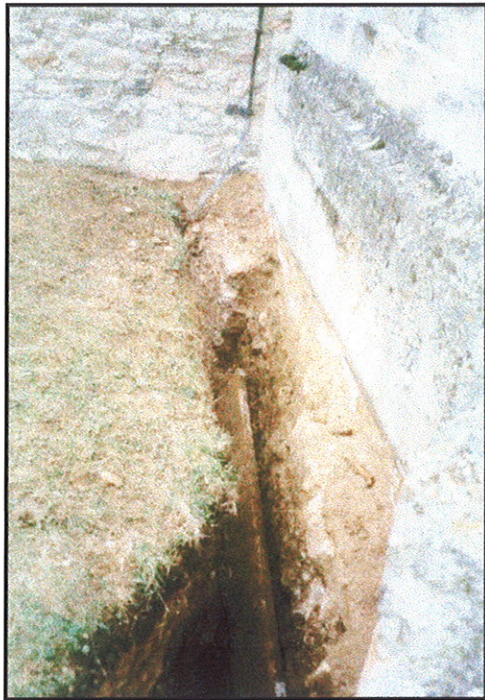
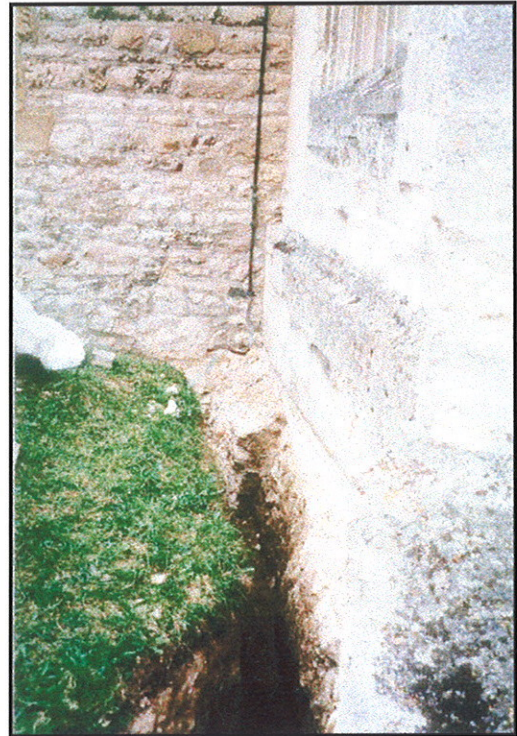
Aisle south wall: Irregular foundation offset, with one deeper patch, possibly over

old grave. In the aisle/transept corner is a deep foundation pier of chalk, brick and concrete, probably modern underpinning. (photos 1 & 2)

Photo 1 & 2: Foundations of the south aisle and south transept.

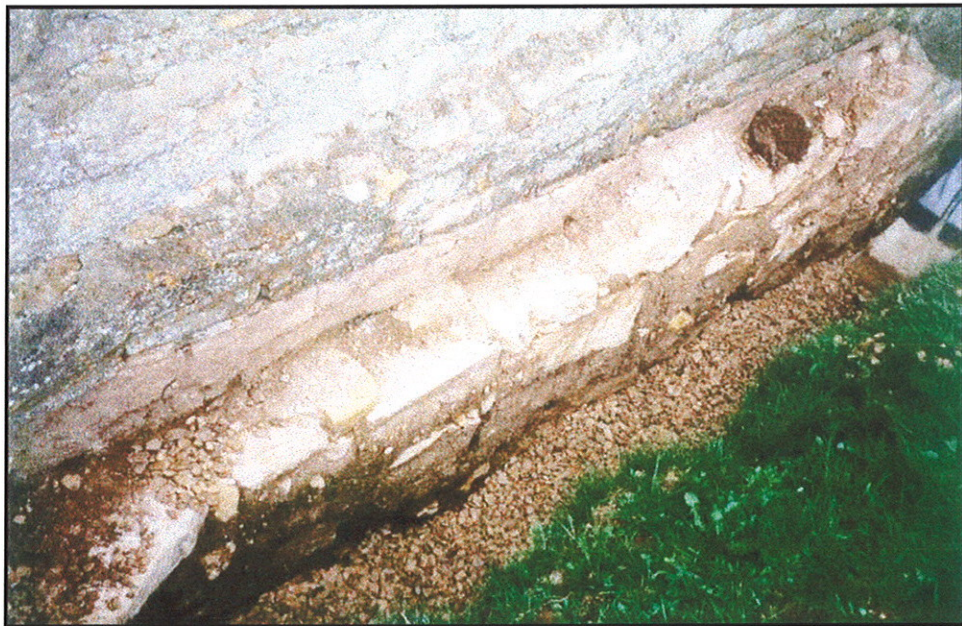
Porch west and east walls: A single stone offset foundation, covered (on west) with concrete/ brick/chalk from former drain. (photo 3)

Photo 3: West side of south porch.

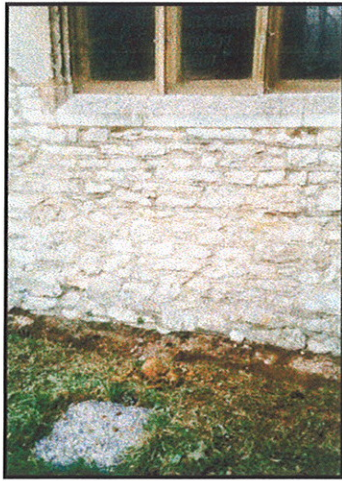
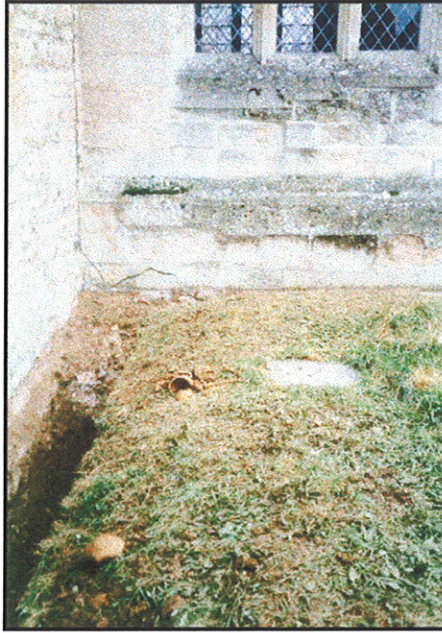
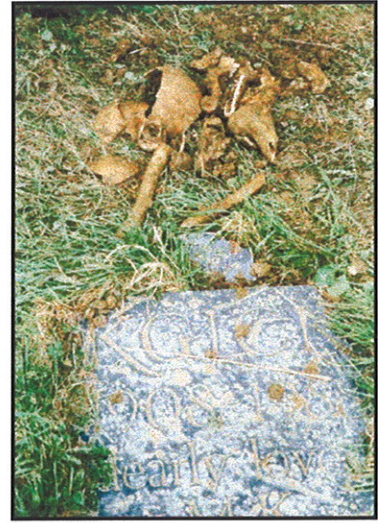
Fragmented skeletal material (charnel) was considerable. No complete skeletons were unearthed, although this may have been due in part to the method of digging with spades. Numerous long bones were brought to the surface as well as skull fragments. These were all bagged up for reinterment by Father Roger Jackson, and smaller fragments were left close to their original siting and covered in shingle when infilling for the new drains took place (Photo 7). The soil below the modern engraved dormer window in the south aisle produced skull and bone fragments close to a ground level marked grave (Photos 4,5,6).

Photo 4, 5 & 6: Skull and bone fragments found close to the dormer window in the south aisle.

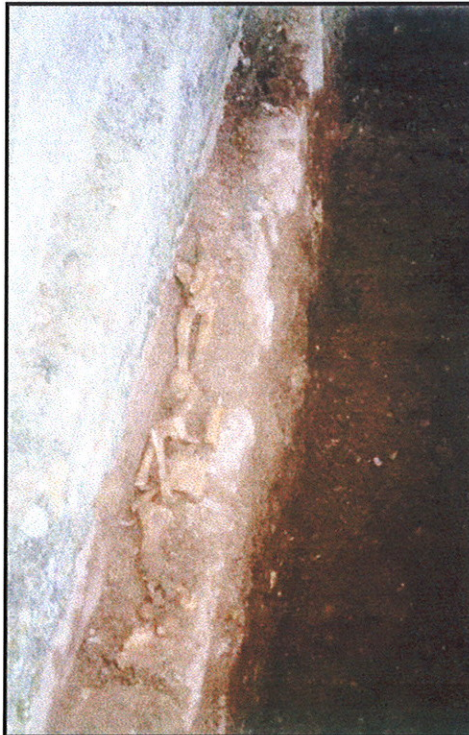
Chancel south wall: A neatly offset foundation of rubble blocks, getting larger towards the east. (photo 7)

Photo 7: Charnel fragments close to south wall of chancel.

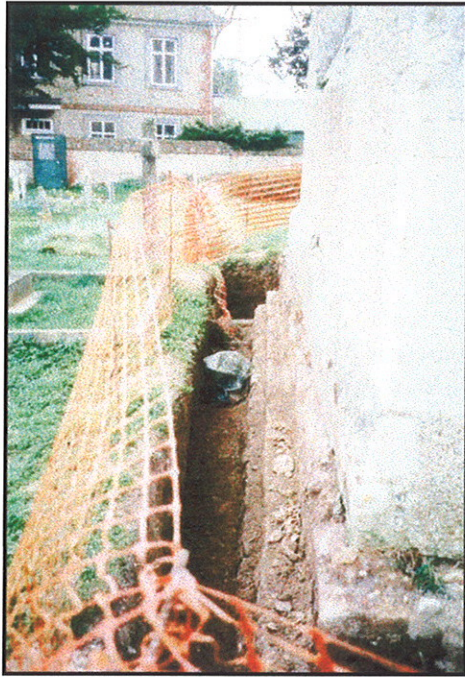
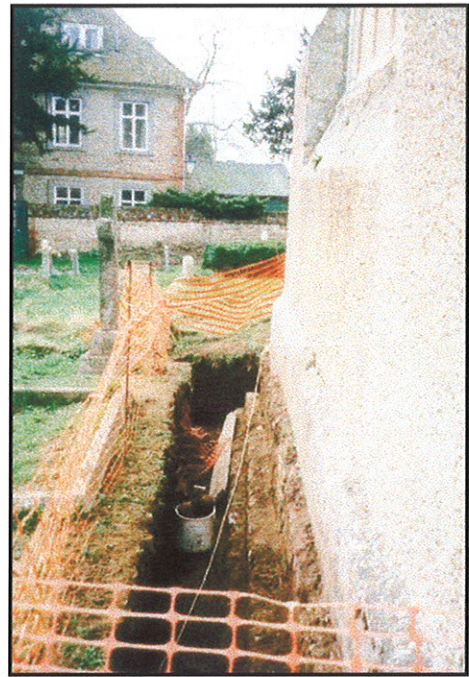
Following the digging of Test Pit 1, a stepped footing was unearthed (Photos 8-11) but it was not possible to dig further down than the prescribed 1 metre in order to investigate further.

Chancel east wall: Similar to south wall, but with two offsets, and with large ashlar blocks at the corners. (photos 8-12)

Photo 8 & 9: Foundations of the chancel east end, facing south.

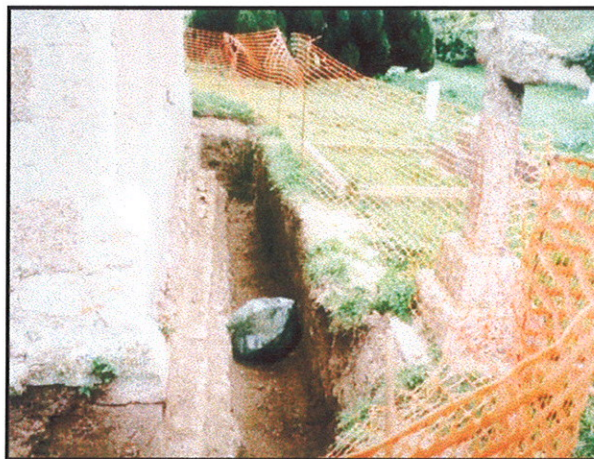
Photo 10: Foundations of the chancel east end, facing north.

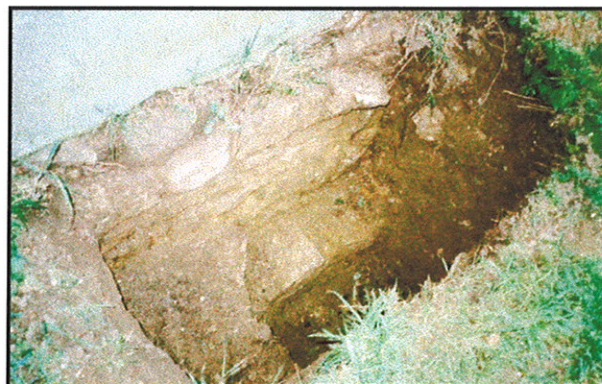
Photo 11: Foundations exposed to the rear of the chancel.

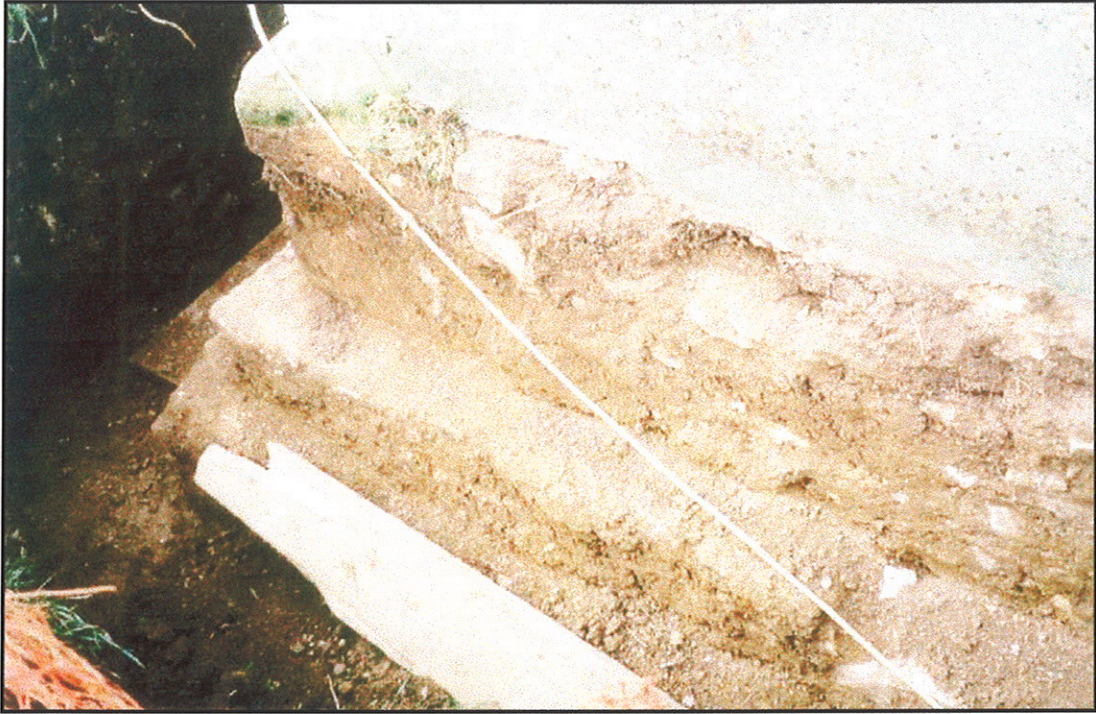
Photo 12: South end of east wall of chancel.

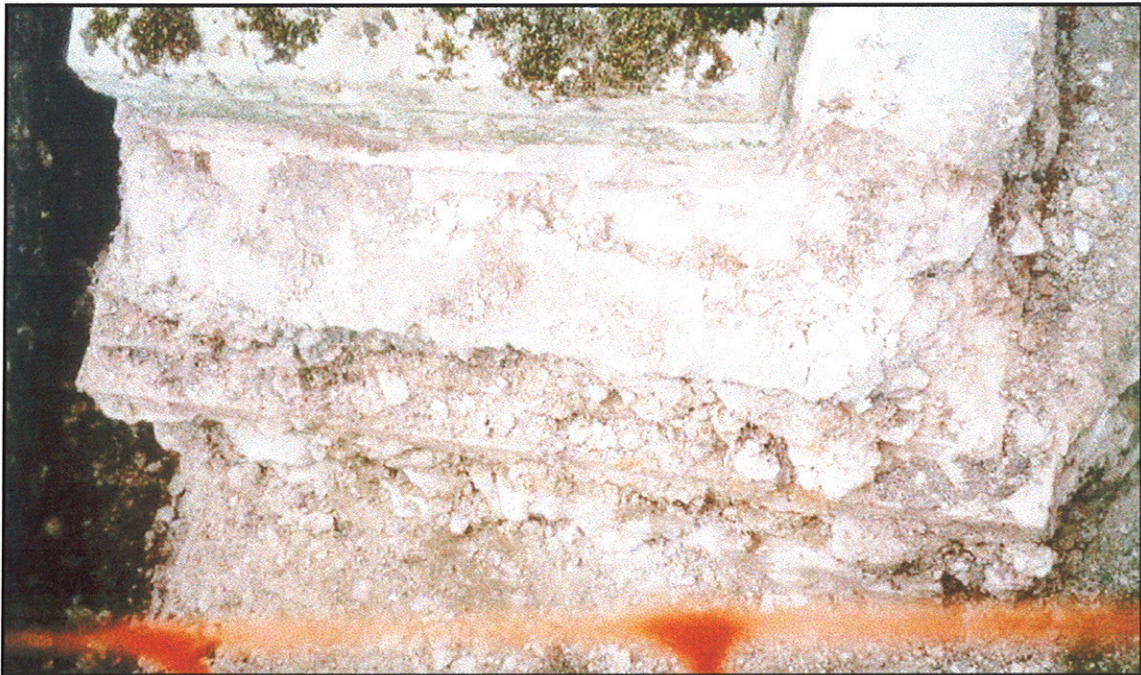
Transept north wall: Foundation rubble flush with wall (no offset); trench interrupted by 19th-century brick (double) vault in centre of wall. The north east corner buttress have large chalk/brick/mortar foundation, i.e. modern underpinning. (photos 12 & 13)

Photo 13: North east buttress of the north transept wall.

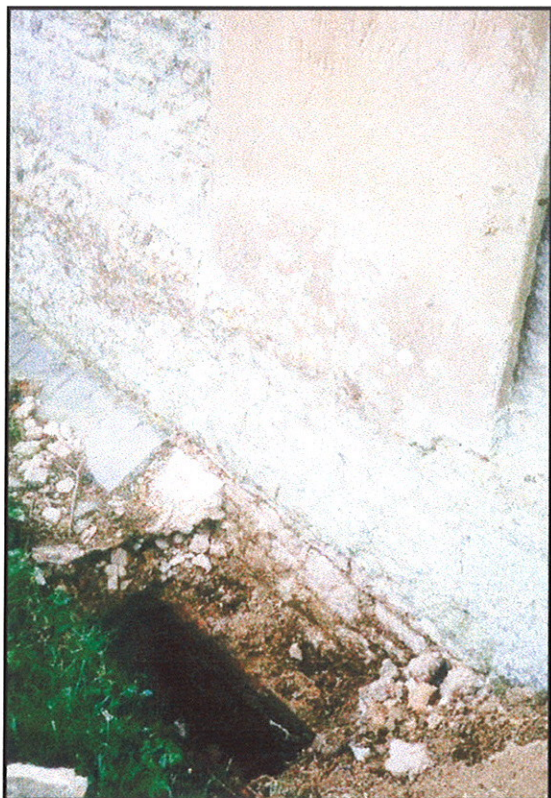
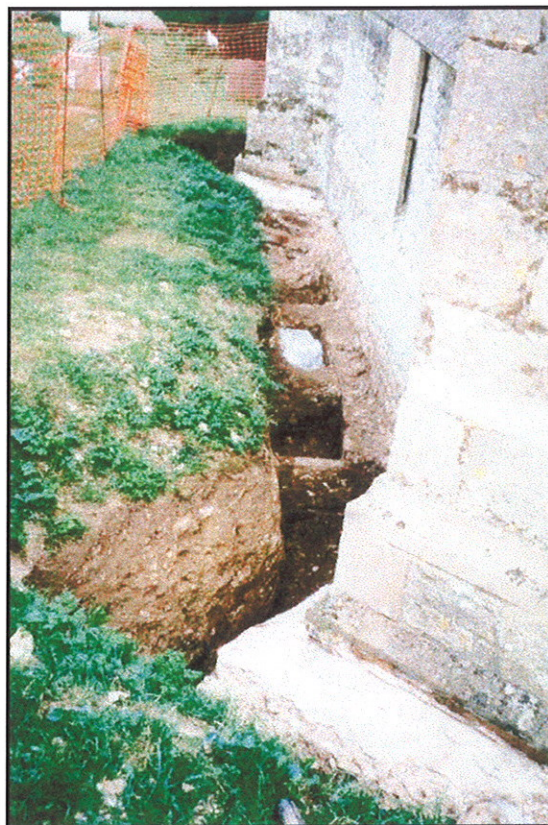
The soil directly beneath a badly weathered and indecipherable plaque set into the wall produced a coffin-shaped length of brickwork divided into sections (Photos 14,15,16) which was covered by a surface layer of mortar and limestone fragments. Time and resources did not permit deeper excavation of this pit, but it is interesting that it is on the outside wall corresponding to the 'possible' location of the grave of Valentine Bownds, mentioned above. No explanation is obvious as to any connection with the tomb recess under the north window of the north transept. Disturbance of this part of the site during the Victorian era or later is a possibility judging by the age of this brickwork. It was decided to leave this in position and route the new drain around it.

Photo 14 & 15: Foundations of north transept wall, revealing a brick burial vault.

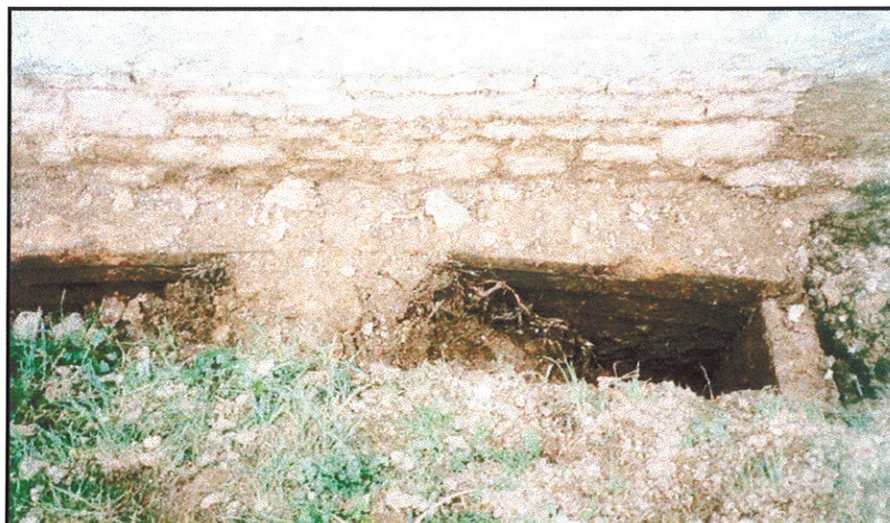
Photo 16: Detail of brick vault by north transept wall.
