## Croome Park Worcestershire

### Archaeological excavations and landscape assessment of Parkland Landscape features

**Oxford Archaeology**

14 December 2001

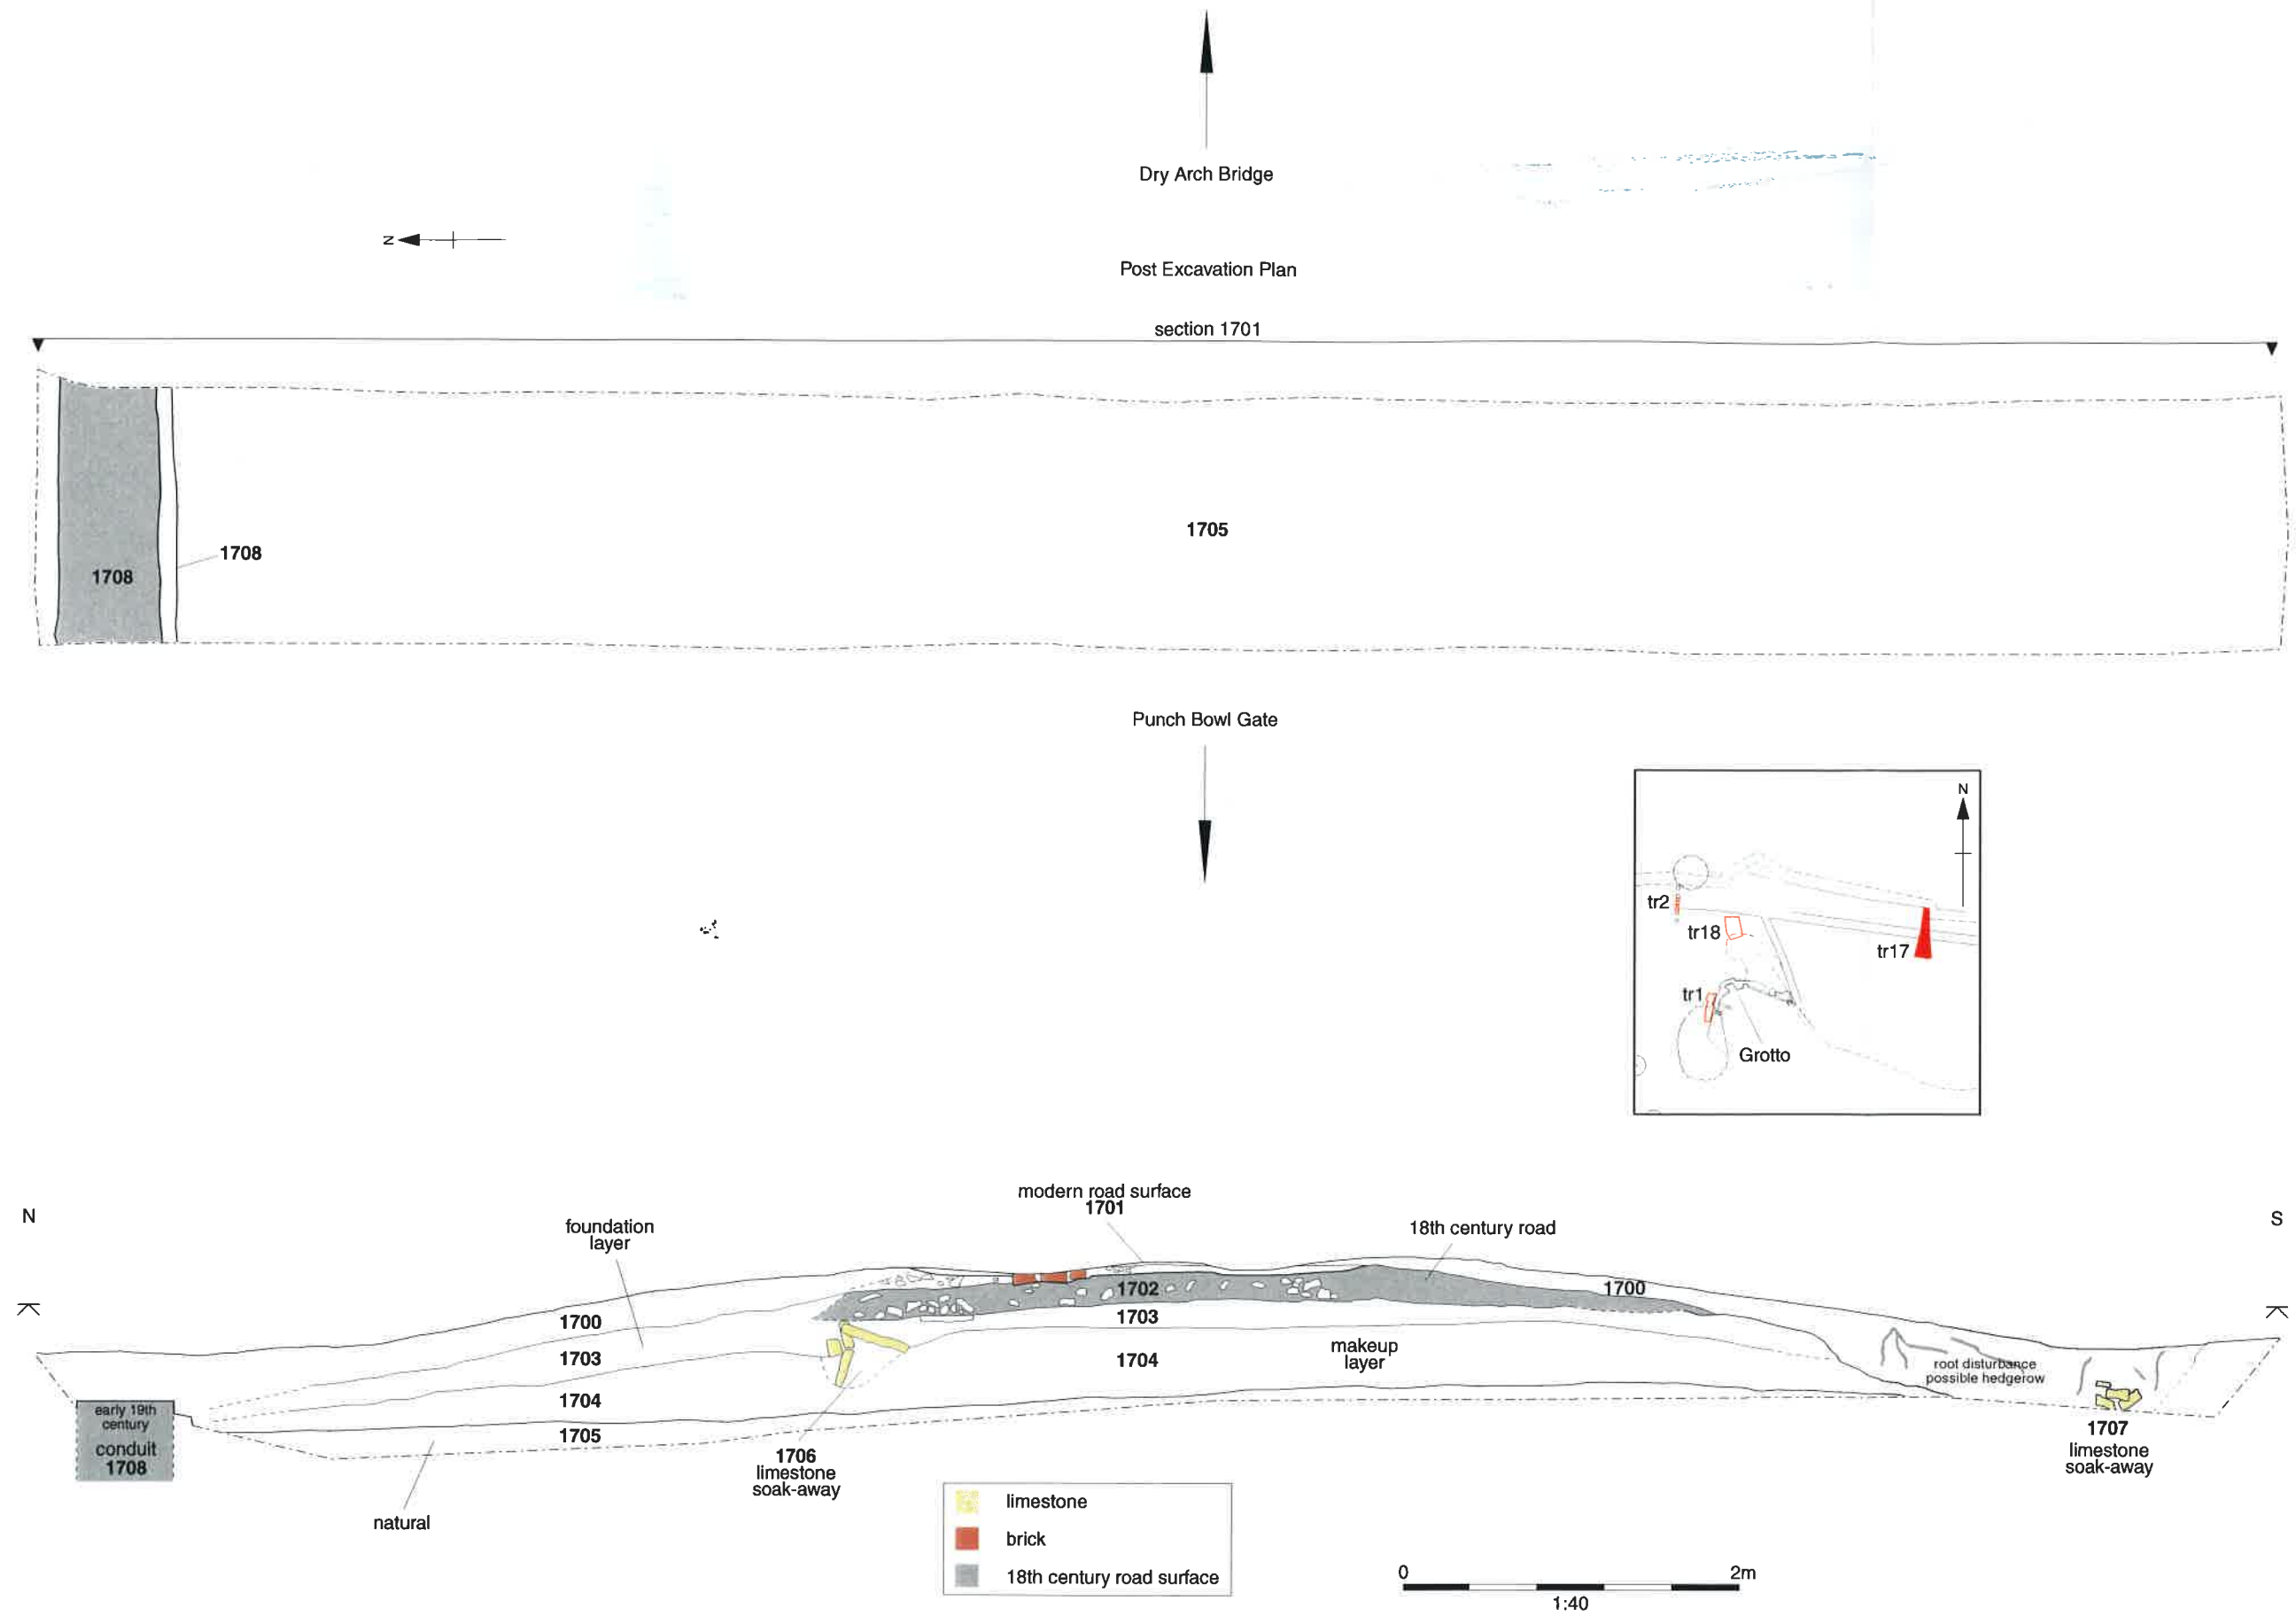
Figure 2: Trench 17 plan and section

- 2.1.2 Trench 17 is perhaps the most important of these five as it involved sectioning the carriageway to determine its construction, makeup and phasing. Figure 2 shows this section. As can be seen the construction of the carriageway (at this point along its length) is relatively simple. There are two substantial makeup layers (1704 and 1703) over which a relatively thin layer (1702) (c. 0.16m deep) of rounded pebbles has been constructed. These pebbles are the same as others found on pathways and roads encountered in other trenches (Trenches 2, 6, 7, 15 and 16).

- 2.1.3 The modern road surface, (1701, loose crushed limestone chippings) as with other trenches (Trenches 2, 15 and 16), has had a detrimental impact on the physical survival and character of the carriageway:

1. The current modern surface material on the carriageway should be removed and replaced with a historically valid material, in keeping with the material revealed during the excavations.
2. The edges of the carriageway should be explored by means of limited controlled excavation to determine the true extent of the kerb identified in Trench 16.
3. The results of the Recommendation 2 should be used to determine the nature of the edging for the carriageway utilised during its restoration.
4. No direct physical evidence was located for the hedging alongside the carriageway. It therefore felt unwise to plant a hedge without further investigation.

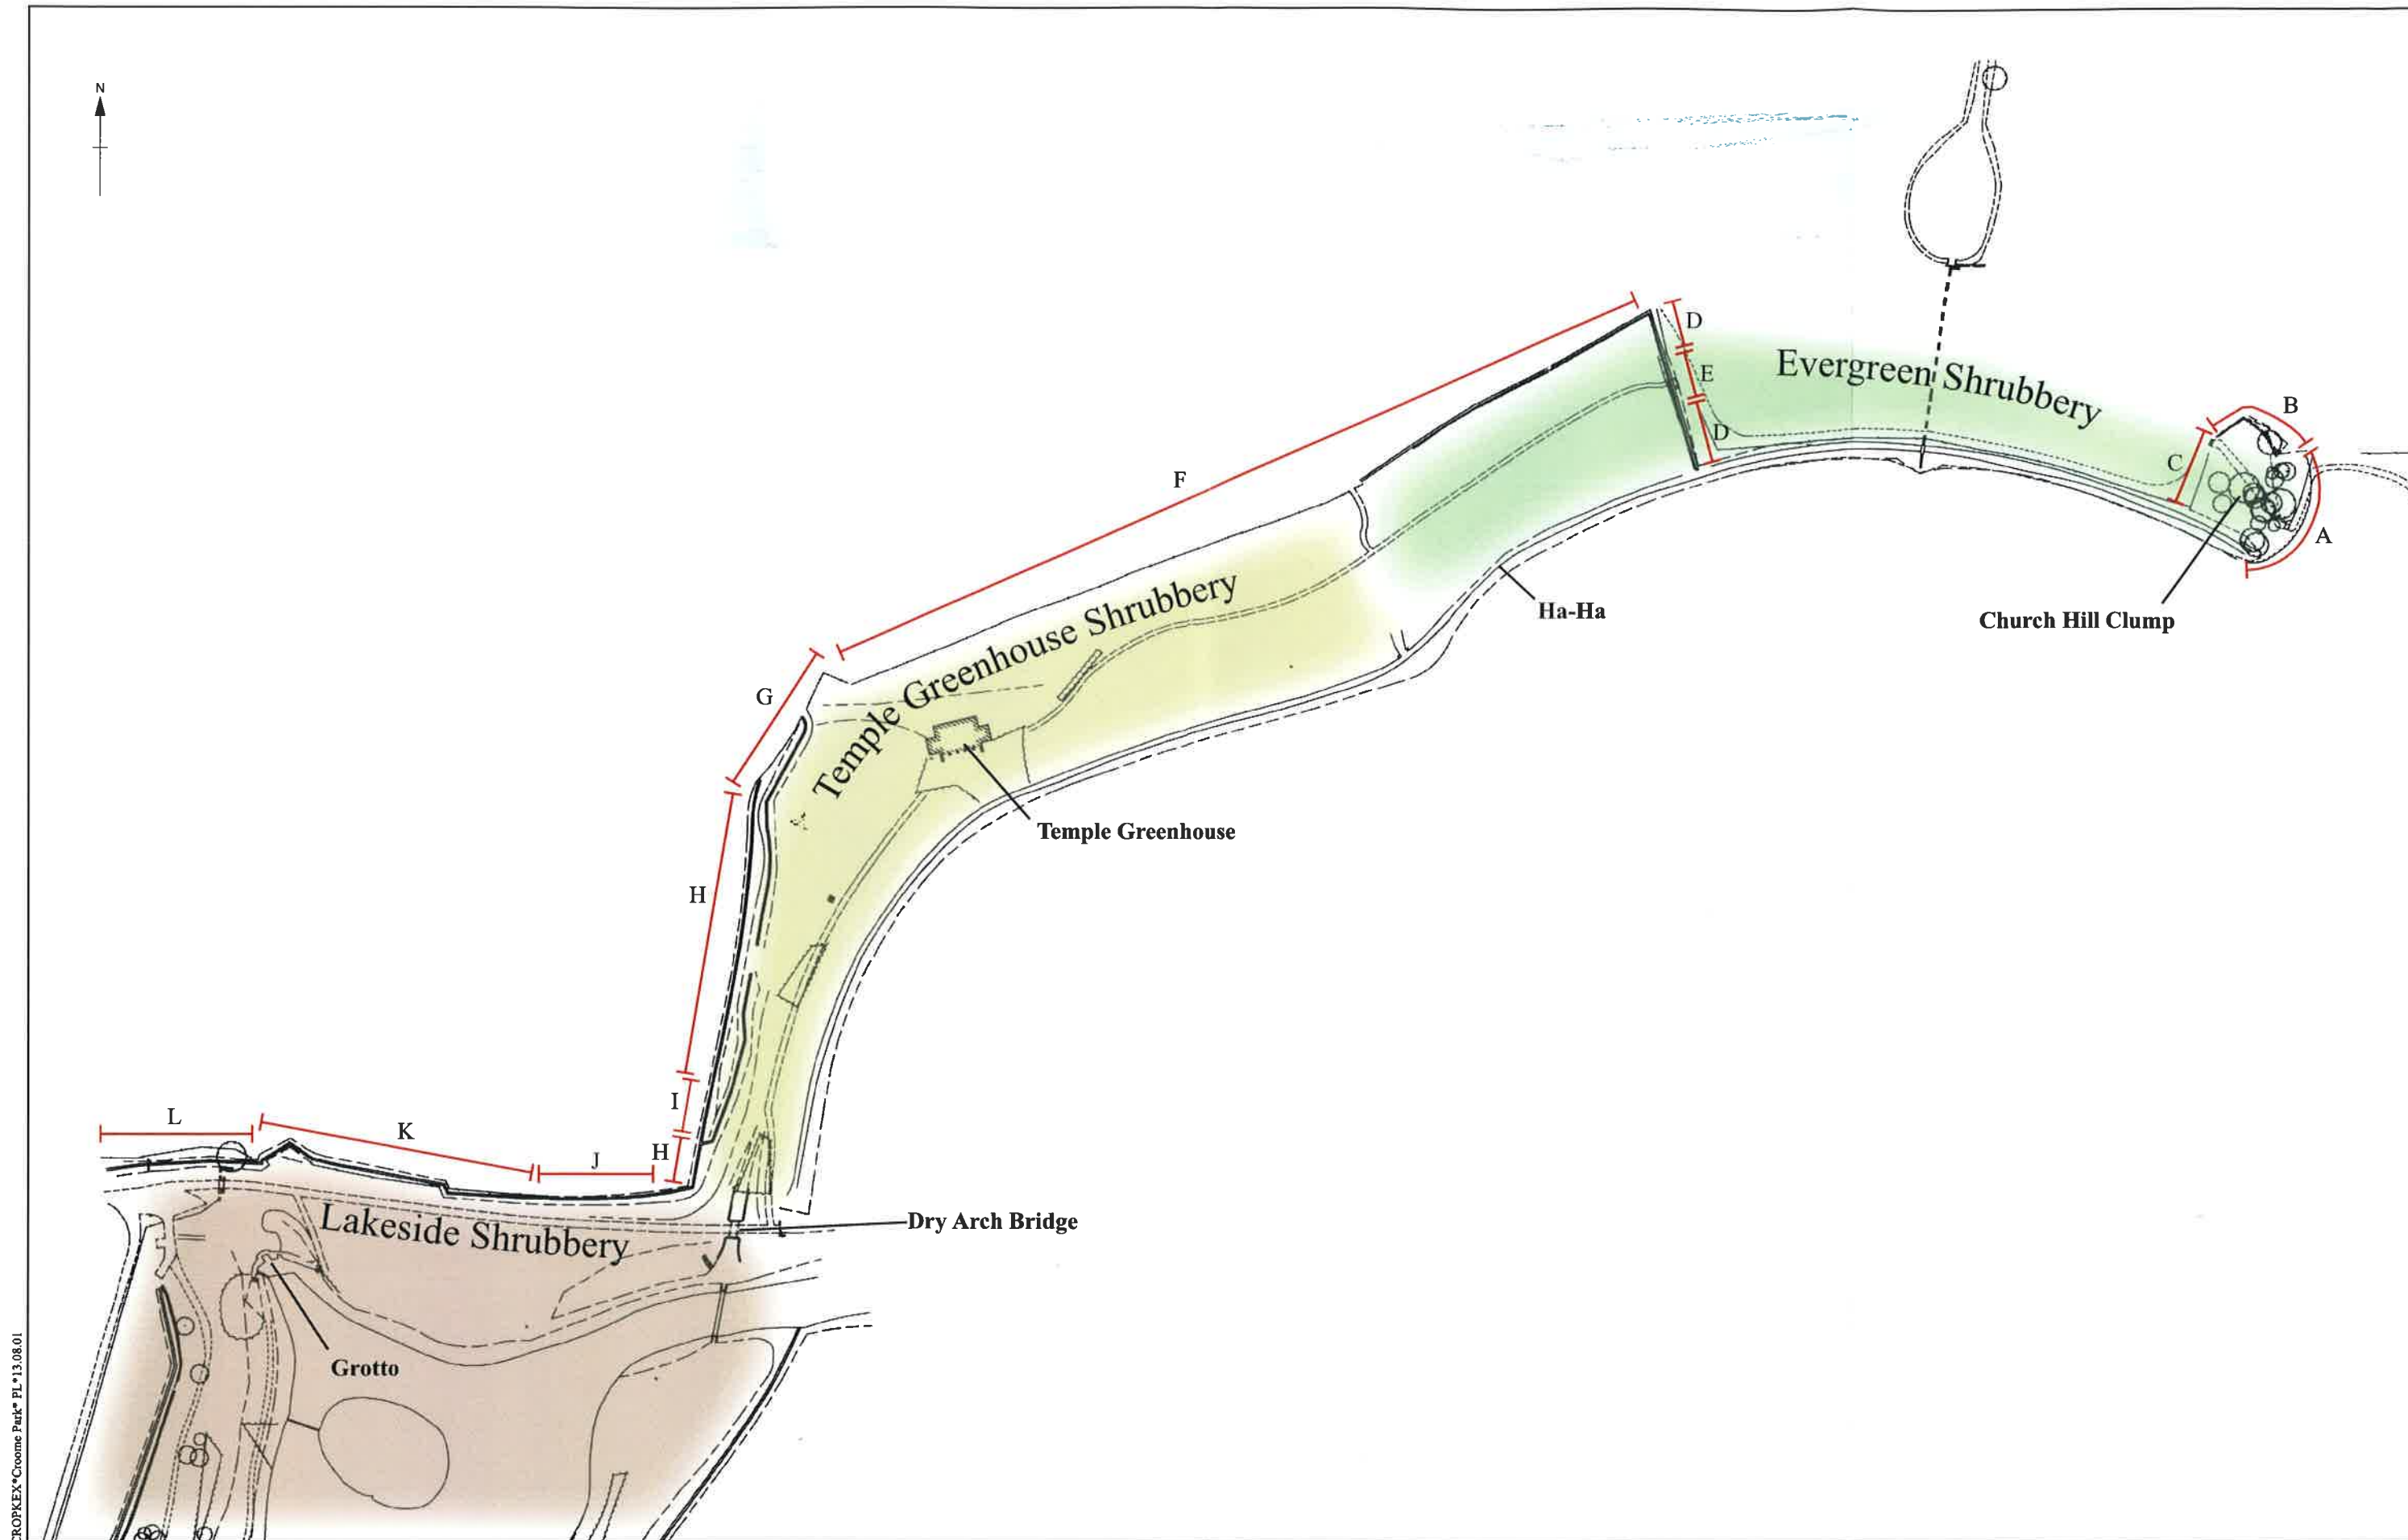
Figure 3: Boundary Assessment. (Not to Scale)

Section	Type	Description
<b>a</b>	<i>Paling Base</i>	Dressed limestone paling bases revealed during excavations in Trench 19. The palings bases were set in lead approximately 0.1m apart and had a square profile. A small section of upstanding palings in very poor condition survives at the junction of <b>a</b> and <b>b</b> . The section consists of upright iron palings, with a square profile, held together by a flat horizontal top bar with raised spikes.
<b>b</b>	<i>Iron Railing</i>	Five bar iron railings. Round top bar and four flat horizontal bars below. Bars threaded through regular vertical uprights. Section in mixed condition but relatively complete, if somewhat dilapidated.
<b>c</b>	<i>Iron Railing</i>	Same style as <b>b</b> but in very poor condition, generally collapsed and difficult to trace.
<b>d</b>	<i>Iron Railing</i>	Same style as <b>b</b> and in generally good condition. Some damage and dilapidation but mostly upright.

<b>e</b>	<i>Modern Wood</i>	Modern wood paling fence with large, vehicle sized, gates in centre. In good condition.
<b>f</b>	<i>Hedge and Ditch</i>	Mixed boundary, with modern wire and post fencing dominating and earlier and partially grown out hawthorn hedge. The external face of the boundary is marked by a ditch.
<b>g</b>	<i>No Data</i>	Area inaccessible due high ground cover and water
<b>h</b>	<i>Iron Railing</i>	Same style as <b>b</b> and in average condition. Some damage

Section	Type	Description
		and dilapidation but generally upright.
<b>i</b>	<i>Iron Railing</i>	Removed section of Iron Railings, were same style as <b>b</b> now stacked in field
<b>j</b>	<i>Iron Railing</i>	Same style as <b>b</b> but in poor condition, partially collapsed although still traceable. The junction between <b>j</b> and <b>h</b> is very poor with no direct physical linkage observed. It is unlikely that any junction was ever present between the two sections.
<b>k</b>	<i>Iron Railing</i>	Same style as <b>b</b> and in average condition. Some damage and dilapidation but generally upright.
<b>l</b>	<i>Iron Railing</i>	Similar style to <b>b</b> but with different vertical uprights and slightly different horizontal bars. This section seems to be more recent in date.

- 2.3.7 The external boundary of the Temple Greenhouse Shrubbery (Sections **g**, **h**, and **i**) does not seem to have been hedged or bounded in the same way as the external boundary of the Evergreen Shrubbery (Section **f**). A ditch is still present in the southern sections but there are few hawthorn trees that would support the idea of these sections being hedged. Examination of early paintings, i.e. E.F and T.F Burney’s *Entrance at the Park at Cromb 1784*, show that wooden paling and railing fences were used on the site and it may be that such as fence was used along Sections **h** and **i** prior to the arrival of the 19<sup>th</sup> century iron railings.

3. As an initial stage in achieving Recommendation 2 the boundary line of Section **a**, in the form of the limestone bases, should be cleared and revealed along its entire length.

4. As part of Recommendation 2 the iron palings identified in Section **a** should be used as a stylistic template for the replacement of the palings
5. As part of Recommendation 2 the gateway identified in Trench 19 should be reinstated. The gate excavated in Trench 19 should be used as a template for the replacement gate. It may be possible to repair and restore the excavated gate and use this as one half of the new gate, although for conservation reasons this may not be desirable.

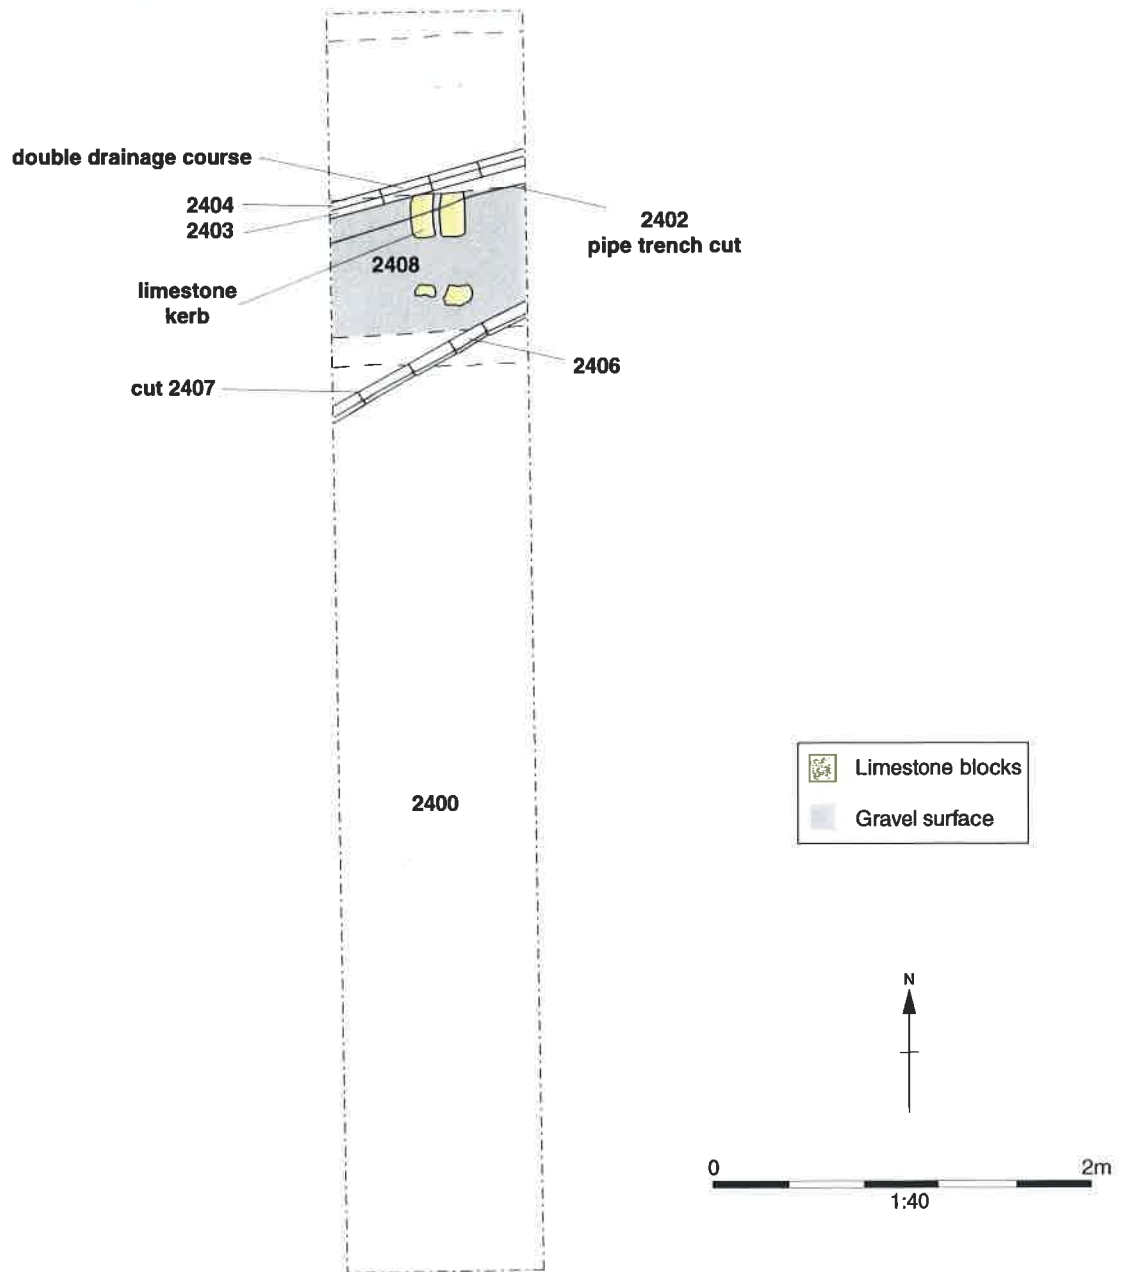
Figure 5: Trench 24 plan

- 2.2.4 Trench 24 was similarly located using the 1796 Snape pan as a primary guide to locate the former course of the path across the now ploughed field. During an initial site visit prior to commencement of the project gravel scatters had been noted in the approximate location of Trench 24 which seemed to indicate that a pathway of some form survived beneath the plough soil.

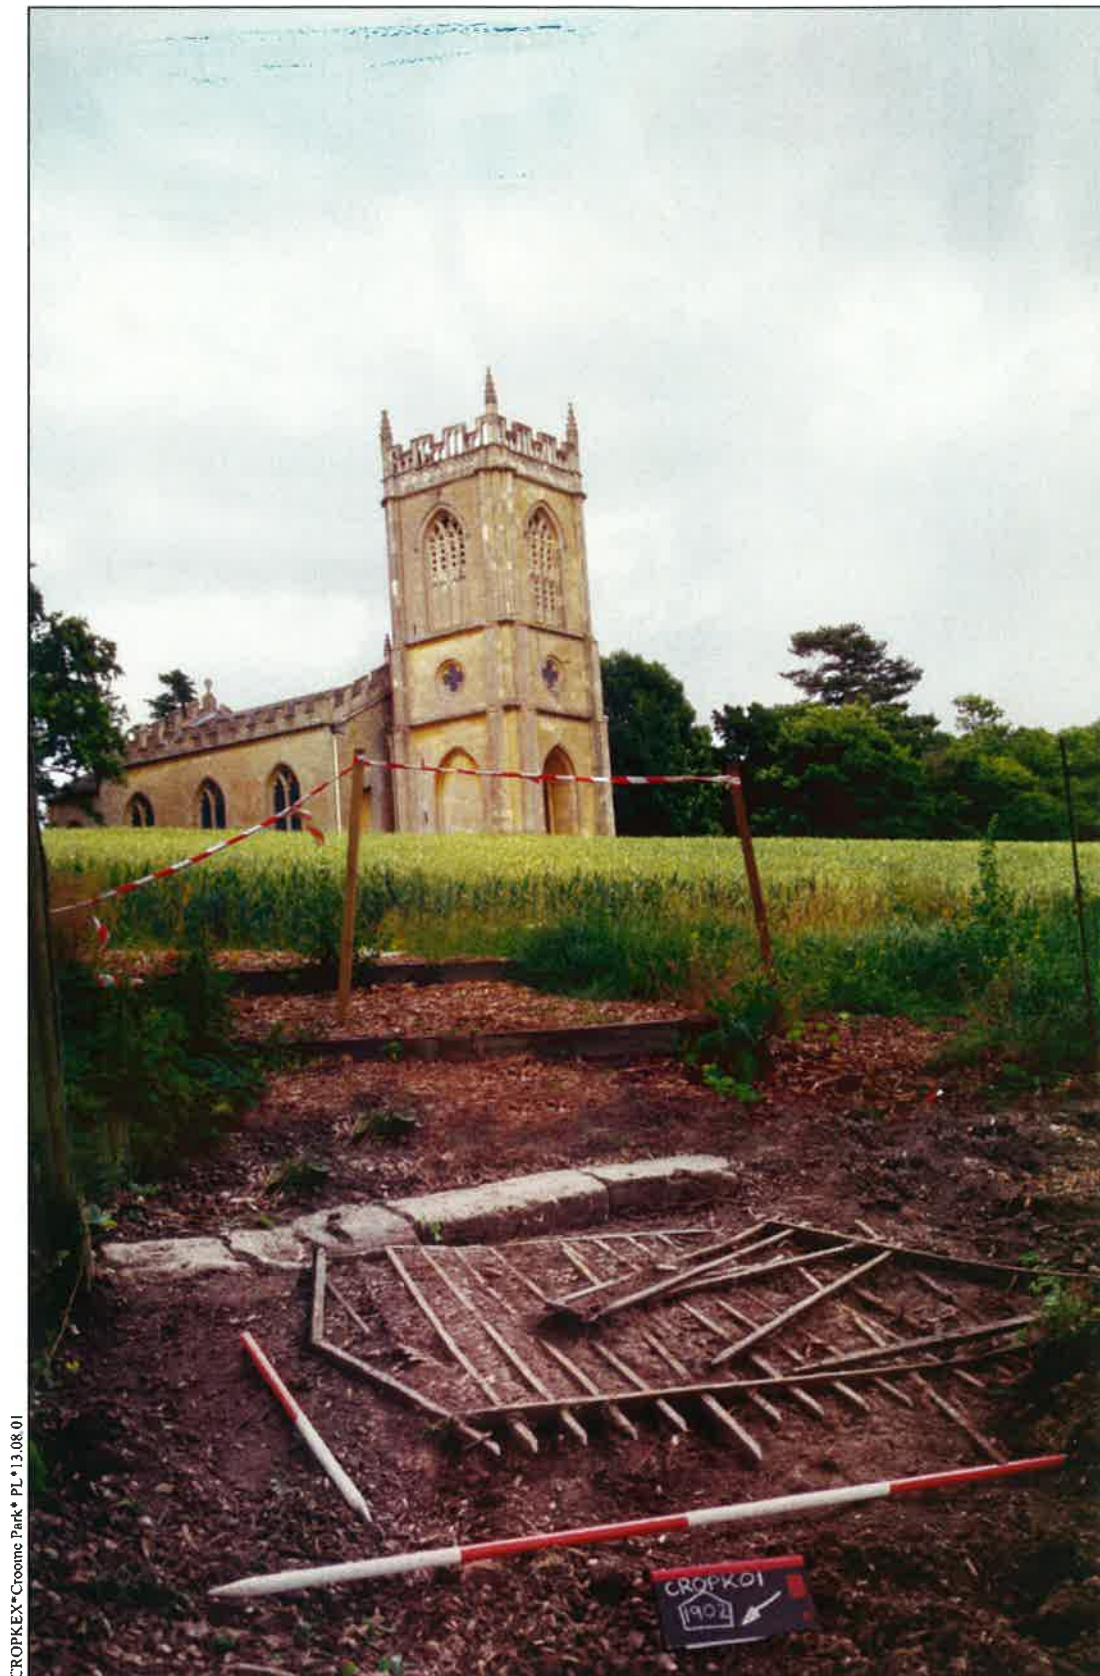
Plate 1: Excavated Gate at top of Church Hill Clump

- 2.1.2 One of the gates was found to be relatively intact and in a reasonable state of repair, considering the manner of its burial. The other gate was in a very poor and fragmented condition with only 3 whole vertical bars and one horizontal bar surviving (see Plate 1).

- 2.1.3 The best preserved gate was comprised of 12/13 vertical iron bars mounted in two horizontal flat bars. Features such as hinges and the chain that held the two gates together were found to still be *in-situ*. The gate sockets and central locking hole are still intact. The base of the gateway is comprised of worn dressed limestone blocks. The well preserved gate was compared with another gate in front of the church, but no stylistic correlation was observed.

- 2.1.4 The gates were also still attached to the collapsed iron palings associated with the boundary running down to the terminus of the *Ha-Ha*. Subsequently the gates were left in-situ, pending National Trust advice, to prevent damage during their removal.

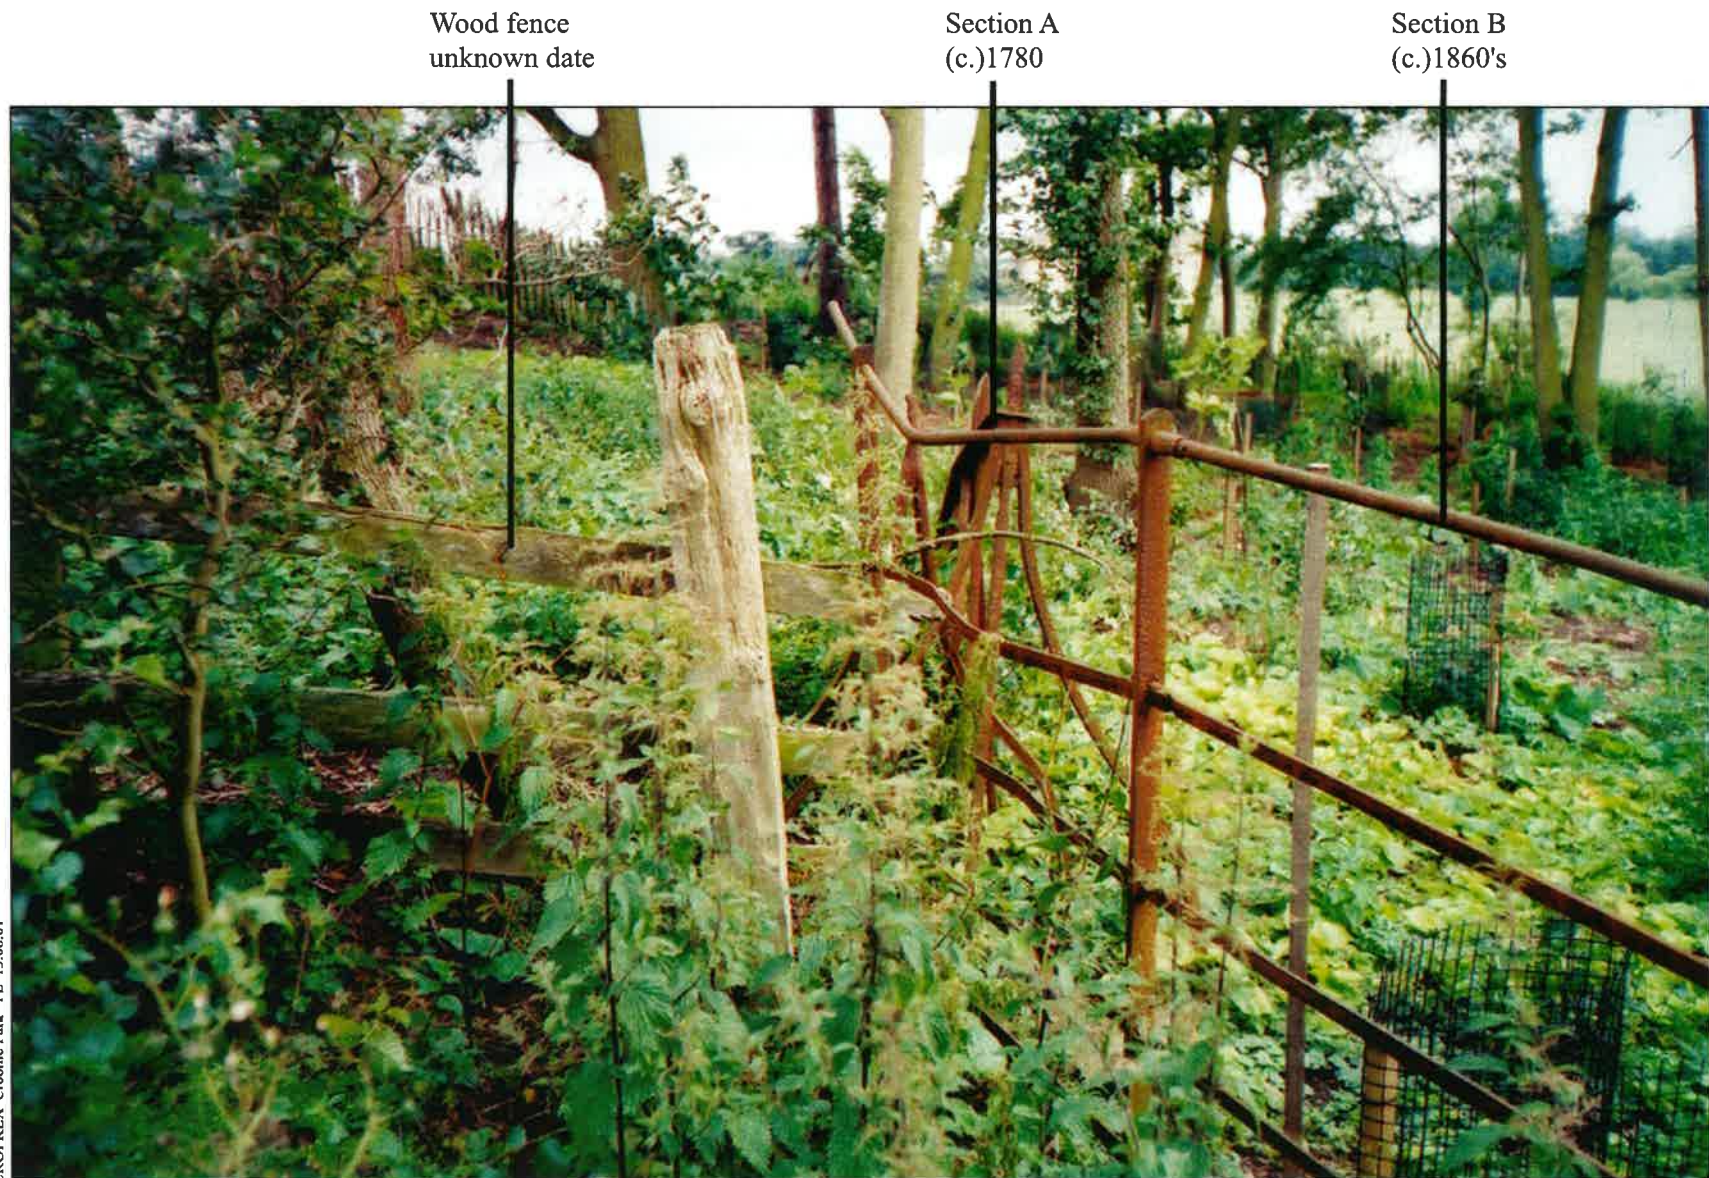
Plate 2: Boundary features in Church Hill Clump

- 1.5.1 The boundary features alongside the Evergreen and Temple Greenhouse Shrubberies are in a mixed state of repair and represent a variety of periods within the site's development.

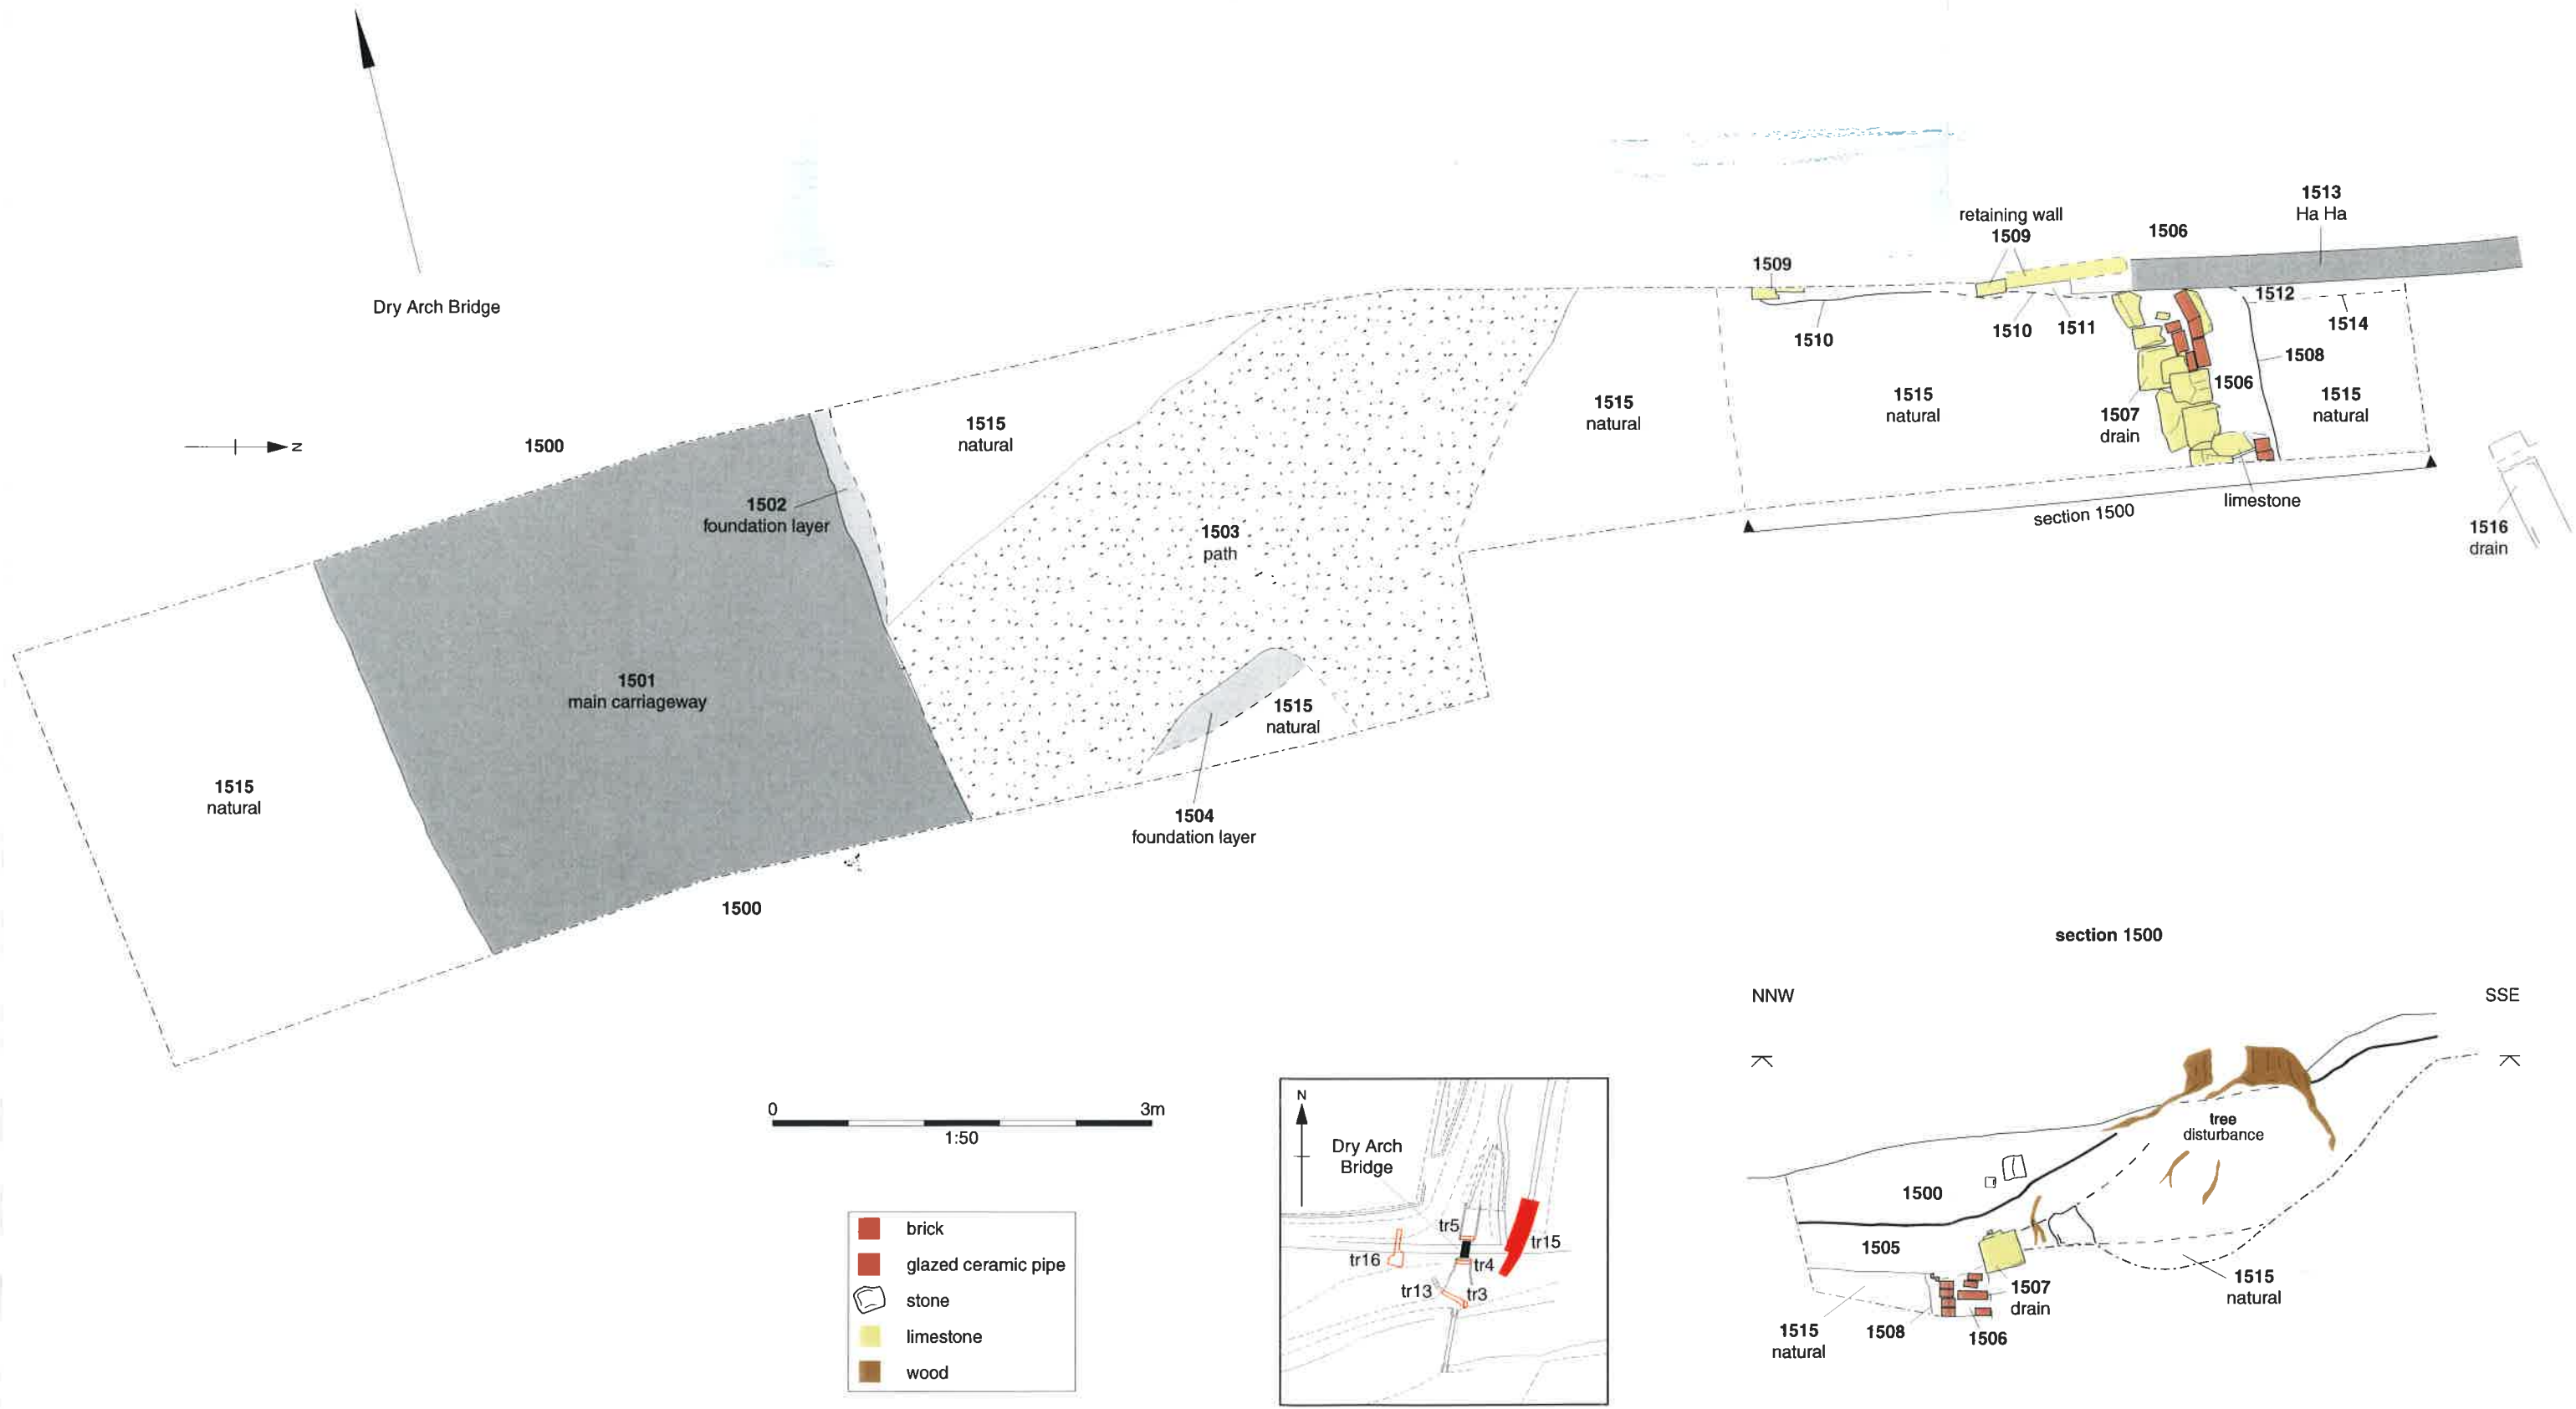
Trench 15: Plan and section

- 2.1.7 Trench 15 was primarily focussed on the relationship of the Ha-Ha with the slope at its southern terminus. The trench did however also reveal the main carriageway and associated path just east of the Dry Arch Bridge. The carriageway and path are both comprised of the classic pebble surface (1501 and 1503 respectively) overlying a makeup foundation layer (1502 and 1504) of brown silty clay. The path (1503) is approximately half the width of the carriageway (1501) and is also narrower than similar paths identified in Trenches 6 and 7 near the Temple Greenhouse.
