# Parterre Gardens Witley Court Great Witley Worcestershire

## Archaeological Investigation Report Volume I

Oxford Archaeology

May 2004

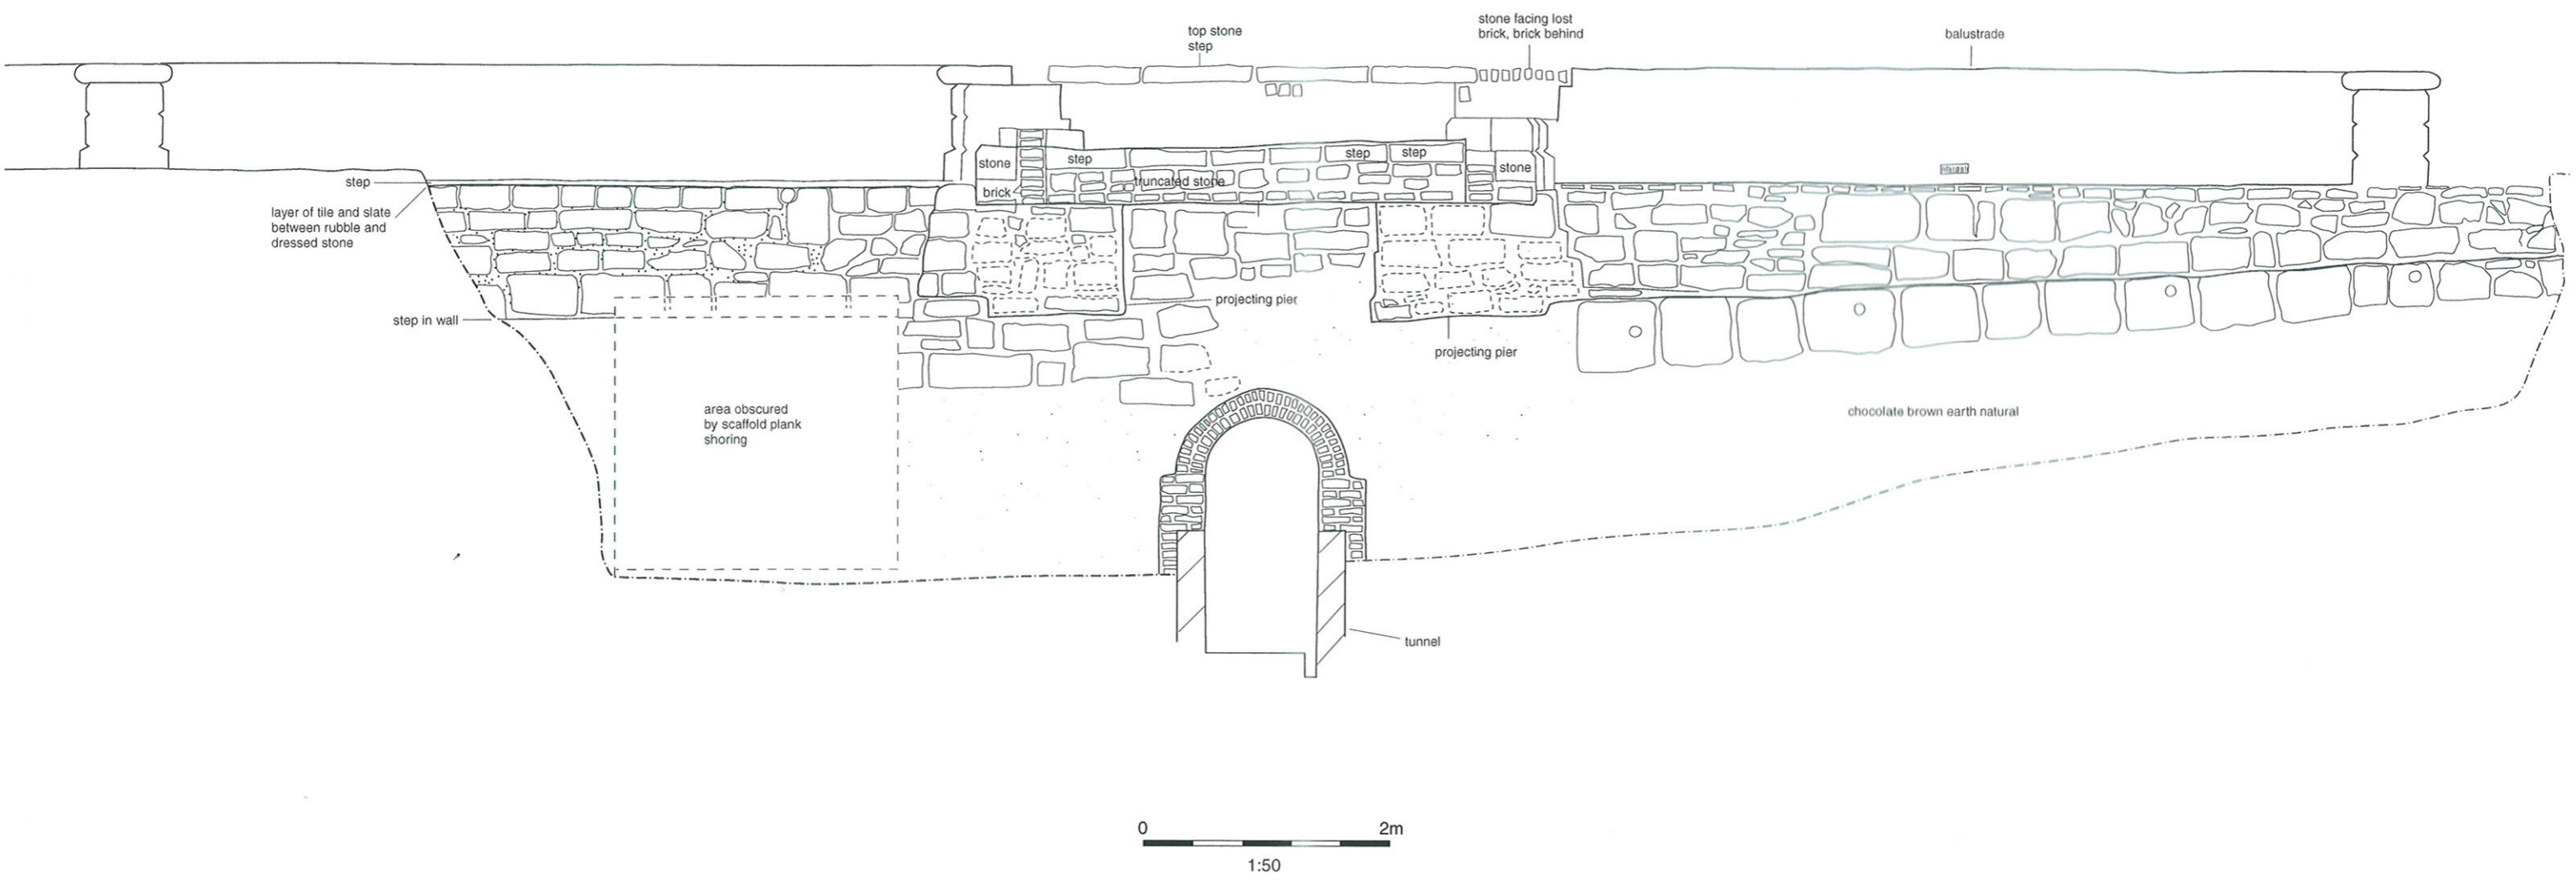
Figure 6 : Elevation of Balustrade, Steps S7 and Tunnel entrance in area of new Pumphouse excavations (Trench 20)

- 7.2.3 The section of exposed balustrade within the excavation area (Trench 20) has been recorded in a detailed elevation showing the three elements of the build; sub-foundation, foundation-proper and balustrade (Fig. 6). The foundation-proper is constructed in sandstone, the sub-foundation of very rough large blocks with some bonding and areas of silt in-filling. The tunnel entrance and antechamber appear likely to have been contemporary with the construction of the balustrade foundations as the deposit sequence indicates that this area was required to be in-filled in order to raise the ground level for the construction of the buttresses which underpin the brick arch foundation recorded beneath steps S7. Furthermore, the slight angle of the brick

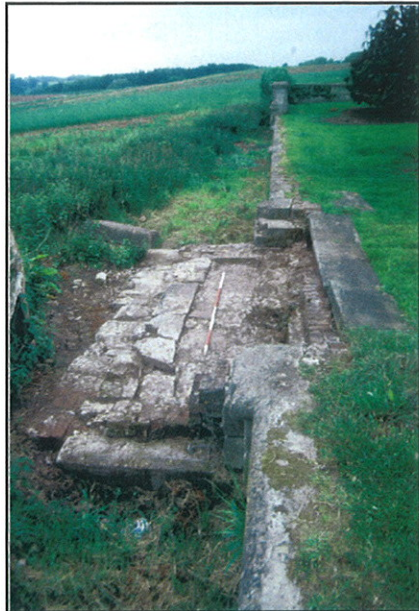
Plate 12 - Existing survival of step foundations S7. Looking south.

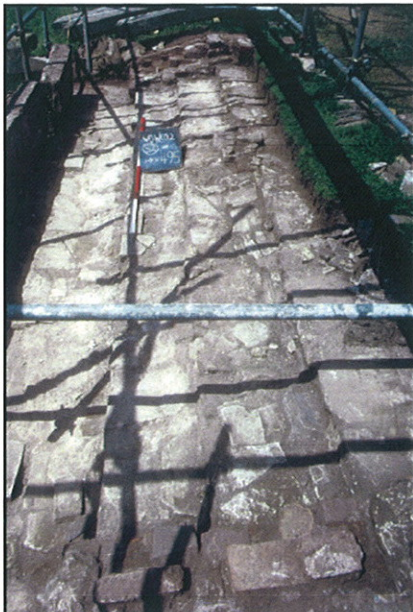
Plate 18 - Trench 7, surviving stringer of steps S2. Looking west.

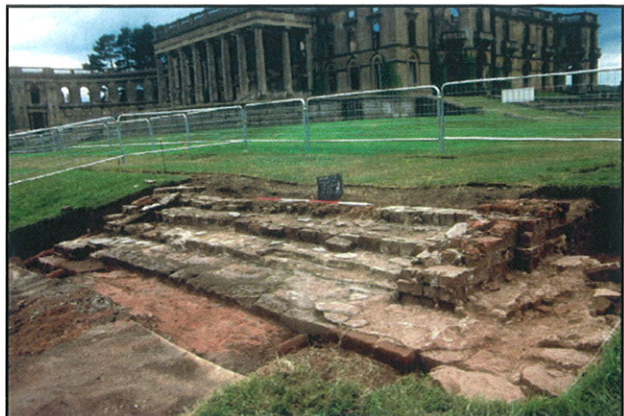
Plate 31 - Trench 17, wall footing 527 exposed beneath step foundations S12. Looking north.

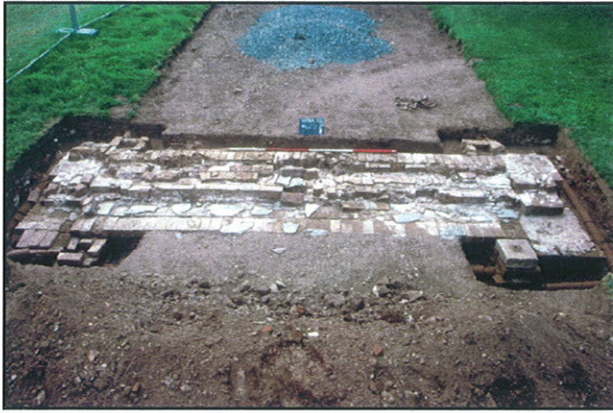
- 7.5.3 Two additional flights of steps (S30 and S31) were revealed approximately 10 m to the north of the West and East pavilions during turf removal for the reinstatement of the main north-south aligned paths within the South parterre garden. Steps S30, located to the north of the West pavilion had been heavily damaged (Plate 42), whilst Steps S31, situated to the north of the East pavilion, appear not to have been subject to such similar disturbance (see Fig. 6; Plates 37-38 and 40).

Plate 38 - Trench 22, detail of surviving stringer and drainage of steps S31. Looking south.

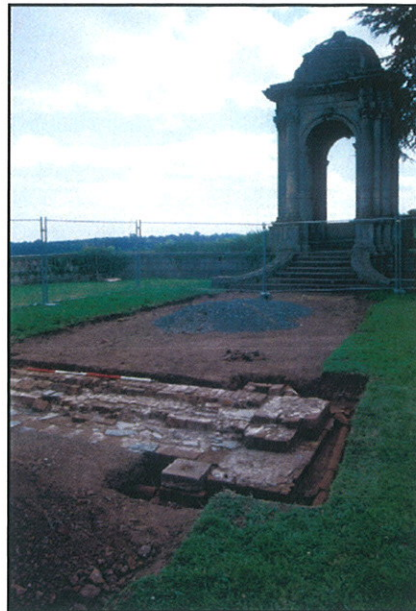
Plate 41 - Trench 15, brick constructed ramp exposed overlying step foundations S1. Looking north.

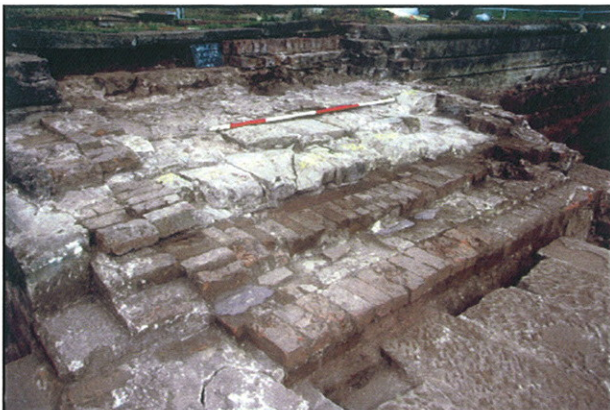
- 7.5.4 Steps S1, which form the access from the South parterre gardens to the Winter garden, were constructed entirely of limestone and were founded on an earlier sandstone structure (Plate 48). This earlier structure may represent the remains of a step base, or, structure related to the house prior to the construction of the Nesfield garden.

Plate 48 - Trench 15, excavation of step foundations S1 after brick ramp removed. Looking north.

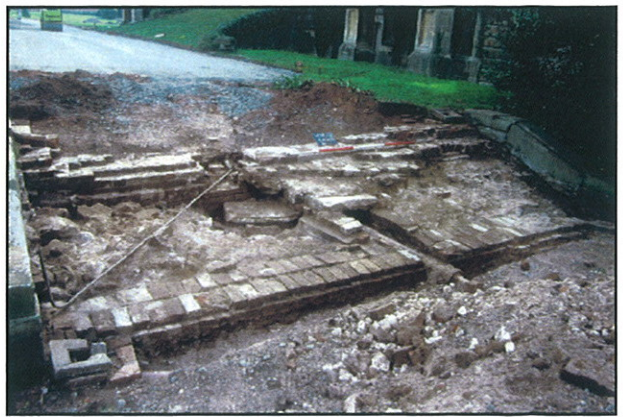
Plate 53 - Trench 100, detail of service that cut step foundations S16. Looking south.

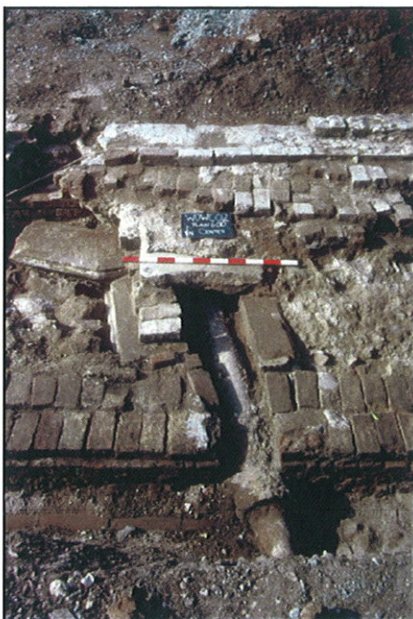
Plate 54 - Trench 100, detail of surviving stringer of steps S16. Looking east.

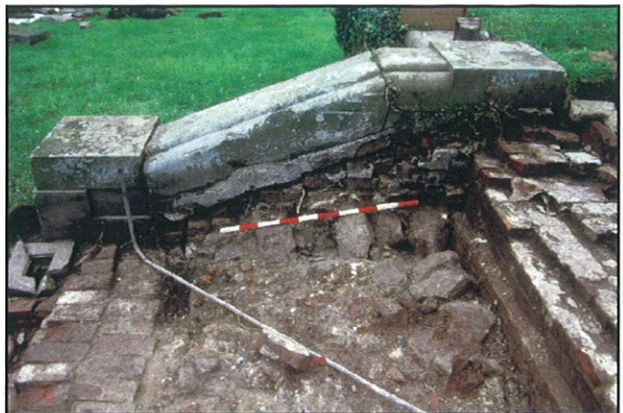
- 7.5.7 The surviving remains of the steps are the clearest illustration within the garden of the extent of its disrepair after the building fell into disuse. The stonework furniture of the steps has been largely robbed away and in a few instances extensive damage and disturbance has occurred to their footings.

Plate 55 - Trench 102, shows current surviving state of step foundations S11 in East Parterre gardens. Looking north.

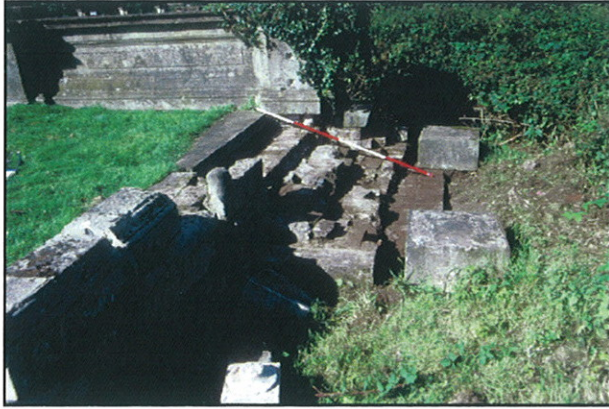
Plate 56 - Trench 103, shows current surviving state of steps S9. Looking west.
