7-15 Fleet Street, London

**Nos 7 – 15 Fleet Street
Fleet Street, London**

Historic Building Analysis of Staircase

OXFORD ARCHAEOLOGY
APRIL 2003

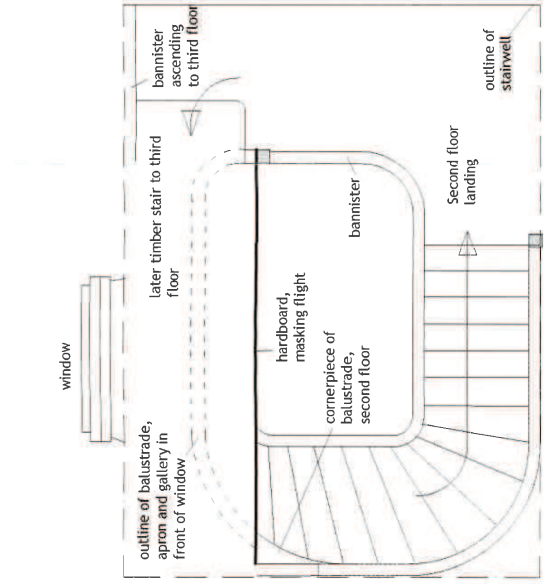
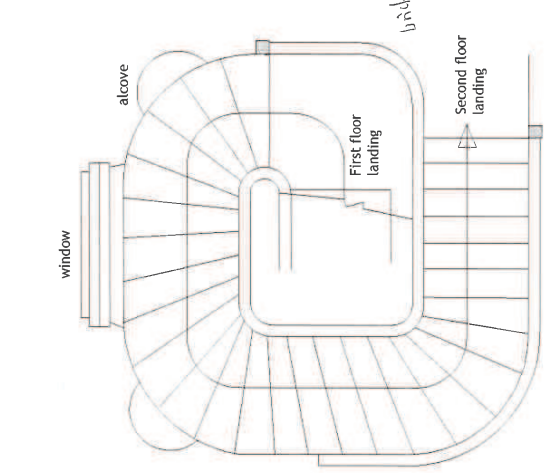
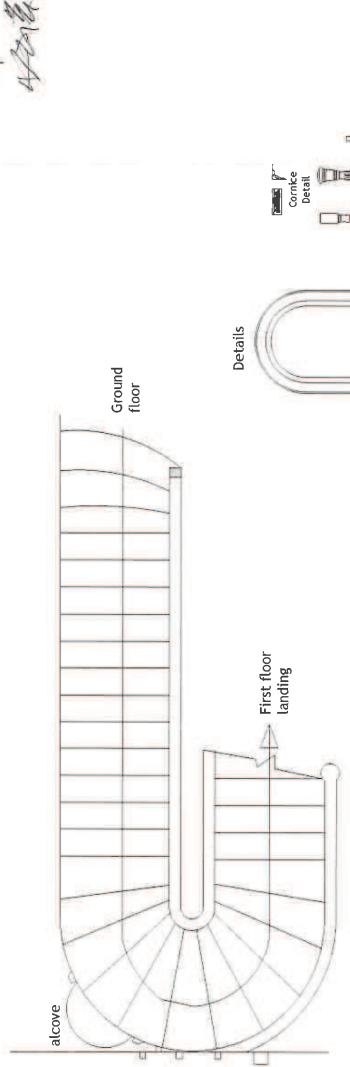
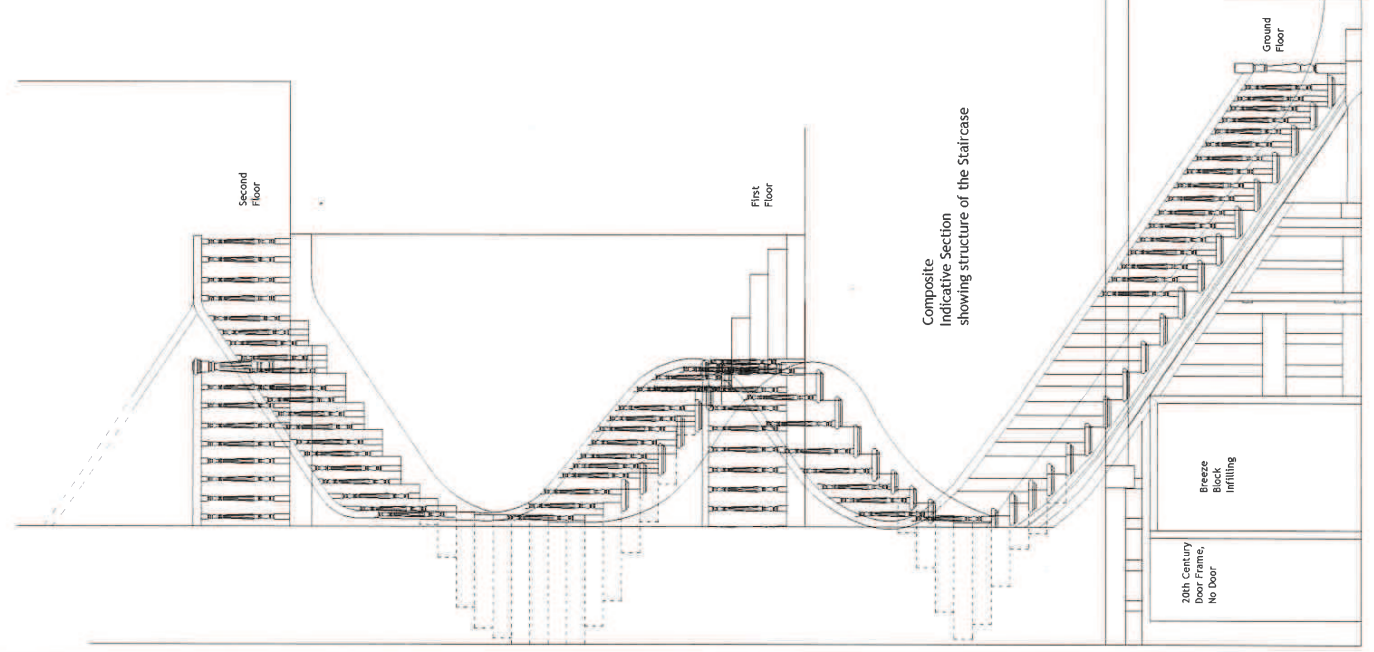
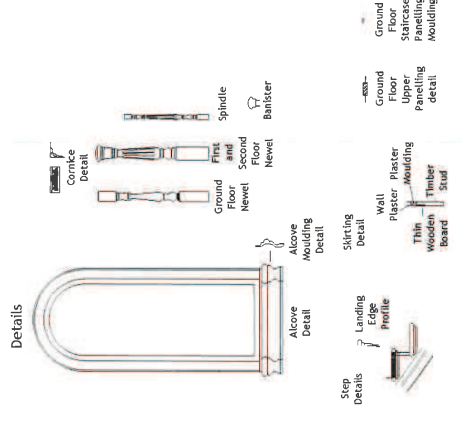
Drawing
No.
Figure 2

Title
The second staircase,
composite section,
plans and details.

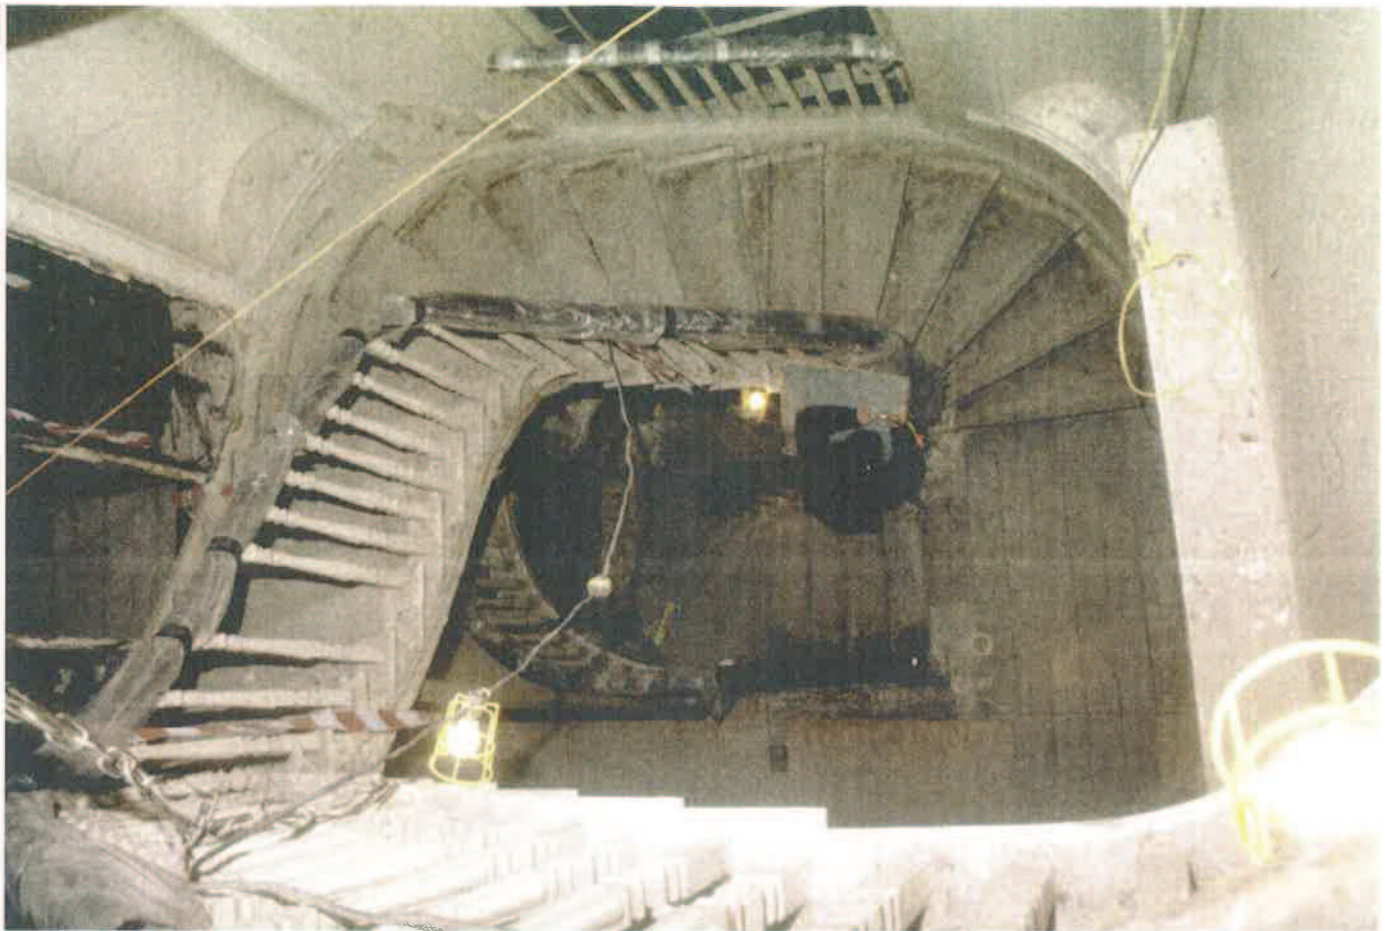
- 4.3.3 However it was clear from the current slope of the stairs and lack of rigidity, that most of the steps affixed to the studwork had failed.
- 4.3.4 This failure seems to be partly due to a poor design and partly due to modern alterations to surrounding structures rather than fabric deterioration.

12 Stairs in-situ, looking down from Second floor

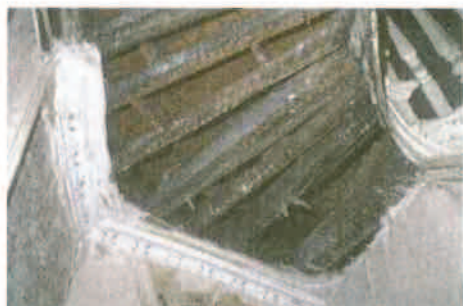
13 Moulding and underside of treaders

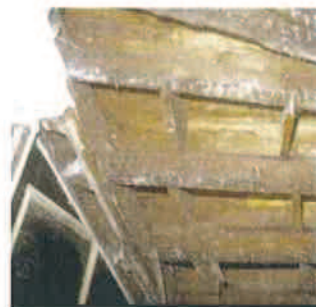
14 Underside of treaders

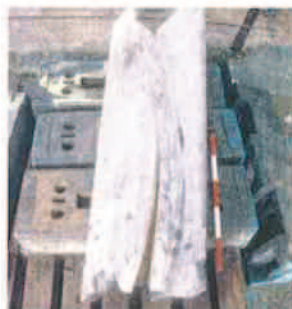
- 4.2.4 It was observed during the Maidstone visit, that since the dismantling, some laminated elements had indeed split, while others had not survived without getting damaged during the process.

15 Curved string element, splitting after dismantling

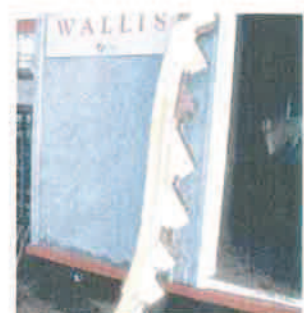
17 Curved string
