Assessment and Outline Management Recommendations for Defence Structures

August 2013

QUEEN ELIZABETH BARRACKS, CHURCH CROOKHAM

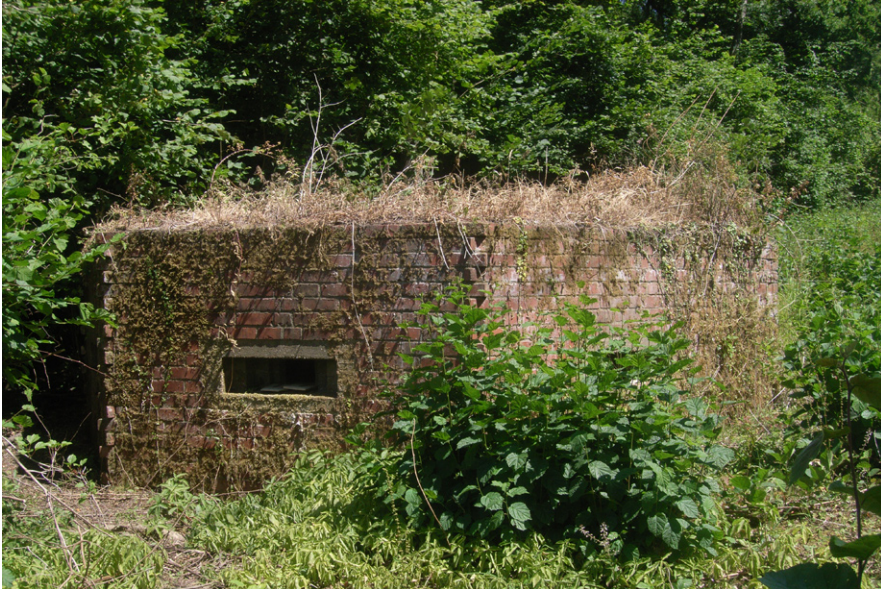
<p>148 (7845)</p> <p>Defence Estate SMR (ref: HACCO3)</p> <p>Hampshire SMR (ref: SU85SW 48)</p>	Type 24 pillbox	<p>SU 80965 50687</p> <p>Situated roughly centrally on the north-west edge of Riddings Copse, adjacent to field.</p>	<p>Sunken brick shuttered pillbox facing south with reinforced concrete core. There are two steps down to internal space at entrance. Internal brick anti-ricochet wall.</p> <p><i>Significant features:</i> all hatch covers remains <i>in situ</i> and some camouflage</p>	<p>Overall condition: Good</p> <p><i>External:</i> vegetation growing around pillbox and on roof, although mostly brambles and grass. Bricks in good condition, with limited degradation.</p> <p><i>Internal:</i> very good. Structure not flooded, but evidently is subject to flooding.</p>

Plate 1: Type 24 pillbox (OA148)

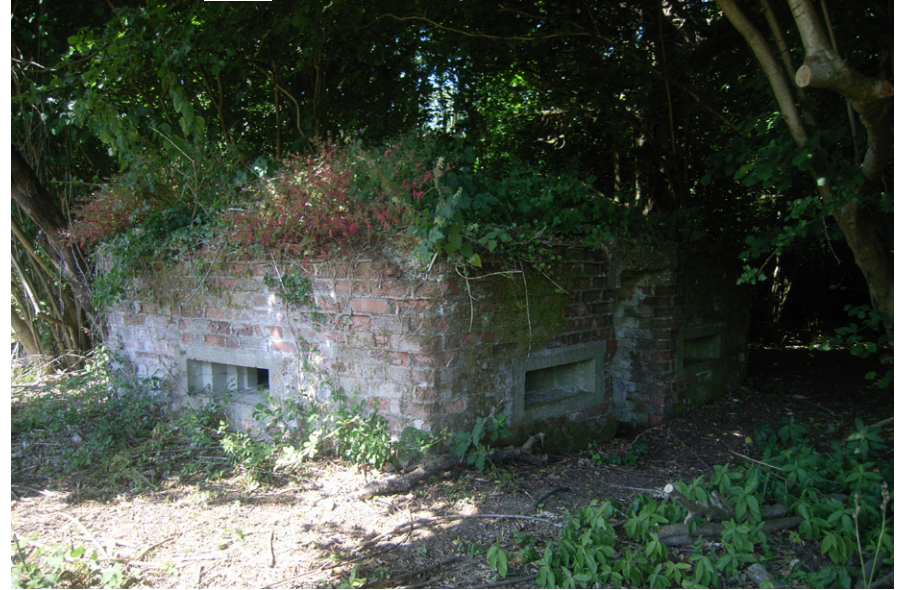
Plate 2: Type 24 pillbox, side elevation (OA152)

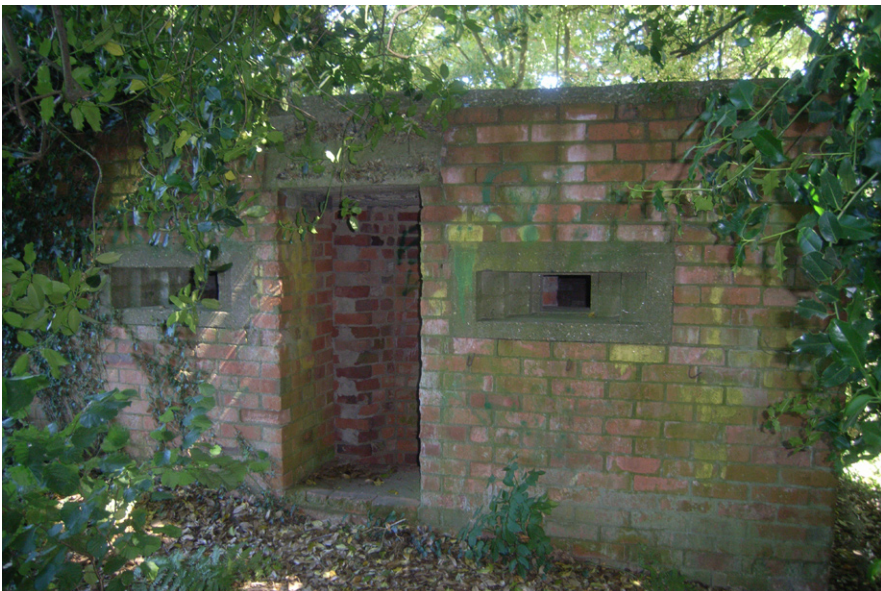
Ref no.	Type	Location and Access	Features	Condition
141 (16930)	Type 24 pillbox	<p>SU 81553 50270</p> <p>Situated within the area sloping south-east towards Ewshot village.</p> <p>The pillbox is located directly above the recreation ground, and is easily accessible via the ground's car park.</p>	<p>Sunken brick shuttered pillbox facing south-west with reinforced concrete core. There are two steps down to internal space at entrance. Internal brick anti-ricochet wall.</p> <p><i>Significant features</i> – camouflage hooks (14), and internal hooks visible to recessed areas within embrasure.</p>	<p>Overall Condition: Fair/ Good</p> <p><i>External:</i> Considerable external vegetation, in particular ivy. The brickwork survives in reasonable condition, although the outer skin is no longer extant in the south-east corner, and it is possible to see the internal core beneath. Large tree growing in close proximity which ultimately will compromise the structural integrity of the pillbox. There is some graffiti to the front face, although this is limited and could easily be removed.</p> <p><i>Internal:</i> very good condition, although one embrasure has been damaged.</p>

Plate 3: Type 24 pillbox, entrance (OA141)

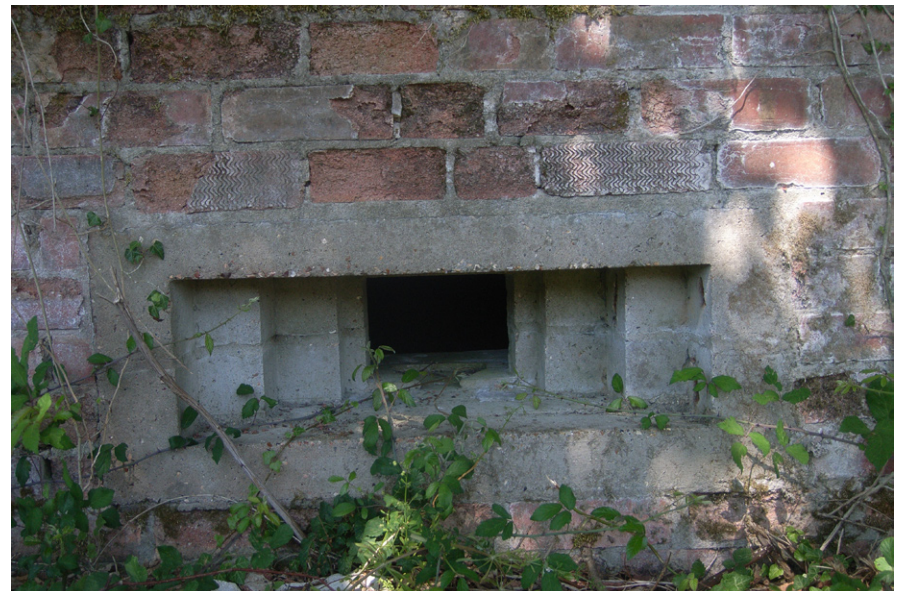
Plate 4: Type 24 pillbox, embrasure (OA152)

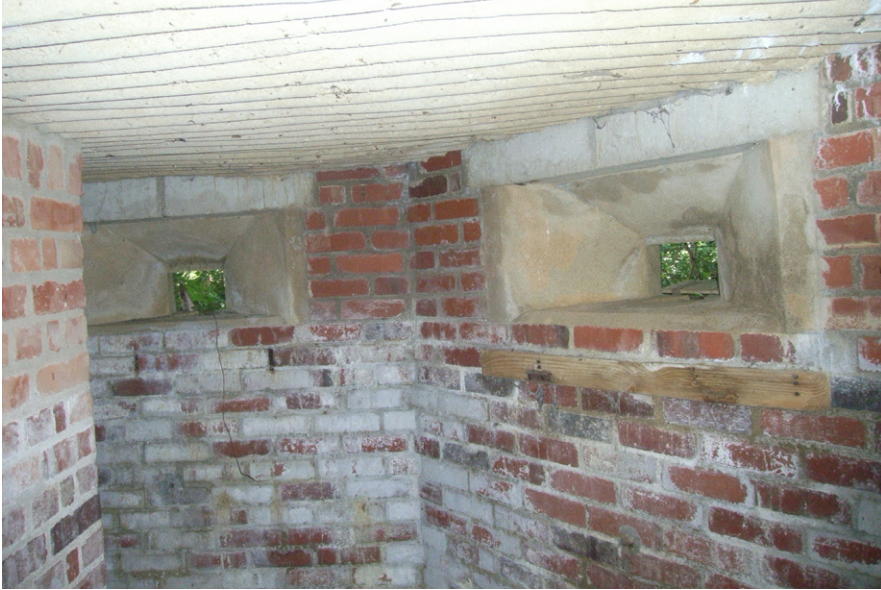
Plate 5: Type 24 pillbox, internal view showing anti-ricochet wall to left and embrasures to right (with hatch visible) (OA142)

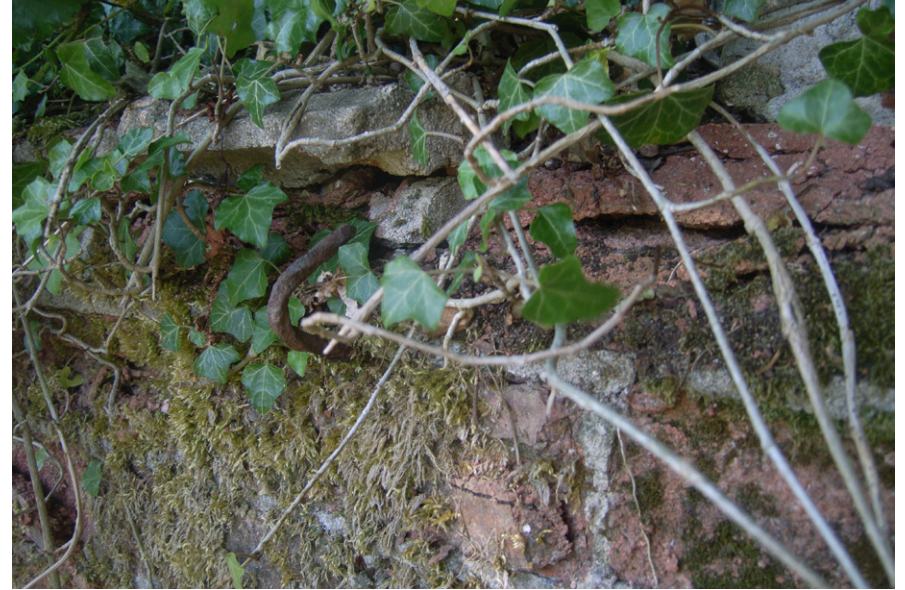
Plate 6: Type 24 pillbox, camouflage hook (OA152)

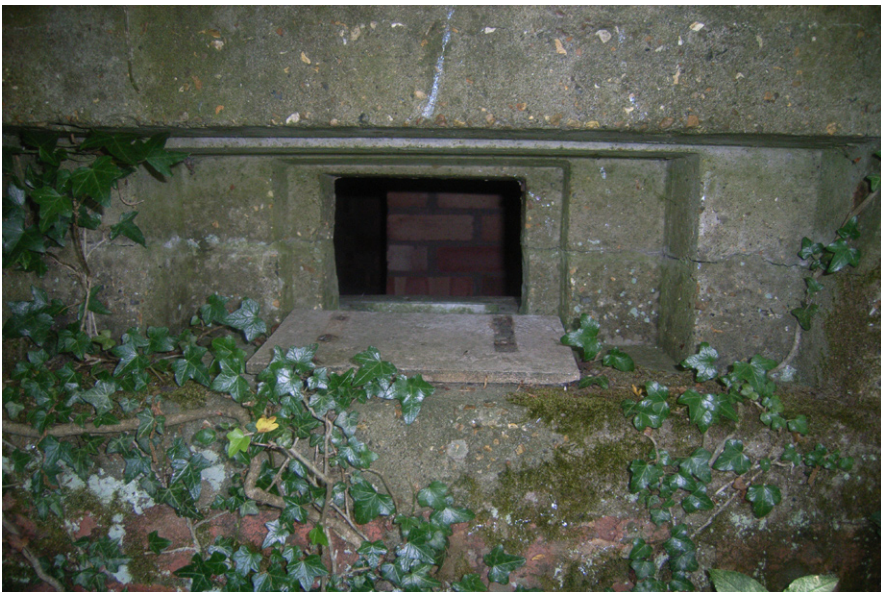
Plate 7: Type 24 pillbox, hatch (OA147)

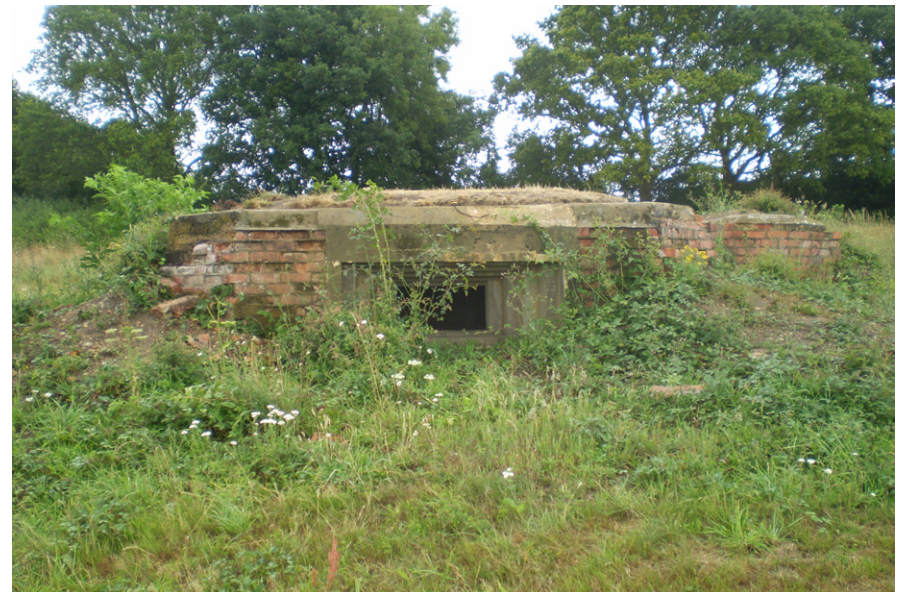
Plate 8: Vickers gun emplacement (OA139) (taken in 2010 survey)

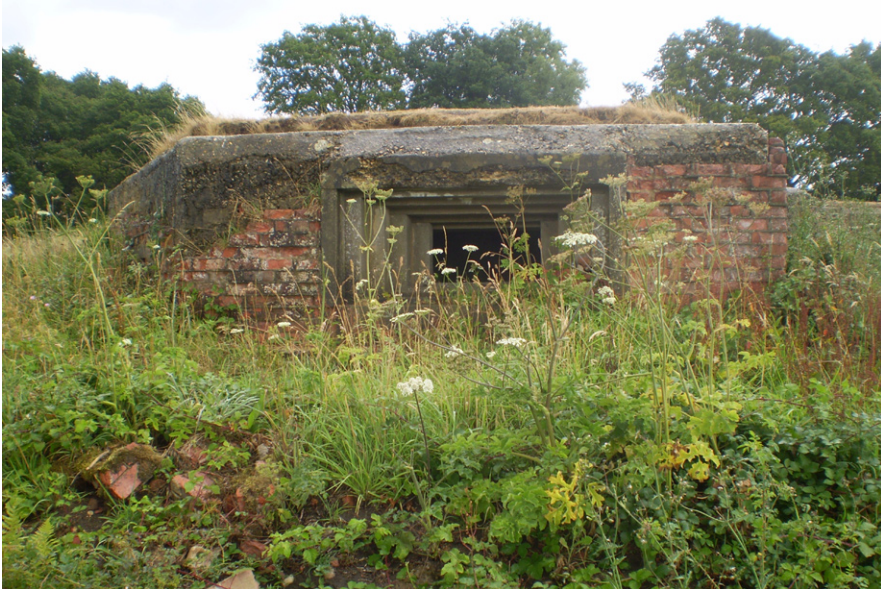
Plate 9: Vickers gun emplacement, stepped embrasure (OA138) (taken in 2010 survey)

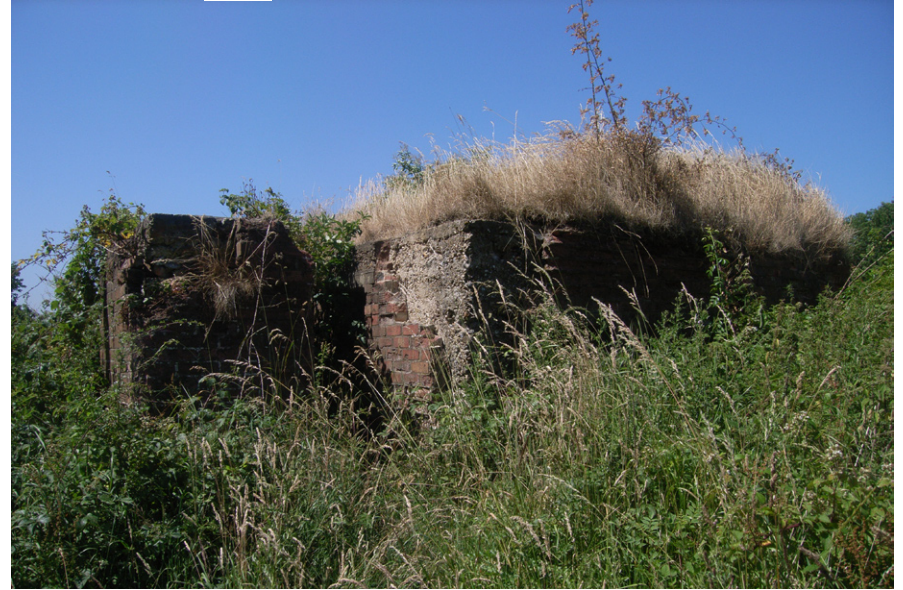
Plate 10: Vickers gun emplacement, blast wall (OA 144)

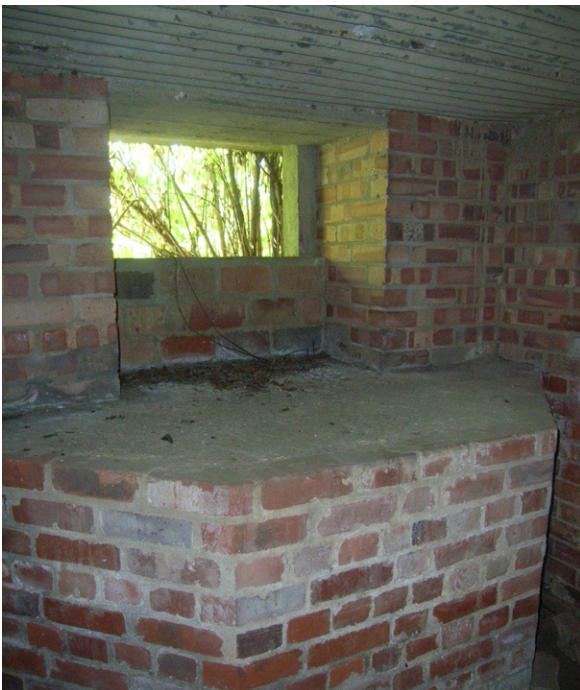
Plate 11: Vickers gun emplacement, internal gun table (OA144)

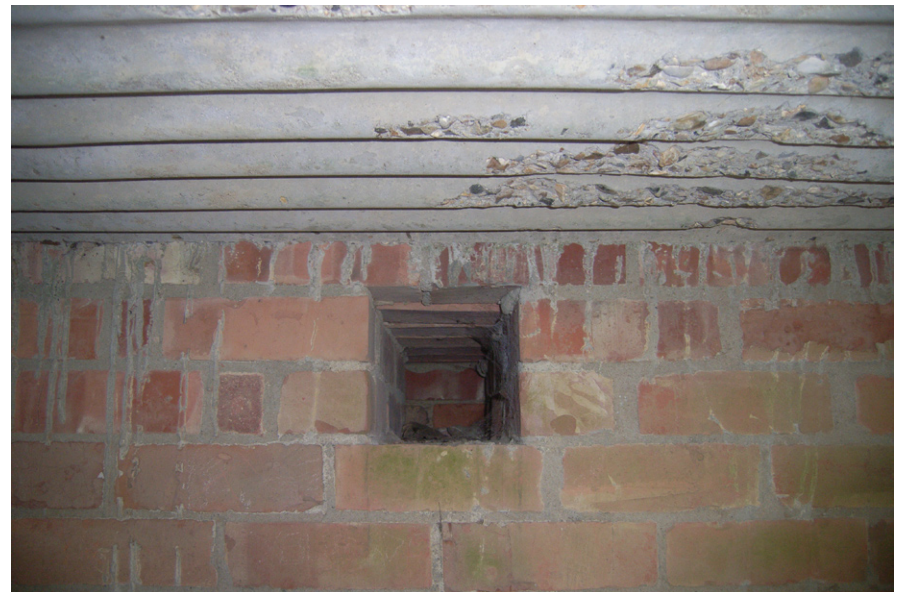
Plate 12: Vickers gun emplacement, air vent in rear wall (OA144)

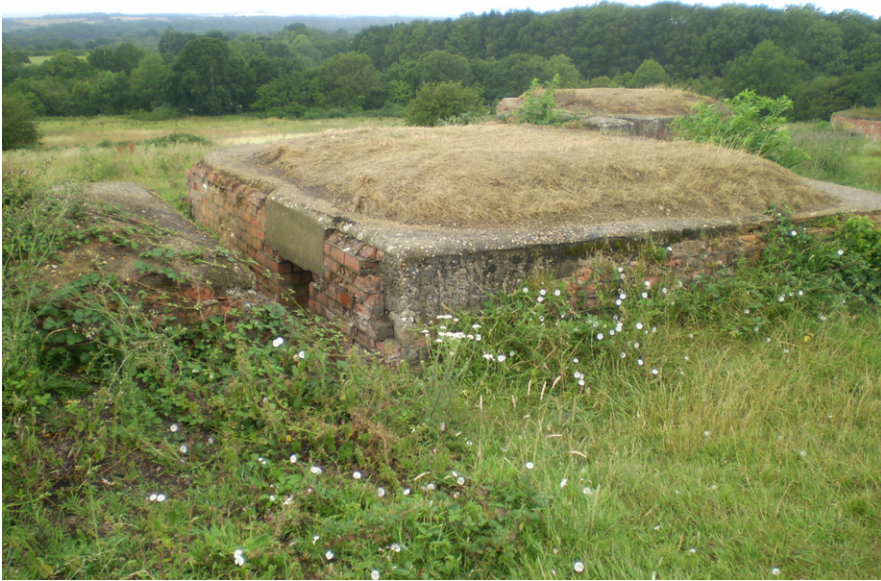
Plate 13: Pair of Vickers gun emplacements (OA 138 and 139) (taken in 2010 survey)

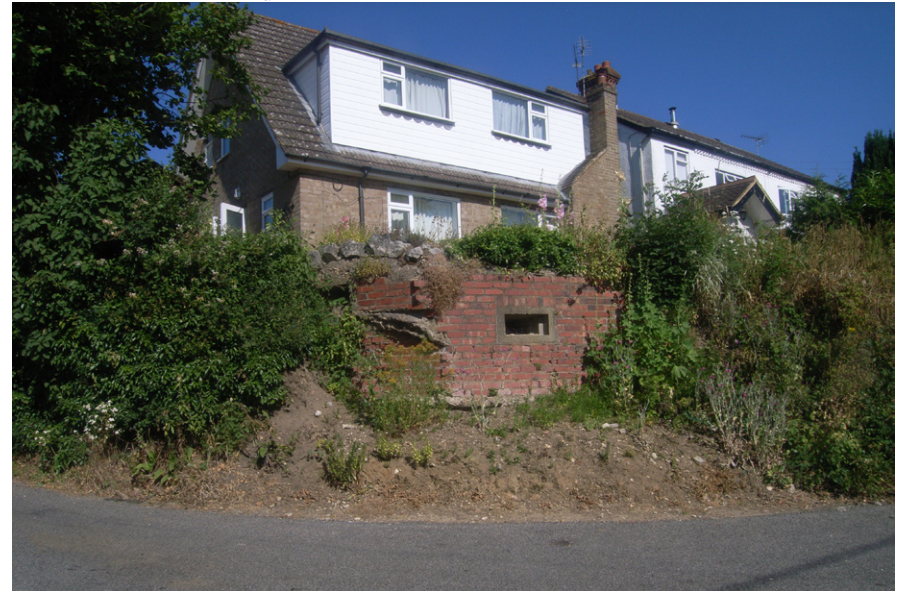
Plate 14: Type 24 pillbox, incorporated within a garden (OA153)

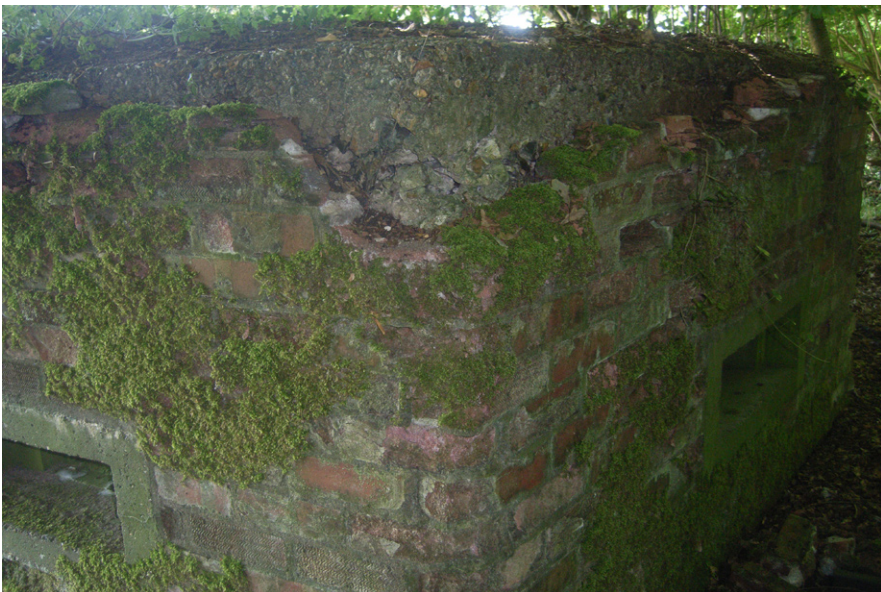
5.2.1 In general the military installations within the SANGS area survive in good condition, and have not been subject to the vandalism often associated with structures of this era. The external face is clay brick, that has deteriorated in some examples more than others, largely because they were constructed from available stocks of bricks some of which have weathered better than others. Externally the chief threat has been vegetation, which inhibits interpretation and more importantly has impacted the structural integrity of the pillboxes and emplacements. Vegetation is evident growing on the roofs and surrounding the external brickwork, which has caused deterioration and in places exposed the inner concrete core (Plate 15). In some cases vegetation is evident growing between brickwork and the concrete core (Plate 16).

Plate 15: Type 24 pillbox, showing exposed concrete core (OA152)

In many structures, the concrete core of the structures has been exposed where the brickwork is no longer *in situ*. This vulnerable brickwork needs to be consolidated to prevent further deterioration, and ensure the structures do not present a risk to visitors. This consolidation may involve the rebuilding of dislodged brickwork and consolidation of deteriorated areas with original bricks found on the floor, or rebuilt using bricks of a similar type. A second option would be to consolidate the brickwork as existing leaving the concrete core exposed. This has the advantage of showing the construction of the defence structures, which may be related to an interpretation board if appropriate.

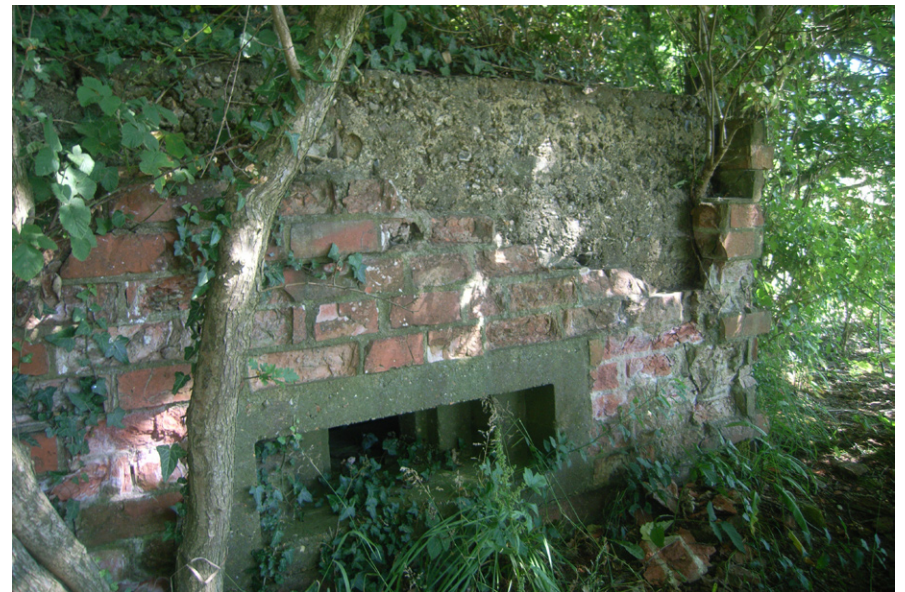
Plate 16: Type 24 pillbox, showing exposed concrete core (OA136)
