All Saints Vestry

Kingston Upon Thames

**Historic Building Investigation
and Recording**

December 2006

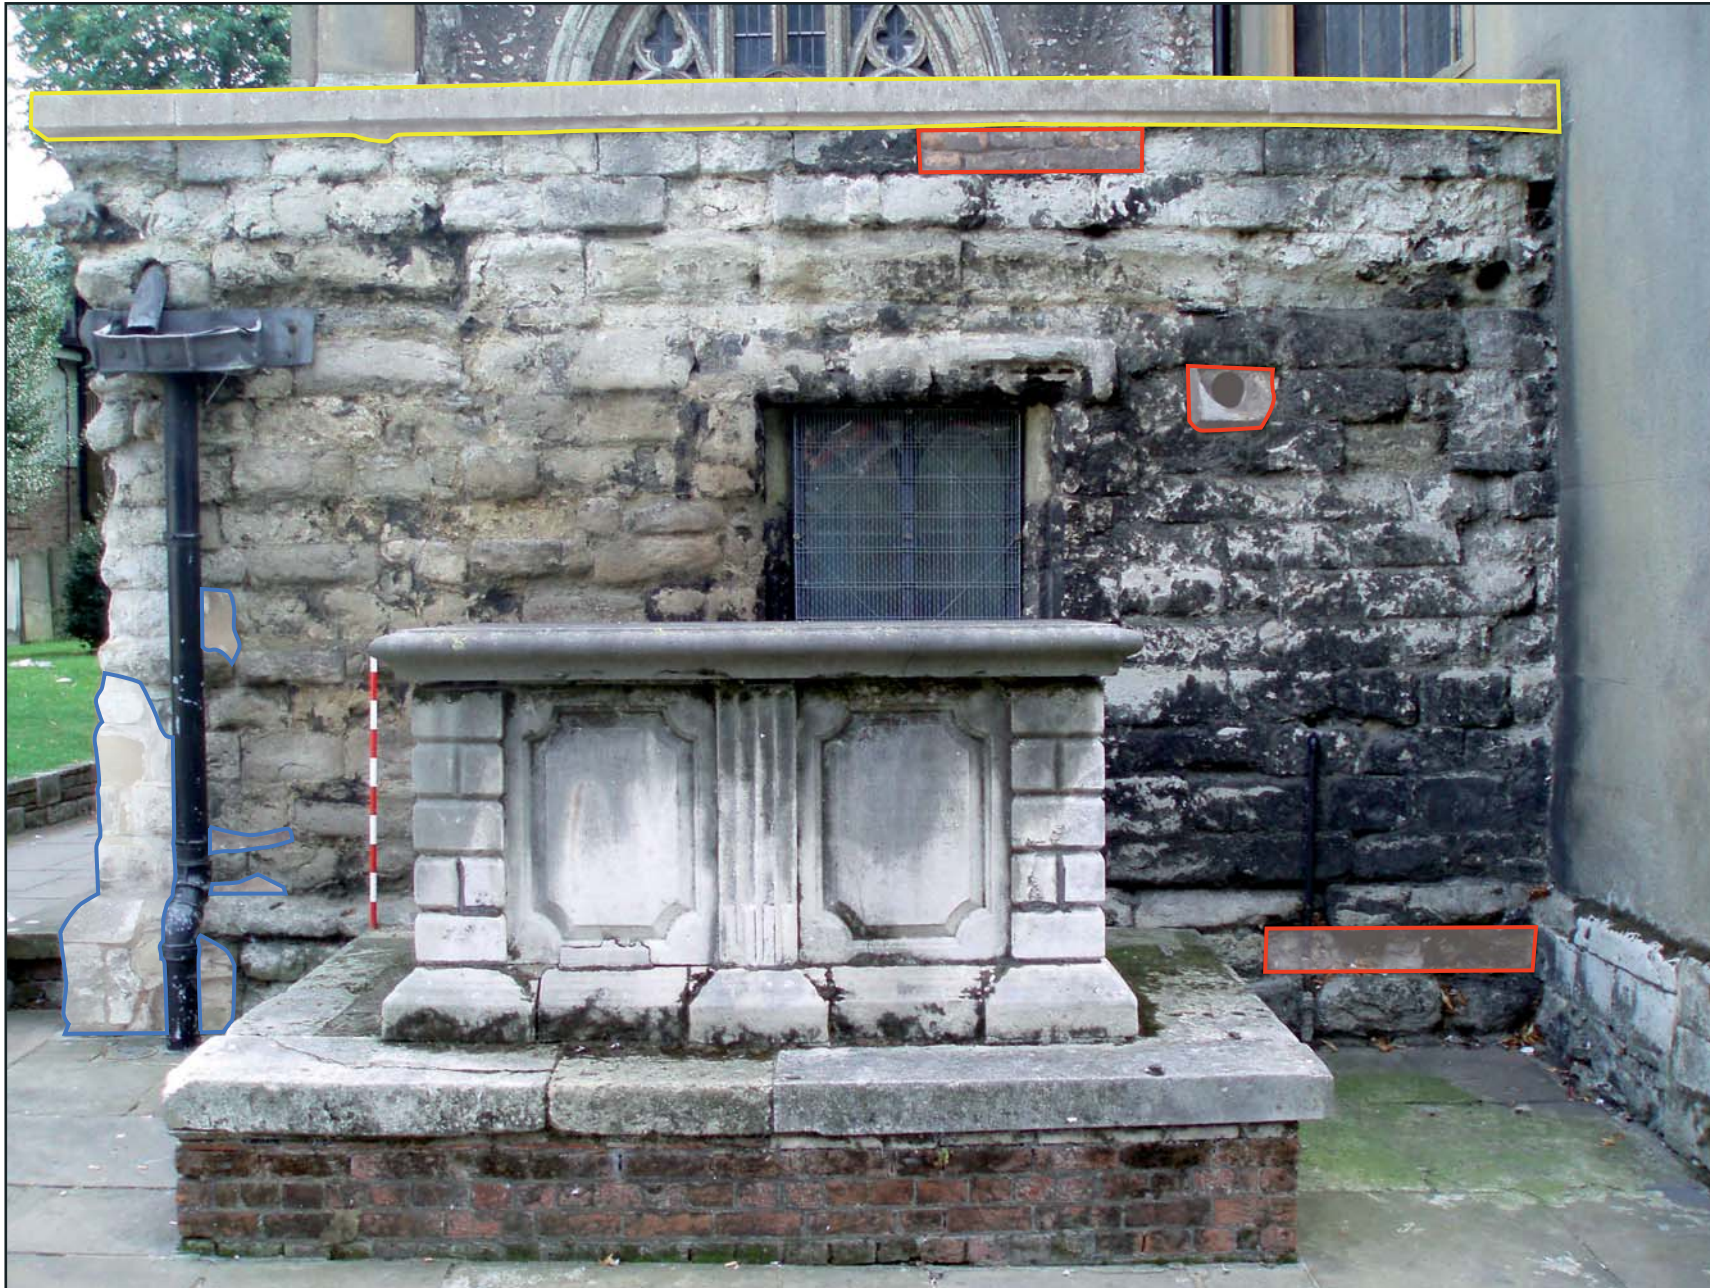
Figure 5: All Saints Vestry, Kingston:Phased north elevation

- 19th Century repair
- Mid-late 20th Century
- Late 20th Century

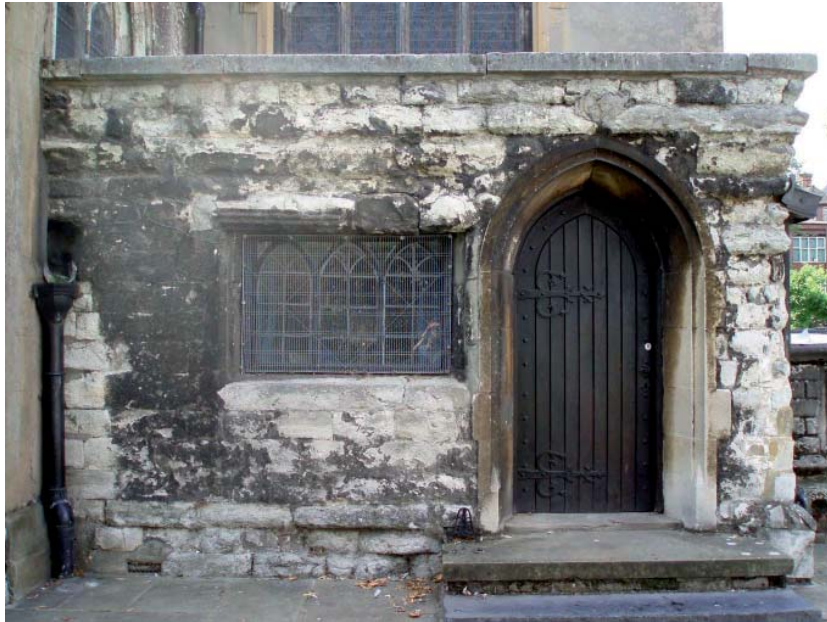
1.1.16 The stonework is mostly primary but large parts are badly eroded and in need of repair. Most stones are very blackened by calcification and pollution but some stones appear clean as fracturing has occurred and the exterior layer has fallen off. This is probably as a result of brushing the stonework for assessment. Some stones are heavily fragmented.

Plate 1: All Saints Vestry, Kingston: East Elevation

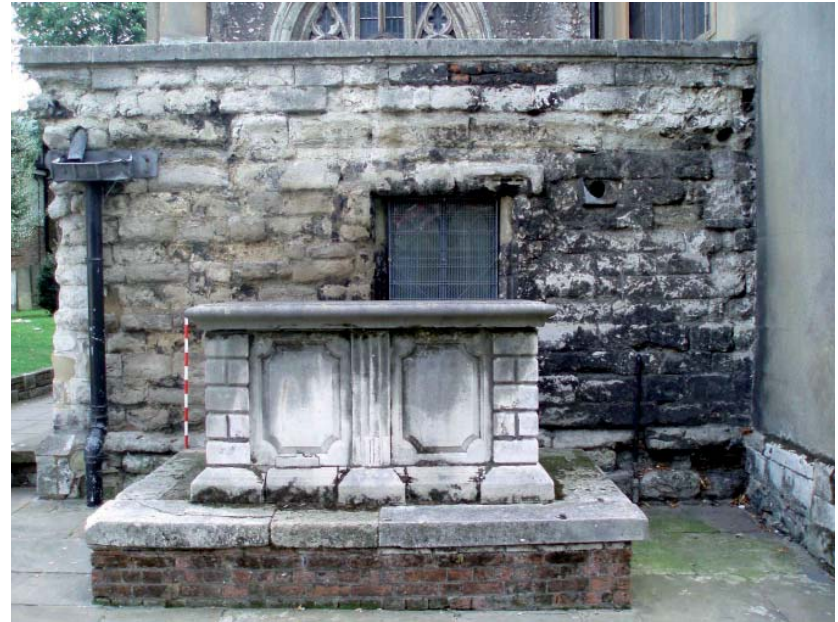
1.1.26 As with the east elevation, the stonework mostly appears primary with some areas of repair and replacement. The string course continues from the east elevation but is very weathered.

Plate 2: All Saints Vestry, Kingston: North Elevation

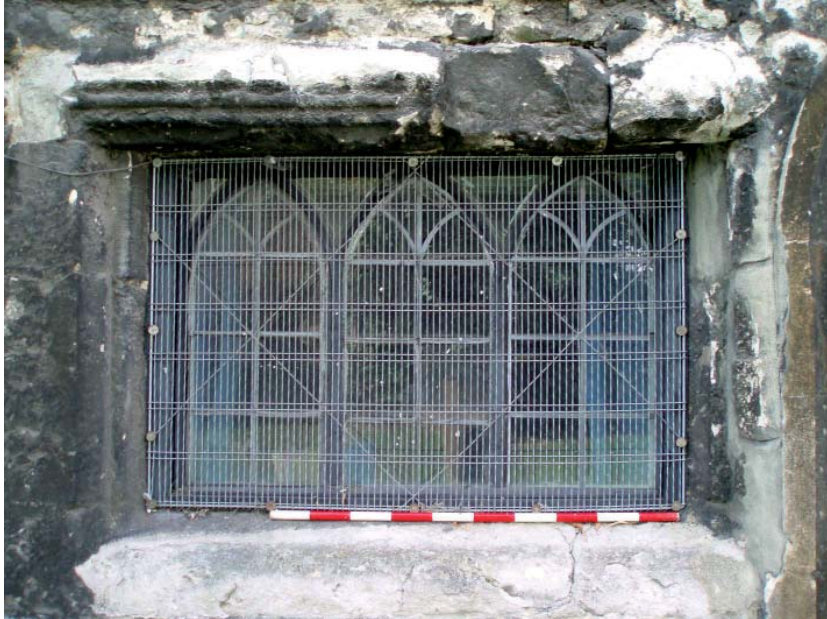
- 1.1.21 Immediately to the south of the door is a primary square headed window (135 x 190 cms) with moulded head, sill and jambs, suggestive of an early 16th century date. The moulded hood around the top of the window is extremely weathered, however the moulding is visible on the southern side. The end of the moulding on the northern side has been cut by the later insertion of the doorway. The moulding arches out approximately 10 cms from the base of the stone. One stone has the face fractured off and therefore has no decorative moulding.

- 1.1.22 The jambs of the window are moulded in a reveal design and there are claw tool marks visible on the south jamb. There is one replacement stone on the north side of the window, this stone also has recent mortaring and is part of repairs to the south eastern jamb of the doorway. The sill is formed from two pieces of stone, which are moulded, and there is a thin layer of slate below the bed joint of the sill masonry at the base of the window. There is a cast iron frame with three arch detail. Some of the lead is recent replacement. The window frame probably dates to the 19th century. The frame and glass are covered by a modern metal protective grille. There is a metal fitment remnant beside the window which is possibly part of a shutter fitting.

Plate 3: All Saints Vestry, Kingston: East elevation - detail of window

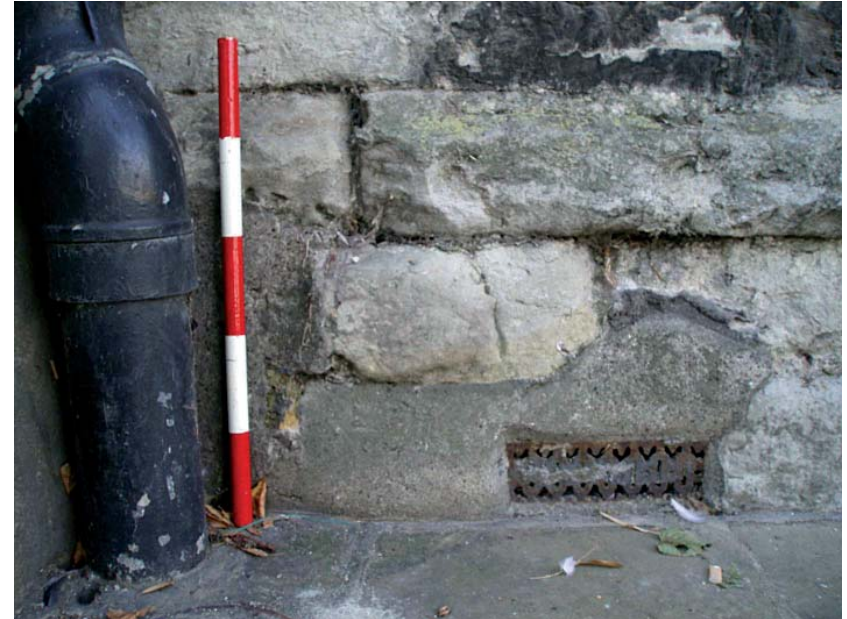
cementitious mortar repair work behind the drainpipe. At the base of the pipe the mortaring extends outwards to a nearby vent. The hole is not lead lined and the stonework within is extremely calcified suggesting it has been there a long time. However, it is probable that this drain was inserted at the time of the 19th century works to the vestry to allow rainwater egress from the newly realigned roof.

Plate 4: All Saints Vestry, Kingston:
East elevation - repair at base of pipe

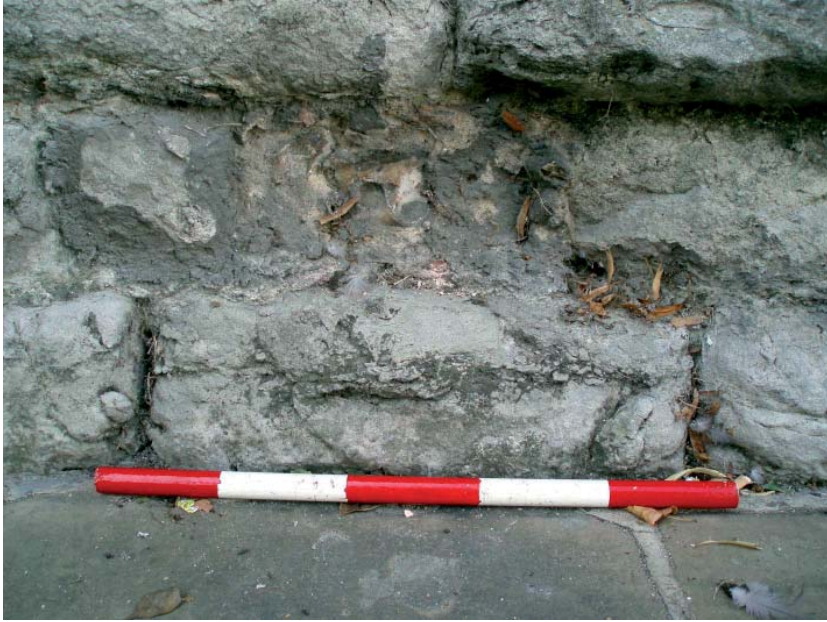
- 1.1.23 At the base of the elevation a single stone has been removed. There is rubble infill but this is recessed into the wall. It is possible that either the rubble infill has eroded or a stone face was applied but has since been lost. This may be the location for a vent which was later closed up.

Plate 5: All Saints Vestry, Kingston:
East elevation - rubble infill at base of elevation

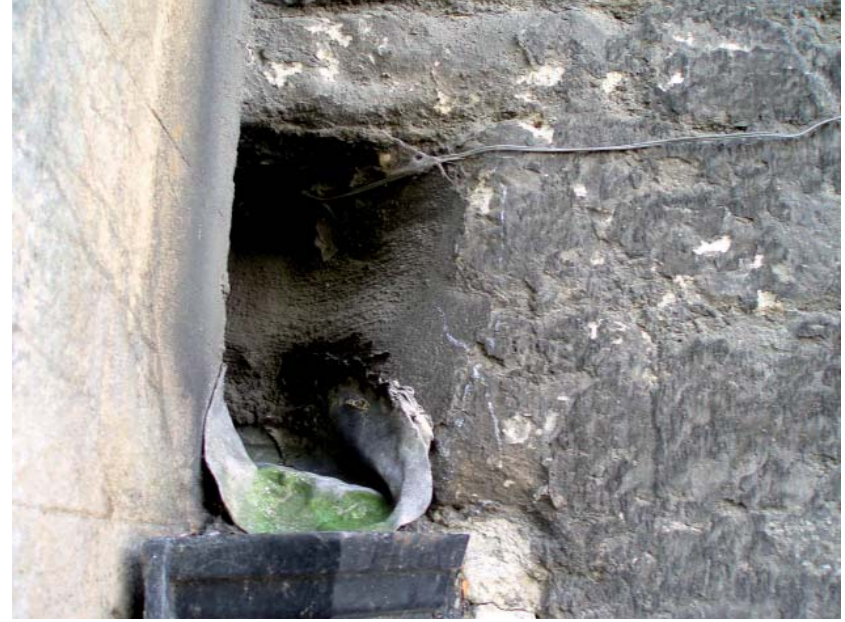
- 1.1.24 There is an unlined drain hole on the southern corner, which begins five courses from the top course. A pipe runs down to the base of the building. There is recent

Plate 6: All Saints Vestry, Kingston:
East elevation - drain hole to south east

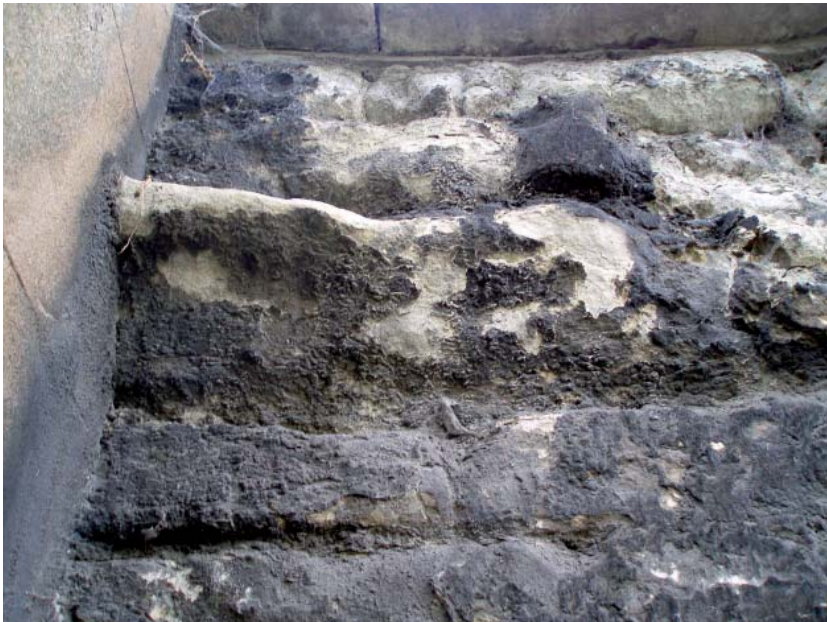
1.1.17 There is a line of prominent string coursing forming the third course down from the top of the wall. The string course is extremely weathered and on this elevation is

most prominent on the extreme south eastern side.

Plate 7: All Saints Vestry, Kingston:
East Elevation - string course

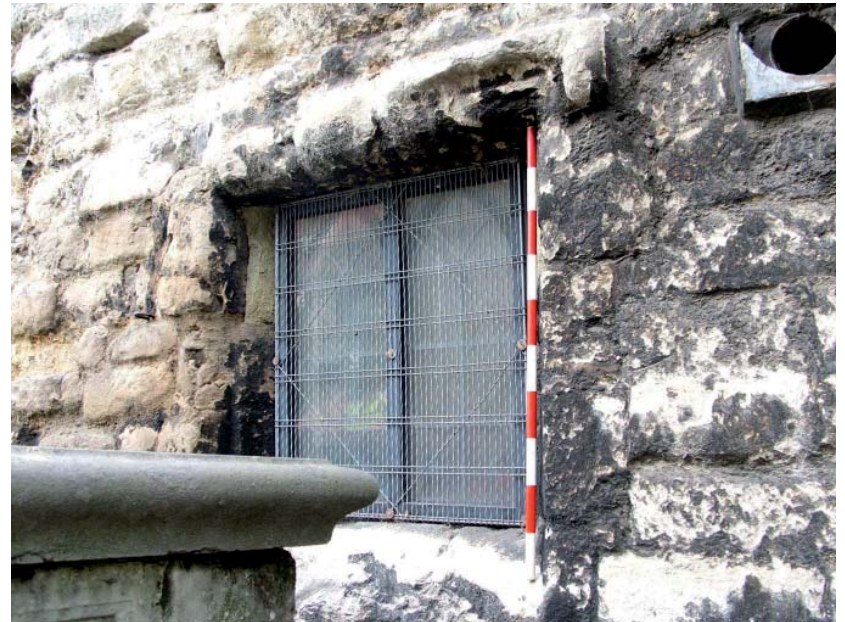
1.1.27 The main feature of the elevation is a window just to the west of centre. At 81 x 89cms the window is narrower than the east elevation window, the hood mould is heavily eroded and the moulding is only visible on the western side. The window has a two arch leaded decoration with clear glass and a protective metal grille. There are two metal fitment remnants either side of the window. The window appears to be primary and is suggestive of an early 16th century date.

Plate 8: All Saints Vestry, Kingston:
North Elevation - window detail

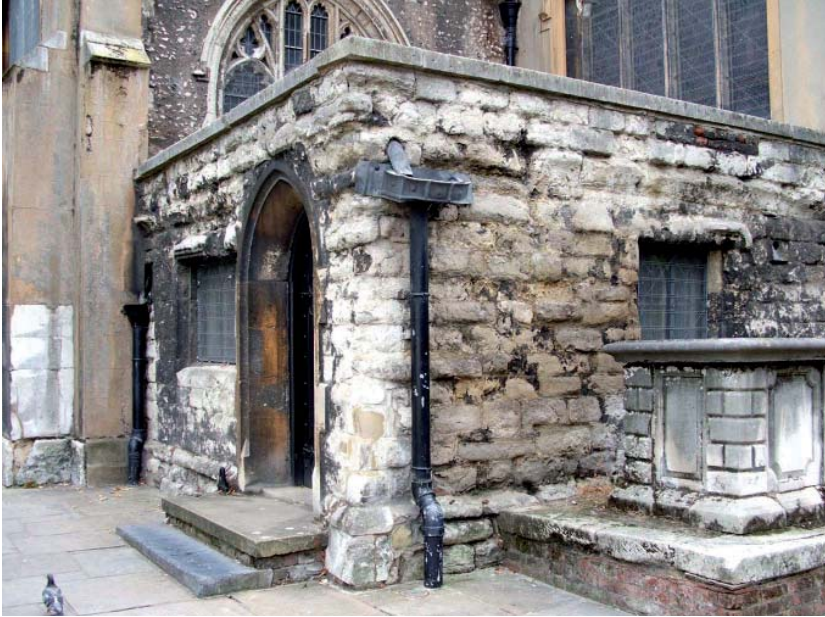
1.1.28 The stonework to the north east of this elevation has a distinctive dark cream colour and the stones are extremely crumbly as a result of damp possibly relating to the drainpipe. The roof of the vestry also leaked on a regular basis (pers. comm. with church volunteer) and this will have affected the stonework.

1.1.29 There are replacement quoins with painted mortaring on the corner of the building as discussed previously in §3.2.10 and there are patches of recent mortaring behind the drainpipe.

Plate 9: All Saints Vestry, Kingston: North Elevation - repairs to corner and discolouration of stonework caused by damp

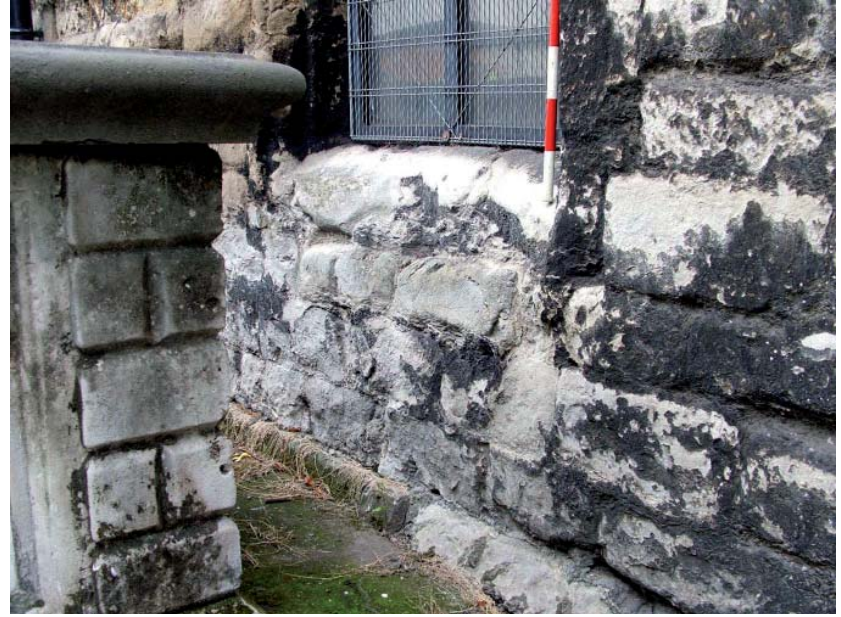
- 1.1.35 Beside this elevation is a chest tomb which has a red brick pedestal abutting against the lower masonry. This tomb has many inscribed plaques most of which are indecipherable. One visible detail is the family name 'Bradney' and a date of 1817 upon one plaque. There are the tops of three possibly upright stone slabs between the lower vestry wall and the pedestal base, probably covering an entrance to a vault underneath.

Plate 10: All Saints Vestry, Kingston: North Elevation - stonework behind the Bradney tomb

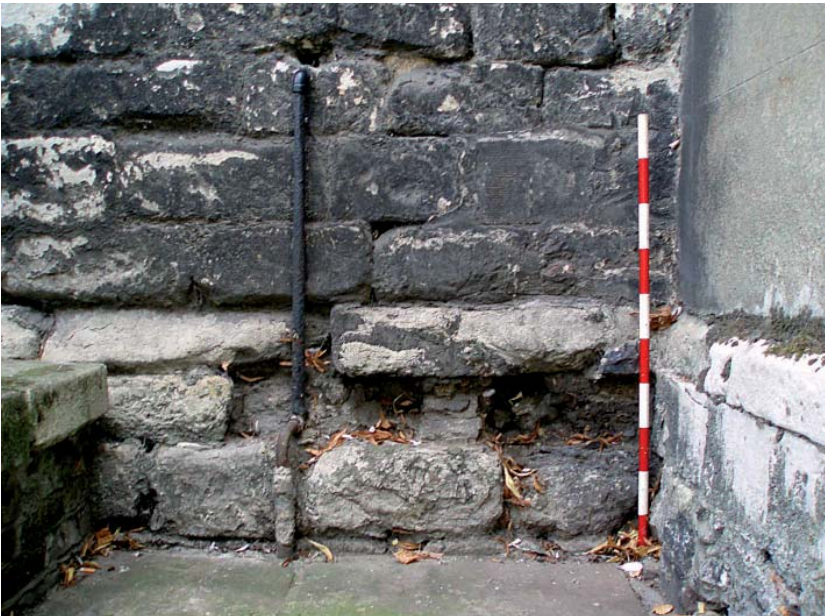
1.1.30 There is a section of red brick replacement on the top course of the right hand side of the building. There are small pieces of red brick/flint infill visible below the window and on top of the course above the drain hole. There is a stone on the 5th course from the bottom on the north western side that appears to be an old replacement. This stone has claw tool marks running horizontally across it.

Plate 11: All Saints Vestry, Kingston: North Elevation - replacement stone with tool marks and weathered plinth

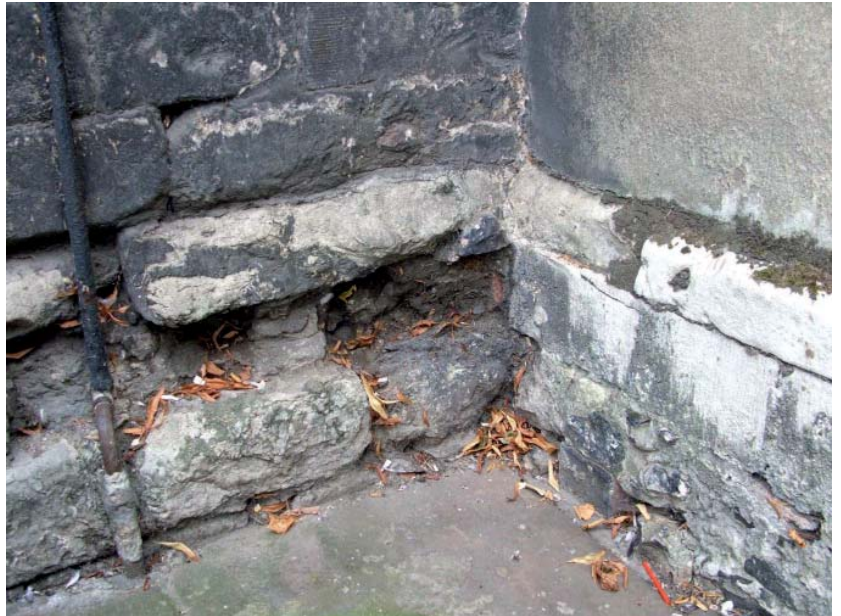
- 1.1.34 From an examination of the join between the vestry and the chapel it can be seen that the vestry is a later addition. The chapel wall is rendered so the join cannot be examined but the stonework at plinth level in both buildings is visible. The corner of the vestry has a specially mitred stone which extends around to form part of the chapel wall. This shows that care was taken to bind the two plinths together but the construction of each is distinct.

Plate 12: All Saints Vestry, Kingston: North Elevation - detail of join with Holy Trinity Chapel

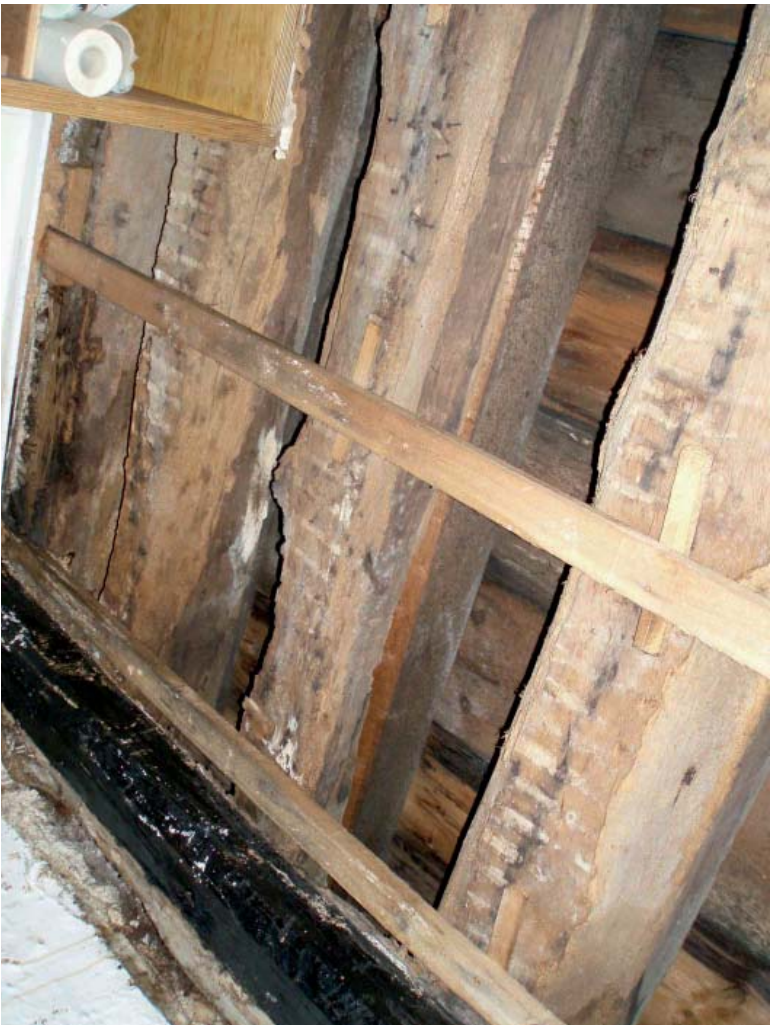
- 1.1.40 When the single-pitch roof was replaced the walls of the vestry were also levelled at the top. The string course remains in its original position upon both elevations.
- 1.1.41 Inside the vestry part of the ceiling has been removed and it was possible to see the oak beams supporting the roof structure. The visible beams measure 10" x 10" and are approximately 16ft long and have imprints of the lath and plaster ceiling that would have once been attached. Some beams have eroded to around 5" deep in parts and, in one case, modern timber had been added to provide extra support.
- 1.1.42 It is possible that some of these beams are primary to the vestry construction and have been reset at the time of the changes to the roofline.

Plate 13: All Saints Vestry, Kingston: Roof timbers inside the vestry

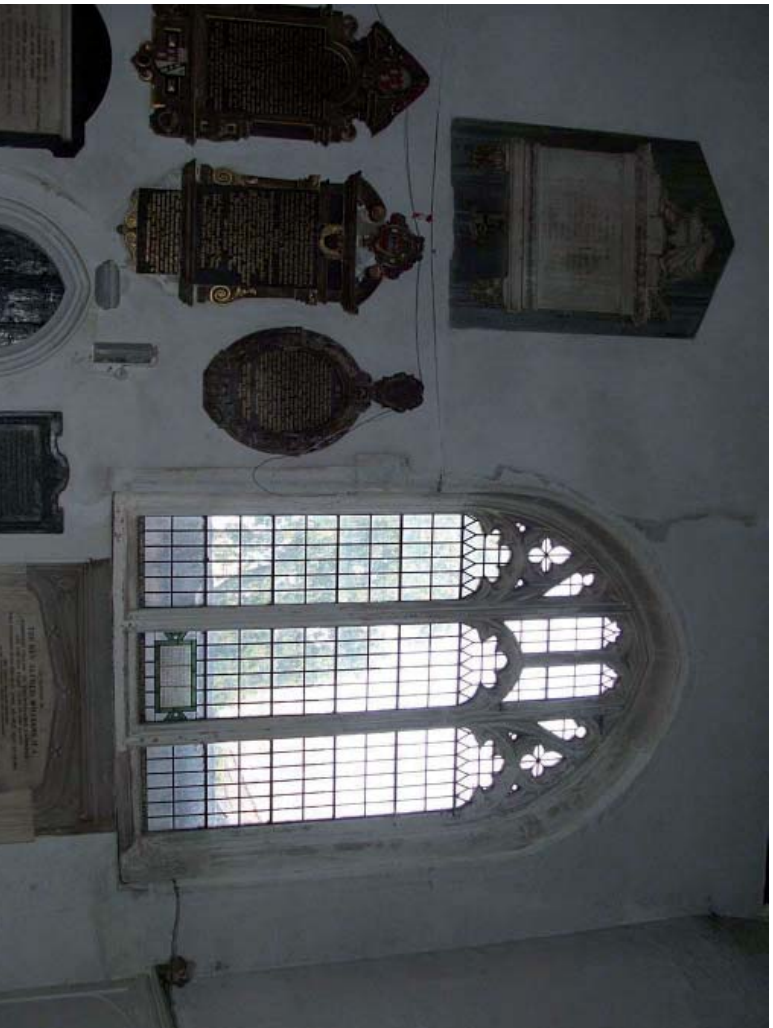
- 1.1.38 During the 19th century works, a medieval perpendicular window was revealed in the north eastern elevation of the chancel. This window had been covered and the wall rendered, probably during the 18th century 'dressing' of the church. The ghost of this window was included in sketches of the church in the 18th century by CT Cracklow (published in 1823) and H Hunt (published in 1851). According to the inscription in the current glass of the window there was a Victorian memorial stained glass window placed there in 1862 indicating that the window was reopened as part of the 1862-6 restoration works.

Plate 14: All Saints Vestry, Kingston: The earlier perpendicular window from inside the church
