St Mary's Church, Shudy Camps A Survey of the Upper Stages of the Tower

Ben Robinson and Anthony Baggs

June 1999

Report No. 160

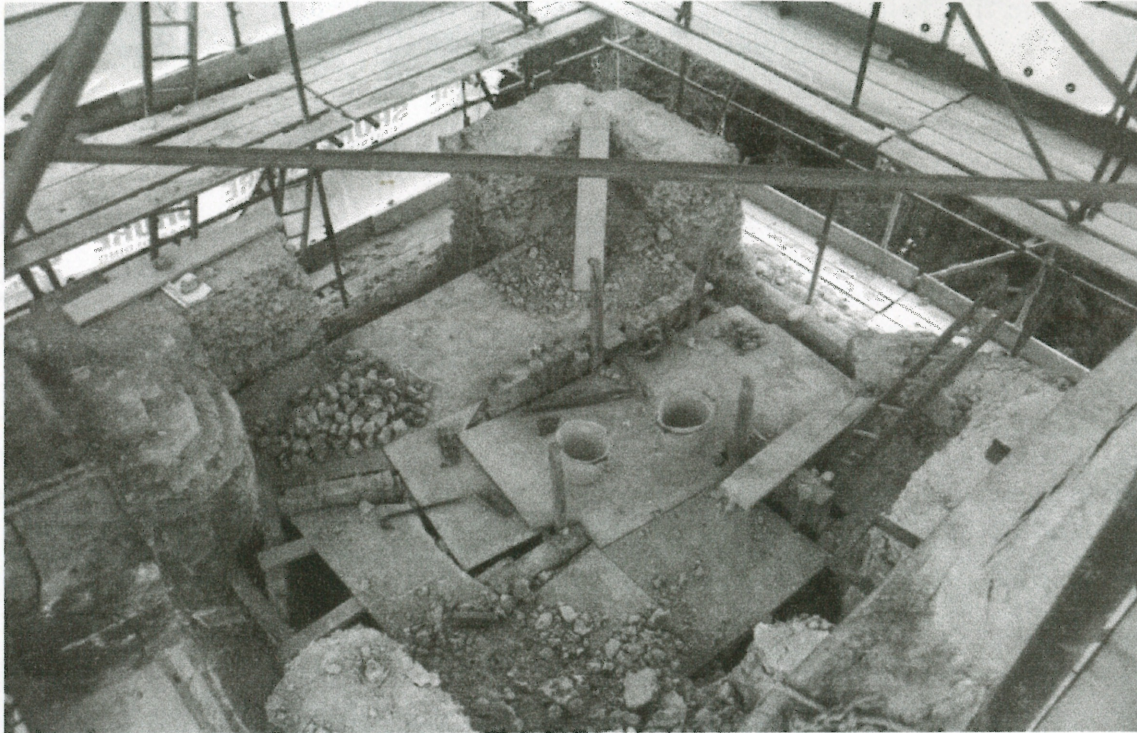
Plate 1 Tower during dismantling, from north-west

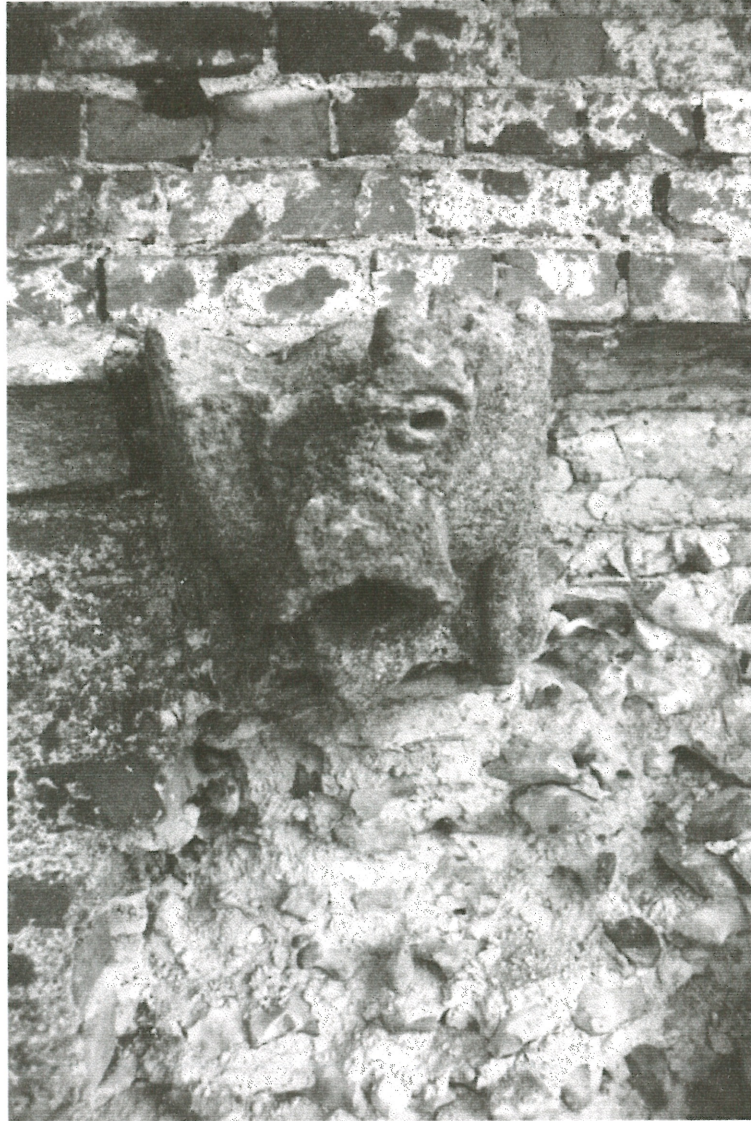
The north and south wall had limestone gargoyles and the west wall had a grotesque (all animal forms) set within the string course.

The shallow-pitch lead roof covering had recently been installed. It is probable that the Barnack limestone dressings and certainly the grotesques and gargoyles were pieces re-used from an earlier upper stage of the tower.

Plate 5 Grotesque on west face of tower parapet

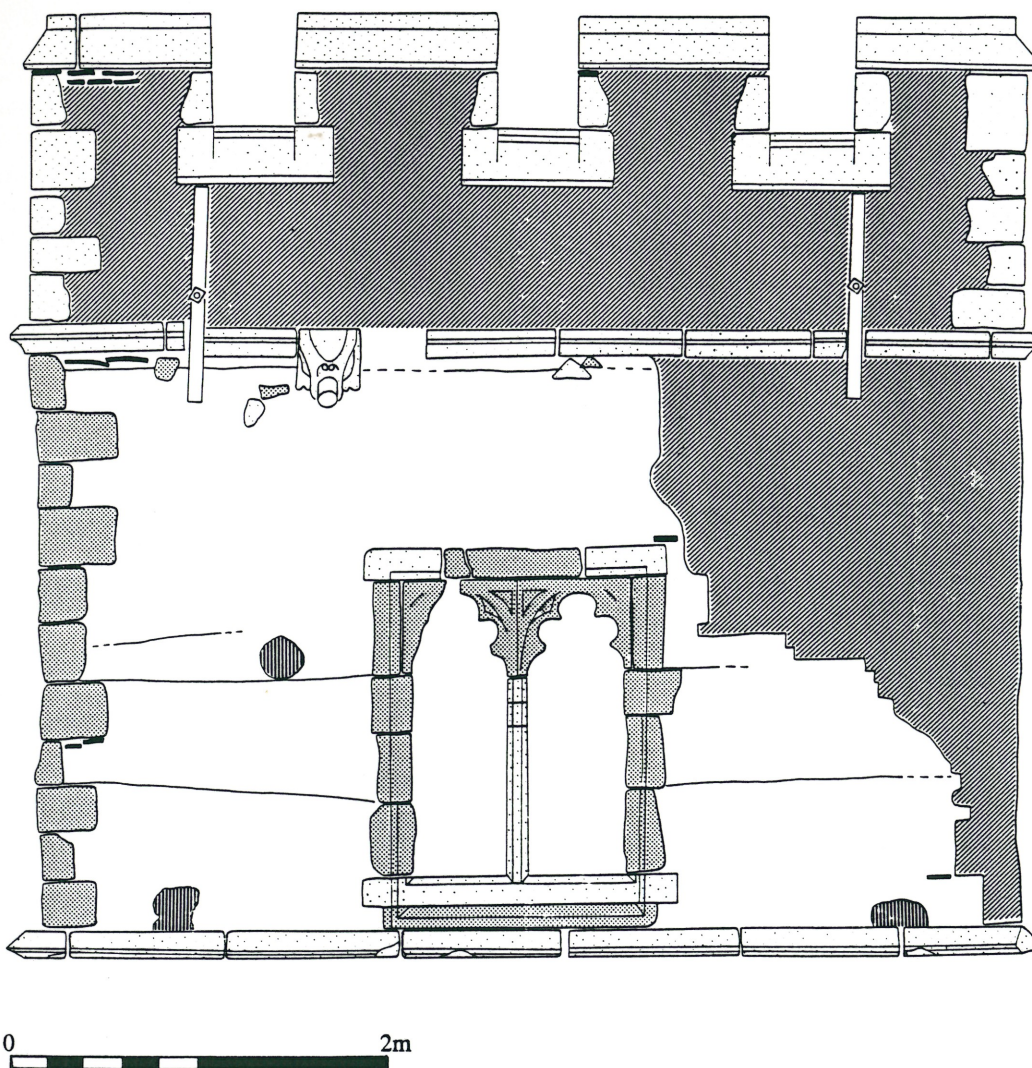
Figure 5 North wall external elevation

A repair of up to four courses of nineteenth century brick (type B1) replaced the outermost course of flint rubble just below the wall plate on the internal face. This was reduced to three courses mid-way along the wall and two courses at its east end. At the west end of the wall, extending to about 1m below the wall plate (and forming part of a repair which had been concentrated on the west wall's internal face) was a small area of uncoursed brick rubble patching (type B5).

The northern face of a large funnel-shaped repair of the north-west corner of the tower which extended onto the west elevation was of brick types B3 and B4. These were largely irregularly bonded, using headers and closers at the repair's limits, but incorporated a pattern of three header courses separated by a stretcher course. A vertical break was visible mid way up. Perhaps indicating two phases of repair.

Two lift lines could be seen on the external face of the north wall. The first was 12 flint courses above the belfry level string course. The second was nine courses above the first to the east of the window and ten courses higher to the west. A lift line could be seen on the internal face extending across the wall at the level of the topmost ashlar of the window jamb.

Three putlock holes were visible externally, a fourth had been blocked by the brick repair of the north-west corner. The lower of these rested upon the belfry level string course. The two upper putlock holes were neatly framed with clunch and capped with limestone lintels. The lintel of the eastern putlock was found to be a fragment of grave cover ($\Delta 11$).

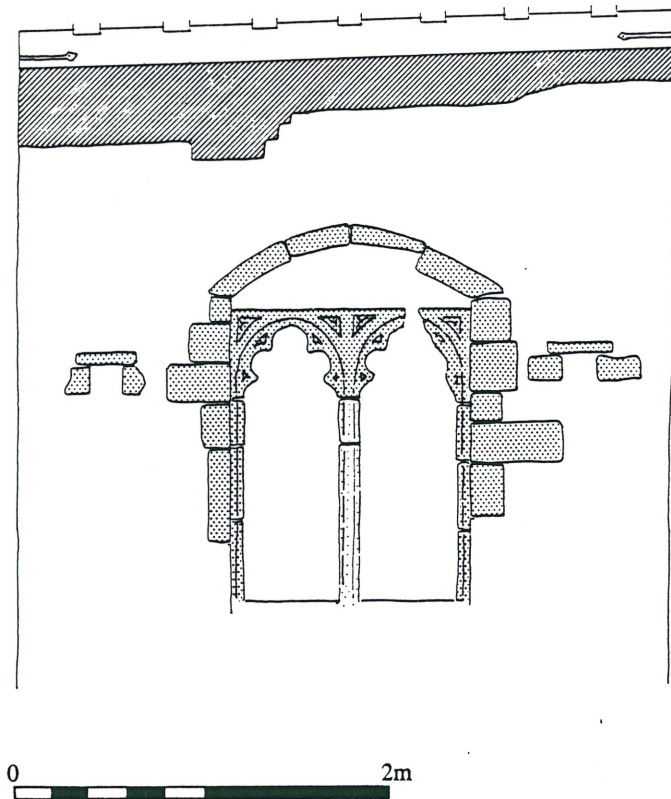
Figure 6 North wall internal elevation (Drawing by A. Baggs)

The render had been completely removed from the external face before the survey. The internal face was almost completely covered with nineteenth century plaster P1 (see *Appendix II* for plaster types). This plaster overlay brick coursing (of type B1 and B6) but was run out to leave the ashlar of the window reveals exposed. The second and fifth ashlars on the east side of the reveal had 'W.K.1699' and 'BR' respectively

inscribed on their west faces. Its removal revealed two small patches of plaster of types P3 and P4 (possibly also nineteenth century) above and to the east of the window. They abutted one another with no clear stratigraphic relationship. P1 also filled a shallow recess in the lower east portion of this internal face. This informal recess had been excavated into the wall to accommodate the swing of the added north-east bell.

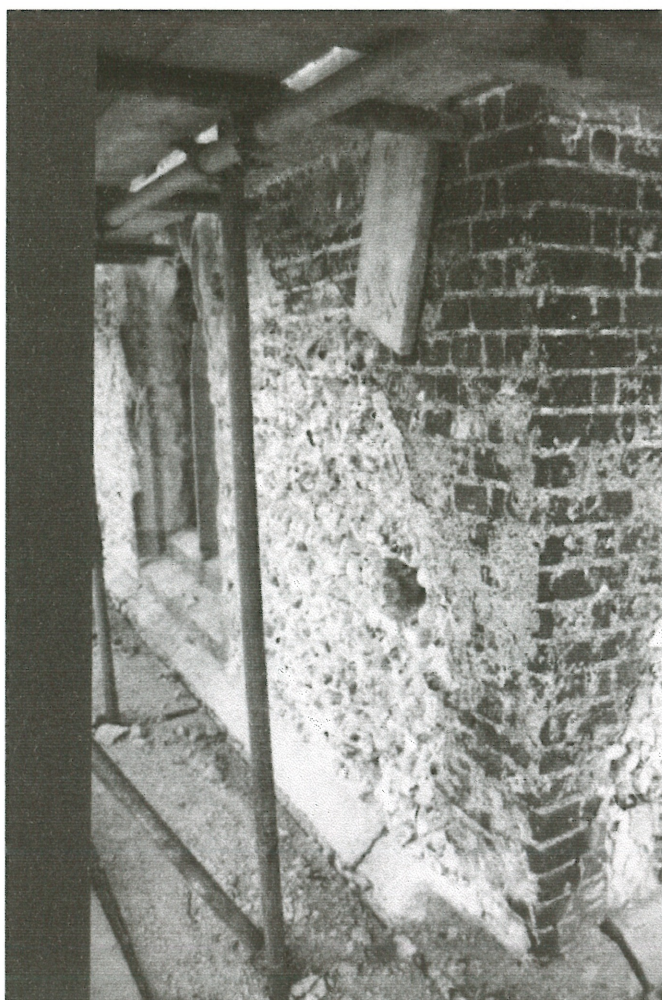
Plate 8 Brick repair of north west corner at belfry level

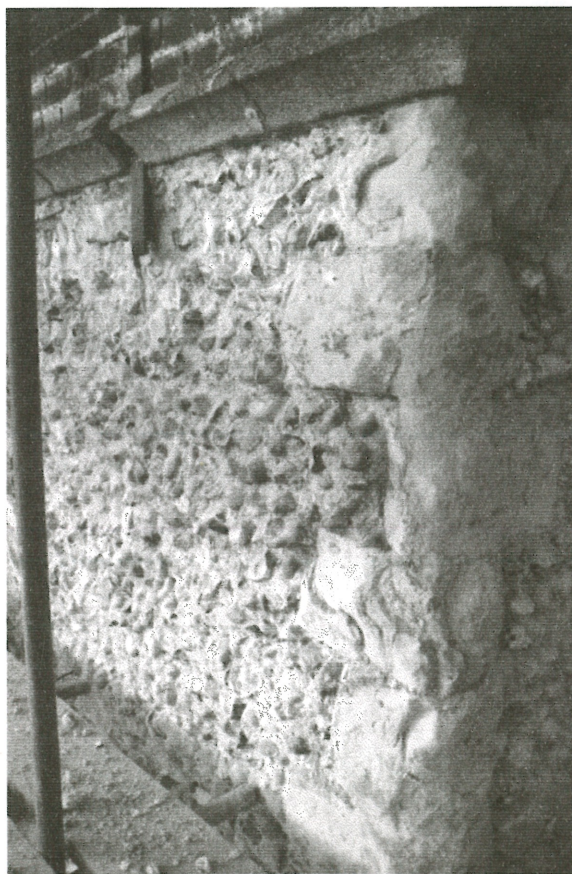
Plate 11 South wall east quoin

A small brick patch (11 courses of type B2) had replaced all but two fragments of the lowest south-east quoins.

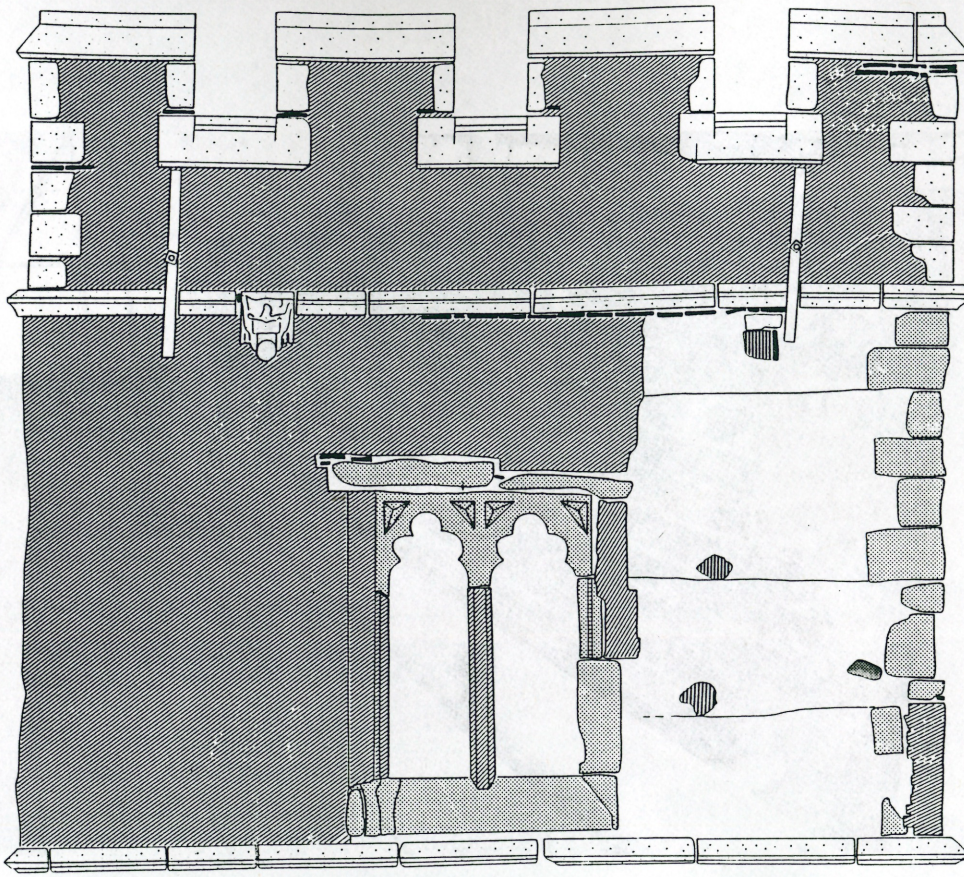
Figure 7 South wall external elevation

A large patch of brown concrete render (which had evidently covered most of the exterior of the tower) remained on the western part of the external face, where it overlay a rebuild of large, regular bricks (type B6). Plaster P1 covered the eastern portion of the internal face but left exposed the brickwork of the western part of the face (also type B6), and the ashlar of the window reveal. The top ashlar of the east side of the reveal had 'HW 1786' inscribed upon it. P1 overlay P7, a small patch of hard creamy-white plaster.

The west part of this wall between parapet level and belfry level string courses, had been entirely re-built in brick (type B6, mostly in English bond though becoming irregular towards the edges of the re-build), leaving only a portion of the wall east of the window in its original coursed flint rubble form. Mid-way up the wall, on the internal face, the brickwork was offset by half a brick. Below this the wall curved to meet the window reveal in order to accommodate the bell frame.

The west jamb, east jamb and mullion of the central two-light window were of brick (type B6). The cusps, sill and lintel were of badly weathered clunch. Moulded bricks (as type Bx) formed the shape of the replaced mouldings and jambs. Render had been applied to both brick and clunch to further mimic the form of the original mouldings. The internal relieving arch of the window was segmental and formed of two courses of headers on edge (also B6).

Lift lines could be seen on the external face of the small portion of original wall that remained to the east of the window. The first was 11 flint courses above the belfry level string course. A second could be discerned 12 courses above this, and a third 17 courses above the second. Only one possible lift line was located on the internal face; here the rubble was less well coursed than on the external face. The flint rubble wall was 860 mm thick mid-way up this stage and 840 mm thick just below the parapet level string course.

Three putlock holes were located. The upper of these was framed with peg tiles and a fragment of limestone on the external face. The lower two surmounted the lift lines and were blocked with clunch lumps. The middle putlock hole was neatly framed with clunch and capped with a limestone lintel on the internal face. The lintel was later identified as a fragment of grave cover (Δ 13) similar to that in the north wall (Δ 11, above).

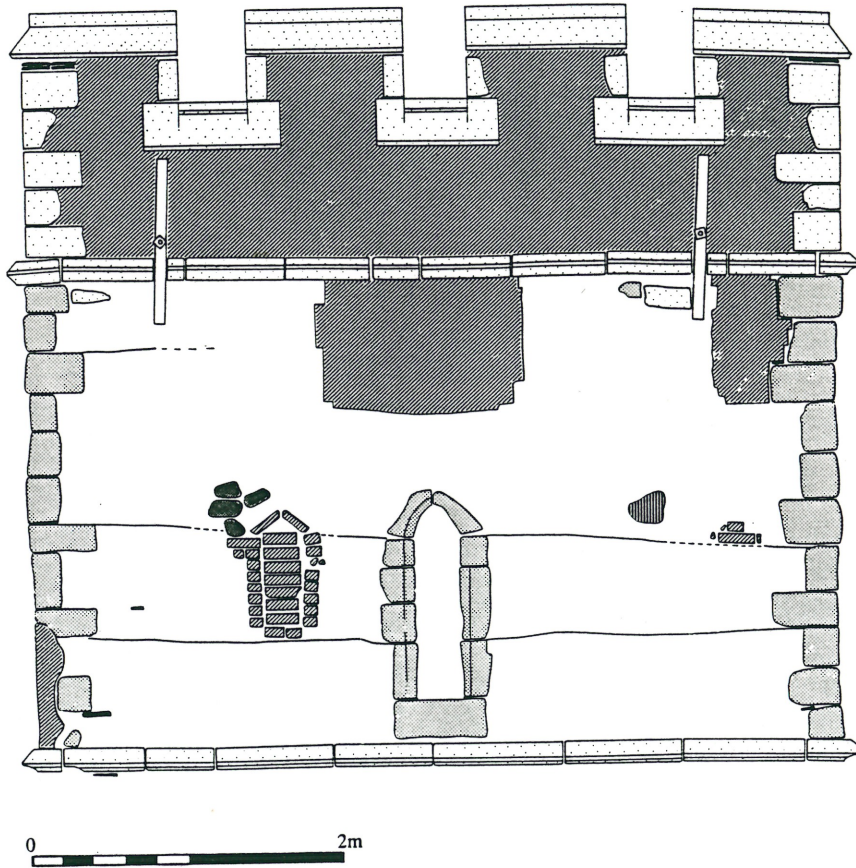
Figure 9 East wall external elevation

A large expanse of brick patching incorporating peg-tile fragments (12 courses, English bond, type B2 bricks – the upper two courses were inclined and separated from the lower course by half a course at one end), was encountered just below the parapet-level string course. Another smaller patch (11 courses, English bond, also type B2) abutted the north-east clunch quoins.

On the external face the opening was framed with half-bats and one complete brick (of type B7, a smallish irregular unevenly fired brick) and capped with two brick slips/tiles (similar in consistency to B7). It had obviously been inserted and seemed to have no real function. This, together with the original window, formed an incongruous and asymmetrical addition to the east wall. It had been bricked up with bricks of type B8. The central lancet of the east wall was formed of clunch.

Two lift lines could be seen on the external face. The first was 11 courses above the belfry-level string course, the second was 10-11 courses above the first. The upper lift line was markedly thicker than the lower (up to 30mm). Short lengths of two possible lift lines could be discerned above these at the southern end of the external face but could not be traced any further due to the irregularity of the coursing at this height. No lift lines were observed on the internal elevation.

A single putlock hole, sealed with a clunch block, was seen to the south of the two windows. A second at the same level was seen to the north.

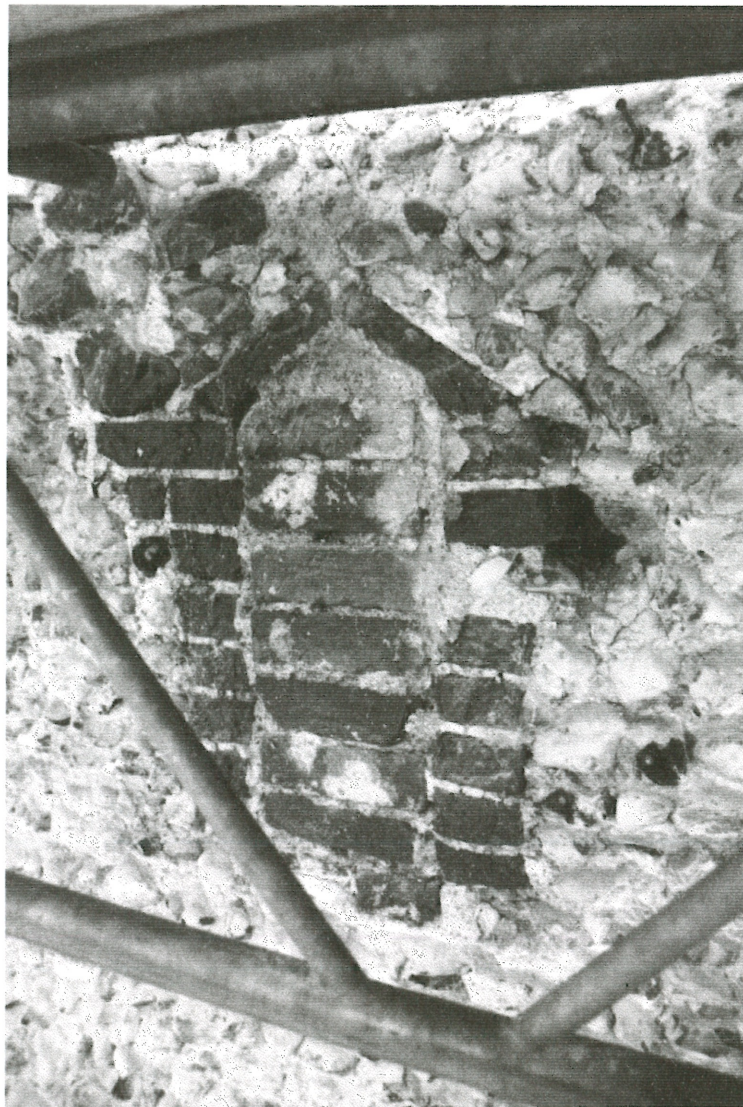
patch and timber work described above) and partly of flint. The blocked reveal of this curious opening was packed with clunch blocks, including one with moulding similar to that of the sides of the two main two-light windows. It had been sealed with plaster P1.

Plate 14 East wall belfry level blocked light

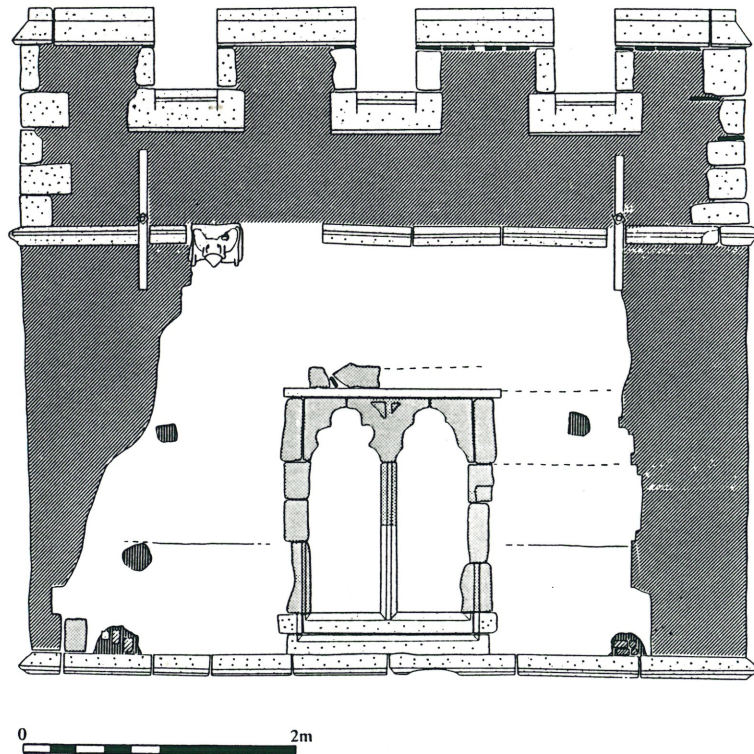
Figure 11 West wall external elevation

There were two extensive areas of brick patching on the external face. The northern patch was of type B3 and B4 and replaced all but a fragment of a single clunch quoin. The southern patch (type B6) was part of the rebuild of the south-west corner of the tower and was the entire width of the wall.

The centrally-placed window was of cusped two-light perpendicular style. Its tracery and jambs were of very badly eroded clunch. The sill was of limestone, as was part of the mullion (a repair). A thin limestone lintel had been inserted beneath its crumbling clunch predecessor.

Attempts at re-pointing during earlier restoration work had resulted in the collapse of part of the flint rubble wall beneath the grotesque and parapet level string course. At this level on all of the tower's external faces, very little mortar remained to bond the rubble together. That which remained was powdery but became much firmer towards the base of the stage.

The flint rubble walling was 860mm wide at mid-window level and 800 mm wide just below the parapet level string course. It was less well coursed above the window on the external face than elsewhere suggesting a rebuild. A lift line was visible 11 courses above the belfry level string course to the south of the window; a possible second could be discerned 11 courses above the first. The lower of these could also be traced in the northern portion of the wall.

Four putlock holes were located. The south upper one was blocked with a lump of clunch. The others were blocked with brick.

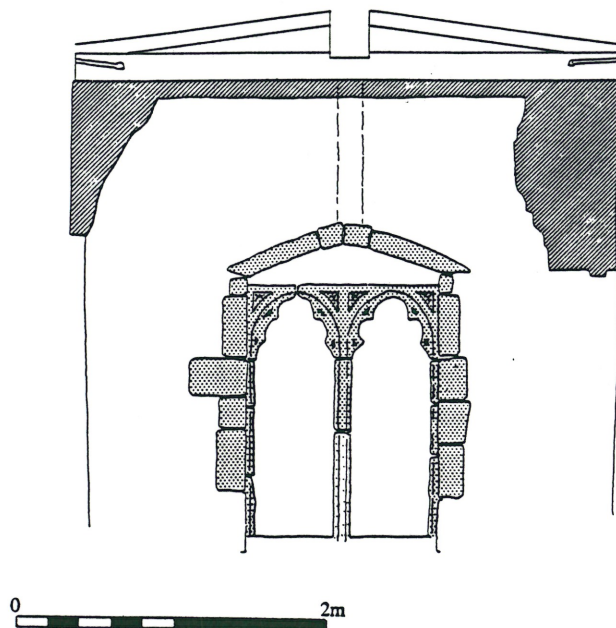
Figure 12 West wall internal elevation (Drawing by A. Baggs)

All the render had been removed from the external face before survey, but plaster (type P1) covered most of the internal face. This sealed two courses of brick (type B1) below the false tie beam, and a crude rubble repair (of brick type B5) at the north end.

It ran out to leave the window reveal ashlar exposed. The second and fifth ashlar had 'NCR' and '1776 M' inscribed on them. The second and fourth ashlar of the south reveal were marked '16' and '1690'. It sealed plaster (P3) which was confined to a small central patch above the window. This patch of plaster had a central scar (c 200mm wide) indicating the position of a former vertical timber which had run from the centre of the window arch to the roof.

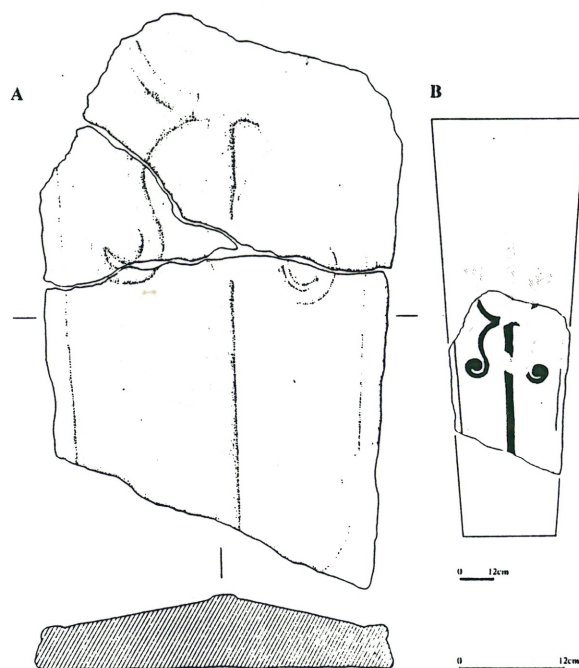
Three pieces of a grave cover were recorded as dismantling progressed. Two pieces ($\Delta 11$ and $\Delta 13$) had been reused as putlock lintels in the north and south walls. The third piece ($\Delta 12$) was removed from the north wall. The three pieces formed the mid section of a Barnack school grave cover. This example shows the raised central ridge and double 'omega' design developed in the twelfth century (Butler 1957).

The use of fragments of the grave cover in the modifications and repairs to the upper part of the tower confirms the presence of an earlier church and disturbance of the grave long after the initial burial.

Figure 13 Grave cover of Barnack stone ($\Delta 11$, $\Delta 12$ and $\Delta 13$) (Drawing by C. Malim)

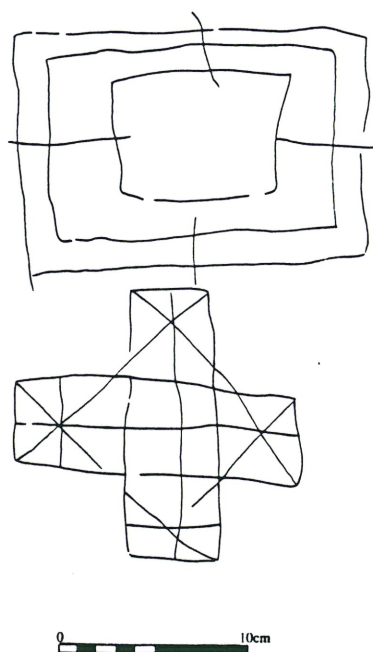
The second came from the east facing face of the eastern sill in the south window. A nine-men's morris board was found in association with another design, probably also a board game, rather than an aid to assist architectural measurements. The position of this piece suggests that upended it formed a convenient temporary gaming table during the building works.

Figure 14 Graffiti 'games': east facing face of the eastern sill in the south window
