Archaeological Investigation at Elms Farm, Folksworth

A Hatton & S Leith

Cambridgeshire County Council

Report No. A106

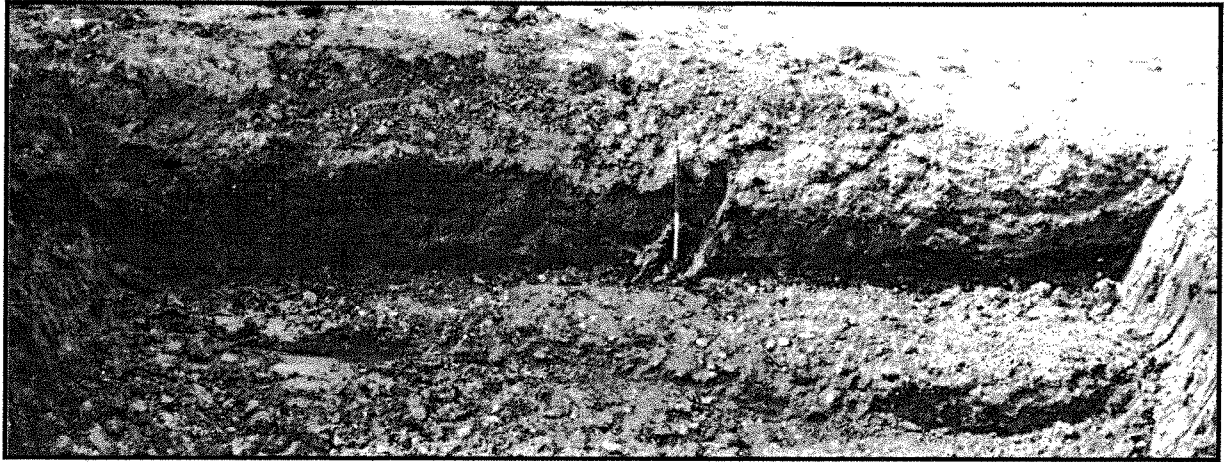
The pond appeared to become shallower towards the west, and did not appear in the east-facing section. This section showed a wide ditch, 1.5m deep and 6m wide (Plate 1). The section showed the following sequence: 1) excavation of the ditch, 2) lining of the cut with a layer of pebbles and brick, 3) build-up of a black organic layer (0.30m thick), and 4) a light brown deposit (1.2m thick) with no evidence of organic material. The bricks in the primary fill dated to the 18th century (P. Copleston pers. comm.).

The wide ditch in the east-facing section, which was cut by the modern pond, may be the moat which was recorded by the RCHM(E) in 1926 as largely obliterated.

Plate 1: East-facing section in Trench 1 showing ditch

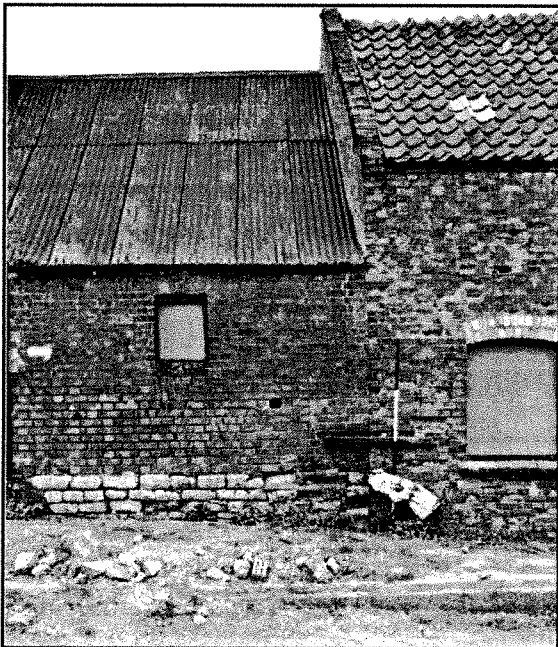
Plate 2: West wall of barn

The barn was largely built of brick and constructed during the later half of the 19th century, however this building was erected on stone foundations from an earlier building in the same location (Plates 2 and 3). Four courses of stone work survived, and was constructed out of either Collyweston or Barnack stone. The earlier building, which had no associated evidence to suggest its date of construction, was demolished down to the foundations by 1870-1900, when the new barn was built. It would have been rectangular in plan, measuring c 24m by 5m.

Two different materials were used in the construction of the roof: the more northerly barn had a pan tile roof, whereas the southern barn's roof was made of corrugated iron (Plate 2). Both parts of the roof were probably erected during the 1950s. The interior roof supports had been replaced fairly recently as they showed no signs of decay. This is quite remarkable due to the fact that the pan tiles were progressively parting company with the roof laths and the corrugated iron was rusting badly, exposing the internal wooden structure of the roof to the elements.

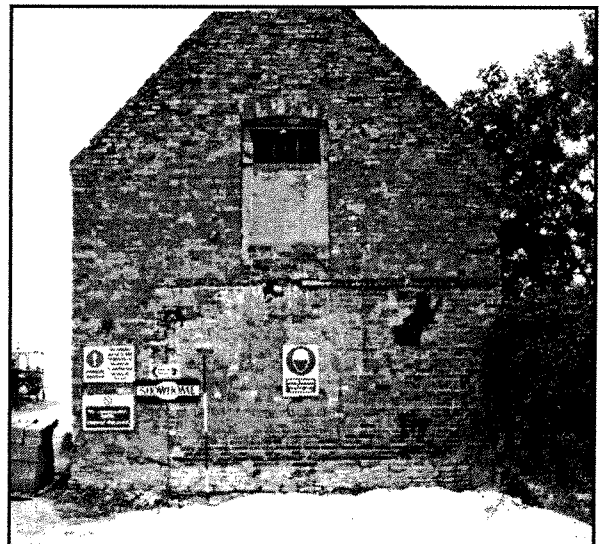
Plate 3: North gable-end of barn

The barn had not been maintained over the years, which can be seen in excessive erosion of the bricks many of which have lost their smooth facing through water and frost action. The fabric of the barn showed evidence of ground subsidence in the form of extensive cracks in the north gable-end, and tie bars have been used to stop the west and east facing walls from 'bellying out'. Apart from the two doorways in the east wall, it would appear that the building was constructed without windows, the evidence for this suggestion derives from the fairly modern window jambs.

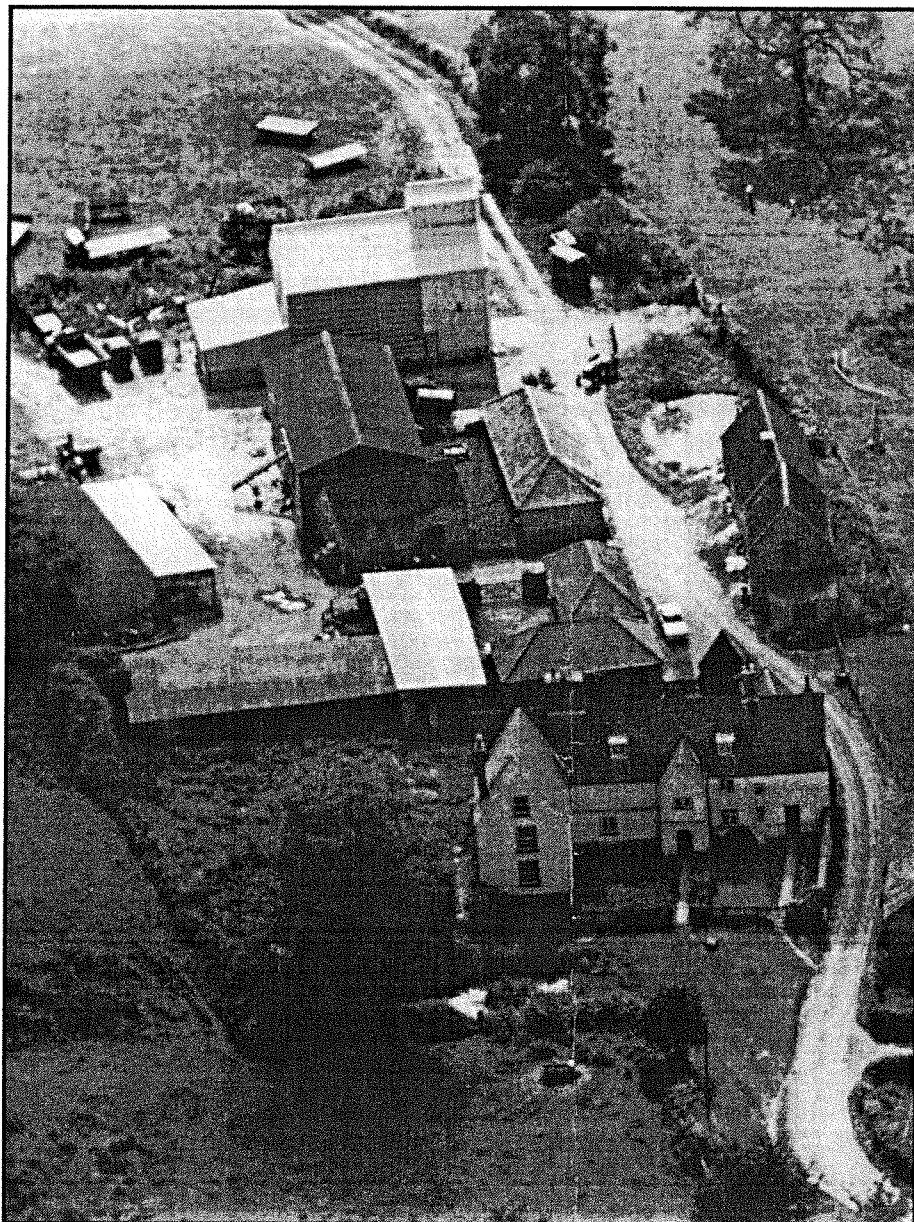
The Cambridge University Committee for Aerial Photography collection contained no photographs showing the proposed moat. However, an aerial photograph taken within the last 30 years (probably in the 1970s) owned by the farmer showed one of these ponds in the north part of the site, and the possible vestiges of the moat in the form of slight earthworks (Figure 2, Plate 4). These were very ephemeral in places, however they indicate a rectangular area of about 320 square metres, enclosed within a moat about 7m wide.

Plate 4: Aerial photograph of Elms Farm c 1970
