## GAWTHORPE GREAT BARN, PADIHAM,

## **LANCASHIRE**

# **Historic Building Survey Report**

Issue No: 2014-15/1531 OA North Job No: L10668

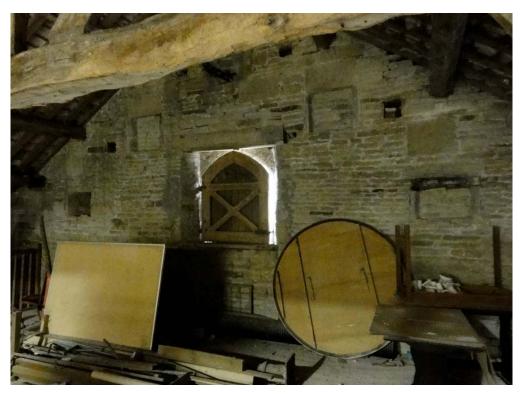
Plate 3: The interior of the upper portion of the southern elevation showing apertures blocked by the later outer skin

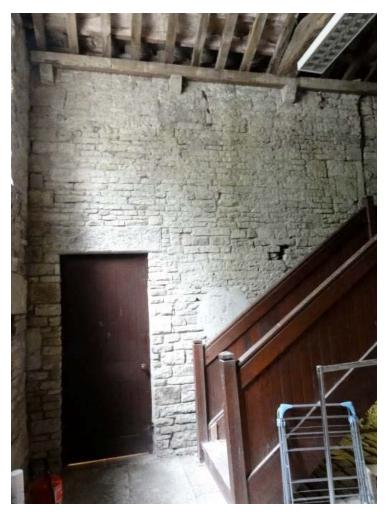
Plate 5: The southern end of the western wall of the Great Barn, looking west. The character of the wall suggests it is probably original, as does the blocked opening just visible above the stairs, near the top of the wall

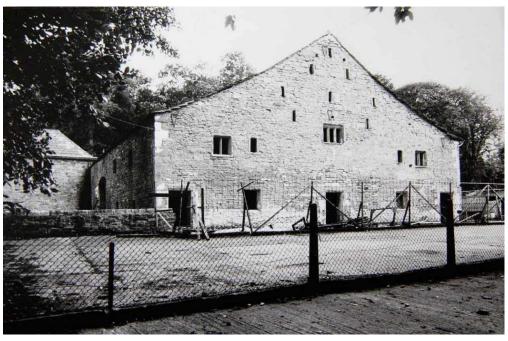
Plate 7: Photograph of the northern elevation of the barn taken in 1984. The three windows visible on the plan of 1981 have already been blocked

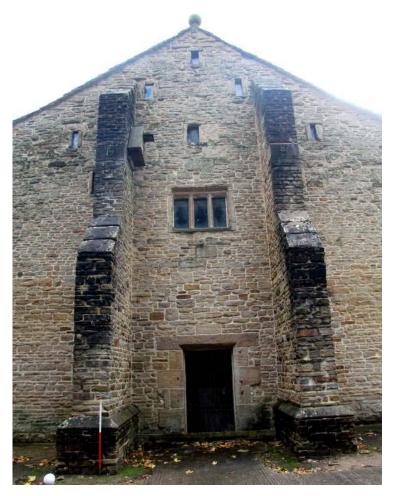
Plate 9: The supporting buttresses at the northern gable end of the Great Barn, with date stone towards the top recording their construction in 1987

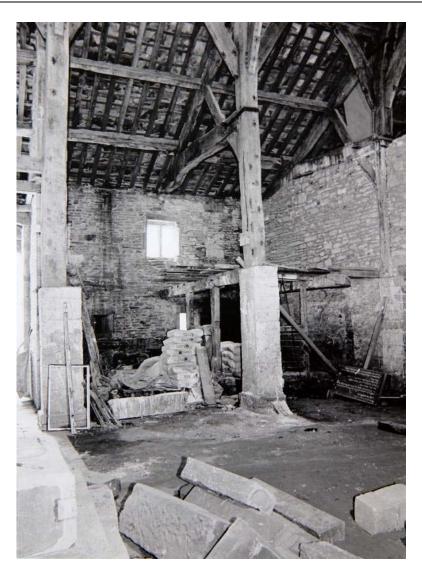
Plate 14: the interior of the barn in 1987, showing the shippon in the southeastern corner during restoration, and also showing a clay floor surface (prior to its replacement with concrete in 2000)

- 3.4.16 *Interior*: internally it is clear from the present barn that the brickwork paths and cobbles in the north-eastern area of the interior of the barn were indeed removed and the floor on either side of the threshing bay was laid in concrete. It is also evident that the two bays to the south of the main western door were partitioned off from the main barn with the erection of a stone wall. A photograph from 1987 suggests that extensive repairs were undertaken to the shippon in the south-eastern corner of the main barn (Plate 14).

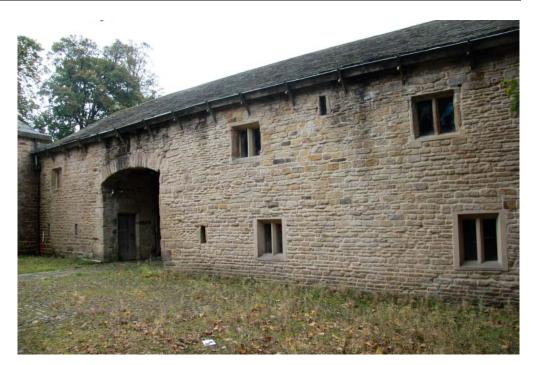
- 4.3.10 East Elevation of the Barn: the east facing long elevation of the main barn (Fig 23, Plate 29) contains a large cart door-opening, as well as five mullion windows and six vertical ventilation slits. The stonework of the elevation is similar to that on the lower portion of the principal elevation, and there is some variability in the nature of the coursing and size and shape of the stonework. Much of the elevation consists of fairly evenly-coursed narrow stonework but there are several areas of larger blocks with wider coursing (Fig 23). There appears to be no particular pattern to this and some may relate to the alterations carried out in the 1980s (Section 3.4.4), although some string courses of larger stonework is present. This is similar to string courses on the west elevation (Section 4.3.23). The elevation appears to have been recently and extensively re-pointed, masking several blocked openings known from the LCC plans to have existed (Fig 16).

Plate 29: The east elevation of the main barn

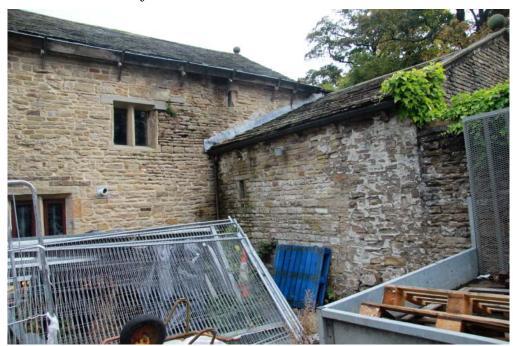
4.3.26 The toilet block extension butts against the elevation at the southern end and, in common with the carriage house on the east side, obscures approximately 25% of the wall area. The pitched roof of the toilet extension slopes to the north, the join being covered with lead flashing (Plate 35). The north elevation of the store/ toilet block extension is of similar appearance to the barn elevation, of fairly regularly coursed stonework with degraded mortar in places (Fig 25). The west side of the elevation has visible patches of lime wash (Fig 25). There is a single, small glazed opening in the elevation which is of similar appearance to some of the vertical ventilation slits on the elevations of the barn. It has simple stone jambs and a stone lintel. An ogee gutter is present and is supported upon six stone brackets identical to those on the south elevation of the extension (Section 4.3.8). An iron down pipe is present at the east side close to the join.

Plate 35: Join between the toilet extension and the west elevation of the barn

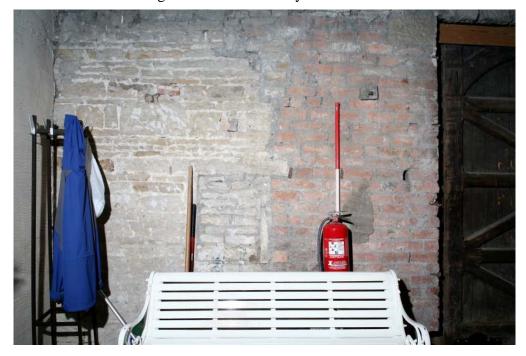
- 4.4.5 The south wall of the room, and the whole of the south wall of the barn in general, exhibit significant phases of alteration (Fig 26) with areas of blocking and repair, and is visible also from the upper mezzanine area (Room 8). The exterior wall of the principal elevation has been refaced which hides all evidence of these fabric changes from being viewed externally (Section 4.3.2). The fabric of the internal face of the wall is similar to that of the main external elevations of the barn (excepting the southern wall) already described, there also being some evidence of possible wider string courses similar to those on east and west elevations. Much of the area below the windows has been altered, the main visible evidence being the rebuilding in red brick of a section of wall incorporating the east side of the central door (Fig 26; Plate 39). The brickwork is laid in stretcher bond, and is of nineteenth century appearance. To the east of this is a blocked aperture (possibly a ventilation hole) that measures approximately 0.5m wide by 0.7m high (Plate 39).

Plate 39: Blocking and alteration on the east side of the internal aspect of the south wall of the barn within Room 1

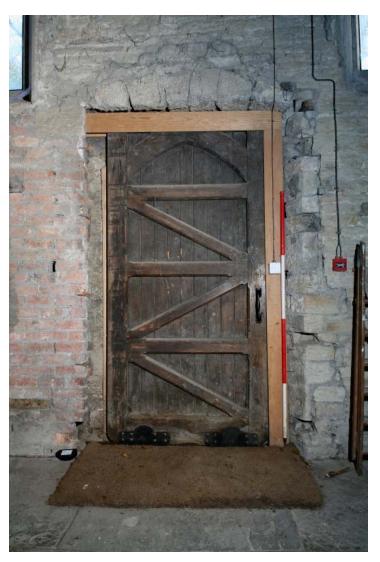
- 4.4.6 The construction of the central doorway is visible and differs from the external appearance which is formal and finely finished (Section 4.3.3; Plate 40). The interior view reveals that the door is of ledge and brace construction all of which are chamfered with run out stops. A segmental arched member at the top of the door reflects the shape of the two-centred arch of the surround; the door frame appears to be a recent replacement. Inspection of the reveal appears to suggest that the opening was cut into the pre-existing wall and may explain the rebuilt section of wall on the other side of the door. This may have collapsed during insertion of the doorway.

Plate 40: Central doorway in the south wall of Room 1

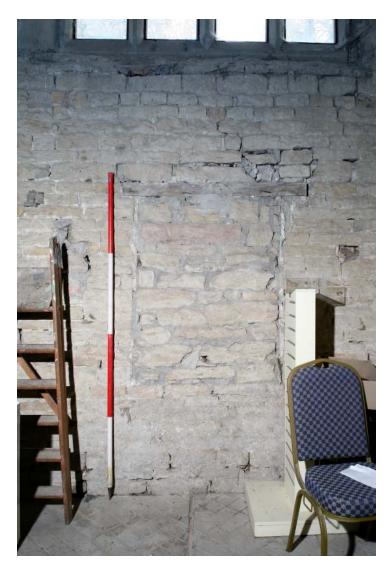
- 4.4.7 To the west of the central doorway is a further blocked opening that is larger than that to the east of the door and has a timber lintel (Fig 26; Plate 41). This measures approximately 1m wide by 1.3m tall and was probably a former window that was covered during the erection of the outer wall; there is no evidence for this having ever been a doorway.

Plate 41: Blocked aperture to the right of the main door on the internal aspect of the south wall of the main barn within Room 1

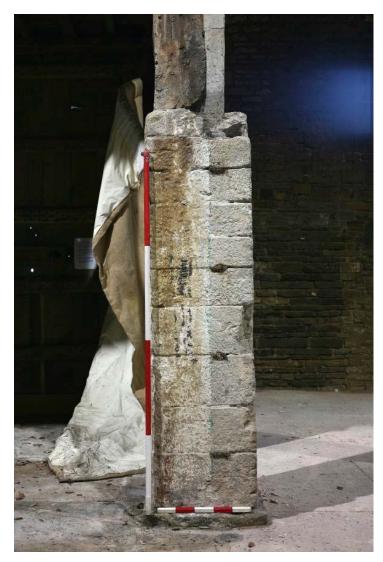
Plate 54: Example of vertical scarring on a stone plinth

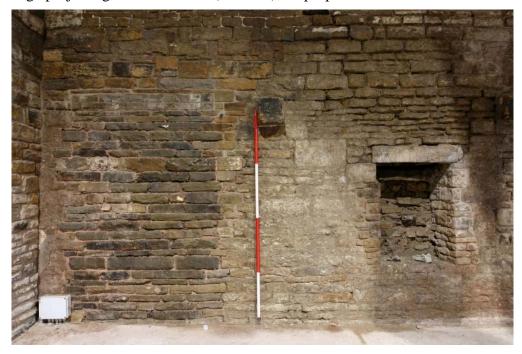
Plate 64: Blocked door and window on the west internal elevation of the barn
