# **Kirk Mill, Chipping, Lancashire**

## **Archaeological Building Investigation**

**Oxford Archaeology North**

August 2013

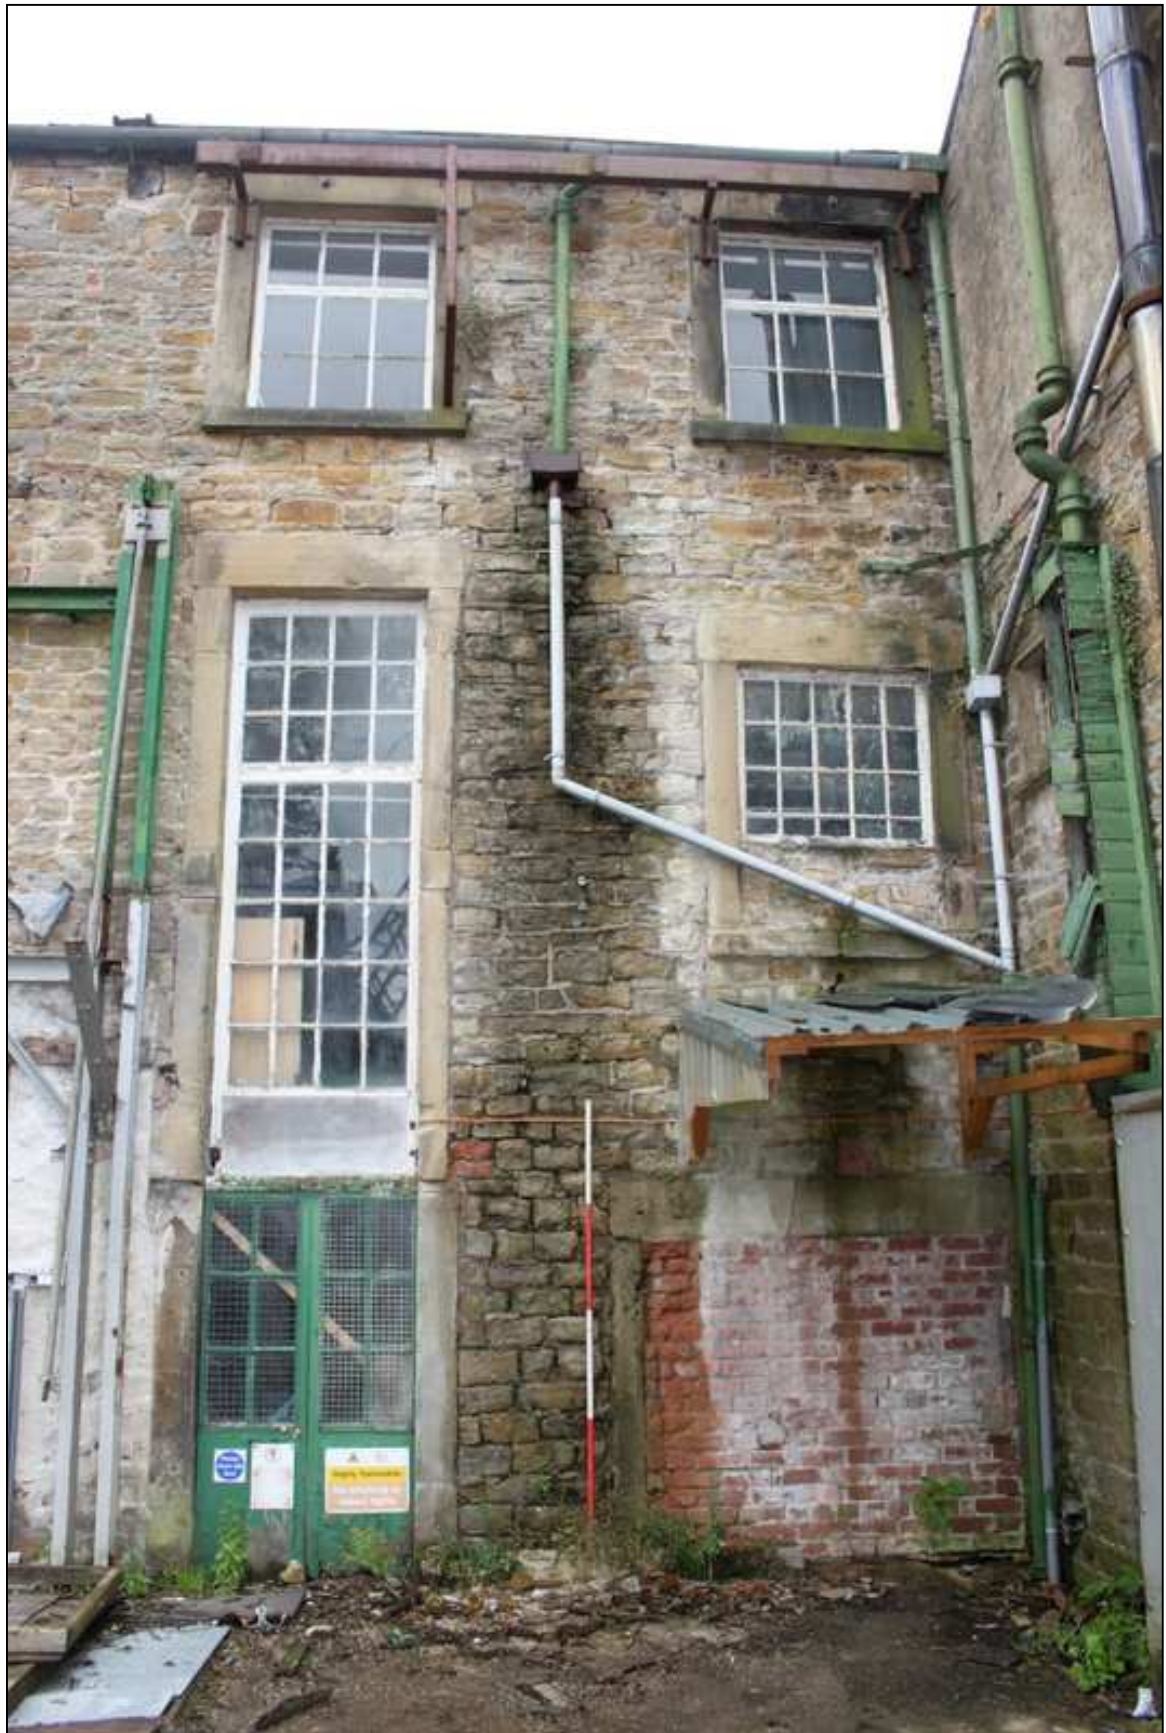
- 3.2.4 The eastern bay of the main façade houses the present waterwheel, and has similar windows to those elsewhere, at first- and second-floor level, that on the first floor having been reduced in height subsequently (Plate 8). It has a wider dressed doorway at ground-floor level, which afforded access directly to the waterwheel, presumably to allow maintenance of the buckets. This doorway was blocked with brick subsequently (Plate 8).

Plate 8: Façade of engine and wheel houses

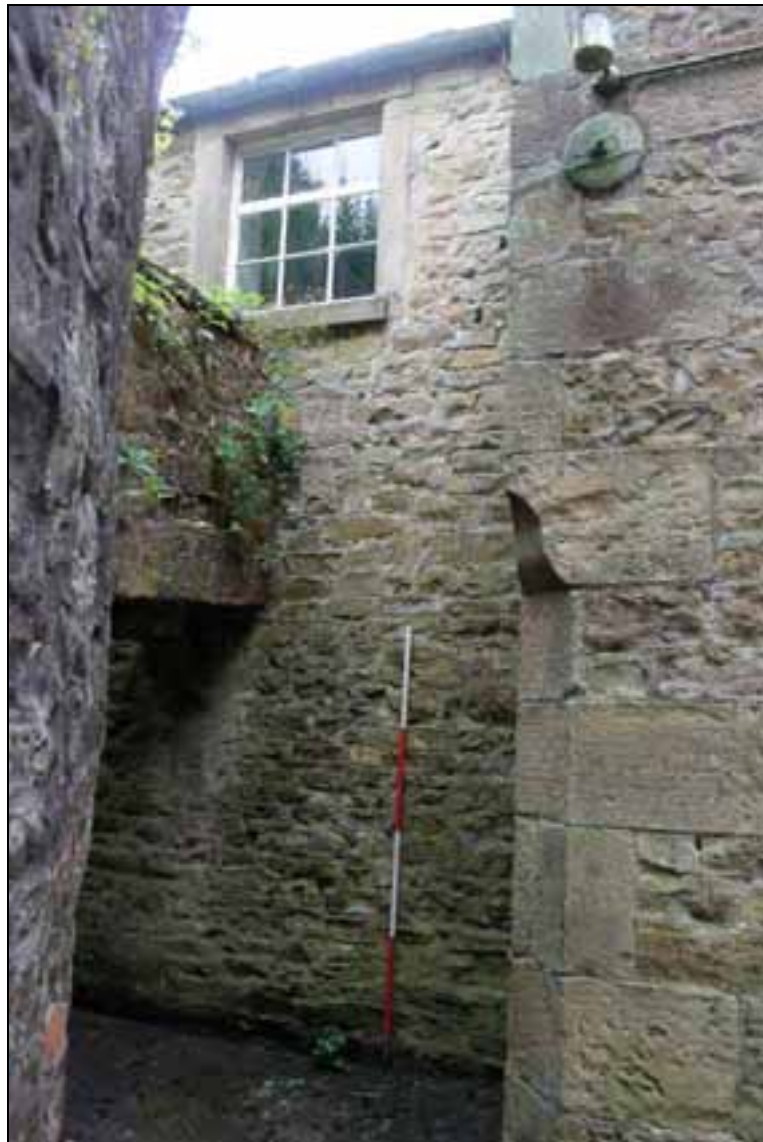
3.2.5 The earliest surviving element of the rear (northern) wall of the mill is in the position of the engine and wheel houses. This wall is of similar sandstone rubble, roughly-coursed construction, with windows at second-floor level, similar to those of the southern façade (Plate 9). At first-floor level, the headrace for the waterwheel entered the eastern bay, and comprised coursed sandstone side walls above a concrete base, with steel stirrups above a sandstone sill in the wall face (Plate 10). This was flanked by similar rubble walls, each with a large sandstone block base (Plates 9 and 11), both presumably representing earlier side walls of the head race. That to the west provides further evidence that the original waterwheel was placed in the western of the two bays, as it would have positioned the headrace into that bay. The documentary evidence suggests that the original waterwheel of the cotton mill was placed externally, and that the area was only enclosed when the wheel was replaced by a wheel in the position of that now present. However, internal evidence (*Section 3.3.29, below*) strongly suggests that the north wall of this structure was repositioned, by a distance of approximately only 4' (1.21m) to the north, almost certainly undertaken to incorporate a larger waterwheel (possibly the extant waterwheel).

Plate 9: North wall of wheel house and chamfered return of main mill

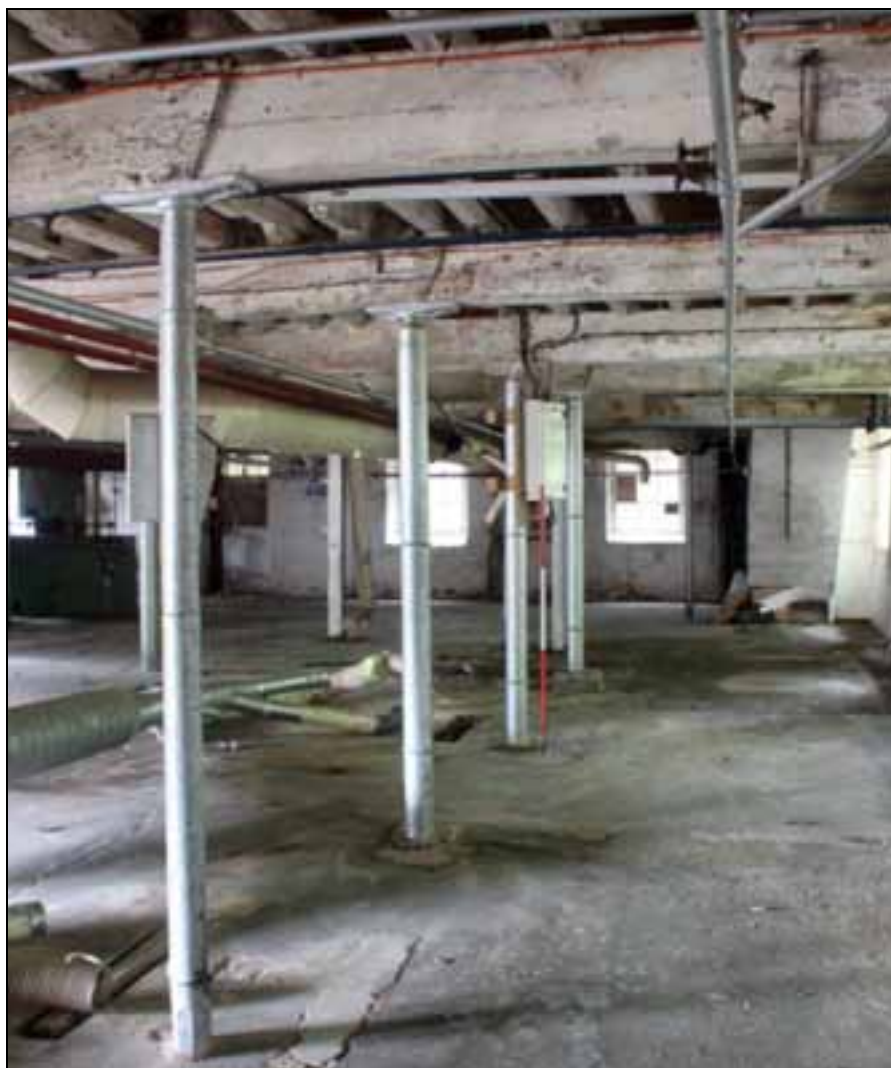
*Plate 28: Inserted columns on the ground floor*

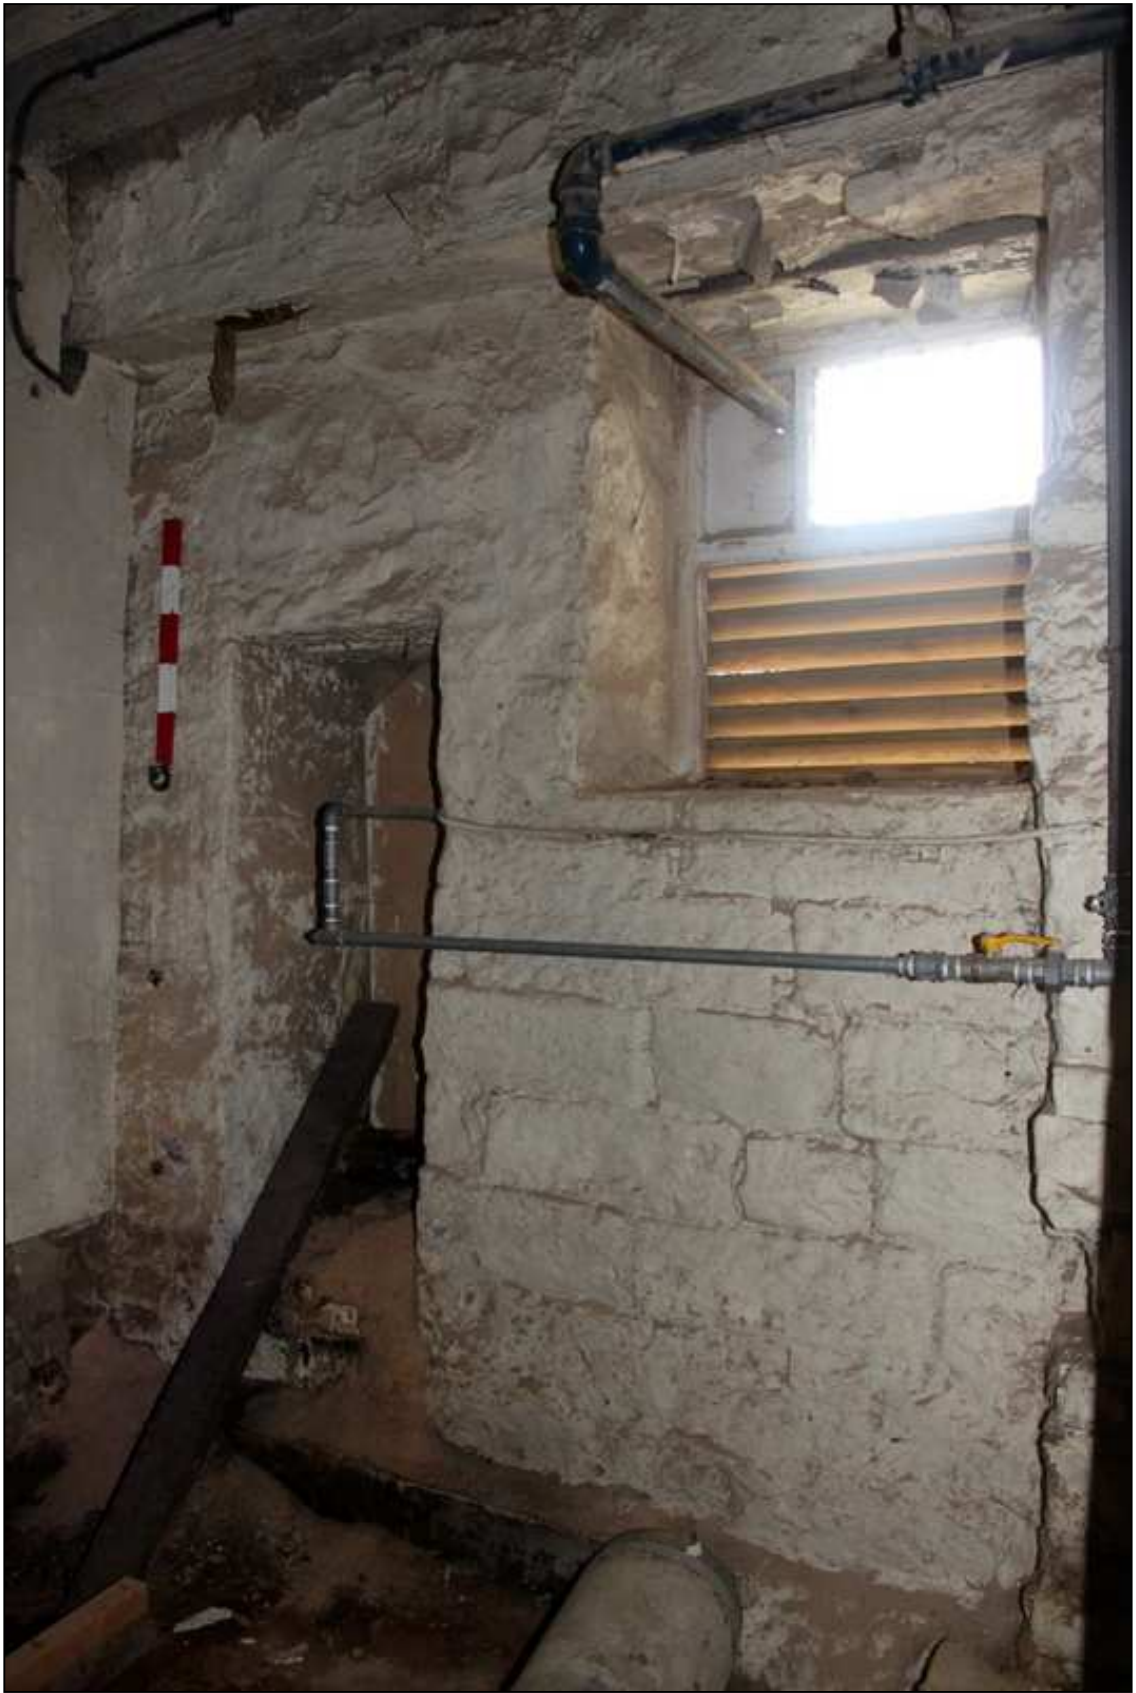
3.3.16 In the eastern bay of the ground floor of the original structure, a partitioned area latterly housed a large machine linked to the main dust extraction unit. The window aperture appears remodelled to the full width of the bay on its eastern side, with a timber lintel above a stone wall infilling, recessed 6" behind the original wall face. This housed a 31" wide, 3' high casement adjacent to a 19 x 53" vertical aperture, externally stone blocked and with a projecting internal sill (Plate 44). This is similar in style to a rope drive bearing aperture, but possibly housed the drive to an external pit saw.

Plate 44: Blocked aperture in the south wall of the engine house, with possible bearing box on the left

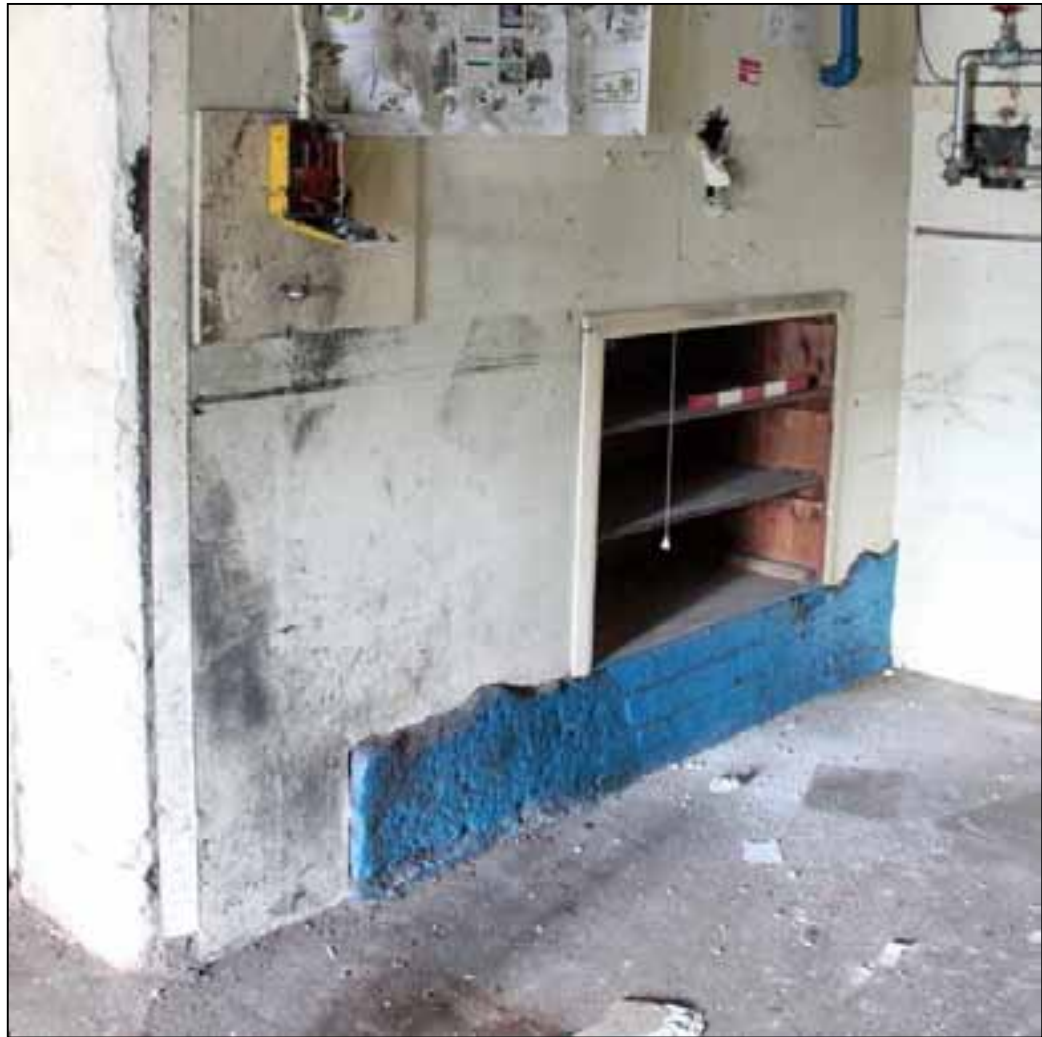
3.3.17 The floor of the adjacent 8' 4" wide bay is 2' higher. This bay has a transverse stone wall, placed on the probable alignment of the original north wall, and which has an 8' southerly return on its western side (Fig 2). At its base, the return has a 7' sandstone block with a central 30" wide rebate, infilled with brick (Plate 45). A cupboard above infills an original aperture through the wall, blocked by a board on the western face. This relates to an axle and drive shaft, but it remains unclear whether this was associated with an earlier waterwheel than that present in the bay to the east, or a later engine, which was almost certainly placed in this bay.

*Plate 45: Pad for axle mounting, with curved rebate infilled with brick*

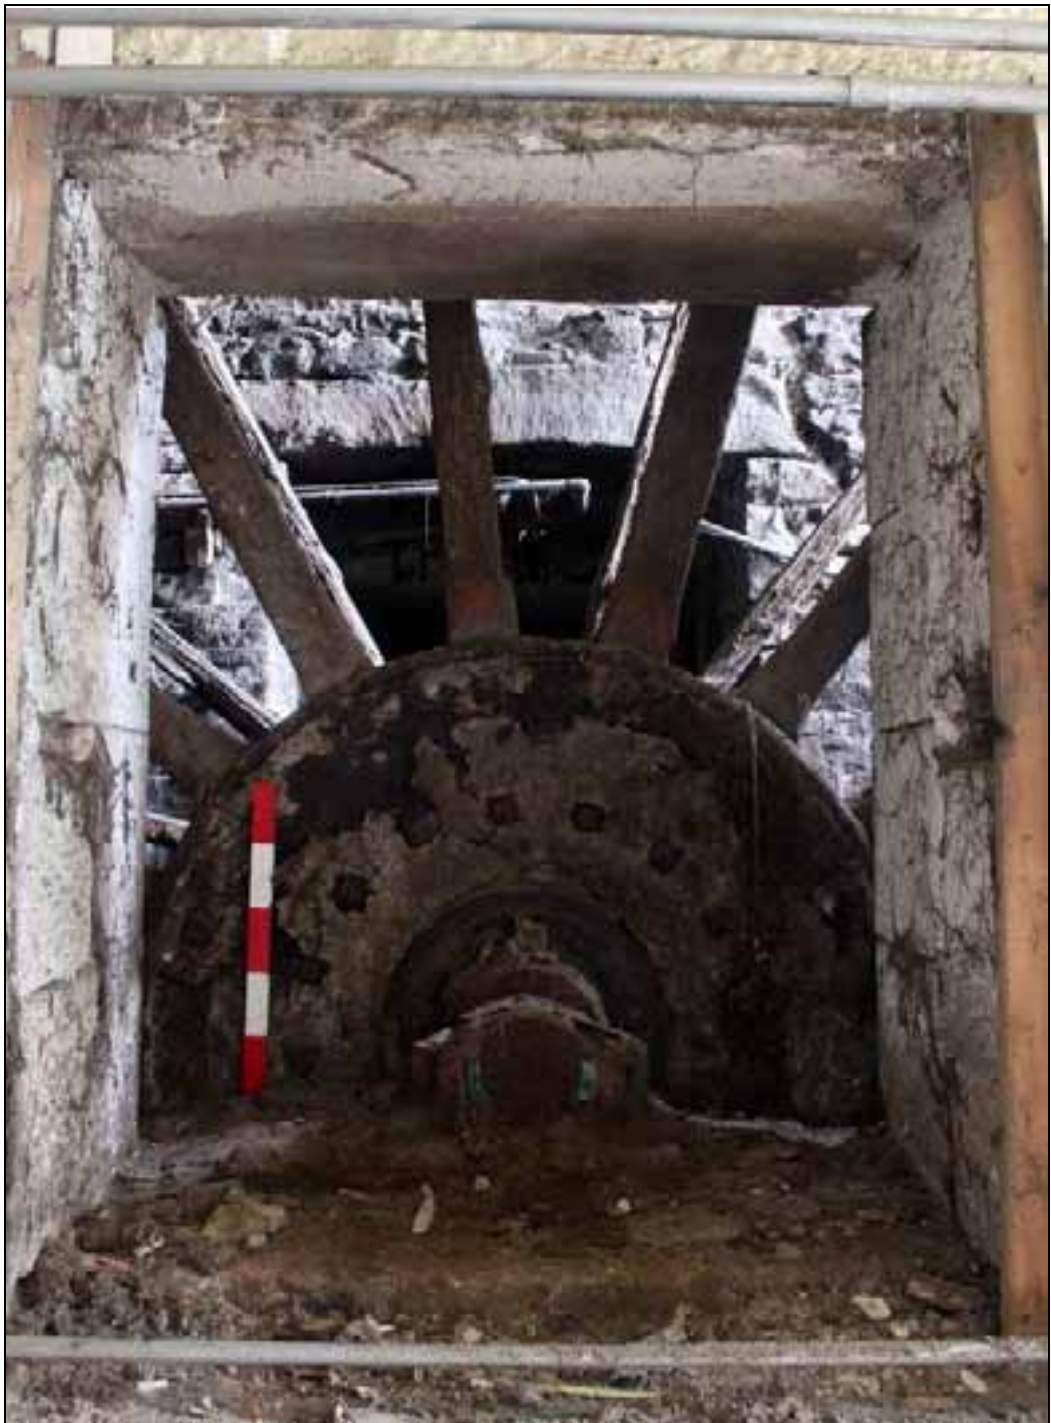
3.3.18 The east wall has a brick-blocked doorway at its southern end, adjacent to a full-height doorway in the south wall, which appears original. The west wall has a corbel at its northern end, placed below beam height in the main structure to the west, but significantly below the rebuilt ceiling within this bay. A 3' 6" x 4' 6" aperture to the south houses the axle of the extant waterwheel, and is of dressed block construction (Plate 46). The 5¼" diameter iron axle has a phosphorus bronze lining to its mounting, the top plate of which has been removed (Plate 46).

*Plate 46: Waterwheel axle*

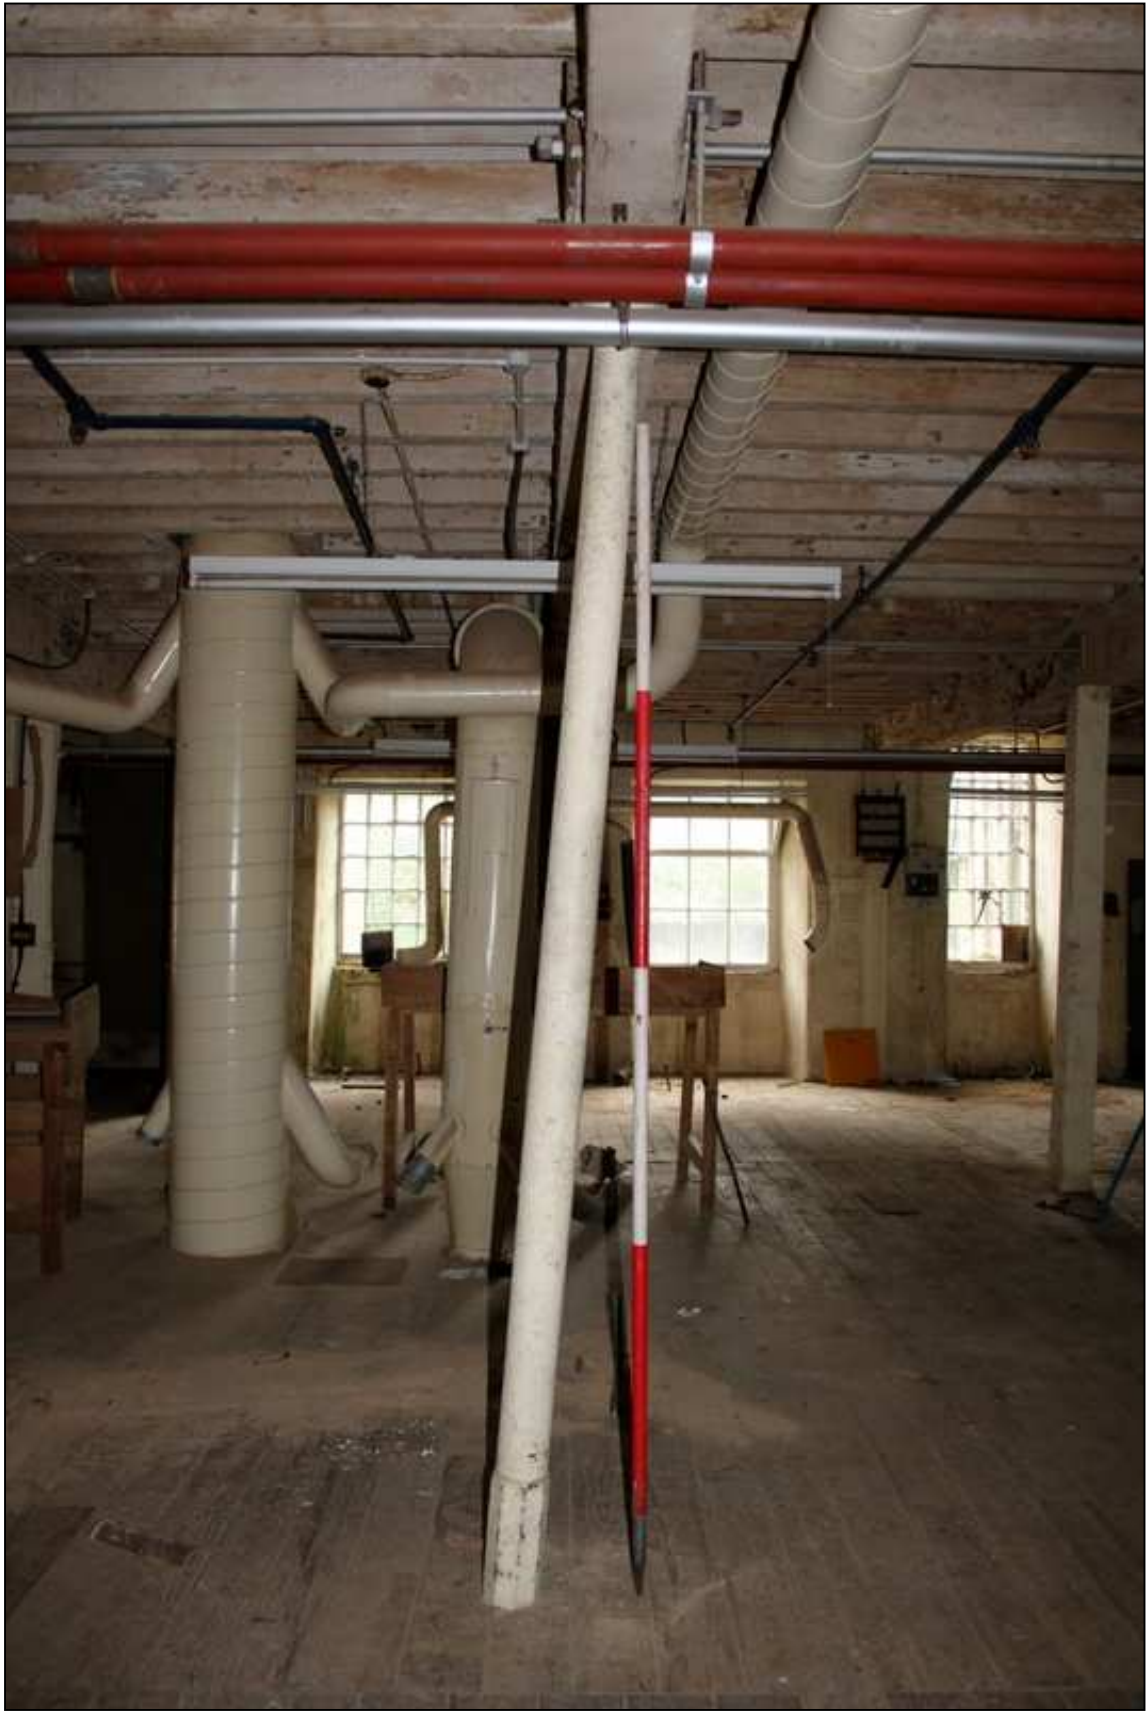
*Plate 54: Deflection of first-floor column*

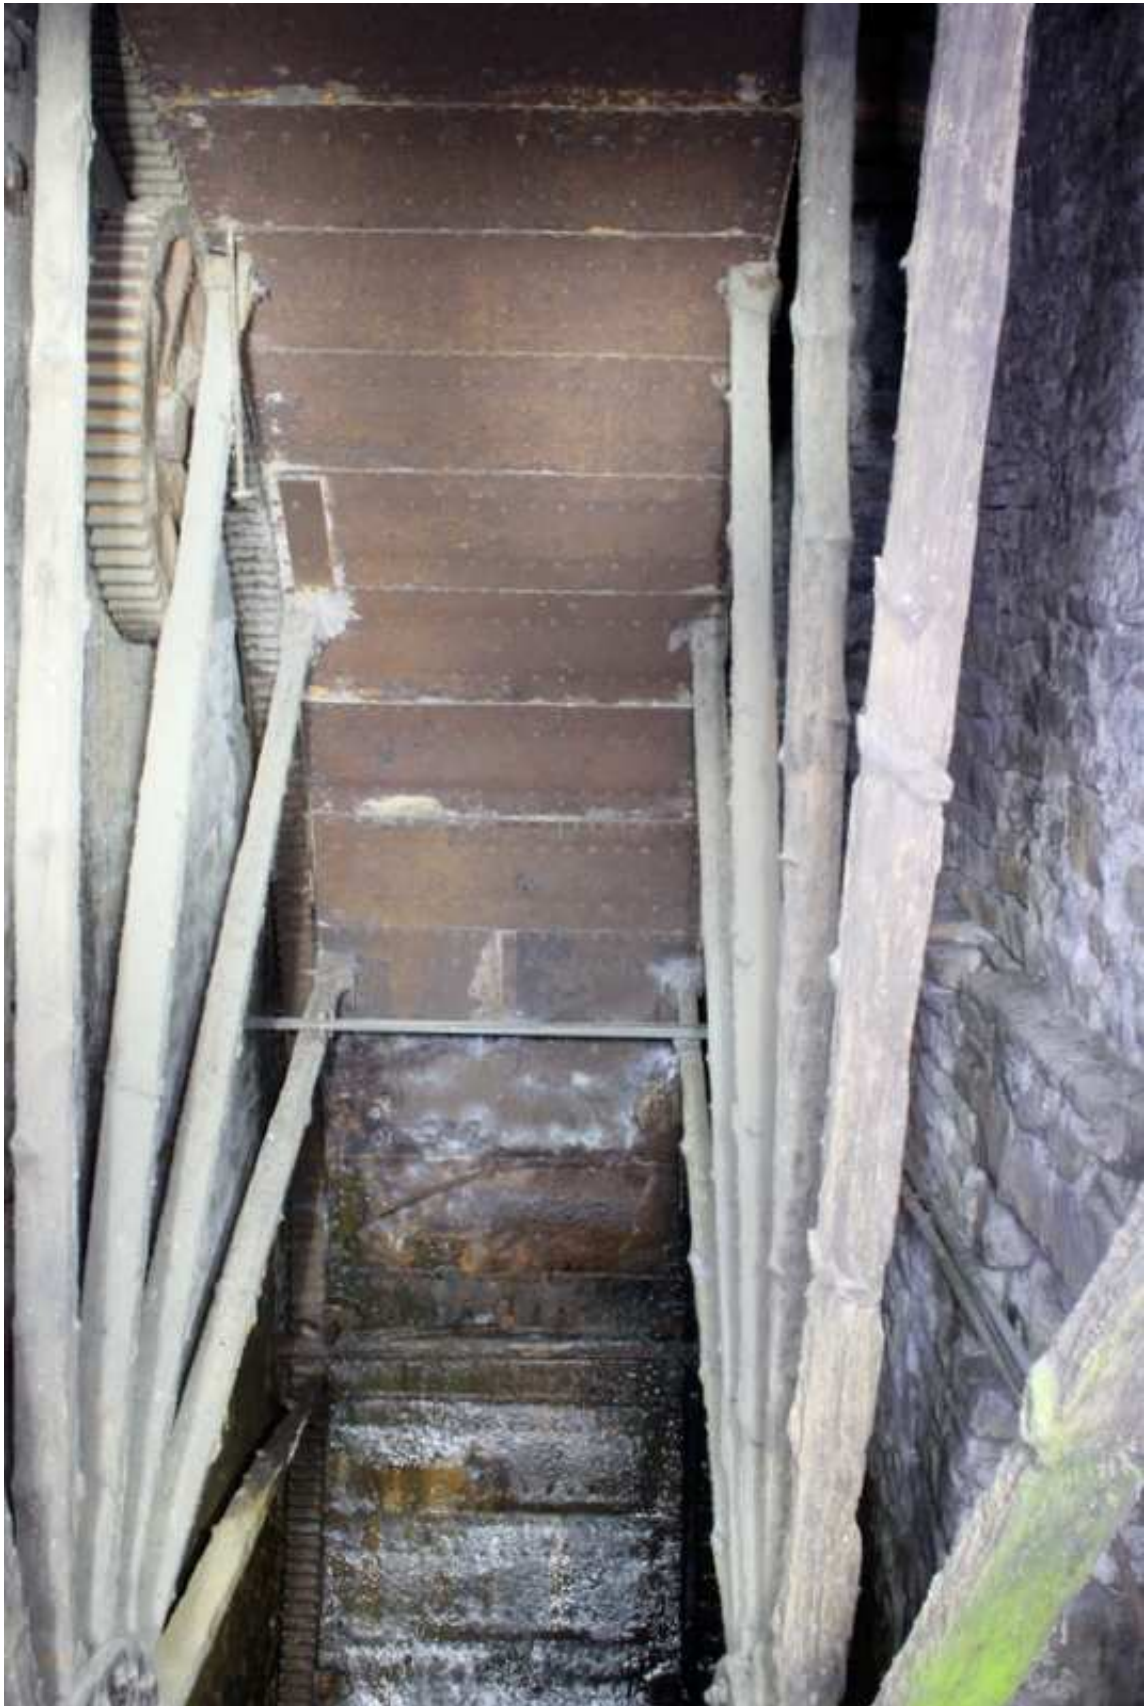
- 3.3.32 The current waterwheel is the full height of the ground and first floors, and almost the full 7' width of the bay in which it is housed (Plates 69 and 70). This represents an extension to the original mill, with this waterwheel probably being erected whilst an original waterwheel continued to function in the adjacent bay to the west. The high breast-shot wheel has cast-iron rims housing metal sheet elbow-buckets (Plate 71), supported by slender timber spokes socketed into a small diameter cast-iron hub (Plates 69 and 70).

*Plate 69: Extant waterwheel with slender timber spokes*

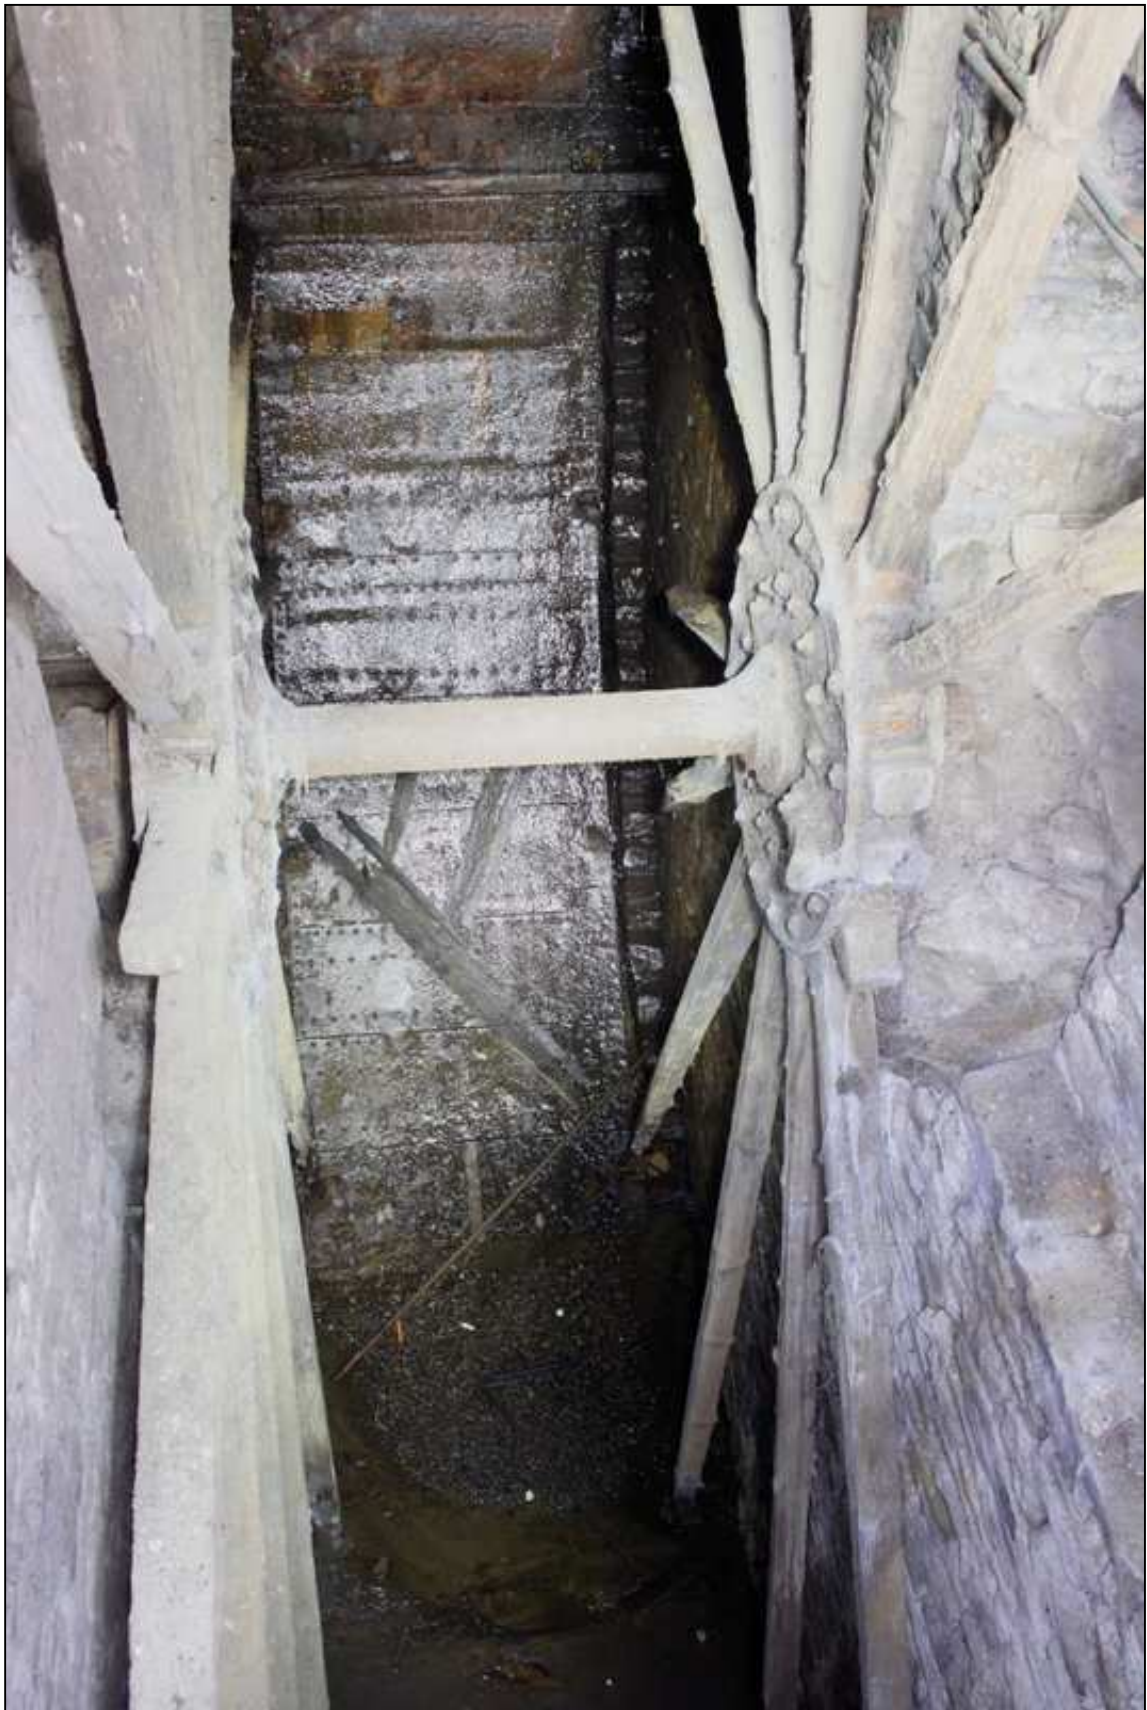
*Plate 70: Axle and eastern bearing of waterwheel*

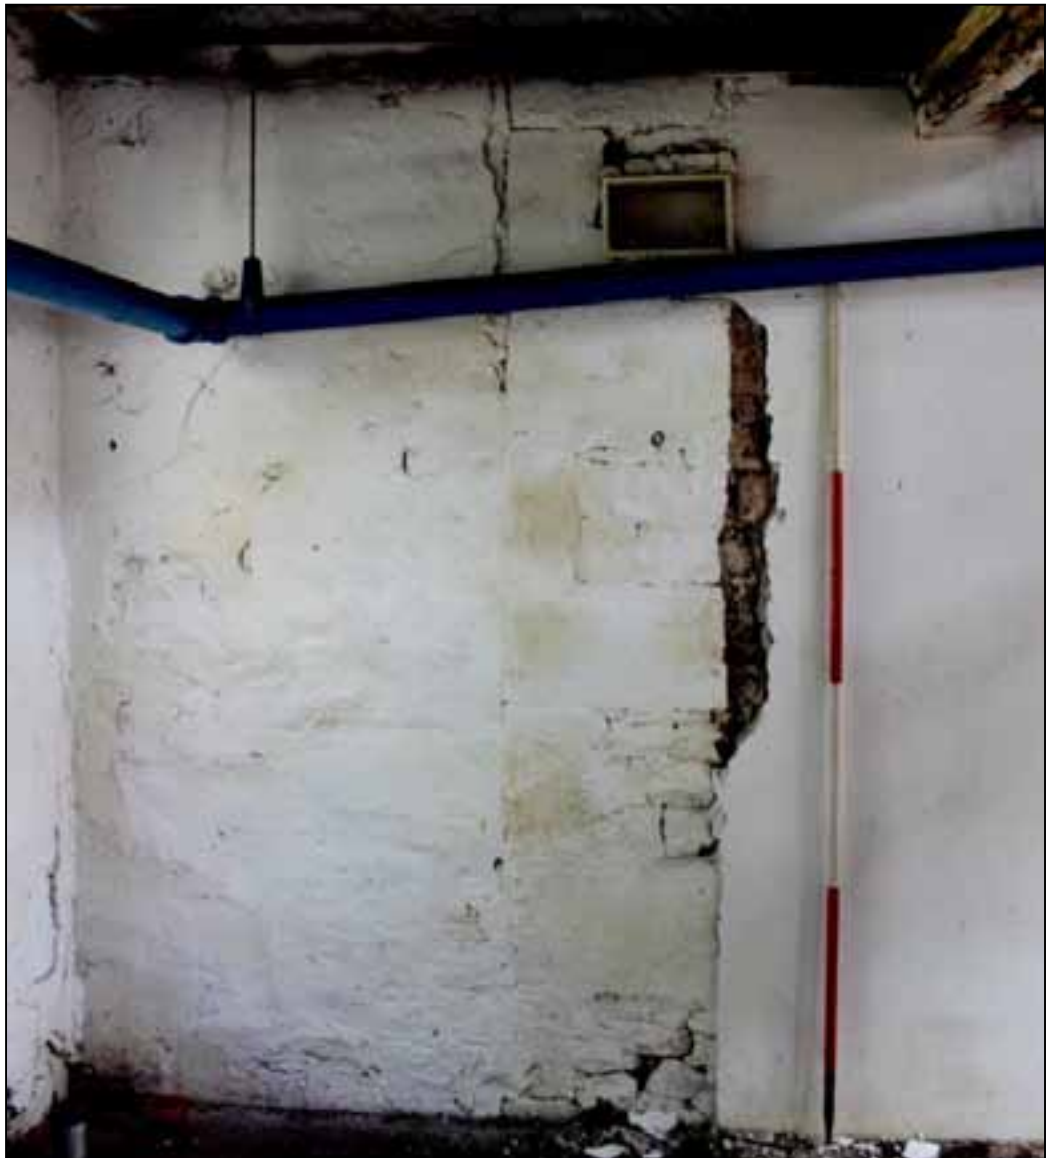
3.3.39 In the north-east corner of the original main body of the mill, a butt joint between two phases of construction was clearly visible (Plate 81). This has dressed sandstone blocks on the southern side, demonstrating that this originally represented an original southward return of the wall, and therefore that the waterwheel house was extended beyond the mill, prior to the repositioning of the north wall of the spinning block. An end-bearing box, placed immediately below ceiling height within the dressed blocks of the wall return (Plate 81), represents a late insertion, and demonstrates that a line shaft was placed within this position following the extension of the mill, matching those on the floors below. Evidence for a further line shaft, placed immediately north of centre within the original structure was observed as on the floors below, with bolt-hole pairs, and cut-outs in each tie beam (Plate 77), with additional drum scars on the eastern face of several timbers (Plate 77). Similar bolt pairs for a line shaft on the opposite side of the timber props to the tie beam were also observed, and were similar to those on the floors below.

*Plate 81: Quoins of wheel house in east wall of main mill*

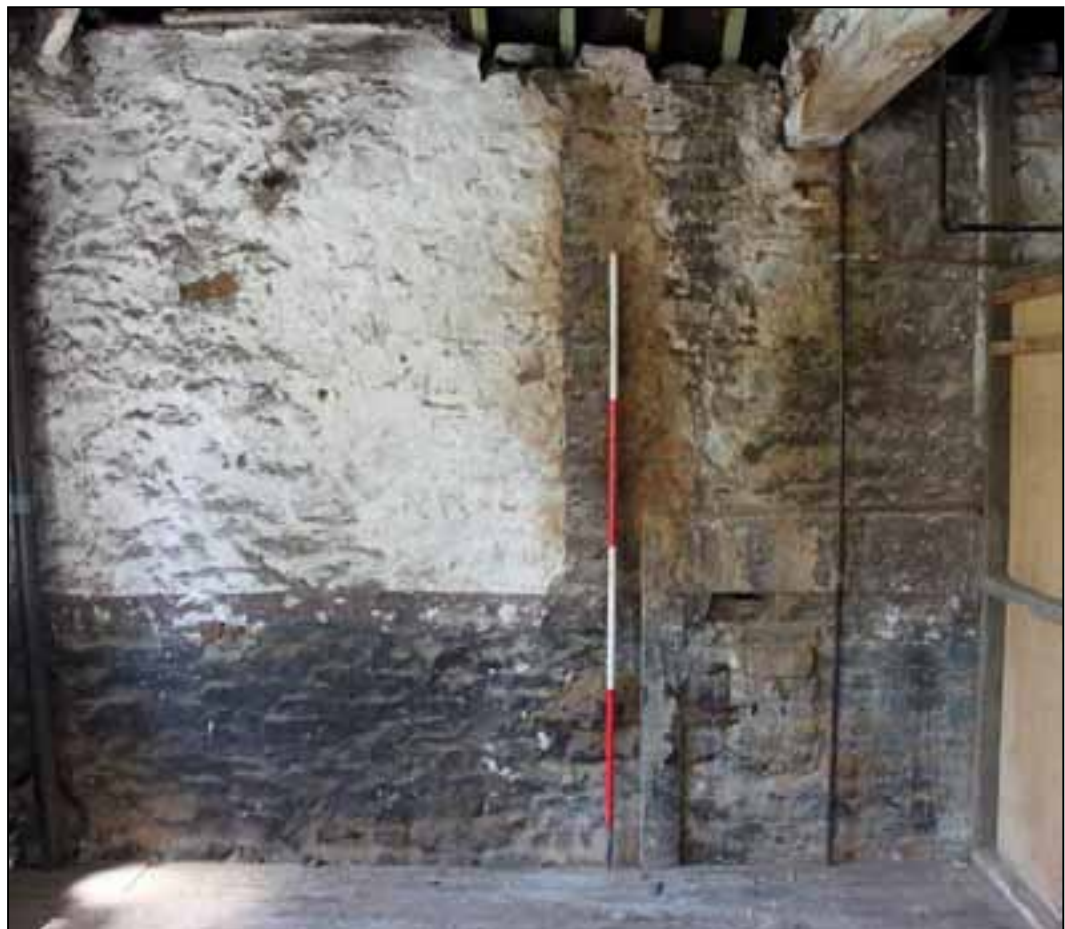
- 3.3.41 Within the western extension of the mill, a blocked aperture in the north wall had dressed stone jambs and lintel, and appeared to have formed a fireplace (Plate 82). This may have formed a small office in the original construction of the west wing, where it extended beyond the main mill at that time. It was presumably blocked when the earlier structure was extended, with the whole of the western extension forming part of the enlarged spinning floor.

*Plate 82: Jamb and lintel of fireplace in north wall of west wing*

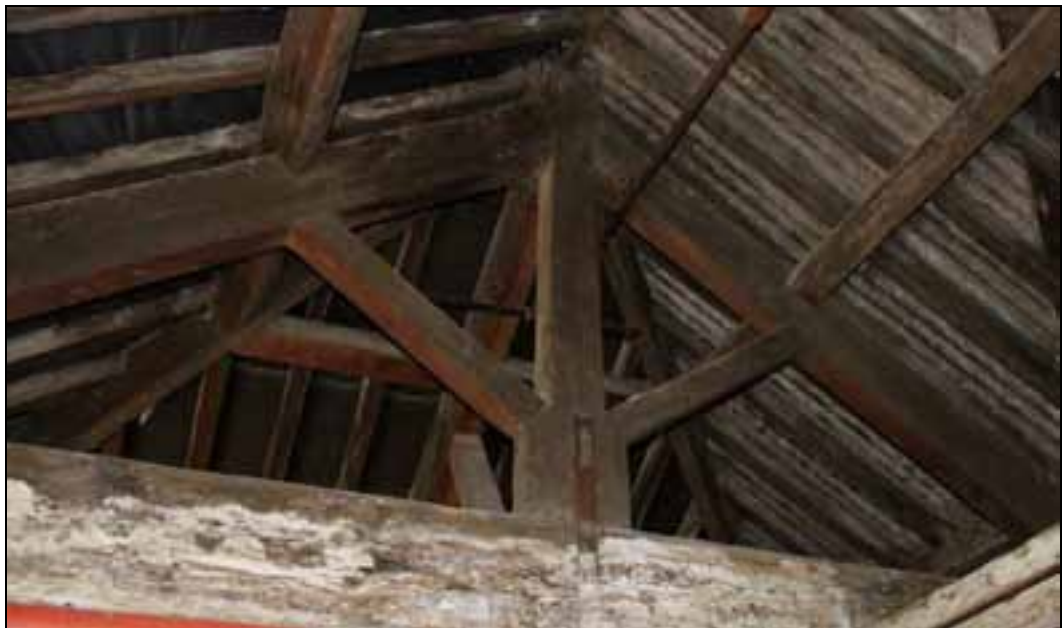
- 3.3.43 The western extension of the mill has a perpendicular roof formed of braced king post trusses, with the king post stirruped to the tie beam with an iron strap (Plate 85). Despite the obstruction caused by the king posts, longitudinal trimmers between the tie beams have double-tenon mortices in their faces for floor joists (Plate 86), indicating that the roof space was utilised.

*Plate 85: King post truss above west wing*

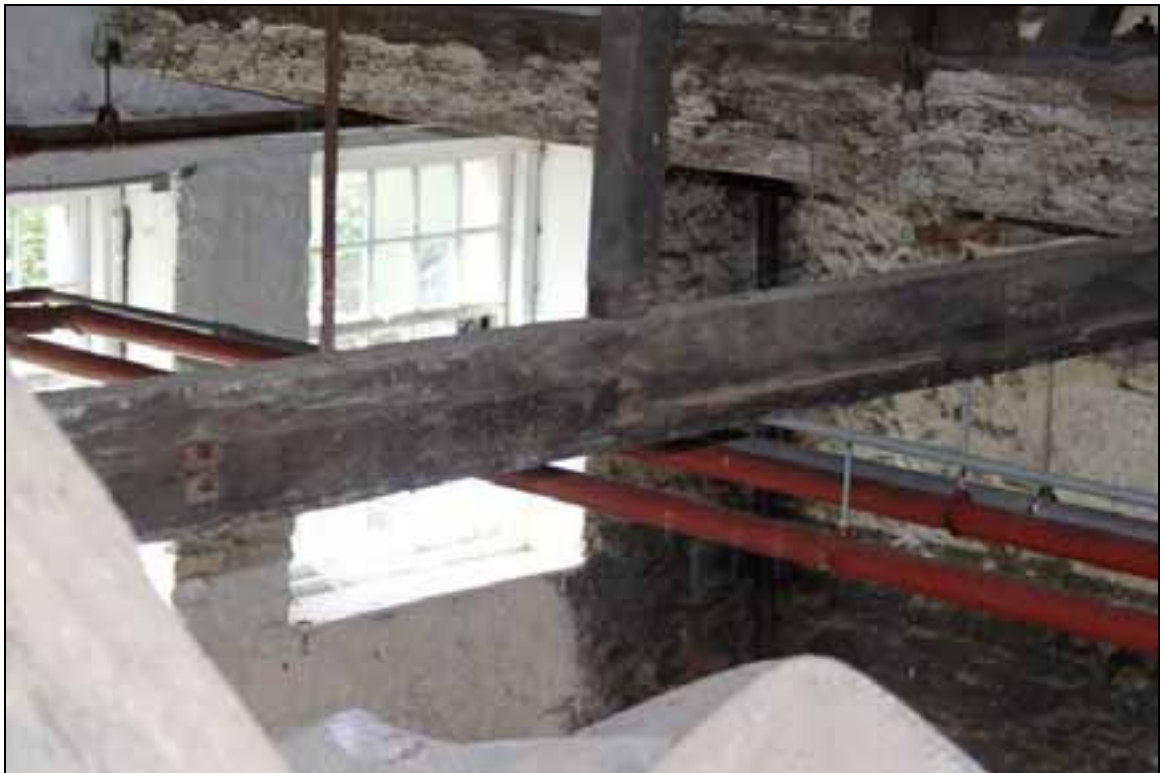
*Plate 86: Mortices for ceiling joists above west wing*

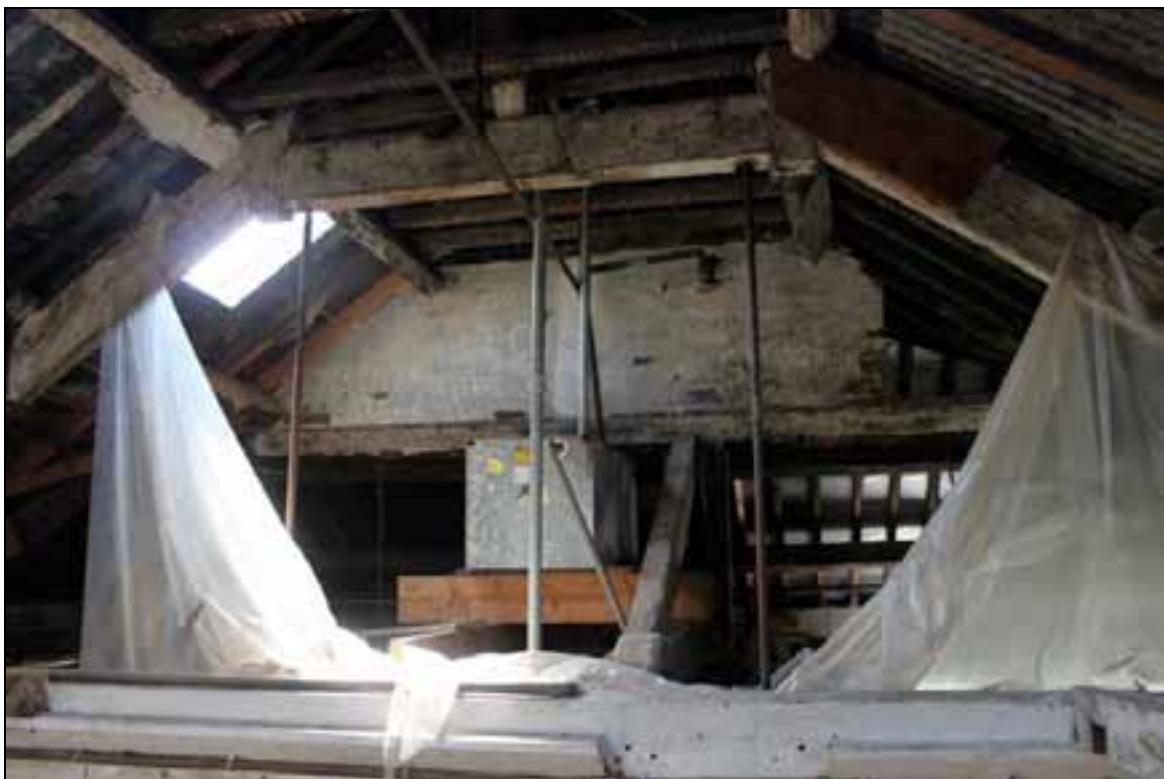
- 3.3.44 The western end of the roof was presumably originally hipped, and thus a new truss needed to be installed to carry the ridge from the original roof to that of the perpendicular extension, in order to avoid a valley between the two roofs. The truss installed was of queen post type, with two vertical members having a jowled head (Plate 87), carrying the shorter principal rafters, a straining beam placed between the two posts, and the weight of the upper purlin, which was housed in a notch within the head (Plate 88). These queen posts were also cut subsequently, and replaced with a pair of iron rods, placed immediately on their inside (Plate 87).

- 3.3.45 A lath and plaster wall was also inserted into the roof space between the two roofs (Plate 87). The purlins of the new west roof were trenched, through purlins, rather than being butt-ended, as in the earlier roof, and were longitudinally jointed with simple splayed scarf joints (Plate 89).

*Plate 87: Lath and plaster partition between roofs of main mill and west wing, and queen post truss with replacement iron rods*

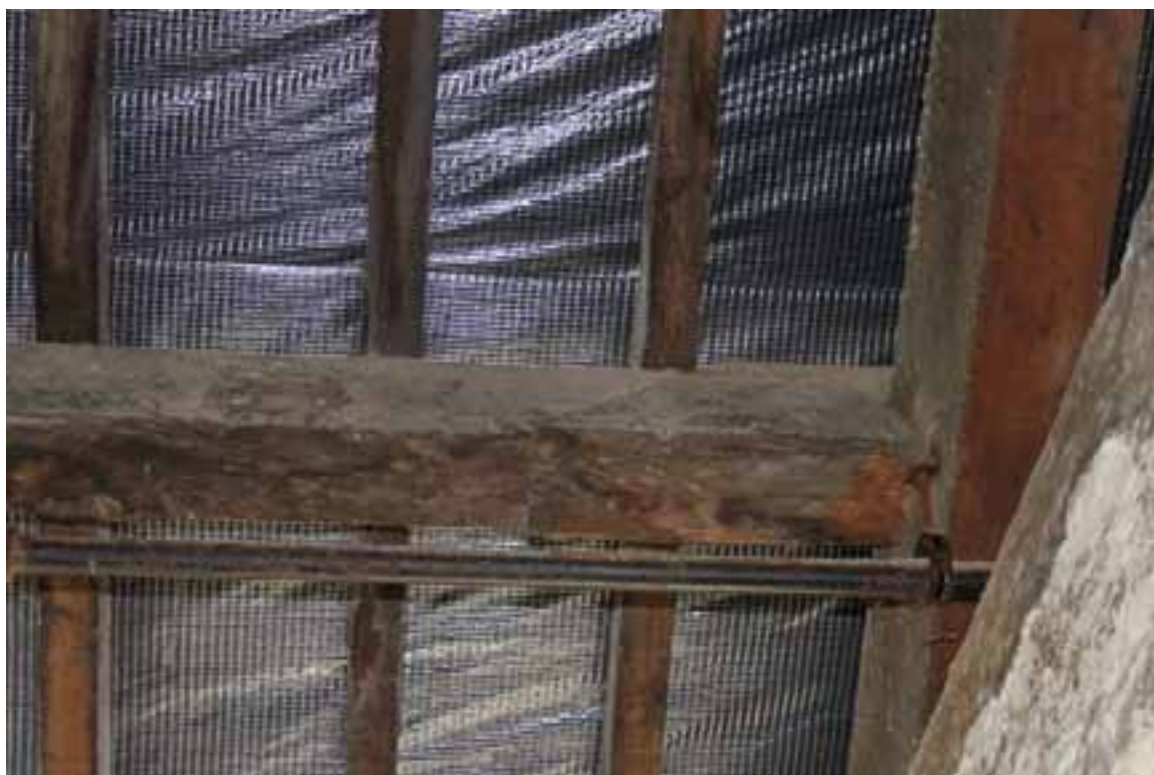
*Plate 89: Scarf joint in purlin of west wing*
